1. Report No. RC-1605	2. Government Accession No.	3. MDOT Project Manager	
4. Title and Subtitle Twenty Year Performance Review of Michigan's European Concrete Pavement		5. Report Date October 7, 2013

**Twenty Year Performance Review of Michigan's European
Concrete Pavement**

John F. Staton

**Construction Field Services Division
Research Report**

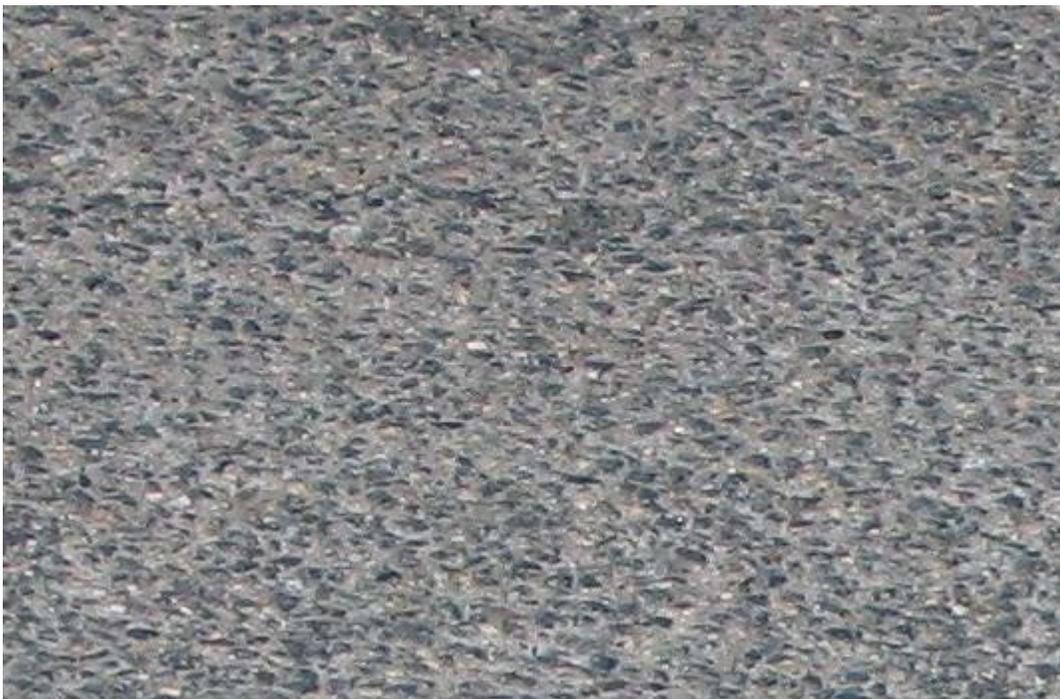
FIGURE 3. Exposed Aggregate Surface

The pavement surface has an exposed aggregate texture that is intended to reduce tire interaction noise and improve frictional characteristics. The construction process followed a patented procedure (International Patent No. 0086188) that was developed by Robuco Ltd, of Belgium. Briefly, the freshly placed concrete was sprayed with a set retarder and then covered with two-mil plastic sheeting. The sheeting was removed the next day (after 20 hrs.) and the surface was brushed to expose the coarse aggregate. An average texture depth of about 1.0 mm was achieved, which was less than the intended target value of 1.1 to 1.5mm. Figure 3 shows a typical photo example of the present texture condition. To date, there has been minimal loss of exposed stone.
