INVESTIGATION OF TRAFFIC-INDUCED  
VIBRATIONS AT 3018 WOODRUFF ST., LANSING

Research Laboratory Section  
Testing and Research Division  
Research Project 74 TI-257  
Research Report No. R-955

Michigan State Highway Commission  
E. V. Erickson, Chairman; Charles H. Hewitt,  
Vice-Chairman, Carl V. Pellonpaa, Peter B. Fletcher  
John P. Woodford, Director  
Lansing, January 1975

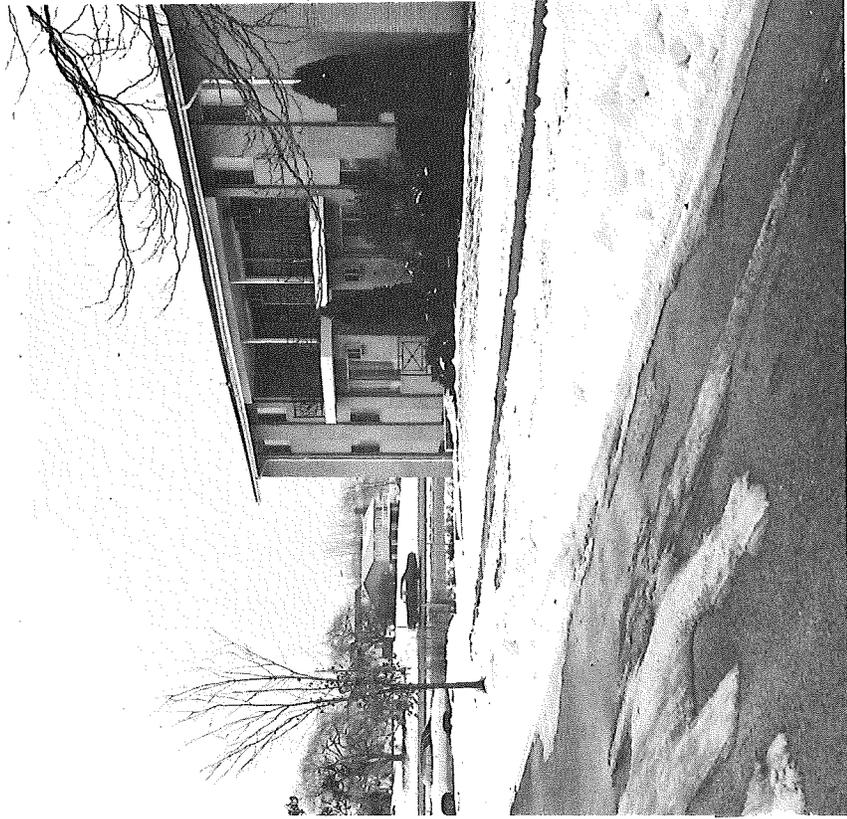
The apartment building at 3018 Woodruff is the only building in the complex which the owners report to have structural damage, and also is the closest to US 127 (Fig. 1). The building contains individual apartments, and is a brick veneer, two-story structure with a full basement. It is approximately eight years old.

▲ Figure 1. Building at 3018 Woodruff St, Lansing, Michigan.
