# Incident History

**Michigan Public Service Commission**

**2016** Pipeline  
Safety  
September 26-28 **Conference**

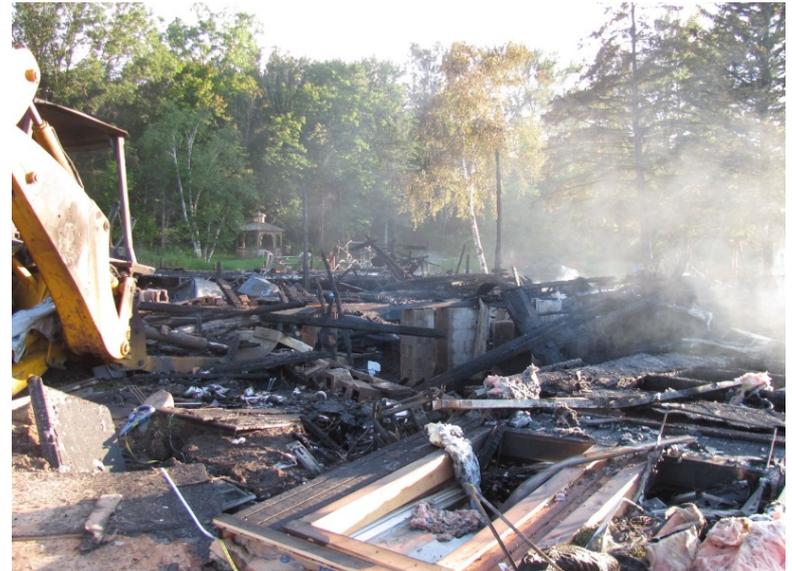
- Explosion at residence.
- Third party damage – Homeowner excavating with backhoe snagged gas service.
- Heat fusion joint at a 1” to ½” service line reducer failed and separated.
- Homeowner called the operator to report the damage.
- Operator employee was onsite investigating the leak when the explosion occurred.
- 2 fatalities and 1 injury.
- Homeowner called MISS DIG. Staking accurate. No evidence of hand exposure.
- \$361,435 damages.

- Notice of Amendment:
- 192.603(c) The Administrator or the State Agency may...require the operator to amend its plans and procedures as necessary to provide a reasonable level of safety.
- Operator shall amend their procedures to require their first responders to understand what type of work order they are investigating (inside or outside gas leak).
- Operator shall amend their procedures to require their first responders to immediately conduct inside leak investigations when responding to any gas leak where the caller indicated gas odor inside a building, including third-party damages that may include a broken main or service.

- Recommendations:
- Recommend that operator evaluate the need for first responders to carry squeeze-off tools with a capacity larger than  $\frac{5}{8}$  inch.
- Recommend that operator accurately document perceptibility tests on the work order for tests related to incidents.
- Recommend that operator utilize a form/drawing to document leak investigations in response to a fire or explosion. Form/drawing should include enough details to clearly identify the scope and findings of the leak investigation.
- Recommend that operator's leak test of service lines involved in an incident are completed at operating pressure.

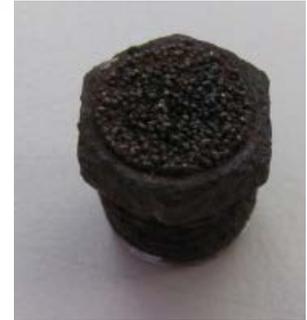
- Leaking shaft seal on Biffi pilot assembly at regulator station caused a blowdown valve to open at a compressor station.
- Vent above shaft seal was plugged with ice after severe ice storm, preventing the gas leaking through the shaft seal from venting.
- This caused an increase in pressure above the seal, simulating a drop in pressure below the seal.
- Signaled blowdown valve to open.

- Recommendations:
- Recommend that operator orient the newly installed pilots in a manner to reduce or eliminate the potential for ice and debris to accumulate on the pilot body vent.
- Recommend that operator develop a reoccurring preventative maintenance work order that meets or exceeds the manufacturer's recommendations for maintenance and testing of all newly installed pilots.
- Recommend that operator ensure that employees are knowledgeable with the operation, maintenance, and testing requirements associated with the newly installed pilots.
- Recommend that operator conduct a system-wide study to identify pilot assemblies that may have issues with vent orientation and internal seals and take any necessary remedial action.

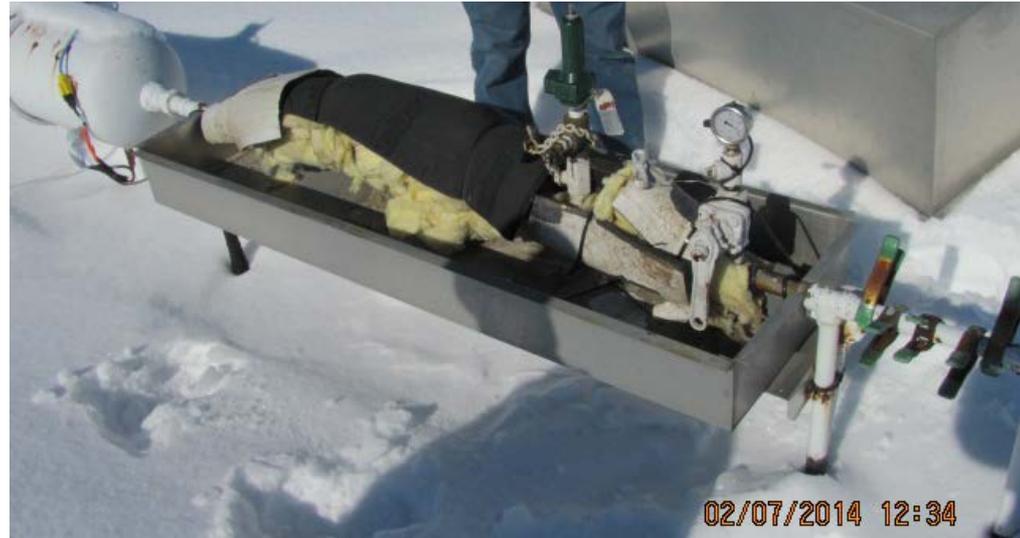
- ESD of Compressor Station
- No permanent heat-trace on pilot gas regulator.
- Pilot gas system over-pressured due to frozen regulator.
- Relief activated and then froze open as well.
- Pilot gas pressure bled down to zero psig which triggered the ESD.

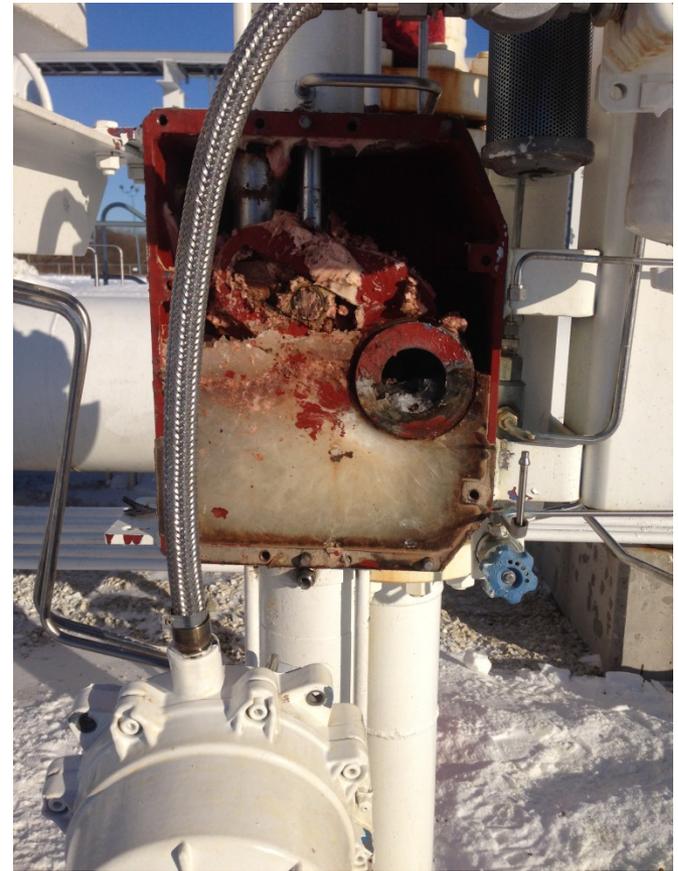
- One of two compressor blowdowns activated and vented to atmosphere.
- The other compressor blowdown valve had a frozen pneumatic pilot switch which prevented the blowdown valve from operating.
- The two station blowdown valves activated, but were unable to operate due to the presence of ice in the actuator gear boxes.

- Compliance Action:
- 192.199(e) - Not having pressure relief devices discharge into the atmosphere without undue hazard. Pressure relief devices for the pilot gas system vented into enclosure boxes for the pilot gas regulator assemblies.
- Recommendations:
- Recommend operator implement a program to check for liquids in the gas piping upstream of the pilot gas systems at compressor stations.
- Recommend operator inspect heat trace wires at other stations to determine if similar pilot gas systems are properly hard-wired.
- Recommend all valves that have an actuator enclosure should be inspected for water throughout operator's system.

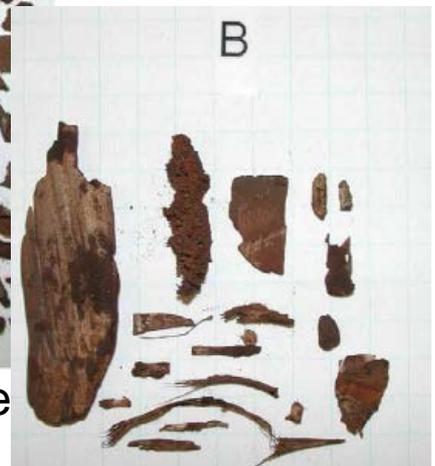
Weld splatter and twisted wire

- Debris moving through distribution system caused double regulator failure.
- Working-monitor regulator station.
- Caused 139 psig pressure on a 60 psig system.
- 120 miles of distribution main and 7,010 gas services overpressured.

- Recommendations:
- Recommend operator conduct a study to determine:
  - The need to install filters upstream of regulator stations where regulator boot wear from debris is periodically observed.
  - The need for additional safety measures to enable earlier detection of overpressure situations and mitigate the possible consequences.
  - The need for weekly regulator station pressure-recording chart inspections and replacements on stations that do not have relief valves or SCADA transducers located after each pressure cut.

- Recommendations:
- Recommend operator perform a probable cause analysis when regulators/relief valves malfunction or fail and results in an overpressure situation.
- Recommend operator take measures to ensure that GMAW welding is conducted in a manner such that pieces of wire are not introduced into the gas stream.
- Recommend operator review construction practices related to sealing pipe ends prior to being tied together.
- Recommend operator review construction practices regarding pipeline cleaning prior to being entered into service.
- Recommend operator utilize appropriate length pressure-recording charts for regulator stations.

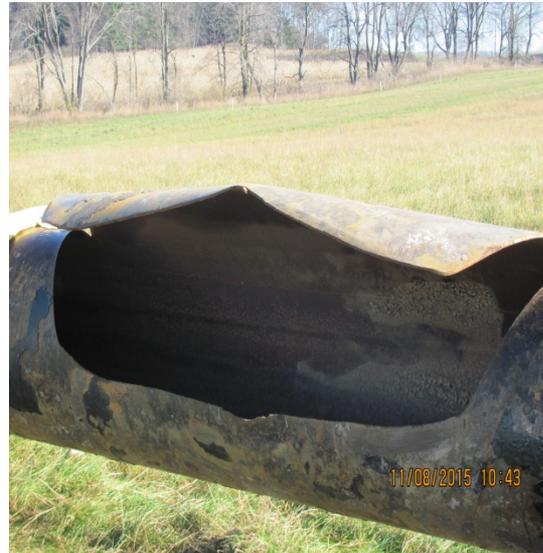
#1

Hydrostatic testing of ~22.3 miles of pipe

- 2 test sections.
- 1 hour spike and 7 hour leak.

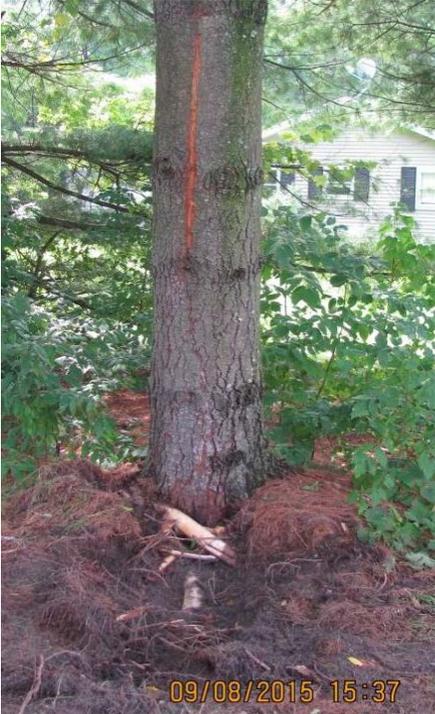
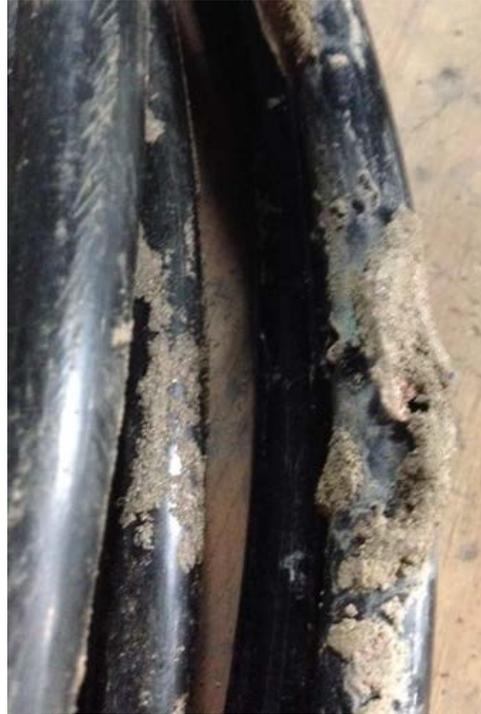
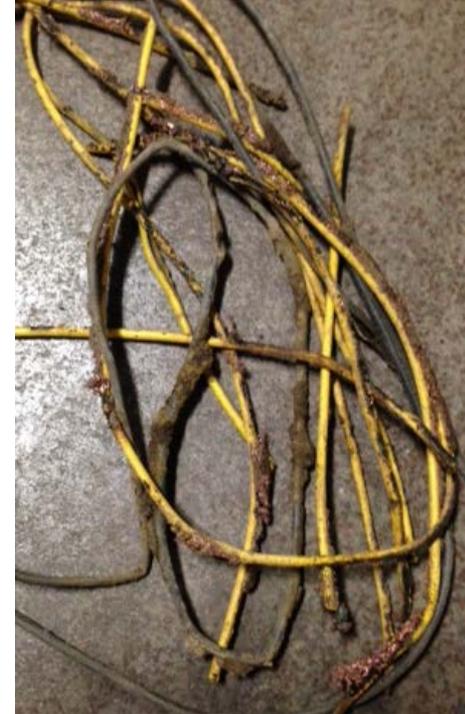
- Lighting strike causes damage to gas service line.
- Resident reported an outside gas leak.
- Service Worker detects 100% gas under roadway prior to explosion.
- Distribution crew arrives to excavate service line tee.
- Explosion occurs.
- No injuries.
- Positive gas reads detected above the gas main and extending through the front yard following explosion.
- \$102,840 damages.

- 192.603(b) – Not keeping records to administer the procedures established under 192.605. Records were not adequate to demonstrate the scope and extent of the leak investigation before and after the explosion.
- 192.605(a) – 4 counts of not following the operator’s leak investigation procedures before and after the explosion. Specifically regarding bar testing over the pipelines, mains, and services in the area. \$40,000 fine.

- Recommend Service Workers notify their appropriate Field Leader that a leak survey is needed if they identify evidence of a lightning strike.
