Phase 100 – Phase 1 and Phase 2
Exterior Structural Conditions and Cost Assessment

Belle Isle Boathouse Detroit, Michigan

File No. 751/22346.SMD
WTA Project No. 2022039
September 29, 2022

Phase I Structural Report

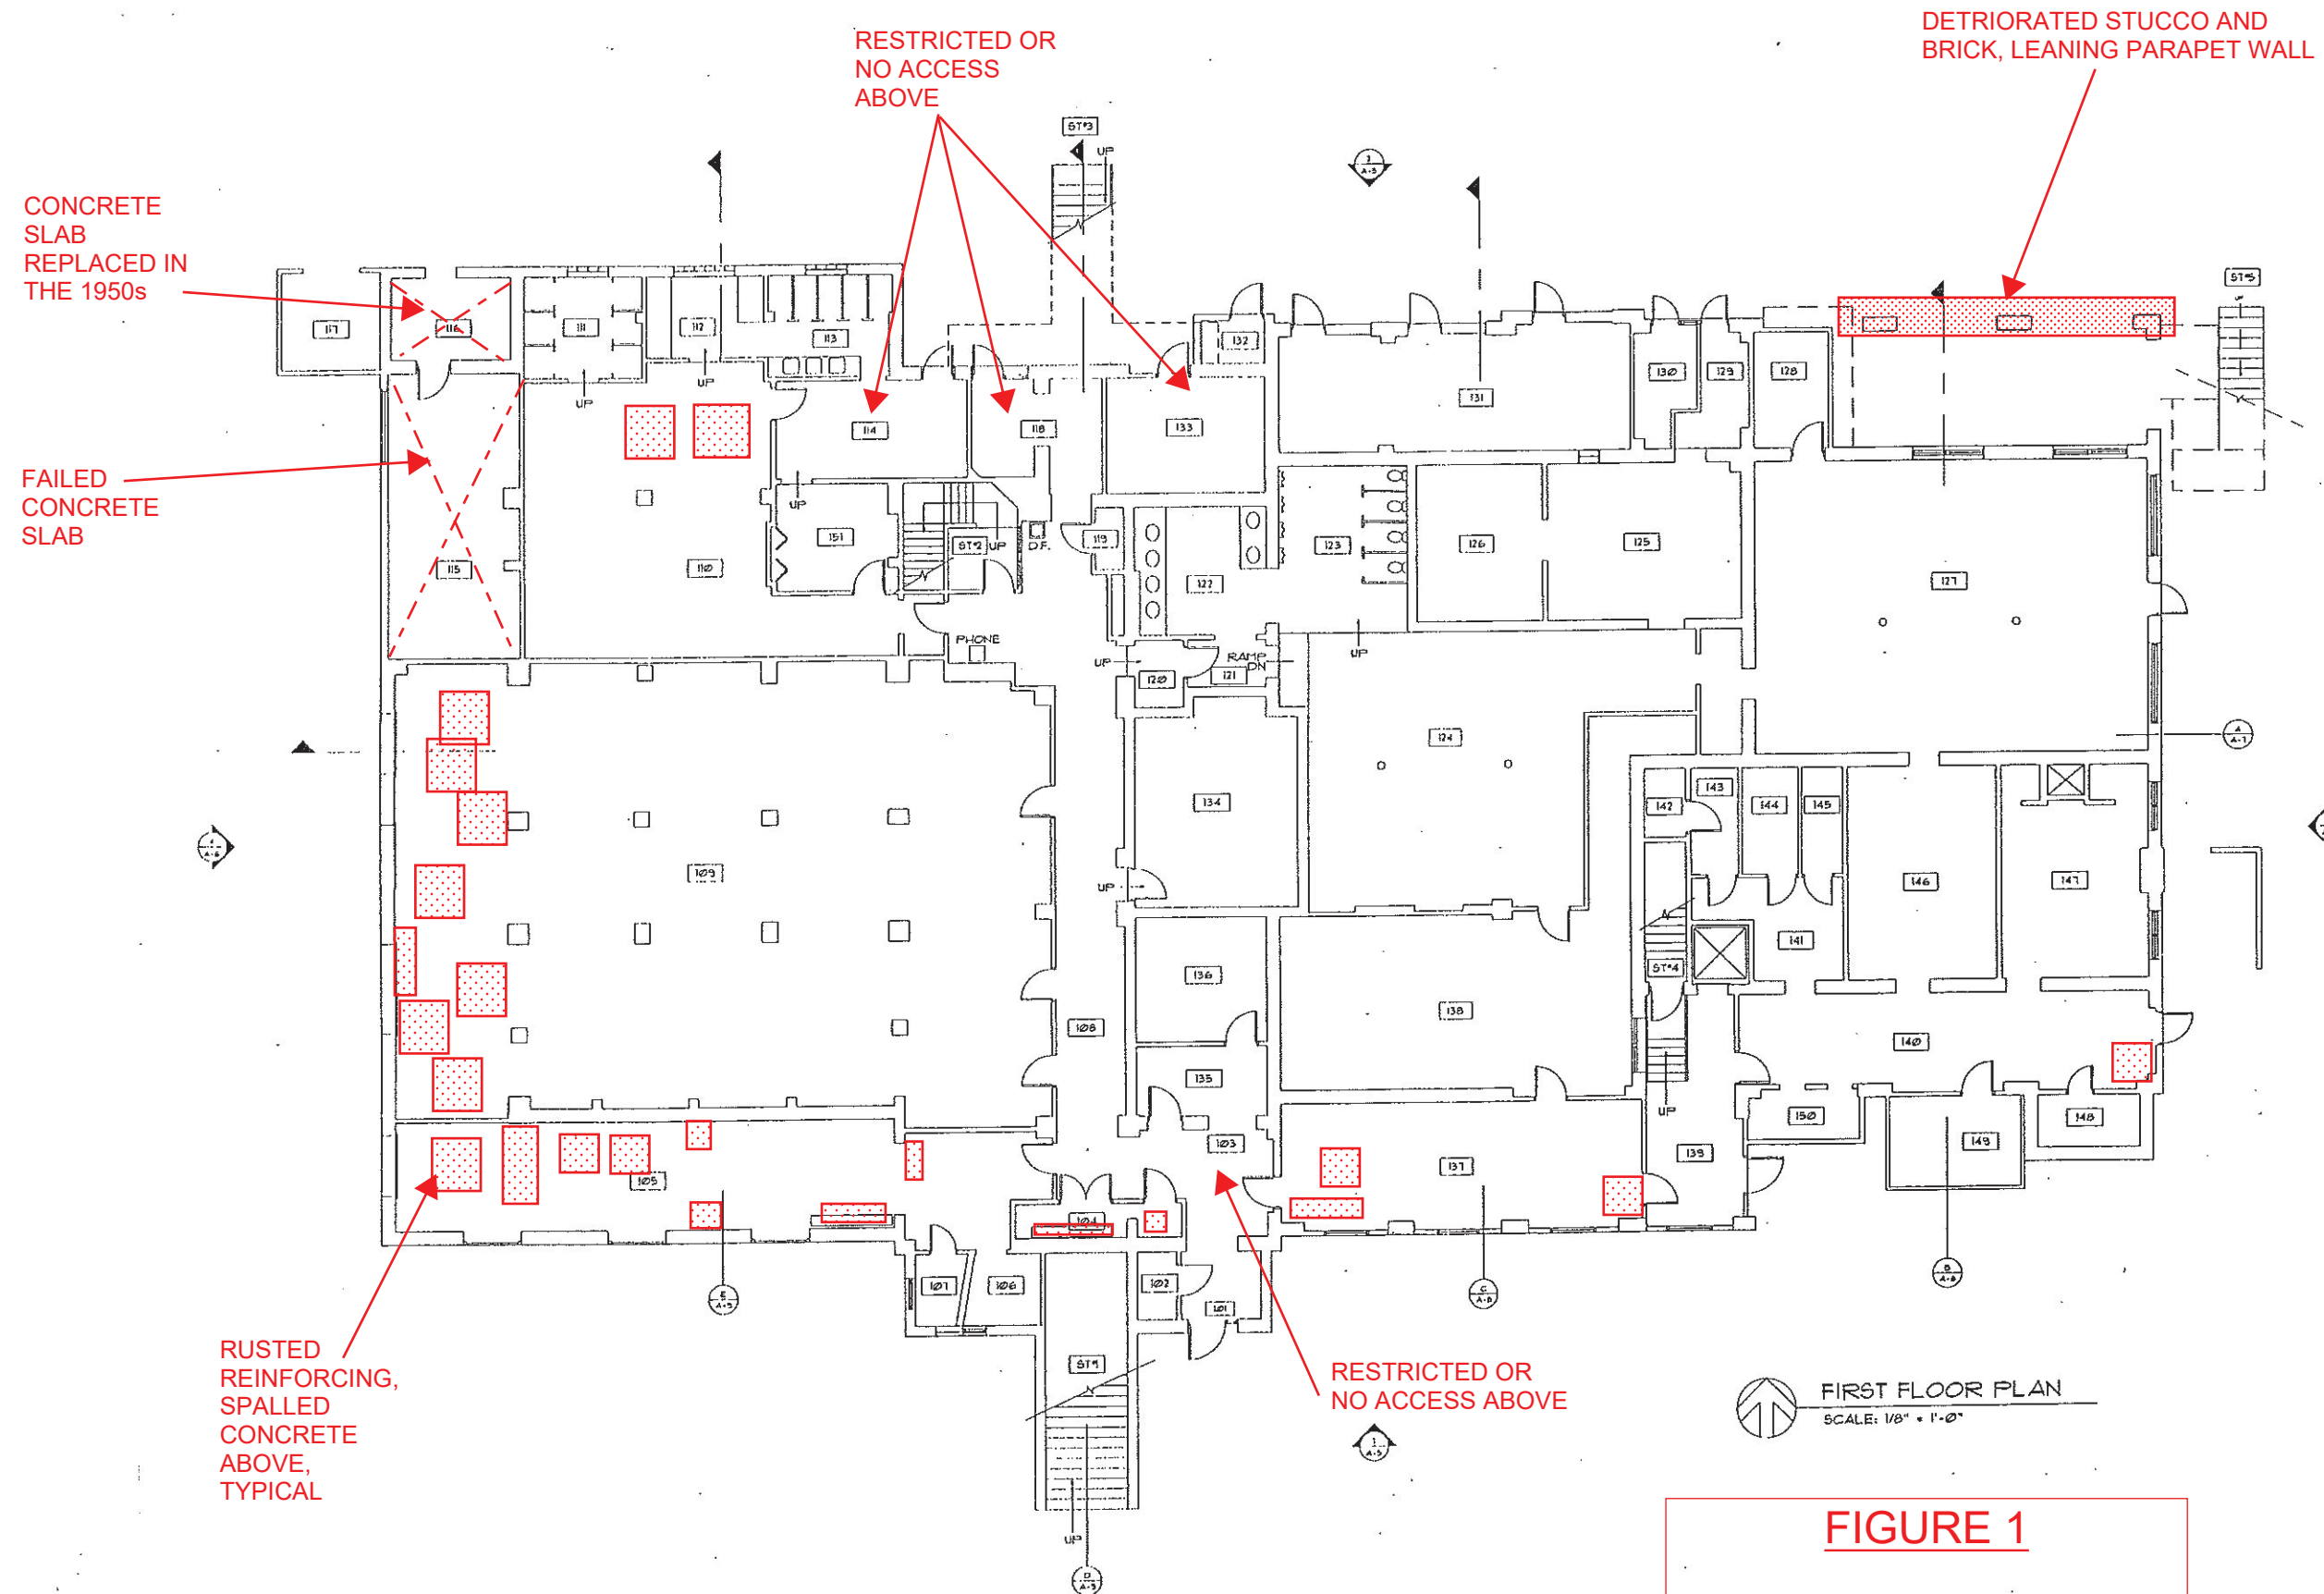
FIGURE 1
Drawing provide by:
Friends of Detroit Rowing

Earlier in 2022, a portion of the west exterior concrete Terrace slab had collapsed into Room 115 (See Appendix “A”, Figure 1). This failure was the catalyst for this Assessment. Other than the area of collapse, the Owner questioned the remaining exterior conditions, and if restricted access was required elsewhere. Because time was critical, it had been determined by all parties that this Assessment needed to be separated into phases. Phase 1 would immediately assess the current exterior building conditions, and determine areas of potential restriction. Phase 2 would further address the potential scope of required work and the associated costs for (3) options, as stated above in the Introduction.

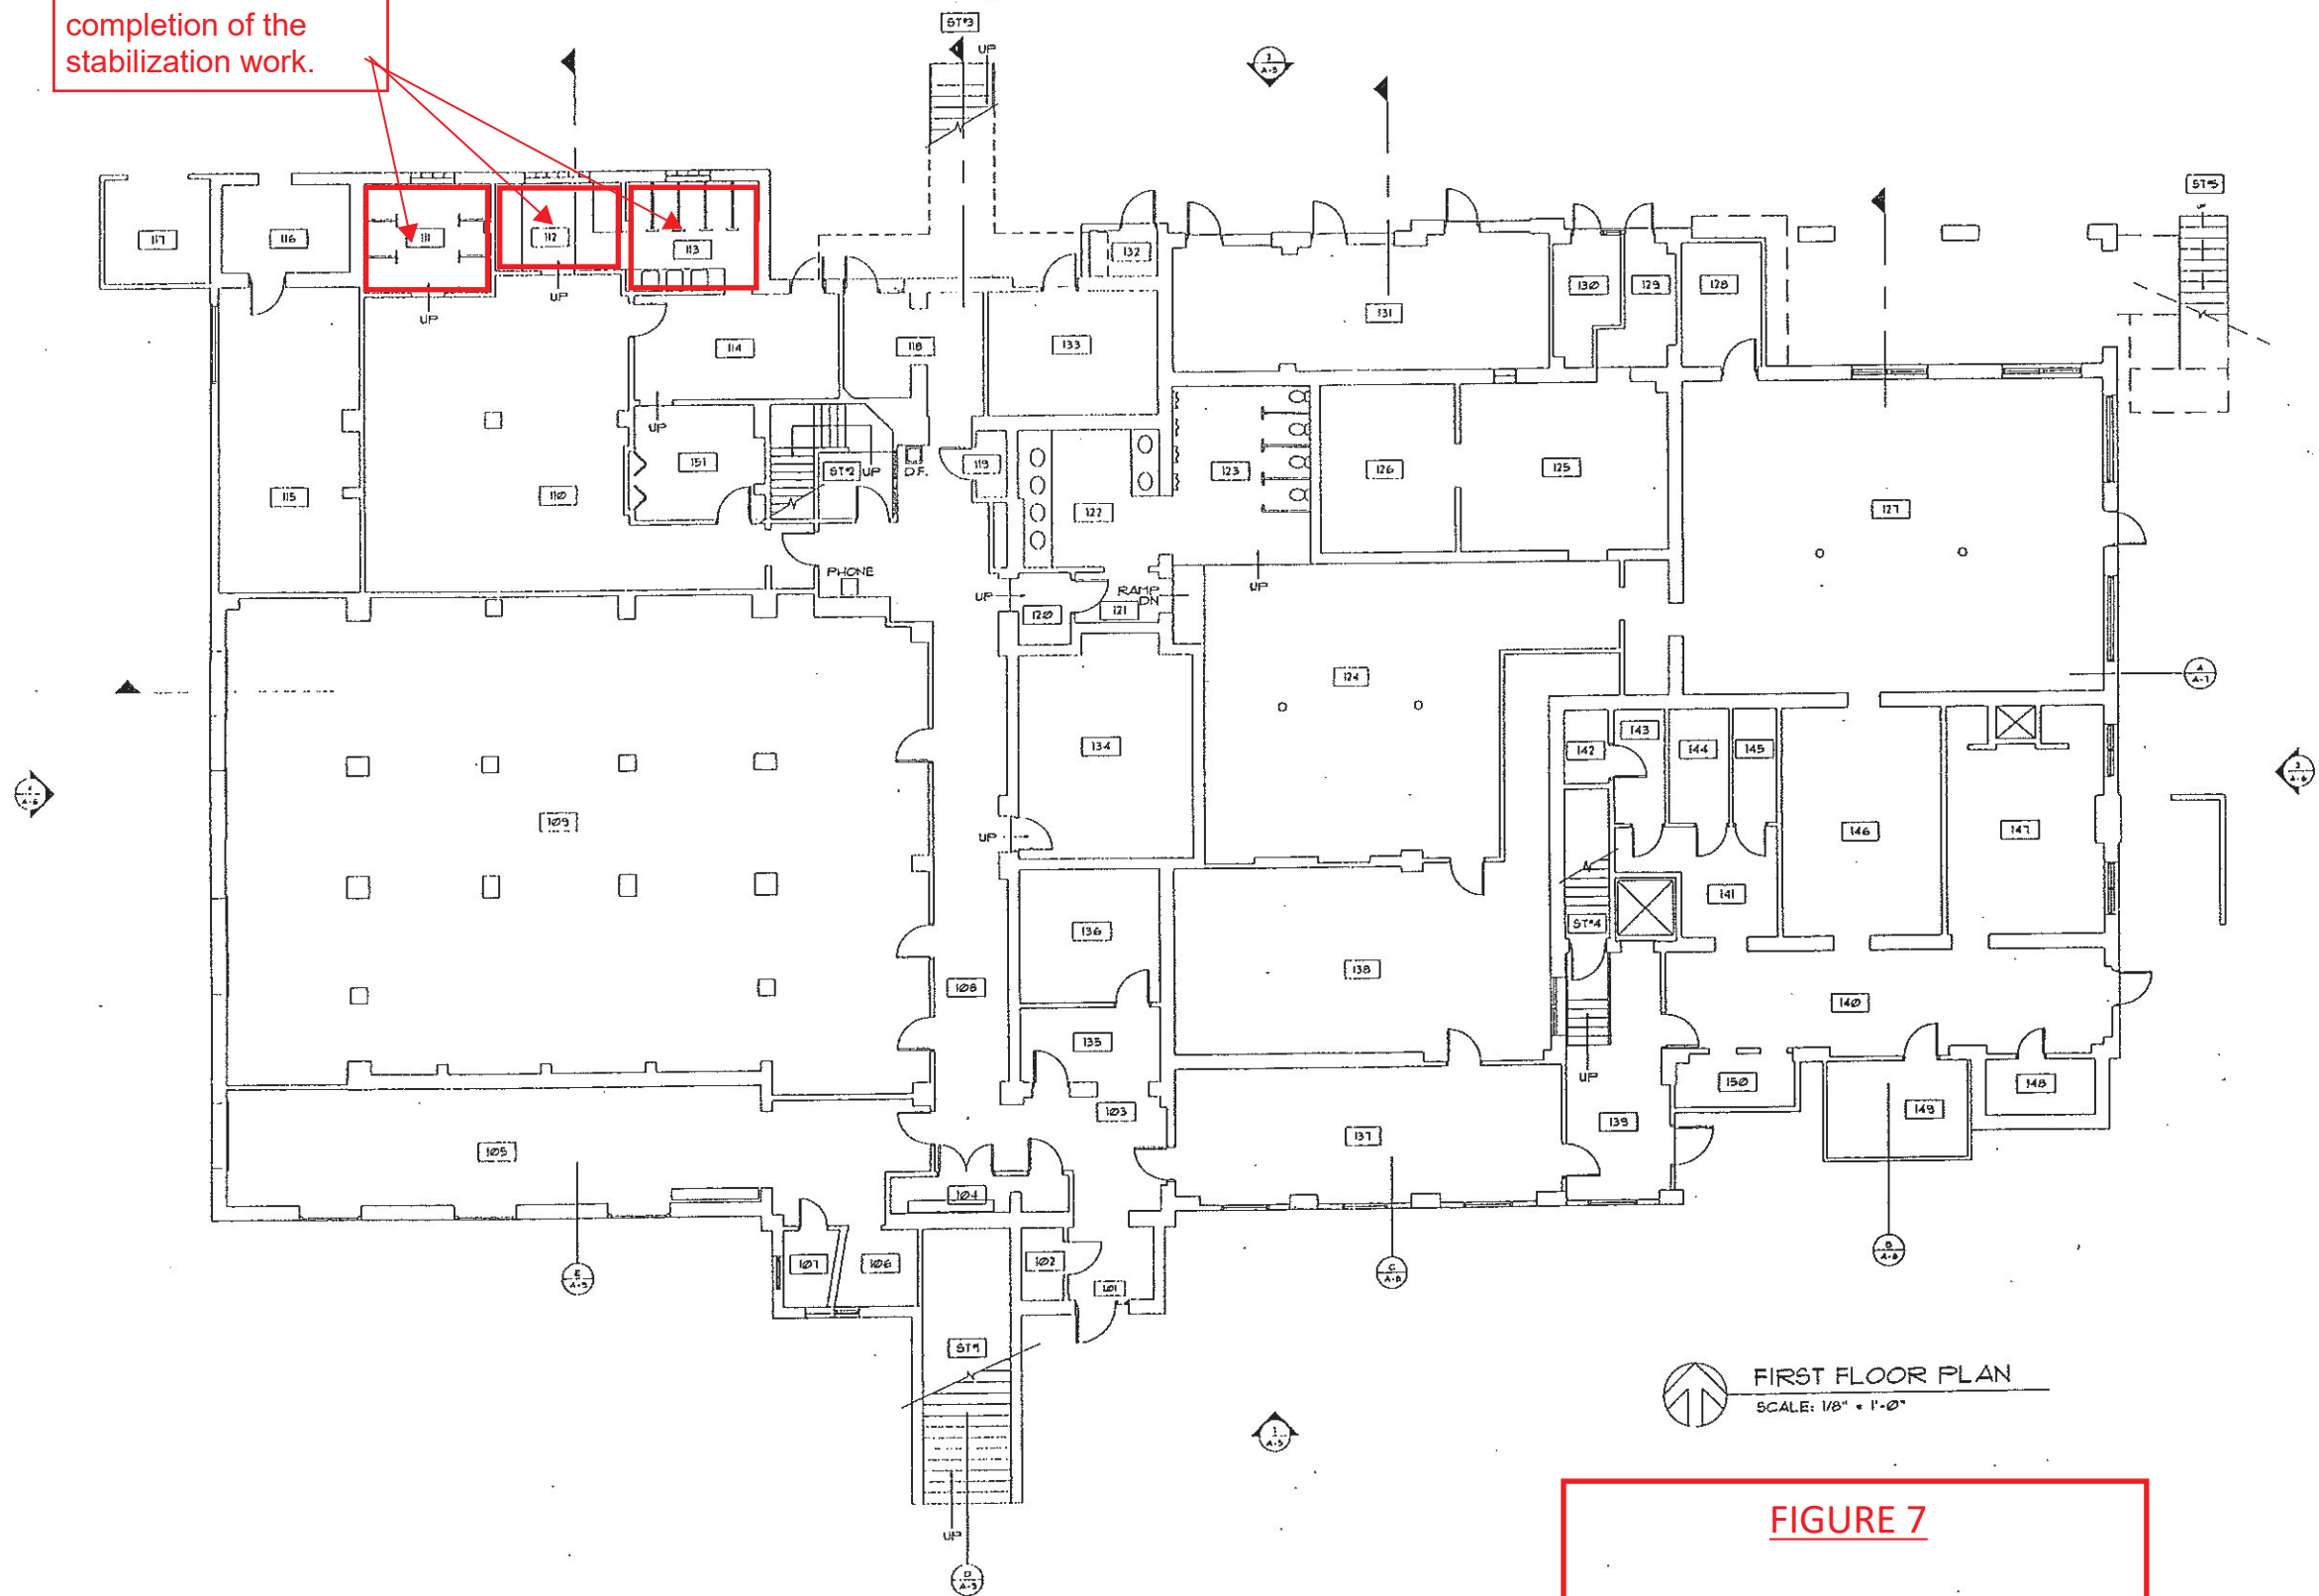
FIGURE 8
Drawing provided by:
Friends of Detroit Rowing

Along with stabilization requirements to the mothball option, the Appendix “C” option addresses restricted occupancy. Areas that would remain restricted after the stabilization work are indicated by Figure 7 and Figure 8. At these areas there are signs of slight displacement of the exterior wall from a lack of proper foundation support. This condition should be continually monitored for any further movement. The total

Areas to remain restricted after the completion of the stabilization work.
