PHOTOGRAPHIC LOG

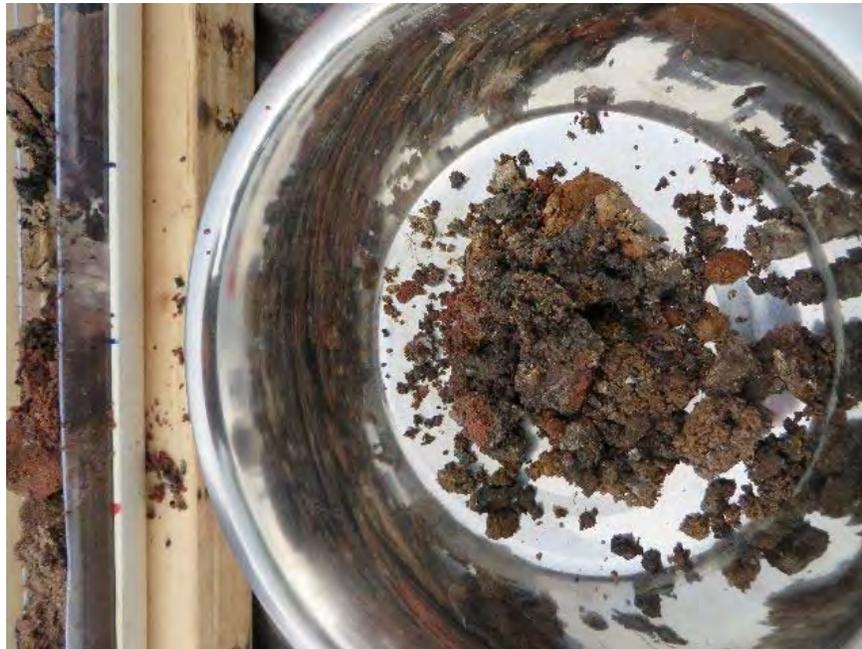
Photograph 1: 6/12/14: View looking north/down at brick and ceramic-like fragments located at the public beach in the Hubbell Beach and Slag Dump Area. Photograph taken by A. Keranen.

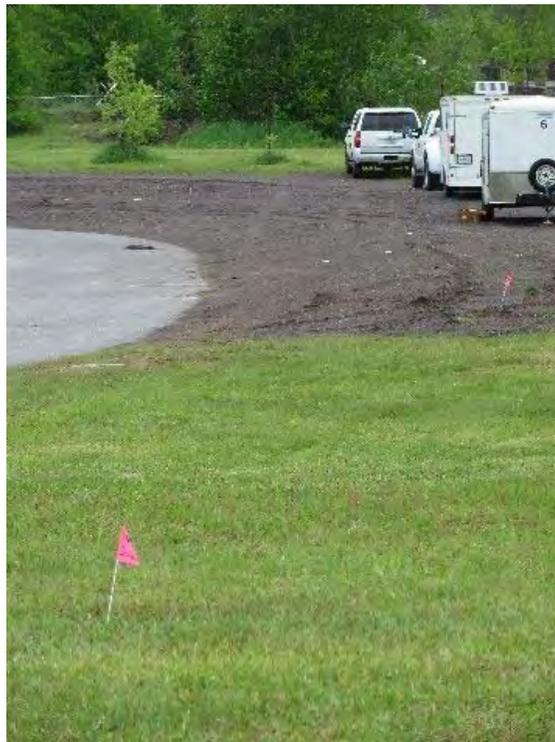
Photograph 3: 6/14/14: View looking south at sample location CHLL-SB18 located at the Lake Linden Village Park in the Lake Linden Recreation Area. Photograph taken by A. Keranen.

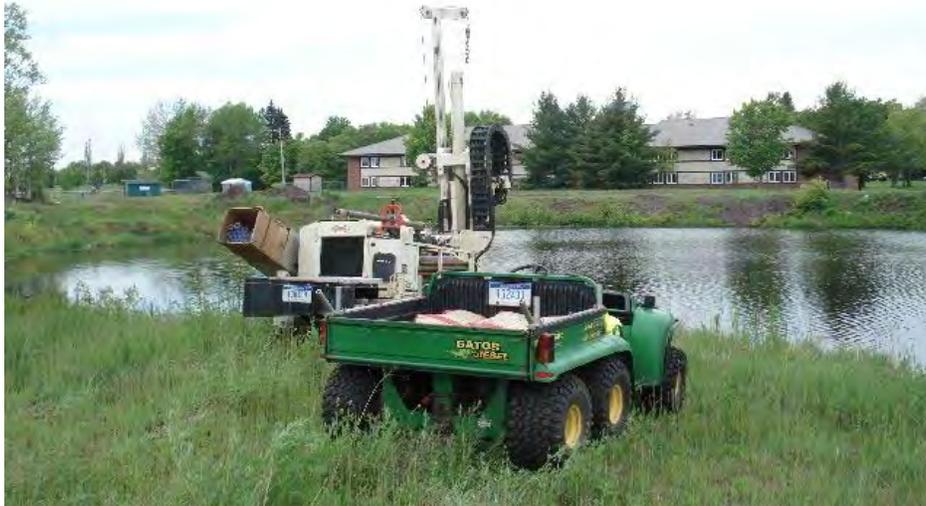
Photograph 4: 6/14/14: View looking south at sample locations CHLL-SB21 and CHLL-SB22 located in the western portion of the Lake Linden Village Marina property in the Lake Linden Recreation Area. Photograph taken by A. Keranen.

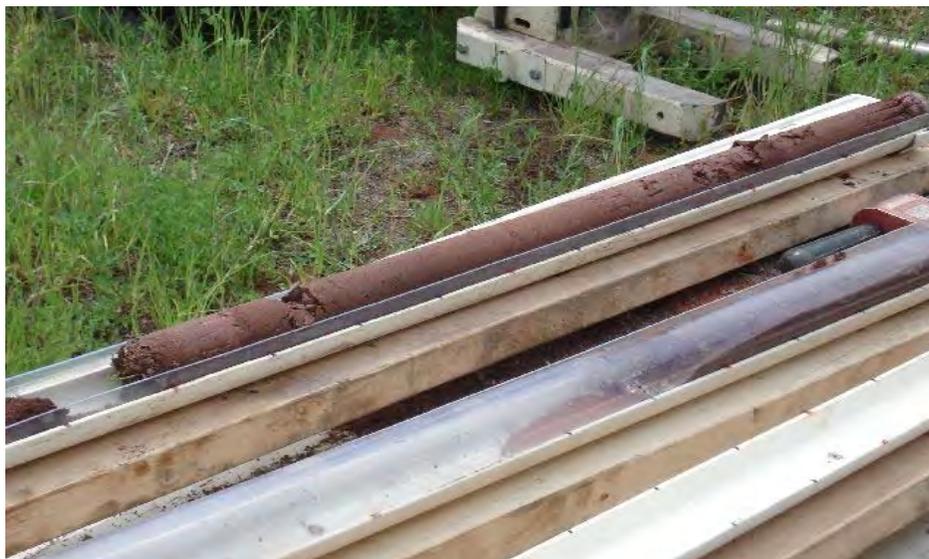
Photograph 5: 6/16/14: View looking west at the advancement of a soil boring at sampling location CHLL-SB06 in the Lake Linden Recreation Area. Photograph taken by D. Liebau.

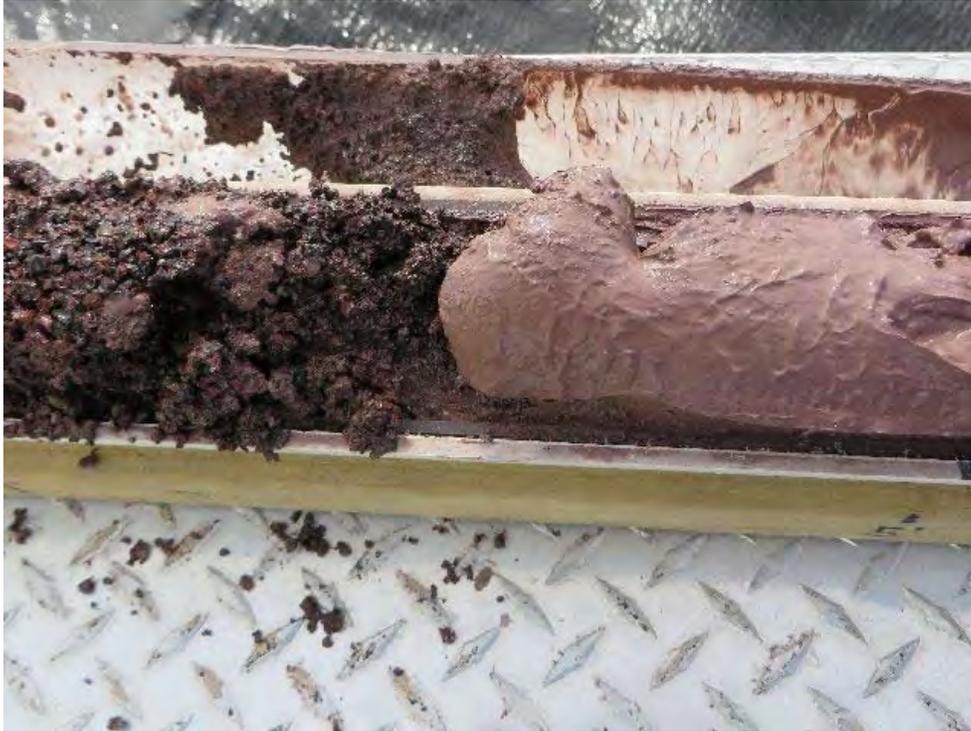
Photograph 12: 7/15/14: View looking down at a sediment core collected from offshore of the Hubbell Processing Area. Photograph taken by A. Keranen.

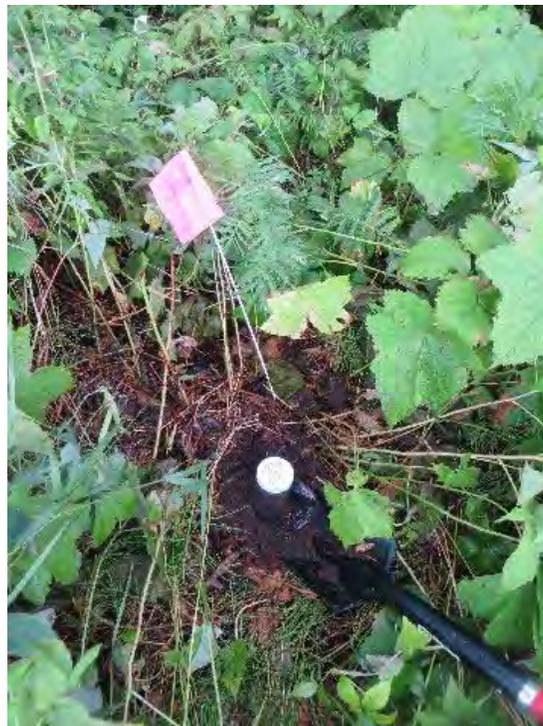
Photograph 21: 8/19/14: View looking down at the collected sample from location CHLL-SB135. Photograph taken by A. Keranen
