ATTACHMENT A  
Property Inspection Checklist  
Abandoned Mining Wastes - Torch Lake Non-Superfund Site  
Calumet and Hecla - Tamarack City Operations

Ahmeek Mill Processing Area

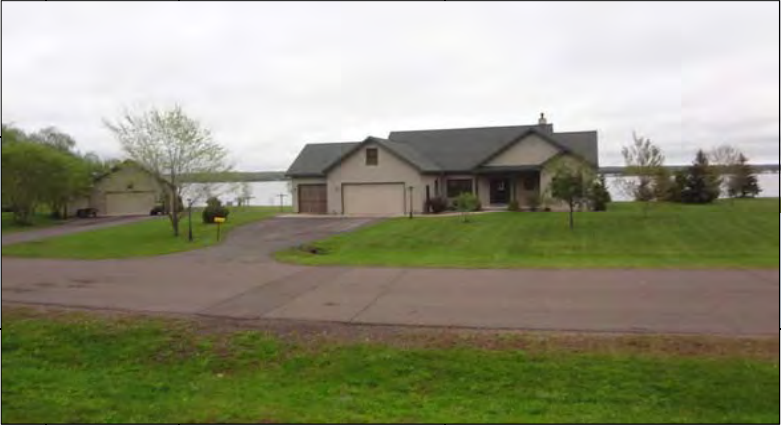
View looking east at the subject property.

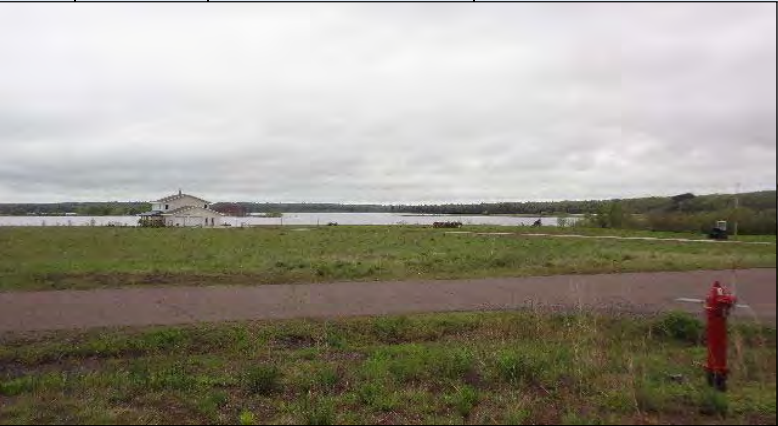
View looking east at the subject property.

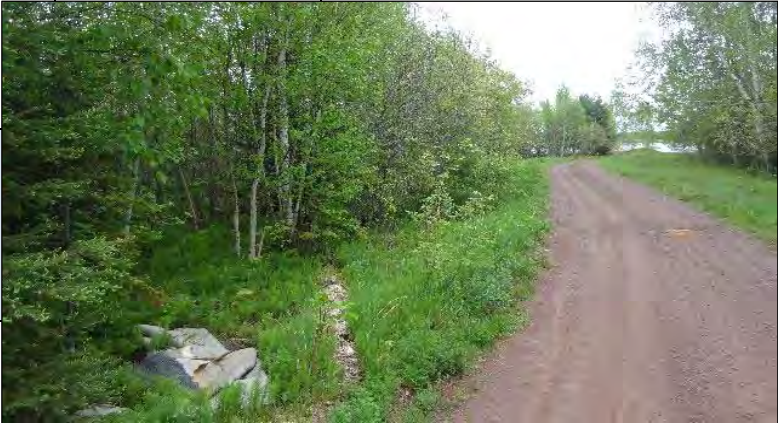
View looking east at the access road that splits the parcel at the subject property.

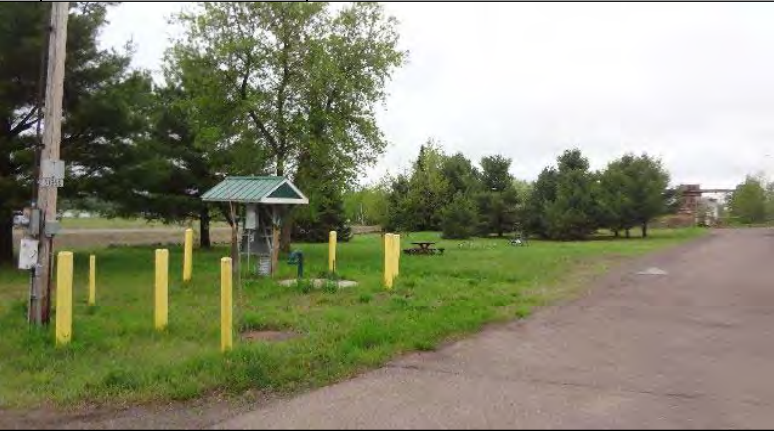
View looking southeast at the subject property.

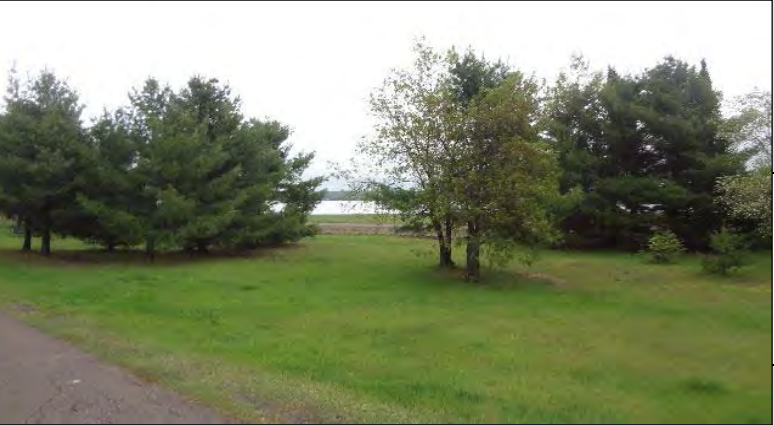
View looking northeast at the subject property.

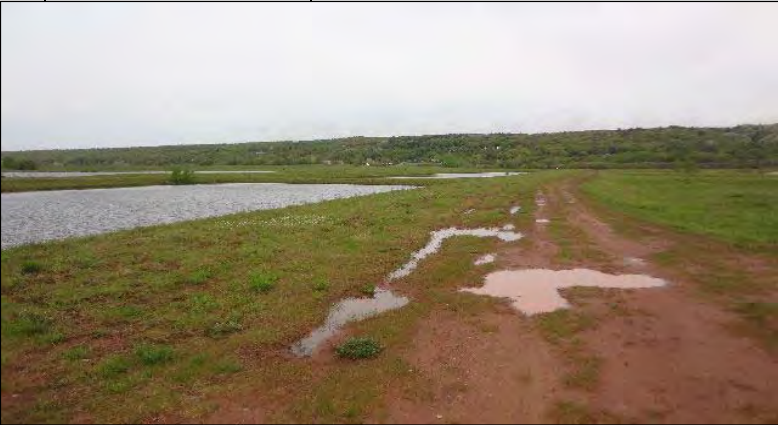
View looking west at the gated entry to the subject property.

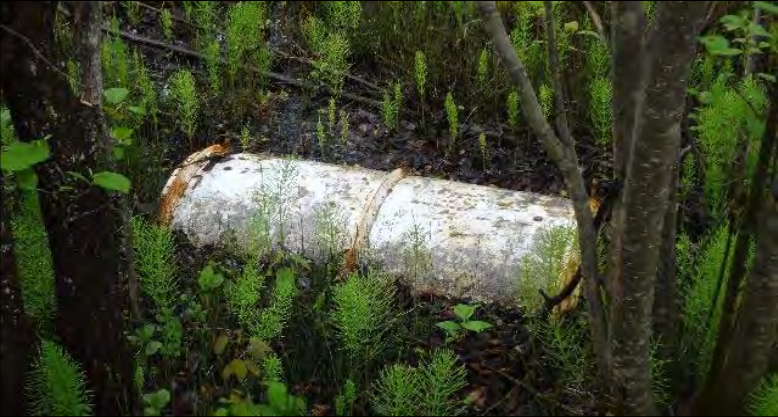
Check as Appropriate:		Record Field Measurements:	Provide Written Description Including Condition, Content, and Similar Material Properties:	Document as Applicable:				
Potential Chemical or Physical Hazards	✓	Location/Coordinates	Description	Estimated Size/Area/Volume	Quantity	Units	Sample Recommendations	Notes
Suspect ACM		Latitude: 47.16537197  Longitude: -88.436860309	CHTC-DM01: A white, ribbed cylinder, approximately 18 inches in diameter and approximately 3 feet long. Appears to be a container, possible pressure vessel. Partially buried.

Surface soil location CHTC-SS01-0-6" is representative of environmental conditions in the vicinity of the reconnaissance location.
Residual Process Materials								
Potentially Abandoned Containers	✓							
Soil Staining/Stressed Vegetation								
Potential PCB or Mercury Containing Equipment								
Other: _____								
Suspect ACM		Latitude:  Longitude:

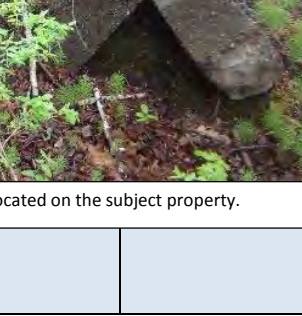
Soil and groundwater samples collected from boring location CHTC-SB47 and CHTC-GW43 are representative of environmental conditions in the vicinity of the reconnaissance location.
Residual Process Materials								
Potentially Abandoned Containers								
Soil Staining/Stressed Vegetation		Longitude: -88.43634201						
Potential PCB or Mercury Containing Equipment								
Other: <u>Partially buried pipe</u>	✓							
Suspect ACM		Latitude:

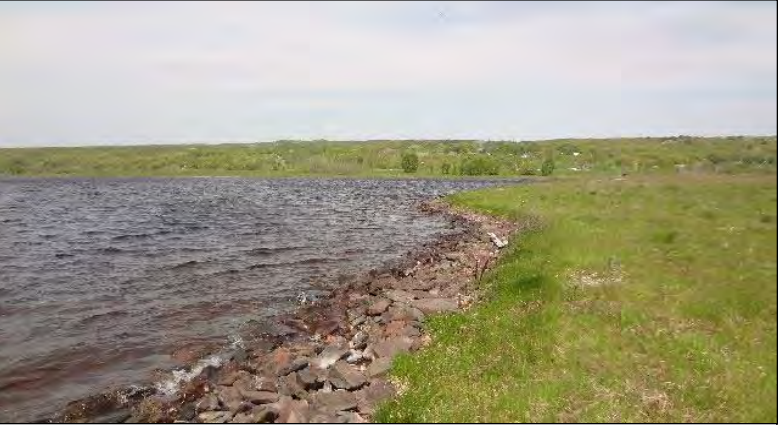
Check as Appropriate:		Record Field Measurements:	Provide Written Description Including Condition, Content, and Similar Material Properties:	Document as Applicable:				
Potential Chemical or Physical Hazards	✓	Location/Coordinates	Description	Estimated Size/Area/Volume	Quantity	Units	Sample Recommendations	Notes
Suspect ACM		Latitude: 47.163894766  Longitude: -88.441823258	CHTC-SBR02 - Outlet of a concrete culvert that crosses from the west side of M26, where former stamp mill operations existed, to the east side of M26 where stamp sands were historically deposited.

Soil and groundwater samples collected from boring location CHTC-SB48 and CHTC-GW44 are representative of environmental conditions in the vicinity of the reconnaissance location.
Residual Process Materials								
Potentially Abandoned Containers								
Soil Staining/Stressed Vegetation								
Potential PCB or Mercury Containing Equipment

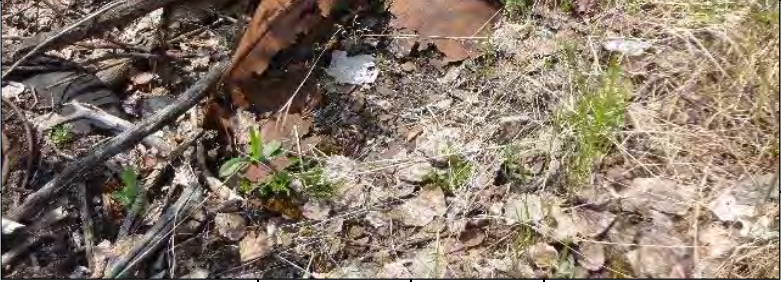
Surface soil location CHTC-SS02-0-6" is representative of environmental conditions in the vicinity of the reconnaissance location.
Residual Process Materials								
Potentially Abandoned Containers	✓							
Soil Staining/Stressed Vegetation								
Potential PCB or Mercury Containing Equipment								
Other: _____		Latitude: 47.165026394  Longitude: -88.443400219	CHTC-DM03: Rusted, partially crushed, open and damaged, 55-gallon drum, lying on its side. The drum is labeled "Dowfroth 250, manufactured by Dow Chemical Company".

Drum sampling location CHTC-DM01 is representative of the contents of the drum identified during reconnaissance activities.

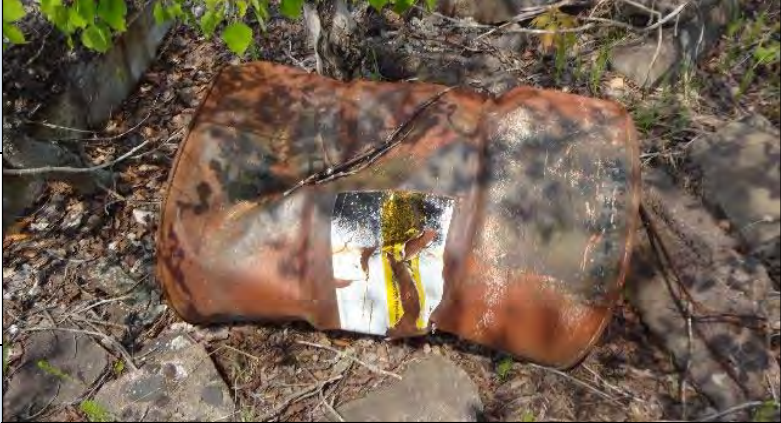
View looking southwest/down at reconnaissance location CHTC-DM05 located south of the mining era ruins at the subject property.			Surface soil location CHTC-SS07-0-6" is representative of environmental conditions in the vicinity of the reconnaissance location.
Other: _____								
Suspect ACM								
Residual Process Materials								
Potentially Abandoned Containers	✓							
Other: _____		Latitude: 47.164743251  Longitude: -88.443647995	CHTC-DM05: Rusted, highly-weathered and degraded, crushed, 55-gallon drum. Grayish-brown, rust fragments and granular material appear to be present on the interior of the drum.

Drum sampling location CHTC-DM02 is representative of the contents of the drum identified during reconnaissance activities.

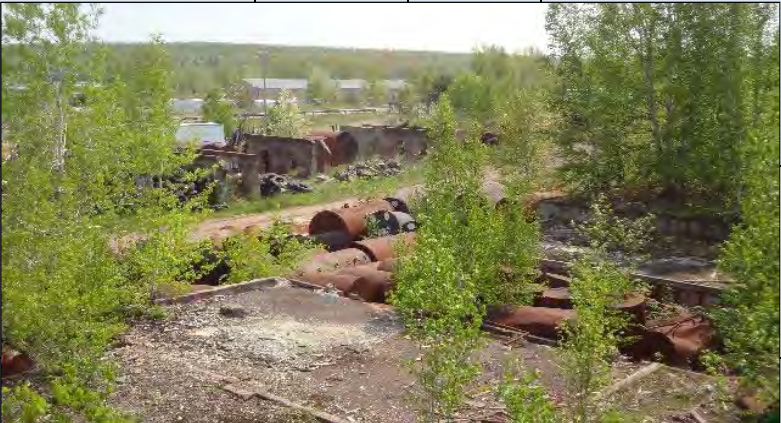
Suspect ACM								
Residual Process Materials								
Potentially Abandoned Containers	✓							
Soil Staining/Stressed Vegetation								
Potential PCB or Mercury Containing Equipment		Latitude: 47.164193836  Longitude: -88.443550947	CHTC-DM10: Rusted, empty drum, crushed, damaged, partially buried and obscured by vegetation. Located in a wet, marshy area along the southern fence line of the property.

Surface soil location CHTC-SS08-0-6" is representative of environmental conditions in the vicinity of the reconnaissance location.
Other: _____								
Suspect ACM								
Residual Process Materials								
Potentially Abandoned Containers	✓							
Other: _____		Latitude: _____  Longitude: _____

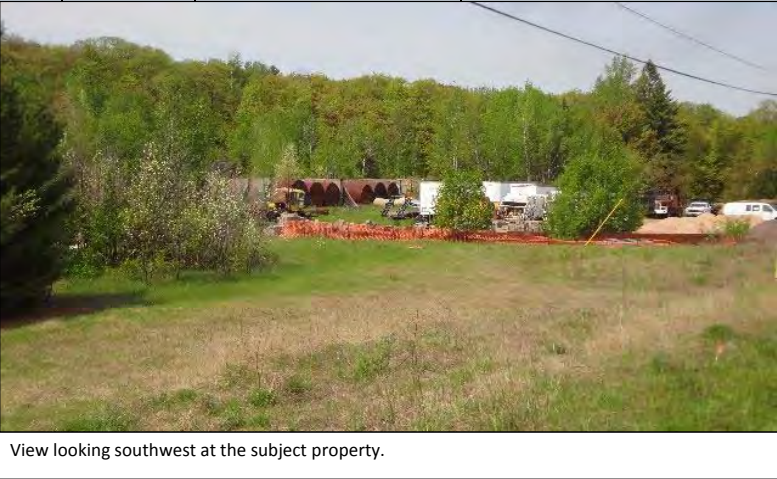
View looking southwest at the subject property.
