Appendix D
Potential Physical and Health Hazard Inventory - Reconnaissance Logs
Abandoned Mining Wastes - Torch Lake Non-Superfund Site
Calumet and Hecla - Lake Linden Operations

Trap Rock Dump - Shoreline Development Group

10/6/2014

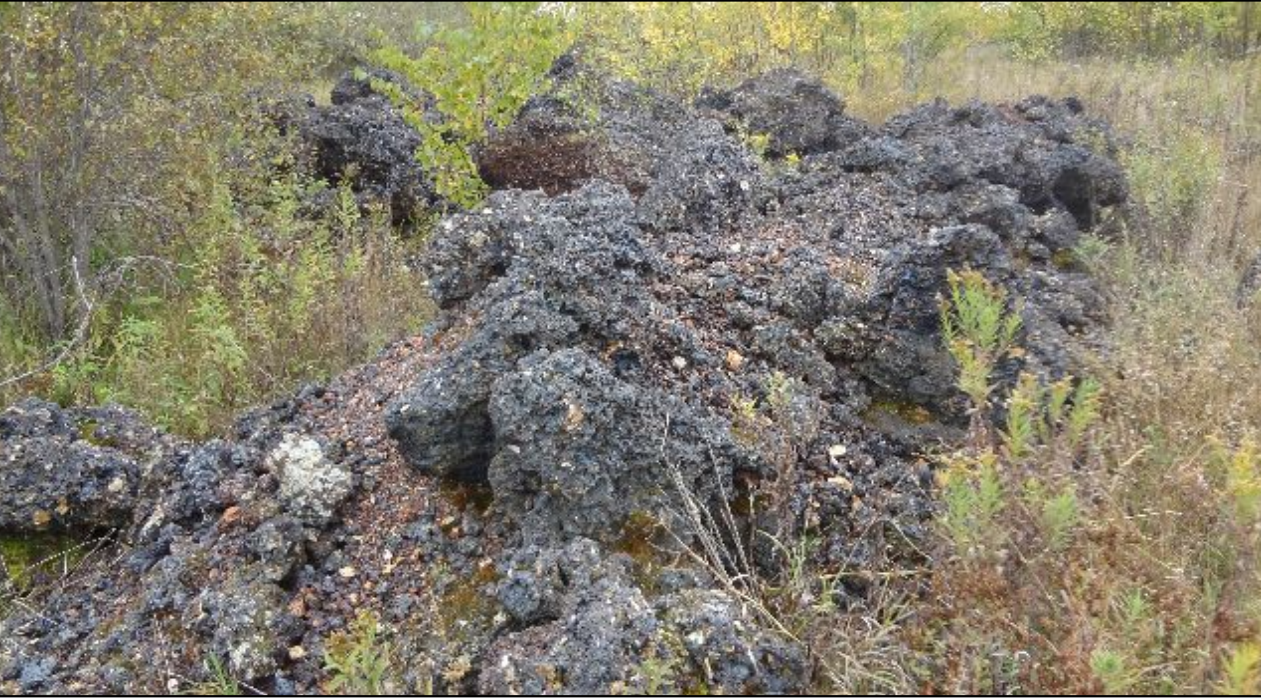
View looking south at a clinker piles located on the property.

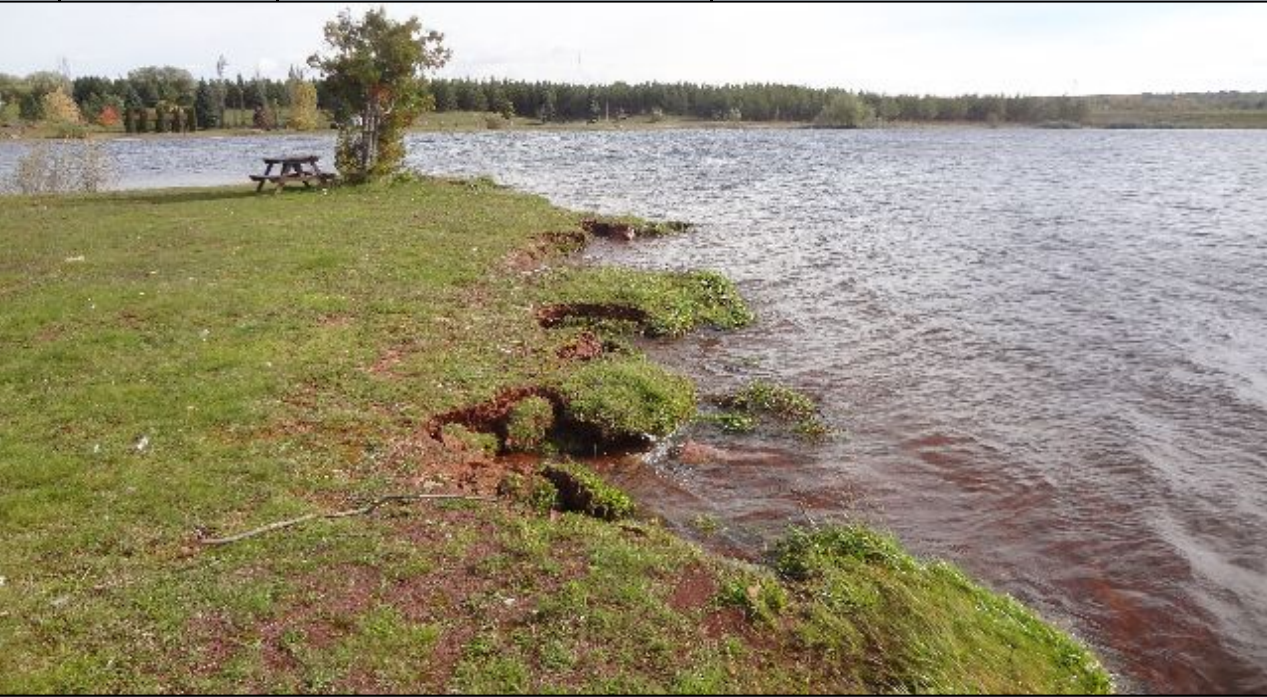
View looking east at eroded portions of the cap/shoreline in the eastern portion of the subject property.

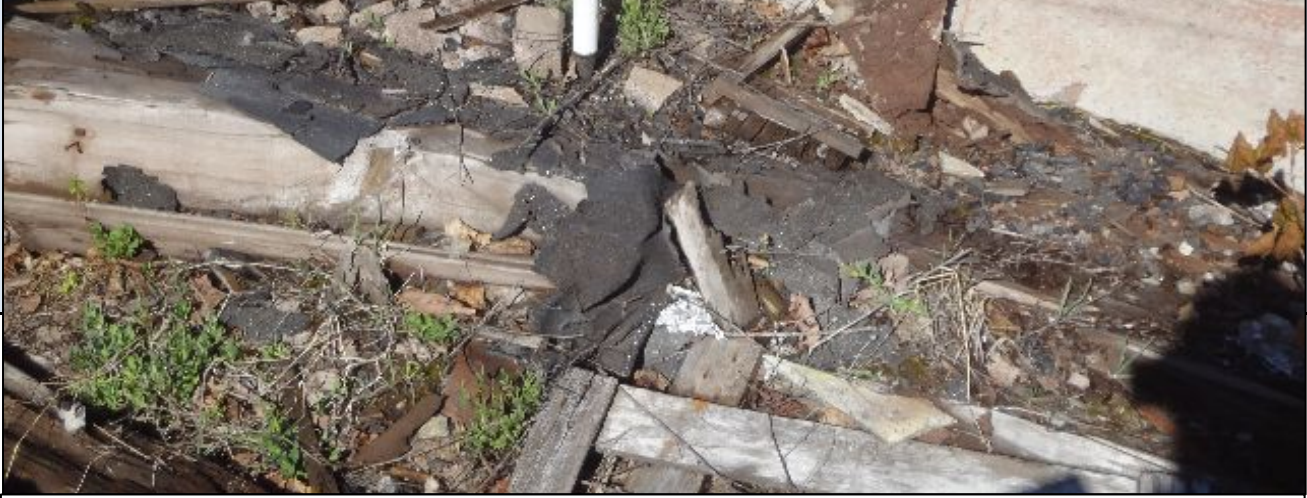
Soil Staining/Stressed Vegetation		Longitude: -88.411033						
Potential PCB or Mercury Containing Equipment								
Other: _____								
Suspect ACM	✓	Latitude: 47.187563	CHLL-SACM08 - Suspect cementitious board fragment with asphaltic roofing material in a trench in the floor of the former stamp mill/reclamation plant. The material is weathered, damaged, and friable.

Material sample CHLL-ASBBLK43-063015 collected during the targeted inspection activities is consistent with the material identified during the reconnaissance activities.
Residual Process Materials								Material sample CHLL-ASBBLK44-063015 collected during the targeted inspection activities is consistent with the material identified during the reconnaissance activities.
Potentially Abandoned Containers								
Soil Staining/Stressed Vegetation		Longitude: -88.411016						
Potential PCB or Mercury Containing Equipment

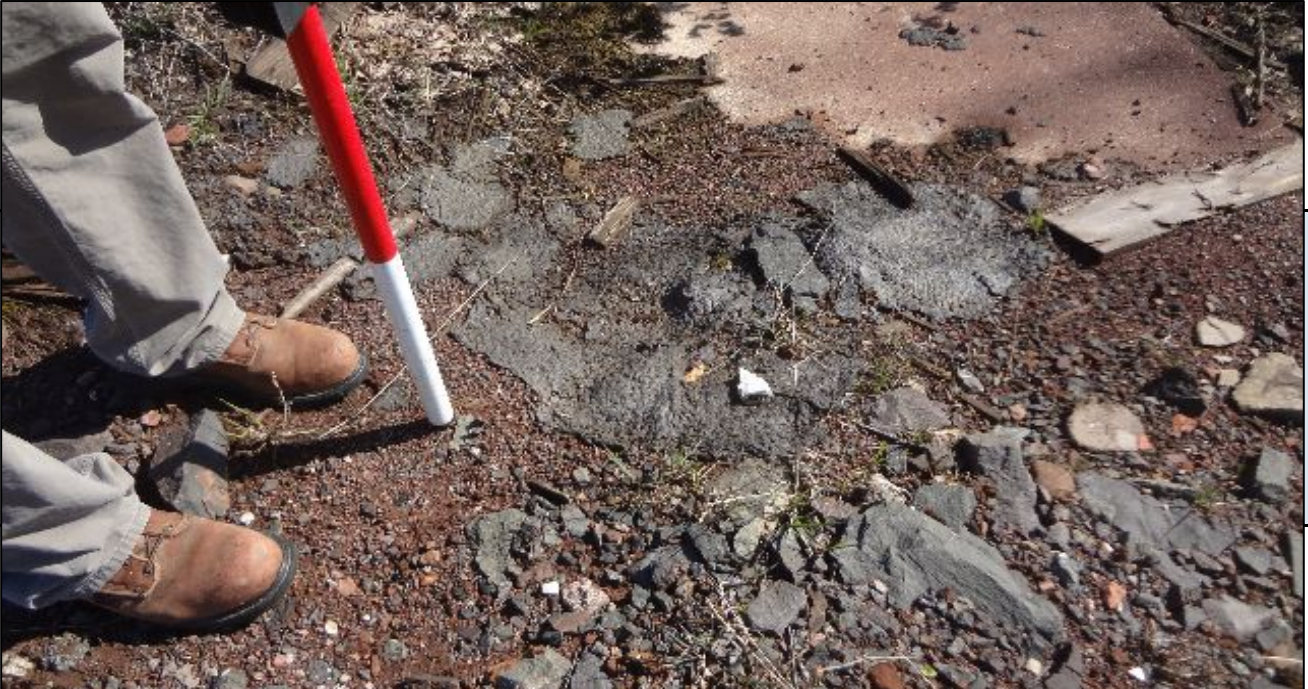
Check as Appropriate:		Record Field Measurements:	Provide Written Description Including Condition, Content, and Similar Material Properties:	Document as Applicable:				
Potential Chemical or Physical Hazards	✓	Location/Coordinates	Description	Estimated Size/Area/Volume	Quantity	Units	Sample Recommendations	Notes
Suspect ACM	✓	Latitude: 47.187342	CHLL-SACM13 - Suspect thermal system insulation commingled with stamp sand on the floor of the former stamp mill/reclamation plant. The material is weathered, damaged, and friable.

Material sample CHLL-ASBBLK39-063015 collected during the targeted inspection activities is consistent with the material identified during the reconnaissance activities.
Residual Process Materials								Material sample CHLL-ASBBLK46-063015 collected during the targeted inspection activities is consistent with the material identified during the reconnaissance activities.

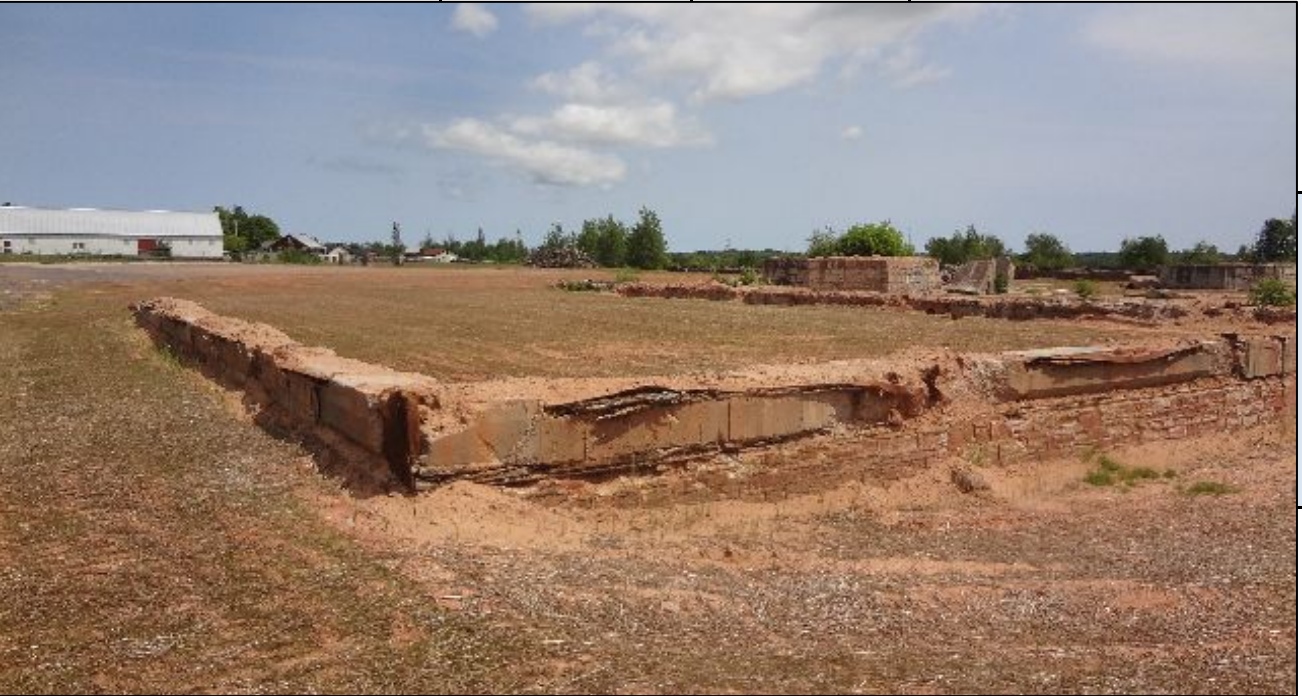
Check as Appropriate:		Record Field Measurements:	Provide Written Description Including Condition, Content, and Similar Material Properties:	Document as Applicable:				
Potential Chemical or Physical Hazards	✓	Location/Coordinates	Description	Estimated Size/Area/Volume	Quantity	Units	Sample Recommendations	Notes
Suspect ACM	✓	Latitude: 47.184957194	TRANSITE - Suspect grayish white transite fragment.

Material samples CHLL-ASBBLK60-070115 and CHLLASBBLK63-070115 collected during the targeted inspection activities are consistent with the material identified during the reconnaissance activities.
Residual Process Materials								Material sample CHLL-ASBBLK62-070115 collected during the targeted inspection activities is consistent with the material identified during the reconnaissance activities.
Potentially Abandoned Containers								
Soil Staining/Stressed Vegetation		Longitude: -88.411604434

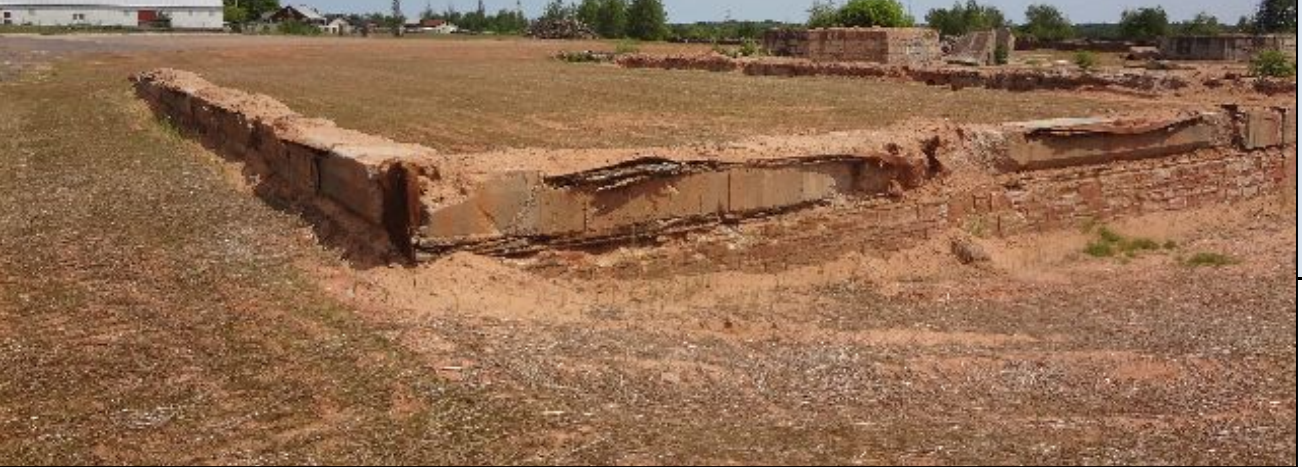
Potential PCB or Mercury Containing Equipment								
Other: _____								
Suspect ACM	✓	Latitude: 47.185022793	ROOFING - Black asphaltic roofing material.

Surface soil location CHLL-SS17-0-6"" is representative of environmental conditions in the vicinity of the reconnaissance location.
Residual Process Materials								
Potentially Abandoned Containers								
Soil Staining/Stressed Vegetation		Longitude: -88.41143796						
Potential PCB or Mercury Containing Equipment								
Other: _____								
Suspect ACM		Latitude: 47.184909472	DRUMS - Two rusted, crushed, drum carcasses protruding from the hillside.

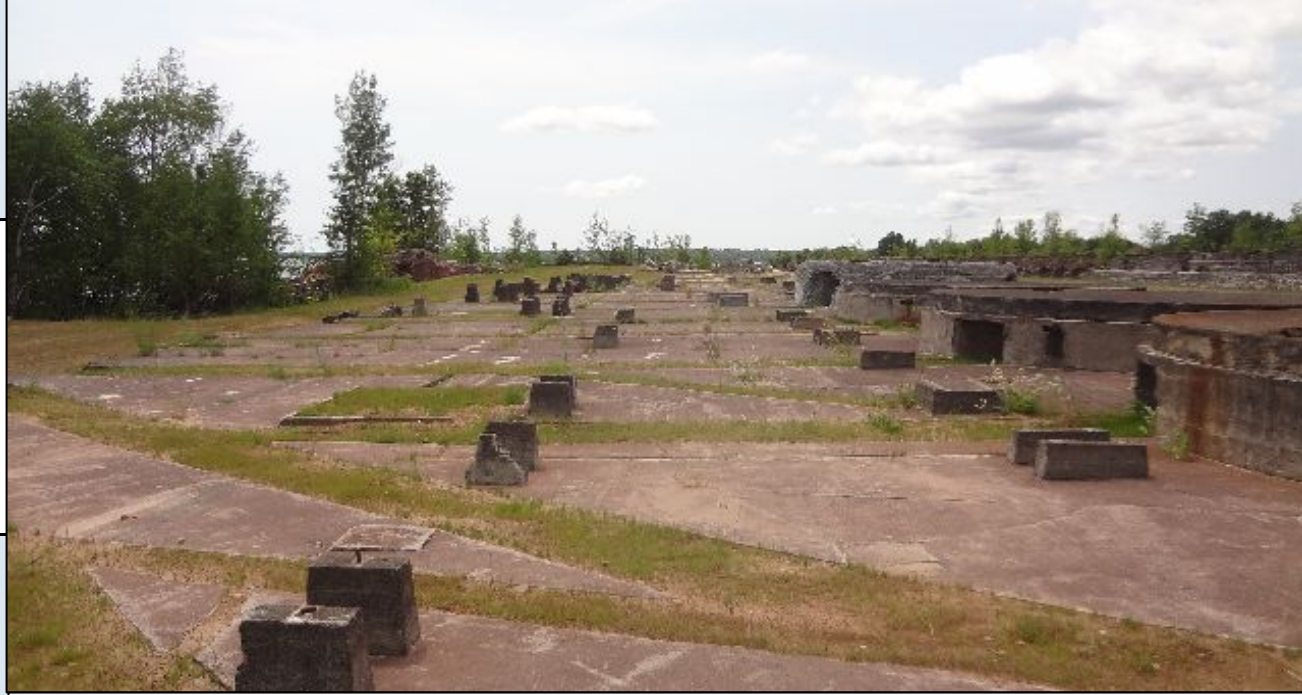
Other: _____								
Suspect ACM		Latitude: 47.184857124	DRUM - One rusted, crushed, drum carcass protruding from the hillside.

Surface soil location CHLL-SS16-0-6"" is representative of environmental conditions in the vicinity of the reconnaissance location.
Residual Process Materials								
Potentially Abandoned Containers								
Soil Staining/Stressed Vegetation		Longitude: -88.411716282						
Potential PCB or Mercury Containing Equipment								
Other: _____								
Suspect ACM	✓	Latitude: 47.184397058	SUSPECT THERMAL SYSTEMS INSULATING MATERIAL - Whitish gray fibrous insulating material

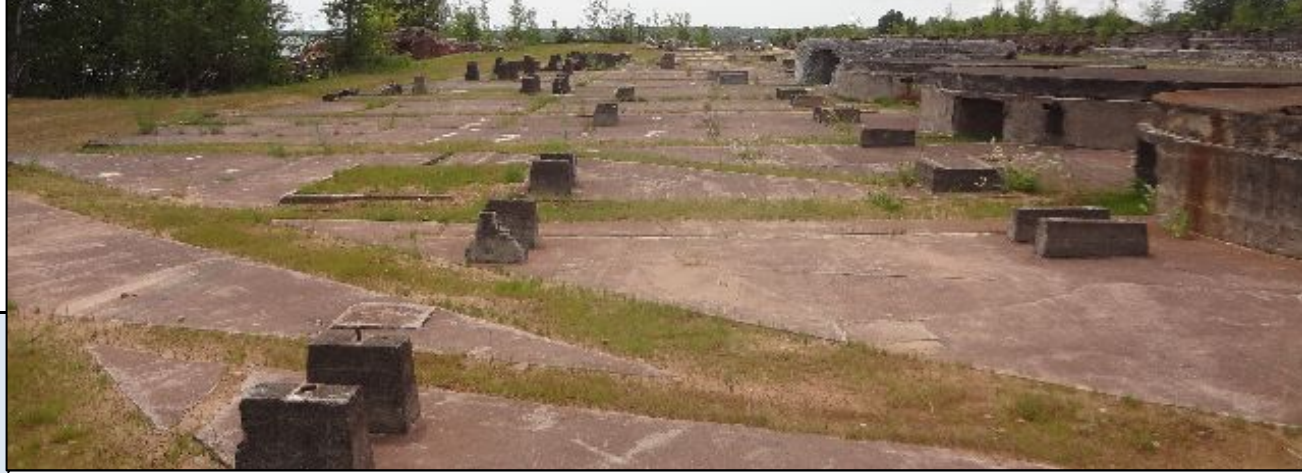
Material sample CHLL-ASBBLK64-070115 collected during the targeted inspection activities is consistent with the material identified during the reconnaissance activities.
Residual Process Materials								
Potentially Abandoned Containers								
Soil Staining/Stressed Vegetation		Longitude: -88.414122548

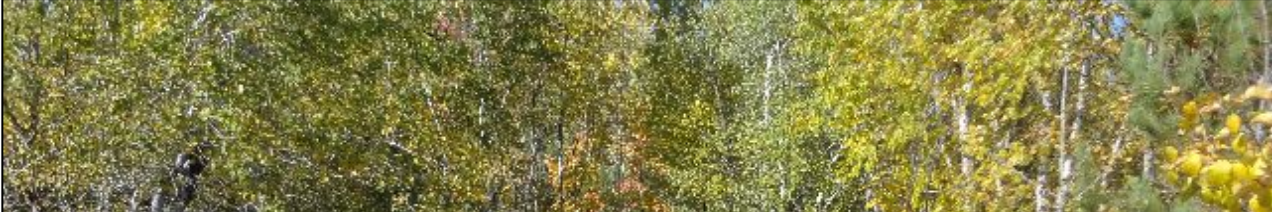
Potential Chemical or Physical Hazards	✓	Location/Coordinates	Description	Estimated Size/Area/Volume	Quantity	Units	Sample Recommendations	Notes
Suspect ACM	✓	Latitude: 47° 10'52.877"	Debris Pile with metal, tin siding and possible drum carcass

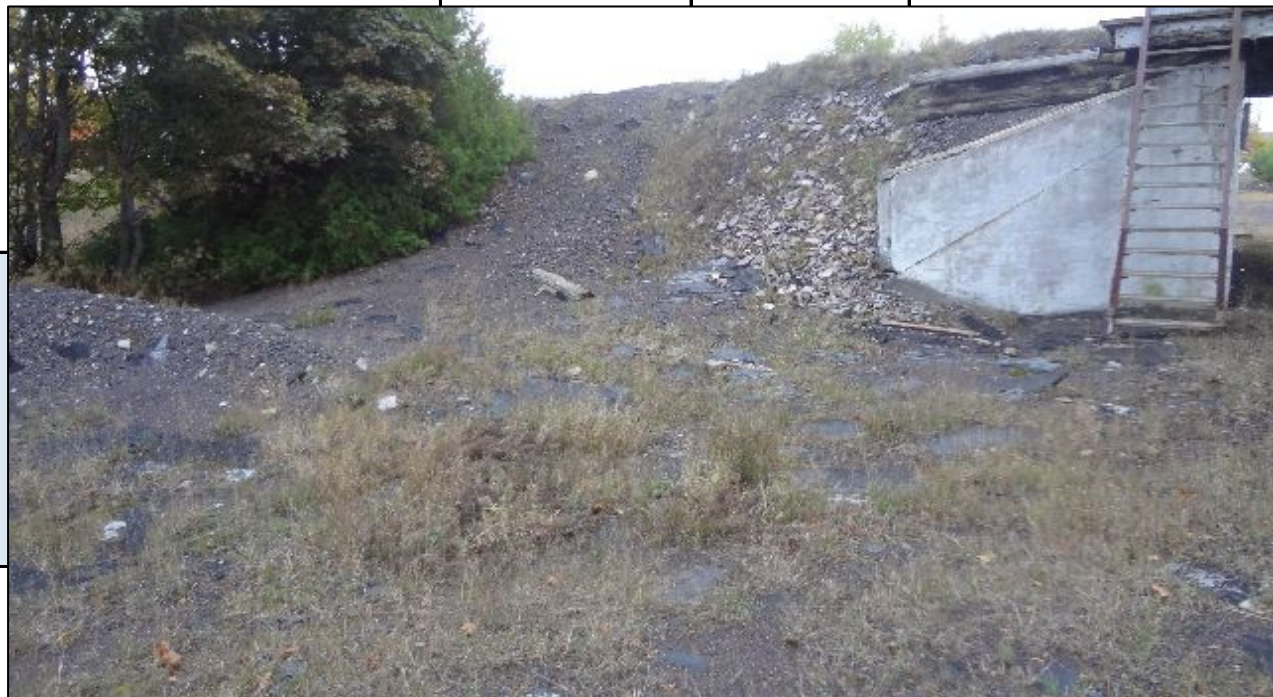
Potential Chemical or Physical Hazards	✓	Location/Coordinates	Description	Estimated Size/Area/Volume	Quantity	Units	Sample Recommendations	Notes	
Suspect ACM	✓	Latitude: 47° 10'42.934"	SACM-07 - Debris pile with asphaltic roofing material, transite, and cementitious wall board material.

Material samples CHLL-ASBBLK14-101414, CHLL-ASBBLK15-101414, CHLL-ASBBLK16-101414, and CHLL-ASBBLK17-101514 were collected from the vicinity of location SACM-07 during targeted inspection activities.	
Residual Process Materials									
Potentially Abandoned Containers									
Soil Staining/Stressed Vegetation									
Potential PCB or Mercury Containing Equipment									
Other: _____									
Suspect ACM	✓	Latitude: 47° 10'46.526"	SACM -06 - Small canvas/fibrous material

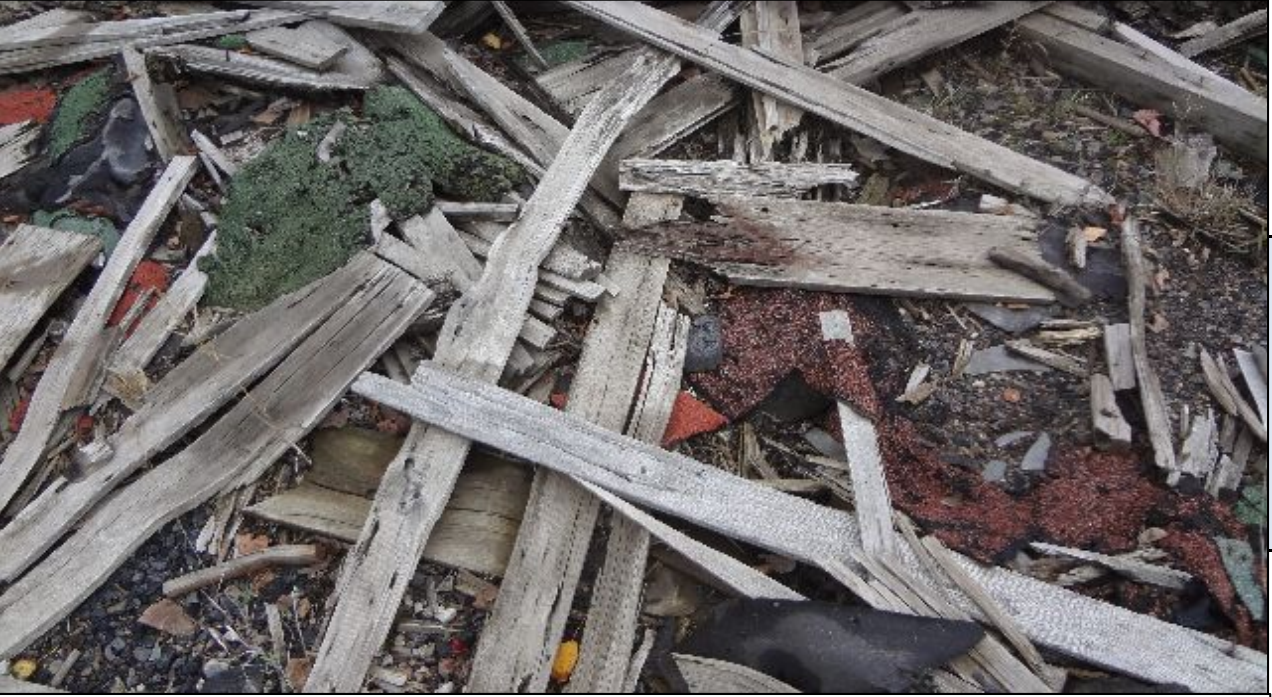
Potential Chemical or Physical Hazards	✓	Location/Coordinates	Description	Estimated Size/Area/Volume	Quantity	Units	Sample Recommendations	Notes
Suspect ACM	✓	Latitude: 47° 10'42.345" Longitude: -88° 25'08.801"	SACM-12 - Transite fragments on the ground surface

Material sample CHLL-ASBBLK19-101414 was collected from the vicinity of location SACM-12 during targeted inspection activities.
Residual Process Materials								
Potentially Abandoned Containers								
Soil Staining/Stressed Vegetation								
Potential PCB or Mercury Containing Equipment								
Other: _____								
Suspect ACM	✓	Latitude: 47° 10'40.282" Longitude: -88° 25'09.893"	SACM -13- Green and red asphaltic roofing material in a debris pile/demolished structure.

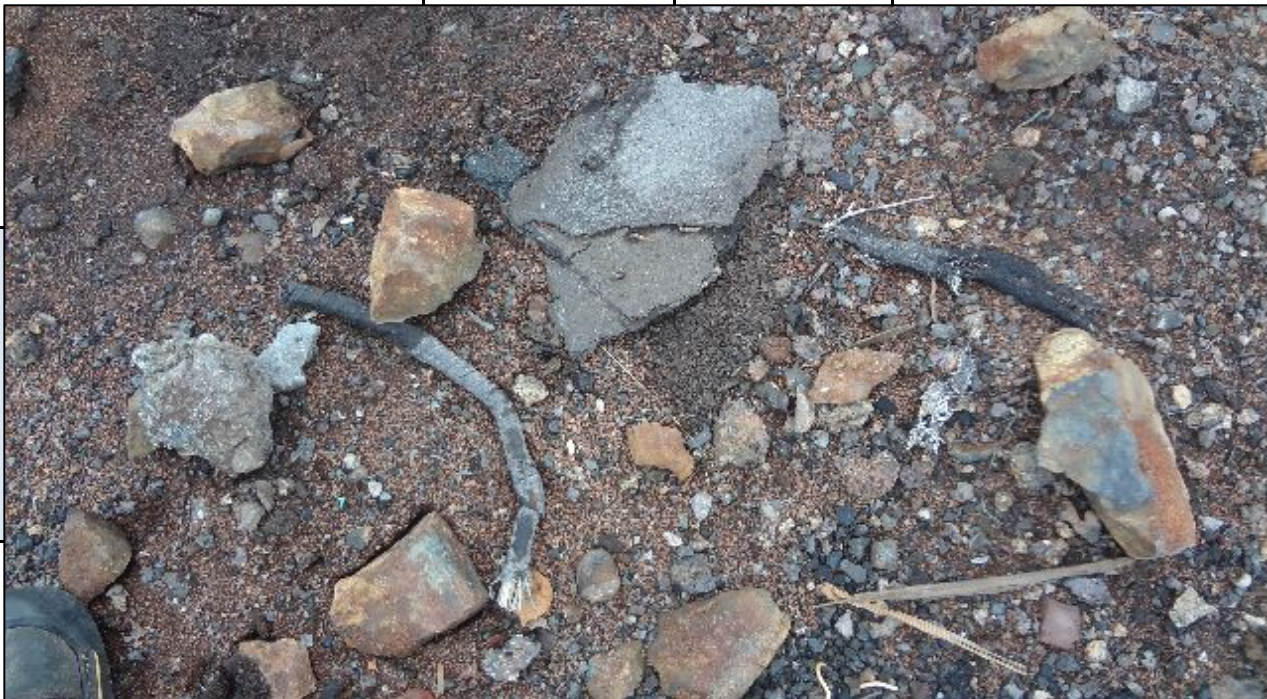
Potential Chemical or Physical Hazards	✓	Location/Coordinates	Description	Estimated Size/Area/Volume	Quantity	Units	Sample Recommendations	Notes
Suspect ACM	✓	Latitude: 47°.177445620	SACM-15 - Black asphaltic roofing material. Potential PCB/asbestos contaminated wire/cable wrap nearby.

Material sample CHLL-ASBBLK24-101414 and surface soil sample CHLL-SS09-101514 were collected from the vicinity of location SACM-15 during targeted inspection activities.
Residual Process Materials								
Potentially Abandoned Containers								
Soil Staining/Stressed Vegetation								
Potential PCB or Mercury Containing Equipment	✓							
Other: _____								
Suspect ACM		Latitude:

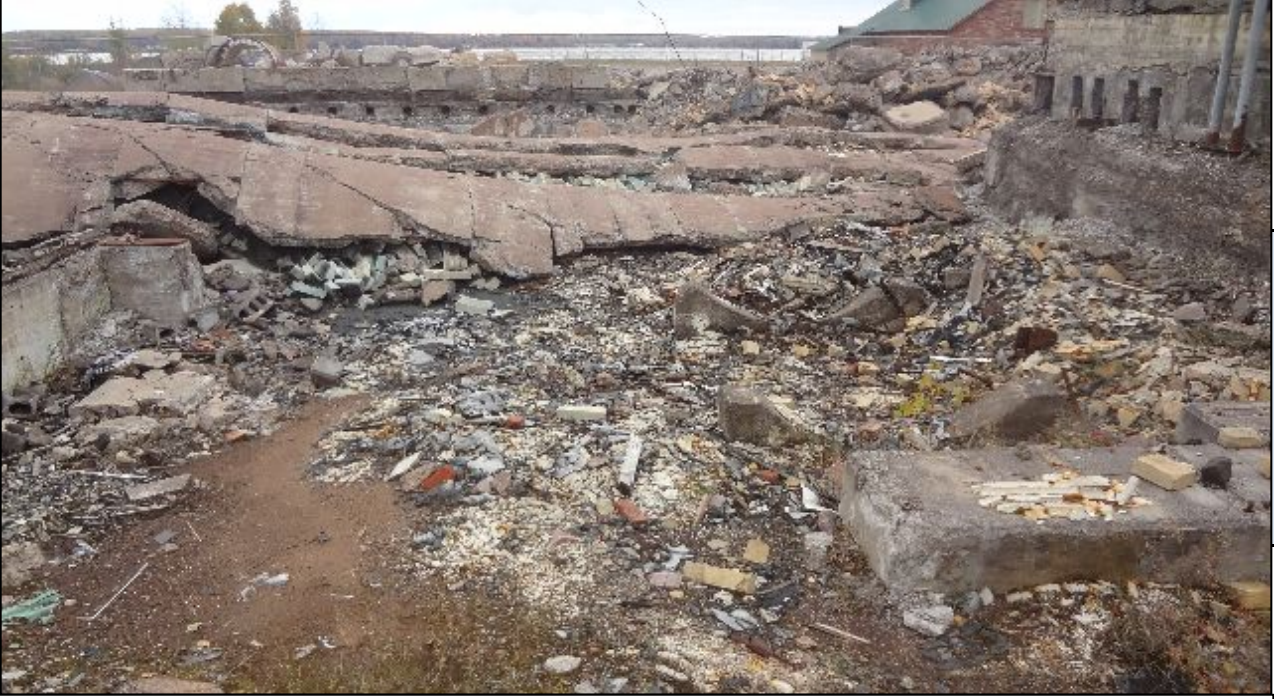
Check as Appropriate:		Record Field Measurements:	Provide Written Description Including Condition, Content, and Similar Material Properties:	Document as Applicable:				
Potential Chemical or Physical Hazards	✓	Location/Coordinates	Description	Estimated Size/Area/Volume	Quantity	Units	Sample Recommendations	Notes
Suspect ACM	✓	Latitude: 47° 10'37.960"	SACM -16 - Transite fragments and black asphaltic roofing material fragments

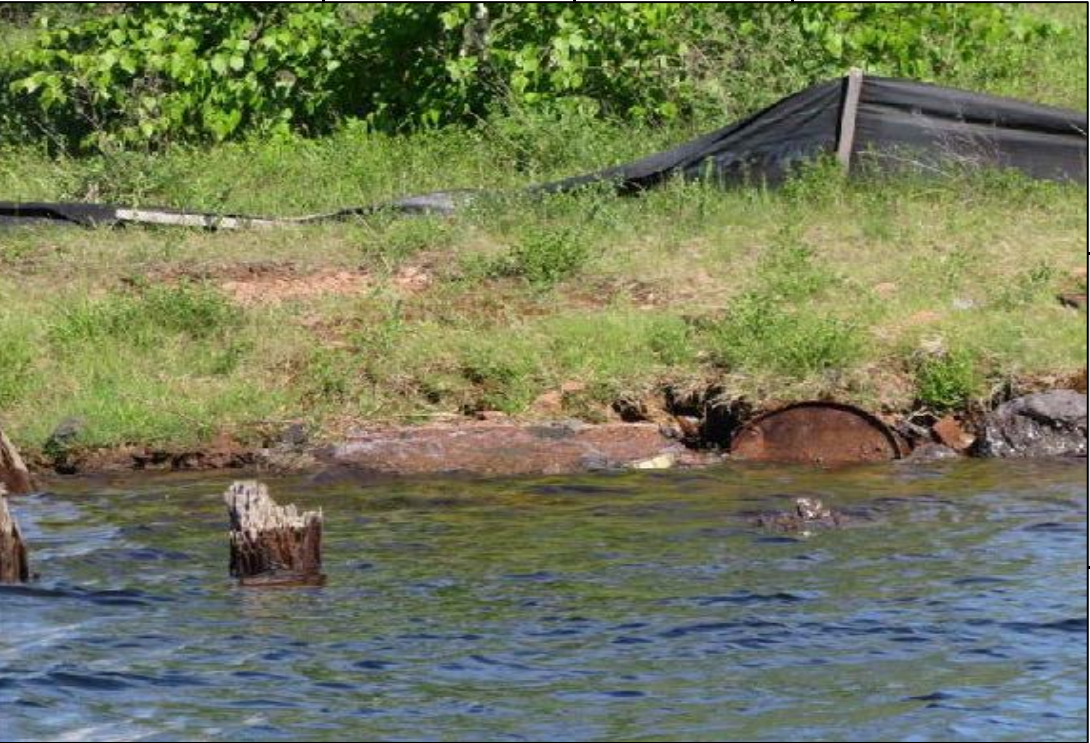
Check as Appropriate:		Record Field Measurements:	Provide Written Description Including Condition, Content, and Similar Material Properties:	Document as Applicable:				
Potential Chemical or Physical Hazards	✓	Location/Coordinates	Description	Estimated Size/Area/Volume	Quantity	Units	Sample Recommendations	Notes
Suspect ACM		Latitude: 47.174503653	SUBMERGED DRUM - An intact submerged drum observed in approximately 1 foot of water

Drum sampling location CHLL-DM04 is representative of the contents of the submerged drum identified during reconnaissance activities.
Residual Process Materials								
Potentially Abandoned Containers	✓							
Soil Staining/Stressed Vegetation		Longitude: -88.422700892						
Potential PCB or Mercury Containing Equipment								
Other: _____								
Suspect ACM		Latitude: 47.17453134	SUBMERGED DRUM CONTENTS - A drum carcass containing black solid material observed in approximately 1 foot of water

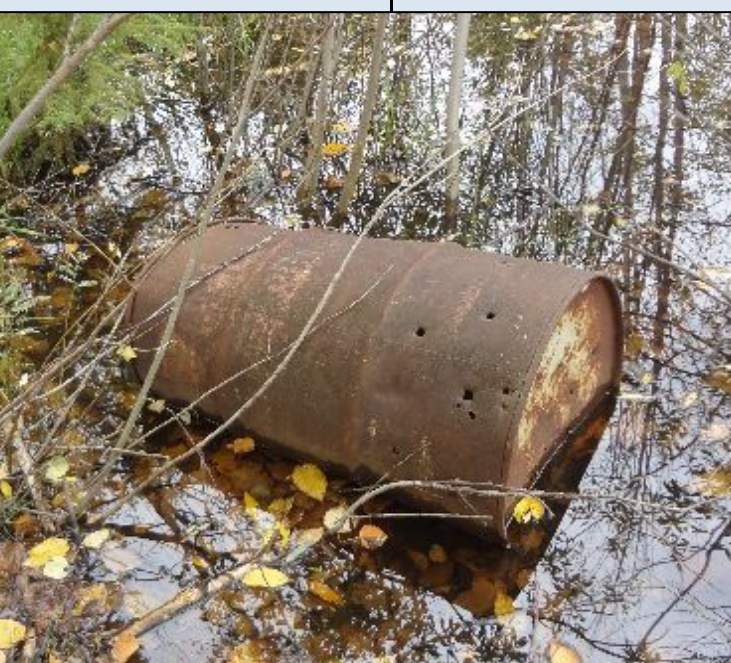
View looking southwest at an abandoned container located on the subject property.

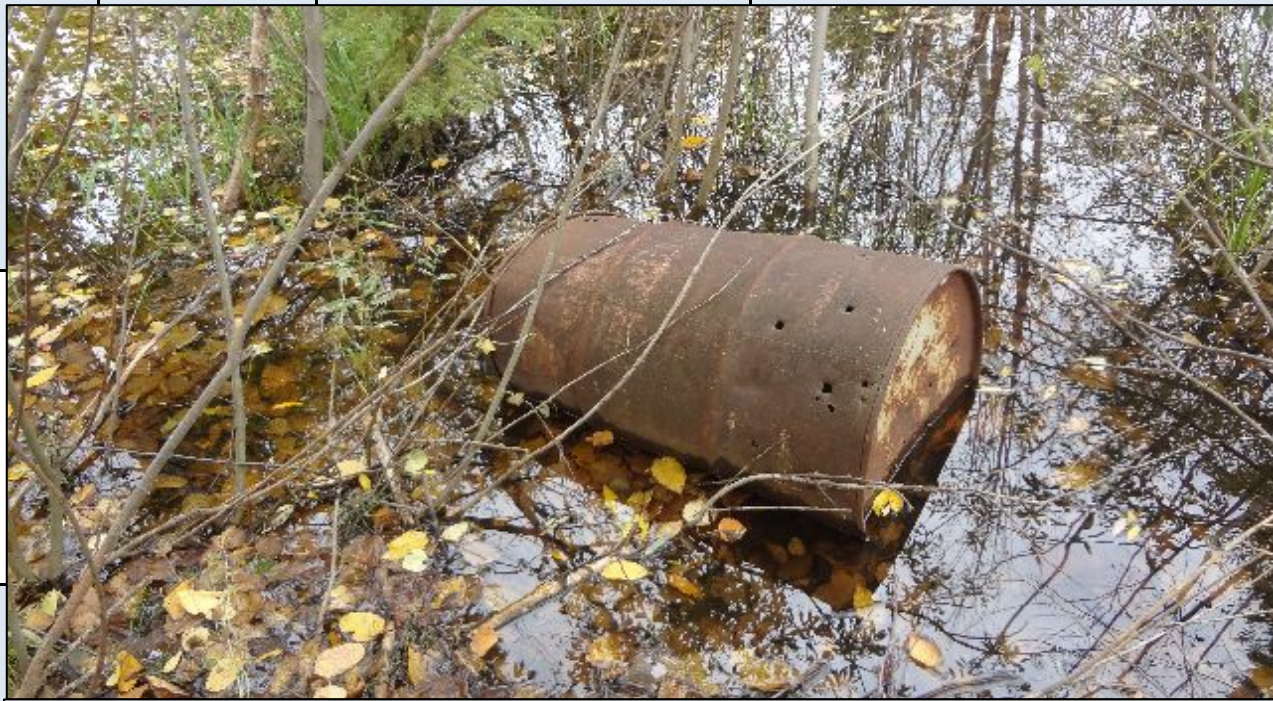
View looking southwest at an abandoned container located on the subject property.
