**ABANDONED MINING WASTES TORCH LAKE NON-SUPERFUND SITE  
CALUMET AND HECLA - LAKE LINDEN OPERATIONS  
TARGETED INSPECTION FORM**

Inspection Date: 10/14/14 Feature Identification/Name COAL DOCK SUBSTATION  
Geographic Area: HUBBEL COAL DOCK Property Identification Number: 014.307.001-25

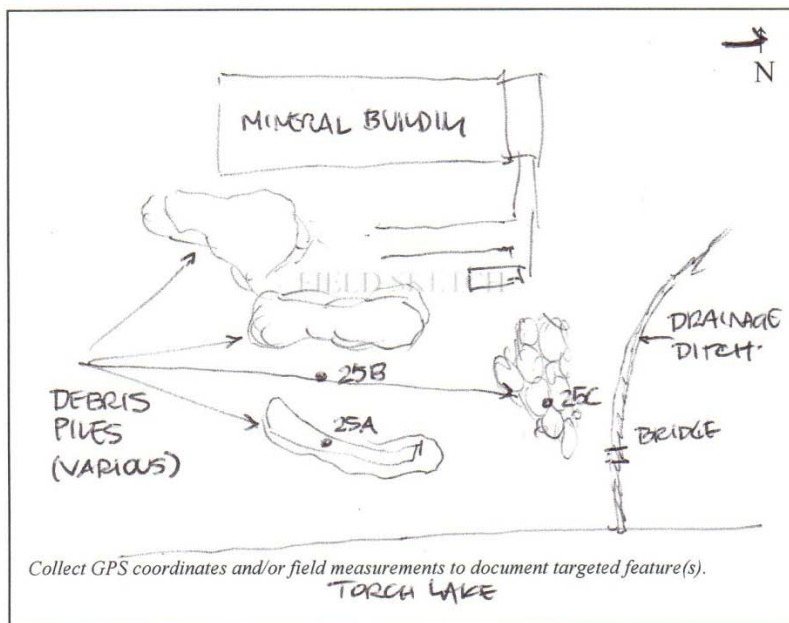
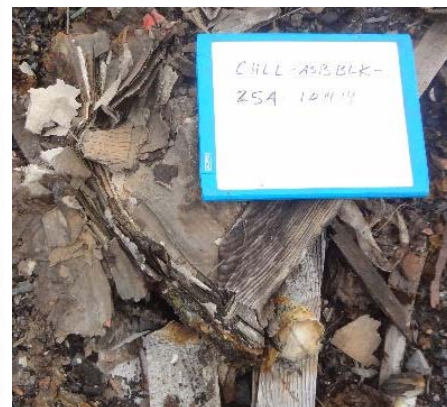
Inspection Date: 10/14/14 Feature Identification/Name DEBRIS PILE - CORRUGATED PAPER

CARDBOARD LIKE CORRUGATED PAPER - PRESENT IN MULTIPLE DEBRIS PILES DAMAGED, WEATHERED, TAN TO GREY DEPENDING ON DEGREE OF WEATHERING

MATERIAL IS GENERALLY PRETTY WEATHERED, WATER AND WIND EROSION COULD TRANSPORT DAMAGED MATERIALS; MATERIAL IS WIDELY DISTRIBUTED ACROSS THE SITE IN PILES WITH PHYSICAL HAZARDS PRESENT.

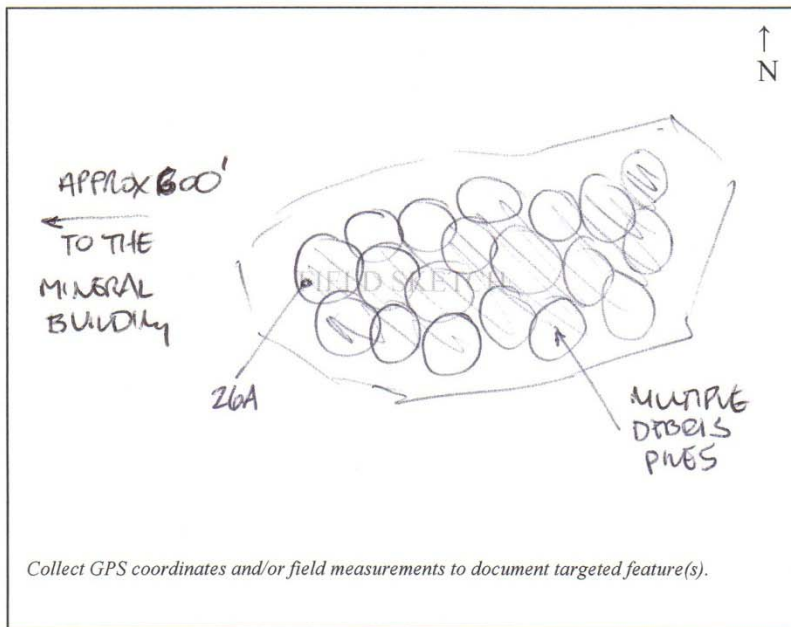
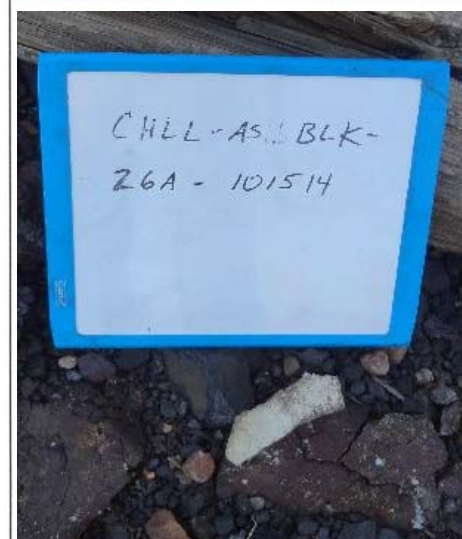
Inspection Date: 10/15/14 Feature Identification/Name DEBRIS PILE / TRANSIT FRAGMENT

COLLECT CHLL-ASB BK-26A-101514 - WHITISH GRAY TRANSIT FRAGMENT, DAMAGED  
SAMPLE COLLECTED AT 0800

DEBRIS PILES PRESENT PHYSICAL HAZARDS TO POTENTIAL MESSENGERS  
WATER AND WIND EROSION PRESENT POTENTIAL CONTAMINANT MIGRATION  
ISSUES, INCREASING POTENTIAL FOR INHALATION EXPOSURE AND DISPERSION IN  
Other Relevant Below and Above Ground Features (Conduit, Drainage Swales, Culverts):  
SOIL

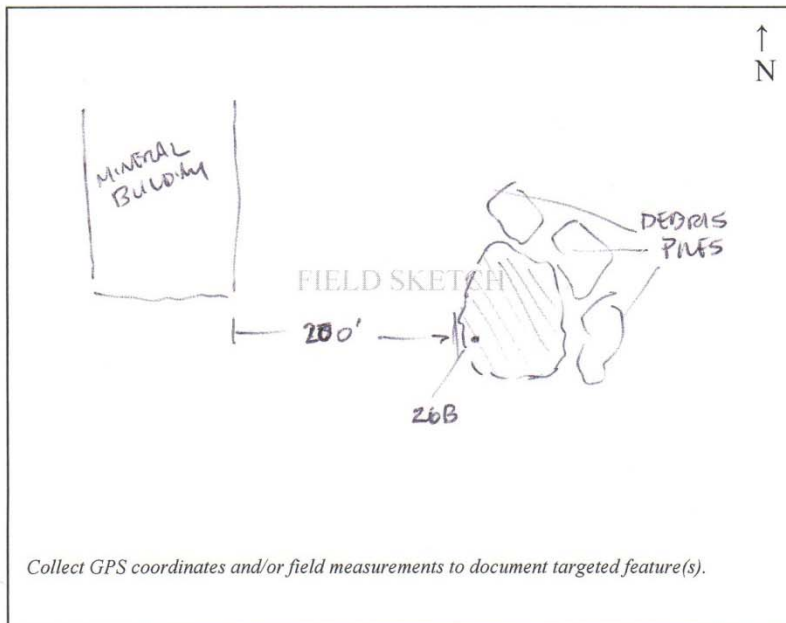
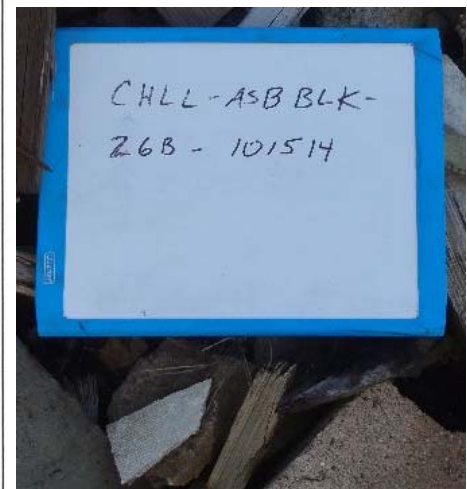
Inspection Date: 10/15/14 Feature Identification/Name DEBRIS PILE - TRANSITE FRAGMENT

CHLL-ASBBLK26B-101514 - WHITISH GRAY TRANSITE FRAGMENT, DAMAGED  
SAMPLE COLLECTED AT 0815

DEBRIS PILES PRESENT PHYSICAL HAZARDS TO POTENTIAL TRESPASSERS.  
WATER AND WIND EROSION PRESENT POTENTIAL CONTAMINANT MIGRATION  
ISSUES, INCREASING POTENTIAL FOR INHALATION EXPOSURE AND DISPERSION  
Other Relevant Below and Above Ground Features (Conduit, Drainage Swales, Culverts):  
IN SOIL

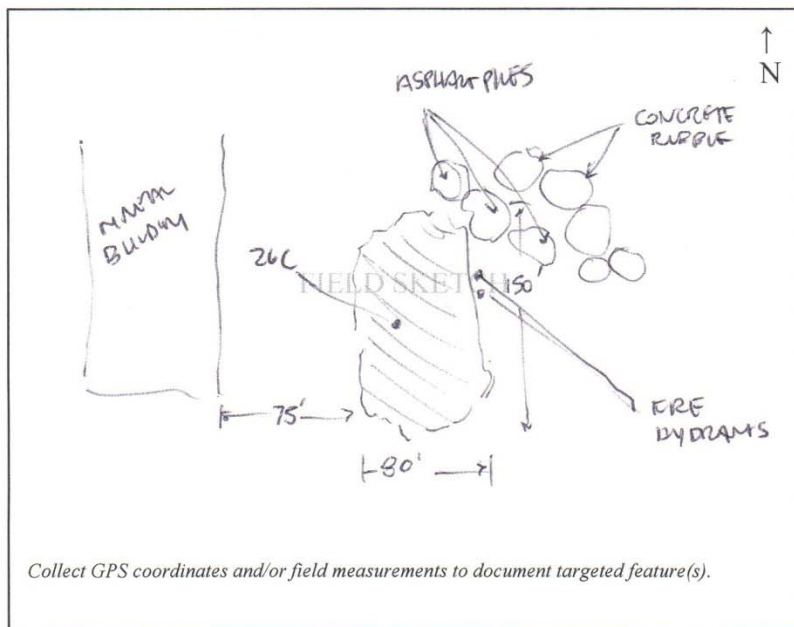
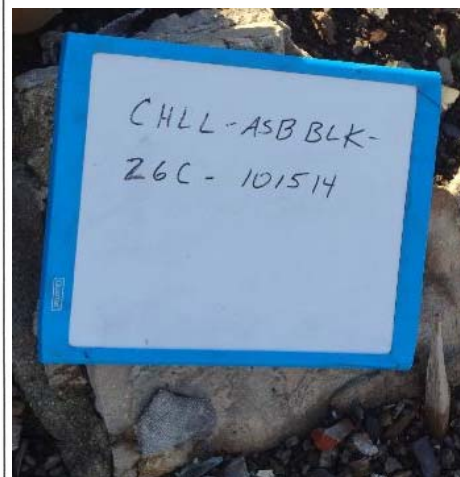
Inspection Date: 10/15/14 Feature Identification/Name: DEBRIS PILE - TRANSIVE FRAGMENT

CHLL-ASBBLK26C-101514 - GRAYISH WHITE TRANSIVE FRAGMENT, DAMAGED  
SAMPLE COLLECTED AT 0820

DEBRIS PILES PRESENT PHYSICAL HAZARDS TO POTENTIAL MESSENGERS  
WATER AND WIND EROSION PRESENT POTENTIAL CONTAMINANT MIGRATION  
ISSUES, INCREASED POTENTIAL FOR INHALATION EXPOSURE AND DISPERSION  
Other Relevant Below and Above Ground Features (Conduit, Drainage Swales, Culverts): IN SOIL

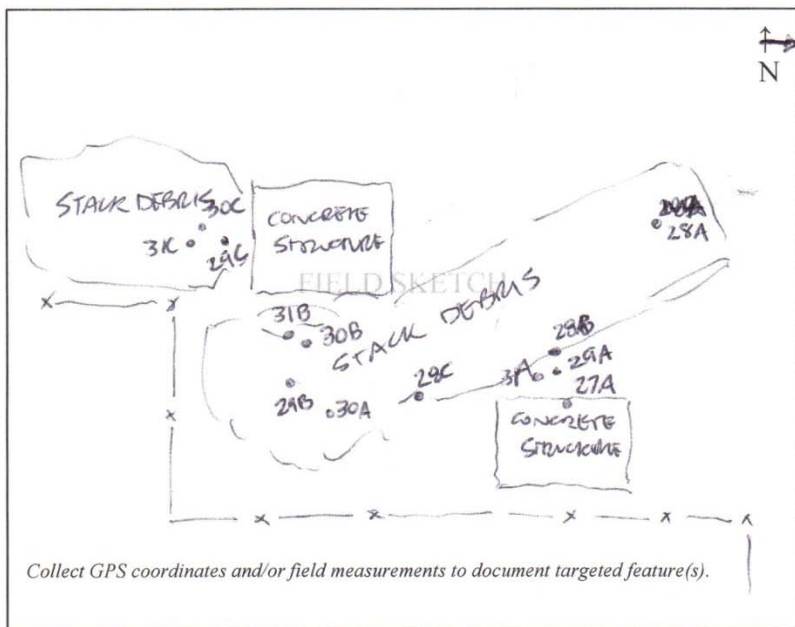
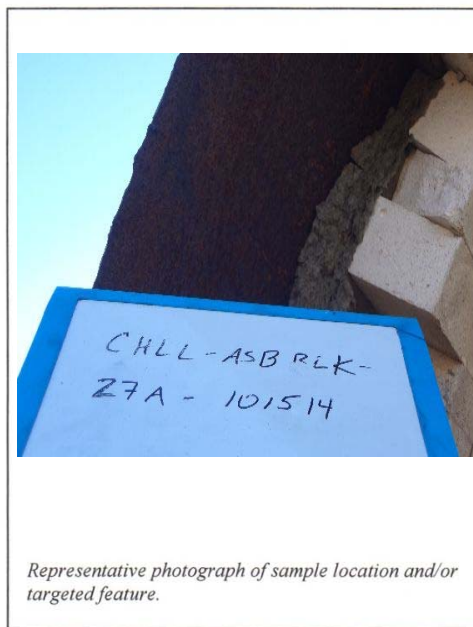
Inspection Date: 10/15/14 Feature Identification/Name SMELTER STACK DEBRIS

AREA NORTH AND WEST OF THE FORMER SMELTER PROPERTY; APPEARS TO BE TWO STACKS ONE NORTH CLOSER TO THE MINERAL BUILDING AND ONE SOUTH; STACKS CONSTRUCTED OF VARIOUS SHAPES AND SIZED FIRE BRICK; FINE GRAINED GREENISH BLUE SEDIMENT ERODING FROM STACK DEBRIS, INFILTRATING ON NEIGHBOR PROPERTY  
**Sampling Activities (Sample Description, Sample Time, Requested Analyses):**  
CHL-ASBBUK27A-101514 - GRAYISH BROWN FIBROUS INSULATING MATERIAL (BETWEEN BRICK AND MORTAR)  
CHL-ASBBUK28A-C-101514 - WHITE (SOME BLUE GREEN STAINED) FIRE BRICK "A.P. GREEN 5x6 KEY"  
CHL-ASBBUK29(A-C)-101514 - ORANGE, BLACK SPECKS, WEOSTER FIRE BRICK.

POTENTIAL DIRECT CONTACT, INHALATION HAZARDS TO TRESSPASSERS AND POTENTIALLY WORKERS  
**Other Relevant Below and Above Ground Features (Conduit, Drainage Swales, Culverts):**  
STACK DEBRIS PILES APPEARS AS IF IT WAS LEFT IN PLACE AFTER BEING KNOCKED DOWN DEBRIS FIELD IS LARGE WITH NUMEROUS PHYSICAL HAZARDS, METAL DEBRIS, BRICK AND UNEVEN TERRAIN; WATER AND WIND EROSION APPEAR TO BE WASHING MATERIAL FROM THE STACK PILE AND IS ENCRACHING ON NEIGHBORING PROPERTY

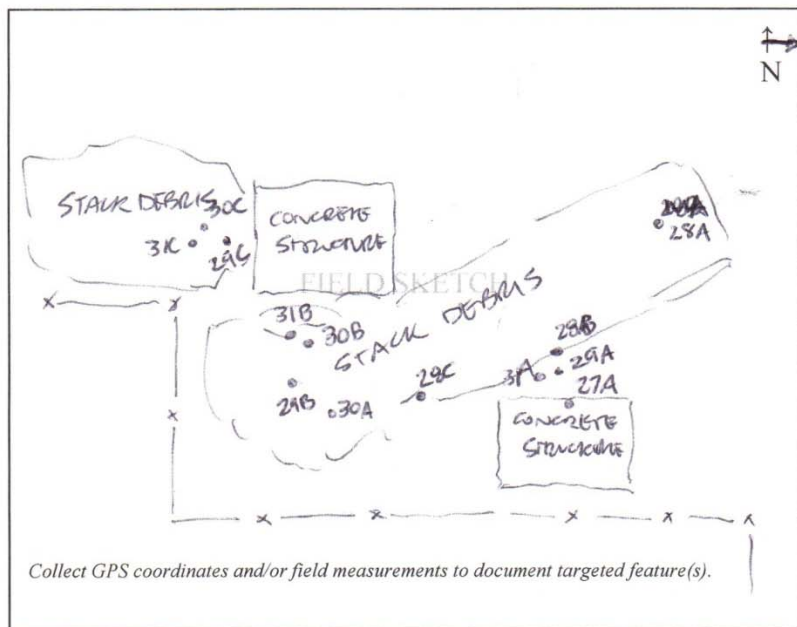
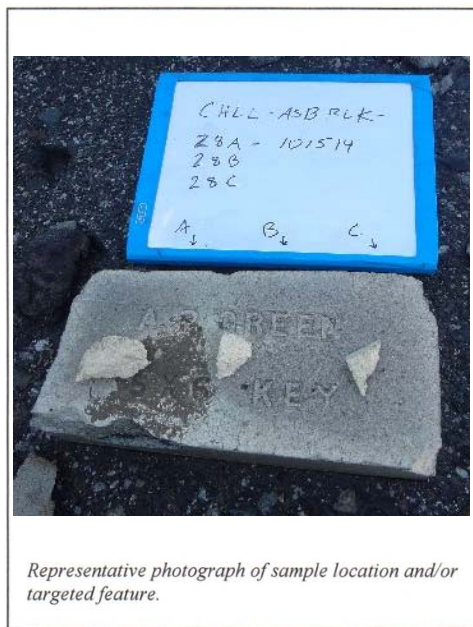
Inspection Date: 10/15/14 Feature Identification/Name SMEALTER STACK DEBRIS

AREA NORTH AND WEST OF THE FORMER SMEALTER PROPERTY; APPEARS TO BE TWO STACKS ONE NORTH CLOSER TO THE MINERAL BUILDING AND ONE SOUTH; STACKS CONSTRUCTED OF VARIOUS SHAPES AND SIZED FIRE BRICK; FINE GRAINED GREENISH BLUE SEDIMENT ERODING FROM STACK DEBRIS, INFILTRATING ON NEIGHBOR PROPERTY  
Sampling Activities (Sample Description, Sample Time, Requested Analyses):  
CHL-ASBBUK27A-101514 - GRAYISH BROWN FIBROUS INSULATING MATERIAL (BETWEEN BRICK AND MORTAR)  
CHL-ASBBUK28A-C-101514 - WHITE (SOME BLUE GREEN STAINED) FIRE BRICK "A.P. GREEN 5x6 KEY"  
CHL-ASBBUK29(A-C)-101514 - ORANGE, BLACK SPECKS, WEOSTER FIRE BRICK.

POTENTIAL DIRECT CONTACT, INHALATION HAZARDS TO TRESPASSERS AND POTENTIALLY WORKERS  
Other Relevant Below and Above Ground Features (Conduit, Drainage Swales, Culverts):  
STACK DEBRIS PILES APPEARS AS IF IT WAS LEFT IN PLACE AFTER BEING KNOCKED DOWN DEBRIS FIELD IS LARGE WITH NUMEROUS PHYSICAL HAZARDS, METAL DEBRIS, BRICK AND UNEVEN TERRAIN; WATER AND WIND EROSION APPEAR TO BE WASHING MATERIAL FROM THE STACK PILE AND IS ENCRORACHING ON NEIGHBORING PROPERTY

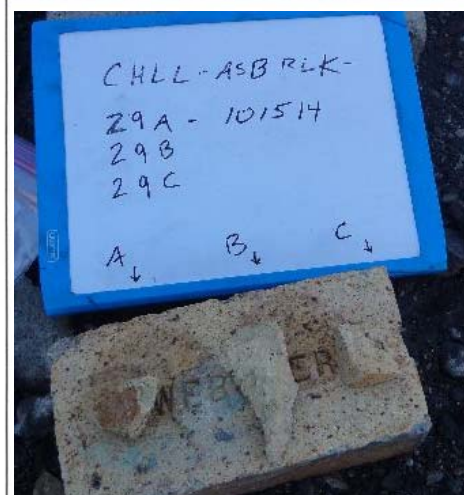
Inspection Date: 10/15/14 Feature Identification/Name SMELTER STACK DEBRIS

AREA NORTH AND WEST OF THE FORMER SMELTER PROPERTY; APPEARS TO BE TWO STACKS ONE NORTH CLOSER TO THE MINERAL BUILDING AND ONE SOUTH; STACKS CONSTRUCTED OF VARIOUS SHAPES AND SIZED FIRE BRICK; FINE GRAINED GREENISH BLUE SEDIMENT ERODING FROM STACK DEBRIS, INFILTRATING ON NEIGHBOR PROPERTY  
**Sampling Activities (Sample Description, Sample Time, Requested Analyses):**  
CHL-ASBBUK27A-101514 - GRAYISH BROWN FIBROUS INSULATING MATERIAL (BETWEEN BRICK AND MORTAR)  
CHL-ASBBUK28A-C-101514 - WHITE (SOME BLUE GREEN STAINED) FIRE BRICK "A.P. GREEN 5x6 KEY"  
CHL-ASBBUK29(A-C)-101514 - ORANGE, BLACK SPECKS, WEOSTER FIRE BRICK.

POTENTIAL DIRECT CONTACT, INHALATION HAZARDS TO TRESSPASSERS AND POTENTIALLY WORKERS  
**Other Relevant Below and Above Ground Features (Conduit, Drainage Swales, Culverts):**  
STACK DEBRIS PILES APPEARS AS IF IT WAS LEFT IN PLACE AFTER BEING KNOCKED DOWN DEBRIS FIELD IS LARGE WITH NUMEROUS PHYSICAL HAZARDS, METAL DEBRIS, BRICK AND UNEVEN TERRAIN; WATER AND WIND EROSION APPEAR TO BE WASHING MATERIAL FROM THE STACK PILE AND IS ENCRACHING ON NEIGHBORING PROPERTY

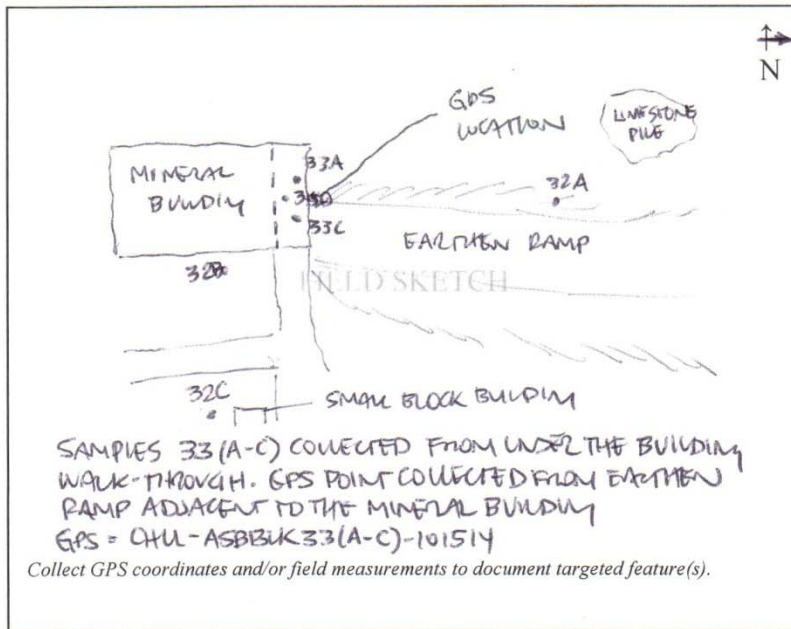
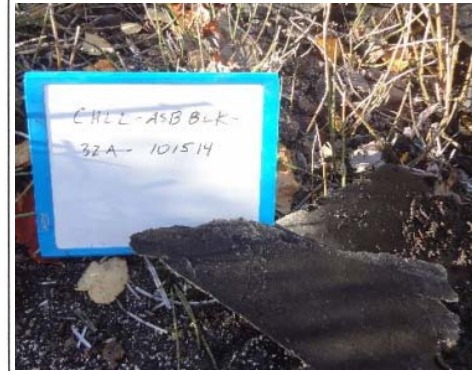
Inspection Date: 10/15/14 Feature Identification/Name MINERAL BUILDING - PLASTER & ROOFING

**Other Relevant Below and Above Ground Features (Conduit, Drainage Swales, Culverts):** TRANSPORT OF THE TRESSPASSERS COULD BE EXPOSED TO DAMAGED MATERIALS. DAMAGED MATERIALS

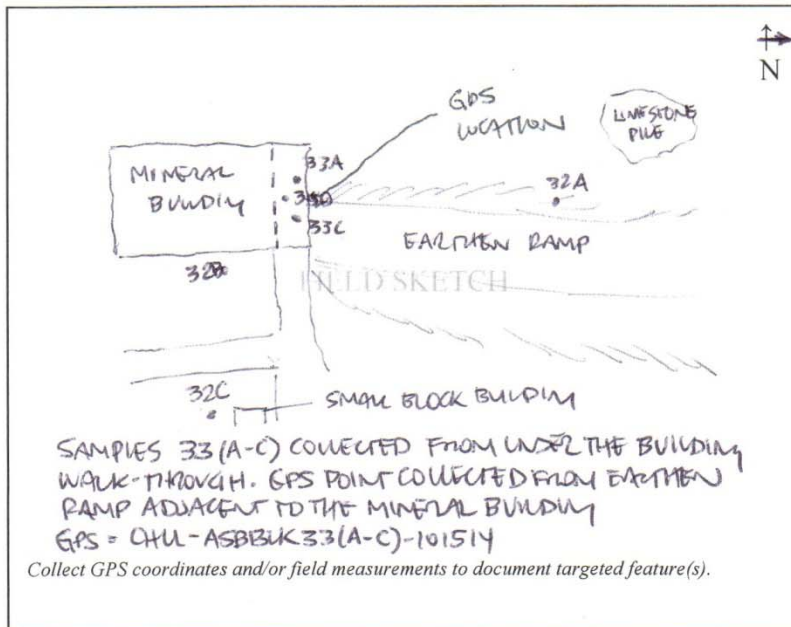
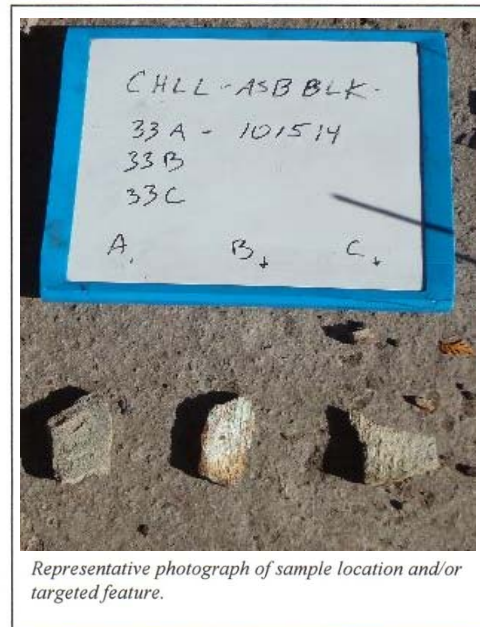
Inspection Date: 10/15/14 Feature Identification/Name MINERAL BUILDING - PLASTER & ROOFING

**Other Relevant Below and Above Ground Features (Conduit, Drainage Swales, Culverts):** TRANSPORT OF THE TRESSPASSERS COULD BE EXPOSED TO DAMAGED MATERIALS. DAMAGED MATERIALS

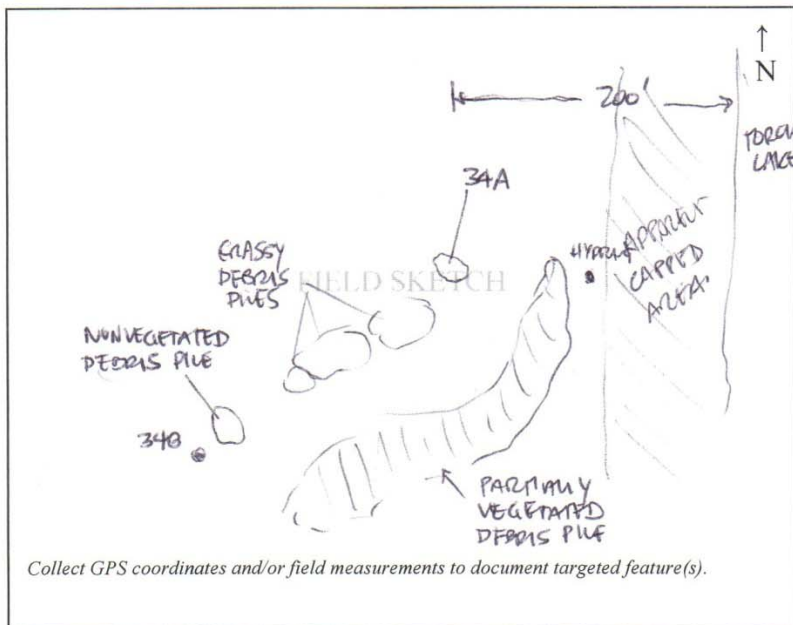
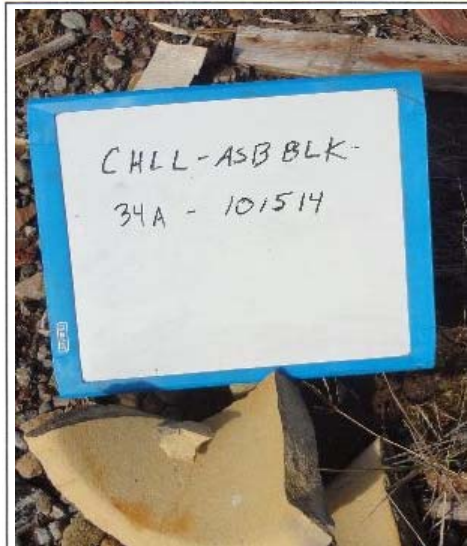
Inspection Date: 10/15/14 Feature Identification/Name MINERAL BUILDING - DEBRIS PILE

MATERIALS ARE DAMAGED, BUT GENERALLY APPEAR TO BE RESISTANT TO EROSION FORCES, COLORS ARE NOT OBVIOUSLY DULLED OR DEGRADING; PILES ARE SMALL, BETWEEN 5-10' IN DIAMETER, LESS THAN 1 FOOT TALL, - PHYSICAL HAZARDS ARE LIMITED

OVERALL AREA IS COVERED BY WASTE PILES, BLACK CINDER MATERIAL AND STRESSED VEGETATION, PILE (34A) IS LOCATED IN STANDING WATER

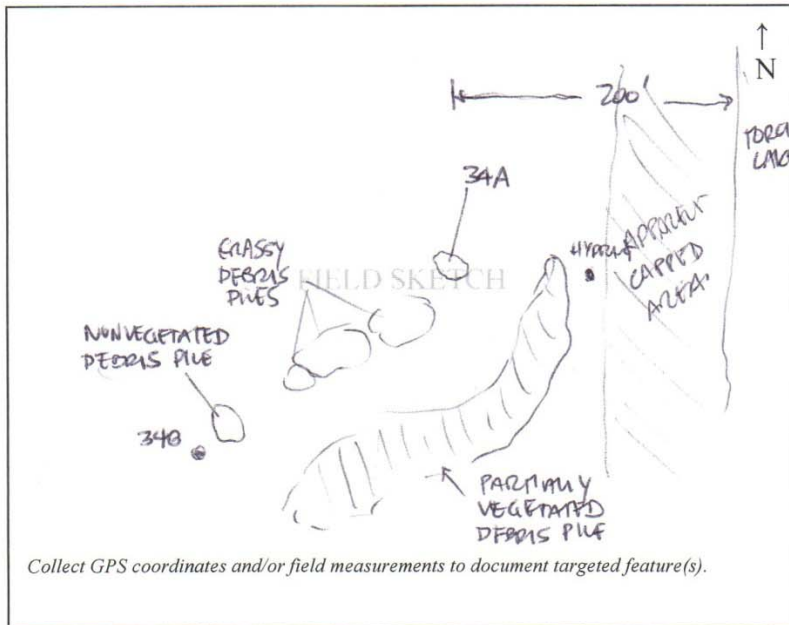
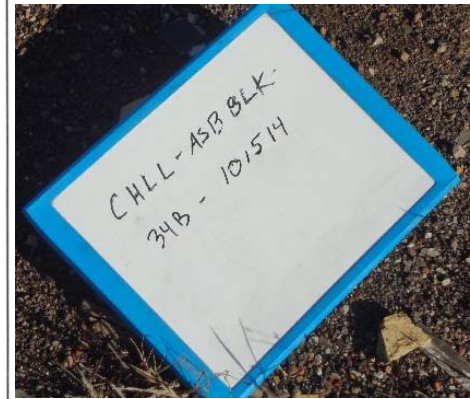
Inspection Date: 10/15/14 Feature Identification/Name MINERAL BUILDING - DEBRIS PILE

MATERIALS ARE DAMAGED, BUT GENERALLY APPEAR TO BE RESISTANT TO EROSION FORCES, COLORS ARE NOT OBVIOUSLY DULLED OR DEGRADING; PILES ARE SMALL, BETWEEN 5-10' IN DIAMETER, LESS THAN 1 FOOT TALL, - PHYSICAL HAZARDS ARE LIMITED

OVERALL AREA IS COVERED BY WASTE PILES, BLACK CINDER MATERIAL AND STRESSED VEGETATION, PILE (34A) IS LOCATED IN STANDING WATER

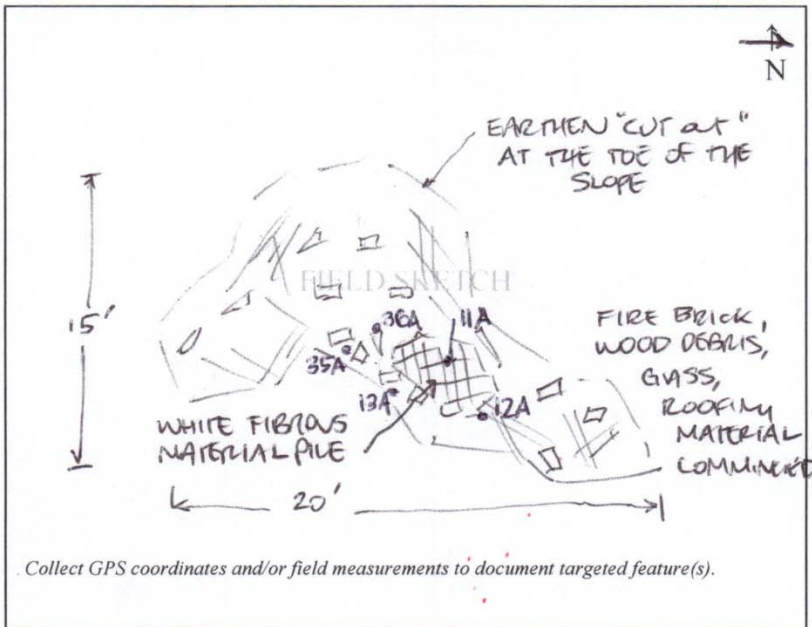
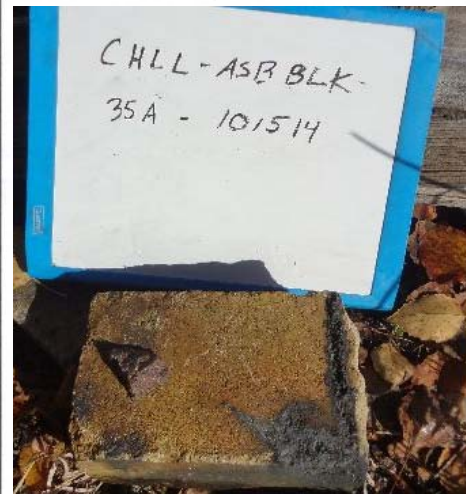
Inspection Date: 10/14/14 Feature Identification/Name COMMINGLED DEBRIS PILE

DEBRIS PILE ALONG THE HILLSIDE INCLUDES BRICK AND BUILDING MATERIALS, WOOD DEBRIS WITH A WHITISH GREY FIBROUS PILE IN THE MIDDLE; MATERIAL IS DAMAGED AND FRAGILE; POTENTIAL EXPOSURE TO TRESPASSERS DUE TO SACM

CHL-ASBBLK35A-101514: PINK FIRE BRICK  
CHL-ASBBLK36A-101514: YELLOWISH ORANGE FIRE BRICK  
SAMPLES COLLECTED AT 1030

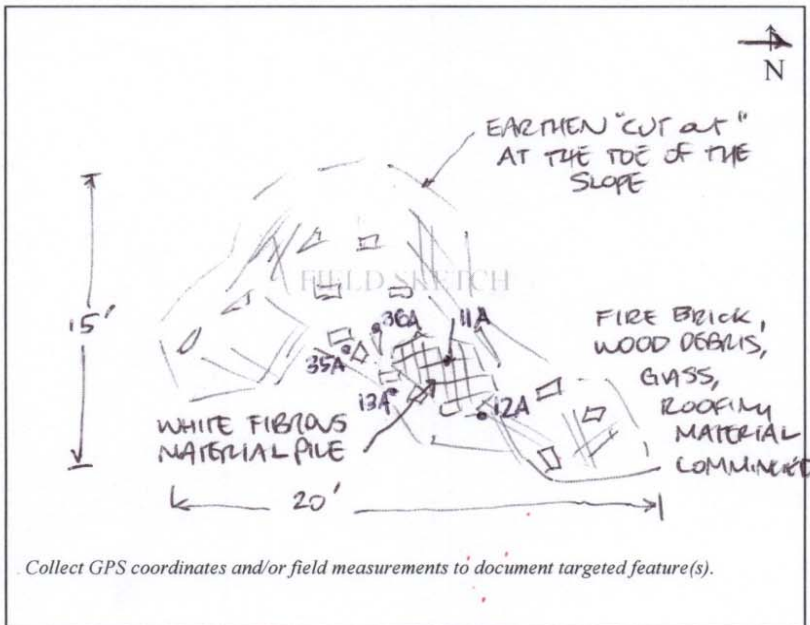
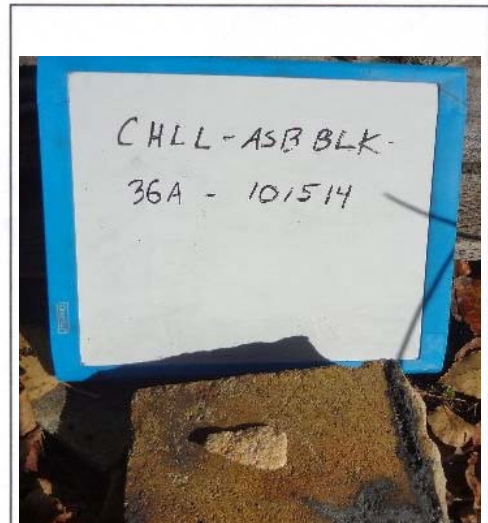
Inspection Date: 10/14/14 Feature Identification/Name COMMINUED DEBRIS PILE

DEBRIS PILE ALONG THE HILLSIDE INCLUDES BRICK AND BUILDING MATERIALS, WOOD DEBRIS WITH A WHITISH GREY FIBROUS PILE IN THE MIDDLE; MATERIAL IS DAMAGED AND FRAGILE; POTENTIAL EXPOSURE TO TRESPASSERS DUE TO SACM

CHL-ASBBLK35A-101514: PINK FIRE BRICK  
CHL-ASBBLK36A-101514: YELLOWISH ORANGE FIRE BRICK  
SAMPLES COLLECTED AT 1030
