Appendix E
Monitoring Well Plugging and
Abandonment Reports

*2015 Monitoring Well Abandonment
Report*

Monitoring Well Abandonment Summary

GE Apparatus Service Center
18075 Krause Street, Riverview, Michigan

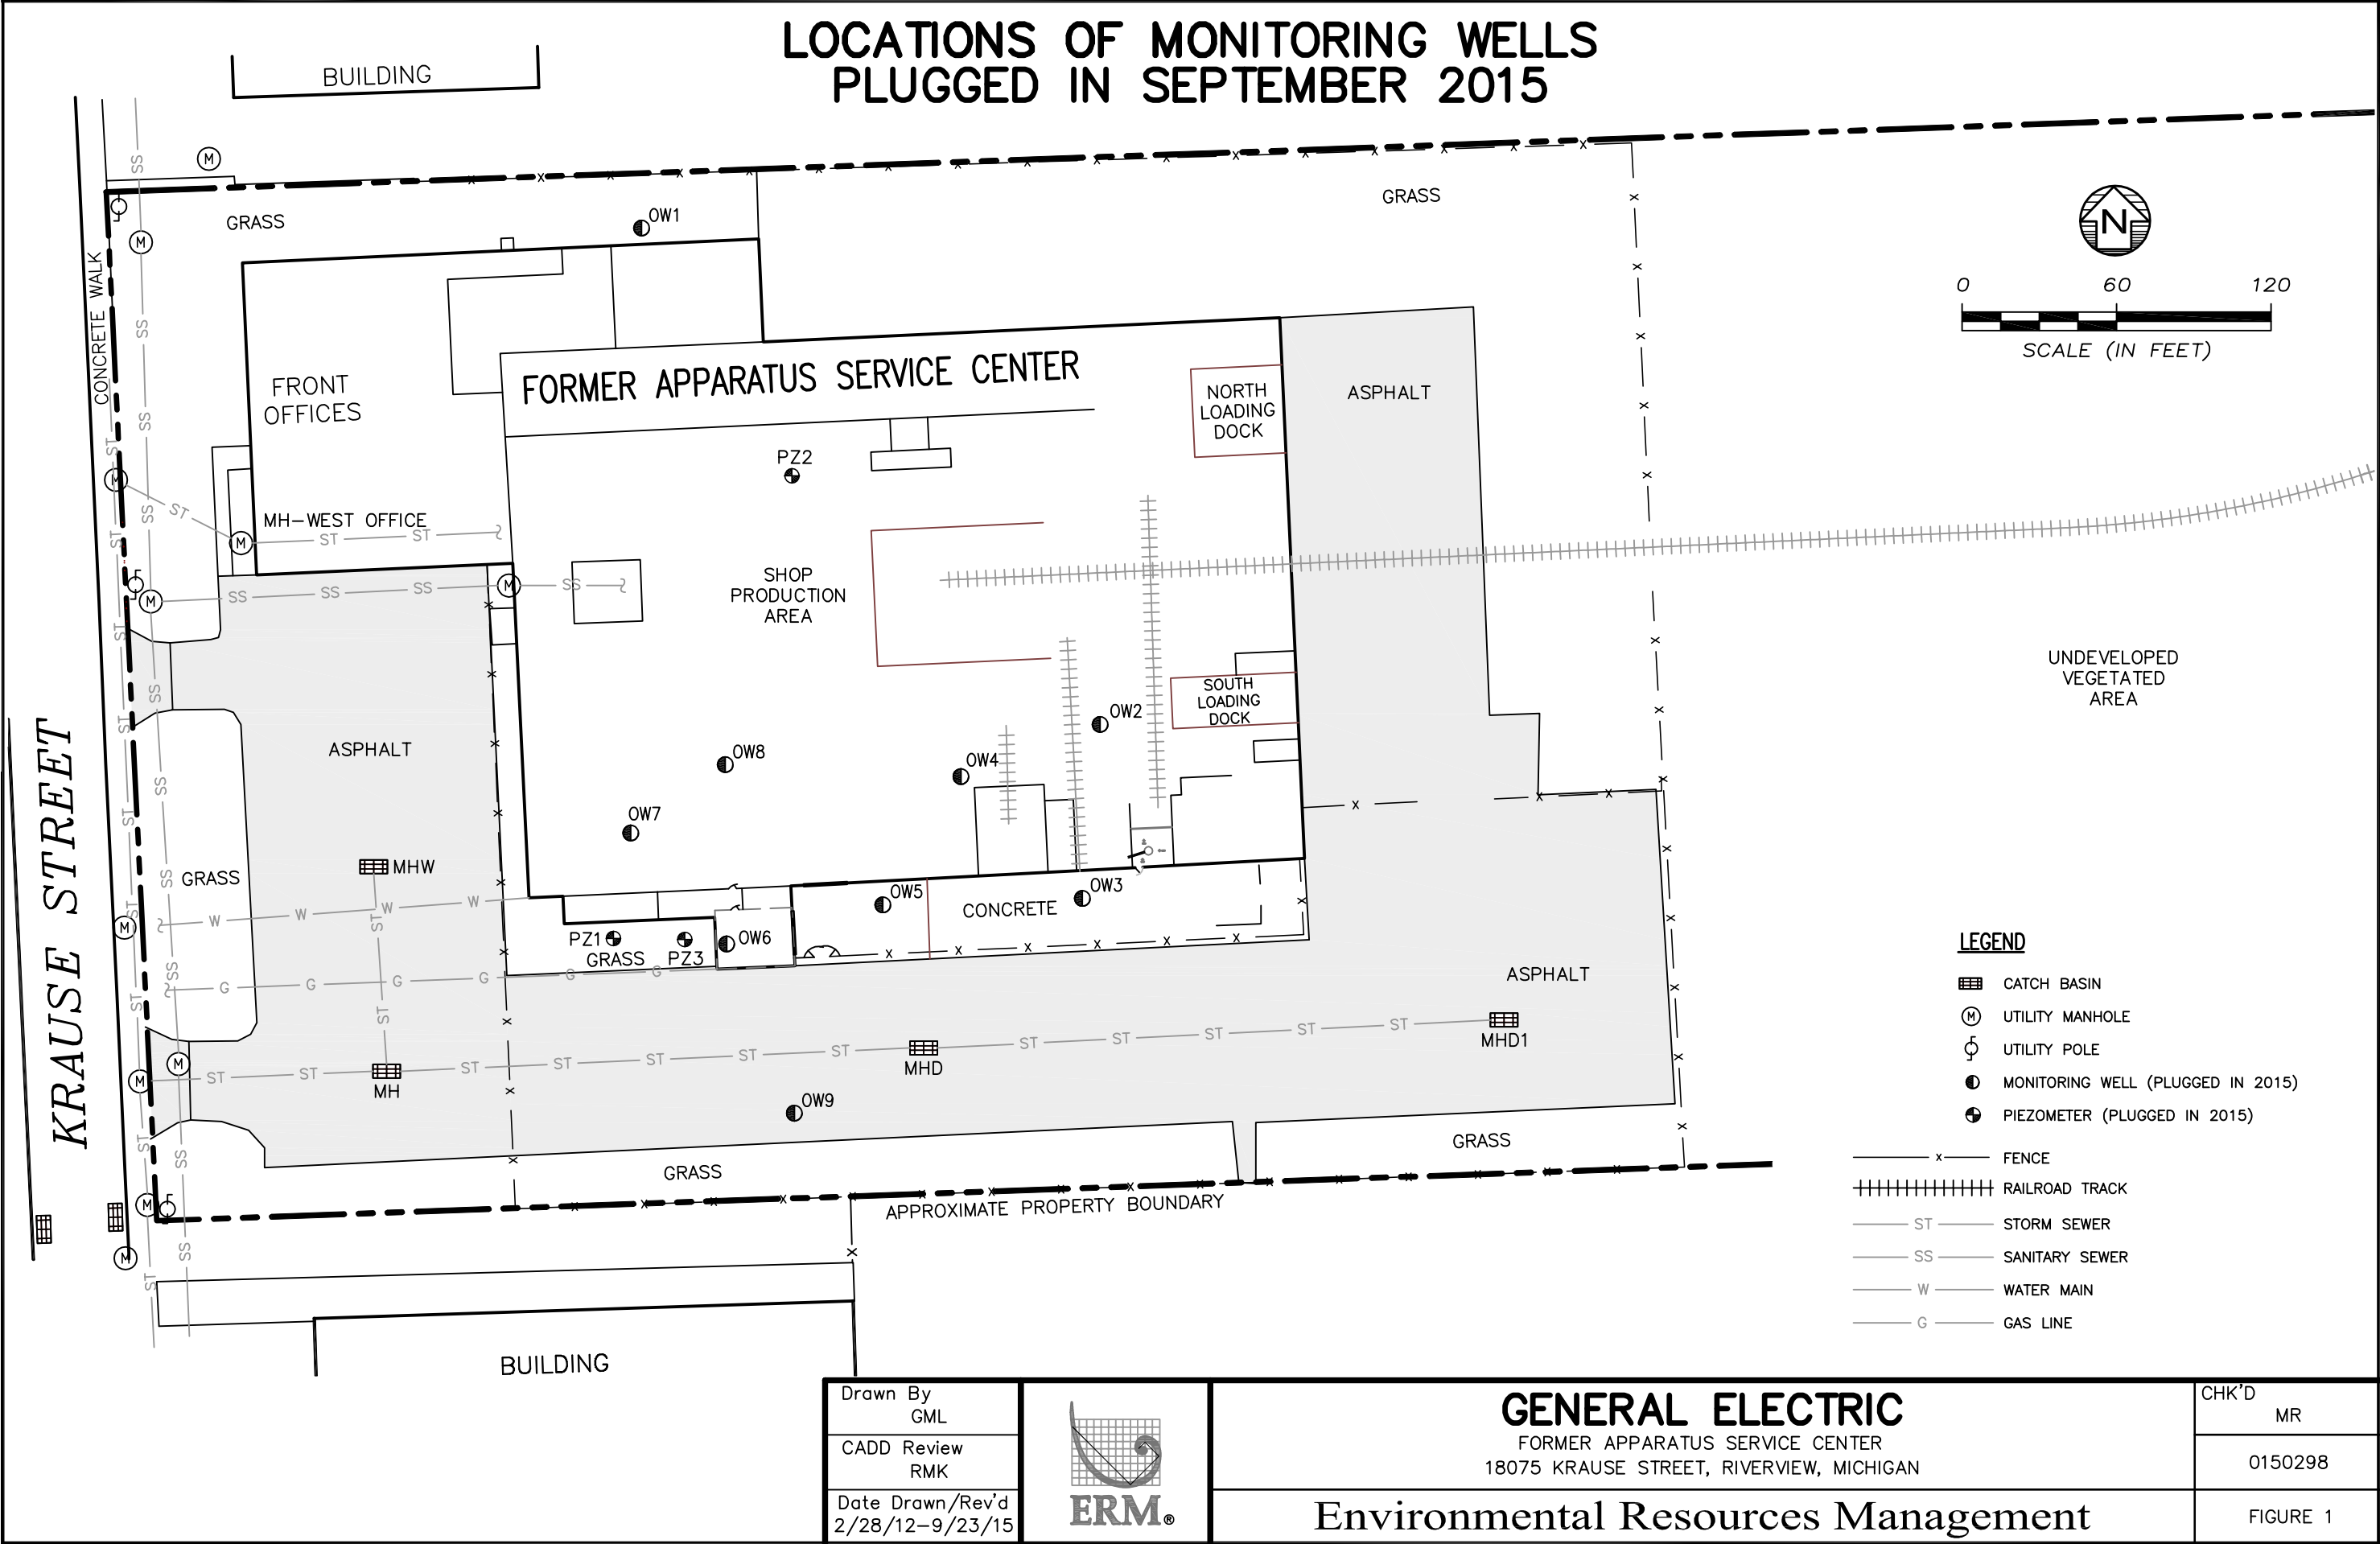
PZ3	3.5	Bentonite	Screen/casing removed
OW1	10	Bentonite	Screen/casing removed
OW2	9	Bentonite	Screen/casing removed
OW3	8	Bentonite	Screen/casing removed
OW4	8.5	Bentonite	Screen/casing removed
OW5	8	Bentonite	Only four feet of casing could be pulled from borehole due to casing break.
OW6	9	Bentonite	Screen/casing removed
OW7	8.5	Bentonite	Screen/casing removed
OW8	9	Bentonite	Screen/casing removed
OW9	9	Bentonite	Screen/casing removed, last six inches of sealed borehole were capped with concrete.

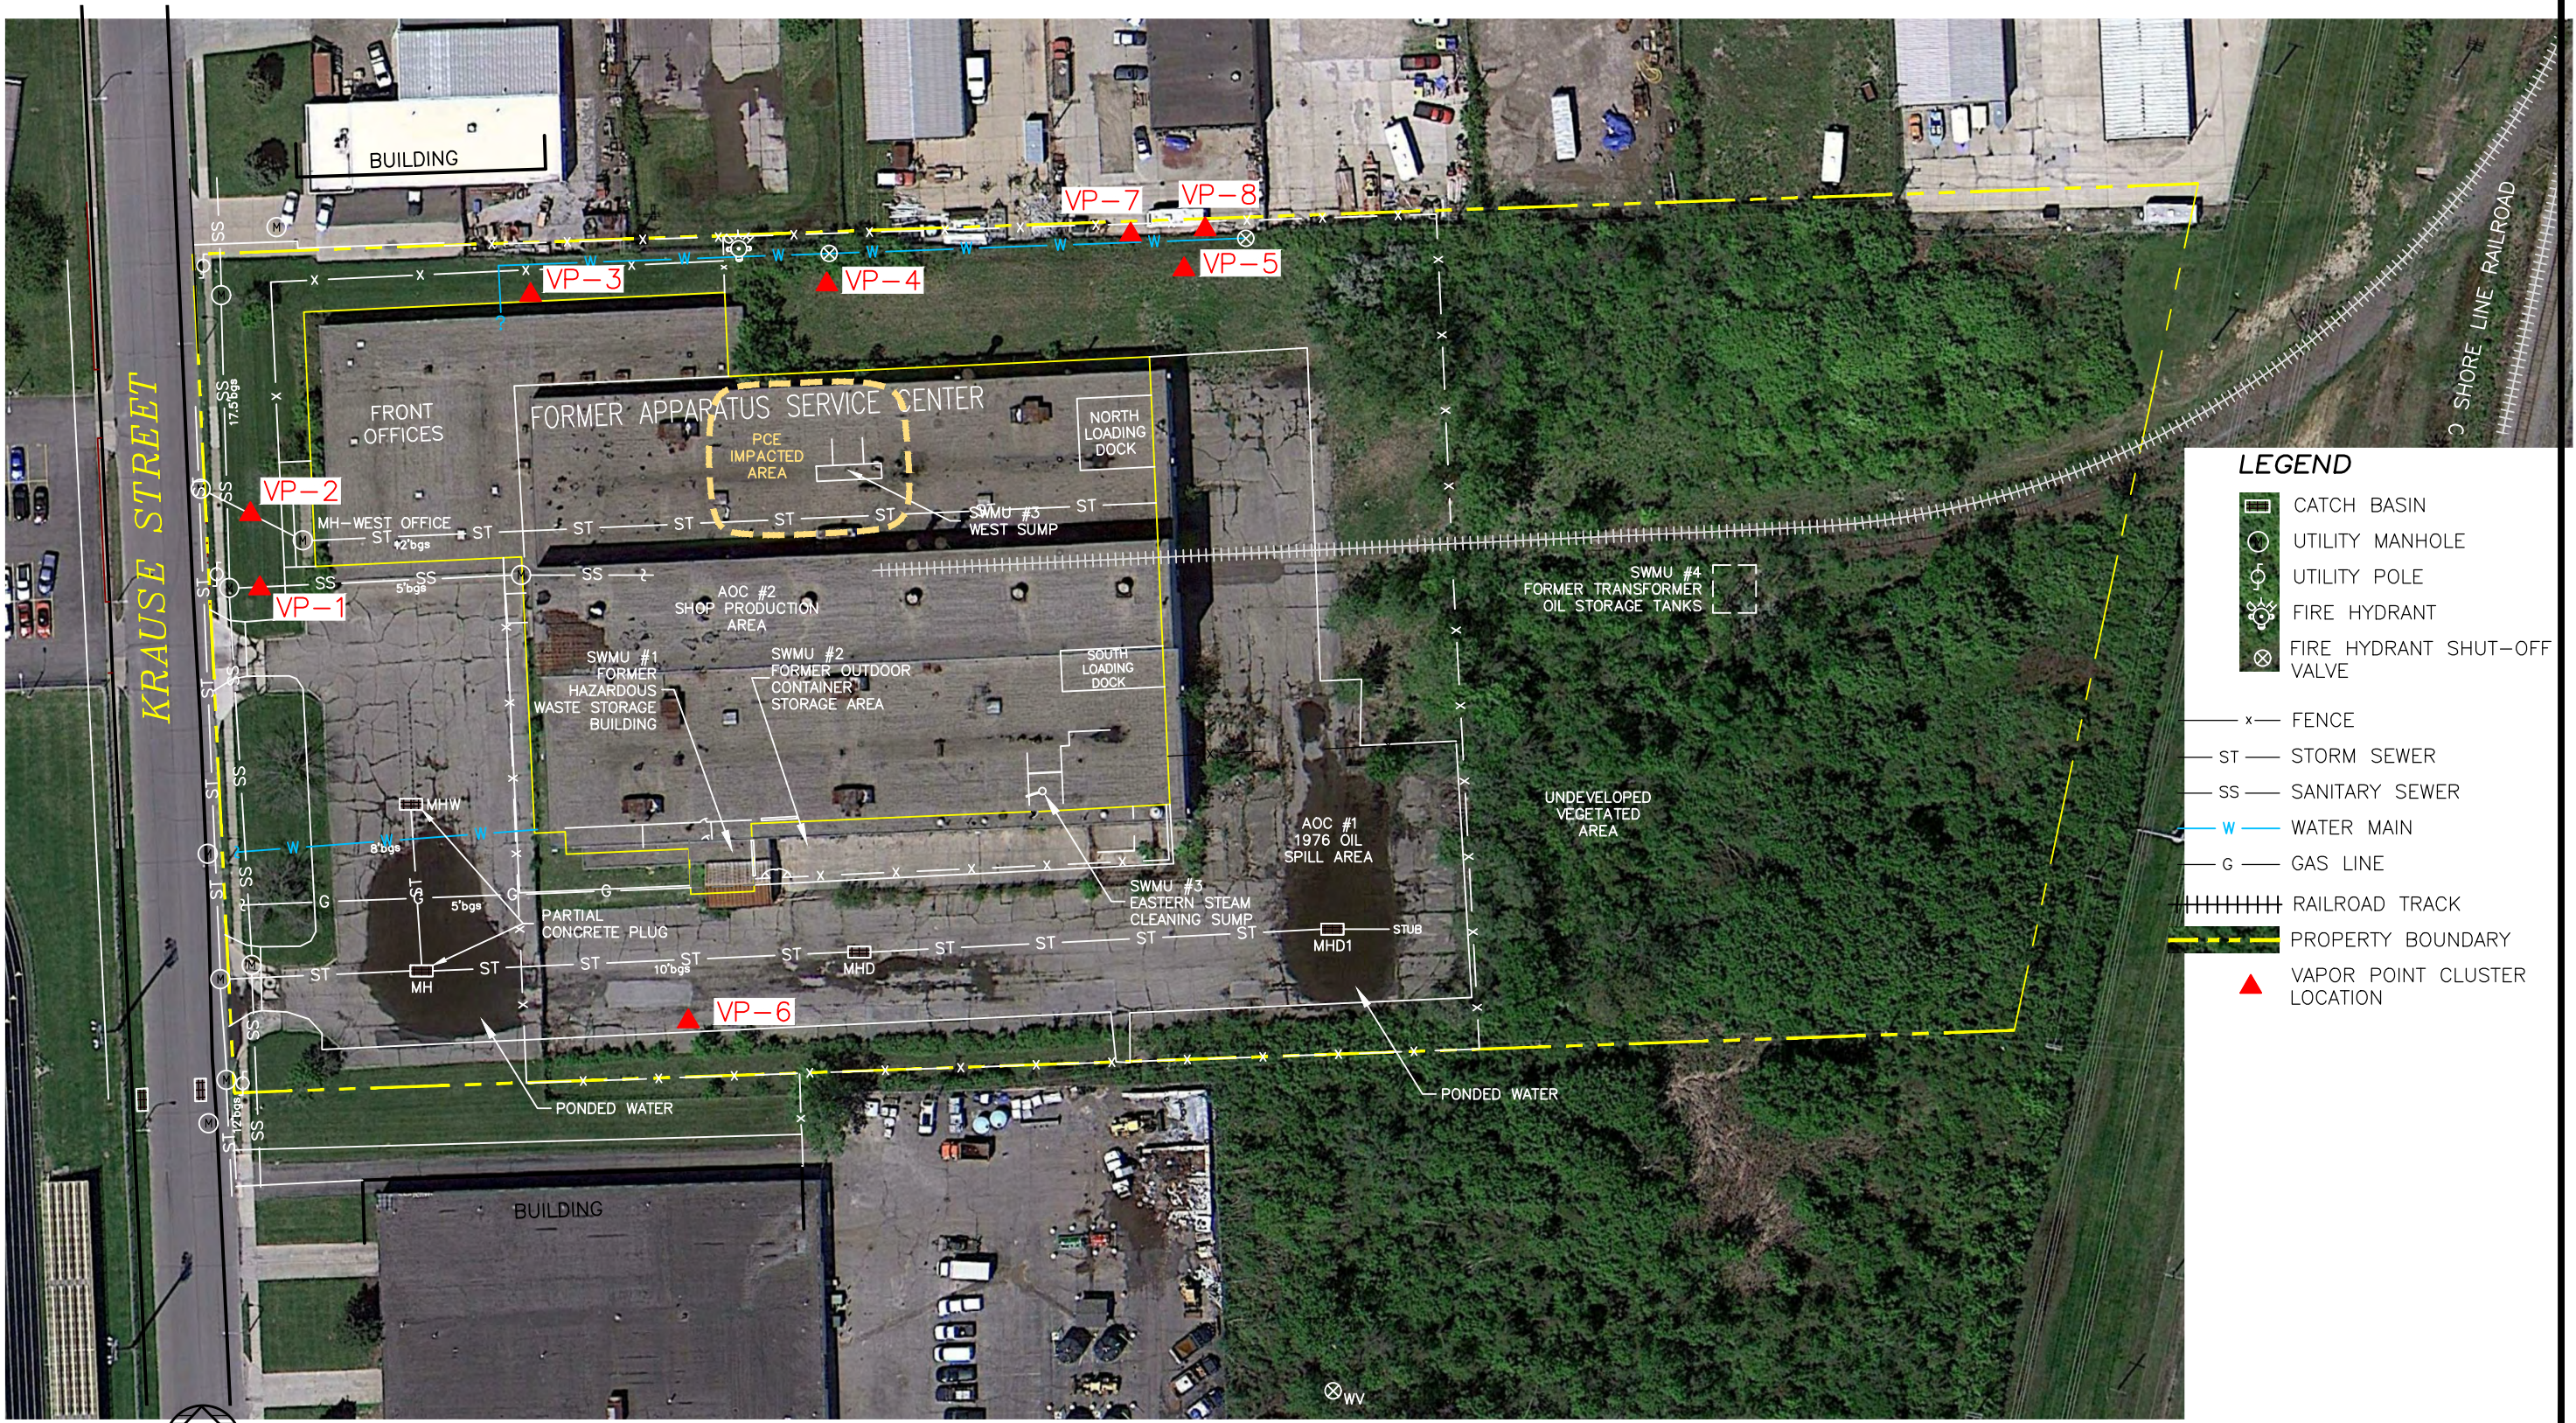
FORMER MONITORING WELL AND SOIL VAPOR PROBE LOCATIONS

Eight wells and ten soil vapor probes were plugged and abandoned by Terra Probe. The vapor probes were left in-place and the tubing connecting the probes were removed from the ground. The locations of the monitoring wells and soil vapor probes are located on Figure 1. A
