City of Traverse City
400 Boardman Avenue
Traverse City, Michigan 49684

ADMINISTRATIVE CONSENT ORDER

BOARDMAN RIVER ASSESSMENT

Prepared By:
Will Harman, PG
March, 2015

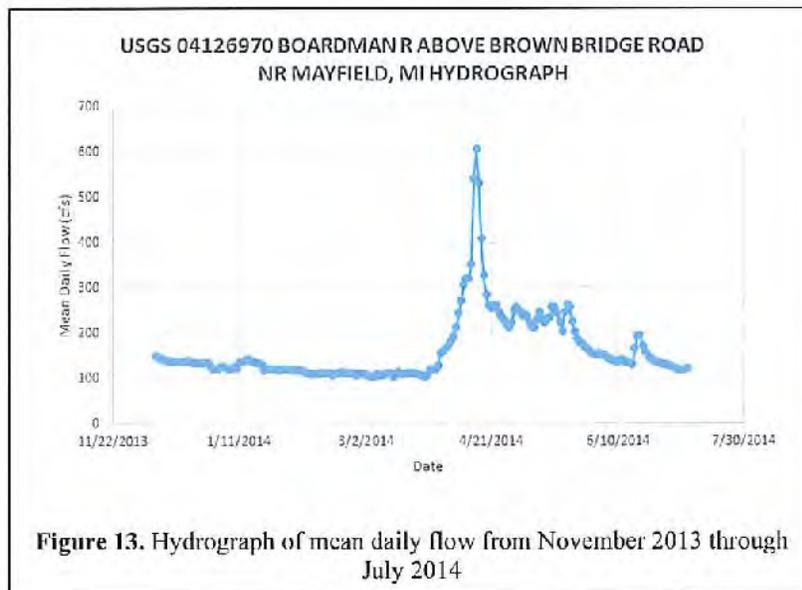
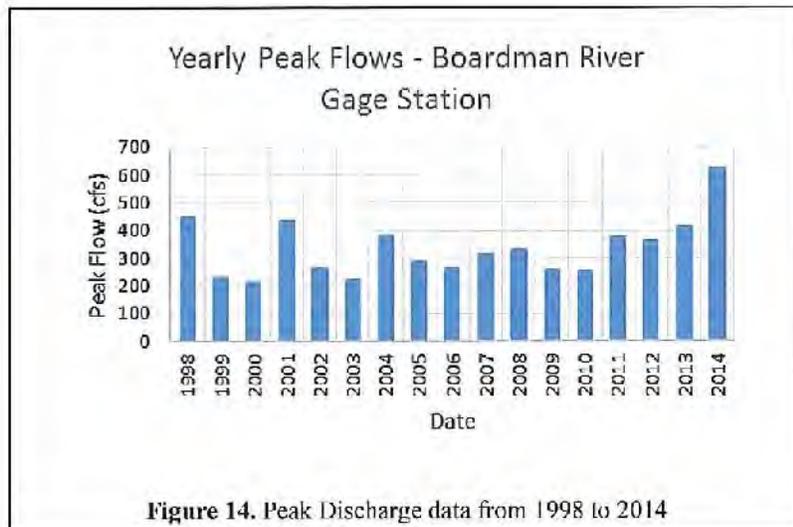
Between the December 2013 and July 2014 assessments, a large flood occurred in the Boardman River Watershed due to a rain on snow event. A hydrograph was created from the USGS gage station data showing mean daily flows between the two assessments. **Figure 13** shows that the flood occurred in April 2014 and **Figure 14** shows that the peak discharge for the April event was approximately 624 cfs. Using the flood frequency table in **Table 4**, the estimated return interval is just under a 100 year-event. The 100-year flood event means that there is a 1% probability of seeing a flood of that size each year. **Figure 14** also shows that this is the largest flood to occur since at least 1998 and that the 1998 flood was considerably smaller at 449 cfs. This is important to the assessment results because large floods can create large changes in channel geometry if there are vertical or lateral instability problems. In other words, this flood is a good test to see if the TDS failure/dam removal and associated sedimentation caused negative changes to channel geometry at sites 4, Brown Bridge or 5, Shumsky (See vertical stability results).

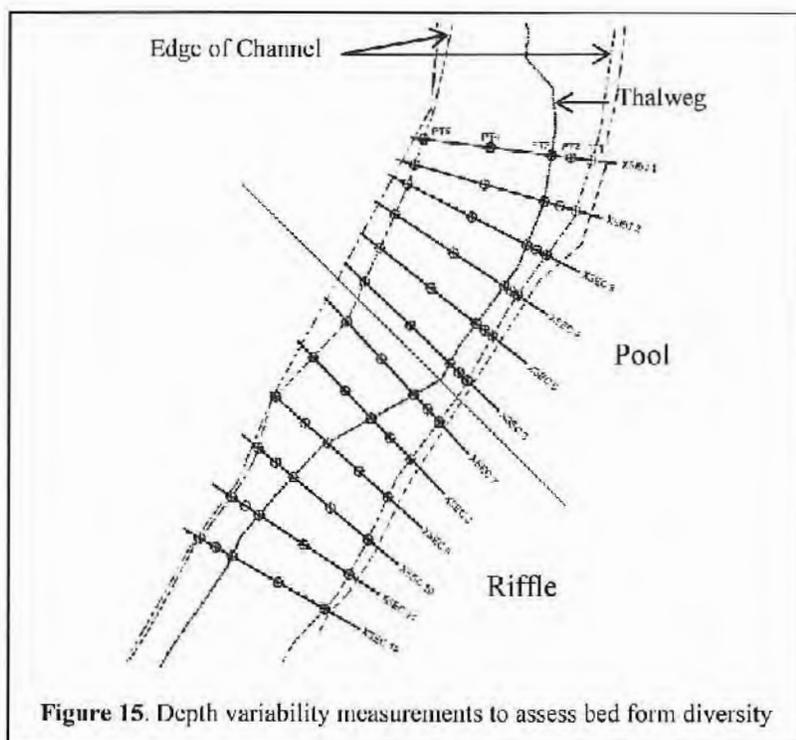
Figure 15. Depth variability measurements to assess bed form diversity

A plan view of the sampling methodology is shown for site 4, Brown Bridge Road Reach in **Figure 15** to illustrate where points are sampled.

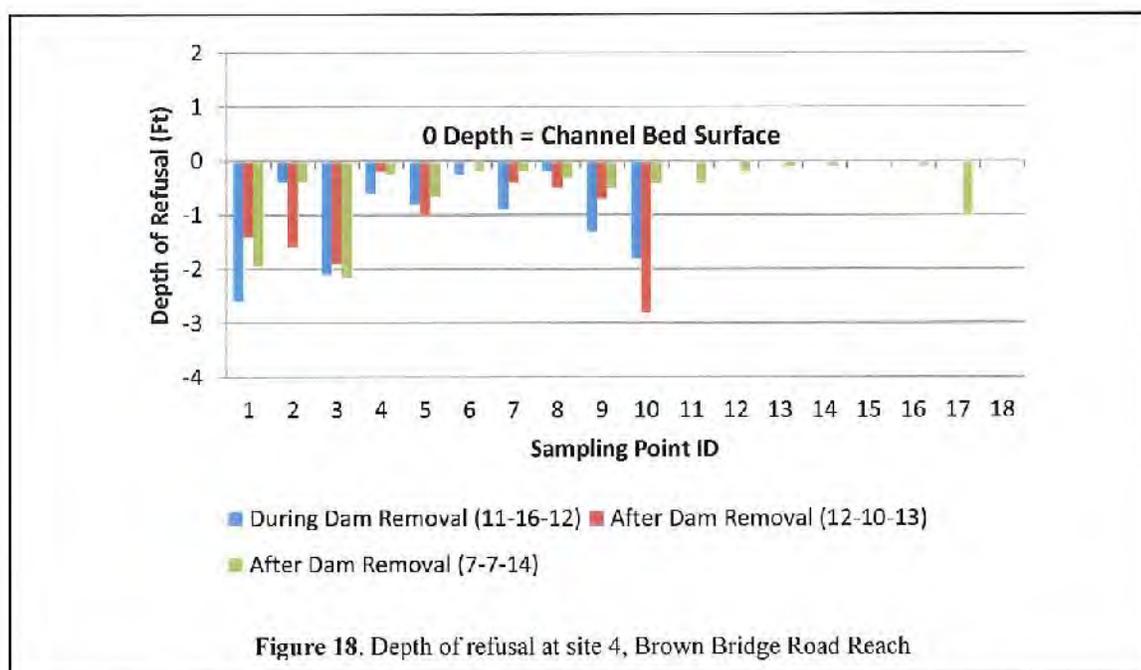
Figure 18 shows the depth of refusal results for site 4, Brown Bridge Road. The zero depth on the graph represents the streambed elevation and the negative numbers show how far the steel/fiberglass graduated rod penetrated the bed sediments. Generally, the bar penetrated “soft” material like sand and small gravel that is scoured and filled during storm events. Coarse gravel is located below the refusal depth. The graph shows the depth of refusal generally decreasing in a downstream direction with the exception of points 9 and 10. These points are most likely influenced by scour and fill processes created by Garfield Road. Soft sediments are minimal downstream of Garfield Road with the exception of point 17, which is a deep pool near old Garfield Road.

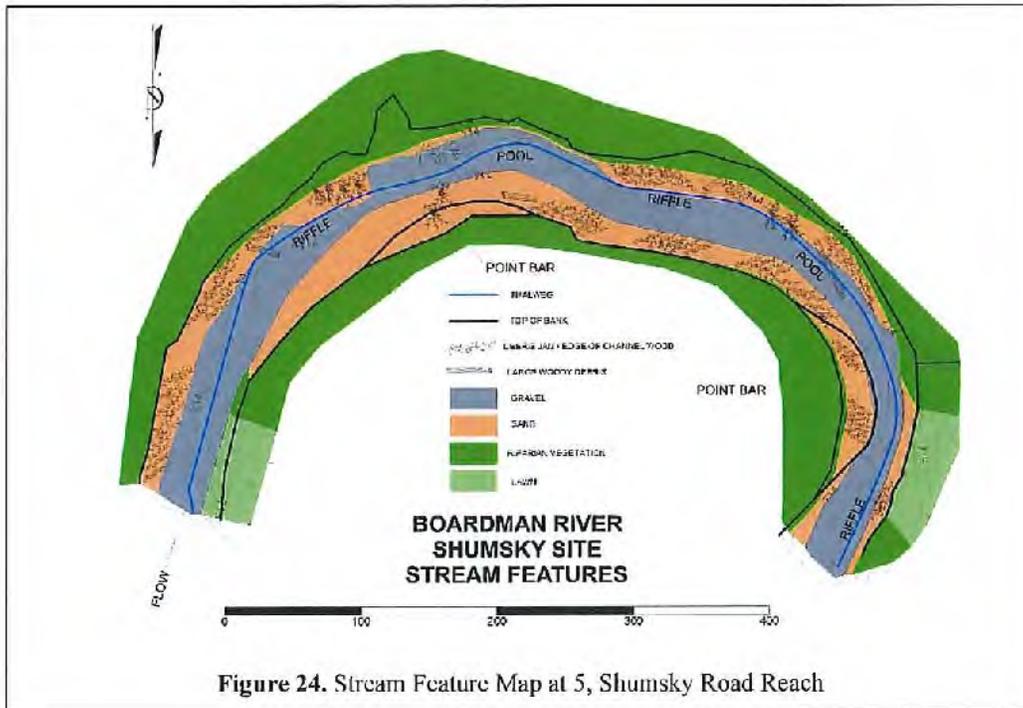
Figure 24. Stream Feature Map at 5, Shumsky Road Reach

Results from the bed form diversity assessment include the stream features mapping, detailed topography map, and depth variability plots. The stream feature maps are shown for sites 2, Forks Campground; 4, Brown Bridge Road; and, 5, Shumsky Road on **Figure 22**, **Figure 23**, **Figure 24**, respectively. Full-page versions of these maps are included in Appendix 2. The feature maps all show similar patterns; the streambed is primarily comprised of gravel material throughout the thalweg, both in riffle and pool habitats. Sand dominates the inside of the meander bends forming well-developed point bars. Sand also accumulates along the channel margins if LWD is present. This is typical of healthy rivers. Point bars are depositional areas due to centrifugal and other forces that occur in meander bends. The point bar is a low energy habitat. The LWD creates boundary roughness and encourages sand deposition within the wood structure. The thalweg remained free of excessive deposition in all three study reaches, with one exception, indicating that sediment transport processes are working. The one exception is at site 4, Brown Bridge Road where there is a mid-channel bar located downstream of the road crossing. It is labeled on the map and shown below in **Figure 25**. This bar was not present prior to the TDS failure (personal communication with Frank Dituri and Steve Largent) and probably formed due to extreme velocities exiting the culvert during the TDS-failure flood. There is a very deep scour pool just downstream of the culvert, which is likely the source area for the deposited material. The mid-channel bar is located in the area of max aggradation shown on **Figure 17**. Other than this bar, there is no major difference in the character of stream features between the upstream site at 2, Forks Campground and the downstream sites (4, Brown Bridge and 5, Shumsky).

Minor differences include variations in the location of sand based on geometry differences and the location of LWD. Site 2, Forks has more sand in the pool and less sand in the riffle margins than the downstream sites. This is likely caused by a LWD jam and channel constriction near the lower end of the reach. These jams will create backwater conditions during higher flows, and in this case backs up water into the meander bend. This causes the point bar to merge with a lateral bar. There is less sand in the riffle margins than sites 4, Brown Bridge and 5, Shumsky because there is less wood in the margins. From a stream function perspective, the important points are: 1) sand deposits are located upstream and downstream of the former impoundment, 2) sand is depositing on point bars and between LWD pieces and within jams, and 3) there is a gravel thalweg throughout the riffle and pool habitats. These are all indicators that sediment transport processes are functioning like a healthy river.
