INTERIM RESPONSE PLAN

5851 West Jefferson Avenue | Detroit, Michigan
PM Project Number 01-5303-3-0001

RE: Interim Response Plan
5851 West Jefferson Avenue, Detroit Michigan
Former Revere Copper and Brass
EGLE Site ID No. 82000136
PM Environmental Project No. 01-5303-3-0001

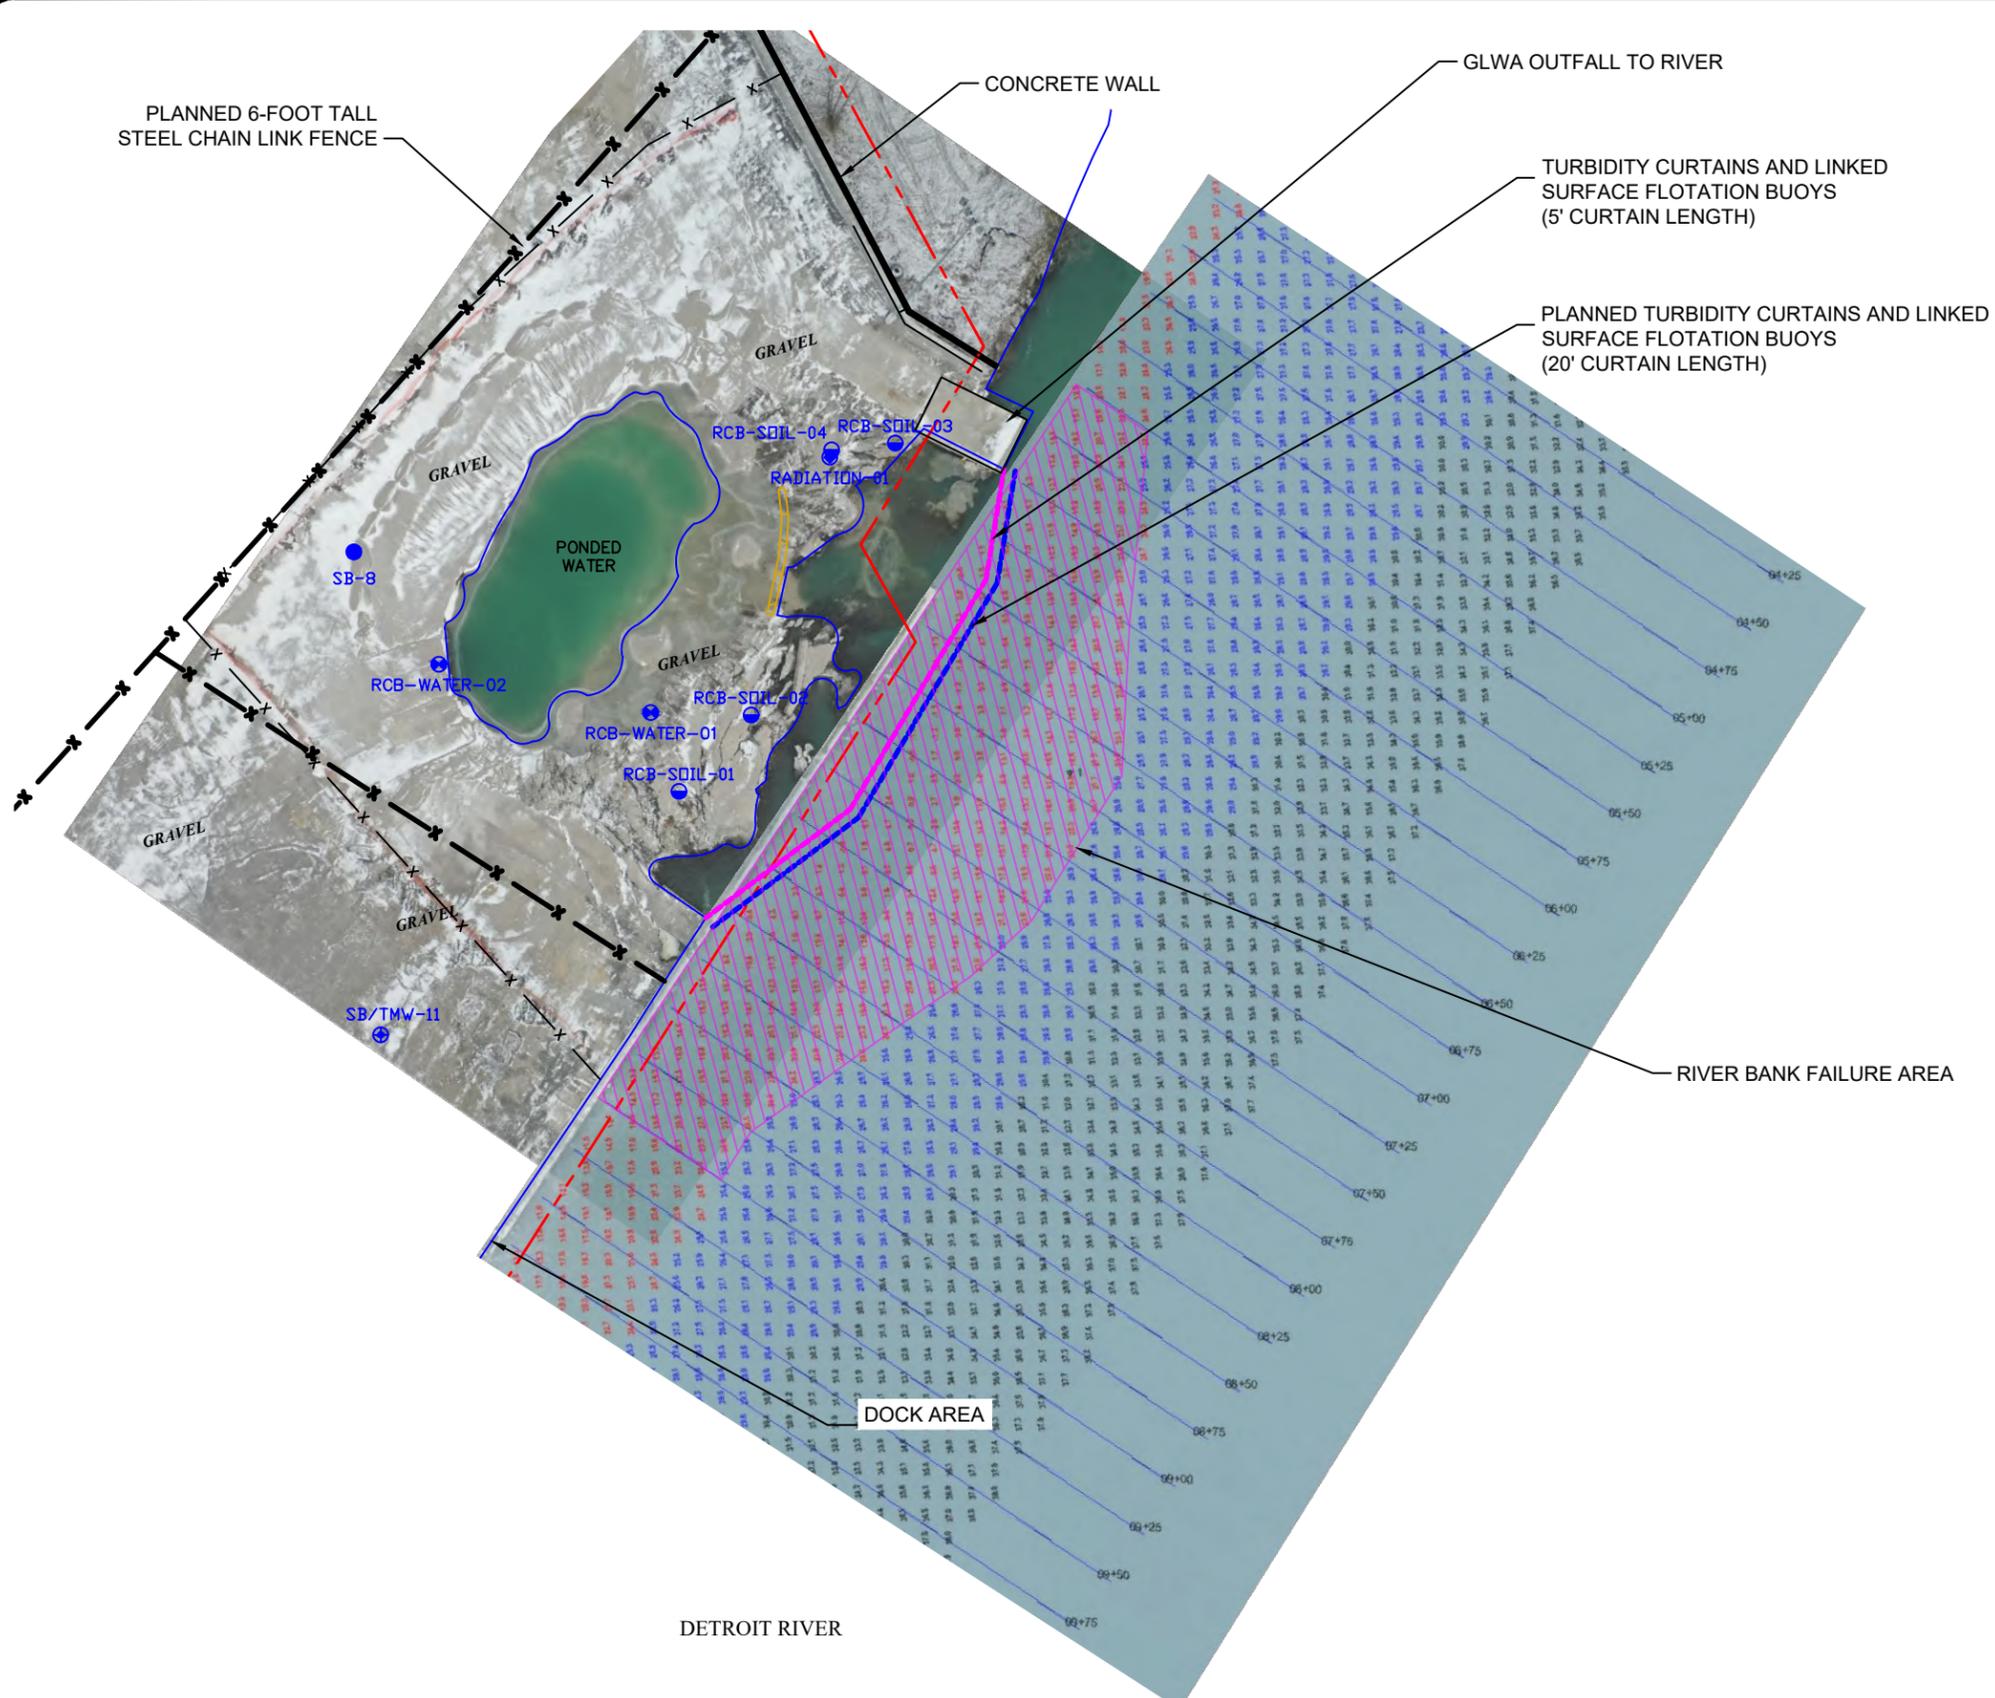
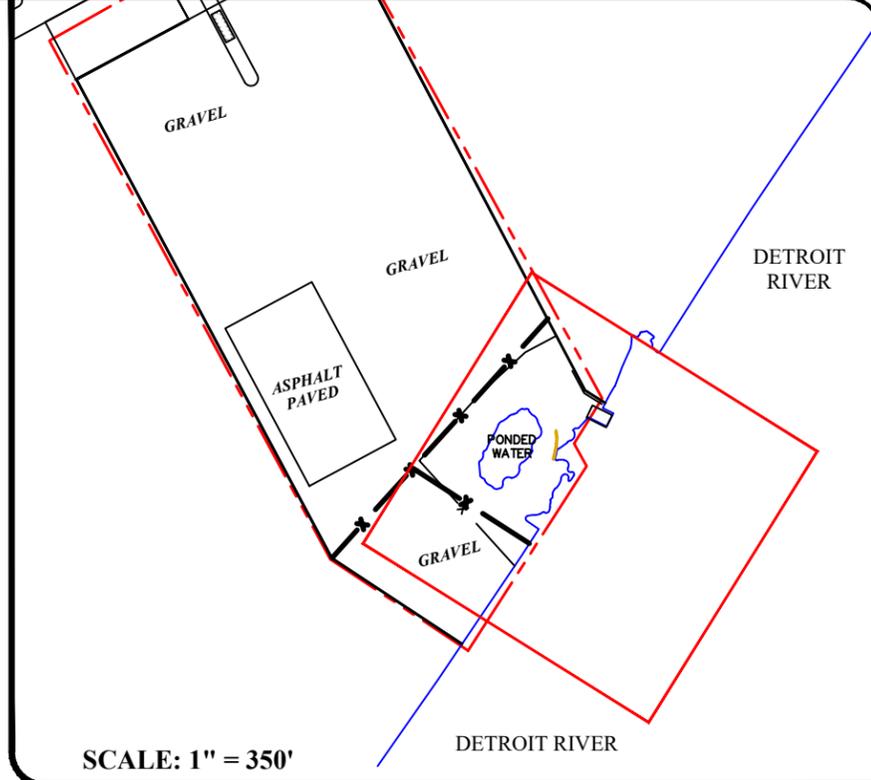
A failure of approximately 200-feet of shoreline along the bank of the Detroit River at 5851 West occurred at the subject property on November 26, 2019. The failure resulted in the displacement of soils from the subject property to an area of the Detroit River immediately east of the former shoreline boundary (refer to Section 1.4 below).

The cross sections include a comparison of pre and post-failure conditions (i.e. bottom depths) and document that the bank failure material extends approximately 400-feet southward from an area located approximately 15-feet north of the northern subject property boundary (i.e. from sounding line 05+25 to sounding line 09+00), and is present at locations between 50 and 115-feet from the shore line (Figure 3). The approximate thickness of the bank failure material ranges from less than a foot to a maximum of 21-feet, with an estimated volume of 9,000 cubic yards. Table 1A in Appendix A includes a summary of bank failure material thicknesses based on the Hydrographic surveys.
