Appendix F – Road Safety Audit

**Downtown Kalamazoo – Stadium Drive, Michigan
Avenue, Kalamazoo Avenue and Michikal Street (I-94
BL/US-131 BR/M-43)
(Southwest Region)**

Road Safety Audit (JN 127117)

FINAL REPORT

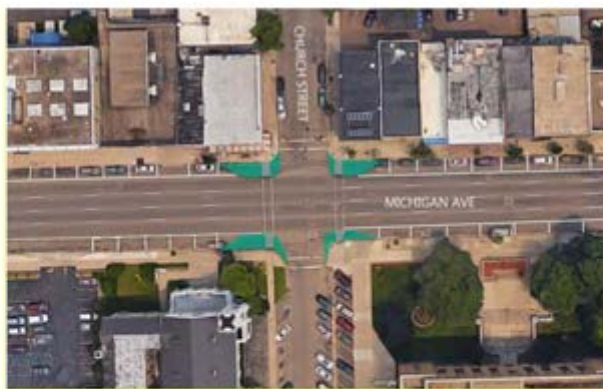
- At the intersection of West Michigan Avenue and Church Street, a number of issues were observed which were detrimental to pedestrian safety. The sidewalk was in very poor condition, the sidewalk ramps were not ADA compliant, and there were no pedestrian crossing signs. These issues are exacerbated by the nature of the location of the unsignalized intersection on a high-speed multi-lane corridor.

- Install curb extensions as seen in the image below to reduce the current crossing distance from approximately 73' to 50' or less. The less time pedestrians spend in uncontrolled vehicle travel lanes greatly improves the probability of a safe crossing maneuver.
- Create a high visibility crossing fit with special emphasis "ladder-style" pavement markings and W11-2 "Pedestrian Traffic" signs to increase driver awareness that pedestrians may attempt to cross at the location.

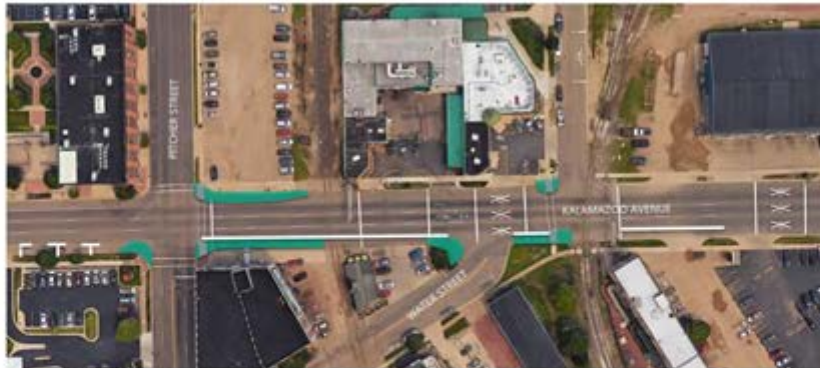
- Throughout the study region, the RSA team observed a widespread lack of parking space delineation and edge lines, which can induce sideswipe collisions as motorists are unaware of the proper travel path.

- For a short term solution, add pavement markings to delineate parking spaces and edge lines.
- In the long term, construct curb extensions (bump-outs) throughout parking areas (as depicted below) with marked parking stalls, for reasons described earlier in the report.

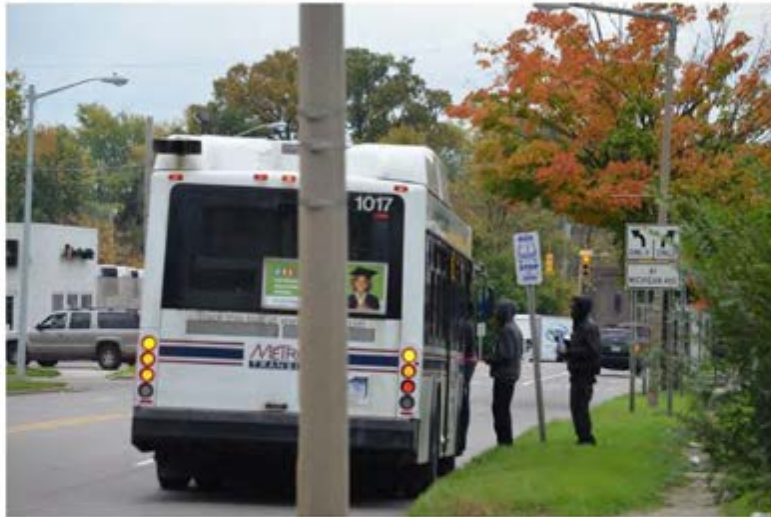
- In the vicinity of the bus stop on Riverview Drive near Hotop Avenue, there are no marked crosswalks despite the high pedestrian demand as a result of the bus stop.

- Install a high visibility crossing, fit with special emphasis "ladder-style" pavement markings at a location that suits present pedestrian travel patterns.
- Conduct a traffic study to determine what, if any, type of mid-block crossing would be appropriate.

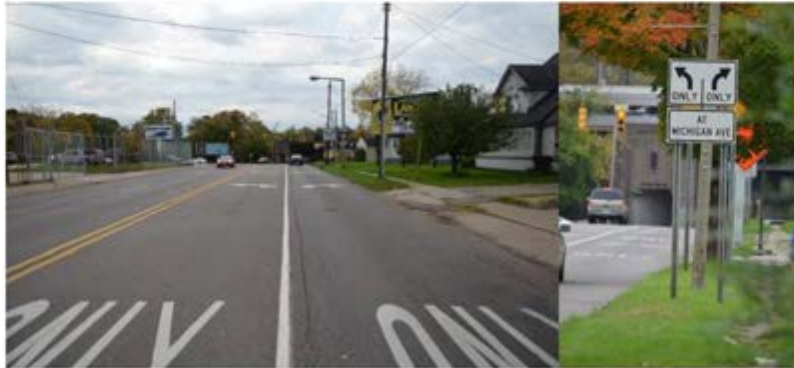
- On southbound Riverview Drive on approach to East Michigan Avenue, the advance lane assignment signs are representative of a right turn lane, when the outside lane is actually a through lane. Motorists may incorrectly prepare for a right turn or change lanes unnecessarily, creating a situation prone to sideswipe collisions.

- Remove the R3-7b "Left Only, Right Only" sign and the R10-11b "NO TURN ON RED" signs, as the right lane does not turn at the intersection.
- Install R3-7e "Left Only, Thru Only" signs to match revised pavement markings that correctly denote the lane assignments for the approach.

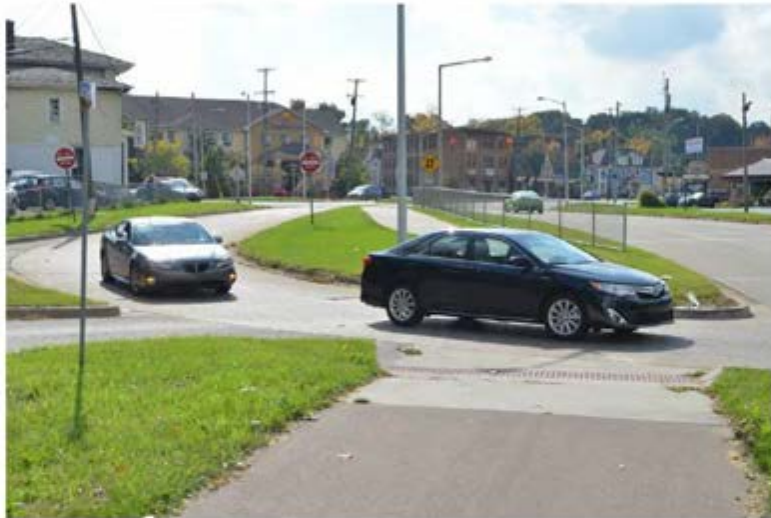
- At the Michikal Street at Elm Crossover intersection, the R5-1 “DO NOT ENTER” signs on Elm Crossover southeast of the intersection are set too far back away from the intersection. An unfamiliar motorist could potentially drive the wrong way on Elm Crossover before noticing the signs, which may result in a head-on collision.

- Relocate the R5-1 signs closer to Michikal Street in a manner that provides adequate and safe forewarning that Elm Crossover is a one-way, westbound street.

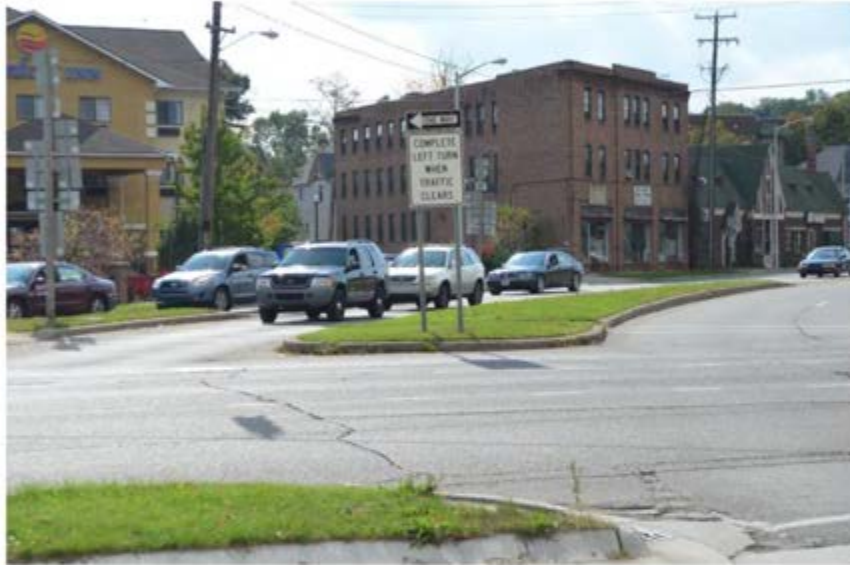
- The current sign, which warns “COMPLETE LEFT TURN WHEN TRAFFIC CLEARS” is too ambiguous and may confuse motorists. The sign does not convey which direction of traffic must clear, leaving an unfamiliar driver to ignore the sign and potentially enter the intersection against oncoming traffic, resulting in a head-on or angle collision.

- Create and install a new sign with a revised message, possibly as shown below:

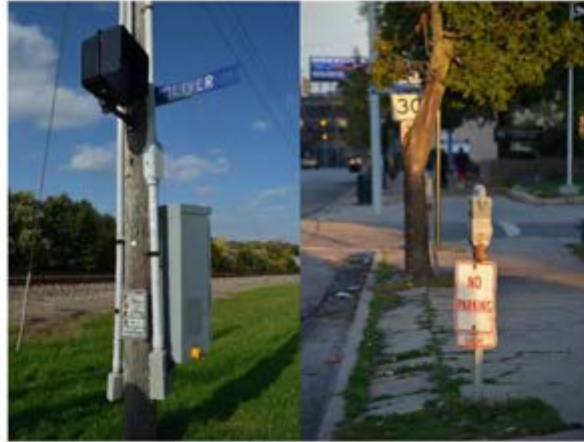
- Throughout the RSA study limits, the D3-1 street name signs are not clearly identified. Street name signs which are difficult to read can create driver confusion, which could potentially result in wrong way driving or late lane decisions.

- Coordinate with future signal projects or find other means to increase the size and visibility of D3-1 street name signs. The image below depicts a possible approach:

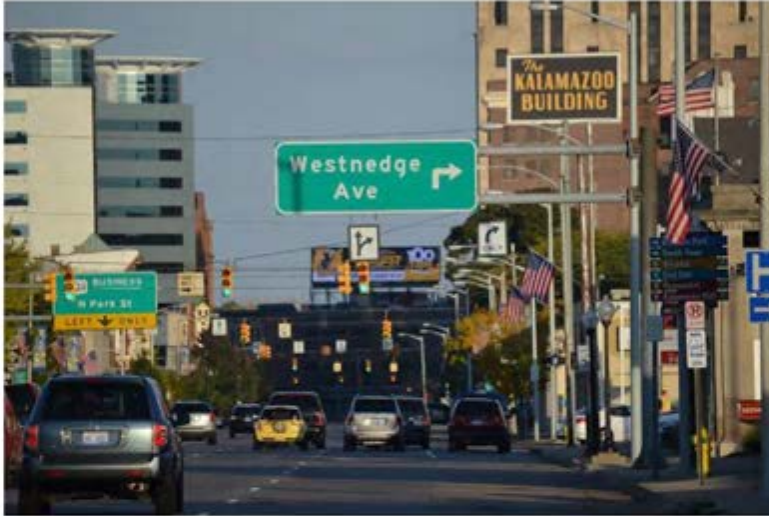
- The overhead guide sign on eastbound West Michigan Avenue on approach to Westnedge Avenue does not meet current design guidelines. The sign message is unclear, which may influence undesirable weaving and merging behavior, facilitating sideswipe collisions.

- Upgrade the sign to meet current specifications using an arrow per lane with the option lane treatment. An example is shown below:

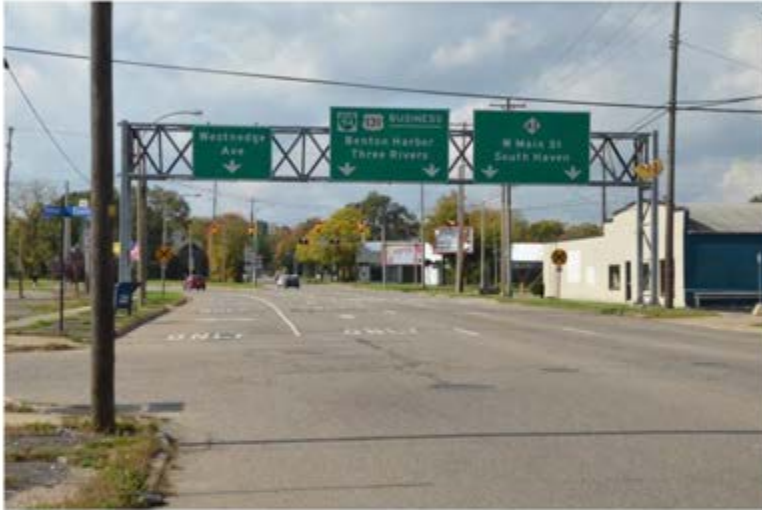
- The guide signs on the truss on Kalamazoo Avenue before Michikal Street do not effectively convey the lane assignment at this location. For example, there is no indication that the middle lane is an option lane. Lane assignment confusion could result in sideswipe collisions.

- Upgrade the signs to meet current specifications with arrows per lane, indicate the option lane, and clearly identify route numbers. An example is shown below:

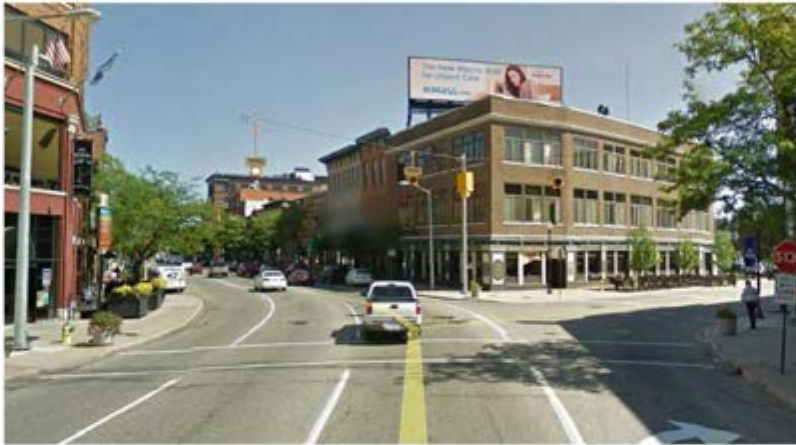
- At the intersection of East Michigan Avenue and Portage Street, there are two flashing yellow bulbs over three lanes and one flashing red over the right turn lane.

- Consider adding a third yellow flasher and center each over its respective lane. The current configuration may be confusing for motorists.
- Potentially change the solid balls to diagonal arrows to warn motorists of the approaching bend in the road.

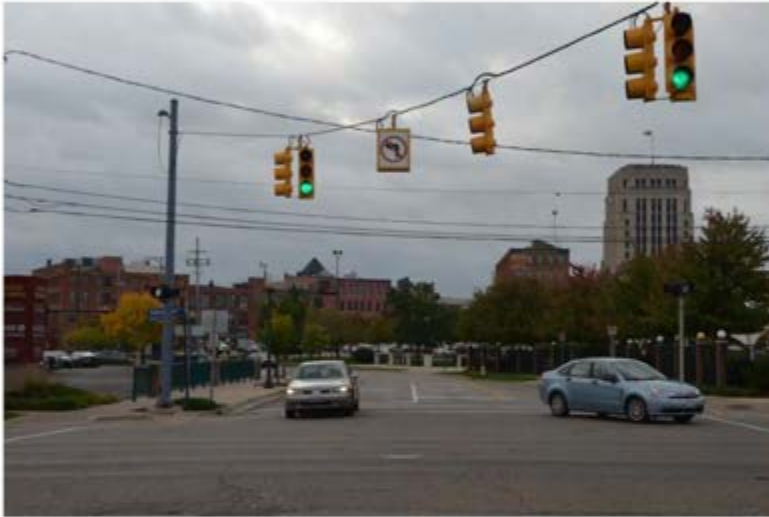
- At the intersection of Edwards Street and Kalamazoo Avenue, it appears that Edwards Street was converted from a two-way street to a one-way street without removing the unnecessary signal heads. A motorist may look right from the driveway north of the intersection to see the signal heads downstream, travel the wrong way on Edwards Street, and collide with an oncoming vehicle head-on.

- Remove the signal heads as needed and provide a "DO NOT ENTER" symbol for the case sign facing north.

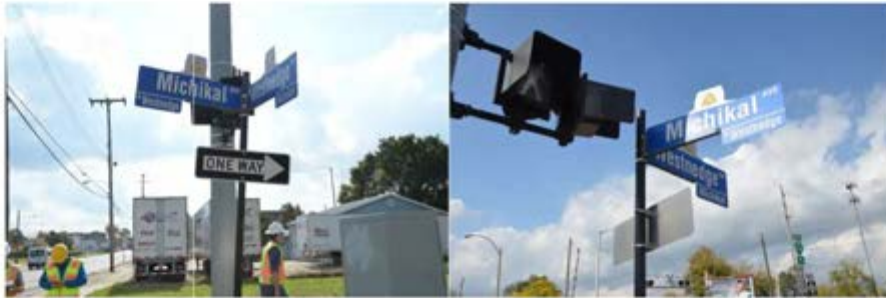
- On the southwest quadrant at the intersection of Kalamazoo Avenue, Westnedge Avenue and Michikal Street, the pedestrian signals are obscured by the street name signs. Given that this is already a difficult location for pedestrians to cross with long crossing distances and high speed vehicles, the pedestrian signals must be visible.

- Relocate the street name signs.

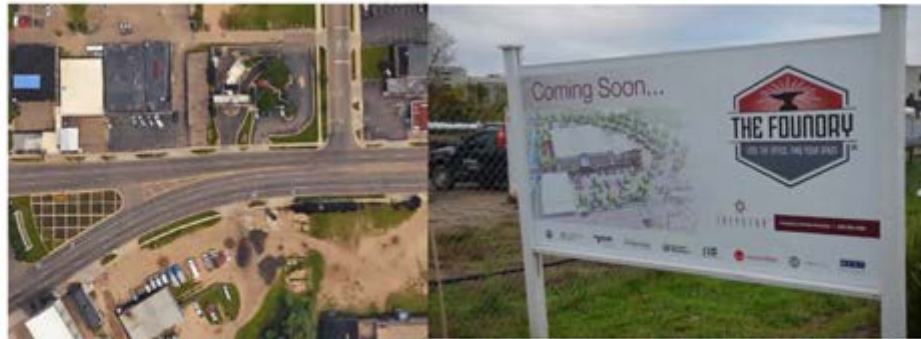
- Given that a new signal is planned to be constructed at the intersection of East Michigan Avenue and Harrison Street, the RSA team believed it to be an opportune time to ensure all potential safety issues were mitigated. The location of the intersection is such that a signal may not be expected by unfamiliar drivers on eastbound East Michigan Avenue.
- The proposed pedestrian path crossing on the west leg of the intersection is offset from the north leg against a heavy southbound left turn. The RSA team was concerned that southbound right-turn traffic may not notice pedestrians attempting to cross East Michigan Avenue.

- Install advance W3-3 "Signal Ahead" warning signs on eastbound East Michigan Avenue with flashing beacons.
- Include supplemental low-level signal heads.
- Revisit the design of the south leg of the intersection to keep the pedestrian crossing as close to the intersection as possible. This will increase the visibility of pedestrians and reduce the potential for southbound right-turning vehicles to collide with a crossing pedestrian.

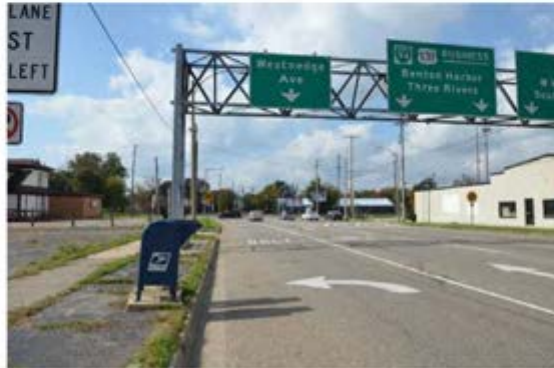
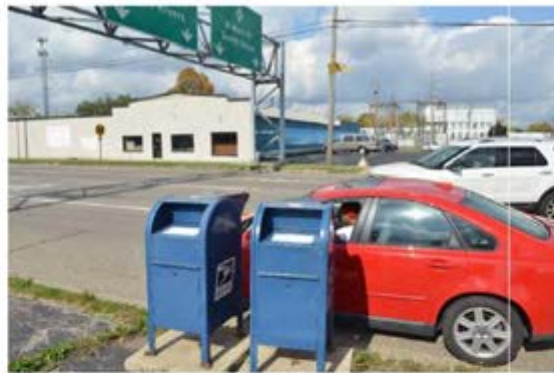
- On Kalamazoo Avenue just prior to Westnedge Avenue, there are two USPS mailboxes located next to the curb on the south side of the road. Vehicles must stop in the left turn lane to deposit mail among vehicles traveling at high speeds. The location of these mailboxes is conducive to sideswipe collisions as vehicles merge in and out of traffic to drop off mail, as well as rear-end crashes when vehicles stop in a travel lane.

- Relocate the mailboxes off of MDOT routes.

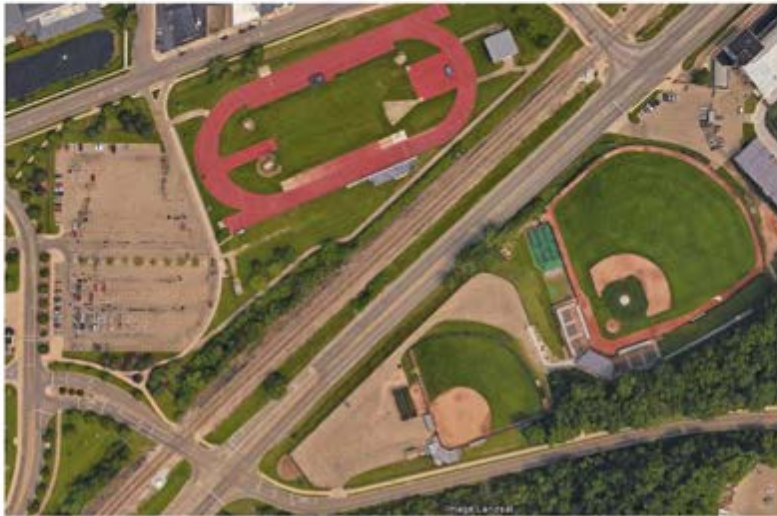
- Stadium Drive from Howard Street to Oliver Street has an extraneous TWLTL without places to turn. This space could be better utilized.

- Investigate the feasibility of removing/reducing the TWLTL reduce to incorporate bike lanes and/or green space in the median.
