# **Region Bridge Support Unit Bridge Field Services**

## ***Alleviating the Effects of Pavement Growth on Structures***

**January 2012**

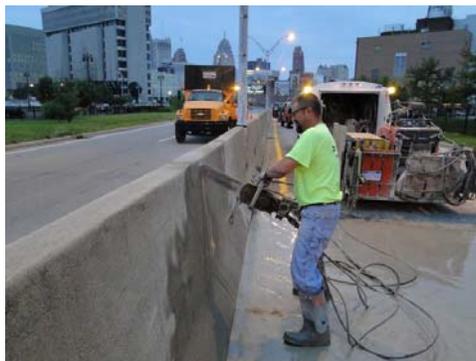
*Figure 32.* Saw cutting concrete barrier wall to relieve pressure

Pressure Relief Joints are installed into 4" wide full depth joint openings. The saw cutting is often contracted because two parallel cuts must be made accurately which is often better performed by a sawing professional. The joint must be continuous extending across the entire road, and any adjoined curb and gutter or concrete barrier wall must be cut as well. Cuts in concrete barrier wall require the use of a concrete cutting chainsaw. Be mindful of electrical conduit locations whenever saw cutting through barrier wall containing lighting.

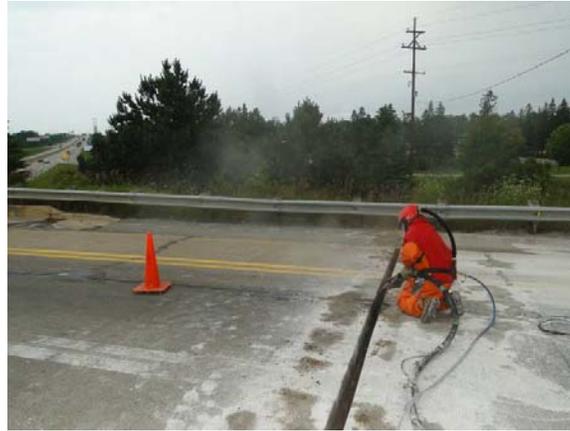
*Figure 33.* Sandblasting the exposed edges of pavement

Once removed, the vertical surfaces must be dried with air and sandblasted to aid the bonding ability of the lubricant adhesive. A vacuum truck is helpful to remove slurry located in the bottom of the joint that is generated during saw cutting.

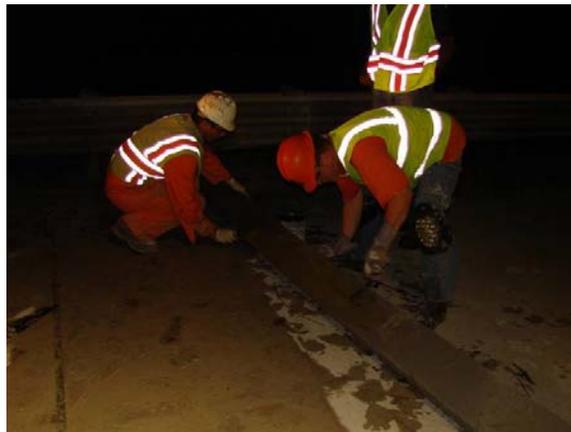
*Figure 34.* Applying lubricant adhesive to both contacting edges

Each contacting edge of closed cell relief joint material must be coated with lubricant adhesive. Inexpensive disposable rollers or steel trowels may be used to spread the material conservatively. Once the sides are coated, the material should be pressed in place by hand working from one end to the other without stretching it. Press the foam into the void so it is recessed approximately one half inch. Tools may be cleaned with xylol or acetone to remove any lubricant adhesive residue.

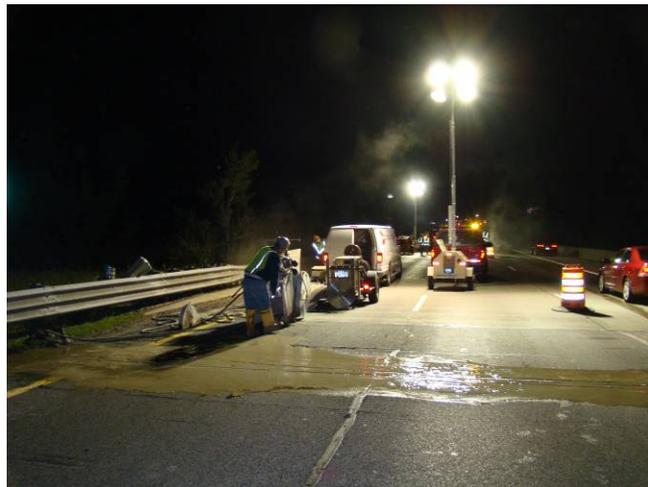
Figure 35. PRJ installations also work well during night time hours

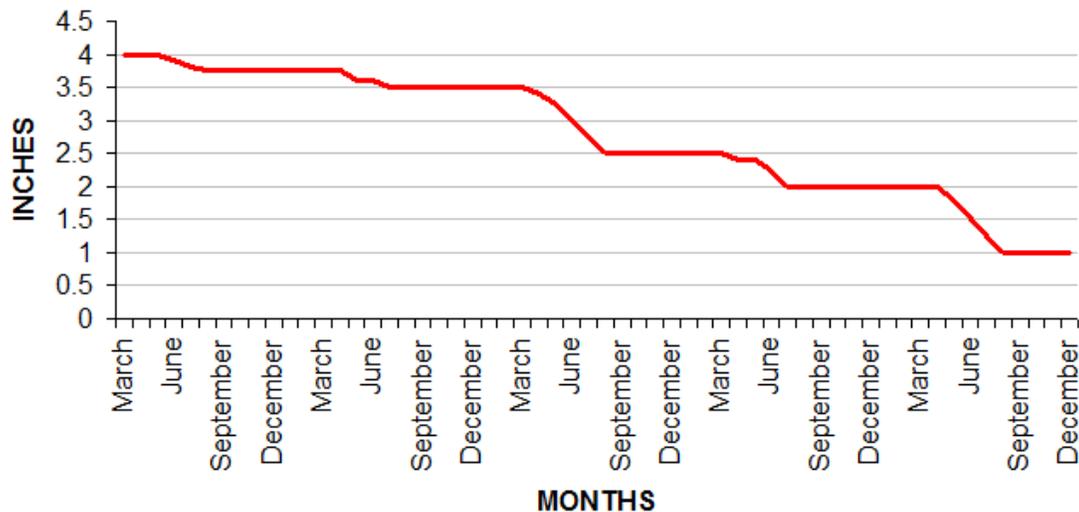
*Figure 37.* Characteristic monthly PRJ measurements

The amount of time required before performing a replacement will vary for each PRJ. A concrete repair project or bituminous overlay on the concrete roadway will significantly reduce the rate at which pavement stresses form. However, if no changes occur and the factors that cause PG are plentiful, replacements will often occur after only 4 years of service.
