SECOND PROGRESS REPORT ON THE
EVALUATION OF VARIOUS TYPES
OF RAILROAD CROSSINGS

Research Laboratory Section
Testing and Research Division
Research Project 75 F-143
Research Report No. R-1079

Michigan State Highway Commission
Peter B. Fletcher, Chairman; Carl V. Pellonpaa,
Vice-Chairman; Hannes Meyers, Jr., Weston E. Vivian
John P. Woodford, Director
Lansing, March 1978

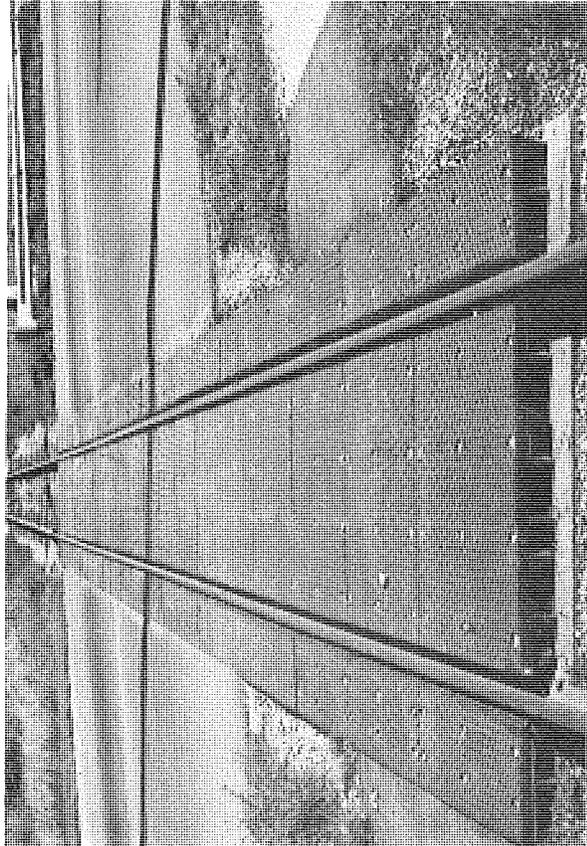
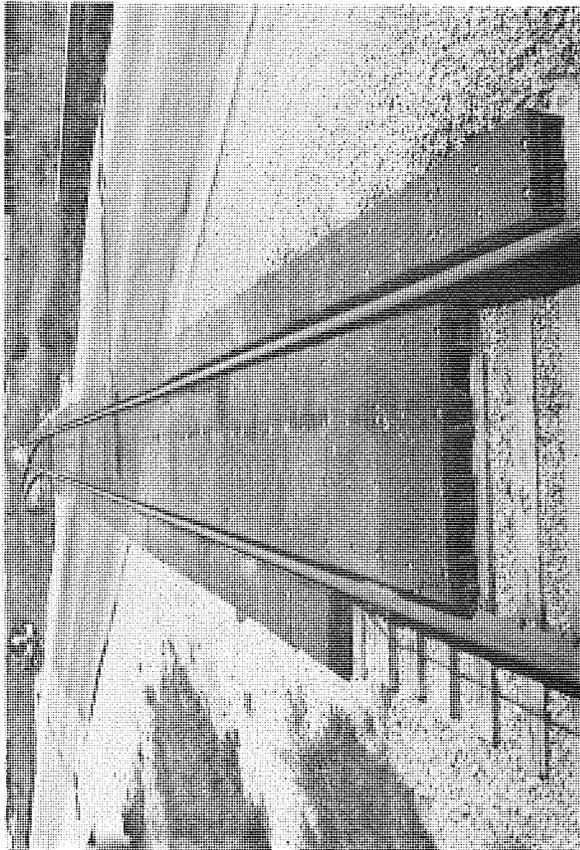
Condition of crossing on M 65 in Twining after one and one-half years of service (left). Cracked surface in side pad (above).

T-Core crossings on US 23 in Omer and M 65 in Twining.
