**APPENDIX D**

**Selected Site Photos**

## **Appendix D. Selected Site Photos**

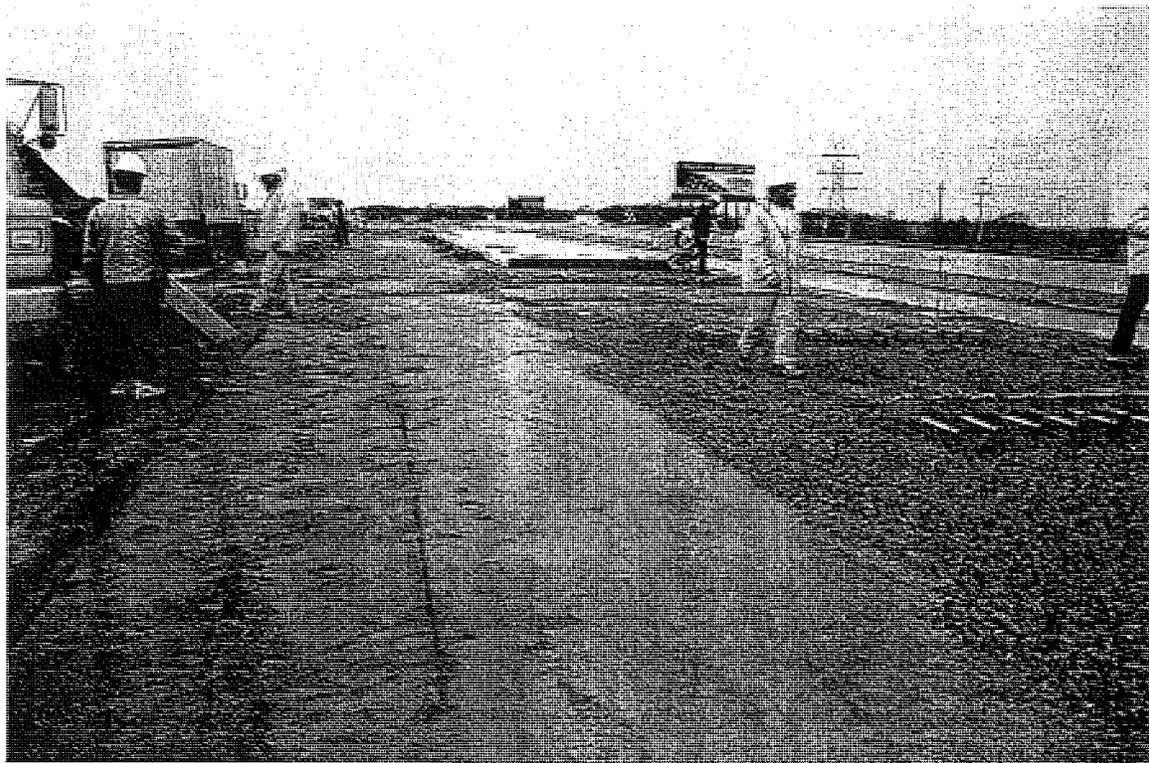
*Photo C37. An overview of CSN# 47065-28215A WB looking west, just prior to paving. The open graded drainage course and dowel cages are visible.*

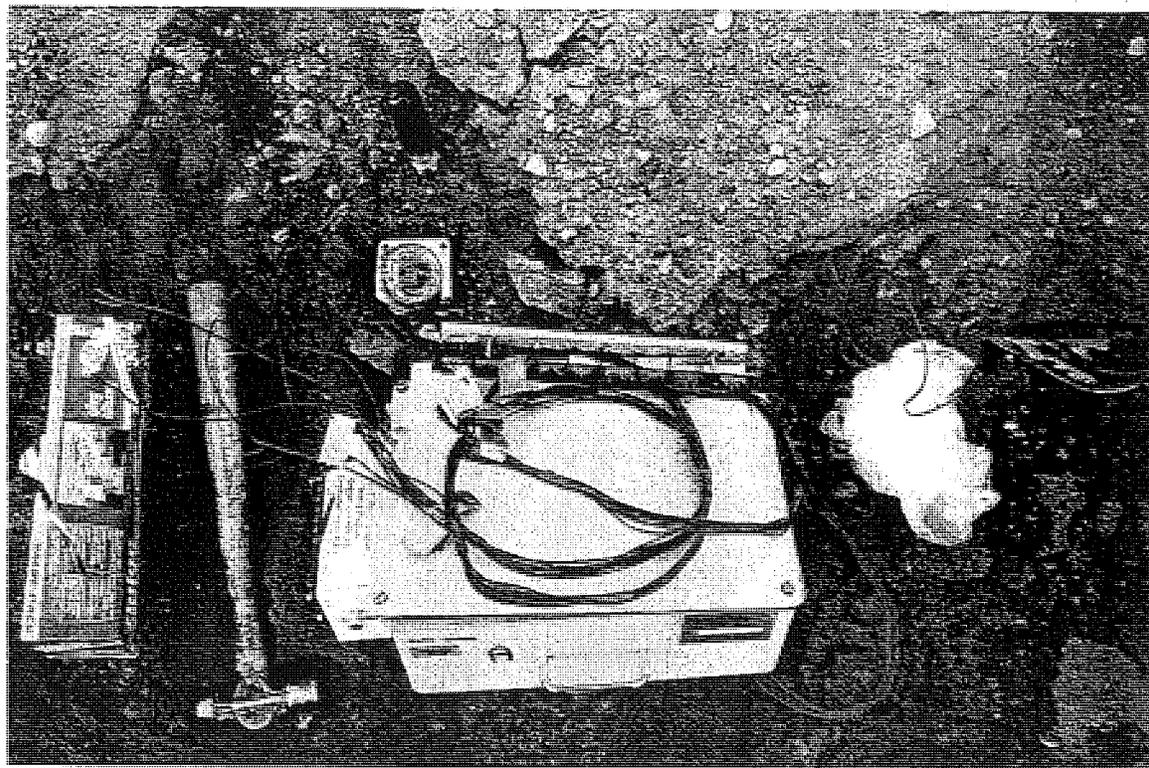
*Photo C38. A view of the temperature profile instrumentation prior to installation in the slab in CSN# 47065-28215A WB. The gray box is the data-acquisition system. Lying on the box is the thermocouple rig, with thermocouples spaced in one inch increments.*

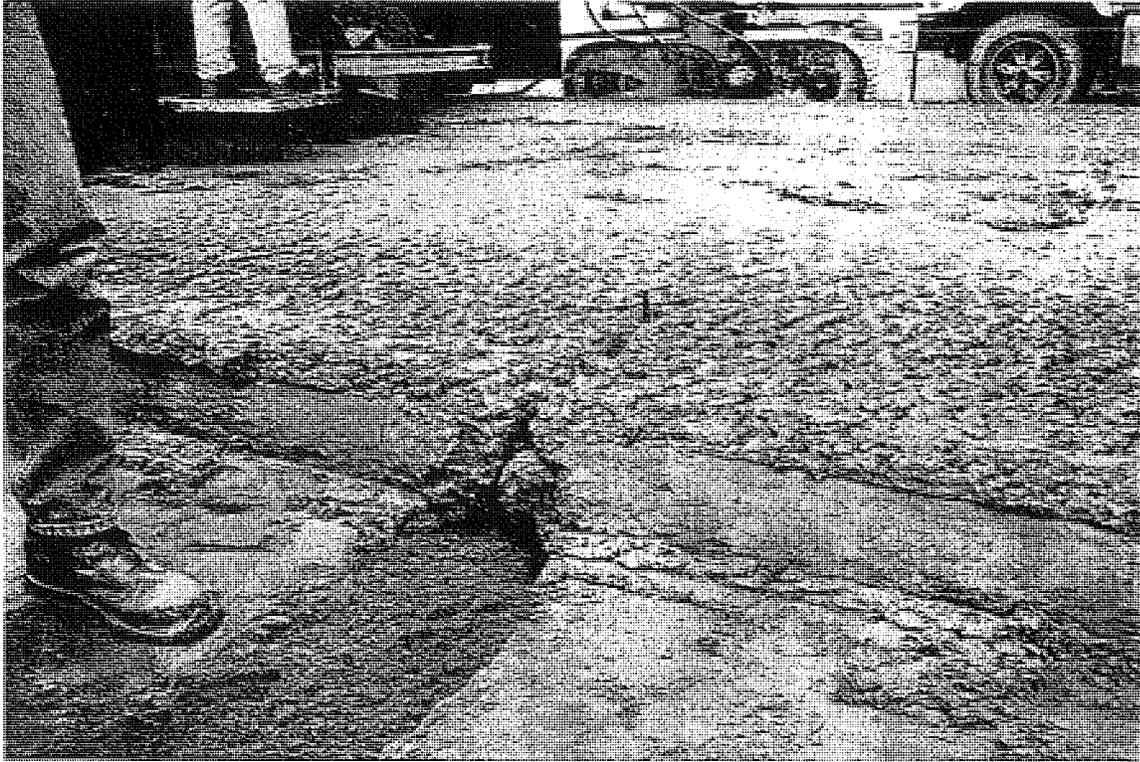
*Photo C39. A view of the thermocouple rig immediately after installation in CSN# 47065-28215A WB. The rig is installed between paving lifts, and the cables are buried to protect them from damage during the second paver pass.*

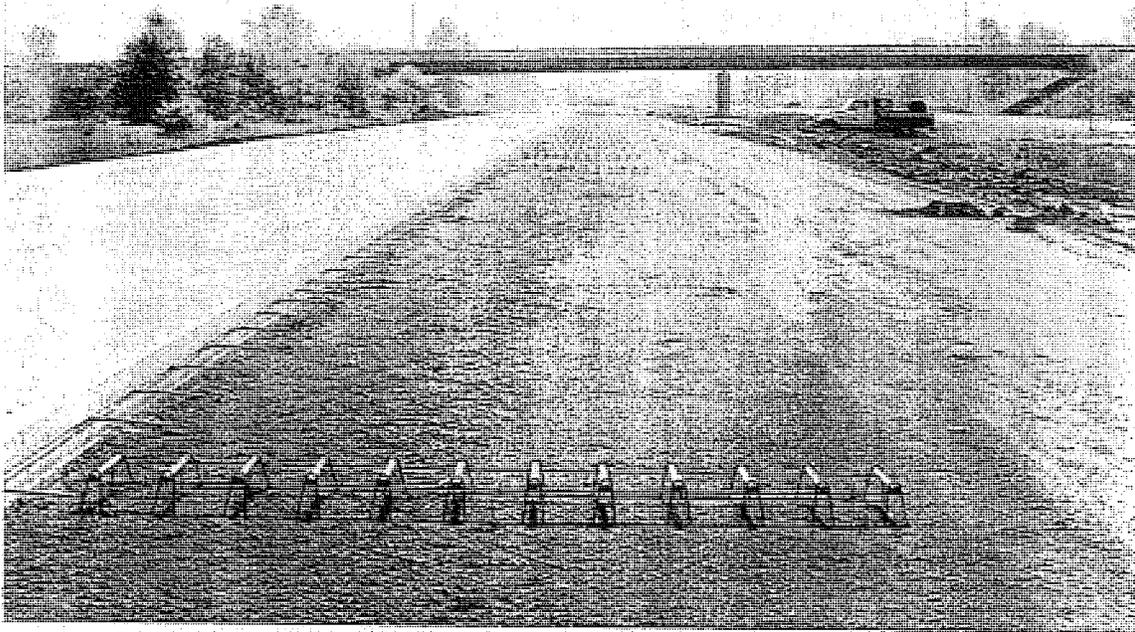
*Photo C53. An overview of CSN# 82291-37305A NB looking south. Three dowel baskets have been removed to allow for study of load transfer efficiency with and without dowel baskets.*

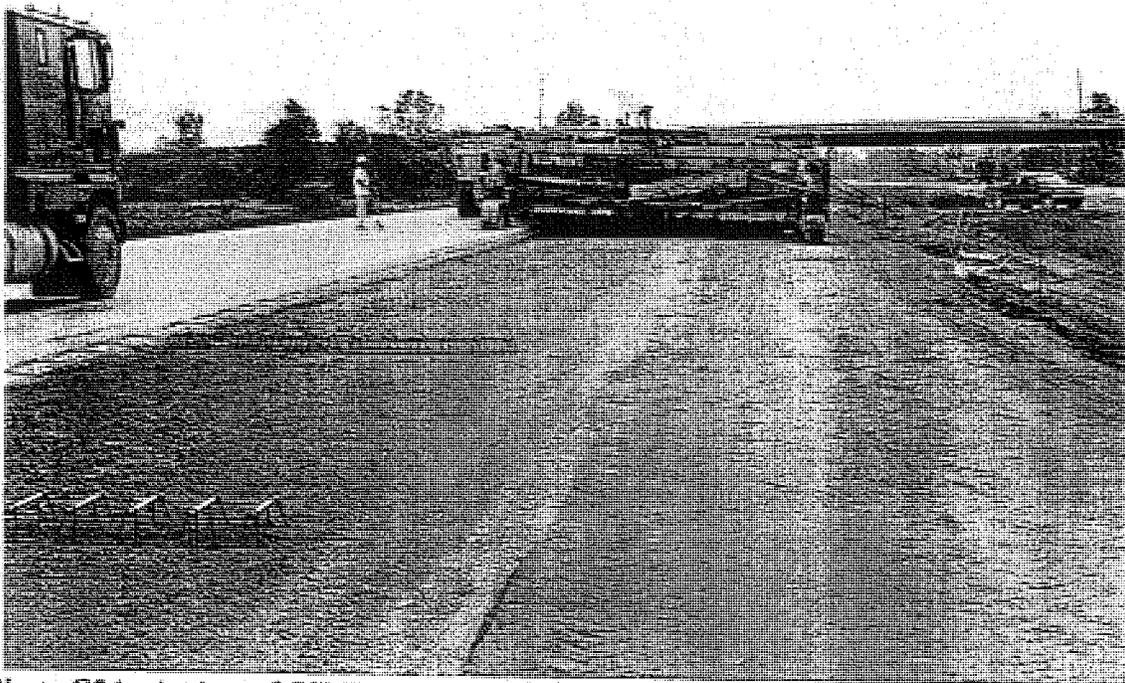
*Photo C54. A view of CSN# 82291-37305A NB looking south as the paving train advances toward the removed dowel section. A thermocouple rig is to be installed in the slab near the location where yellow caution tape is seen.*

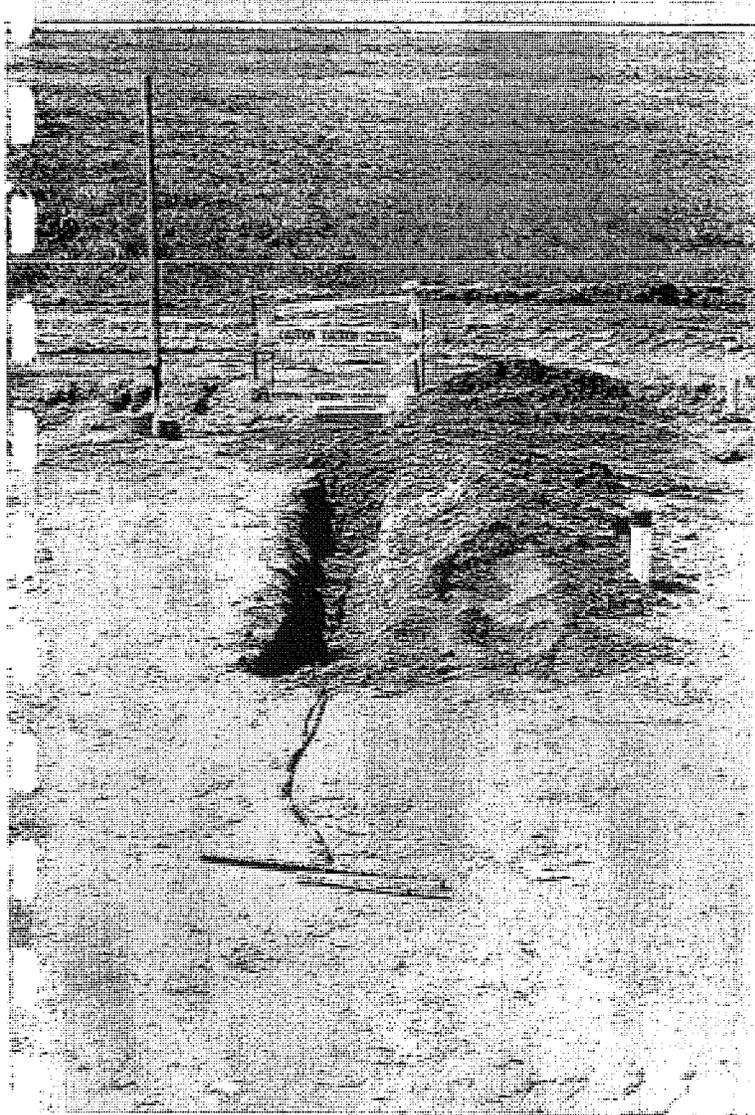
*Photo C55. A view of the thermocouple rig on CSN# 82291-37305A NB prior to installation.*

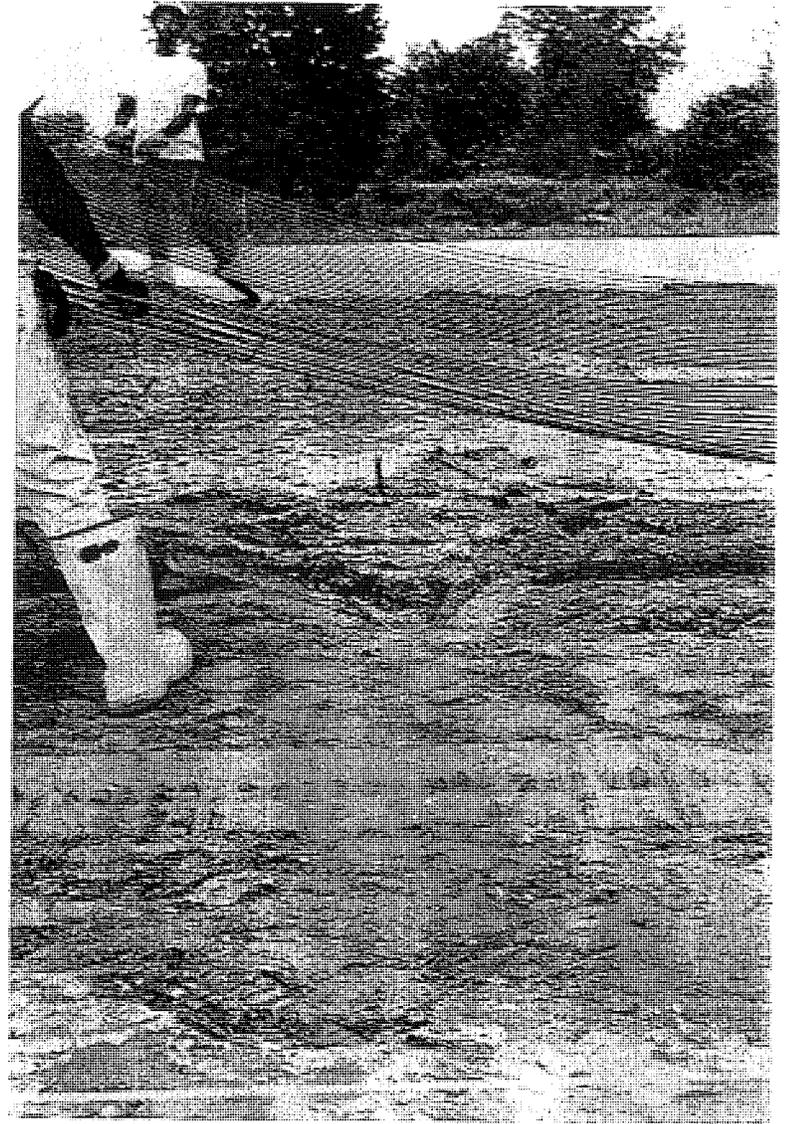
*Photo C56. A view of the thermocouple rig on CSN# 82291-37305A NB after the first paver has passed.*
