**APPENDIX B**  
**UPDATED**  
**KENT COUNTY GEOLOGIC**  
**STABILITY STUDY FOR THE**  
**JOHN BALL ZOOLOGICAL**  
**GARDEN EXPANSION WEST OF**  
**I-196**

Investigation of the Surface Stability Above  
the Former Domtar Industries, Inc. Gypsum  
Mine Located in Grand Rapids, Michigan

Prepared by  
Stan Vitton, Ph.D., P.E.  
Associate Professor  
Michigan Technological University  
Houghton, Michigan 49931

*Submitted:* September 18, 2002  
*Updated:* February 27, 2004

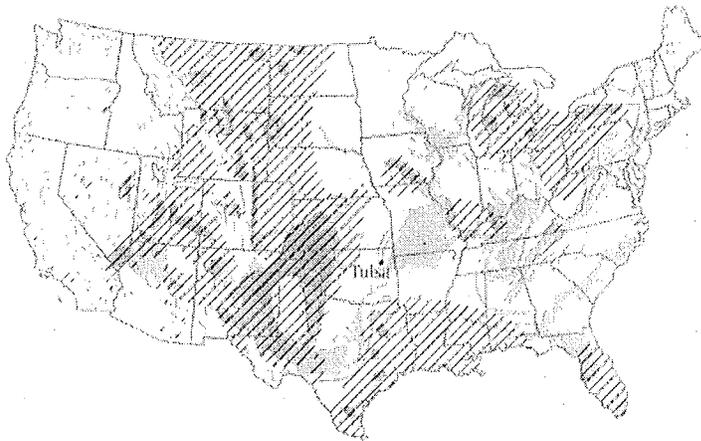
Figure 9. Salt and gypsum underlie about 40 percent of the contiguous United States. Carbonate karst landscapes constitute about 40 percent of the United States east of Tulsa, Oklahoma (White and others, 1995).

Figure 4. Figure 9 from a USGS report showing the location of evaporite rocks in the United States and karst development in both evaporite and carbonate rocks.
