PREVENTIVE MAINTENANCE OF CONCRETE PAVEMENTS

MICHIGAN DEPARTMENT OF STATE HIGHWAYS

J. E. Simonsen

Research Laboratory Section  
Testing and Research Division  
Research Project 72 F-123  
Research Report No. R-859

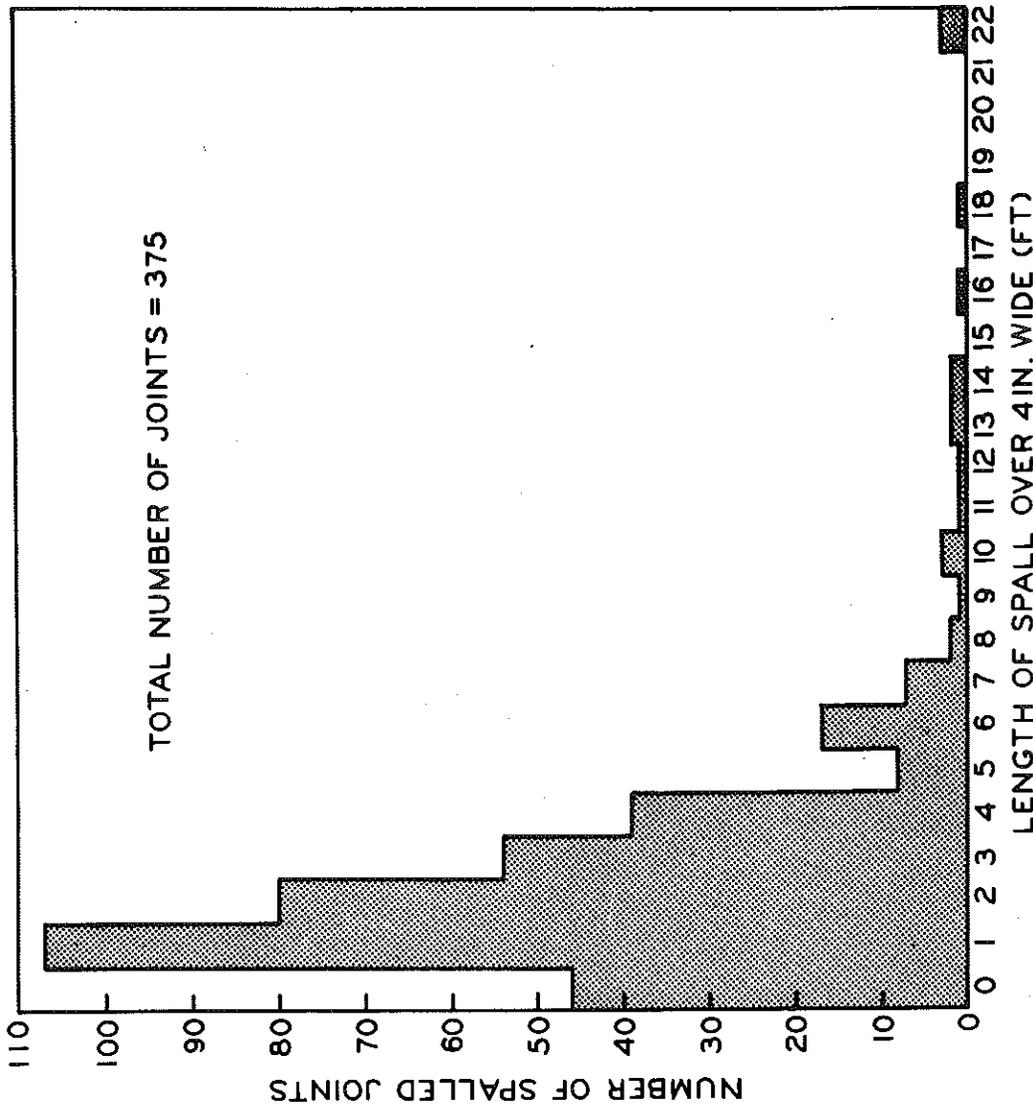
Figure 1. Frequency distribution of spalled joints.

In an attempt to develop a procedure for selecting the joints to be repaired on this project a joint condition survey was made. The survey recorded the estimated length of surface spalls more than 4 in. wide along each joint groove and the width of repair to remove the deteriorated concrete. A frequency distribution of joints with 0 to 22 ft of spall is shown in Figure 1. Of the 375 joints on the project, 13 percent (about 50 joints) had more than 4 ft of spall along their length. At first glance it would seem reasonable to replace these joints. However, as shown in Figure 2, 26 joints, or more than half of the joints with serious surface defects (more than 4 ft of spall), were found to be either 100 or 200 ft apart. The remaining joints in this group were spaced from 300 to 6,200 ft. Therefore, repairing only the joints with more than 4 ft of spall would result in large lengths of pavement without pressure relief.
