**Appendix D – BridgeGuard US-131 Delamination Report**

# Bridge Deck Delamination Report

Bridge: 5002 SB  
Talon Research, Inc.  
09/16/2013

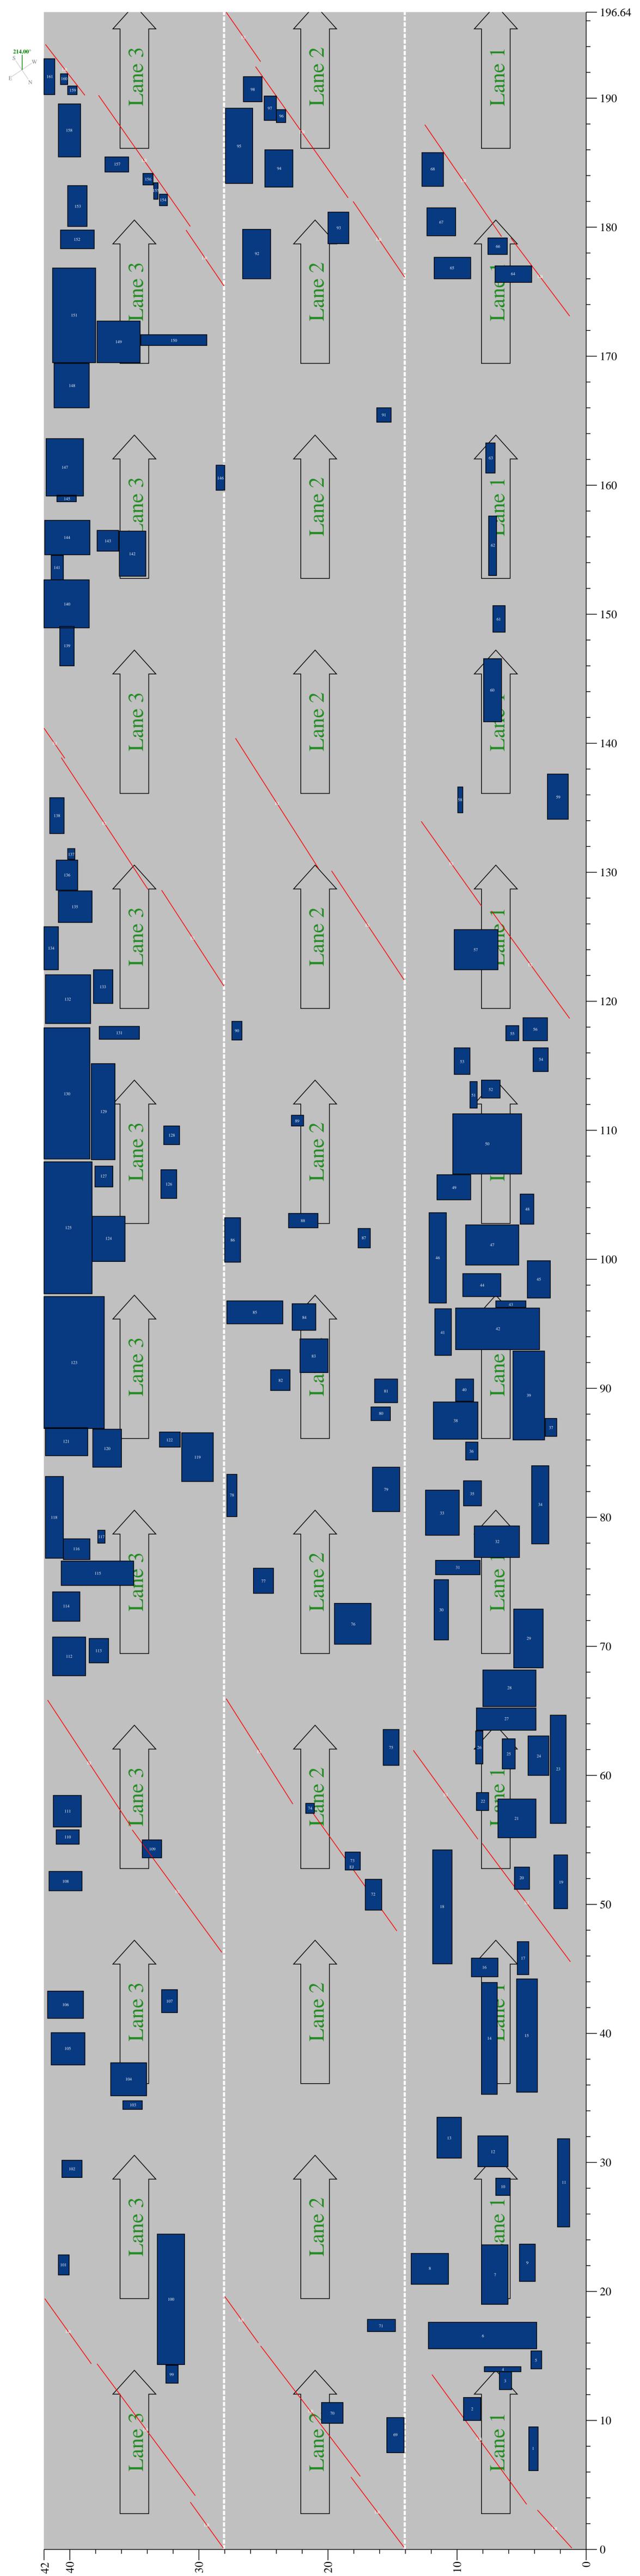
Total Bridge Area (sq ft): 8258.85  
 Defect Area (sq ft): 989.63

# of Defects: 161  
 % Defective: 11.98

161  
11.98

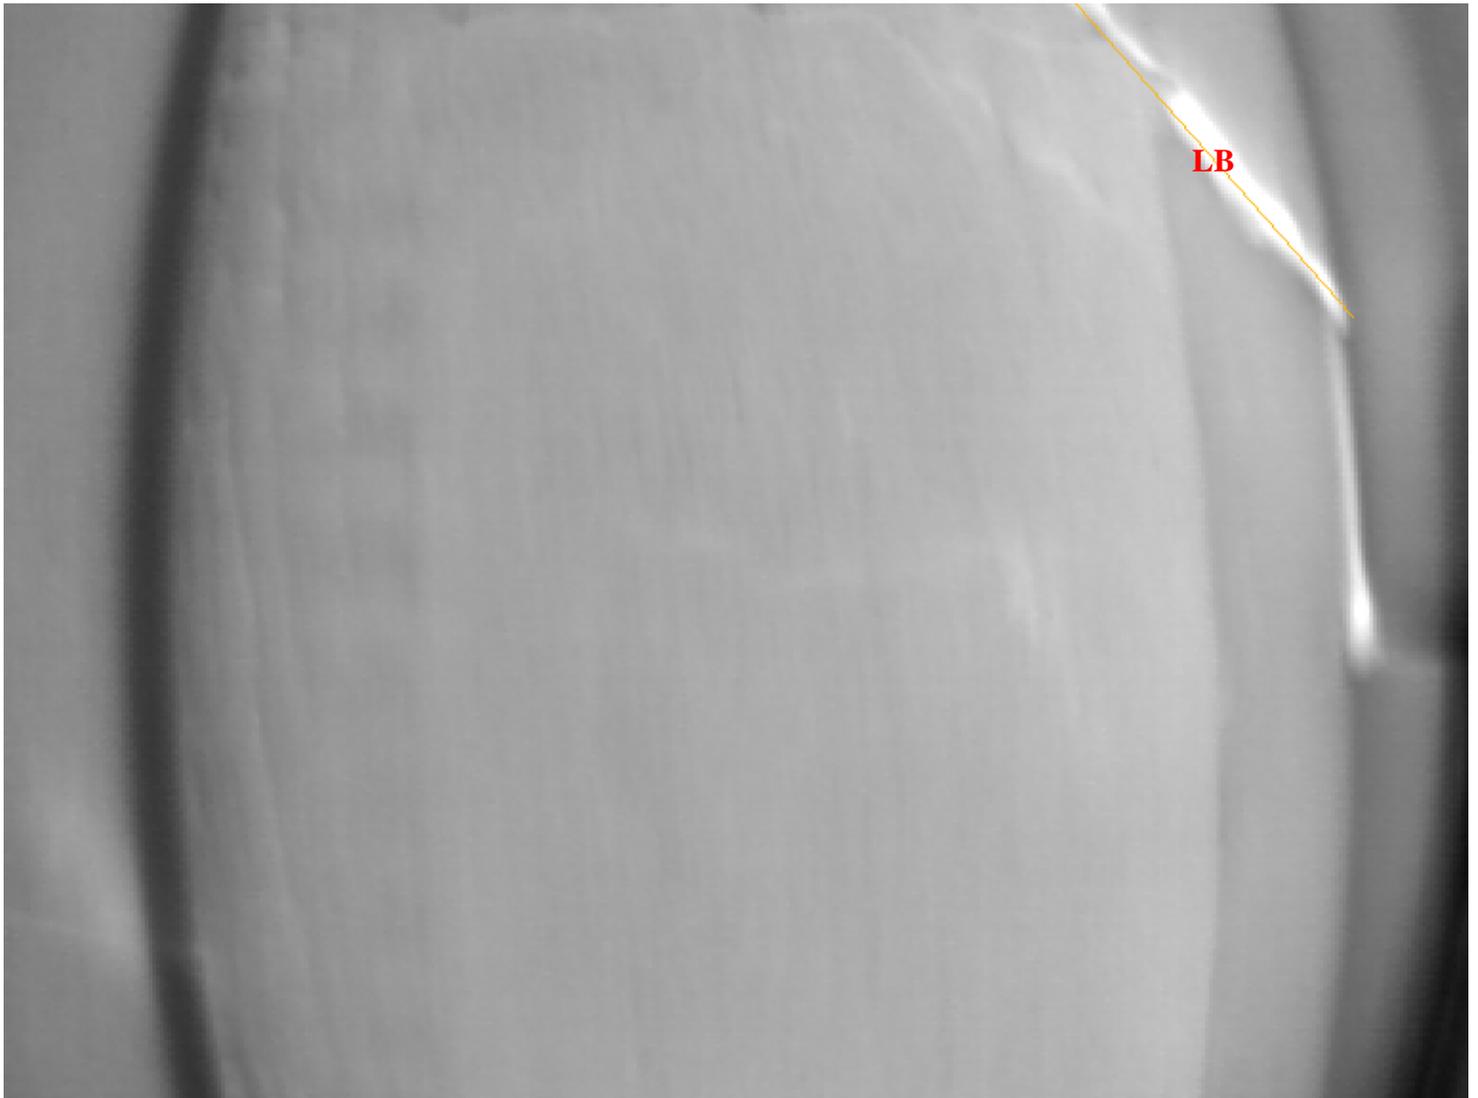
Image Name: 1\_2229000\_56731\_2185.tif

Defect #	LB
Feet from Start	1.59
Feet from Right	2.43
Defect Size	NA
Length x Width (ft)	NA
Type	Lane Bound
