Appendix E – BridgeGuard Maryland Avenue Delamination Report

Bridge Delamination Report

Maryland Ave. over I-96

Freer Road over I-94

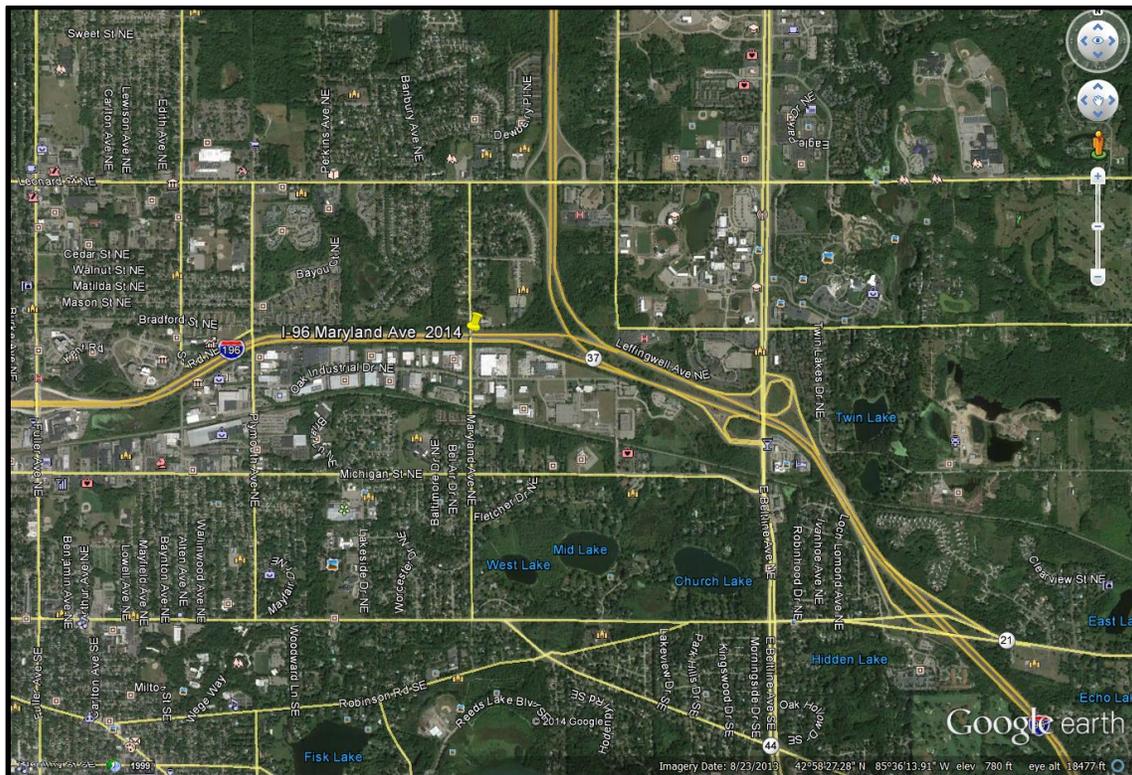
**Bridge Layout
(Top View)**

Maryland Road Summary

| Components | # of Delaminations | Total Element Area (SF) | Delaminated Area (SF) | % Delaminated |
| Deck Top | 8 | 5,520 | 17.6 | 0.32% |
| TOTALS = | 8 | 5,520 | 17.6 | 0.3% |

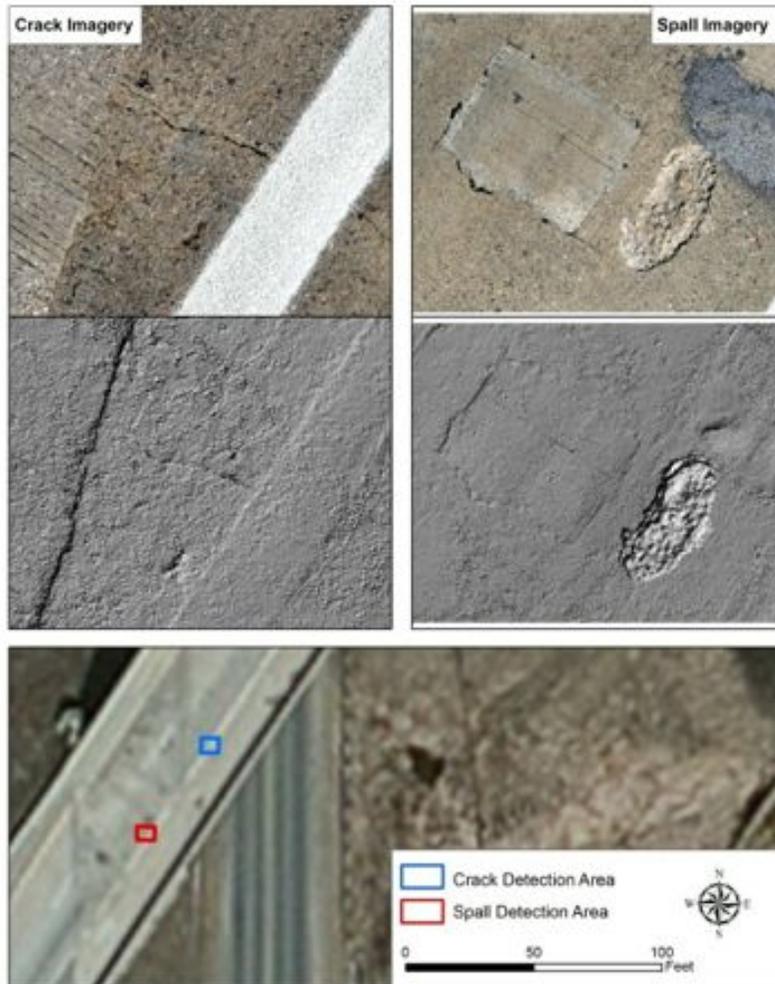
US 131 North Bound 1/2 Millimeter Resolution Output Imagery
Using 3DOBS-Slow (Ortho and Hillshade Imagery)

- High resolution imagery produced from 3DOBS-High Res (slower 36 mp version)
- On the left, is high resolution imagery of crack detection.
- Right is high resolution imagery of spall detection.
- DEM

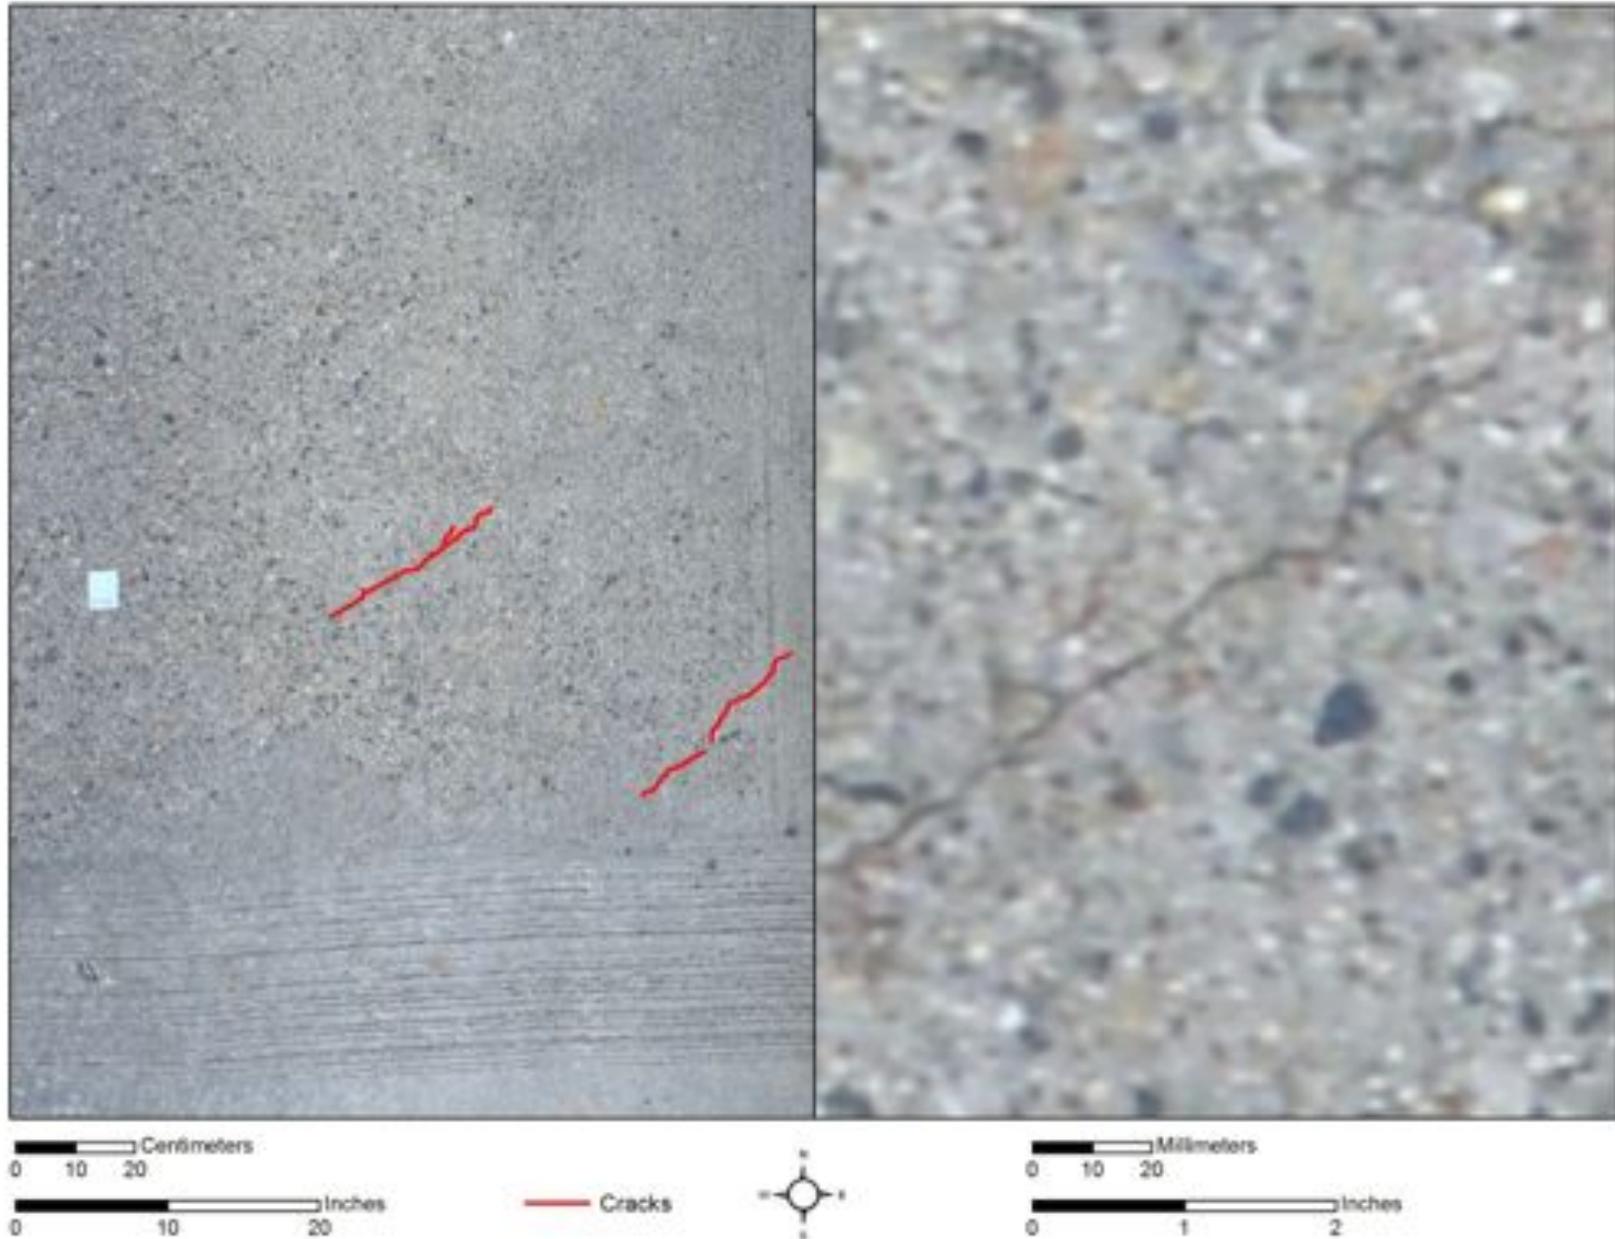
Detail of a 1 mm Crack

- With imagery resolution of 0.5 mm, cracks down to 1 mm (just over 1/32nd inch) can be mapped.
- Maryland Ave cracks:
 - 35 Cracks were digitized
 - Total crack length – 386.6 in

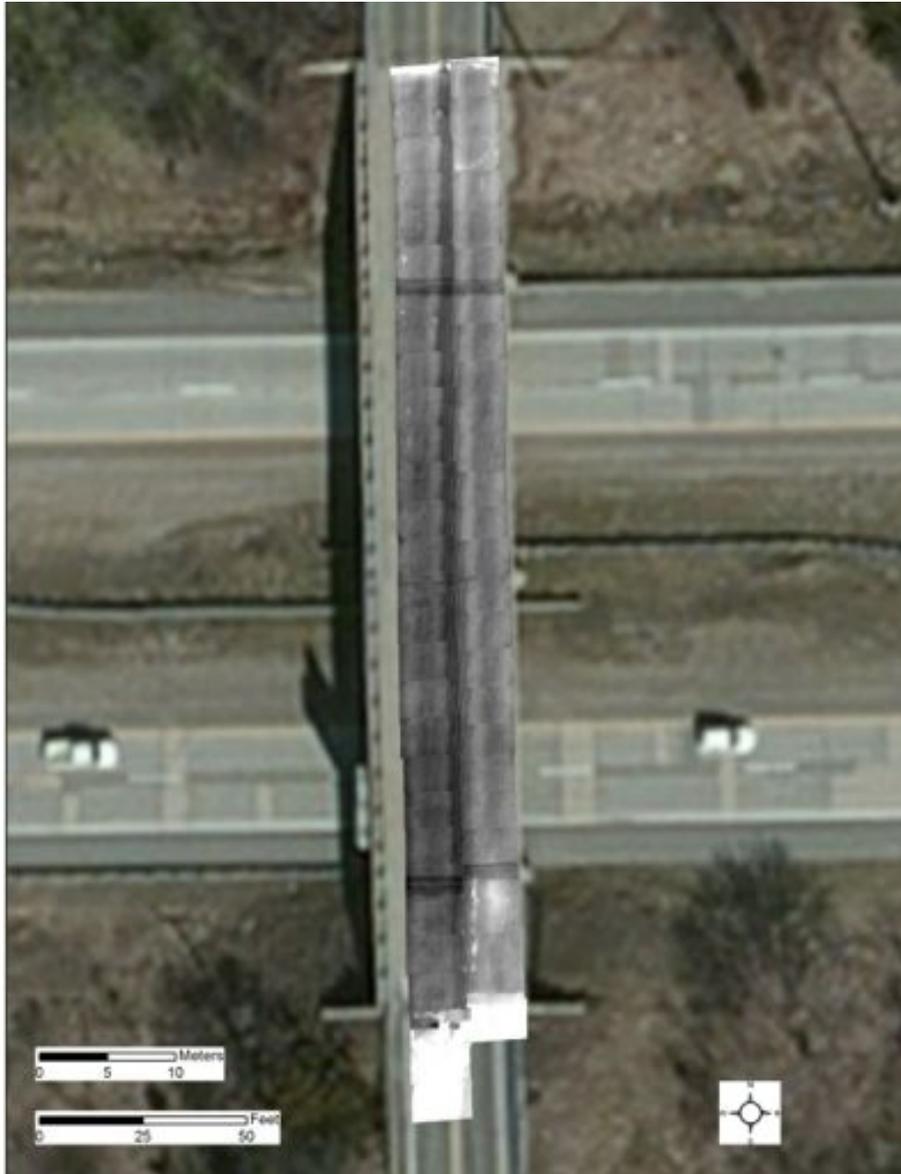
Maryland Ave. Thermal Layer

- Mosaiced thermal layer of Maryland Ave.

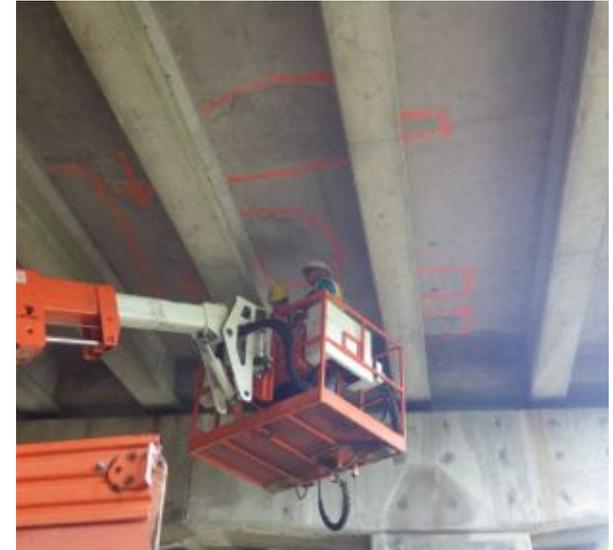
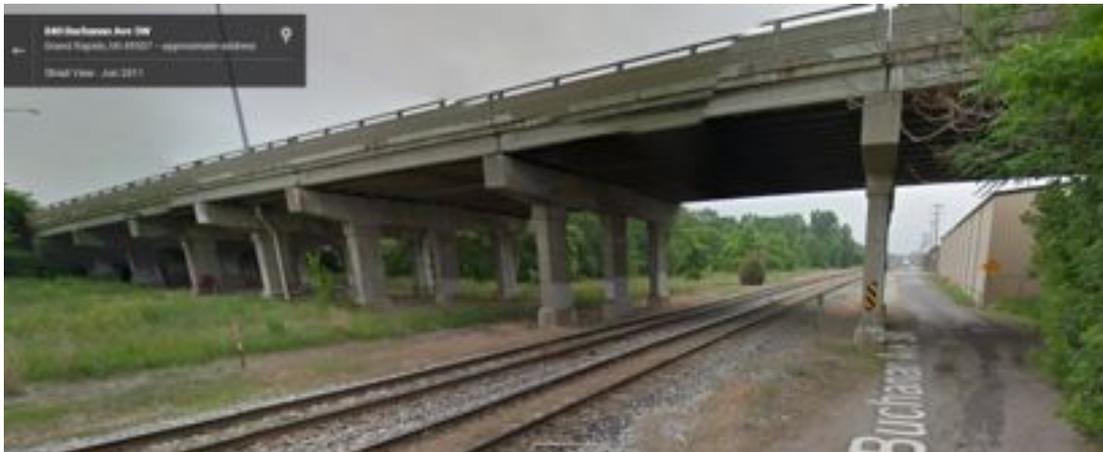
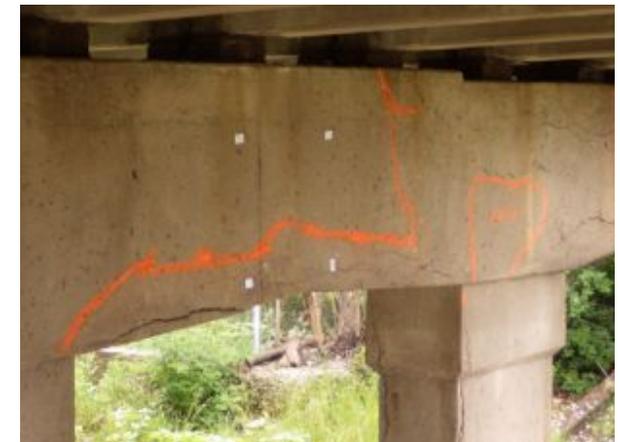
Franklin Ave. over US-131 NB & SB (# 4947) conducted on 6/24/2014

- MDOT hammer sounding inspection
- Collected active IR thermal data in 3 test locations:
 - 2 areas on bridge deck underside
 - Side of pier cap
- Data from 15 min and 5 min heat times

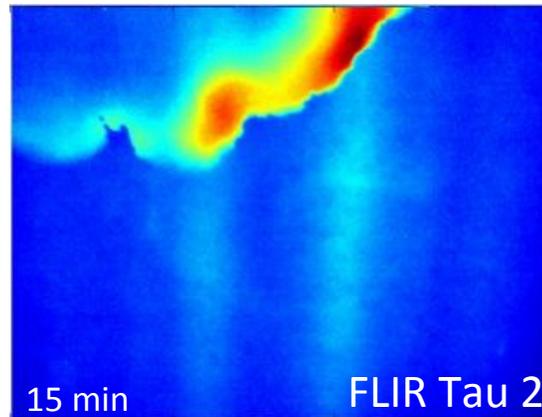
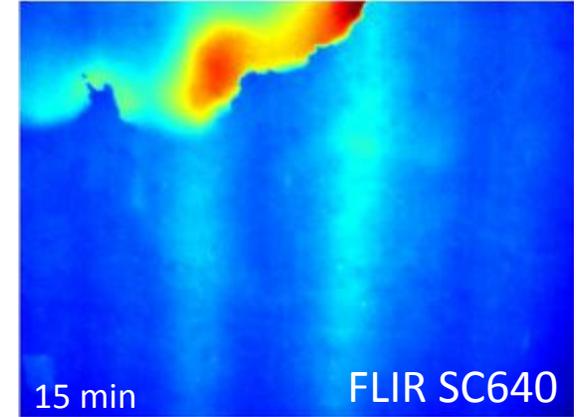
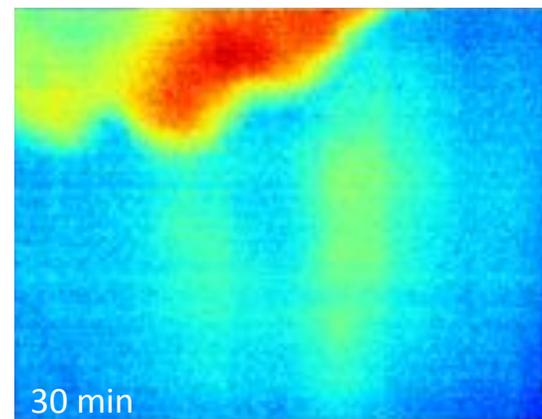
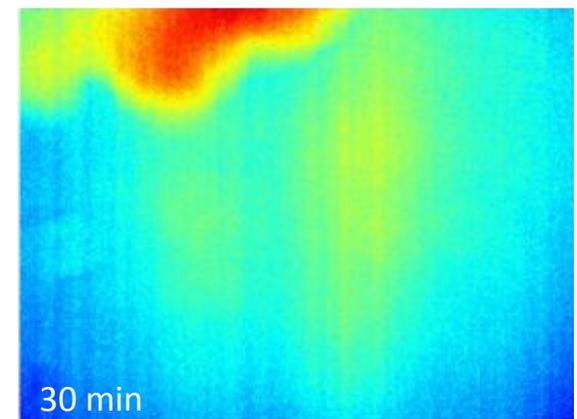
Bridge Deck Underside (Location 2)

- Cameras provide temporal sequence of numerical matrices
 - FLIR SC640 – actual temperature
 - FLIR Tau 2 – digital numbers
- Matrices can be converted to .xlsx, .mat, .tif, .txt or other common formats
- False color map provides image for visual analysis
