**Torch Lake AMW
QMCM Processing Area**

Osceola & Torch Lake Township, Houghton County
T55N R33W Sections 13,14, 23, 24, 26 & 27

**SITE MAP SHOWING 2016
SIDE SCAN SONAR COVERAGE AREA**

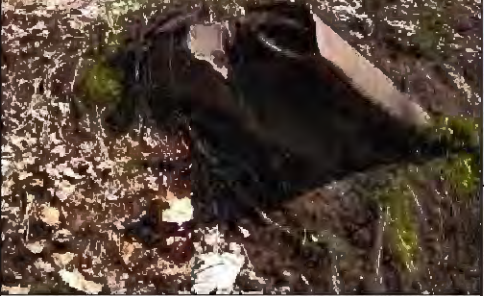
| Check as Appropriate: | | Record Field Measurements: | Provide Written Description Including Condition, Content, and Similar Material Properties: | Document as Applicable: | | | | |
|--|---|---|---|---|---|---|---|--|
| Suspect ACM | | Latitude: 47.13989280N Longitude: 88.46461114W | SACM#72: Pile of debris, includes black tar roofing material buried under leaf litter, area includes wooden floorboard (approximately 10x15 feet) partially buried, may include more debris items | | | | | Material sample QMCM-ASBBLK02-052417 collected during targeted inspection activities is representative of the materials identified during reconnaissance activities. |

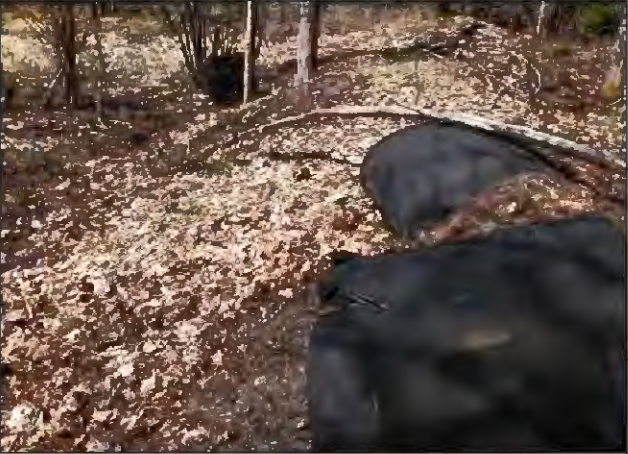
| Check as Appropriate: | | Record Field Measurements: | Provide Written Description Including Condition, Content, and Similar Material Properties: | Document as Applicable: | | | | |
|--|---|---|---|---|---|---|---|--|
| Suspect ACM | | Latitude: 47.13980180N Longitude: 88.46444644W | Same location as SACM#73: Thin circular sheet metal cut-outs with teeth, area contains large pile of layered cut-outs and scattered pieces | | | | | |

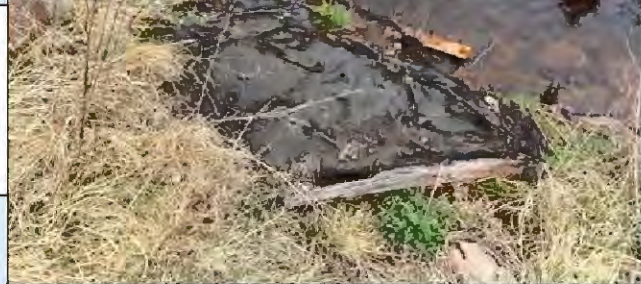
| Check as Appropriate: | | Record Field Measurements: | | Provide Written Description Including Condition, Content, and Similar Material Properties: | Document as Applicable: | | | | |
|---|---|--|---|--|---|---|---|--|--|
| Suspect ACM | ✓ | Latitude: 47.14588667 N Longitude: 88.45738316 W | SACM#53: Black tar roofing material, appears felt-like, fibrous and layered, partially buried along coal dock edge of cap toward remaining dock location, various sized pieces from 1 square foot to quarter sized pieces scattered among coal debris and piled rocks, area extends south towards concrete pylon, larger area includes black weathered roofing material attached to wooden boards that appears layered, but melted together, approximately 25 square feet | | | | | Material sample QMCM-ASBBLK28-052517 collected during targeted inspection activities is representative of the materials identified during reconnaissance activities. | |

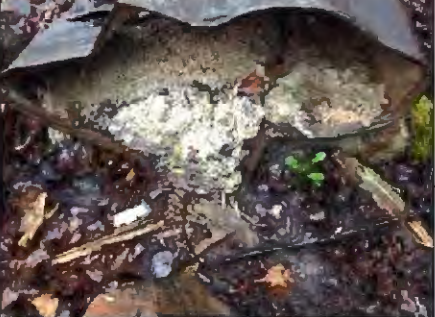
| Check as Appropriate: | | Record Field Measurements: | Provide Written Description Including Condition, Content, and Similar Material Properties: | Document as Applicable: | | | | |
|---|---|---|--|--|---|---|---|---|
| Suspect ACM | ✓ | Latitude: 47.14625785 N Longitude: 88.45934283 W | SACM#52: Black, tar-like roofing material attached to wooden boards, found in concrete and wood basin, two pieces are visible with potentially more buried in leaf litter | | | | | Material sample QMCM-ASBBLK28-052517 collected during targeted inspection activities is representative of the materials identified during reconnaissance activities. |

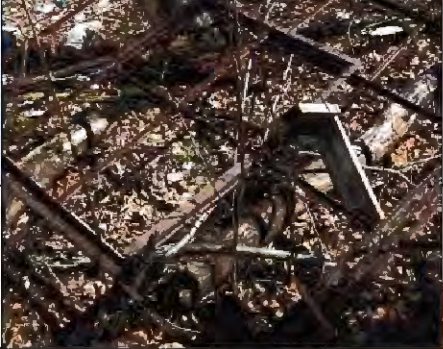
| Check as Appropriate: | | Record Field Measurements: | Provide Written Description Including Condition, Content, and Similar Material Properties: | Document as Applicable: | | | | |
|---|---|---|--|---|---|---|---|--|
| Suspect ACM | ✓ | Latitude: 47.14758350 N | SACM#22: Scraps of white/gray woven fabric with visibly weathered black coating. Visible length is approximately 4 feet and is partially buried. | | | | | Material sample QMCM-ASBBLK70-052617 collected during targeted inspection activities is representative of the materials identified during reconnaissance activities. |

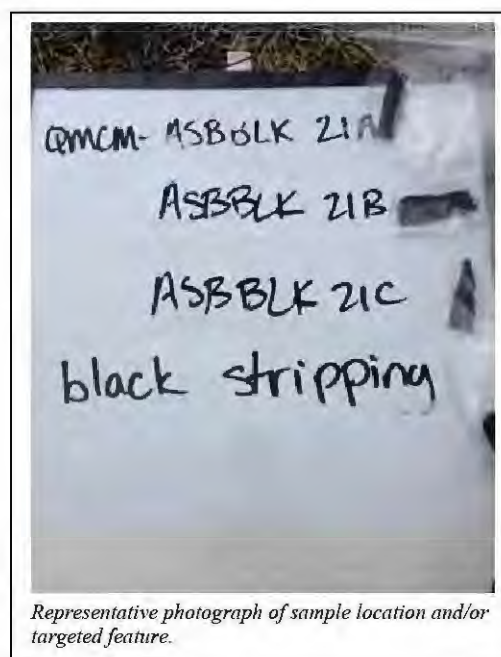
The area is situated at the edge of the capped area east of the Reclamation and Shore Plant foundations. The target feature includes six wood line structures/pits that are filled with water and wood debris. The suspect asbestos containing material is found near the wooden boards near each of the six structures/pits. The caulking material is found in small pieces and still intact and on the wooden boards, approximately 1-2 centimeters in width.

The material is weathered and is in fair condition. The property is partially secured with a 'walk through' gate north and west of the Reclamation and Shore Plants nearby.

The material is located at the edge of the stamp sand cap near the shoreline of Torch Lake.

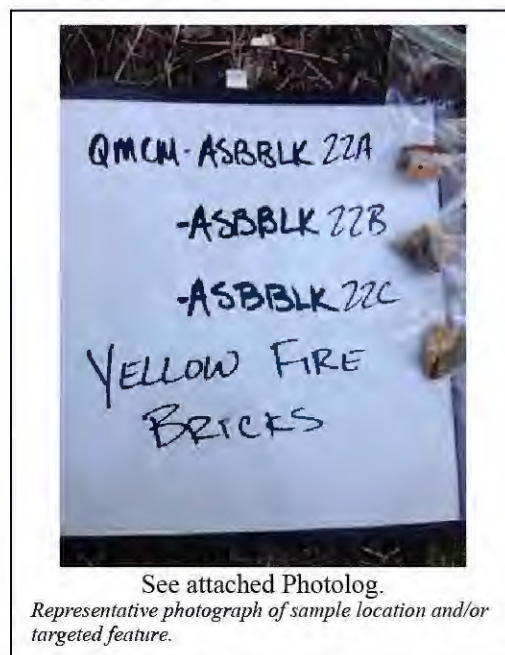
The area is partially wooded and includes mining era foundational remains and debris. Two abandoned drums (one with visible waste) are found in the vicinity. The suspect asbestos containing material included fire bricks (which also pose a physical trip hazard), rope gasket attached to a metal flange on the ground, shingle material and mastic on the south side of the Coal Bin.

The property is partially secured with a 'walk through' gate north and west of the Reclamation and Shore Plants nearby. A breach in the fence is also found closer to the property, making it accessible to trespassers. Rope gasket and gray mastic noted as in poor condition and friable.

The materials are located in a wooded area approximately 200 feet from the shoreline of Torch Lake.

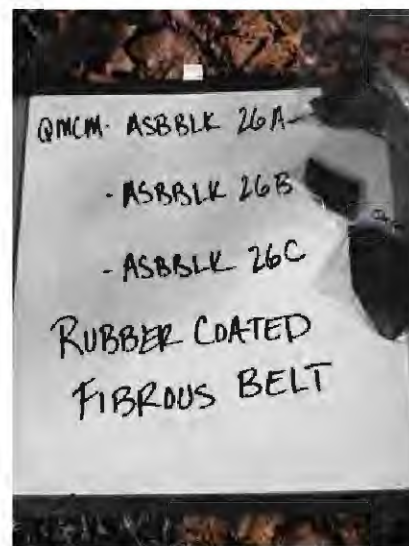
The area is partially wooded and includes mining era foundational remains and debris. Two abandoned drums (one with visible waste) are found in the vicinity. The suspect asbestos containing material includes rubber coated fibrous belting approximately 6-8 inches in width, gray gasket material, felt roofing w/ mastic and black tar mastic. The material is scattered throughout area and partially buried in some locations near the south side of the railroad grade.

The property is partially secured with a 'walk through' gate north and west of the Reclamation and Shore Plants nearby. A breach in the fence is also found closer to the property, making it accessible to trespassers.

The materials are located in a wooded area approximately 300 feet from the shoreline of Torch Lake, except ASBBLK29(A-C), which is located on the shoreline near the Coal Dock.

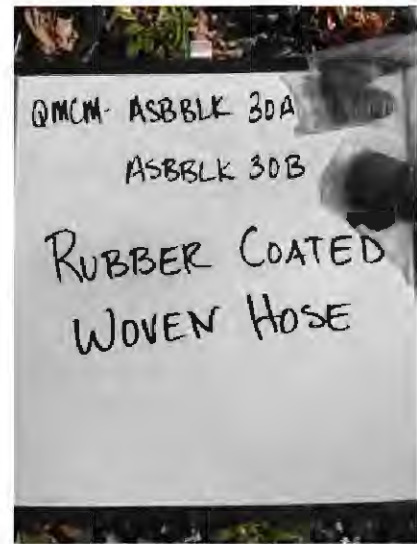
The area is partially wooded and includes mining era foundational remains and debris. Two abandoned drums are found in the vicinity south of Quincy Creek. The suspect asbestos containing material includes woven hosing, woven layered material, roofing and layered felt paper. The material is scattered throughout area and partially buried in some locations near the wooden barge in the woods.

The property is partially secured with a 'walk through' gate north and west of the Reclamation and Shore Plants nearby. A breach in the fence is also found closer to the property, making it accessible to trespassers.

The materials are located in a wooded area approximately 50-100 feet from the Quincy Creek, which drains into Torch Lake.

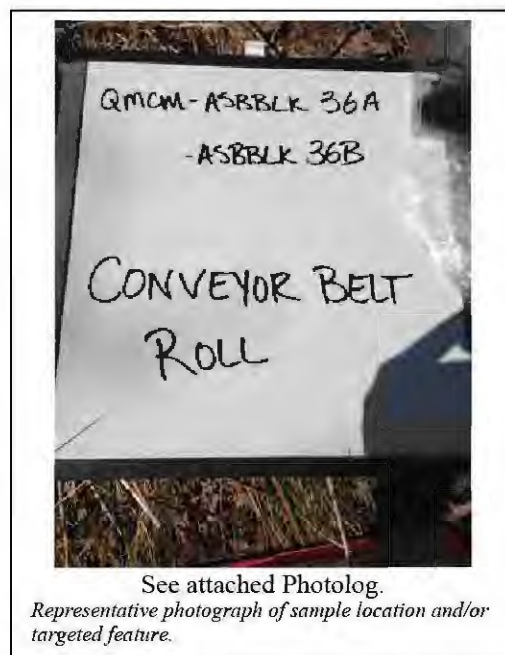
The Dump Site is found near the edge of the capped area in two partially wooded areas. The area is littered with debris that includes apparent industry and household materials. Abandoned drums and drum carcasses are found throughout the area.

The property is partially secured with a 'walk through' gate north and west of the Reclamation and Shore Plants nearby. A breach in the fence is also found closer to the site, making it accessible to trespassers.

The materials are located in a partially wooded area approximately 50-100 feet from Torch Lake. The ground slopes gradually to the east from the dump areas.

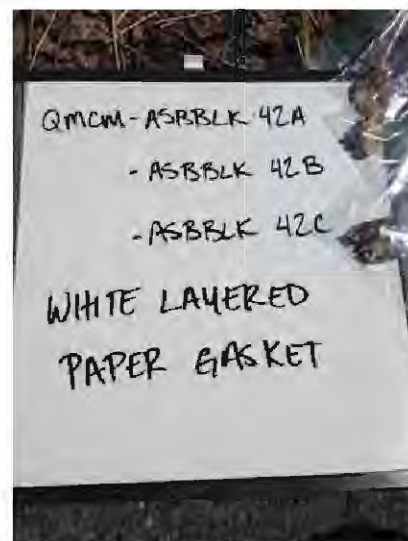
The area includes a concrete foundation (Quincy Booster Pump Station) to the east of the access road and west of the dump site. The concrete slab contains suspect asbestos containing materials such as Transite tiles and gasket material laying on the foundation. Material quantities observed were less than 1 square foot each.

The property is partially secured with a 'walk through' gate north and west of the Reclamation and Shore Plants nearby. A breach in the fence is also found closer to the site, making it accessible to trespassers. White layered gasket noted as friable.

The materials are located approximately 200 feet from the Torch Lake shoreline.

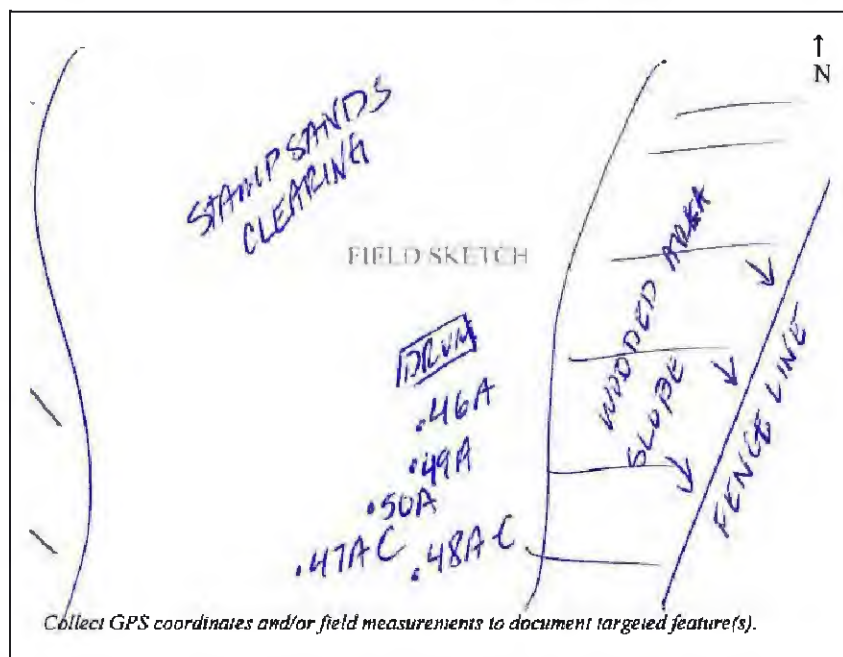
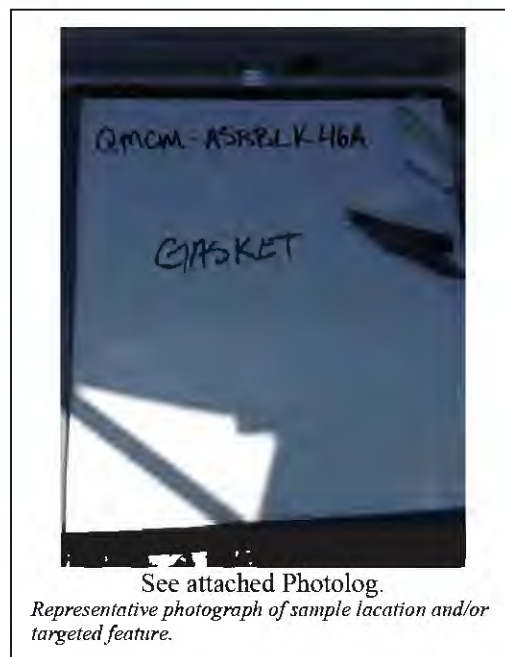
Feature Identification/Name: Wooded area north of Reclamation Plant

Area located North of Reclamation Plant, east of fence line and west of ORV trail. Area contains foundational remains and various abandoned drums in a wooded area. Suspect asbestos containing material includes gaskets, fabric tubing, woven fabric material and fabric belting scattered on the ground and partially buried.

The materials are located in a wooded area to the east of the ORV trail in a partially wooded area. The ground generally slopes to the east toward the fence line and capped area.

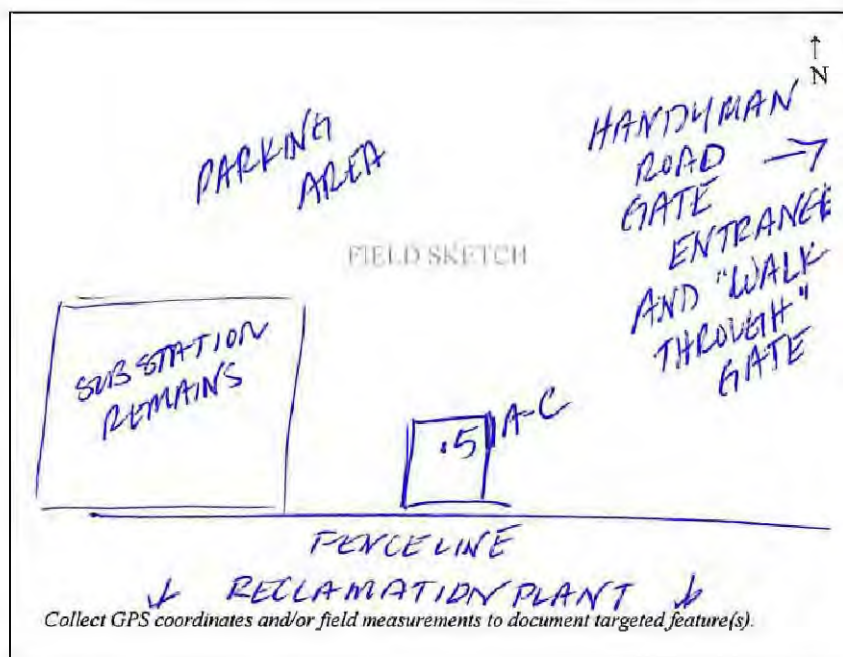
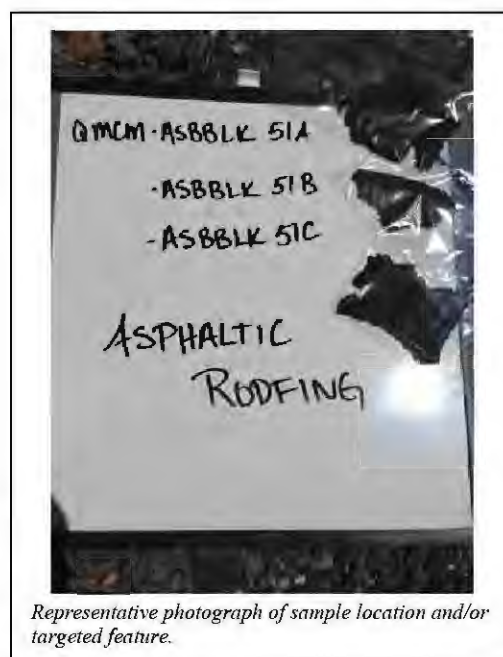
Parking lot area located North of Reclamation Plant, accessible by Handyman Road. Board approximately 5 x 4 feet with black roofing material. Roofing is in poor condition, area is littered with trash.

The parking area is not secured and is accessible. The roofing material has weathered and is in poor condition.

The material is located near drainage ditches carrying water from across M-26 toward Torch Lake.

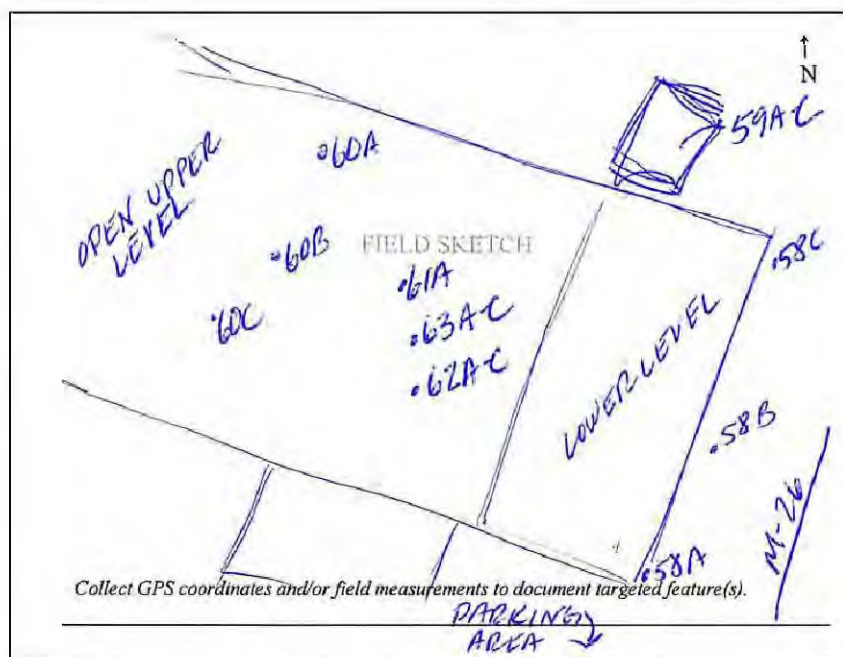
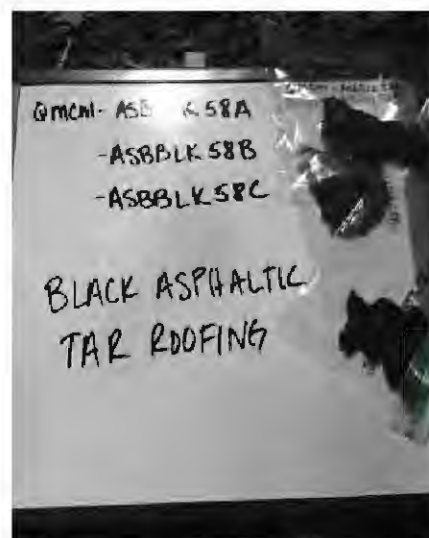
The concrete foundation and area surrounding the remaining portion of the former Stamp Mill includes debris piles and suspect asbestos containing materials. Roofing from the remaining Stamp Mill is found along M-26, roofing from another structure is found along the north side of the Stamp Mill. Suspect TSI material is observed in piles throughout the upper concrete foundation.

The materials are located on the upper portion of the Mill. Various trenches create hazards and pathways for contaminated materials to reach lower levels.

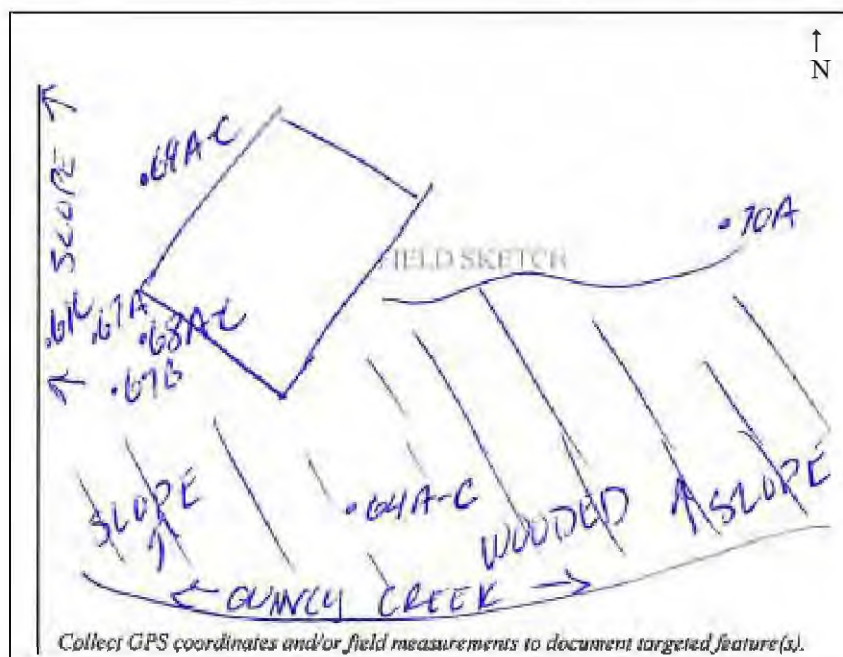
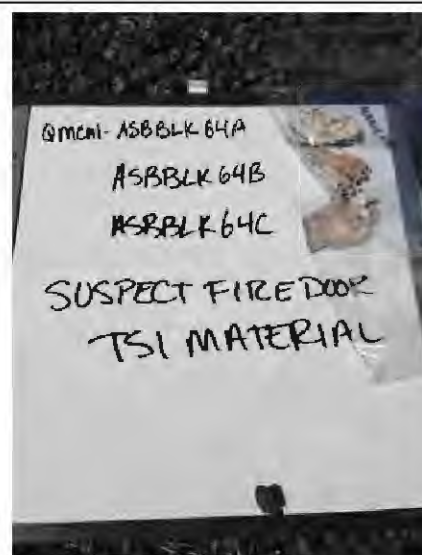
The partially wooded area surrounding the Quincy Turbine (Power) House includes debris and building material on the ground. Suspect asbestos containing material includes various fabrics, tubing, roofing, window glazing, sheeting and suspect TSI material found within a crumbled metal fire door.

The materials are located on the upper portion of the Turbine House area near the Quincy Creek. Various trenches create hazards and pathways for contaminated materials to reach lower levels.

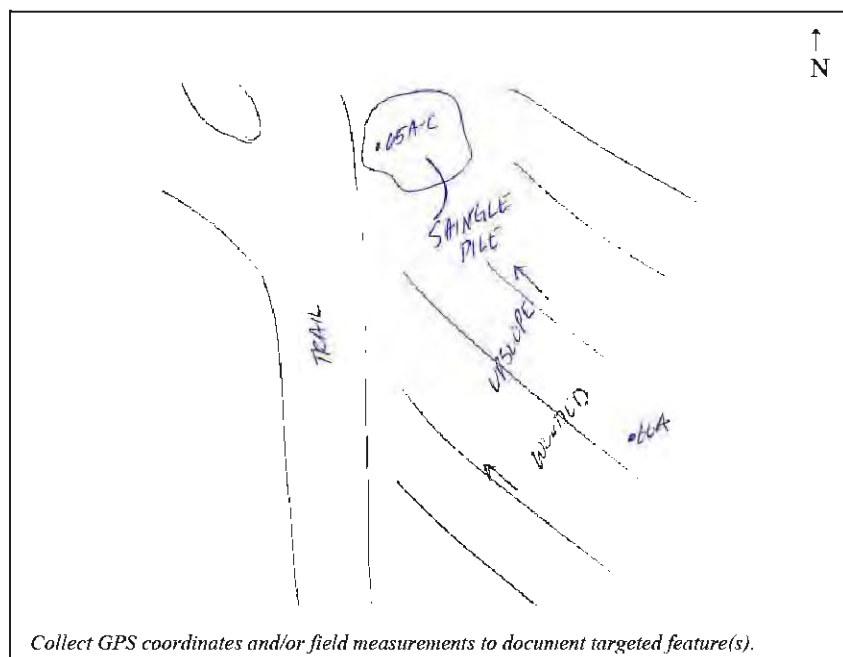
The wooded area to the southwest of the concrete foundation of Stamp Mill No. 1 includes suspect asbestos containing roofing materials and weathered belting. The wooded area also includes abandoned drums and other containers. A pile of roofing material is found at the edge of the wooded area adjacent to the ORV trail, along with other household trash and debris.

The materials are located on the upper portion of a sloped wooded area. Various trenches create hazards and pathways for contaminated materials to reach lower levels.

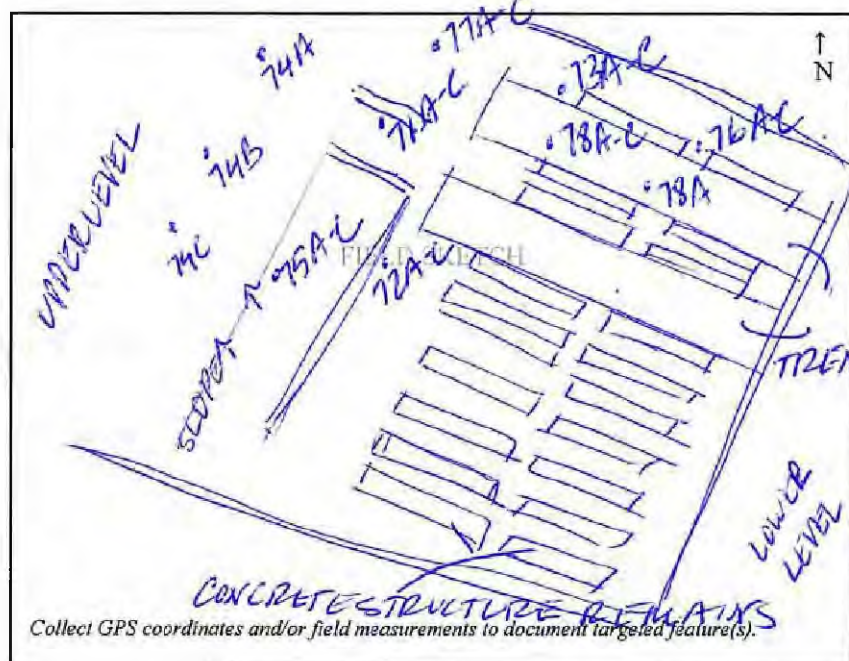
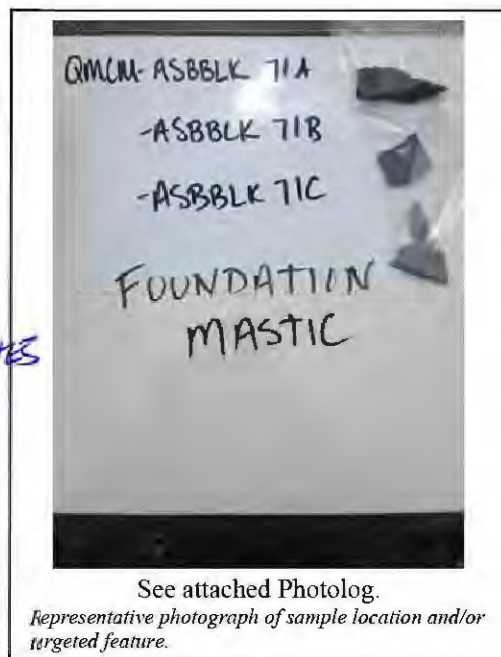
Inspection Date: 5/26/2017 Feature Identification/Name: Upper level Concrete Foundation - Quincy Stamp Mill No. 2

The concrete foundation and area surrounding the remaining portion of the former Stamp Mill includes debris piles and suspect asbestos containing materials. Suspect asbestos containing material includes mastic, felt paper, a variety of woven fabric materials and suspect thermal system insulation.

The materials are located on the upper portion of the Stamp Mill foundation. Various trenches create hazards and pathways for contaminated materials to reach lower levels. Drainage channels for overland flow are found running to the east.

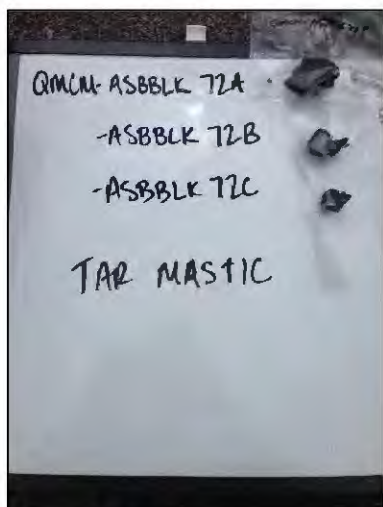
Photo 1: QMCM-ASBBLK72(A-C)-052617

QMCM-ASBBLK72 (A-C)-052617 (loose tar mastic) – collected at 1546

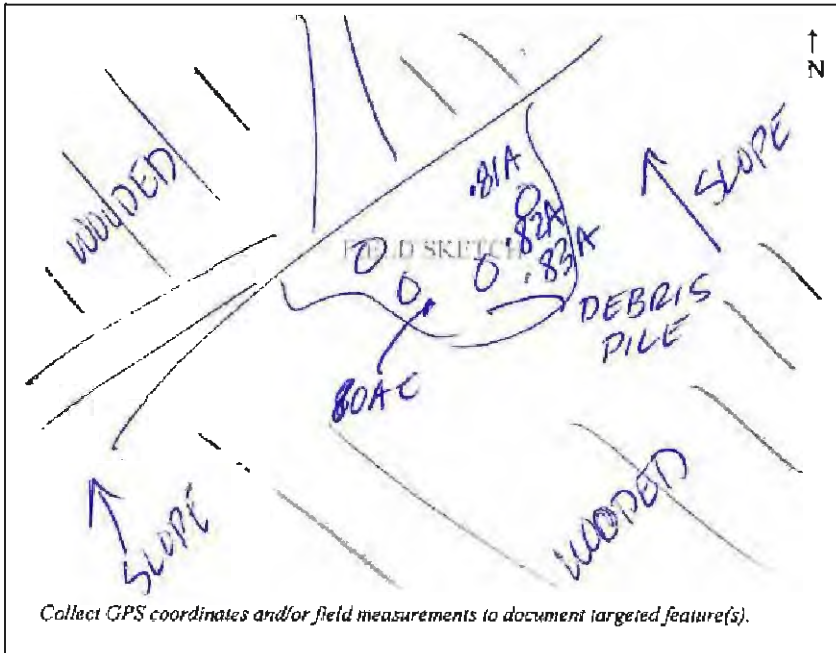
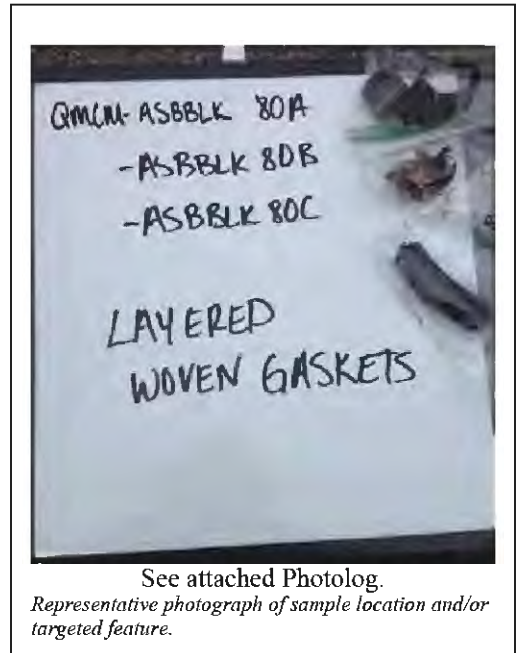
Feature Identification/Name: Wooded hillside north of Quincy Stamp Mill No. 2

The hillside north of the concrete foundation of Stamp Mill No. 2 is the location of suspect asbestos containing material that includes layered gaskets, woven fabrics and felt paper. The 15 ft diameter debris pile includes RPM material.

The materials are located on a wooded hillside north of the Stamp Mill foundation. Drainage channels for overland flow are found as the ground surface slopes to the east.

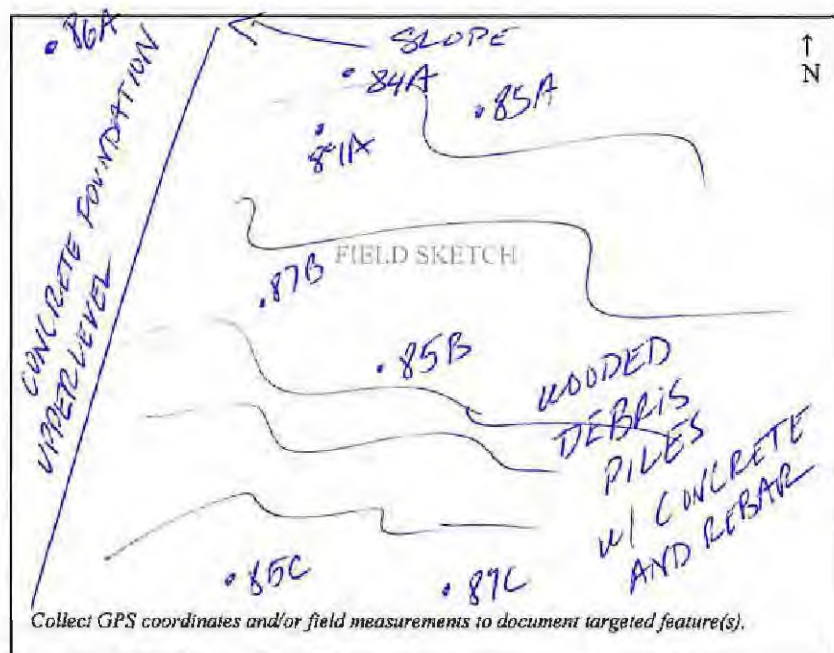
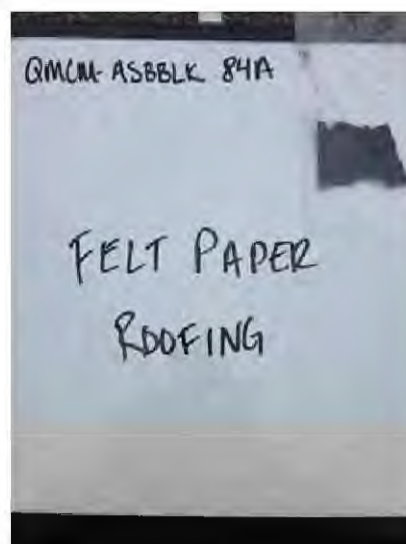
The lower level of the Stamp Mill foundation is littered with large debris piles that include fire bricks and roofing, as well as rebar and concrete debris. Suspect asbestos containing material includes various roofing and fire bricks.

The materials are located on the lower level of the Stamp Mill foundation. Drainage channels for overland flow are found as the ground surface slopes to the east.

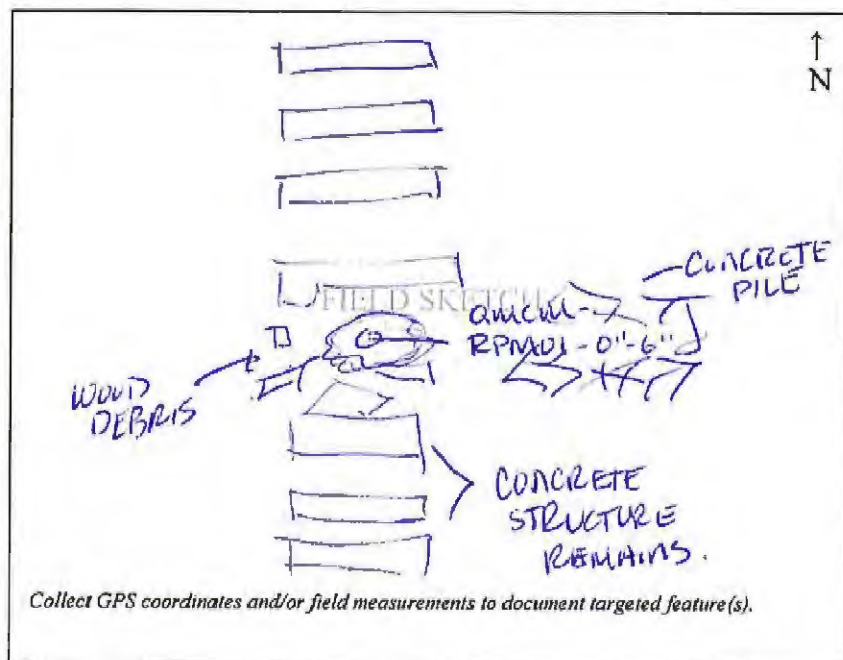
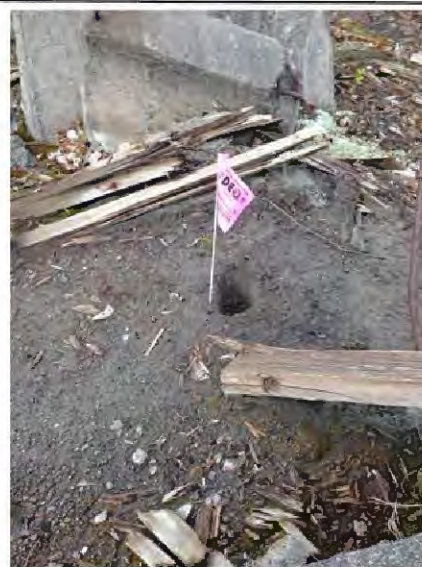
Inspection Date: 05/16/17 Feature Identification/Name QMCN-RPM01-0'-6"

PILE IS LOCATED ON CONCRETE FLOOR OF MILL RUINS, MAY BE SUBJECT TO EROSION

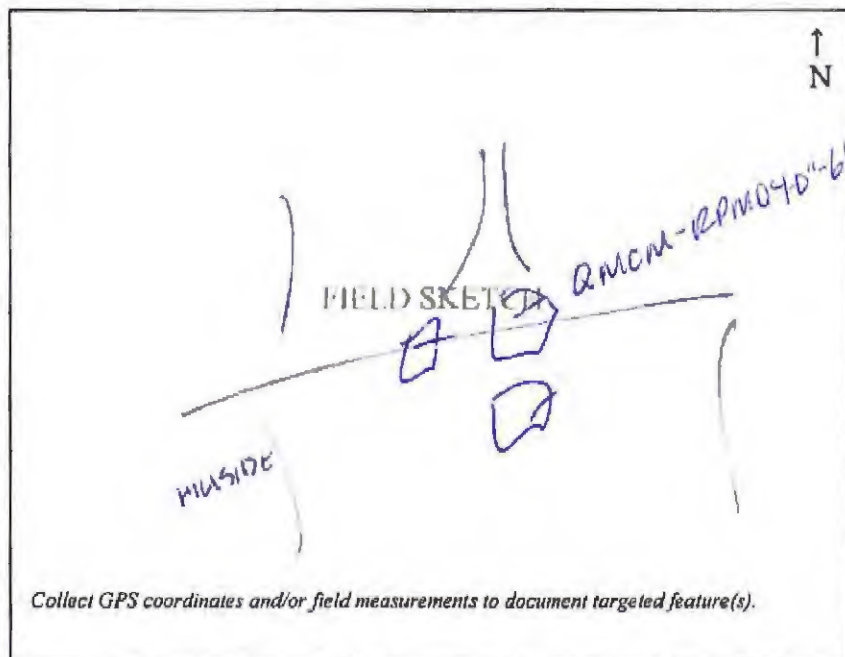
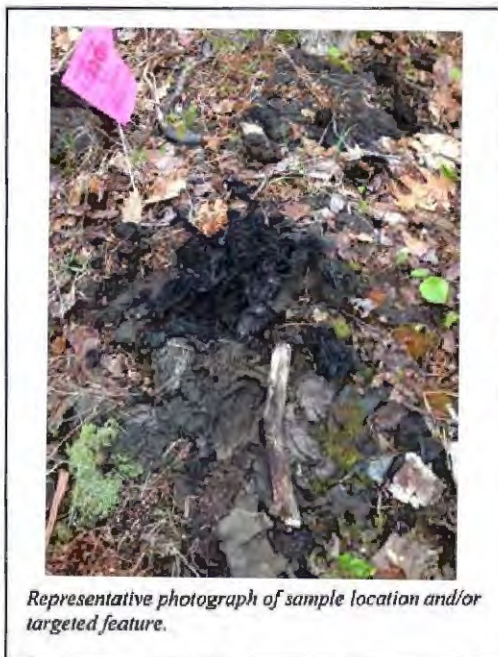
Inspection Date: 05/16/17 Feature Identification/Name QMCN-RPM04-0"-6"

DEBRIS SCATTERED IN AREA- METAL PIECES NEARBY. MATERIAL IS SITUATED ON HILLSIDE, POTENTIALLY EXPOSED TO EROSIONAL FORCES.

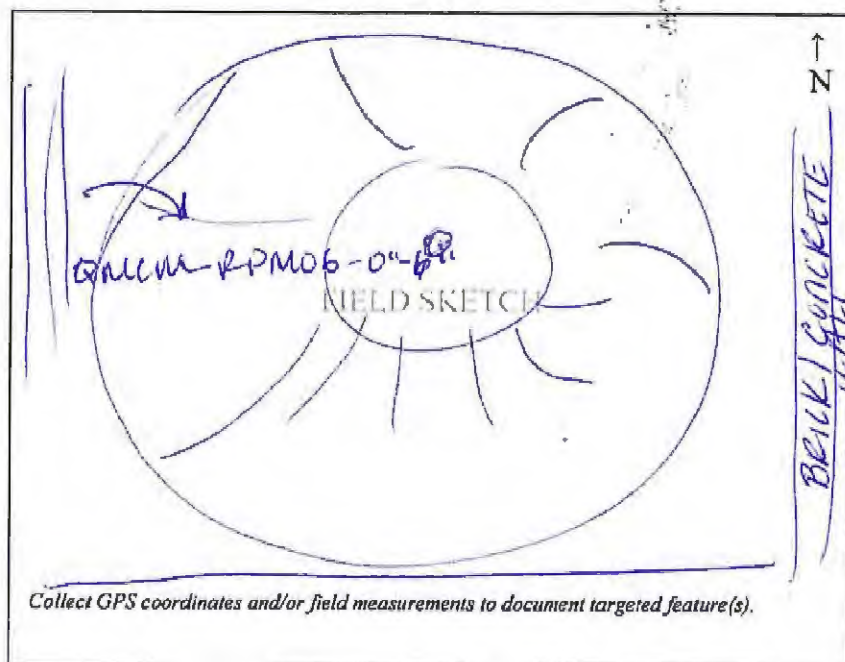
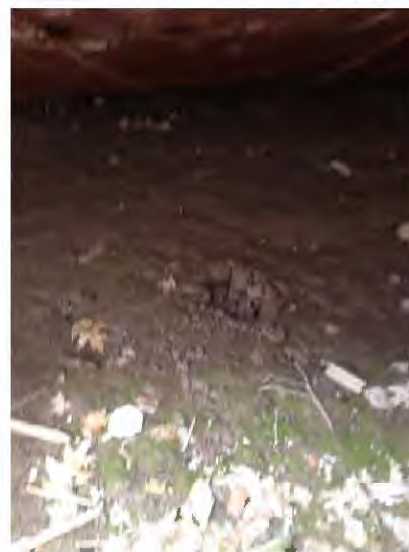
Inspection Date: 05/16/17 Feature Identification/Name: QWCM-RPM06-0'-6"
Study Area: QUINCY STAMP MILL NO. 1 Property Identification Number: 009-023-001-00

MATERIAL IS FOUND BENEATH RUSTED METAL ROOFING IN CIRCULAR WOODEN STRUCTURE IN MINERAL THICKENER

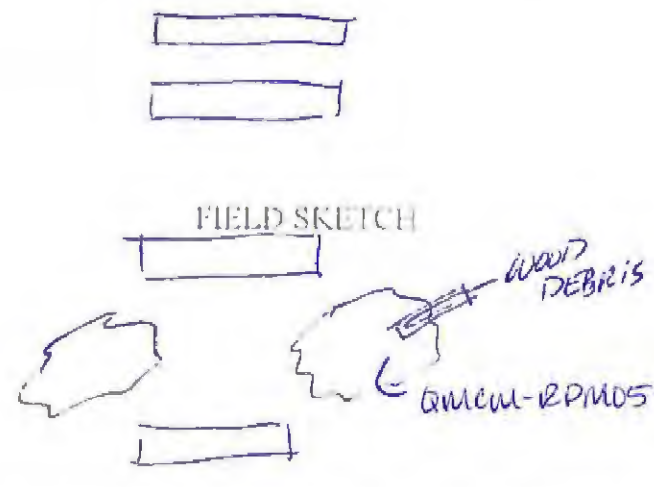
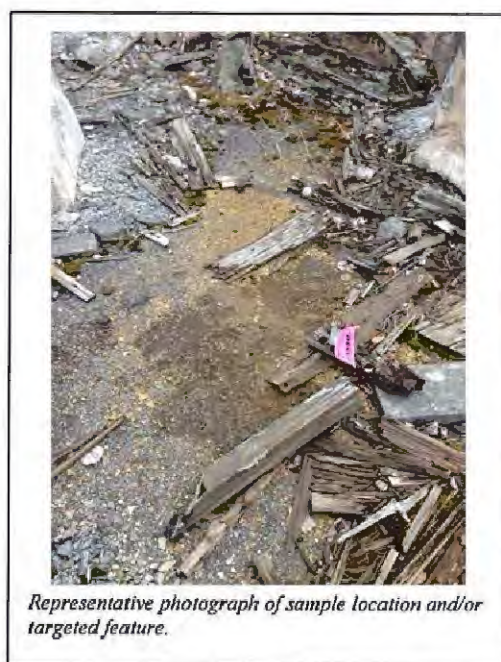
Inspection Date: 05/16/17 Feature Identification/Name: QMCU-RPM05-0"-6"

MATERIAL IS LOCATED ON CONCRETE FOUNDATION FLOOR
 AND MAY BE SUBJECT TO EROSIONAL FORCES

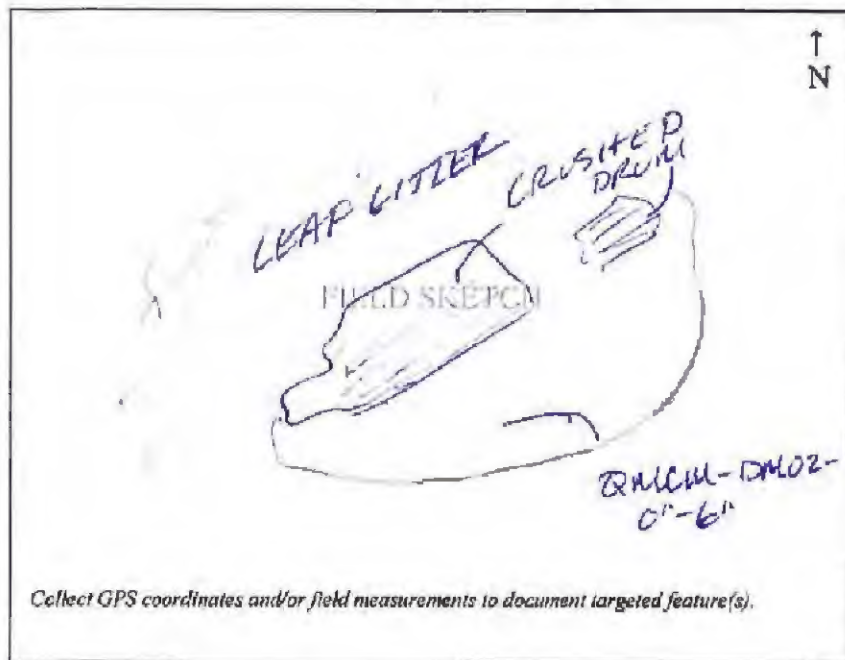
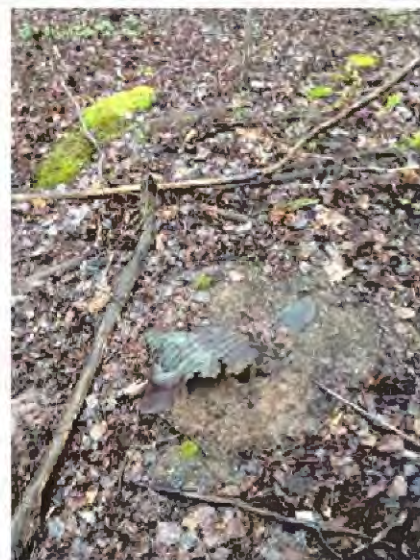
Inspection Date: 05/17/17 Feature Identification/Name QUINCY-DM02-0''-6''

AREA IS IN A CLEARING SOUTHEAST OF A GRADE BIRCH TREES NEARBY. POTENTIAL FOR EROSION

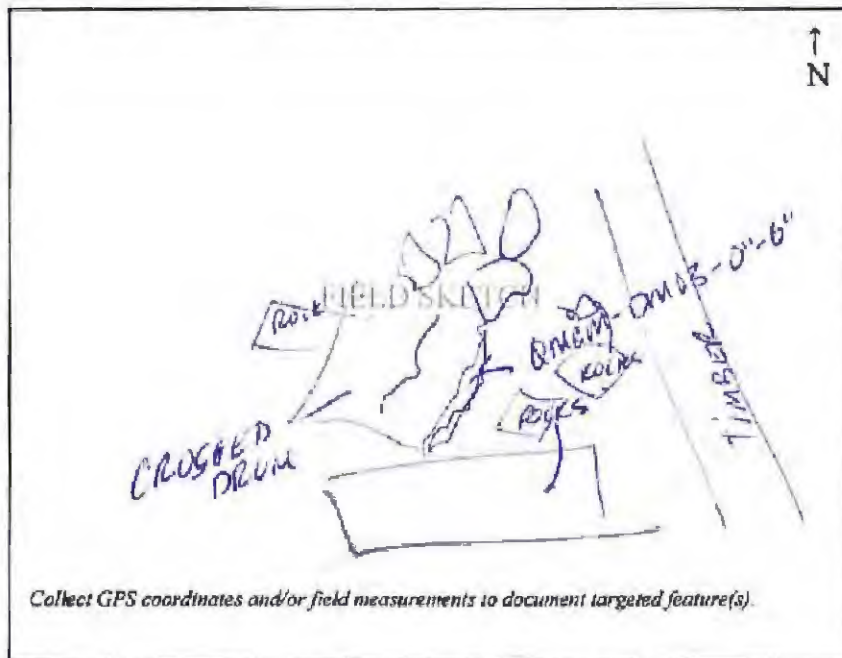
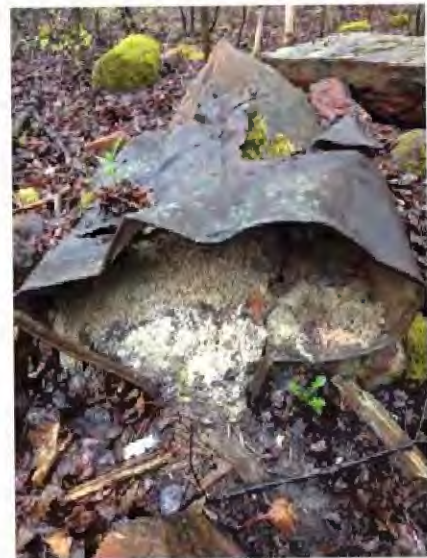
Inspection Date: 05/17/17 Feature Identification/Name: QUINCY - DM03 - 0" - 6"
Study Area: QUINCY MINING - COAL DUMP Property Identification Number: 004-023-001-07

AREA CONTAINS LARGE Boulders, TIMBER DEBRIS NEAR AN OBVIOUS TRAIL NEAR COAL BIN SILO, MATERIAL IS MOSTLY CONTAINED WITHIN DRUM

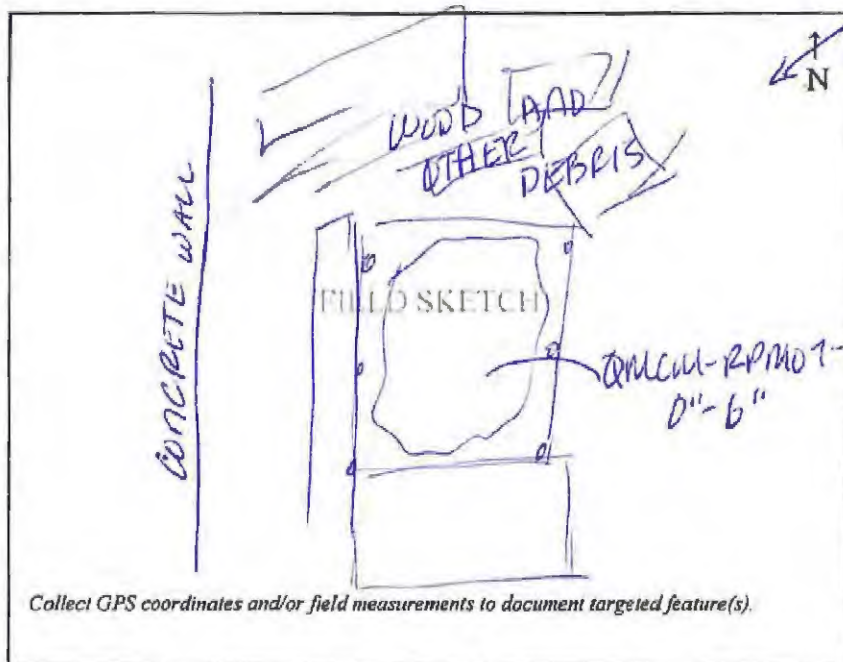
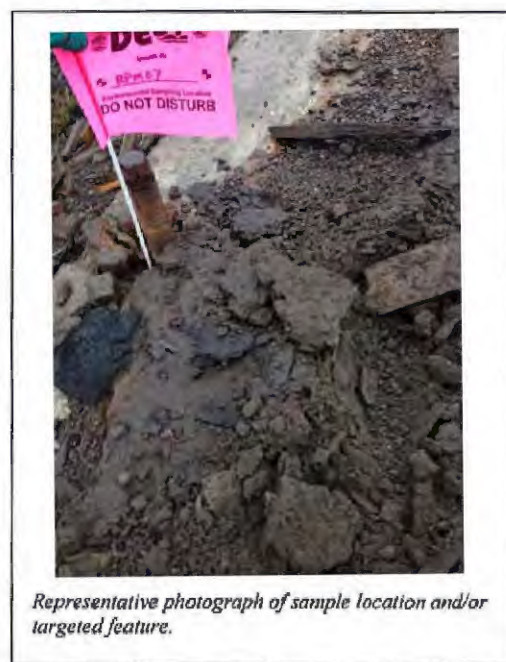
Inspection Date: 05/17/17 Feature Identification/Name QMCU-RPM07-0"-6"

MATERIAL IS LOCATED ON CONCRETE SLABS APPROX. 5'x12'
AND IS NEAR EDGE OF SHORE PLANT POND

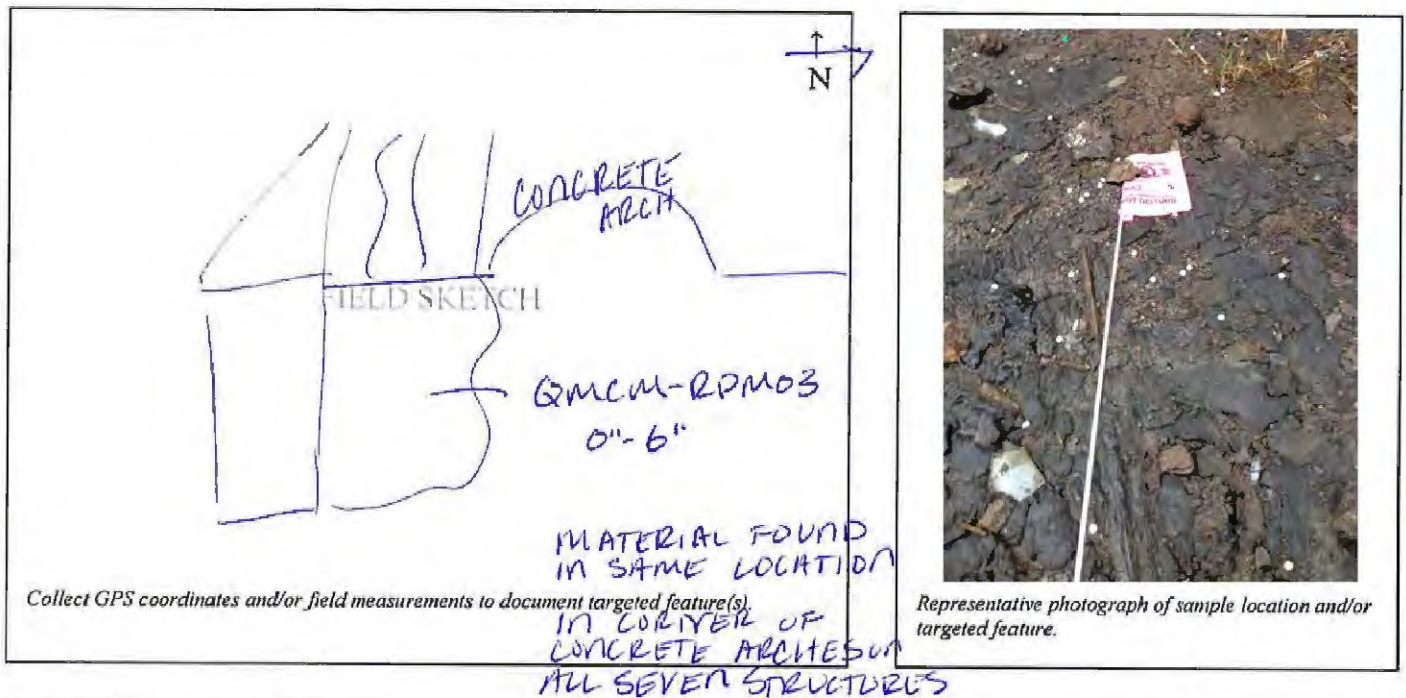
Inspection Date: 05/17/17 Feature Identification/Name QMLCM-RPM03-0"-6"

MATERIAL APPEARS TO BE POOLED WITH THE ORDER OF CONCRETE STRUCTURES THROUGHOUT

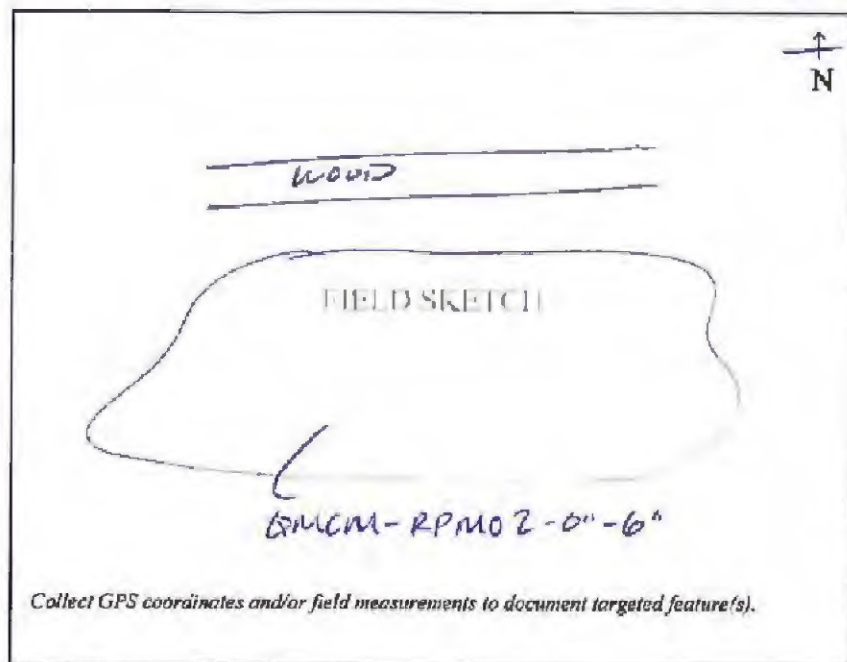
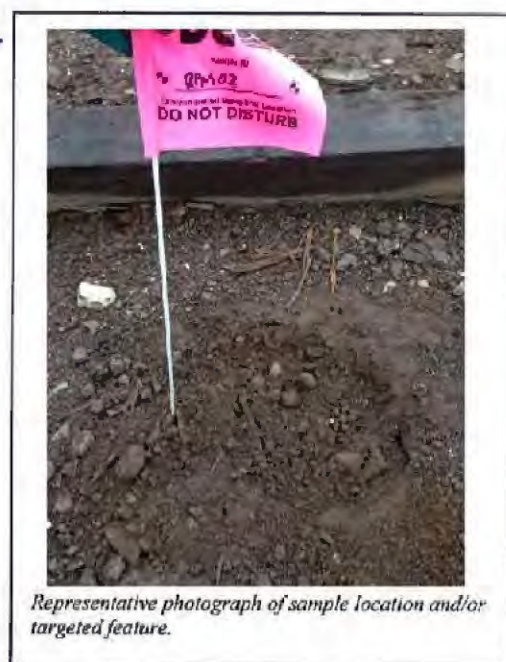
Inspection Date: 05/17/17 Feature Identification/Name QMLCM-RPM02-0''-6''

MATERIAL IS BROWN MED GRAINED WITH GRAVEL PIECES, LOCATED ON CONCRETE FOUNDATION

MATERIAL IS LOCATED IN AREA WHERE EVIDENCE OF TRESPASSERS IS FOUND. PROPERTY IS SECURED WITH GATED FENCE, HOWEVER FOOT ENTRANCES ARE ACCESSIBLE

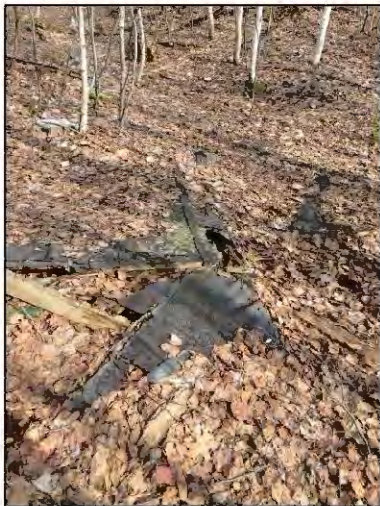
Photo 3: Suspect asbestos containing building material (ACBM) documented at QMCM during reconnaissance activities. Photo taken 4/24/2017.

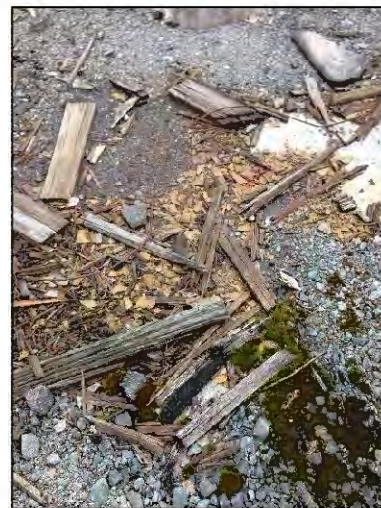
Photo 6: Residual Processing Material (RPM) sampled as QMCM-RPM05-0"-6". Photo taken on 5/16/2017.
