BENTON HARBOR AREA SCHOOLS

2017 Facility Assessment

GMBae Project #5-4061

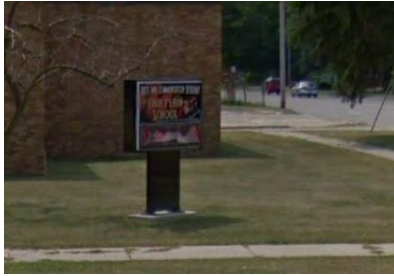
Signage

- LED Sign placed at the corner of Napier and Colfax Streets in good condition

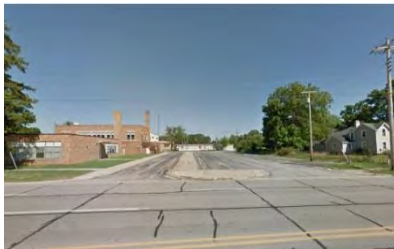
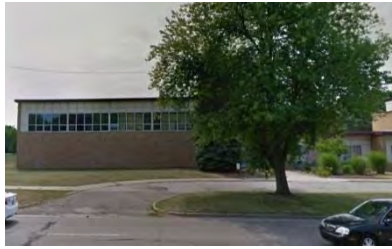
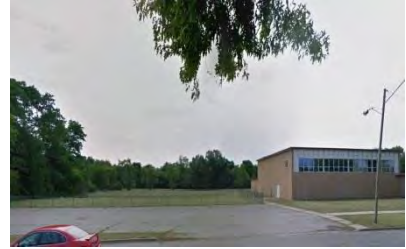
Pavements

- Asphalt and exterior concrete is in poor condition.

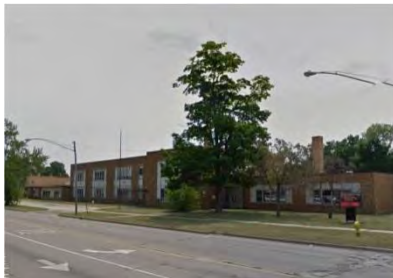
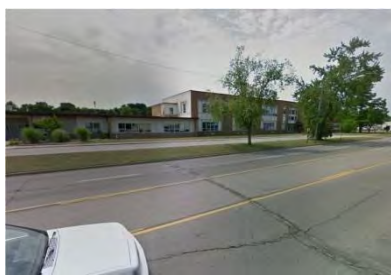
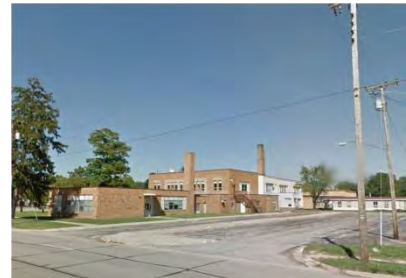
Building Envelope Assessment

- Poured concrete structure, masonry with brick exterior.
- The walls are structurally sound with evidence of moisture intrusion causing damage to the plaster wall finishes
- Aluminum double pane awning operable windows in good condition
- Sills at interior are in need of repair or replacement
- FRP doors installed in aluminum frames are in fair condition
- Single doors are hollow metal in hollow metal frames that are rusted and should be replaced
- The chimney is in poor condition with extensive repair required

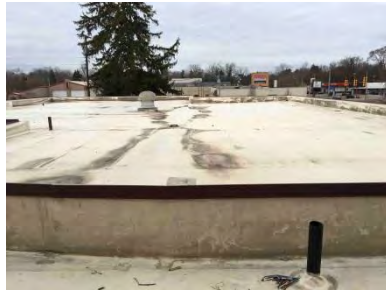
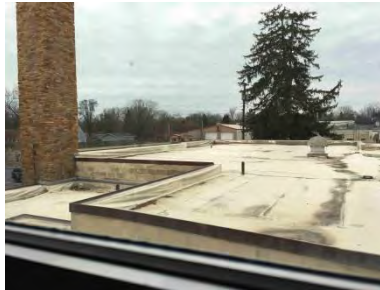
Roof System Assessment

- Duro-Last roof system is showing wear and has had extensive repairs
- No roof overflow drains or scuppers were observed
- Roof deck is wire lath and gypsum plaster at the original building section and is susceptible to deterioration when wet
- Roof deck at the addition is metal deck

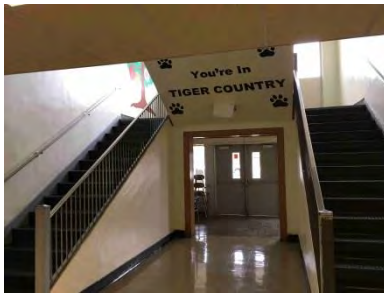
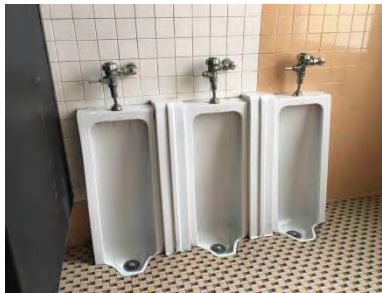
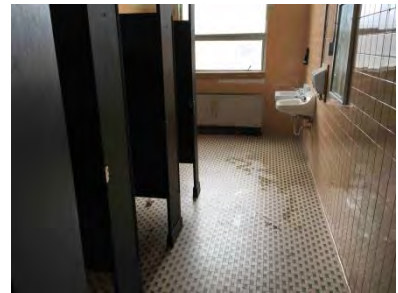
ADA Accessibility Assessment

- Access to second floor level is by stair only
- Toilet rooms are not Barrier Free compliant
- Majority of the doors have knobs and levers are required for ADA compliance

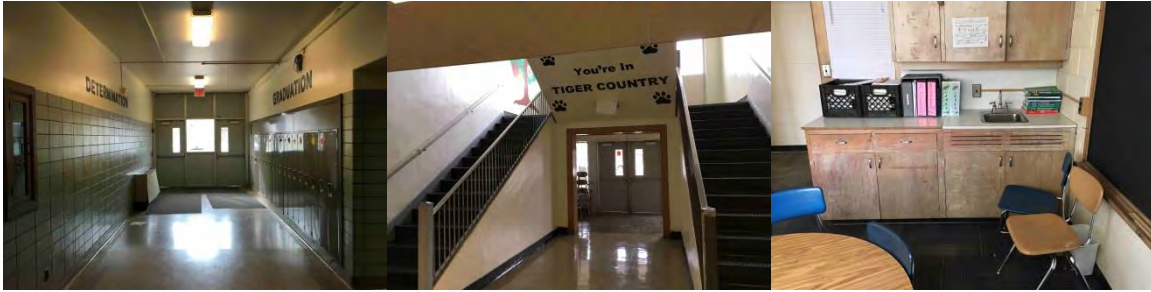
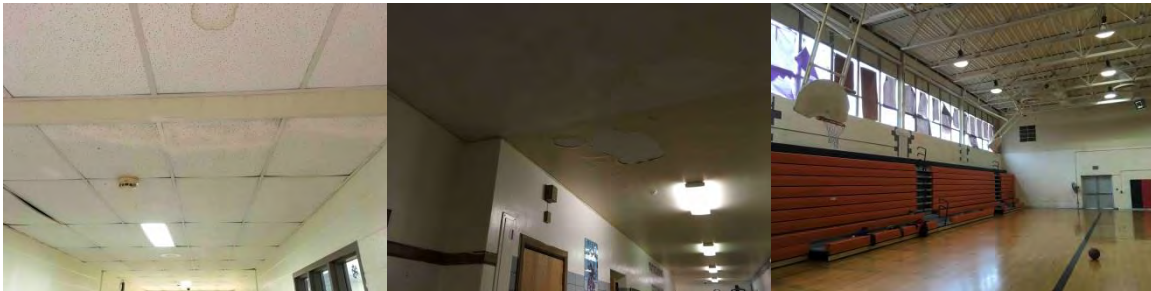
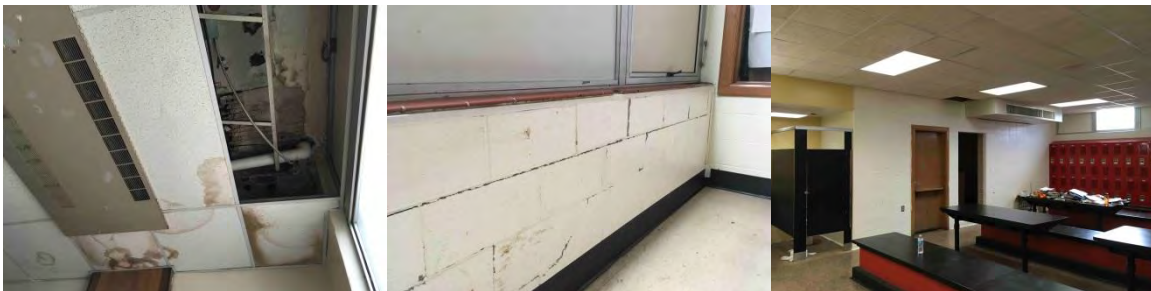
Interior Finishes Assessment

- Corridors have terrazzo floors with some cracks but are in good condition overall
- Classrooms have carpet squares and are in good condition
- VCT is in poor condition in all areas where installed
- Wood gym floor is in good condition

- 2x4 suspended grid is in poor to fair condition with stains and warped tile from roof or pipe leaks
- Exposed 12"x12" adhered ceiling tile is in poor condition
- Plastered ceilings throughout the corridors are in fair condition

- Corridor walls have glazed block up about 7' with plaster above mostly in good condition
- Painted CMU in classrooms with some exterior block showing movement with separation of mortar from block. Paint is generally good.
- Glazed block walls in the kitchen are in good condition
- Exterior walls have deteriorated plaster due to moisture intrusion
- Toilet rooms are ceramic tile that are generally good in the larger rooms

- Older wood casework in poor condition

- Wood doors at classrooms and offices set in wood frames are in poor condition.
- Mechanical room door is hollow metal in poor condition. It is locked with combination lock making the space difficult to access and has the possibility for someone to be locked inside.

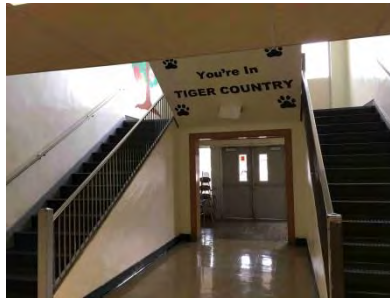
Life Safety Assessment

- This is a non sprinklered building
- Illuminated exit signs are lacking
- Door hardware is a mix of lever and knobsets with panic devices at corridor exiting doors – knobs are non-compliant

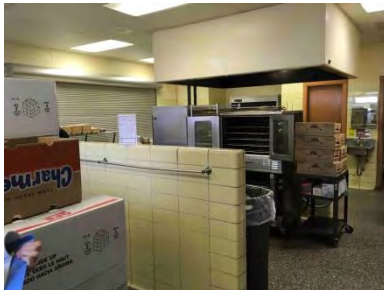
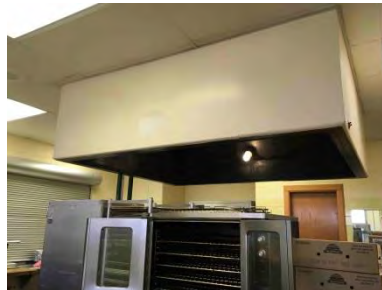
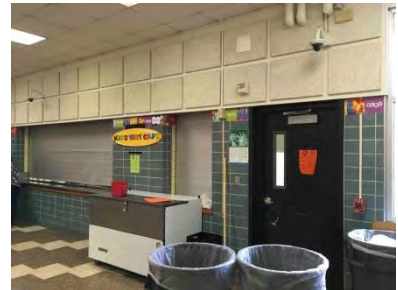
Food Service Assessment

- Very small kitchen that is not utilized for food preparation
- Finishes are outdated and in fair condition

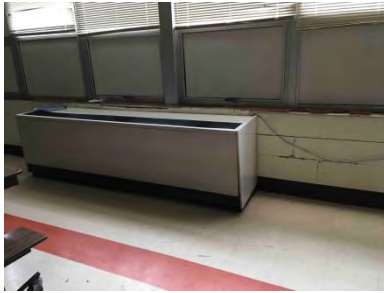
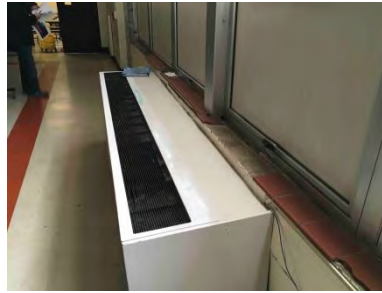
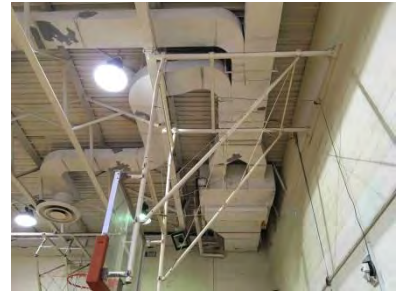
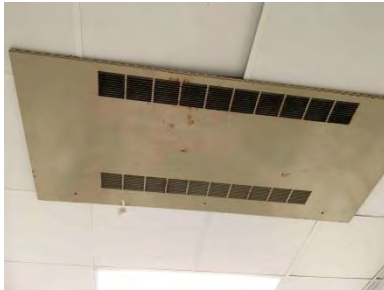
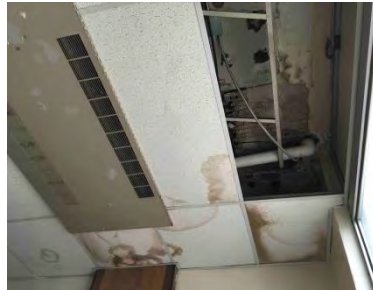
Mechanical & Plumbing Assessment

- Trane horizontal unit ventilators installed in 1999 are in average condition
- A handful of miscellaneous rooftop exhaust fans are old and due to be replaced
- Gymnasium Trane heat/vent unit installed in 1986 is due to be replaced
- RTU above cafeteria installed in 2015 assumed to be in good condition
- Cabinet unit heaters are in poor condition

- (1) Johnston heating hot water boiler, 2,500 MBH capacity, installed in 1989. Boiler is near end of service life. A handful of miscellaneous rooftop exhaust fans are old and due to be replaced.
- (1) Lochinvar heating hot water boiler, 1,440 MBH capacity, installed in 1994. Boiler is near end of service life.

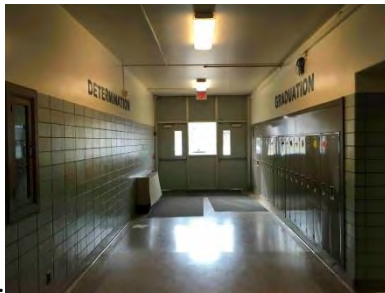
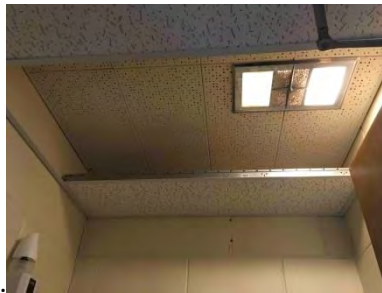
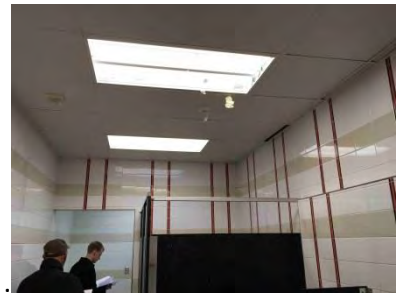
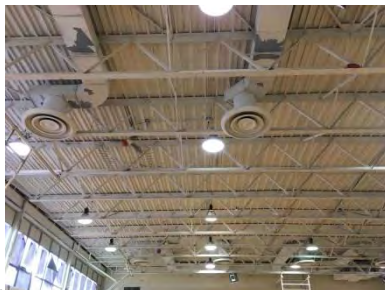
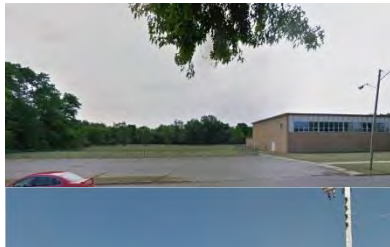
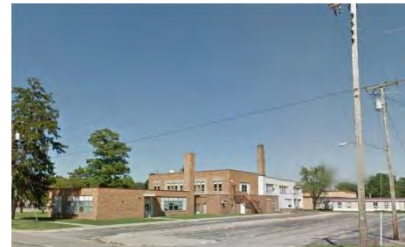
Building lighting is in poor condition.

- The existing lighting is fluorescent and incandescent in the classrooms and common areas. Metal halide in the gymnasium. The update to LED would result in significant monetary savings and energy conservation. This would require all new lighting throughout the building.
- Occupancy sensors are used sporadically throughout the building. There is no existing central lighting control system. If more than 50% of the fixtures were upgraded to LED at one time, a central lighting control system and occupancy sensors would be required per the Michigan Building Energy Code.
- The exterior building lighting and parking lot lighting is metal halide and the quantity of lighting is sparse. Additional LED lighting would be recommended for safety and energy savings.

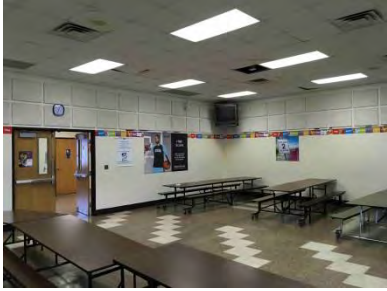
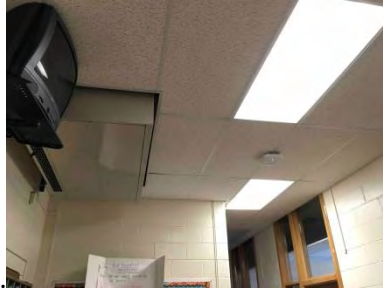
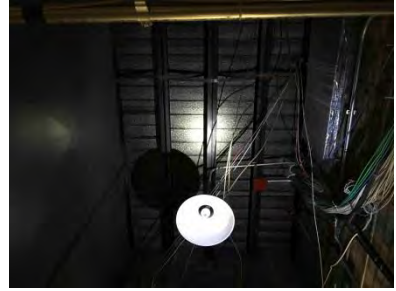
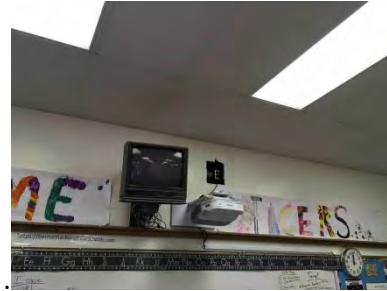
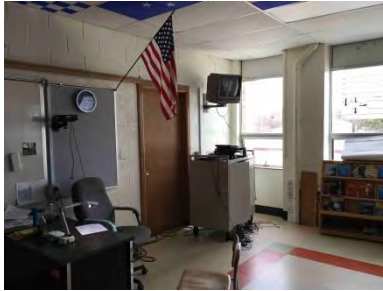
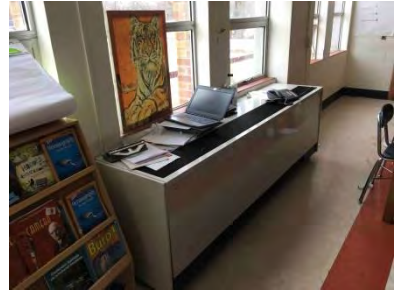
Electrical building system is adequate.

- The existing primary main distribution panel appears to be newer and is in good condition.
- Existing electrical secondary Cutler Hammer and Square D panels are old and it becomes hard to find replacement breakers for this equipment. It is recommended that some of these panels are replaced.
- There is no generator on site; however that is a mobile generator connection in place.
- Electrical duplex receptacles in hallways and classrooms need to be brought up to code. Damaged receptacles are throughout the building and need to be replaced. Junction boxes need to be covered.

Clock/ PA systems are in poor condition.

- Existing paging system is inadequate. New system is recommended to be installed to provide proper life safety communications.
- Central clock system is inadequate. Different clock types are installed throughout the building. New clock system is recommended to be installed.

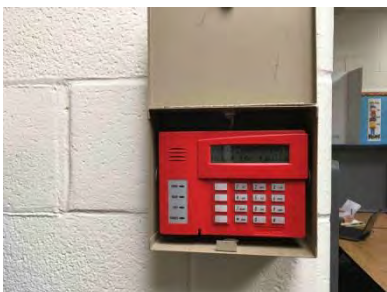
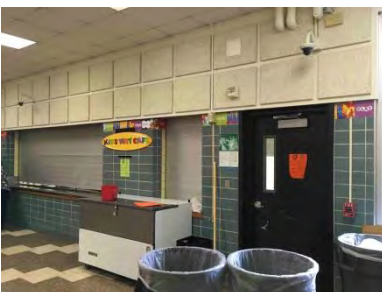
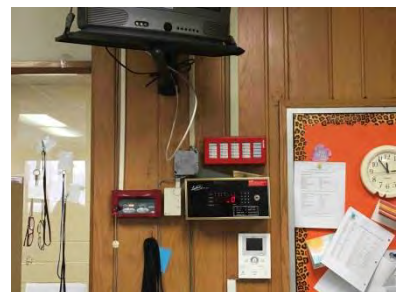
Security Systems are adequate.

- Existing security system is a Honeywell system with cameras, door contacts and motion detectors.
- There is an Aiphone in the building for some secure entrance. A new building access system would be recommended for building security and teacher access to the building.

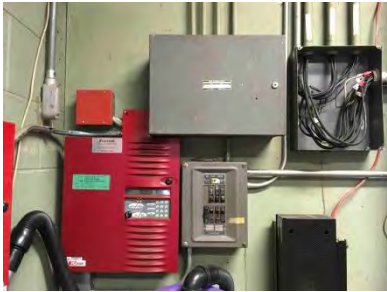
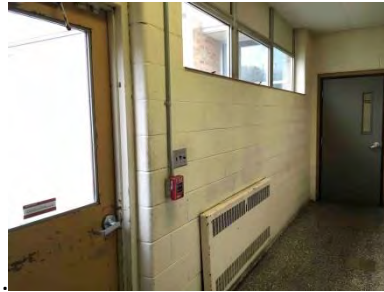
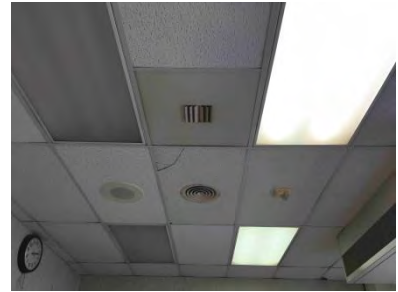
Fire Alarm System is adequate.

- Existing FCI fire alarm. The school district is required to service this system once a year by a licensed contractor. The system does have horn/strobe capabilities but no voice annunciation system, which was adopted by NFPA in 2014. If the owner wants voice annunciation, the system will have to be replaced. The system is adequate and grandfathered with the State without voice annunciation. It is recommended that the existing system is updated and that may require replacement.

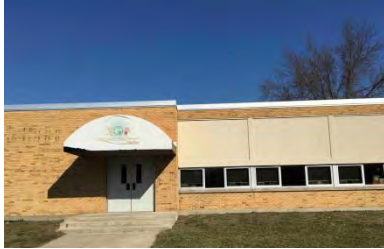
Signage

- There is no exterior signage along the street, only what is on the canopy

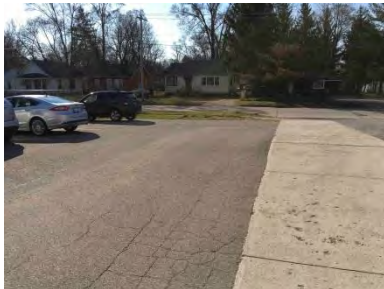
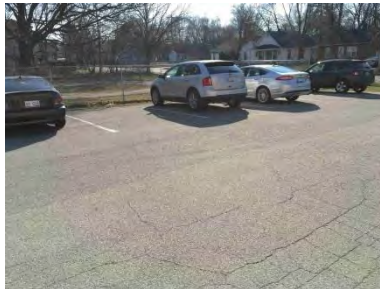
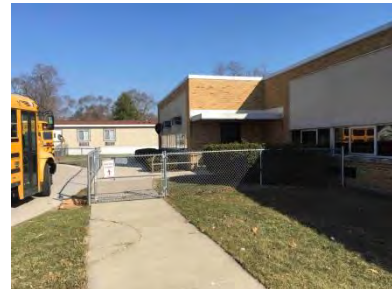
Pavements

- Asphalt and exterior concrete is in poor condition

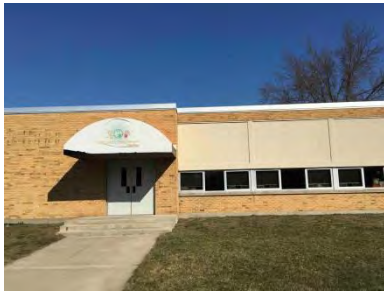
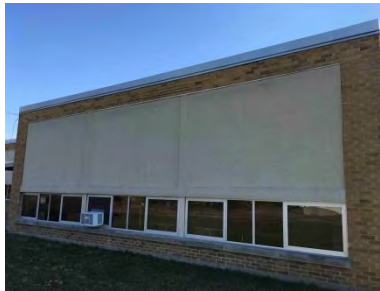
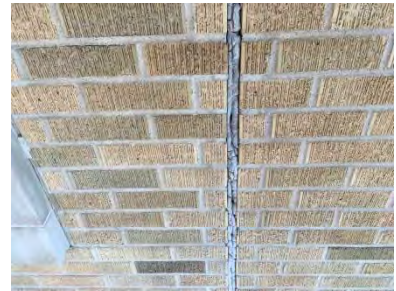
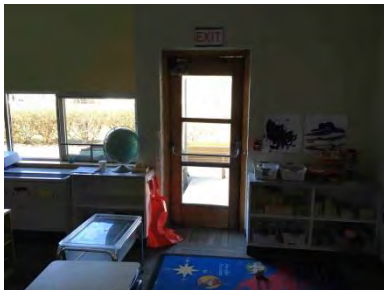
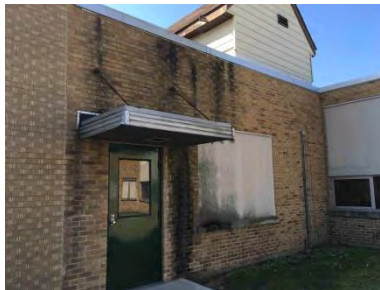
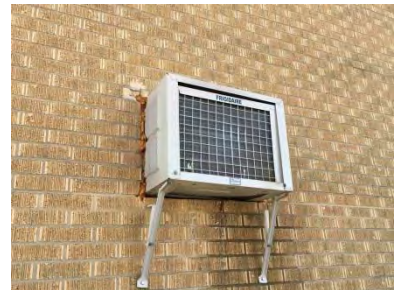
Building Envelope Assessment

- Masonry bearing with brick veneer in good condition
- Control joints and sealants are in fair condition with a few needed to be caulked
- Tuck pointing and brick cleaning is needed
- There are a couple of window air conditioning units installed in masonry walls that are not sealed, allowing water to get in behind the brick veneer
- Aluminum double pane awning windows with EIFS panels above in good condition
- FRP main entry doors installed in aluminum frames in fair condition
- Several exterior hollow metal doors and frames are in very poor condition
- Some wood doors and frames need to be repaired or replaced as they are in extremely poor condition
- Exterior door panic hardware is old and in very poor condition

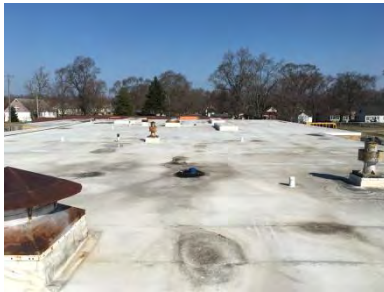
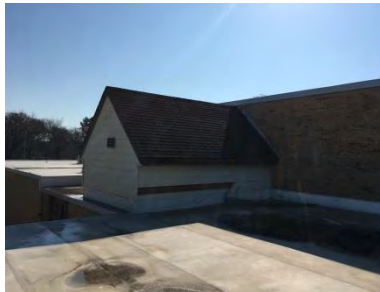
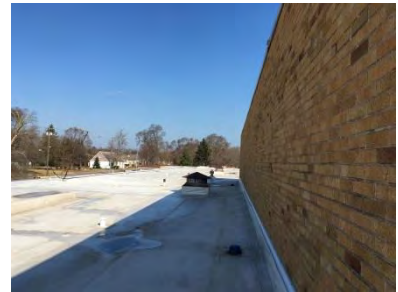
Roof System Assessment

- Steel joist with a composite fiber deck at gym, composite fiber loses its structural integrity when wet, and metal deck at Dance Studio addition.
- Roof membrane is Duro-Last white TPO
- 2004 – 20,000 SF
- 2003 – 20,000 SF
- Condition is good and may be under warrantee
- Several roof drains are in need of being cleaned
- 10'x20' pitched roof fascia is in need of repair
- Very minimal overflow roof drains or scuppers were present

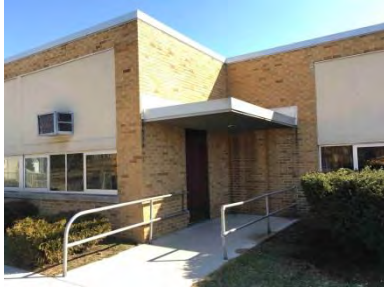
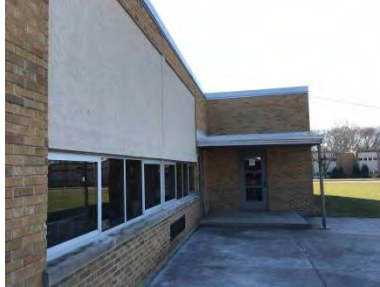
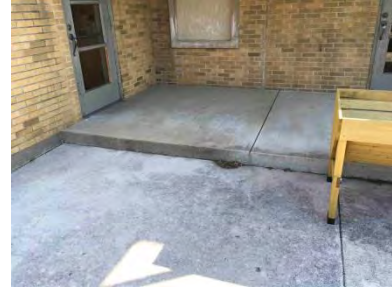
Exterior:

- No tactile warning strips at curb cut-downs
- Two ADA parking spaces

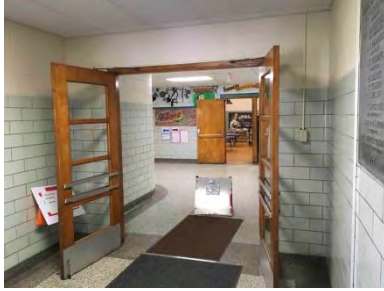
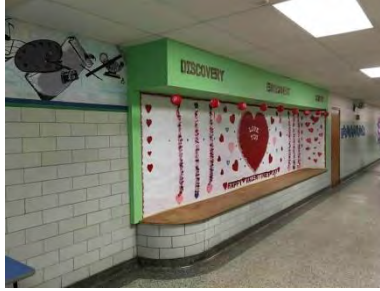
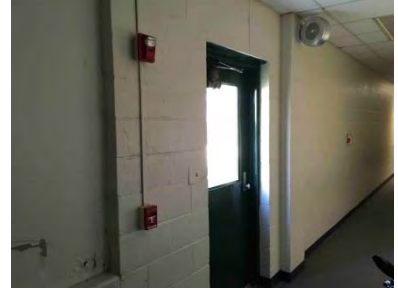
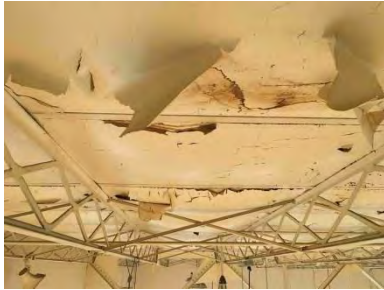
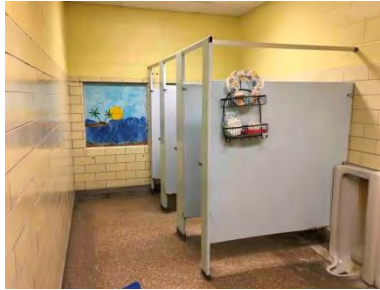
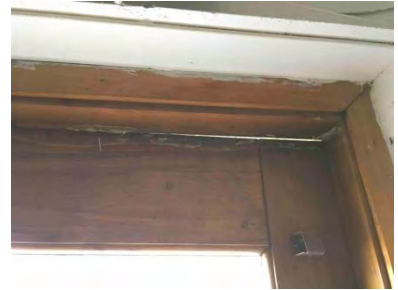
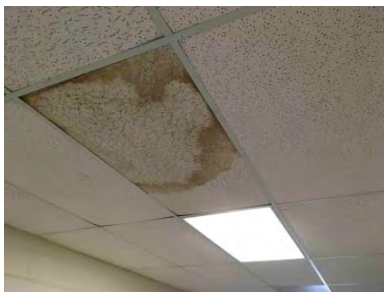
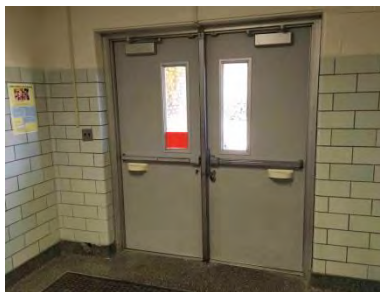
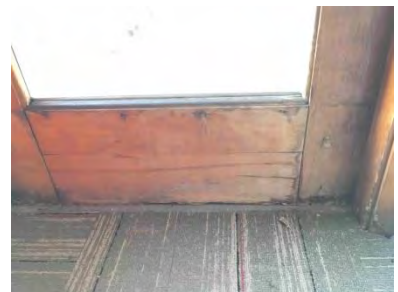
- Terrazzo flooring is in good condition throughout corridors and toilet rooms
- Upgraded carpet squares in classrooms were recently installed and are in good condition
- 2'x4' suspended acoustic ceiling systems are installed in the majority of the building and are in good condition
- Exposed ceiling in the Multi-Purpose room has water damage and repairs are required
- Glazed block located in corridors and toilet rooms are in good condition
- Wood casework and shelving throughout is in fair condition
- Wood doors in wood frames are in fair condition
- Door hardware is old and replacement should be considered

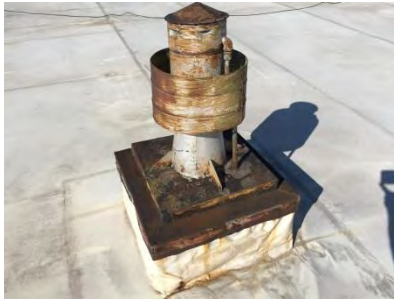
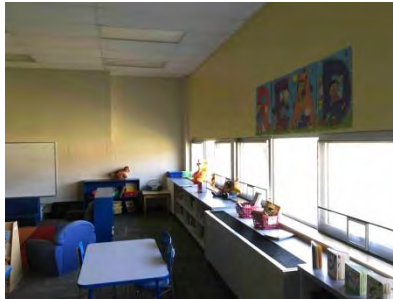
- Trane horizontal unit ventilators probably installed in 1999 are in average condition
- Handful of miscellaneous rooftop exhaust fans are original to building and rusted out
- Kitchen space has inadequate exhaust and is very smelly
- (3) RTUs for gymnasium, dance studio and library installed in 2002 and are near end of service life

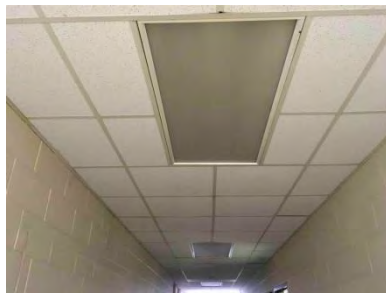
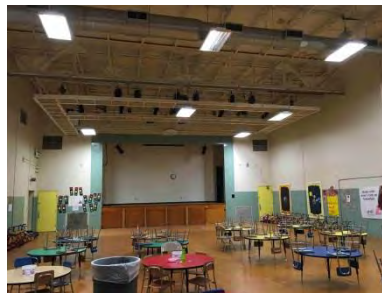
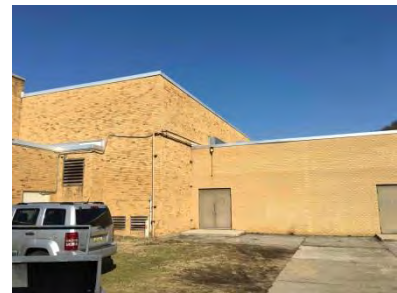
Building lighting is adequate.

- The existing lighting is fluorescent. The update to LED would result in significant monetary savings and energy conservation. This would require all new lighting throughout the building.
- There are no occupancy sensors and no existing central lighting control system. If more than 50% of the lights were to be upgraded to LED at one time a central lighting control system and occupancy sensors would be required per the Michigan Building Energy.
- The exterior building lighting and parking lot lighting is metal halide and the quantity of lighting is sparse. Additional LED lighting would be recommended for safety and energy savings.

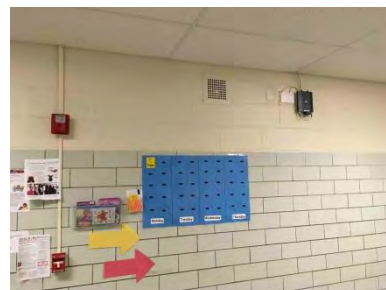
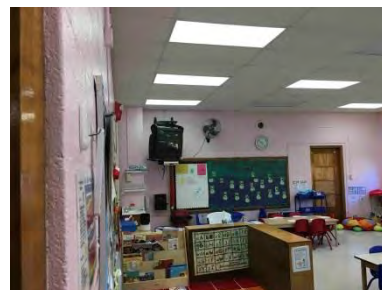
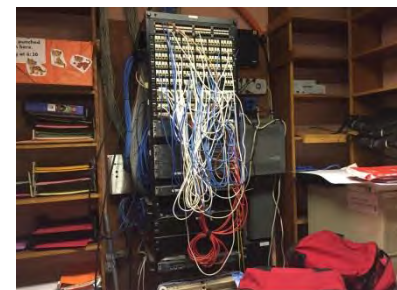
Building technology is adequate.

- Wireless Access Points are installed throughout the building.
- There are t.v./monitors throughout building.
- More wiring supports for wiring and IT closets is recommended.

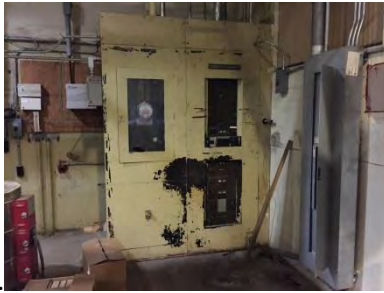
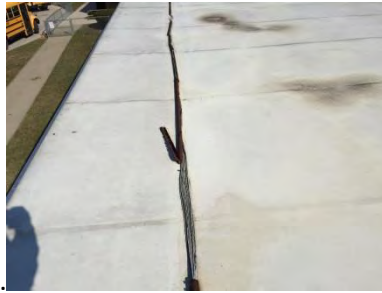
Electrical building system is in poor condition.

- The existing primary main distribution panel is at end of life and needs to be replaced.

- Existing electrical, secondary Cutler Hammer and Square D, are old and new. On the older panels it becomes hard to find replacement breakers for this equipment. It is recommended that some of these panels are replaced.
- There is no generator on site – However there is a connection for a mobile generator
- Damaged receptacles are throughout the building and need to be replaced. Junction boxes need to be covered. Rusted conduits on roof.

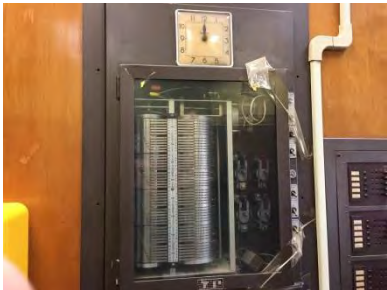
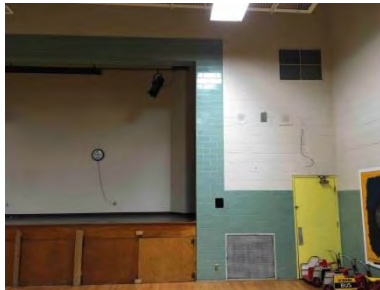
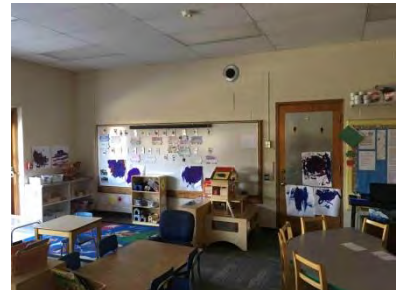
Clock/ PA systems are in poor condition.

- Existing paging system is inadequate. New system is recommended to be installed to provide proper life safety communications.
- Central clock system is a Edwards system and at the end of life. Different clock types are installed throughout the building. Clocks are missing on the walls. New clock system is recommended to be installed.

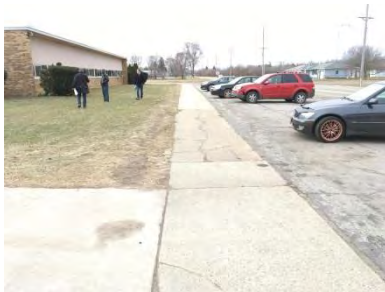
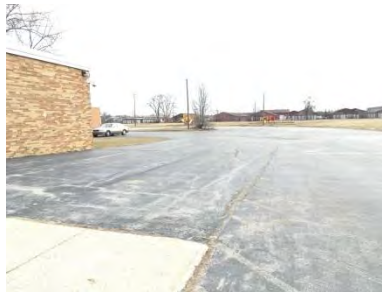
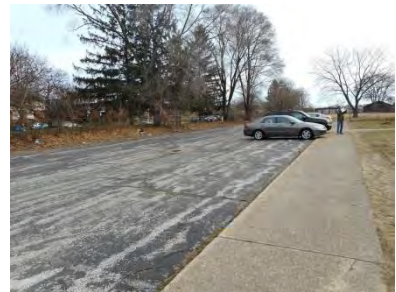
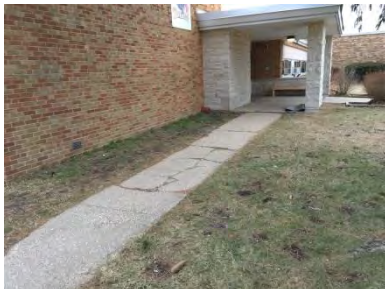
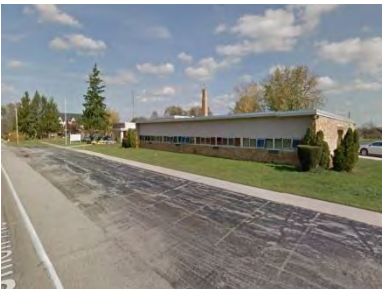
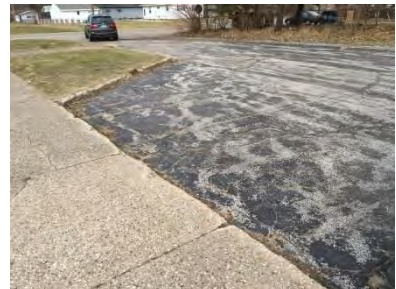
Pavements

- Asphalt and exterior concrete is in very poor condition

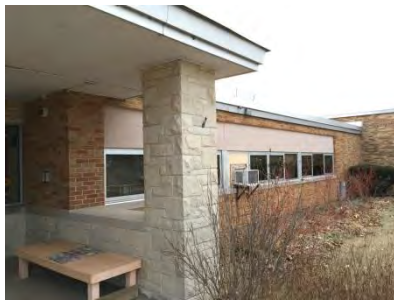
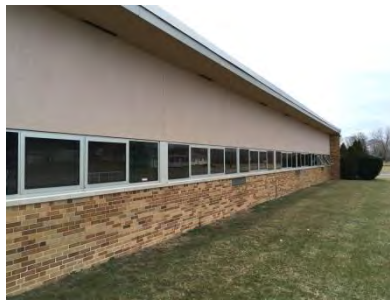
- Masonry block exterior walls with brick veneer and sand stone at main entry. Sandstone is in good condition
- There are some cracking in the brick joints in need of repair
- EIFS panels located above awning windows have some discoloration and minor repairs are required
- Control joints and the perimeter window sealants need to be replaced
- The top portion of the brick chimney stack is deteriorated and repairs are needed
- Aluminum double pane awning type are in good condition
- Exterior window sills need to be tuck pointed to seal voids and to minimize water infiltration
- Doors are aluminum in good condition

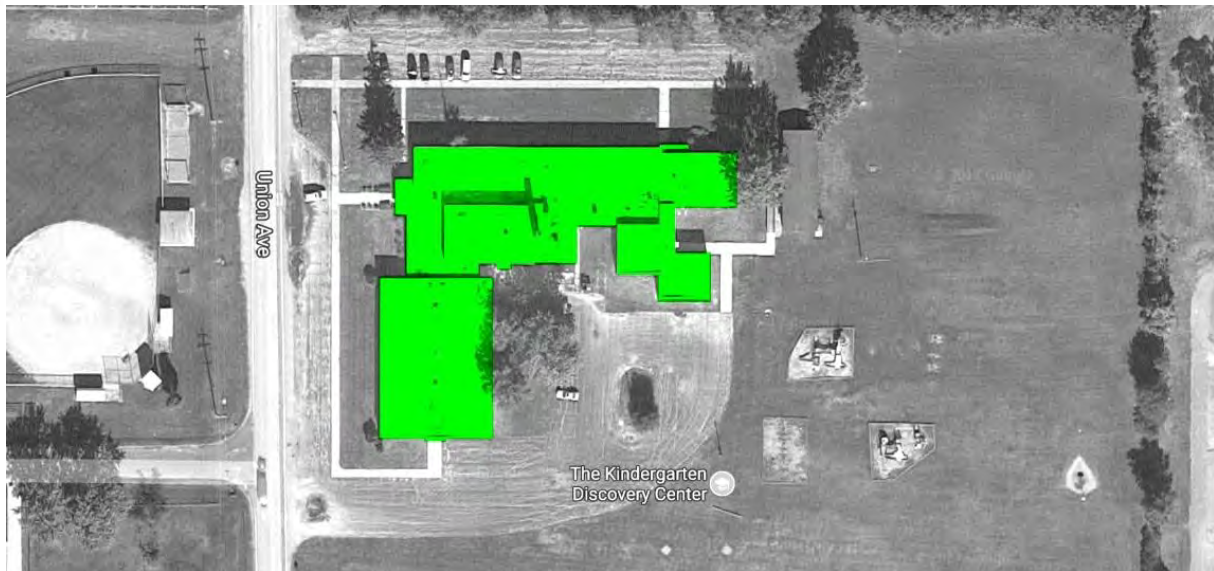
Roof Conditions & Anticipated Service Life Plan

- Approximate roof area of 30,000 SF
- Duro-Last white TPO membrane
- 2009 – 4,000 SF
- 2008 – 7,000 SF
- 2005 – 3,525 SF
- Remainder of the roof appears to be in good condition

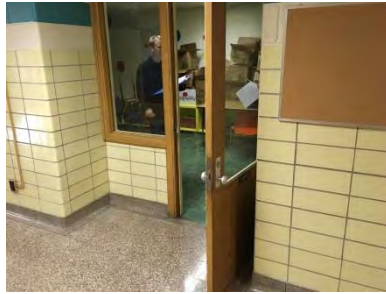
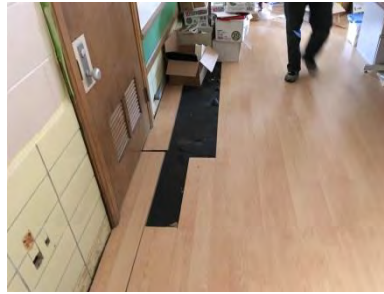
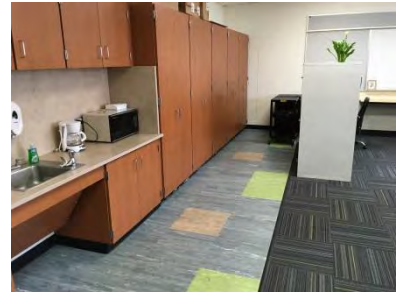
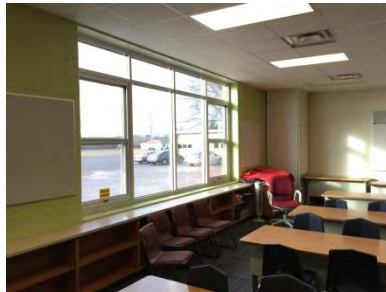
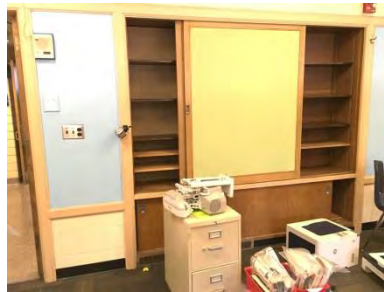
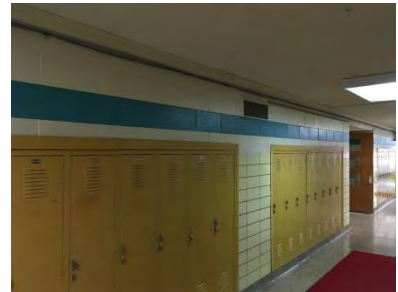
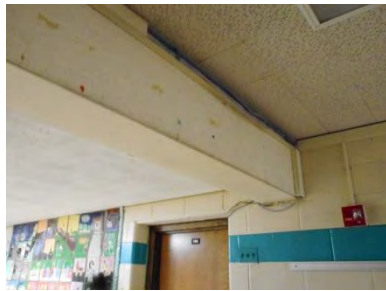
- Terrazzo floors in corridors and toilet rooms still in good condition
- Carpet squares in classrooms installed 2010 in very good condition
- VCT in gym and some classrooms in good condition
- Combination of 2'x4' suspended acoustic ceiling systems, adhered 12"x12" acoustic tile and plaster. The adhered 12"x12" are in poor condition and the remaining is in fair to good condition
- Glazed block walls in corridors, gym, kitchen and some of the classrooms in original building section is in fair condition
- Painted CMU condition is good
- Walls have extensive amount of surface mounted electrical, data and fire alarm conduit and raceway
- Wood casework and wood paneling in the original portion of the building are in poor condition
- Wood doors in wood frames in poor to fair condition

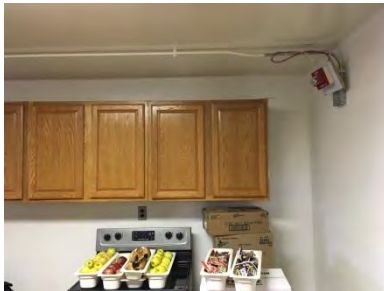
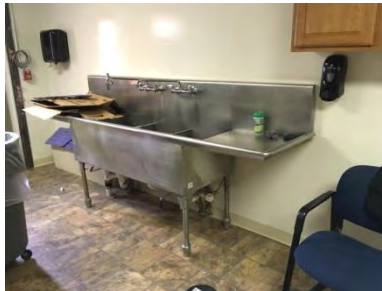
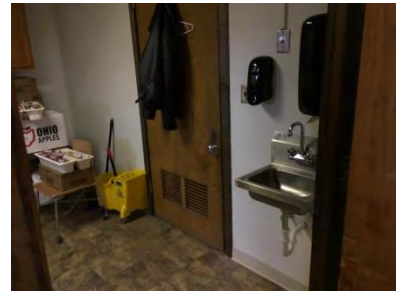
Food Service Assessment

- Very small kitchen utilized for cleaning only
- Electric household range was in place – A commercial hood is required above the range

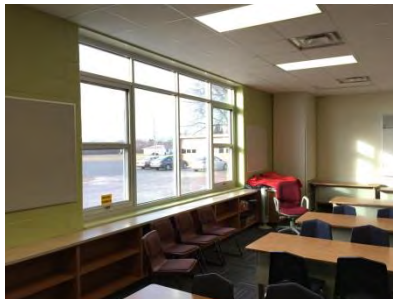
Mechanical & Plumbing Assessment

- Nesbitt horizontal unit ventilators installed in 1999 are in average condition and near end of service life.
- New addition includes vertical unit ventilators with A/C and hot water heat.
- Gymnasium heating and vent unit, not running

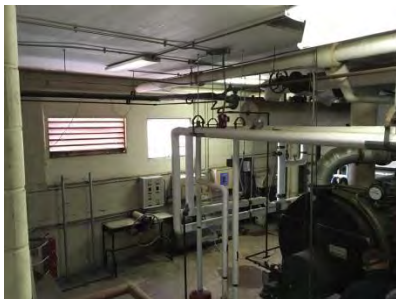
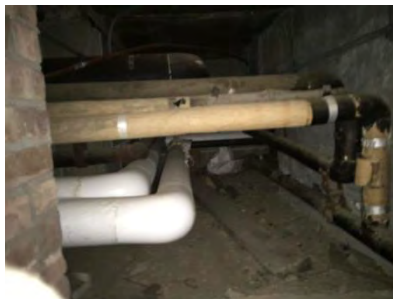
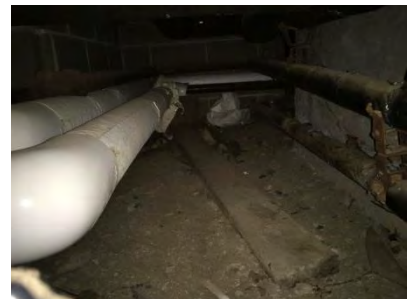
Central Plant Systems

- (1) Johnston steam boiler, 2024 lbs./hr., installed in 1986. Boiler is near end of service life.
- Small steam to HW converter for serving new vertical unit ventilators.
- Steam distribution piping routed thru tunnels, assumed to be original to building with new hot water piping also routed thru tunnels.

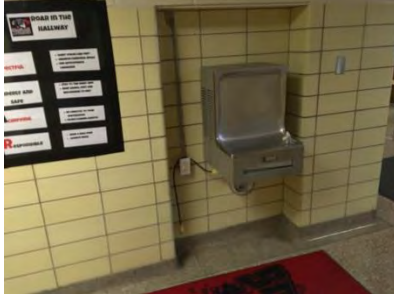
Plumbing Fixtures

- Most fixtures appear to be in average condition and in need of some repair/replacement.

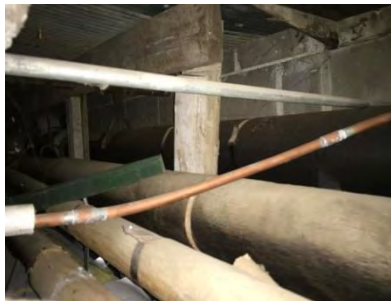
Plumbing Piping and Systems

- Domestic water heater in good condition.
- Plumbing piping is routed thru tunnels and assumed to be original to the building. Original study noted multiple patches and that piping is in poor condition.

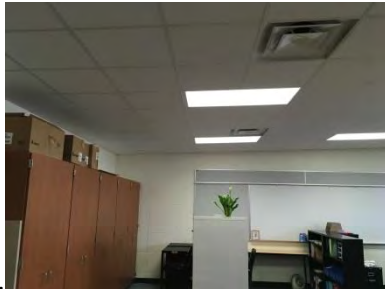
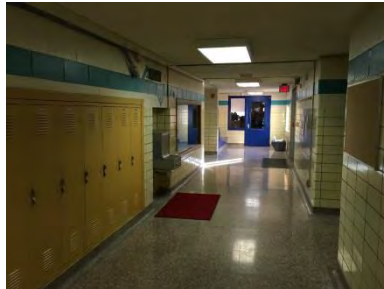
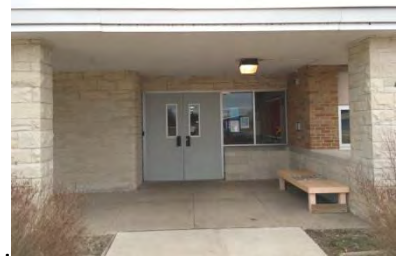
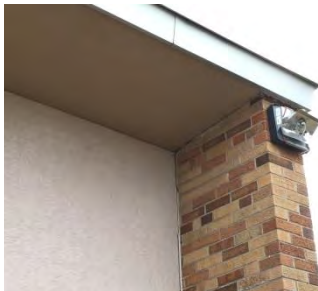
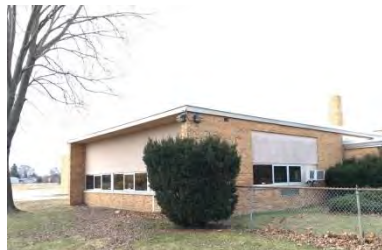
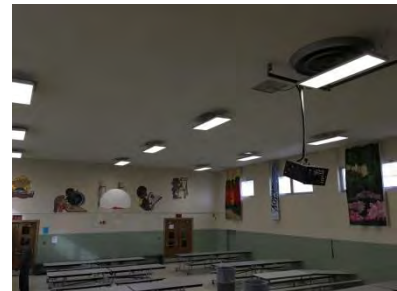
Building lighting is adequate.

- The existing lighting is fluorescent. The update to LED would result in significant monetary savings and energy conservation. This would require all new lighting throughout the building.
- There are no occupancy sensors or central lighting control system. If more than 50% of the lights were to be upgraded to LED at one time a central lighting control system and occupancy sensors would be required per the Michigan Building Energy.
- The exterior building lighting is metal halide and is placed well for security. LED lighting would be recommended to be installed for energy savings at these locations.

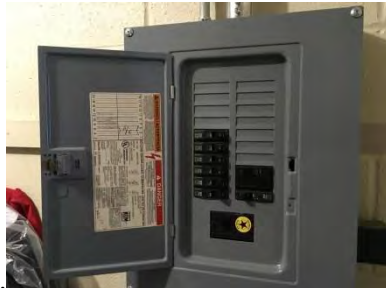
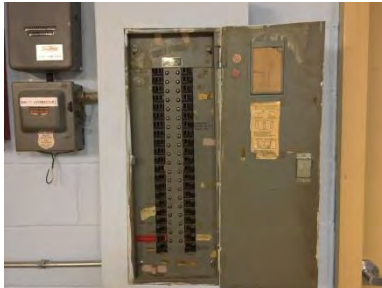
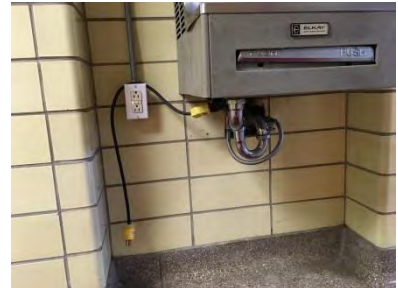
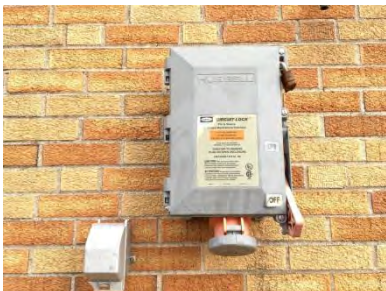
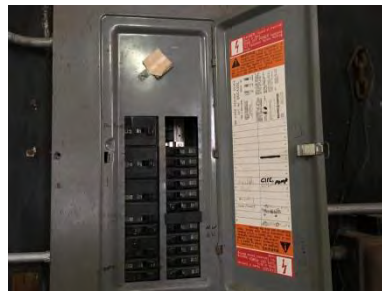
Electrical Building System is adequate.

- Existing electrical secondary Cutler Hammer and Square D panels are old and it becomes hard to find replacement breakers for this equipment. It is recommended that some of these panels are replaced.
- There is no generator on site – However there is a connection for a mobile generator
- Electrical in areas need to be brought up to code for safety. Open junction boxes, open busses in panel boards and cords for receptacles need to corrected.

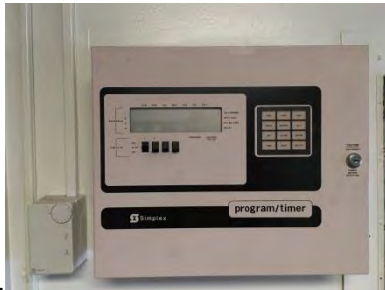
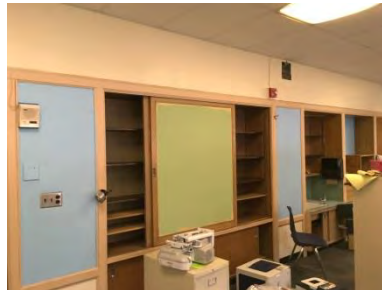
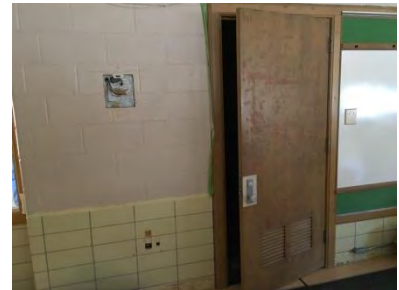
Clock/ PA systems are in poor condition.

- Existing paging system is inadequate. New system is recommended to be installed to provide proper life safety communications.
- Central clock system a Simplex system is inadequate. Different clock types and empty clock boxes are installed throughout the building. New clock system is recommended to be installed.

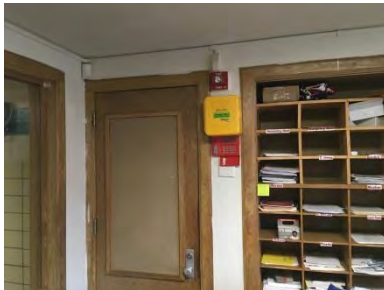
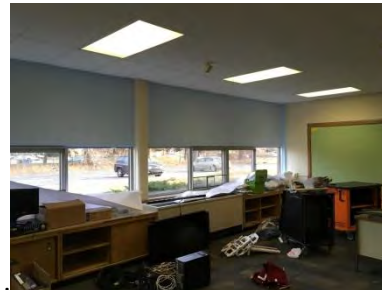
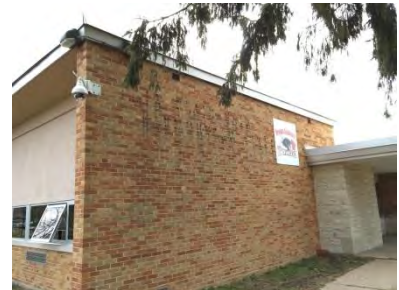
Security Systems are adequate.

- Existing security system has cameras, door contacts and motion detectors.
- A new building access system would be recommended for building security and teacher access to the building.

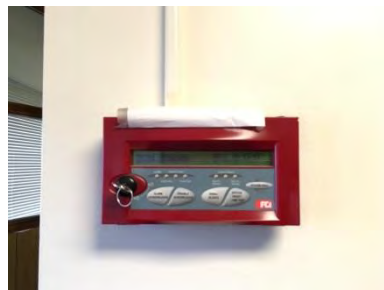
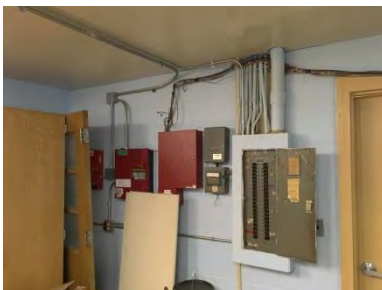
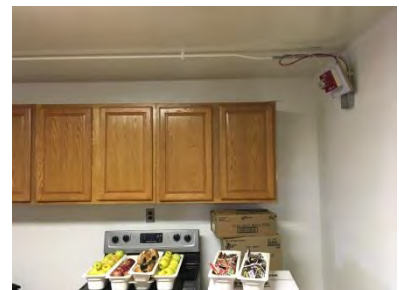
Fire alarm system is adequate.

- Existing FCI fire alarm. The school district is required to service this system once a year by a licensed contractor. The system does have horn/strobe capabilities but no voice annunciation system, which was adopted by NFPA in 2014. If the owner wants voice annunciation, the system will have to be replaced. The system is adequate and grandfathered with the State without voice annunciation. It is recommended that the existing system is updated and that may require replacement.

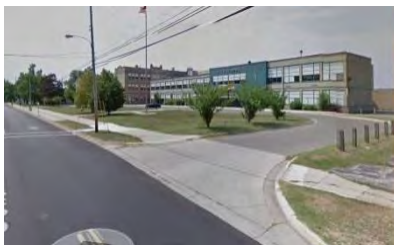
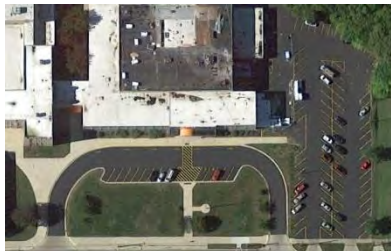
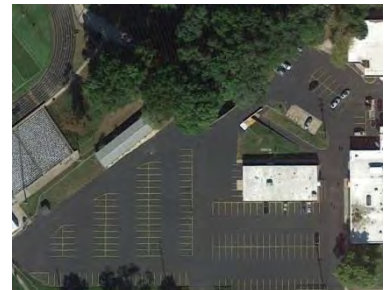
Pavements

- Asphalt drive and parking has been sealed and striped within the last few years
- Very few dedicated ADA parking spaces were observed

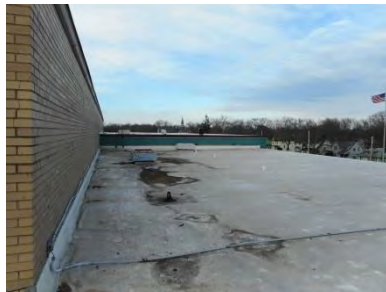
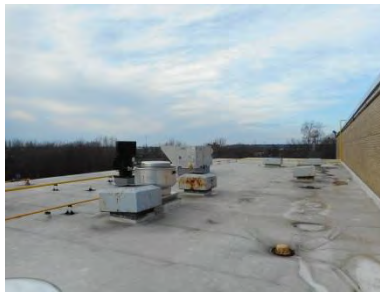
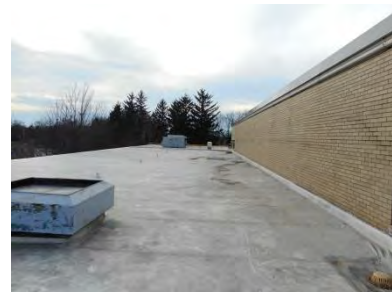
Duro-Last White Membrane with Re-Roof Sections completed in:

- 2016 – Gym Roof
- 2010 – 25,600 SF
- 2009 – 28,400 SF
- 2008 – 26,800 SF
- 2005 – 8,500 SF
- 2004 – 14,000 SF
- 2003 – 18,500 SF

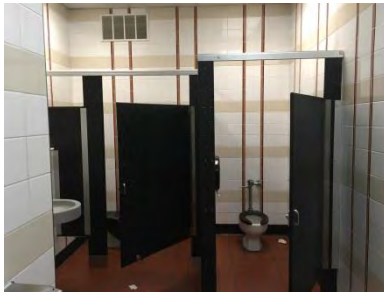
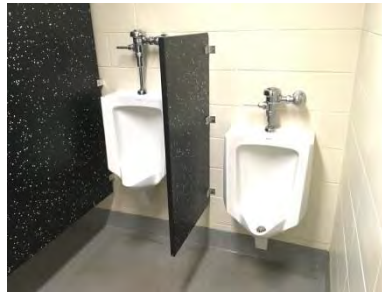
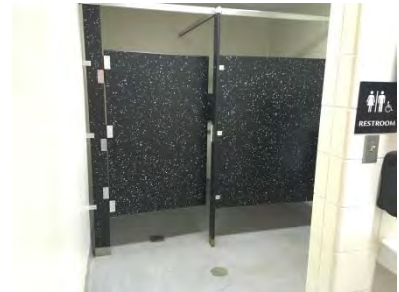
ADA Accessibility Assessment

- Most toilet rooms are not barrier free compliant with a limited number of grab bars
- Several entry points are not BF accessible
- Knobsets are installed on most of the interior doors – Levers are required to be compliant
- Building is equipped with an elevator for access to upper floors
- Recently renovated locker rooms are barrier free compliant

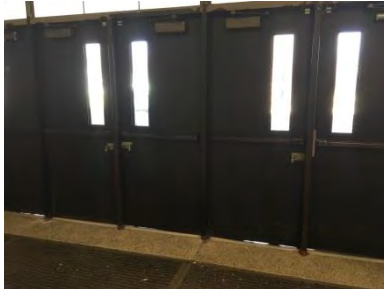
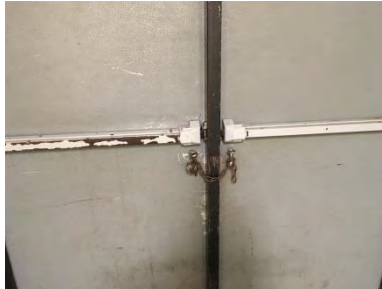
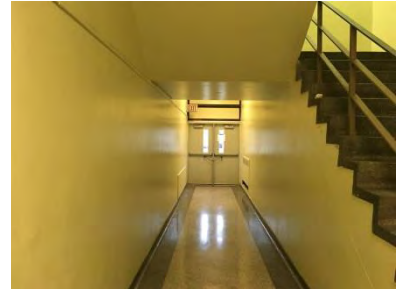
Life Safety Assessment

- Building is non sprinklered
- Illuminated exit signs were found lacking
- Many panic exit doors are either chained and padlocked or dead bolted closed making emergency exiting impossible at many locations

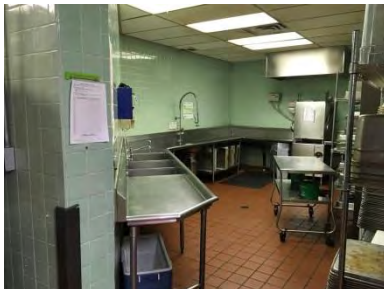
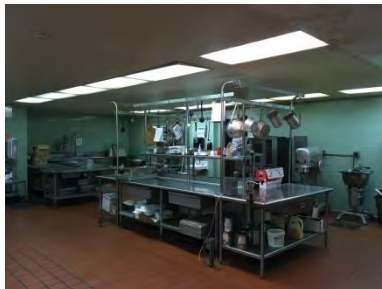
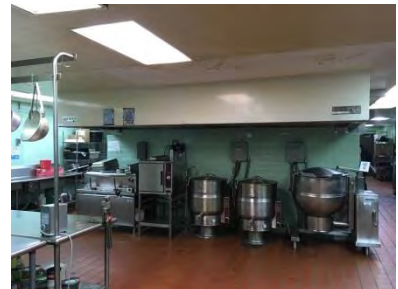
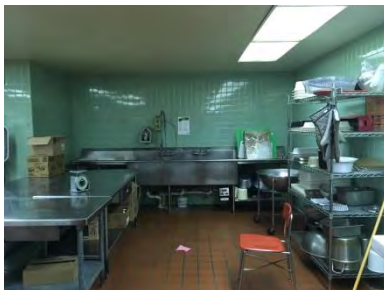
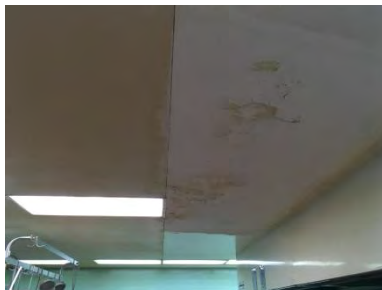
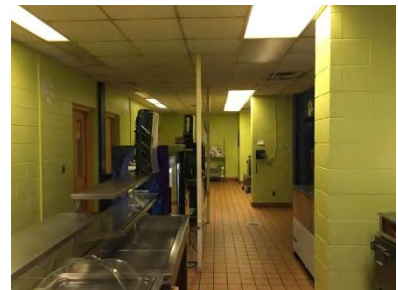
Food Service Assessment

- Finishes are outdated and repairs are needed
- Equipment appears to be in good condition

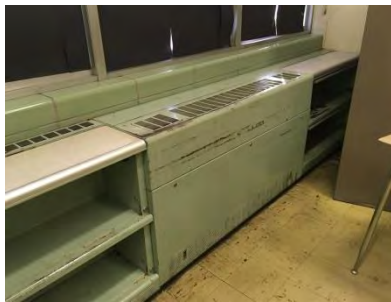
- Library is conditioned only by Nesbitt horizontal unit ventilators that are old and need to be replaced.
- Main office area served by radiator that is not controlled well and was found to be very hot
- Cafeteria served by rooftop unit, condition and age is unknown
- Gymnasium served by two rooftop units, ages are unknown
- Most first floor classrooms have old horizontal unit ventilators that need to be replaced. Some have newer Trane vertical unit ventilators that are in good condition.
- Second floor contains mix of new and updated vertical unit ventilators and a handful of old, original horizontal unit ventilators that should be replaced
- Science renovation spaces in good condition with newer Aeon RTU and lab exhaust fans.
