BENTON HARBOR AREA SCHOOLS

2017 Facility Assessment

GMBae Project #5-4061

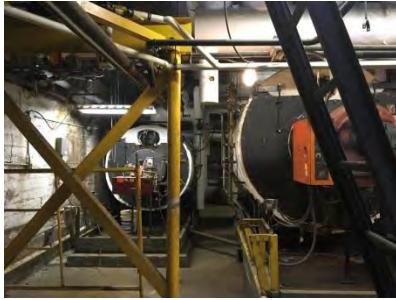
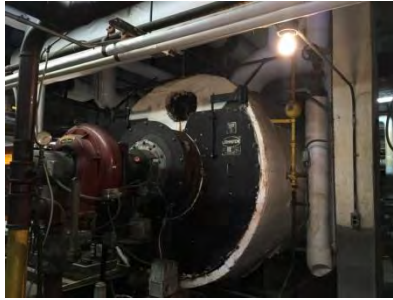
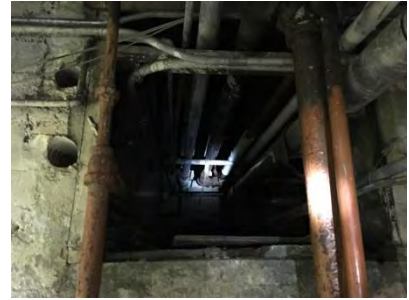
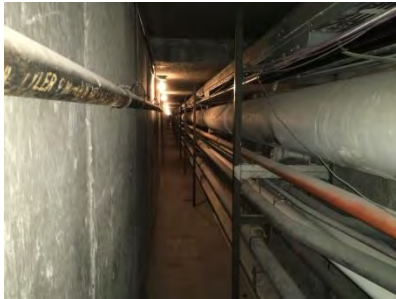
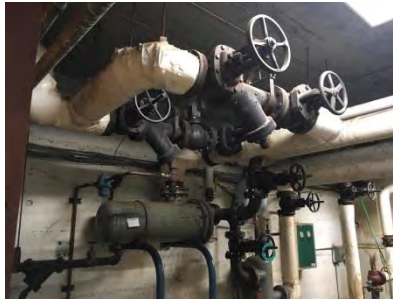
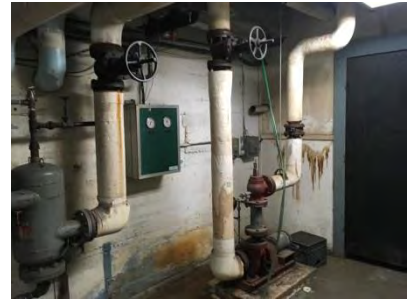
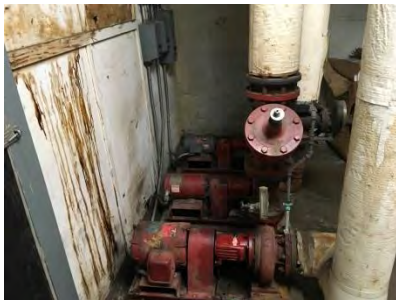
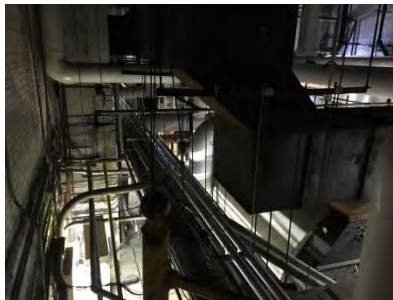
Central Plant Systems

- Primary mechanical room contains (3) Johnston steam boilers. (2) sized at 10,350 lbs./hr. and (1) at 3,450 lbs./hr. Boilers were installed in 1955 and are well beyond expected service life, they need to be replaced.
- Boiler combustion flue ductwork has rusted away at the wall termination so that combustion fumes are now leaking into the mechanical room and is a health hazard
- Steam and condensate piping routed thru tunnels assumed to be original to building. The piping most likely should be replaced.
- Newer steam to hot water converters and pumps used for hot water system presumably serving newer vertical unit ventilators and air handlers. Heating water piping can likely be reused for new hot water heating systems.

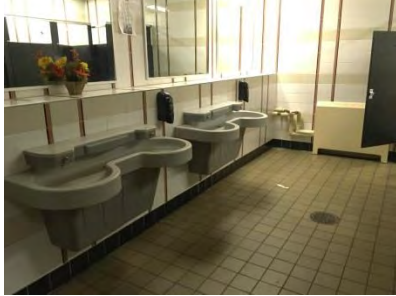
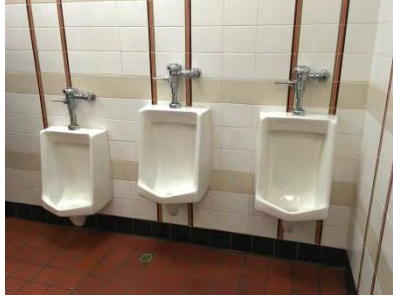
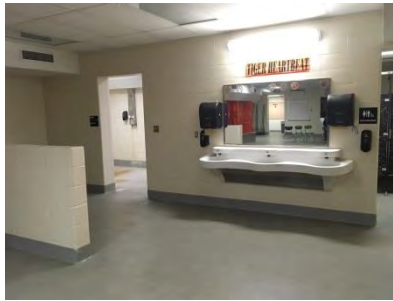
Plumbing Fixtures

- Plumbing fixtures are in fair condition with some needing to be replaced.
- Lower level locker rooms are in good condition with new and upgraded fixtures.

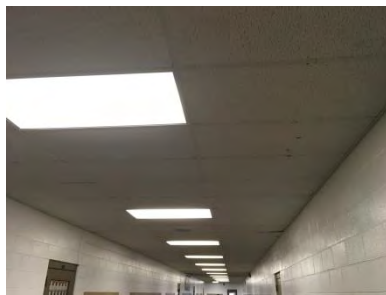
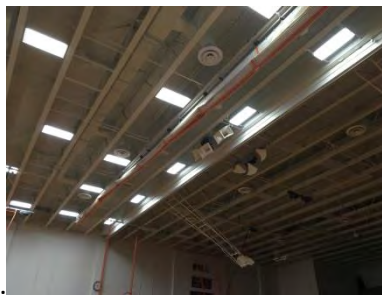
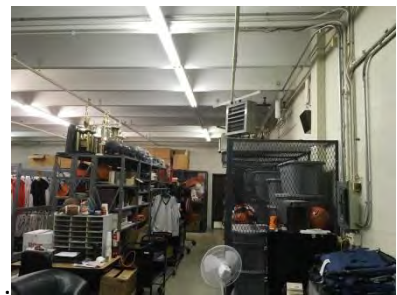
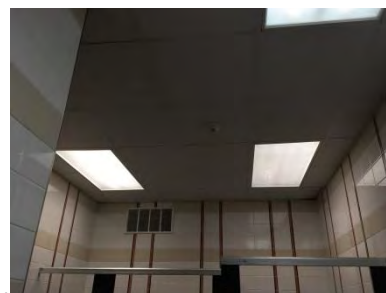
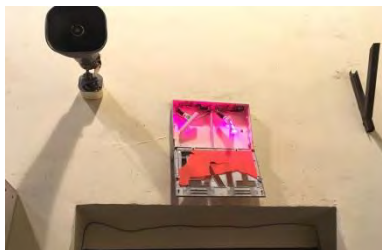
Building Lighting is adequate.

- The existing lighting is fluorescent. The update to LED would result in significant monetary savings and energy conservation. This would require all new lighting throughout the building.
- Occupancy sensors are used sporadically throughout the building. There is no existing central lighting control system. If more than 50% of the lights were to be upgraded to LED at one time a central lighting control system and occupancy sensors would be required per the Michigan Building Energy.
- The exterior building lighting and parking lot lighting is metal halide and the quantity of lighting is sparse. Additional LED lighting would be recommended for safety and energy savings.

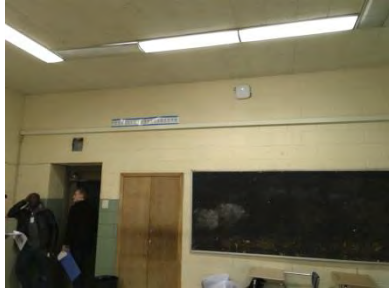
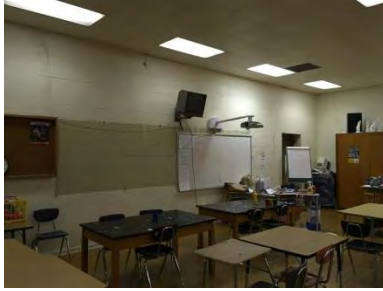
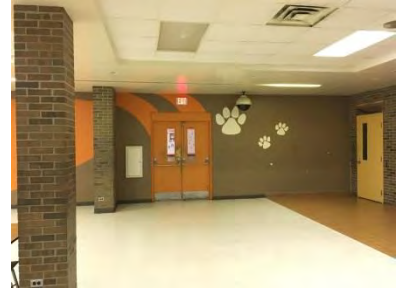
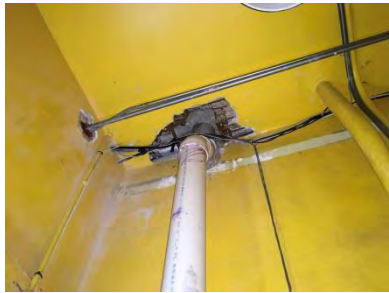
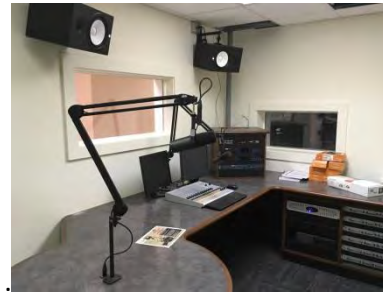
Building Technology is adequate.

- Wireless Access Points are installed throughout the building.
- There is a use of wall mounted projectors in some classrooms.
- There are teachers stations in classrooms tied to the projectors.
- There are TVs/monitors throughout the building.
- More wiring supports for wiring and IT closets is recommended.
- A nice sound system room in the auditorium.

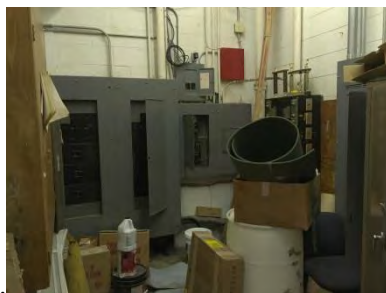
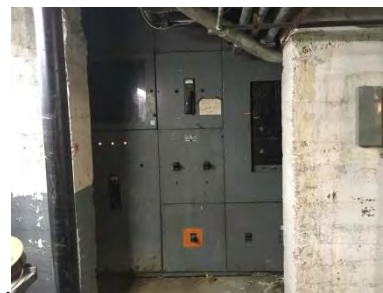
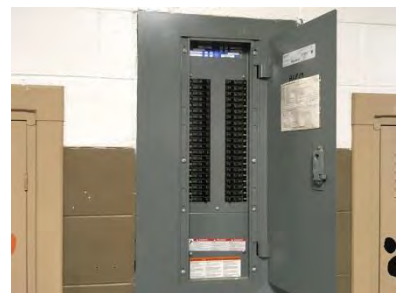
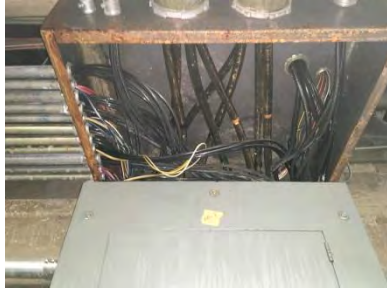
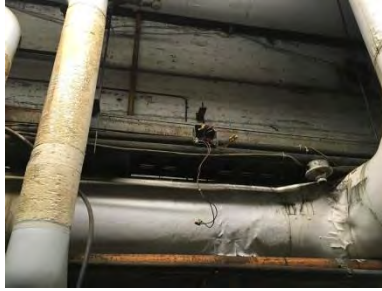
Electrical Building System is adequate.

- The existing primary main distribution panel appears to be newer and is in good condition.
- The location is a life safety hazard as it does not meet the required clear distance in front of the panels.
- Existing electrical secondary Cutler Hammer and Square D panels are a combination of old and new. On the older panels it becomes hard to find replacement breakers for this equipment. It is recommended that some of these panels are replaced.
- There is no generator on site – However there is a connection for a mobile generator
- Electrical duplex receptacles in hallways and classrooms need to be brought up to code. Damaged receptacles are throughout the building and need to be replaced. Junction boxes need to be covered.

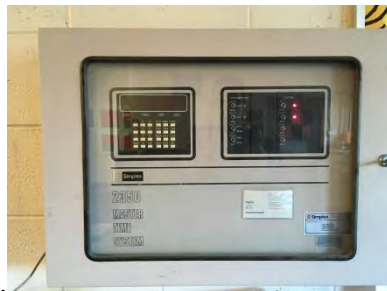
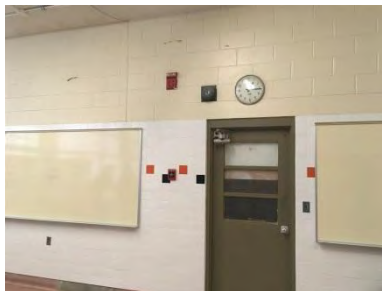
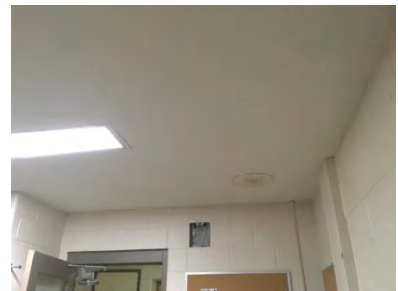
Clock/ PA Systems are in poor condition.

- Existing paging system is inadequate. New system is recommended to be installed to provide proper life safety communications.
- Central clock system is inadequate. Different clock types are installed throughout the building. Clocks are missing on the walls. New clock system is recommended to be installed.

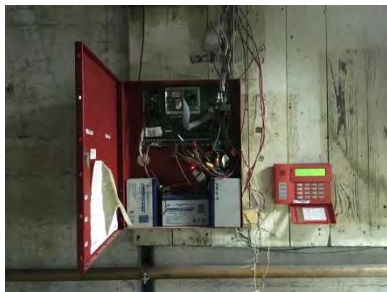
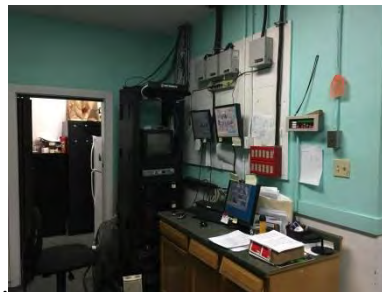
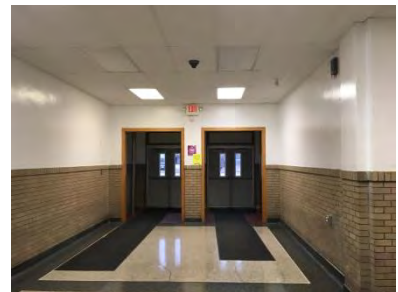
Security Systems is adequate.

- Existing security system is a Simplex system with cameras, door contacts and motion detectors.
- A new building access system would be recommended for building security and teacher access to the building.

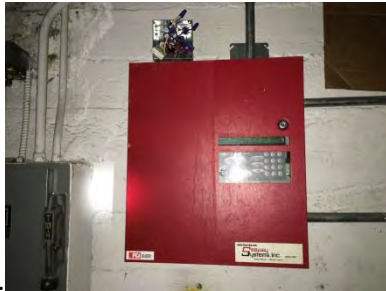
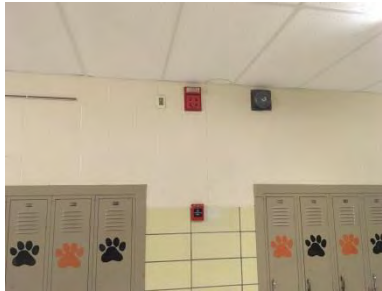
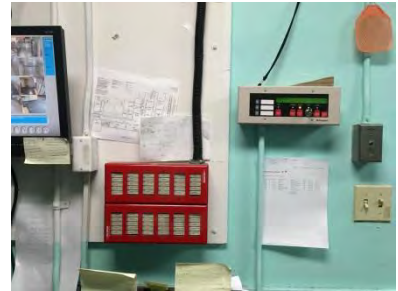
Fire Alarm System is adequate.

- Existing FCI/Simplex fire alarm. The school district is required to service this system once a year by a licensed contractor. The system does have horn/strobe capabilities but no voice annunciation system, which was adopted by NFPA in 2014. If the owner wants voice annunciation, the system will have to be replaced. The system is adequate and grandfathered with the State without voice annunciation. It is recommended that the existing system is updated with hardware and software.

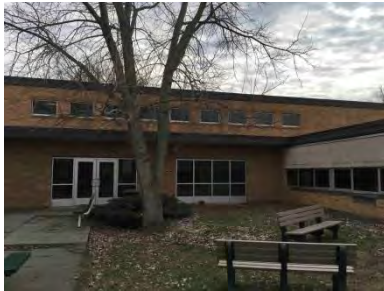
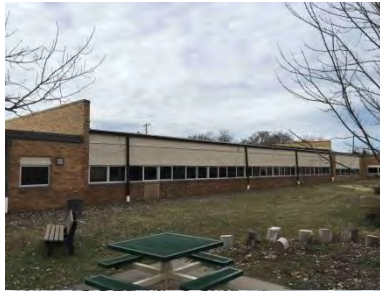
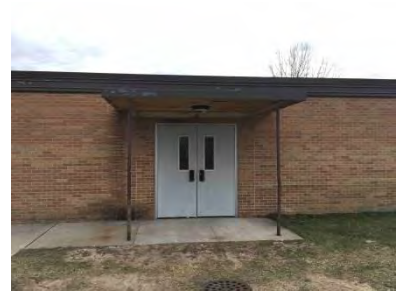
- Masonry with brick exterior in need of some tuck pointing, cleaning and new sealants at control joints and around doors and windows
- EIFS panels above windows need cleaning and restoration in some area.
- Aluminum double pane awning style in fair condition.
- Limestone exterior sills need tuck pointing
- FRP doors in aluminum frames with some hardware in need of replacement
- Exterior hollow metal doors and metal frames in poor condition

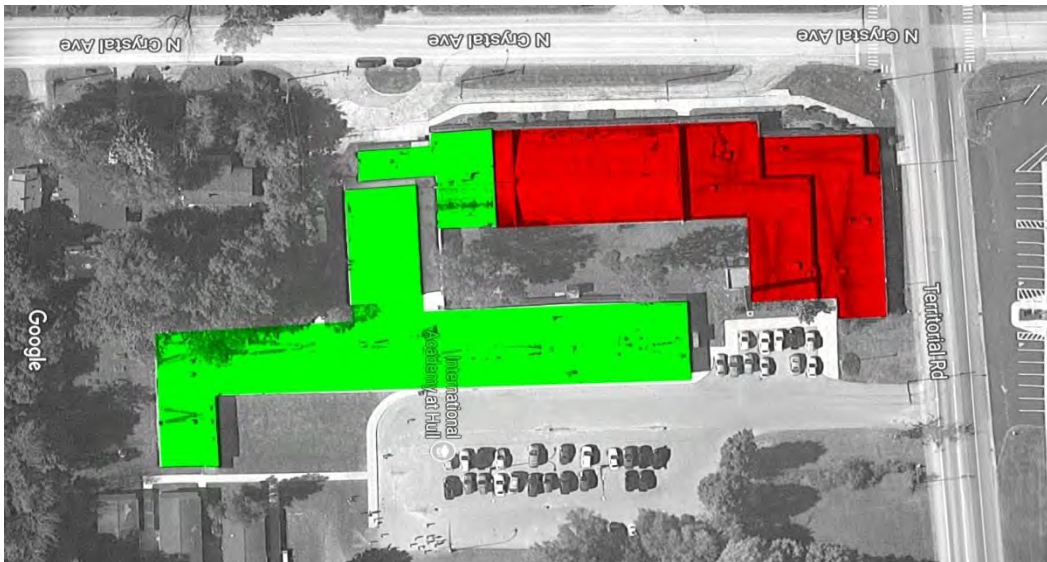
Roof Conditions & Anticipated Service Life Plan

- Approximate roof area 53,400 SF
- Roofing membrane is Duro-Last white TPO in fair condition.
- East section of building appears to be a newer roof membrane

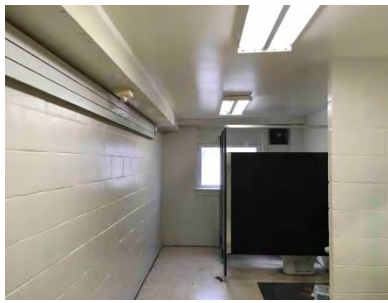
- Toilet rooms and fixtures are not barrier free accessible

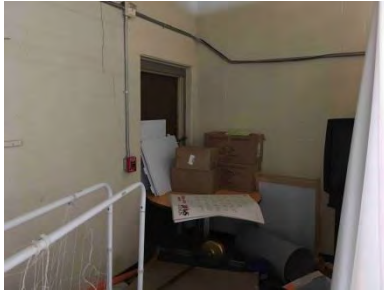
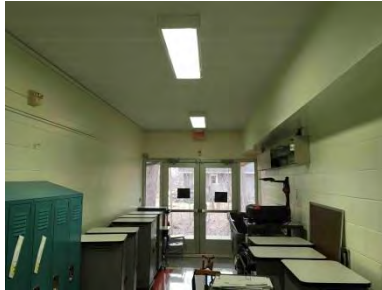
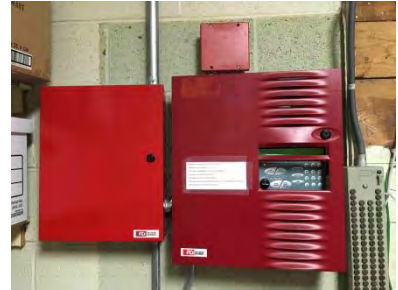
- Fire alarm system throughout
- Some corridors are cluttered and should be cleared

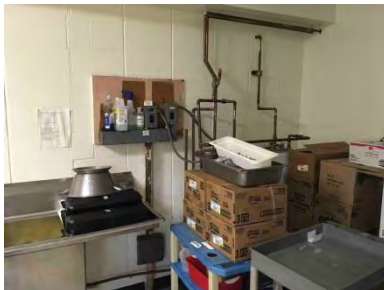
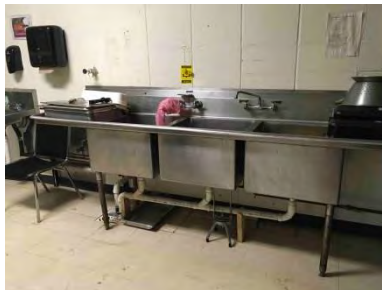
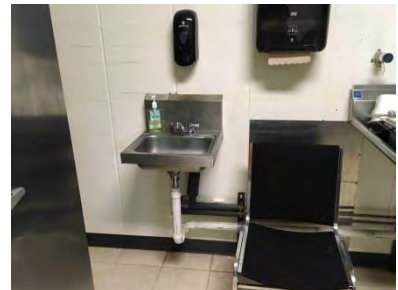
Kitchen is in good condition and is set up to wash dishes only as there are no means for food prep

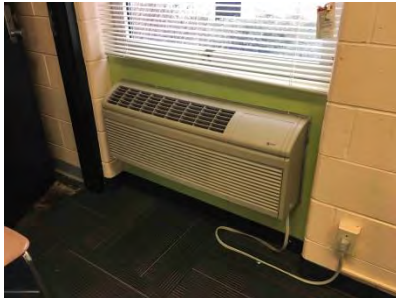
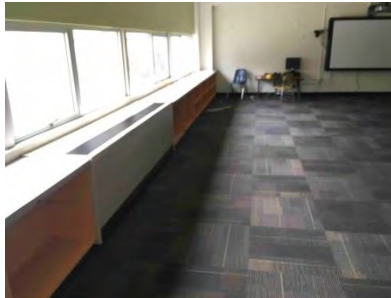
- Trane horizontal unit ventilators installed in 1997 are in average condition.
- Gymnasium has heating and ventilation unit that is old and past its service life.
- Handful of misc. window air conditioners that are 20+ years old and should be removed.

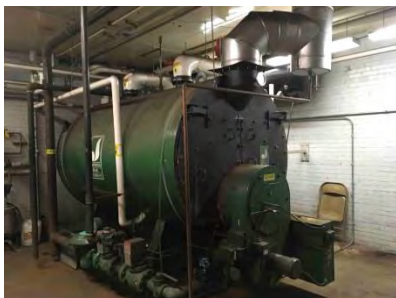
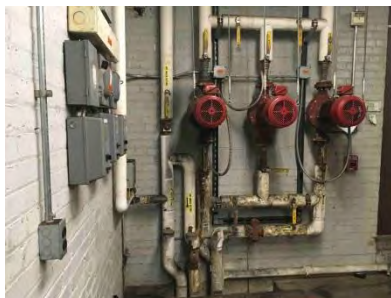
- (1) Johnston heating hot water boiler, 5120 lbs./hr. capacity (not steam), installed in 1994 and is in fair condition. Boiler is nearing end of expected usable life and should be considered for replacement in 3-7 years.
- Pumps/piping in the boiler room are leaking and should be repaired/replaced.

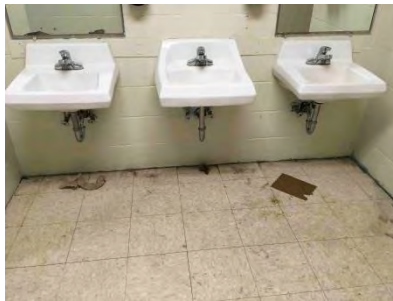
- One bathroom has upgraded fixtures, other bathroom fixtures in fair condition and may need replacing.

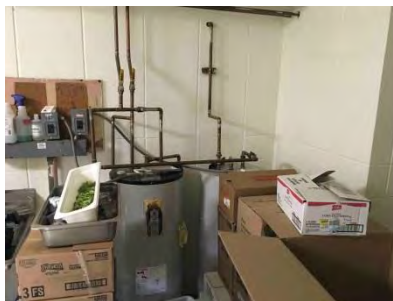
- Plumbing piping is routed thru tunnels and assumed to be original to building.
- Multiple existing electric water heaters. Appear to be in operable condition, but may consider replacing with gas water heaters to reduce operating costs.

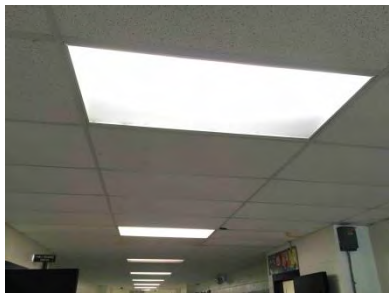
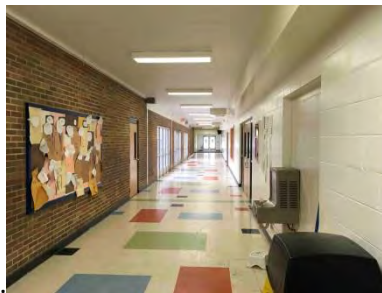
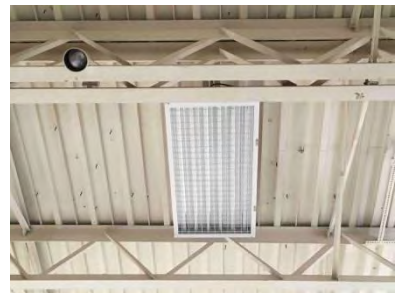
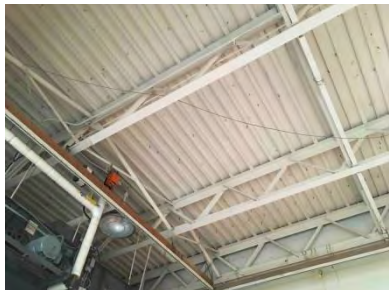
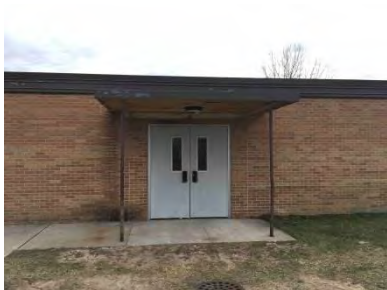
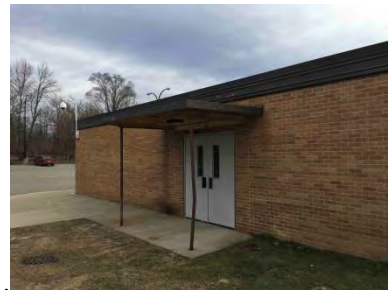
Building Lighting is adequate.

- The existing lighting is fluorescent and metal halide. The update to LED would result in significant monetary savings and energy conservation. This would require all new lighting throughout the building.
- There are no occupancy sensors or central lighting control system. If more than 50% of the lights were to be upgraded to LED at one time a central lighting control system and occupancy sensors would be required per the Michigan Building Energy.
- The exterior building lighting and parking lot lighting is metal halide and the quantity of lighting is sparse. Additional LED lighting would be recommended for safety and energy savings.

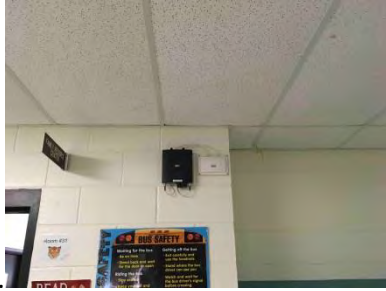
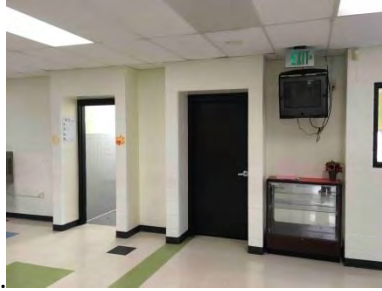
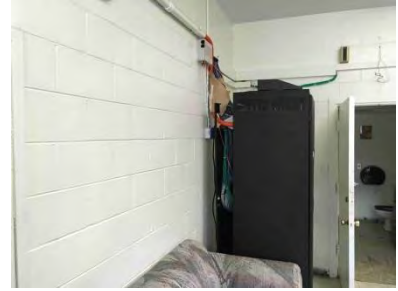
Building Technology is adequate.

- Wireless Access Points are installed throughout the building.
- There is a use of wall mounted projectors in some classrooms.
- There are teachers stations in classrooms tied to the projectors.
- There are TVs/monitors throughout the building.
- More wiring supports for wiring and IT closets is recommended.

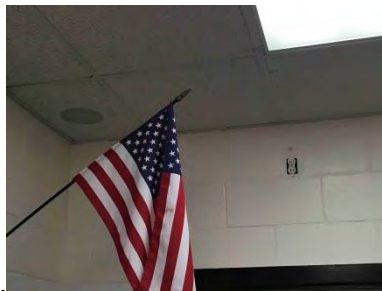
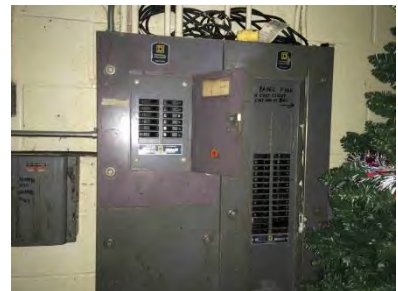
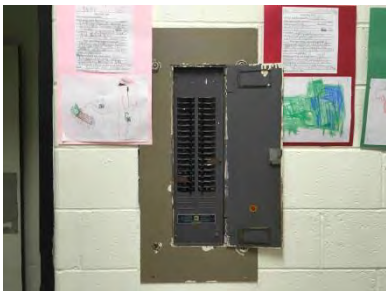
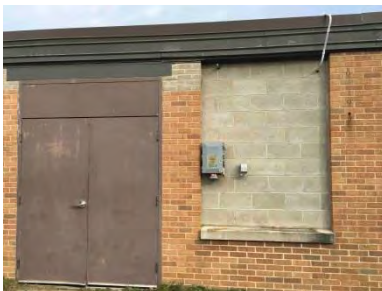
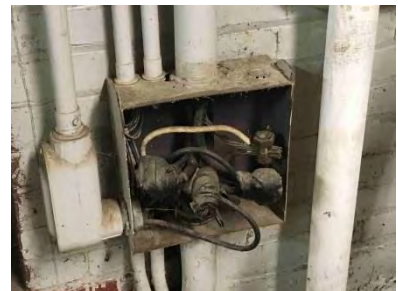
Electrical Building System is in poor condition.

- The existing primary and secondary panels are old and at the end of their life and need to be replaced.
- There is no generator.
- Electrical in the building needs to be brought up to code for safety. There are open panel boards and junction boxes which provide a lot of hazards.

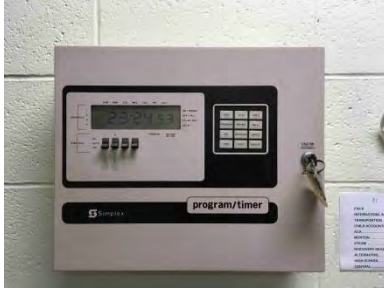
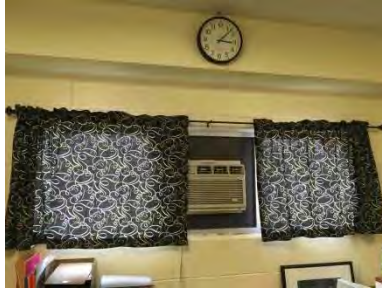
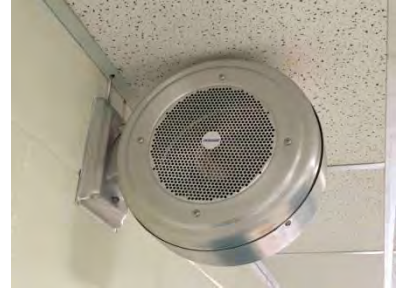
Clock/ PA Systems are in poor condition.

- Existing paging system is a Dukane system and is at the end of its life. New system is recommended to be installed to provide proper life safety communications.
- Central clock system is an existing Simplex system that is at the end of its life. New clock system is recommended to be installed.

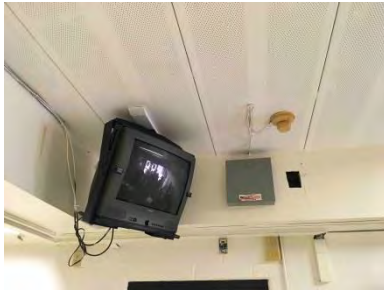
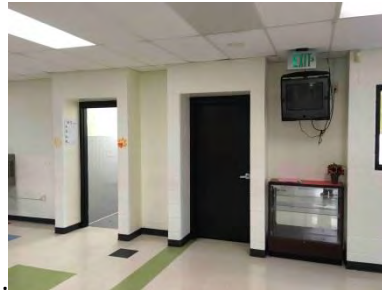
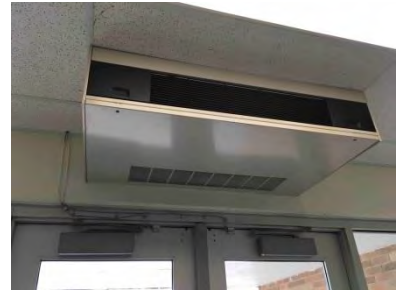
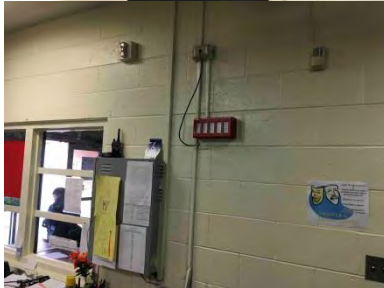
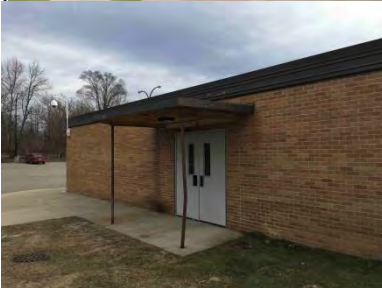
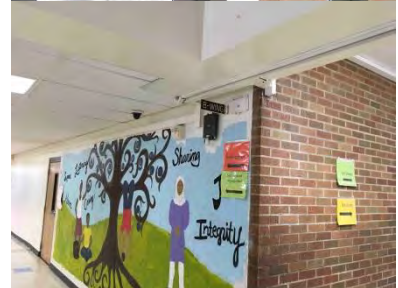
Security Systems are adequate.

- Existing security system has cameras, door contacts and motion detectors.
- There is an Aiphone in the building for some secure entrance. A new building access system would be recommended for building security and teacher access to the building.

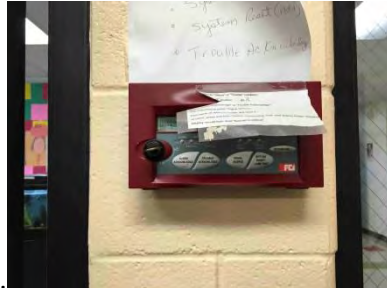
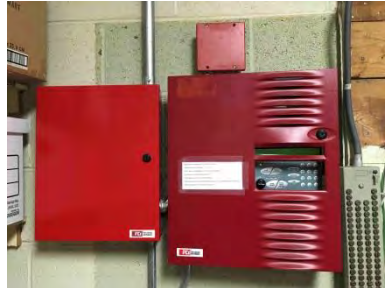
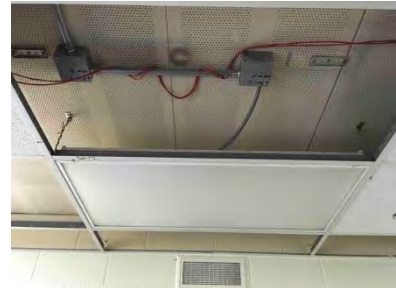
Fire Alarm System is adequate.

- Existing FCI fire alarm. The school district is required to service this system once a year by a licensed contractor. The system does have horn/strobe capabilities but no voice annunciation system, which was adopted by NFPA in 2014. If the owner wants voice annunciation, which was adopted by NFPA in 2014, the system will have to be replaced. The system is adequate and grandfathered with the State without voice annunciation. It is recommended that the existing system is updated and that may require replacement.

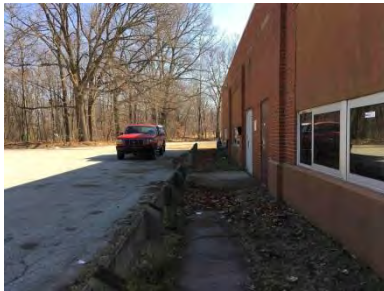
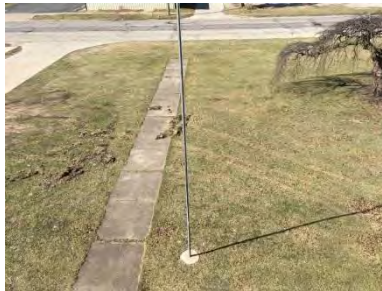
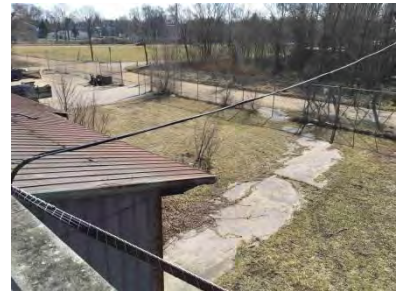
Pavements

- Asphalt and exterior concrete is in poor condition

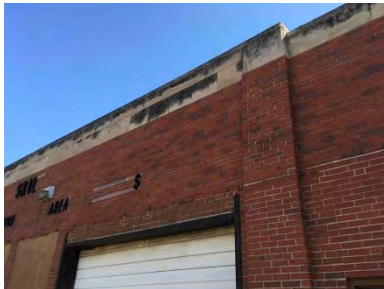
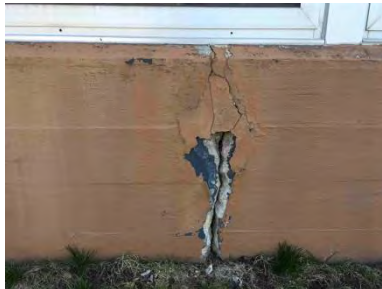
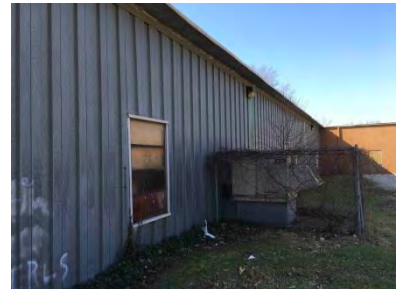
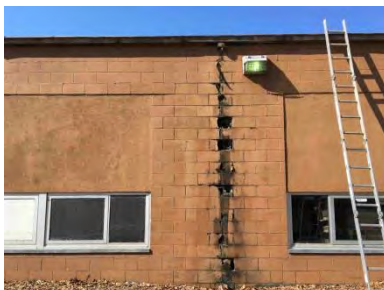
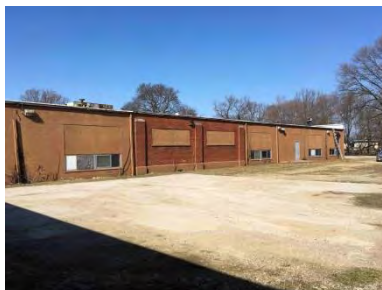
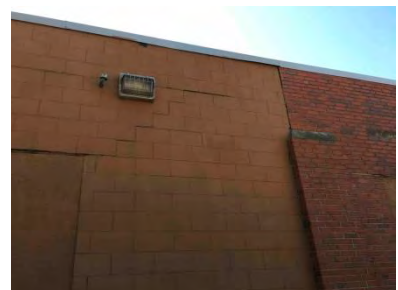
Building Envelope Assessment

- Masonry block with brick veneer in very poor condition with several cracks present
- Aluminum framed windows in poor condition
- Hollow metal doors in poor condition
- Addition on the back of the building is pre-engineered steel building in poor condition

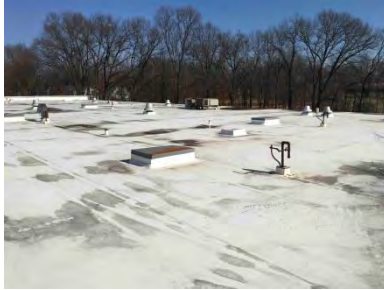
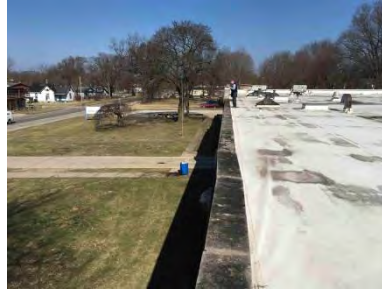
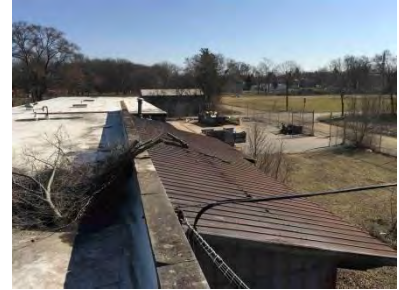
Roof System Assessment

- Approximately 22,500 SF
- White TPO in fair condition

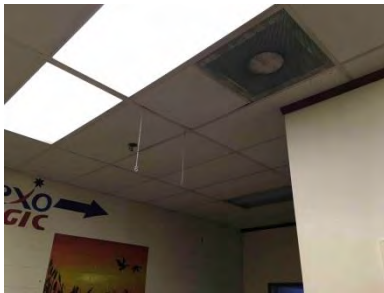
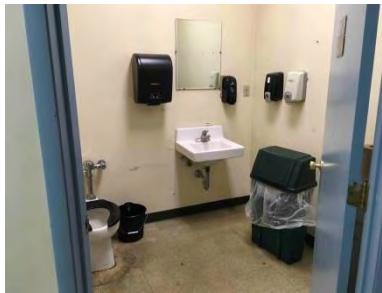
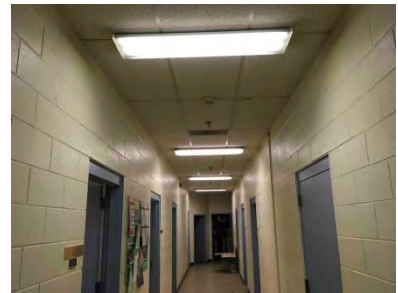
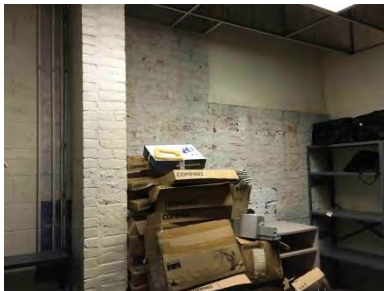
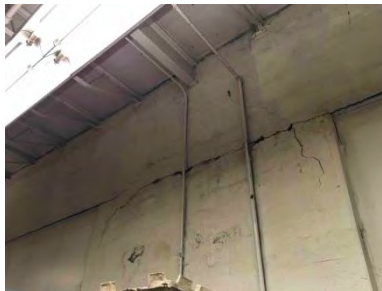
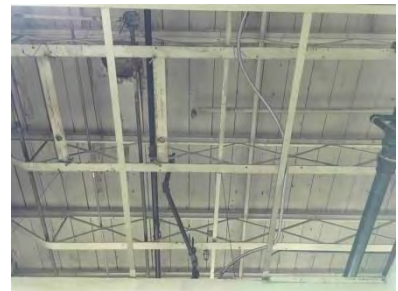
Interior Finishes Assessment

- Office area has carpet and VCT that is in fair condition
- Shop area is exposed concrete in fair condition
- Ceilings in the offices are 2'x2' suspended acoustic system in fair condition
- Shop ceilings are painted exposed structure consisting of steel joists and wood deck or steel joists and metal deck

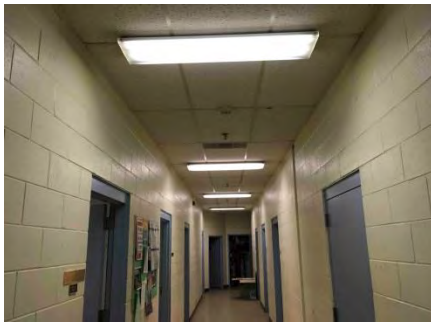
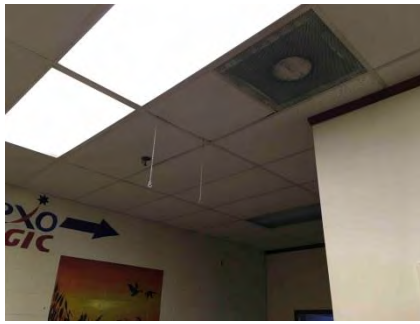
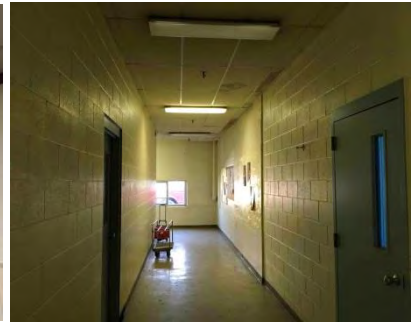
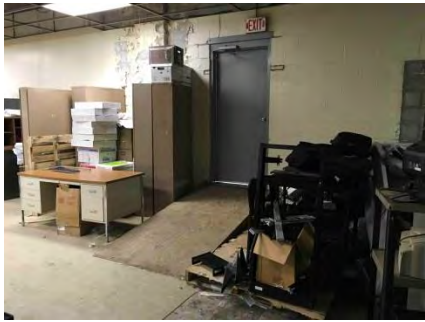
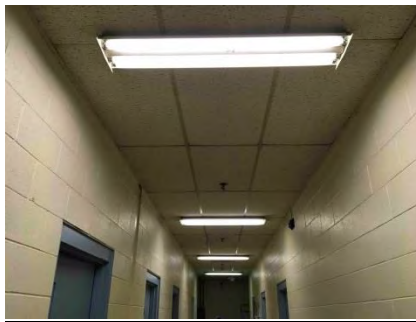
Life Safety Assessment

- Illuminated Exit Signage is lacking in several areas.
- Exterior doors have knob hardware.

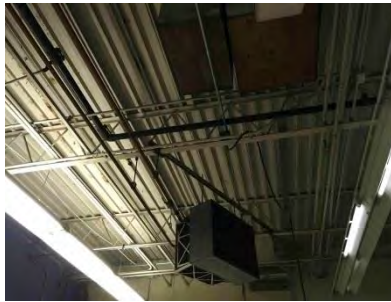
- Maintenance shop has ductwork from previously used RTU's, all RTU's curbs are capped and ductwork is abandoned. Maintenance area has minimal ventilation and exhaust. If vehicles are operated indoors current codes require much more ventilation and specialized exhaust.
- (1) RTU installed in 2010 serves front office area and is in average condition.
- Remainders of spaces are served by ceiling hung hot water unit heaters.

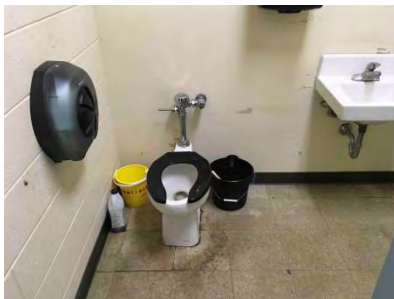
Plumbing Fixtures

- Bathroom fixtures are in average condition.

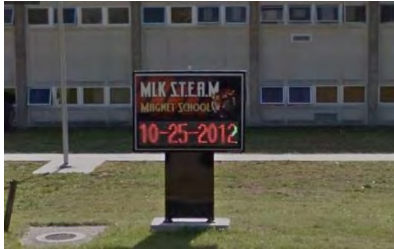
- LED Sign in good condition

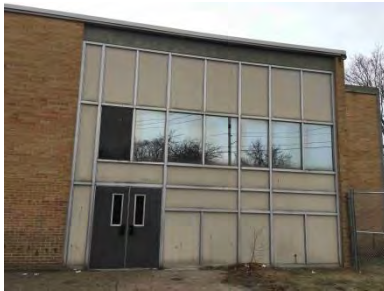
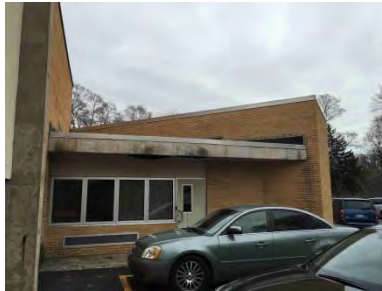
- Exposed concrete and brick in good condition with some repairs needed at concrete support columns
- There are areas with stress cracks in the brick veneer that need repaired
- Aluminum curtain wall system with awning style operable windows. All glass is double pane in good condition
- Main entry doors are FRP installed in aluminum frames and are in good condition. However some of the door hardware is damaged and should be replaced
- Soffit areas are in poor condition with repairs being needed
- Hollow metal doors and frames are rusted through and are in very poor condition

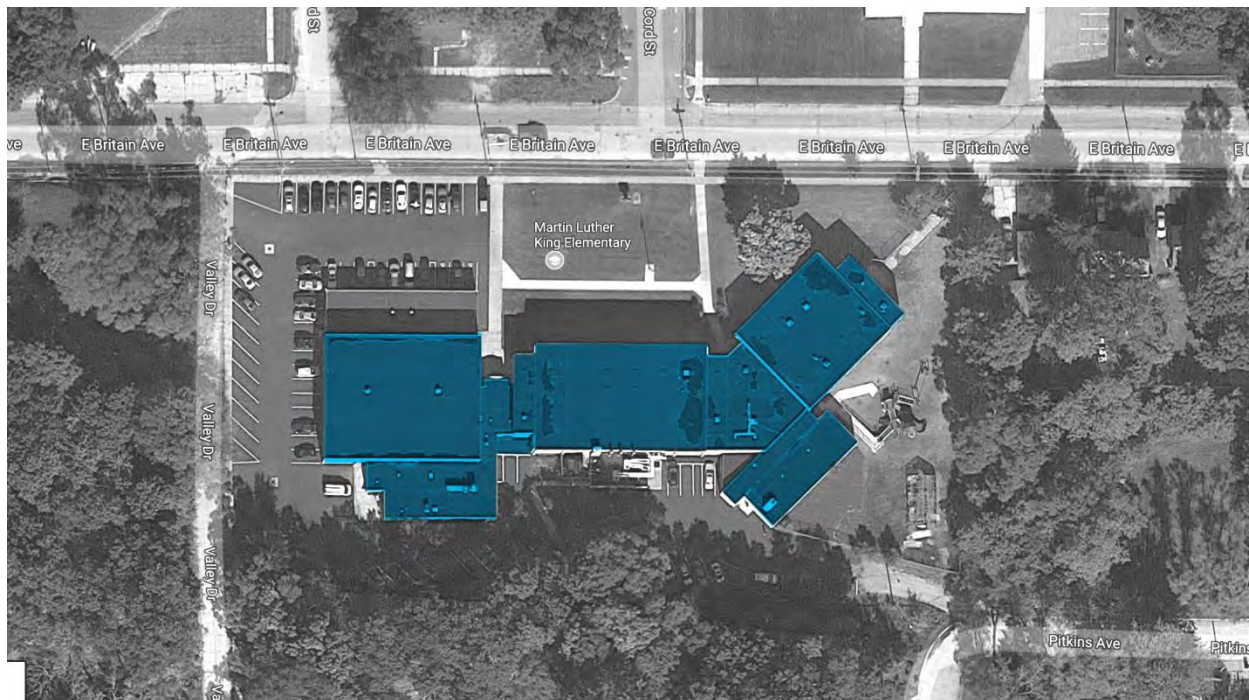
Roof Conditions & Anticipated Service Life Plan

- Approximate roof area 35,400 SF
- Black EPDM in fair condition

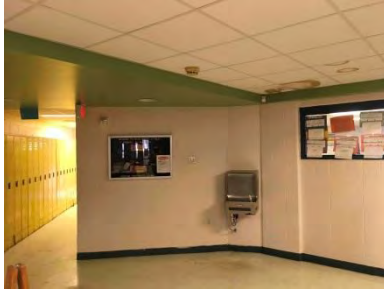
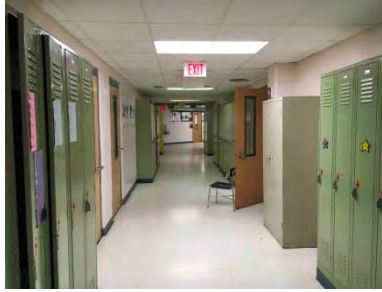
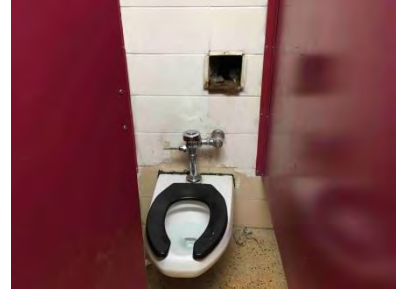
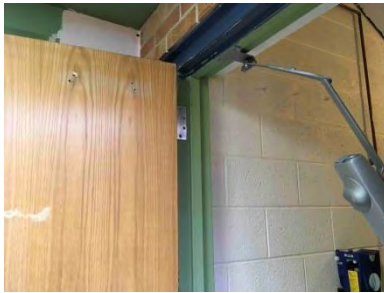
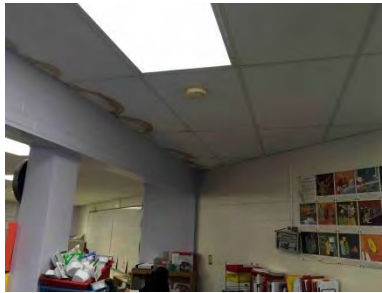
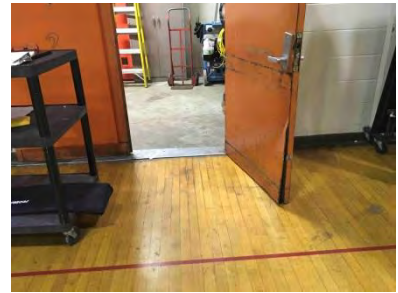
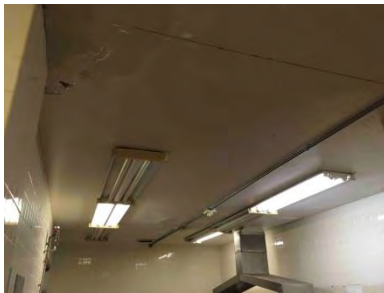
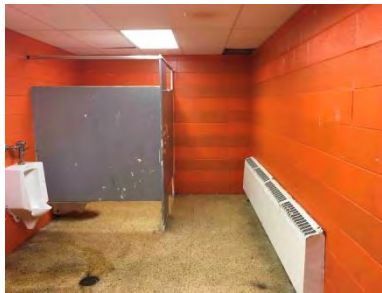
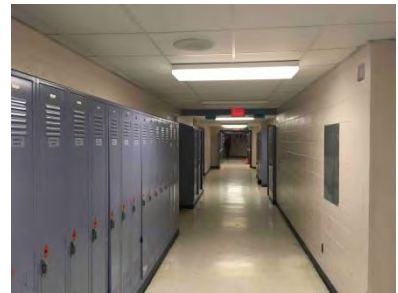
- Flooring
 - Corridors have VCT flooring installed and is in good condition
 - Toilet rooms have terrazzo flooring that is stained but could be cleaned bringing it back to an acceptable finish
 - Ceramic tile at toilet rooms is in poor condition
 - Carpet in classrooms is in good condition however the VCT in these rooms is poor
 - Gym wood flooring is in good condition
 - Quarry tile in the kitchen is in good condition
- Ceilings
 - 2'x4' suspended acoustic ceiling system is overall in good condition. There are many water stained ceiling tile that need to be replaced
- Walls
 - Painted concrete masonry units are in good condition
 - Toilet rooms have ceramic tile and is in fair condition
 - Tiled walls in the kitchen are in good condition
- Doors
 - Wood doors installed in hollow metal frames are mostly in good condition

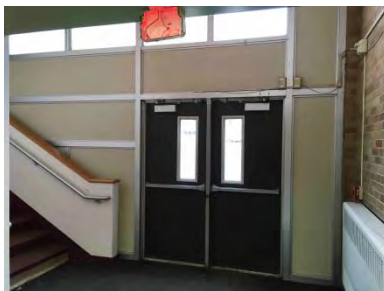
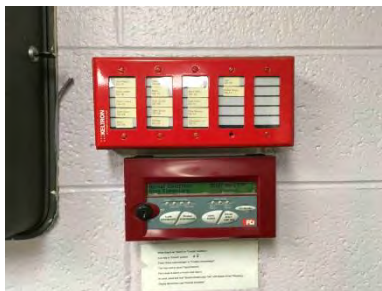
- Building has a Fire alarm system
- Several illuminated exit signs are damaged

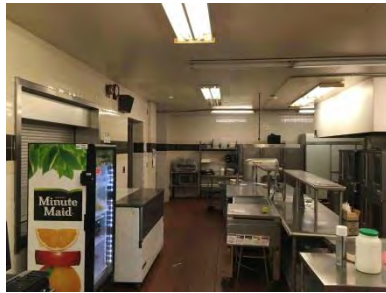
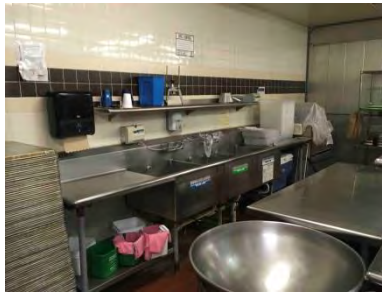
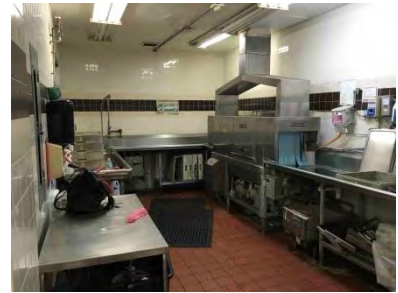
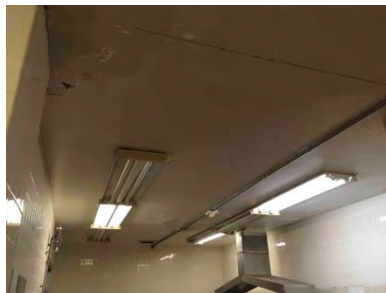
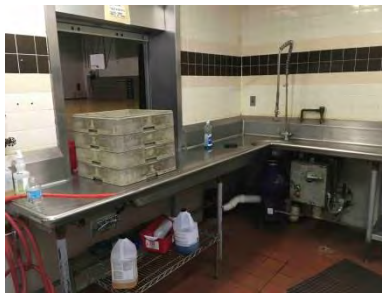
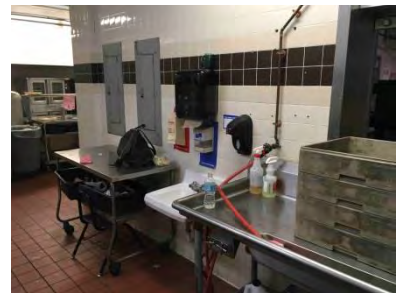
- Equipment appears to be in fair condition
- Ceiling and light fixtures are in poor condition

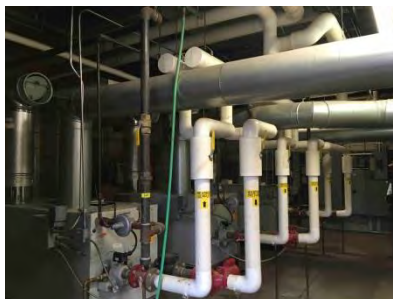
- (3) Lochinvar Copper-Fin heating hot water boilers, 1440 MBH input each, installed in 2000. The boilers appear to be in relatively good condition.
- Heating hot water piping insulation in good condition, some hot water pumps are newer.

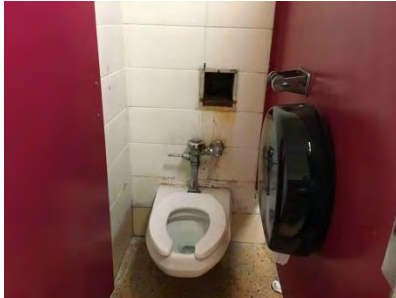
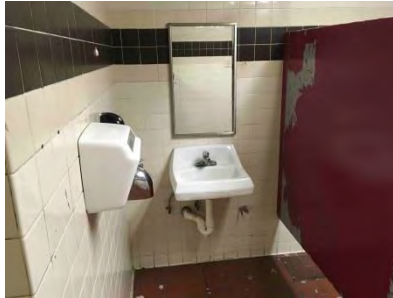
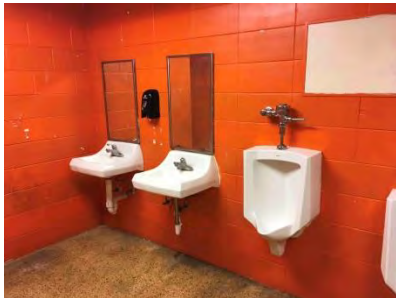
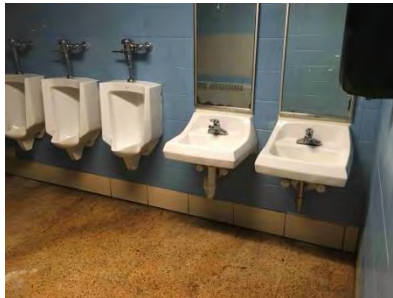
- Bathroom plumbing fixtures are in poor condition and may need to be replaced.

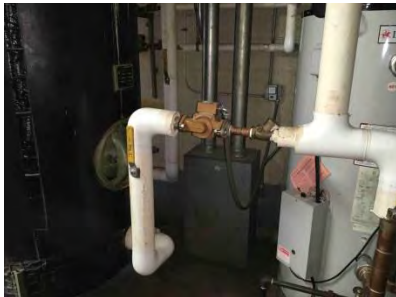
- Plumbing piping routed thru tunnels in fair condition per original assessment.
- Domestic water heaters are in good condition.

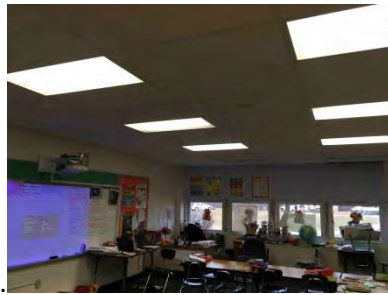
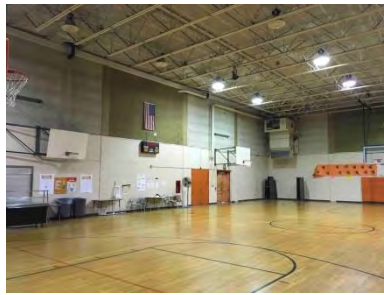
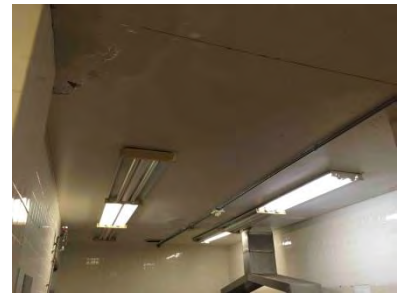
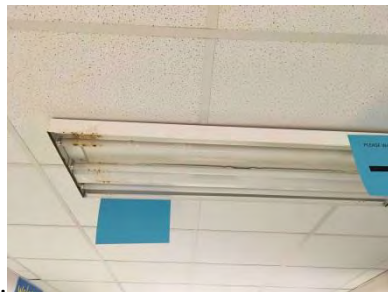
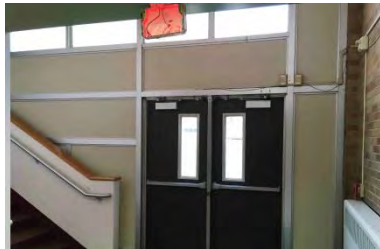
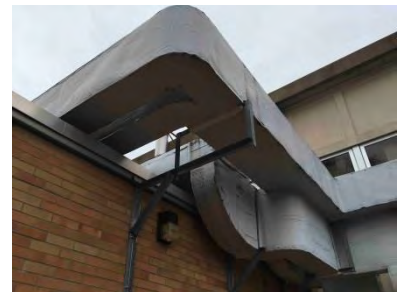
Building lighting is in poor condition.

- The existing lighting is fluorescent in classrooms and common areas and maintenance is required on a good percentage of these fixtures. Metal halide in the gymnasium. The update to LED would result in significant monetary savings and energy conservation. This would require all new lighting throughout the building.
- There are no occupancy sensors or central lighting control system. If more than 50% of the lights were to be upgraded to LED at one time a central lighting control system and occupancy sensors would be required per the Michigan Building Energy.
- The exterior building lighting and parking lot lighting is metal halide and the quantity of lighting is sparse. Additional LED lighting would be recommended for safety and energy savings.

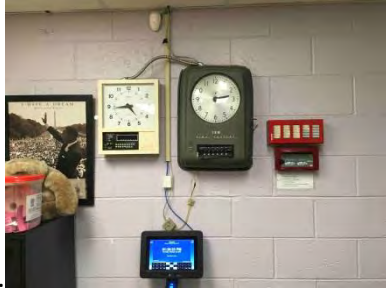
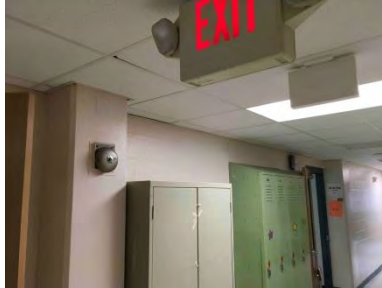
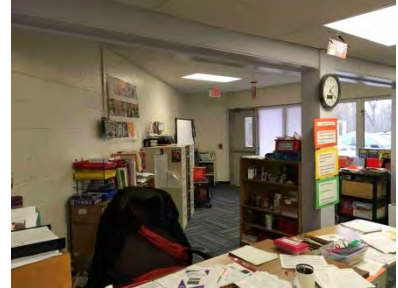
Clock/ PA Systems are in poor condition.

- New p.a. system is recommended to be installed to provide proper life safety communications.
- Existing central clock is out of date. Different clock types are installed throughout the building. New clock system is recommended to be installed.

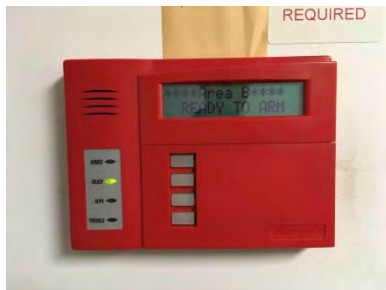
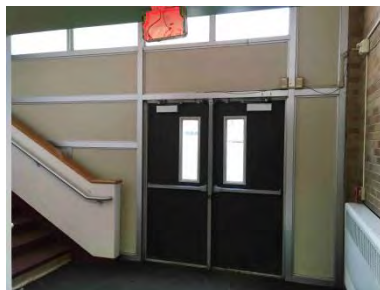
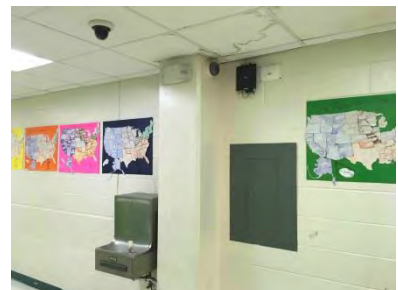
Security Systems are adequate.

- Existing security system is a Honeywell and has cameras, door contacts and motion detectors.
- A new building access system would be recommended for building security and teacher access to the building.

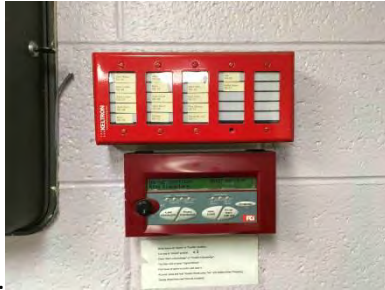
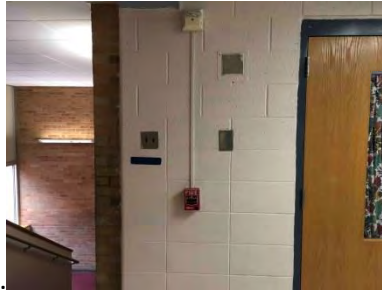
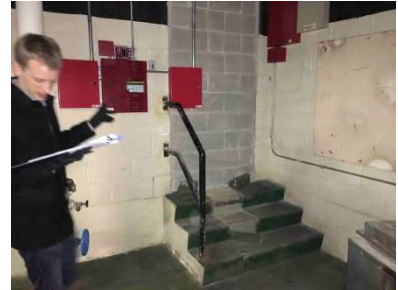
Fire Alarm System is adequate.

- Existing FCI fire alarm. The school district is required to service this system once a year by a licensed contractor. The system does have horn/strobe capabilities but no voice annunciation system, which was adopted by NFPA in 2014. If the owner wants voice annunciation, the system will have to be replaced. The system is adequate and grandfathered with the State without voice annunciation. It is recommended that the existing system is updated and that may require replacement.

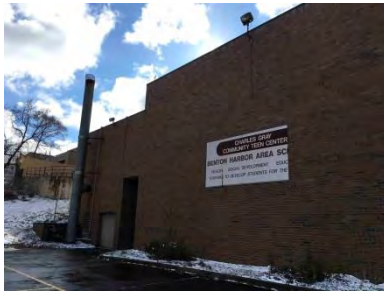
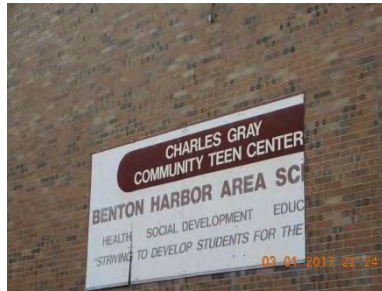
Entrance Signage

- Partial sign remained on the face of the building in poor condition

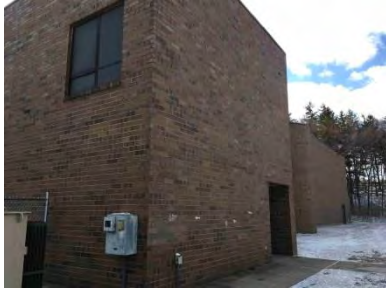
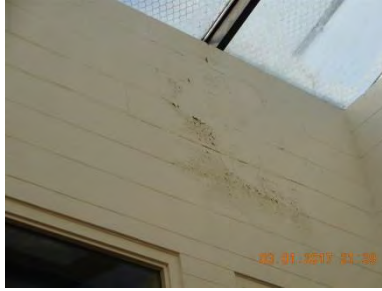
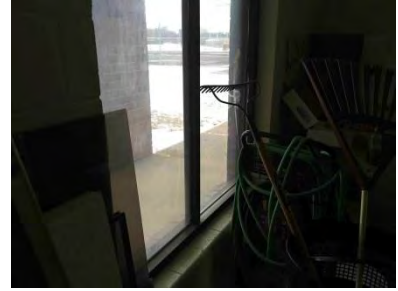
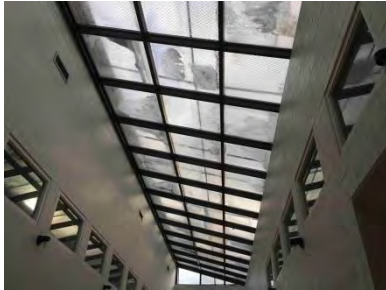
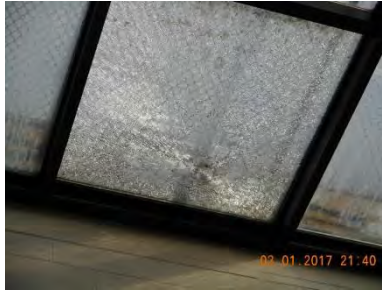
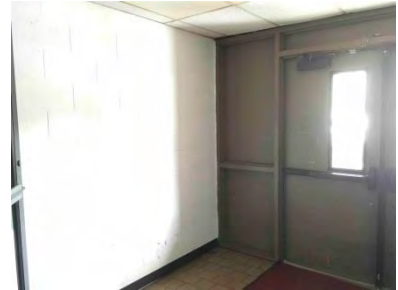
- Asphalt and exterior concrete is in poor condition

- Exterior masonry walls with brick veneer is in good condition
- Some areas showing water infiltration mainly at the skylight
- Double pane fixed glass in aluminum frames are in good condition
- Large skylight section above the second floor corridor is in poor condition with broken panes or seals damaged
- FRP and aluminum doors installed in aluminum frames are in poor condition and need to be replaced
