BENTON HARBOR AREA SCHOOLS

2017 Facility Assessment

GMBae Project #5-4061

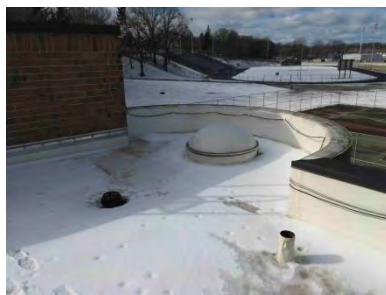
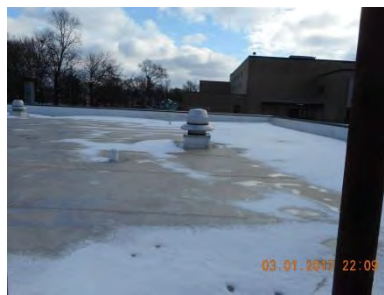
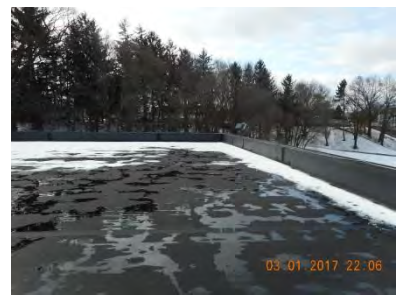
- Approximate roof is 19,000 SF
- Approximately 11,000 SF of black EPDM at the pool
- Approximately 8,000 SF White Duro-Last TPO over the remaining building
- Roof has adequate draining with very little ponding of water
- Skylight is in very poor condition with damaged panels with some indication of leaking

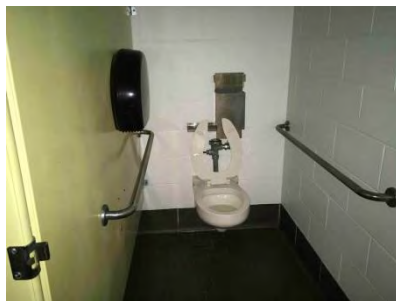
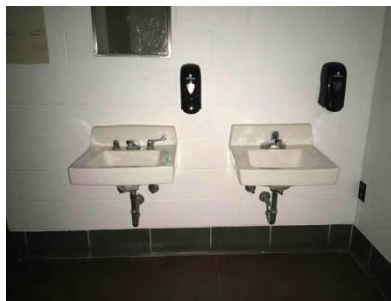
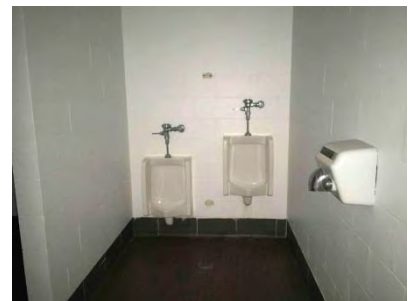
- The building is barrier free accessible and is equipped with an elevator
- Toilet rooms and fixtures are all barrier free

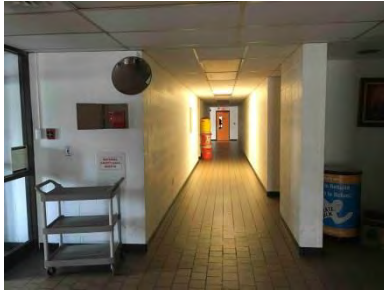
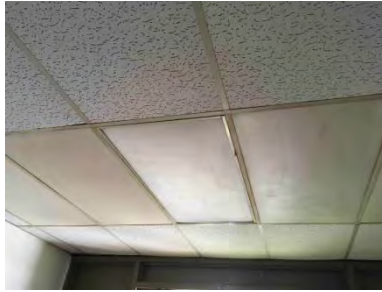
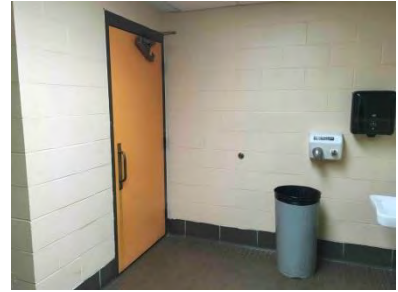
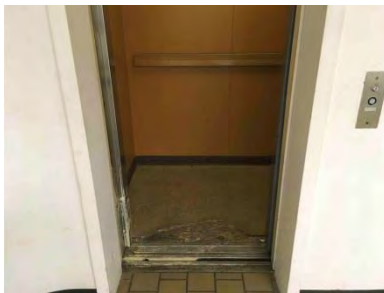
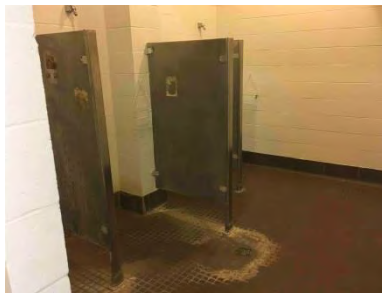
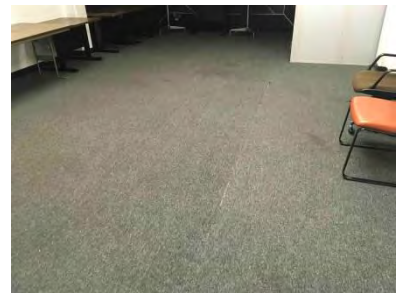
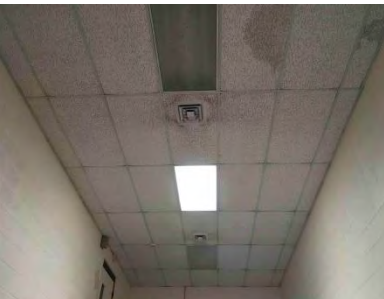
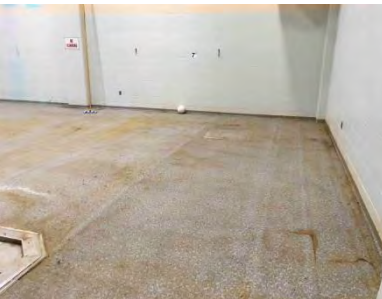
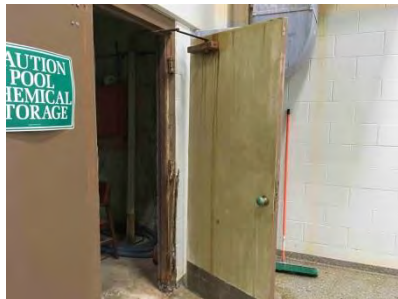
- Flooring
 - Quarry tile is installed throughout the corridors are in good condition
 - Ceramic tile in toilet rooms are in good condition
 - Sports flooring was recently installed in the weight room is in excellent condition

- Office and meeting room carpeting is in very poor condition
 - Sheet vinyl flooring around the pool is in very poor condition and should be replaced
 - Starting block bolts and feet are rusted and need to be replaced

- Ceilings
 - 2'x4' suspended acoustic ceiling systems should be replaced as they are in poor condition due to the many water leaks throughout
 - Ceilings in the locker, shower, pool and weight rooms are all exposed

- Pool roof deck is extremely rusted with several panels being required to be replaced. The entire deck needs to be sandblasted and painted. It is recommended that a testing agency is brought in to verify the structural condition of the steel joists and their connections.

- Main corridor ceiling requires repairs being made with repainting due to the water intrusion at the skylight system
- Walls
 - Mostly painted masonry and are in good condition

- The walls in the pool area need to be cleaned and painted
- Doors
 - Wood and hollow metal in metal frames most are in good condition
 - There are a few doors within the pool area that should be replaced as they are in poor condition

- Toilet and shower partitions are in poor condition and need to be replaced. Toilet room countertops are also in poor condition and need to be replaced.

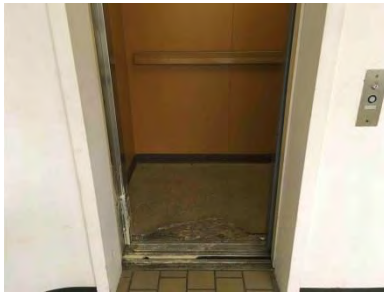
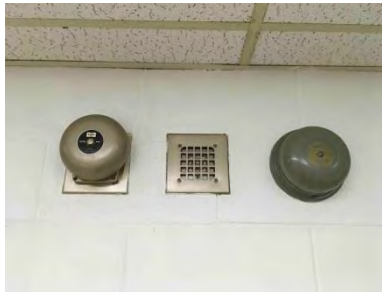
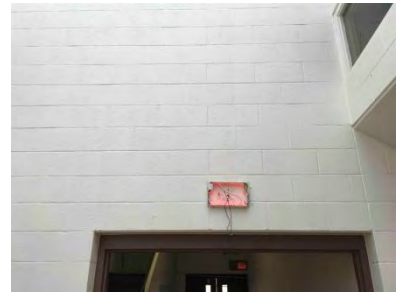
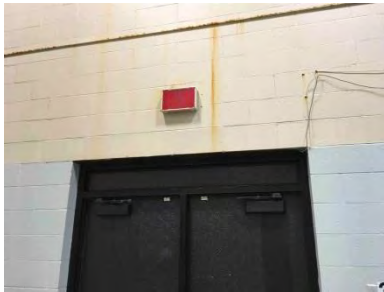
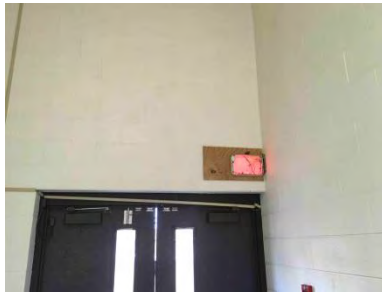
- Illuminated exit signs are in poor condition with many damaged due to vandalism, not functioning or missing altogether
- There are clear paths of egress
- The fire alarm system is outdated with devices not installed in all the required areas
- Panic exit hardware was in place on corridor exiting doors

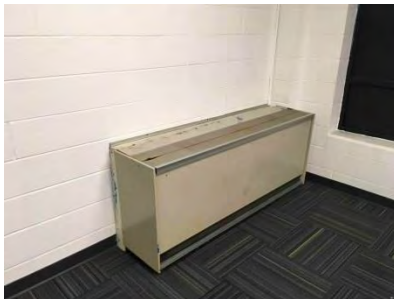
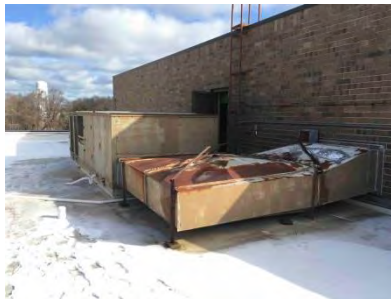
- (1) Trane rooftop mounted DX heating and cooling units, appear to be old and beyond service life.
- Rooftop mounted ductwork is rusted and degrading.
- (1) American Energy Exchange heat recovery rooftop unit appears to be in average condition and newer than Trane unit.
- (1) small Trane RTU installed 2015 in good condition.
- Some horizontal unit ventilators that appear to be in poor condition.

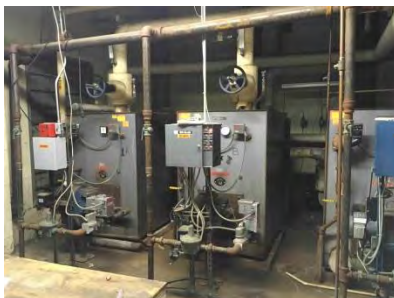
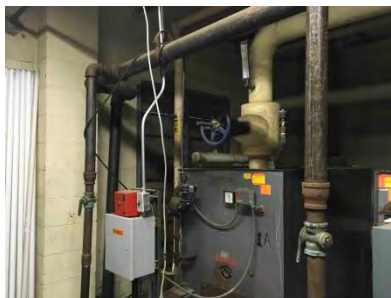
- (3) Weil McLain heating hot water boiler, 1,200 MBH capacity, unknown age but appear fairly old. Boilers are near end of service life.
- Piping appears to be in average condition.

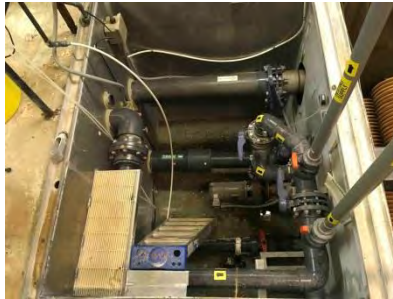
- Duct cable supports are rusted and need to be replaced
- Ductwork shows some signs of corrosion but generally acceptable
- Dehumidification is needed to protect building structure from rust
- Hot water heat exchanger piping, insulation and control valve need to be replaced
- New sump pump needed for pool

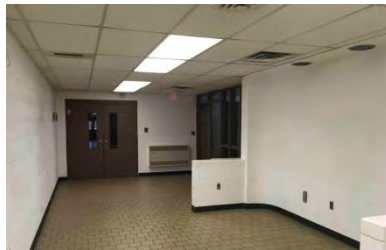
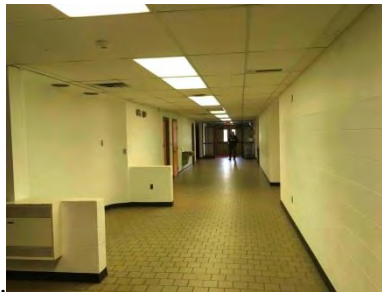
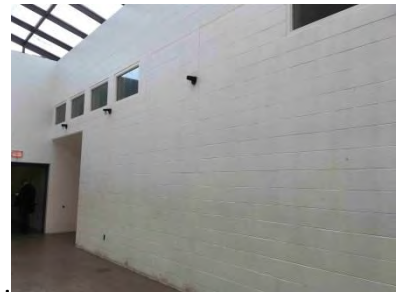
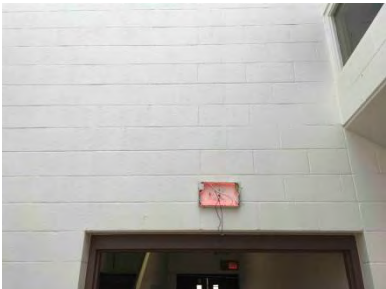
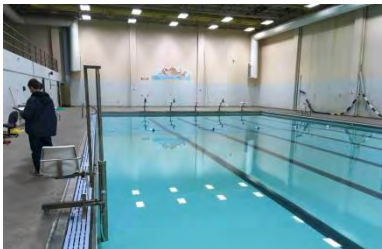
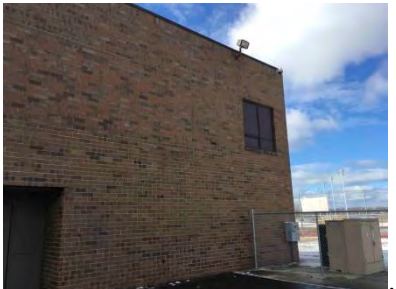
Building Lighting is in poor condition.

- The existing lighting is fluorescent and incandescent. Many lights need repair or replaced. The update to LED would result in significant monetary savings and energy conservation. This would require all new lighting throughout the building.
- There are no occupancy sensors and there is no existing central lighting control system. If more than 50% of the lights were to be upgraded to LED at one time a central lighting control system and occupancy sensors would be required per the Michigan Building Energy.
- The exterior building lighting and parking lot lighting is metal halide and the quantity of lighting is sparse. Additional LED lighting would be recommended for safety and energy savings.

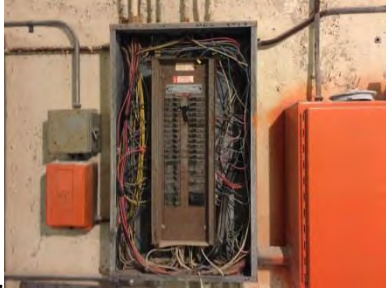
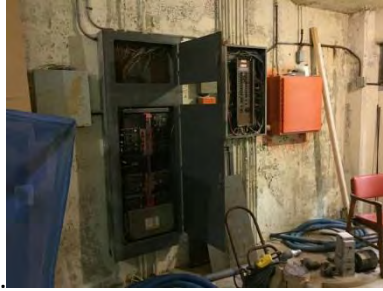
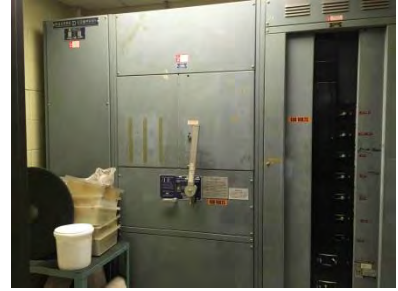
Electrical Building System is adequate with exception of pool area.

- The existing primary main distribution panel is older.
- Existing electrical secondary panels in pool area are corroded, have no covers and need to be replaced. This is a dangerous situation that could cause harm to people and a fire to the building.
- There is no generator on site.

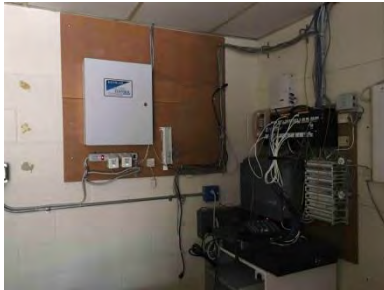
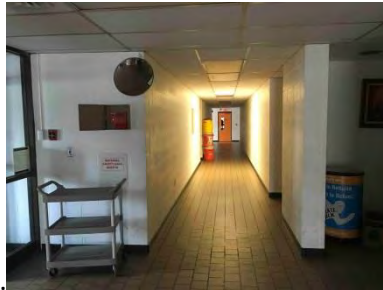
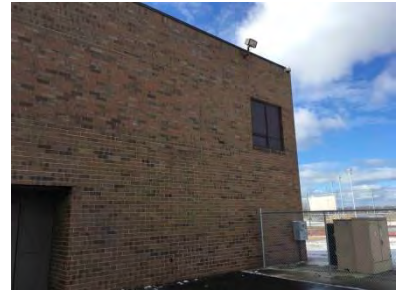
Security Systems are adequate.

- There appears to be a door access system.
- There is a small existing security camera system.

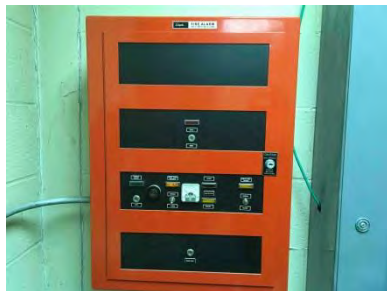
Fire alarm system is in poor condition.

- Existing Simplex fire alarm. The school district is required to service this system once a year by a licensed contractor. The system does have horn/strobe capabilities but no voice annunciation system, which was adopted by NFPA in 2014. If the owner wants voice annunciation, the system will have to be replaced. The system is adequate and grandfathered with the State without voice annunciation. It is recommended that the existing system is replaced.

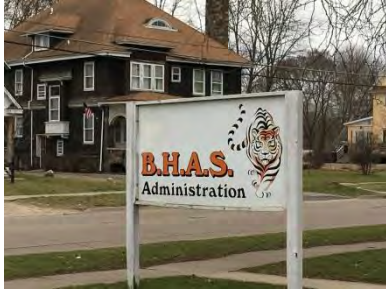
Entrance Signage

- Unlit painted wood sign

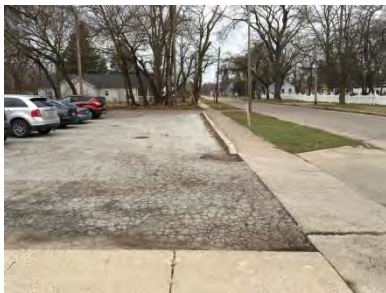
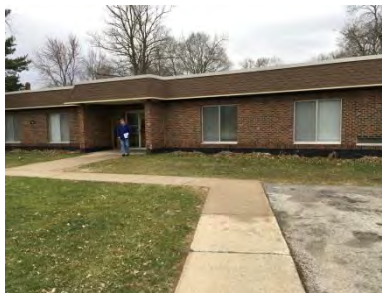
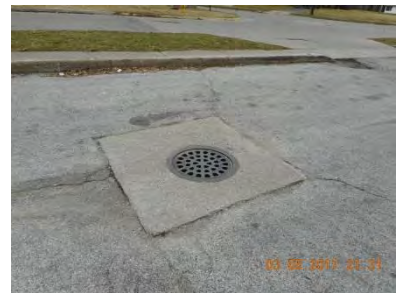
Pavements

- Asphalt parking lot is in poor condition
- The gravel drive to the staff parking lot should have additional gravel placed and re-graded
- Concrete walks are in fair condition

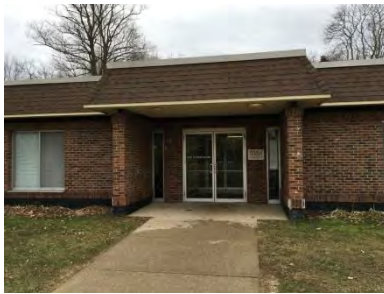
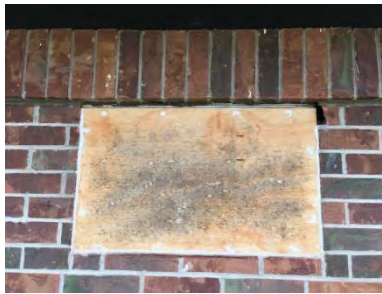
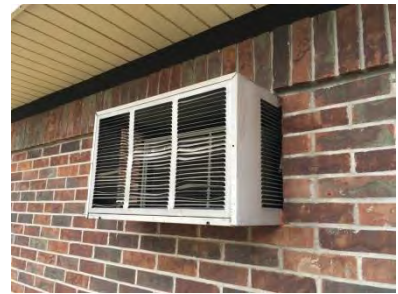
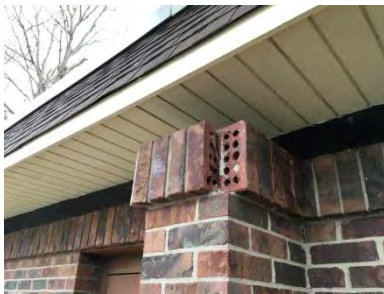
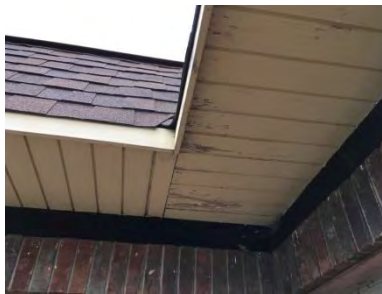
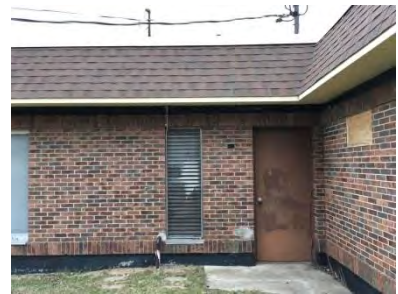
Building Envelope Assessment

- Exterior masonry bearing walls with brick veneer. Several missing brick should be patched in
- There are several exterior openings that are currently covered with plywood and required a permanent weather proof cover to be installed
- Wood soffit and fascia currently in good condition but is in need of painting
- Aluminum double pane windows are in good condition however the perimeter sealants need to be replaced
- Aluminum entry door system in good condition
- All remaining exterior doors are hollow metal in fair condition and required to be cleaned and painted

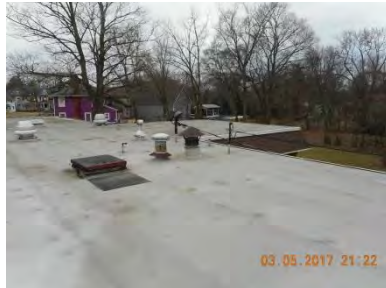
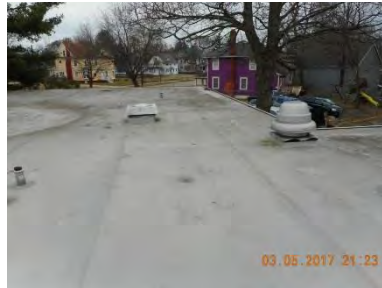
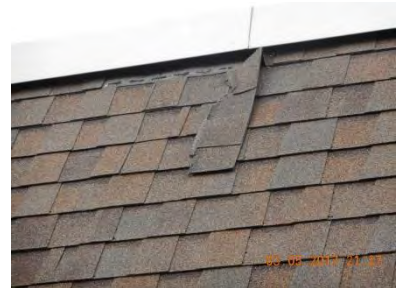
Roof System Assessment

- Approximately 7,000 SF total roof
- White TPO membrane system showing excessive wear
- Perimeter sloped band has mansard shingles installed with some minor repairs required

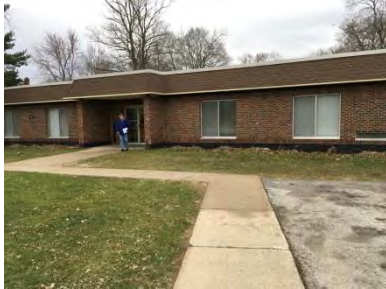
Exterior

- Barrier free accessible from the parking lot to the building

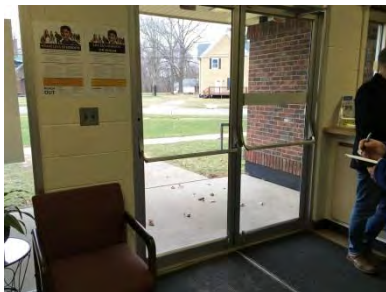
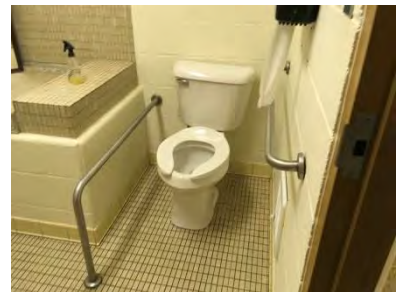
Interior

- Majority of the building is not barrier free compliant as all of the door hardware is knob
- Toilet rooms and accessories are not barrier free compliant

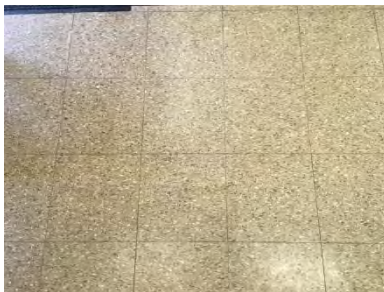
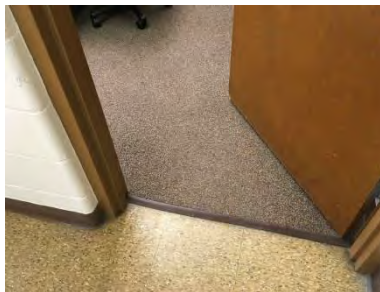
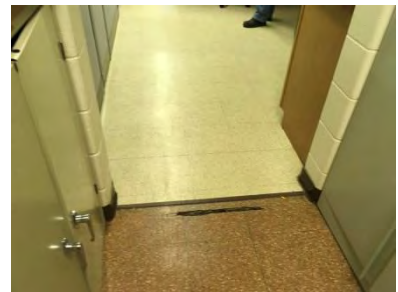
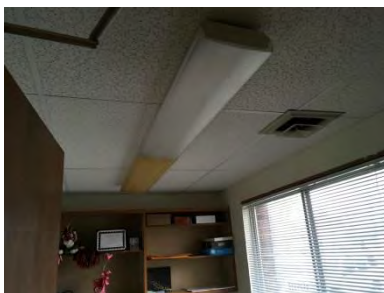
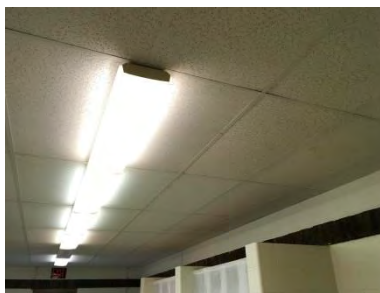
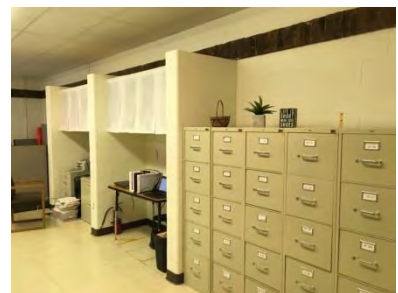
Interior Finishes Assessment

- Flooring
 - Combination of VCT and carpet.
 - Carpet is in good condition as it is relatively new
 - The VCT is fair with some areas of repairs required
 - The toilet rooms have ceramic tile installed in good condition
- Ceilings
 - 2'x'4' suspended acoustic tile system installed throughout. There are several stained tile indicating roof or overhead piping leaks.
- Walls
 - Painted masonry block in good condition
- Casework
 - Wood casework in good condition
- Doors
 - Wood doors installed in hollow metal frames in good condition

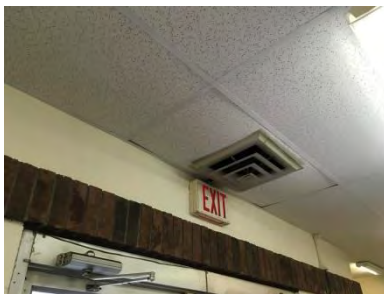
Life Safety Assessment

- A majority of the exit signs are store bought placards and are non-compliant
- Most door hardware is knobsets
- The fire alarm system is old and is not installed in all areas

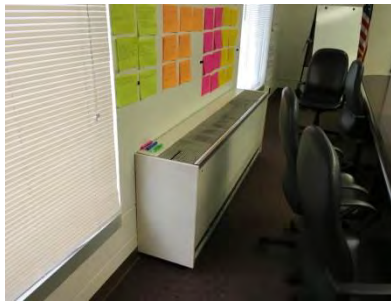
Building Systems

- Front entrance has old and dirty diffusers served by unknown equipment, likely FCU above ceiling or an RTU.
- Unit ventilators appear original to building and due for replacement. The unit ventilators location and sizing is not adequate for current building layout and usage.
- Building ventilation is inadequate. Some office spaces have little or no airflow.
- Kitchen area has large cabinet unit heater and old exhaust hood. Kitchen smells very strong.

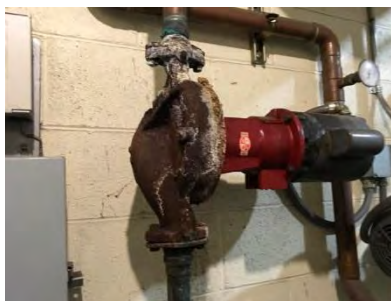
Central Plant Systems

- (1) Lochinvar Heating Hot Water Boiler, 745 MBH capacity, installed in 1994.
- Boiler room piping appears in good condition, no insulation on piping in boiler room.
- Some pump casings are very rusted and old.
- There is a sign for asbestos in the boiler room.

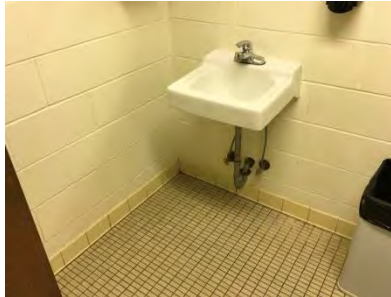
Plumbing Fixtures

- Most fixtures appear to be in satisfactory condition.

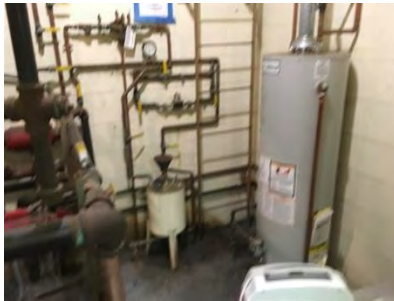
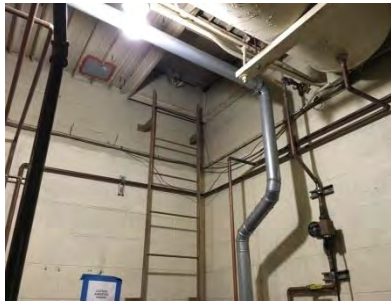
Plumbing Piping and Systems

- Domestic hot water heater appears satisfactory; venting layout seems to not follow typical guidelines.

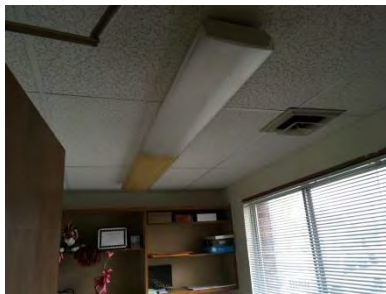
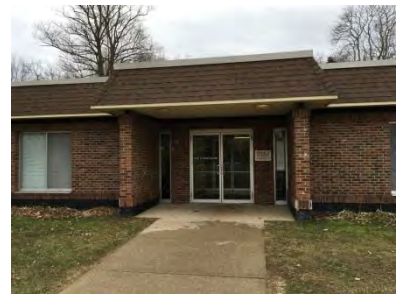
Building lighting is in poor condition.

- The existing lighting is fluorescent and incandescent. The update to LED would result in significant monetary savings and energy conservation. This would require all new lighting throughout the building.
- Occupancy sensors and lighting control would help the efficiency of this building. Michigan Energy Code will require sensors with any lighting update.
- The exterior building lighting is recessed fluorescent and needs to be assisted. It is recommended that these lights be replaced with LED.

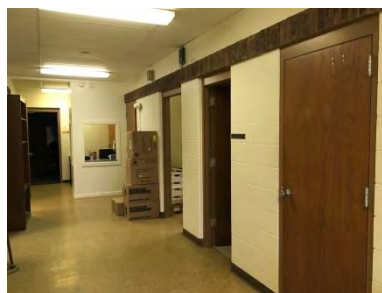
Building Technology is adequate.

- Wireless Access Point is provided.
- There is a use a projector in the conference room.
- There is data/voice for office connections.

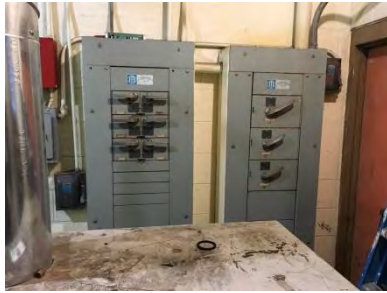
Electrical building system is fair.

- The existing primary ITE main distribution panel is at the end of its life and needs to be replaced.
- Existing electrical secondary FFE panels are old and it becomes hard to find replacement breakers for this equipment. It is recommended that some of these panels are replaced.
- There is no generator on site.

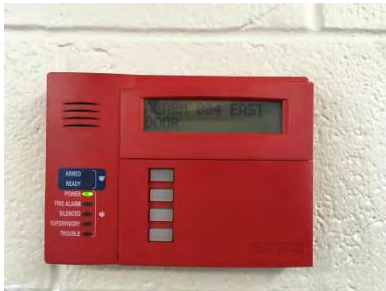
Security Systems are adequate for the use of this building.

- Existing security system is a Honeywell system with no cameras or motion detectors just door contacts.

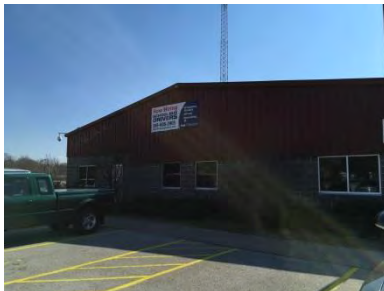
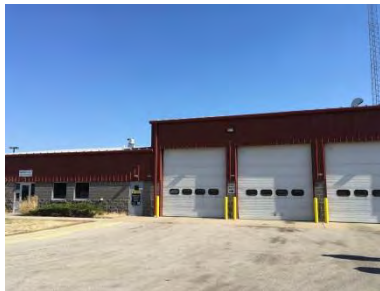
Pavements

- Asphalt and exterior concrete is in good condition
-

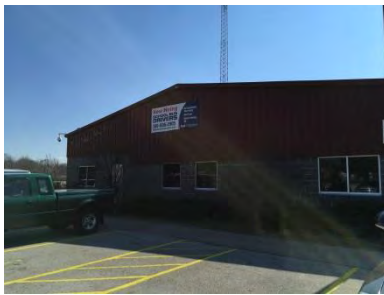
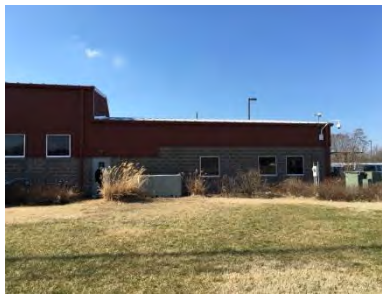
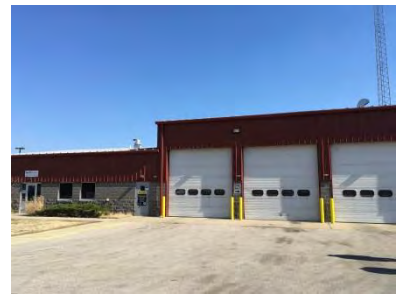
Building Envelope Assessment

- Exterior walls are masonry and metal siding in good condition
- Roof is standing seam with metal coping in good condition
- Main exterior entry doors are FRP set in aluminum frames with the remaining being hollow metal in good condition
- Aluminum fixed double pane window system in good condition

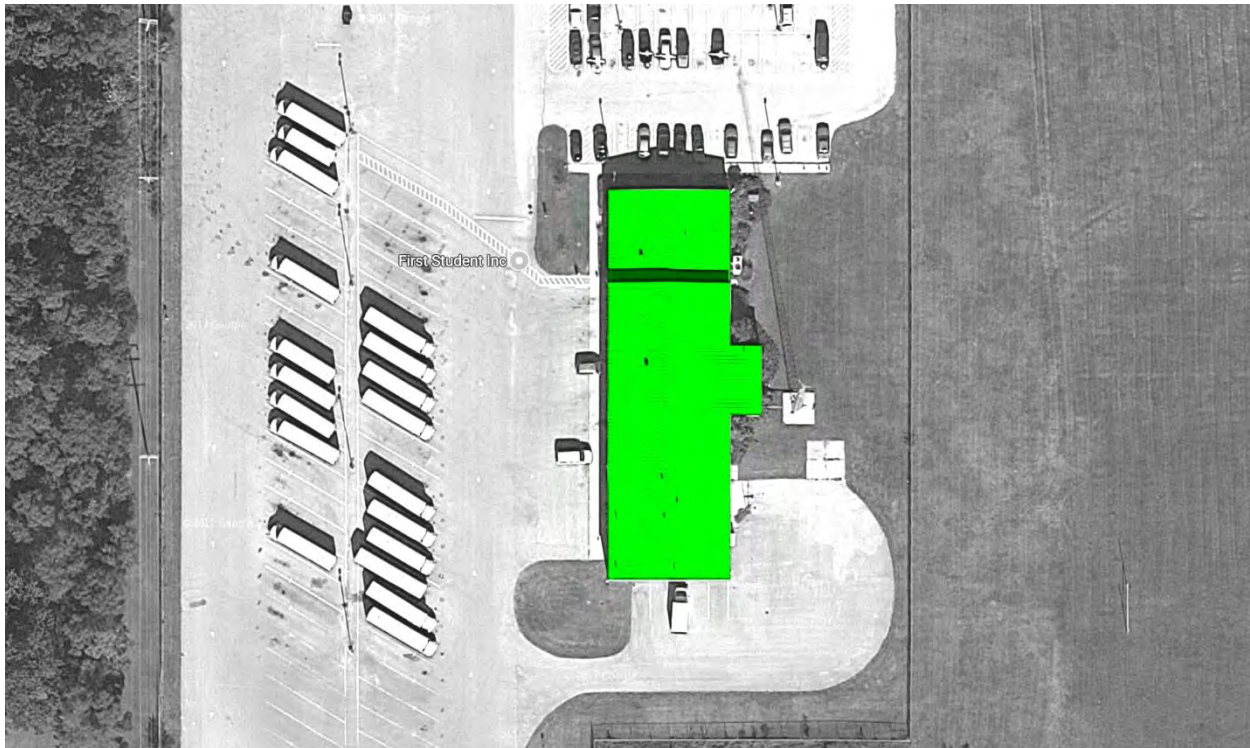
Roof Conditions & Anticipated Service Life Plan

- Approximately 12,500 SF
- Metal standing seam in very good condition

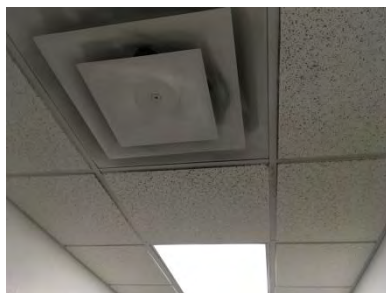
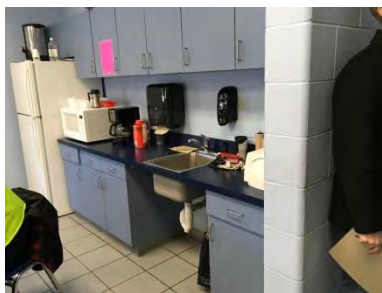
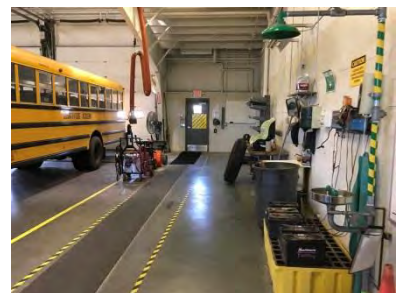
Interior Finishes Assessment

- Flooring
 - Carpet and VCT is installed throughout the office area and is in good condition
 - Painted concrete through the shop area in good condition
- Ceilings
 - 2'x2' suspended acoustic ceiling system in the office in good condition
 - Exposed faced insulation and structure in the shop. Most in good condition with some insulation repairs needed.
- Walls
 - Painted concrete block in good condition
- Casework
 - Plastic laminated cabinets in good condition
- Doors
 - Hollow metal in metal frames all found to be in good condition

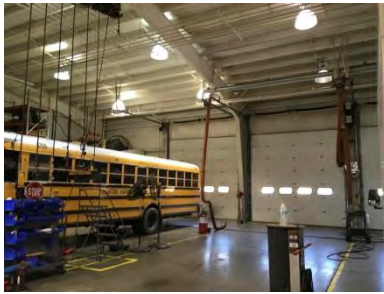
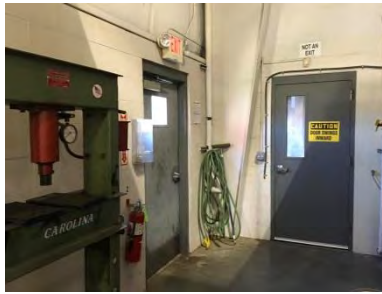
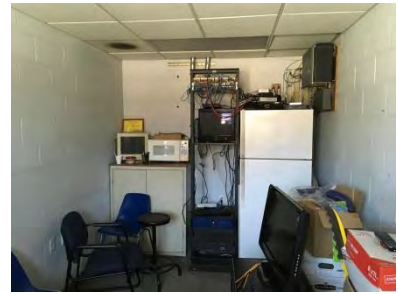
Life Safety Assessment

- Illuminated exit signage at exiting doors was noted
- ADA accessible hardware was installed throughout

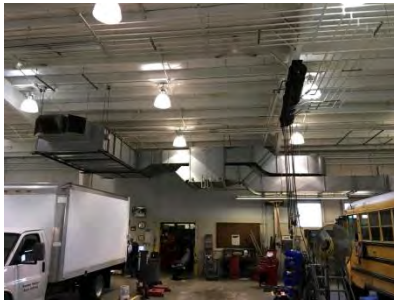
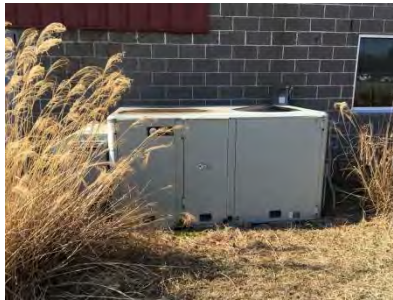
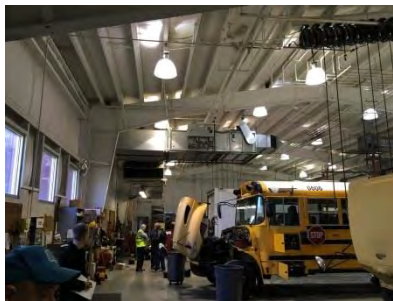
Building Systems

- Bus garage systems appear to be in good condition including vehicle exhaust system, makeup air units with energy recovery and hose reels.
- RTU on grade serves office area installed in 2003 and may be due for replacement in the near future.

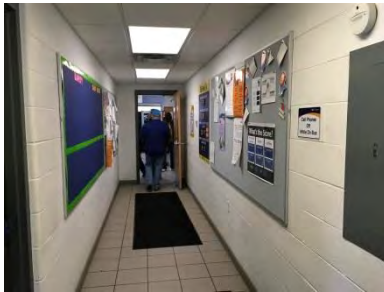
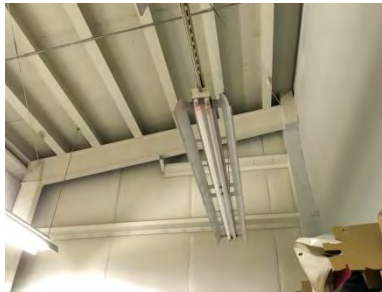
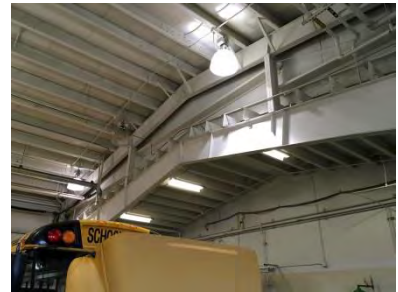
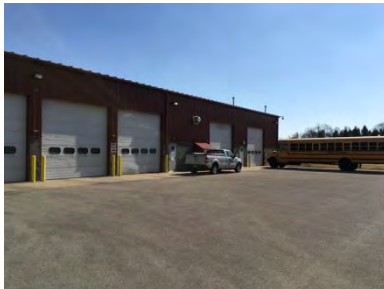
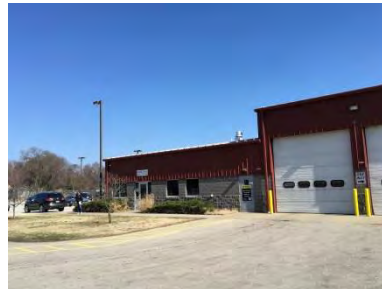
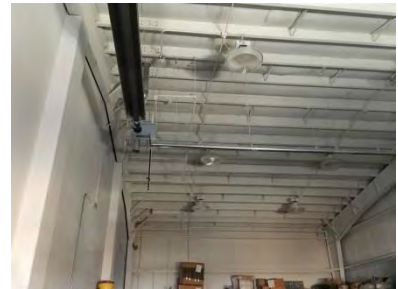
Building lighting is adequate.

- The existing lighting is fluorescent and metal halide. The update to LED would result in significant monetary savings and energy conservation. This would require all new lighting throughout the building.
- There are no occupancy sensors in the building. Installing occupancy sensors would help with energy conservation and monetary savings.
- The exterior building lighting and parking lot lighting is metal halide. . The update to LED would result in significant monetary savings and energy conservation.

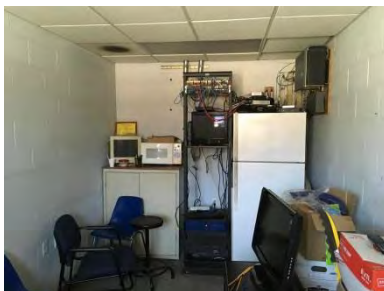
Building technology is adequate and provides for the needs of this building.

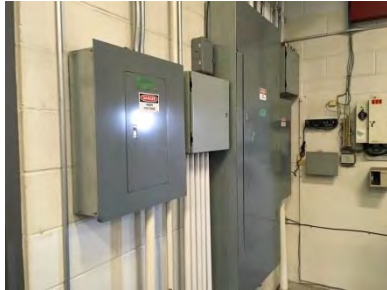
Electrical Building System is adequate.

- The existing primary main distribution is Square D and is in good condition.

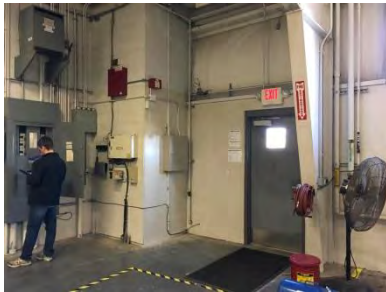
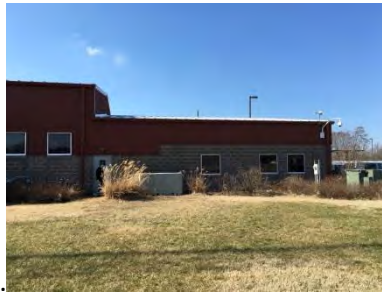
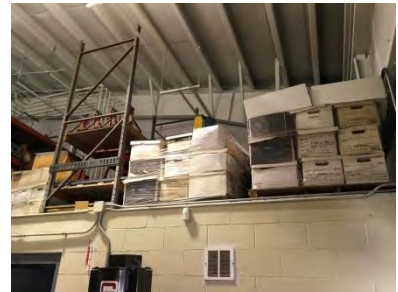
Security Systems are adequate.

- Existing security system is a Secure Alarm system with motion detectors, cameras and door contacts for intrusion detection.
