UNOCCUPIED BUILDINGS

2017 Facility Assessment

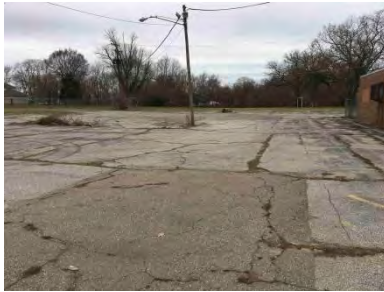
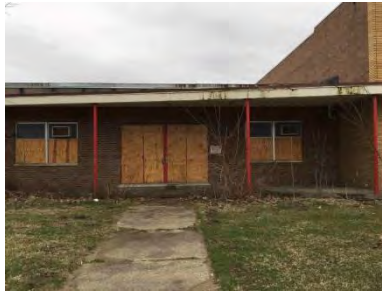
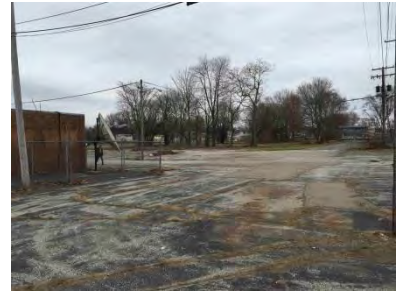
- Asphalt and exterior concrete in extremely poor condition

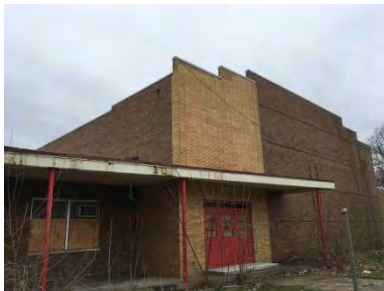
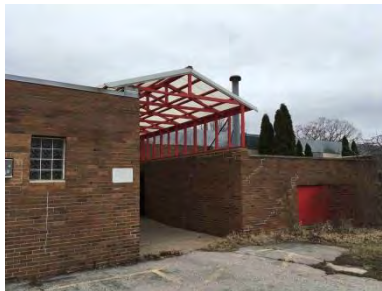
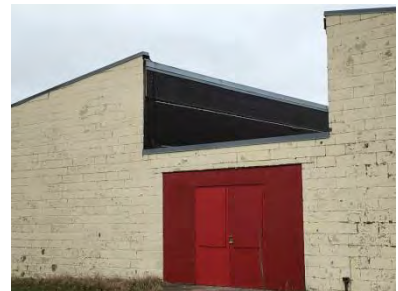
- Exterior walls are concrete masonry with brick veneer in poor condition
- Exterior doors are in poor condition
- Many exterior windows are broken with plywood installed in the openings

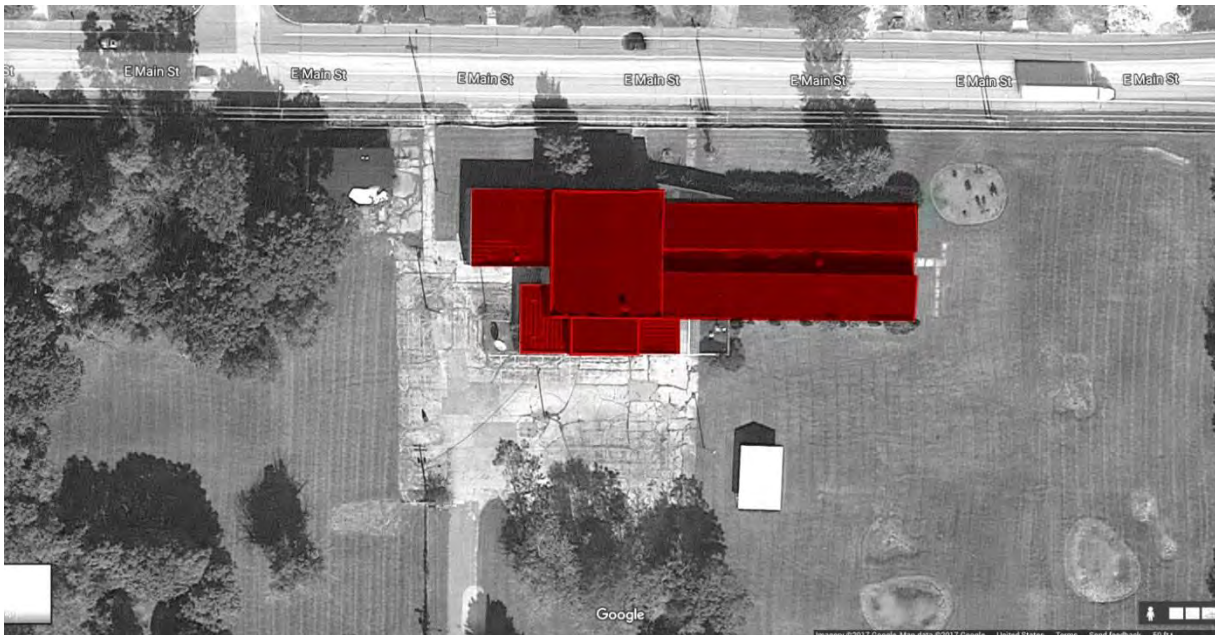
Roof Conditions & Anticipated Service Life Plan

- Approximately 23,000 SF
- Black EPDM in extremely poor condition
- Many roof leaks noted from below.

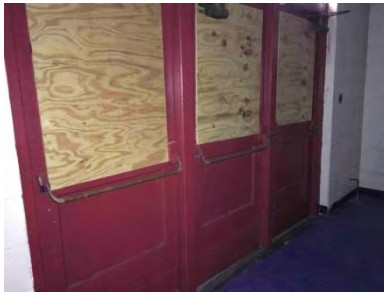
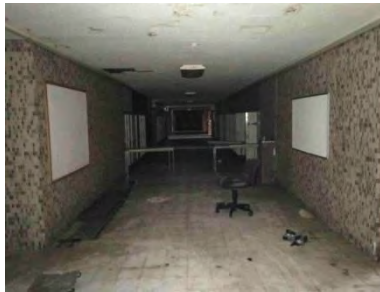
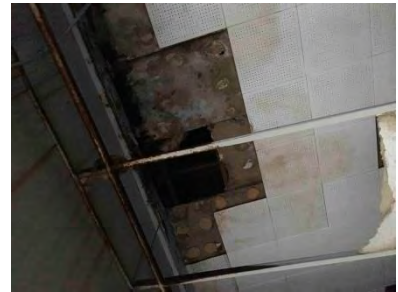
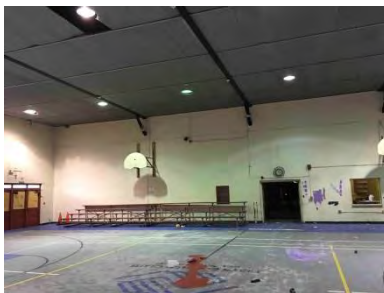
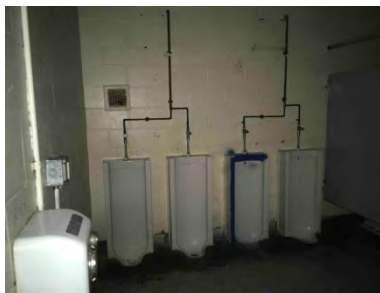
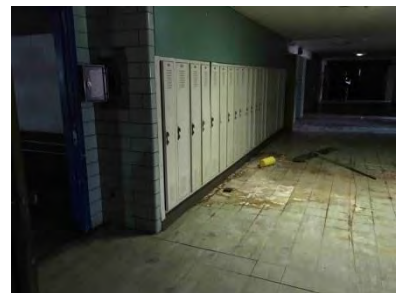
- All interior finishes are in extremely poor condition
- Mold was found growing in many areas throughout the building

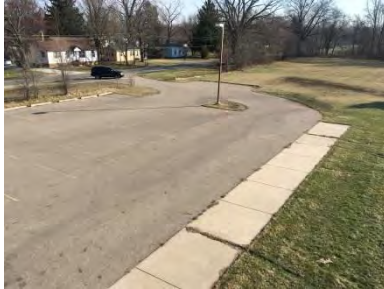
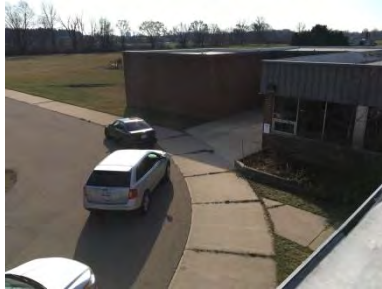
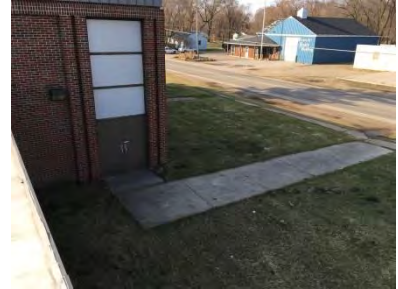
- Asphalt and exterior concrete in fair condition

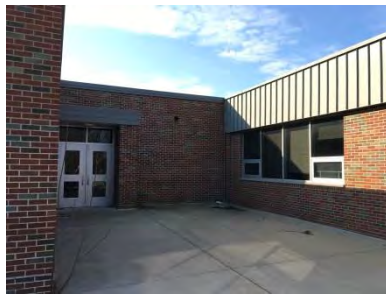
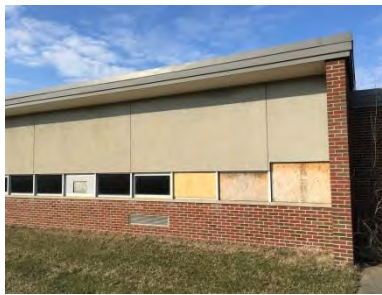
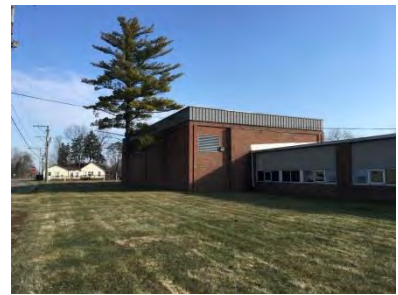
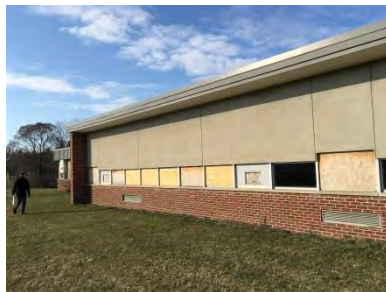
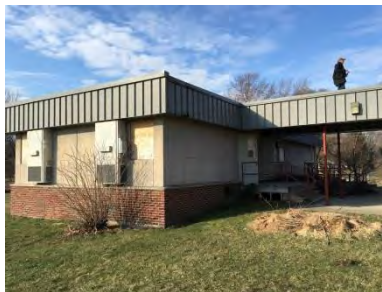
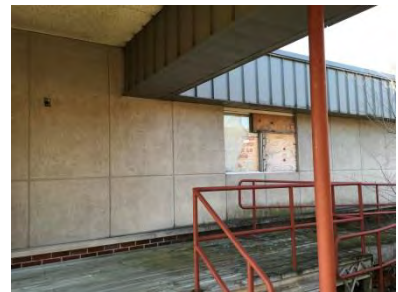
- The building exterior walls are masonry block with brick veneer in good condition
- Windows are aluminum double pane awning style with EIFS in-filled panels above. The EIFS is in poor condition and many glass panels have been broken out with plywood installed.
- Exterior doors are a combination of aluminum, hollow metal and FRP. They range in fair to poor condition.
- The Library is a standalone building that is wood framed with brick, EIFS and metal panel exterior. This portion of the building is in poor condition

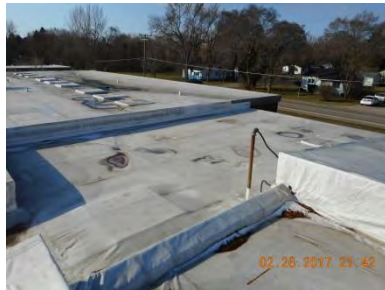
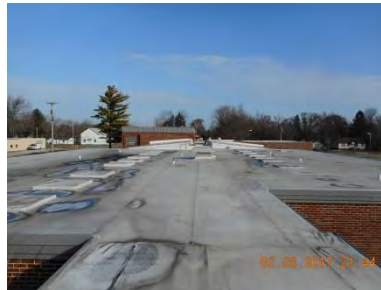
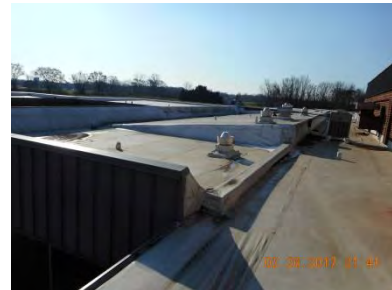
- Approximately 24,000 SF of total roof area
- Dura-Last white TPO system
- 6,000 SF portion was replaced in 2007 in good condition
- Remaining membrane is in fair condition with existing skylights being covered over with methods unknown.

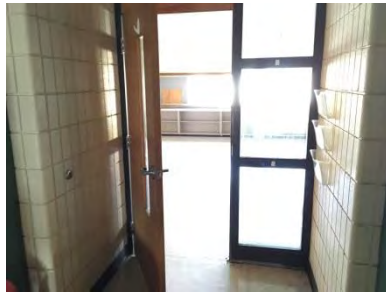
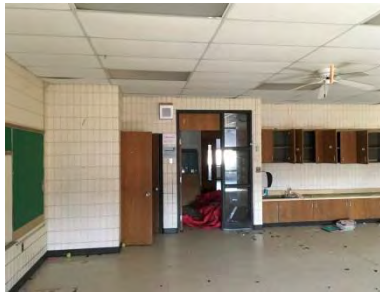
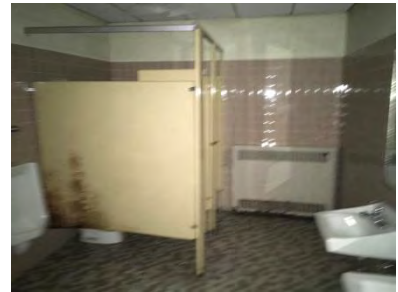
- Toilet rooms do not meet barrier free requirements
- Door hardware is a combination of lever and knob
- Classroom doors have the required latch side clearance

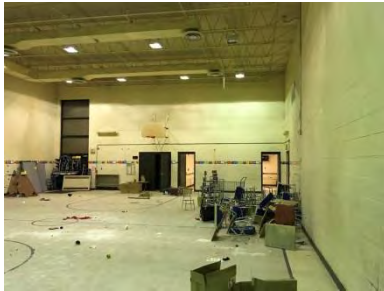
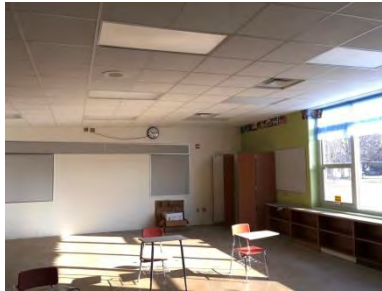
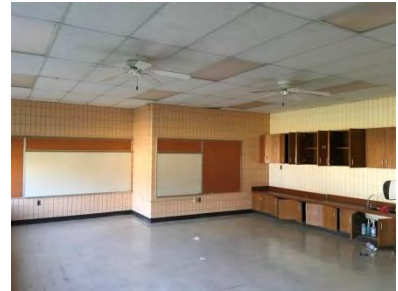
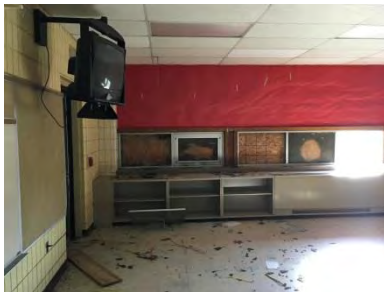
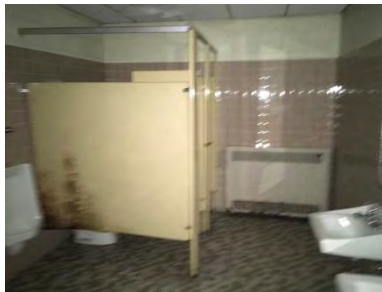
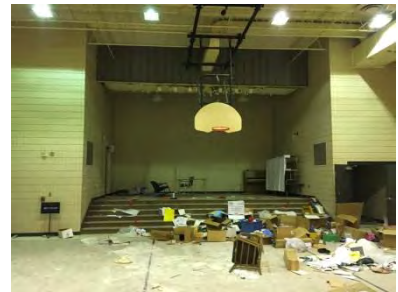
- Terrazzo throughout the corridors in good condition with some minor cracking
- Carpet, VCT and 9"x9" tile installed in classrooms and offices in poor condition
- Majority are 2'x4' suspended acoustic system in fair to poor condition
- Painted masonry block in classrooms with glazed block in the corridors in good condition
- Combination of wood and plastic laminate in poor condition with some areas of surface mold present
- Wood doors in wood frames are all in poor condition

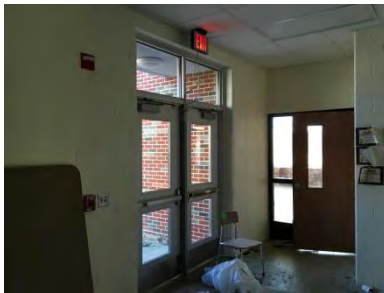
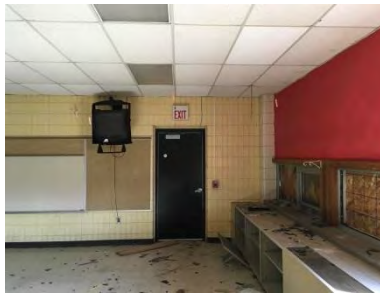
- Illuminated exit signage is installed throughout
- Exterior doors have panic hardware installed
- Fire alarm system is installed throughout

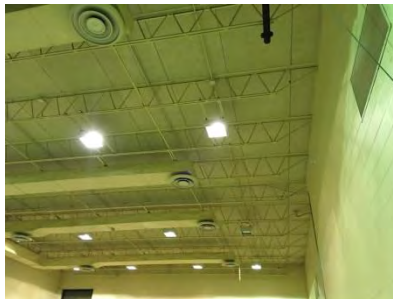
- Gym has a Heating and Vent unit with new smoke detectors. Unit is old, but externally appears in good condition.
- Misc. Fin Tube at perimeter walls
- Most classrooms have Trane horizontal unit ventilators (old) that have their front panels removed, and are beyond expected service life.
- Heating distribution piping routed thru tunnels, assumed to be original to building.
- Newer 2 classroom addition with Vertical Unit Ventilators in good condition.

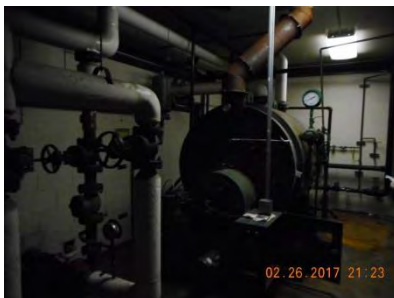
Central Plant Systems

- (1) Johnston Heating Hot Water Boiler, 2024 lbs./hr. capacity (not steam) installed 1987. Boiler is at the end of its expected usable life and assuming boiler is still operational should be considered for replacement in 1-5 years.
- Exposed piping, insulation, boiler and pumps appear to be in satisfactory condition.
- Boiler control panel open and may be damaged.

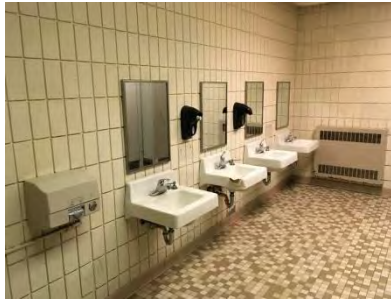
Plumbing Fixtures

- Bathroom fixtures in general appear to be average condition. Some flush valves are missing.

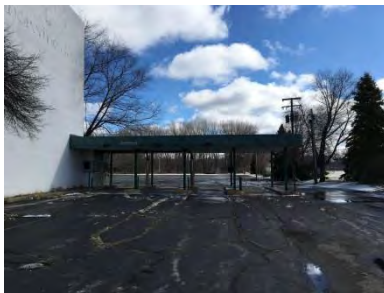
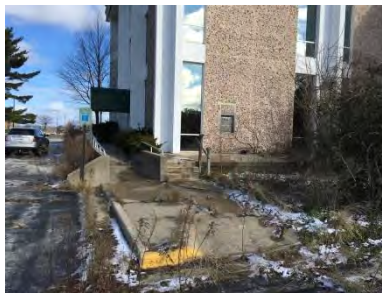
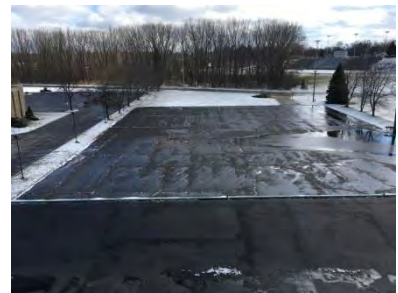
Pavements

- Asphalt and exterior concrete is in very poor condition

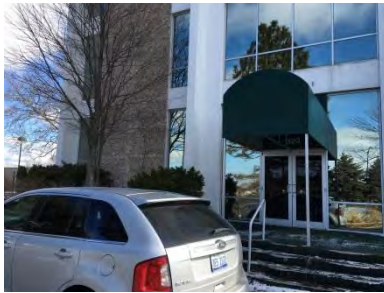
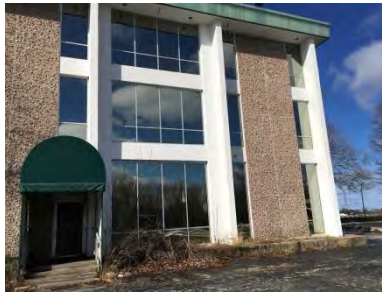
Exterior

- Does not meet barrier free requirements
- Not all entrances/exits are barrier free

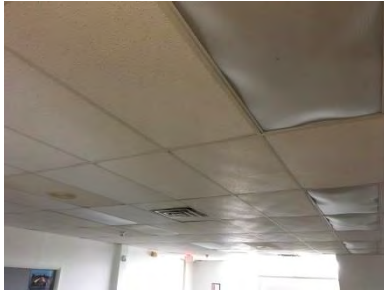
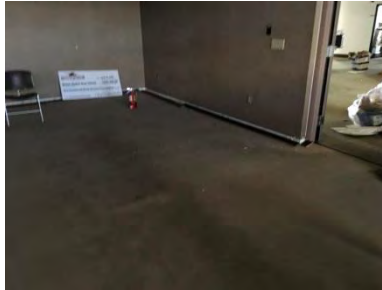
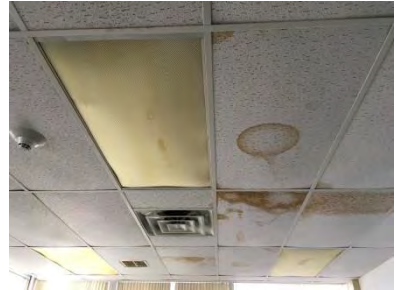
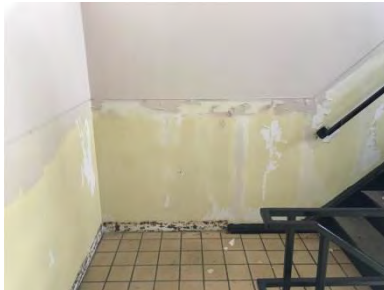
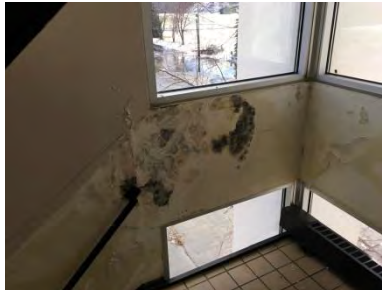
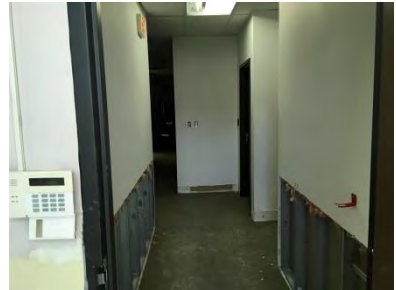
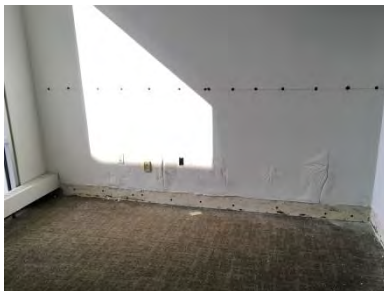
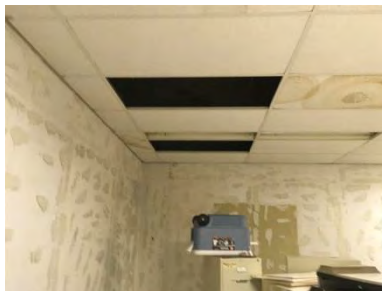
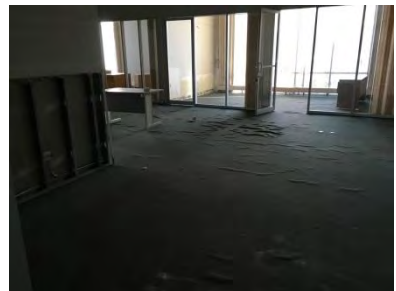
Interior Finishes Assessment

- Interior finishes are in very poor condition with extensive water damage throughout

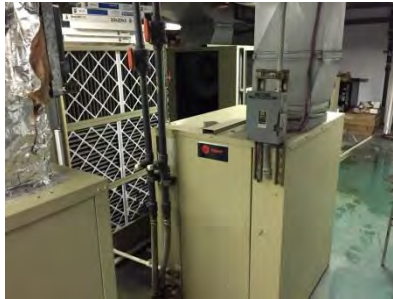
Building Systems

- Perimeter fin tube in average condition.
- (1) Trane RTU appears old and due for replacement.
- (1) Trane RTU mounted on grade, installed in 2002 and near end of service life.
- Several Trane furnace units appear to be in average condition, mechanical room is used as return air plenum for units

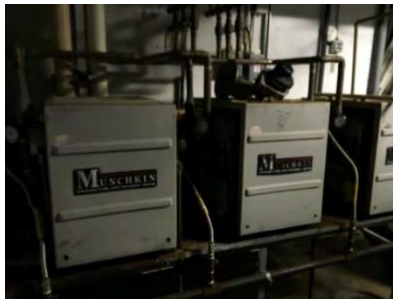
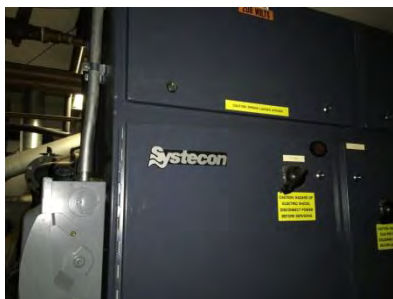
Central Plant Systems

- (1) Lochinvar heating hot water boiler, 750 MBH capacity, installed in 1991. Boiler is near end of service life.
- Systecon packaged chilled water skid with heat exchanger and pumps. Appears to be in average condition, piping is uninsulated.
- (1) Roof mounted BAC cooling tower appears old and near end of service life.

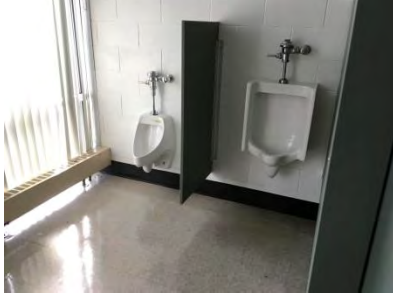
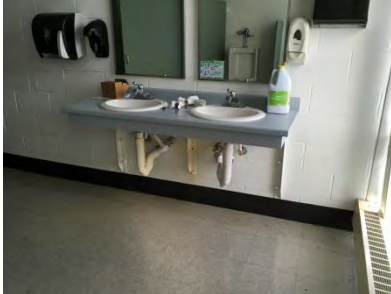
Plumbing Fixtures

- Most fixtures appear to be in average condition and in need of some repair.

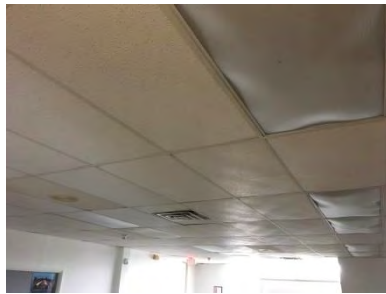
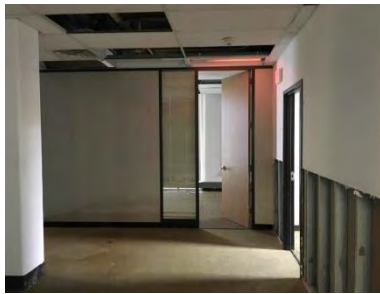
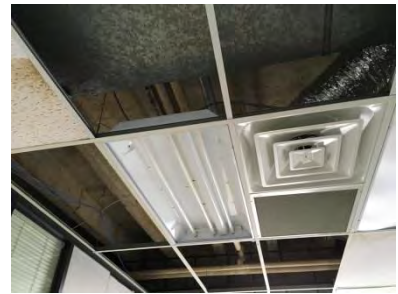
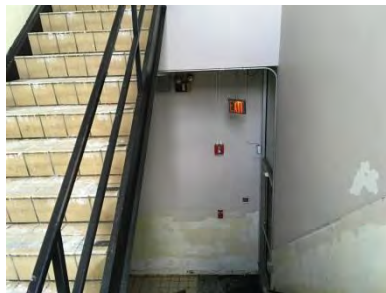
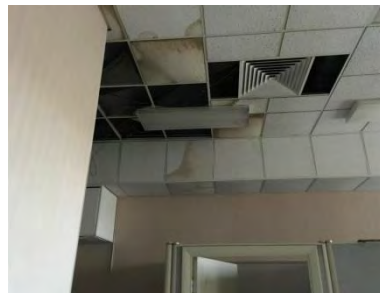
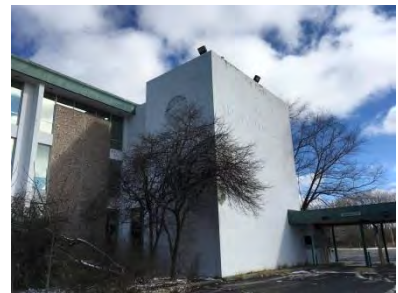
Building Lighting is in poor condition.

- The existing lighting fixtures are damaged fluorescent fixtures which need to be replaced with new lighting. The update to LED would result in significant monetary savings and energy conservation.
- Occupancy sensors in spaces would be recommended for energy and monetary savings.
- The exterior building lighting is metal halide. Changing these fixtures to LED would bring energy and large monetary savings.

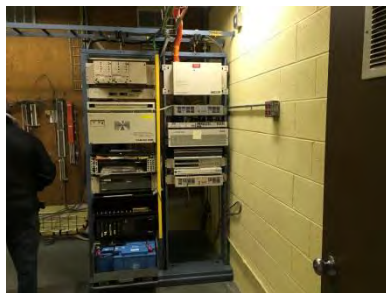
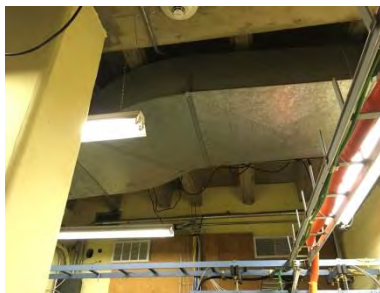
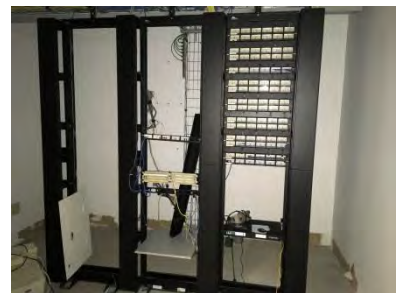
Building technology is in poor condition. There are existing wiring closets and equipment and raceways. Building would require all new technology wiring and devices to make it an educational facility.

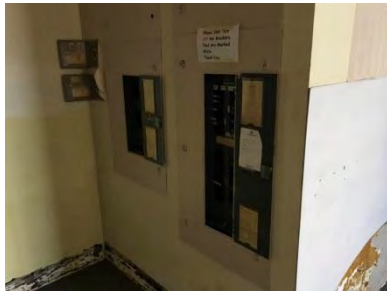
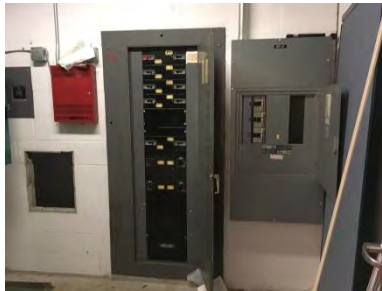
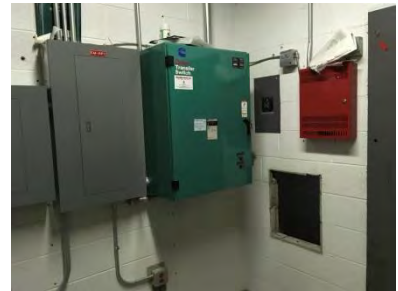
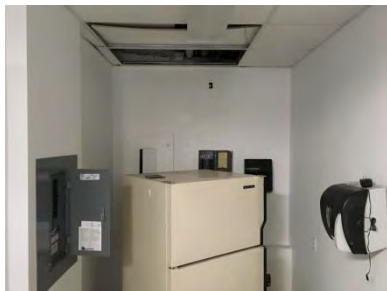
Electrical Building System is fair

- The existing primary main distribution panel is older and at the end of its life and hard to find replacement parts.
- Existing electrical secondary Cutler Hammer and Square D panels are newer and in good condition.
- There is a generator set up and transfer switch on site.
- Electrical duplex receptacles in building need to be brought up to code. Damaged receptacles are throughout the building and need to be replaced. Junction boxes need to be covered.

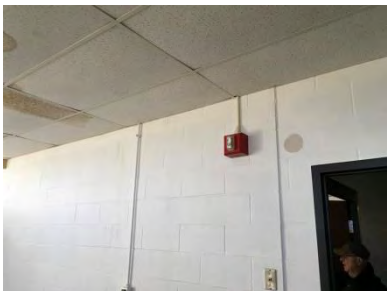
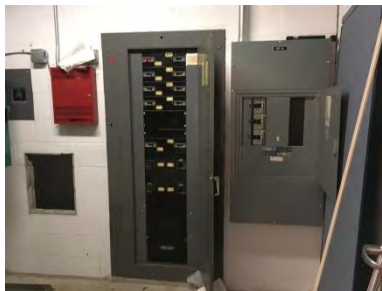
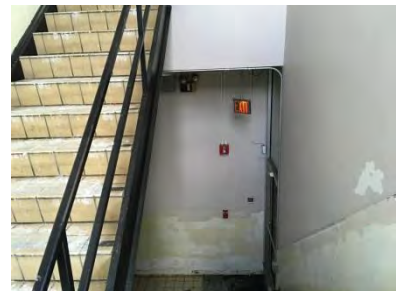
Security System is present but needs to be replaced with installation of new doors, door contacts, motion detectors and readers.

Fire alarm system needs to be replaced.

- Existing fire alarm is old and at end of life.

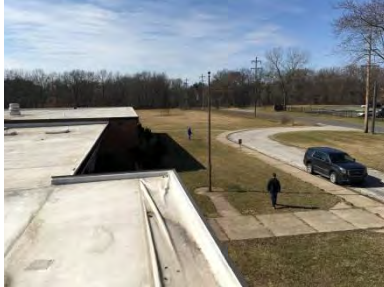
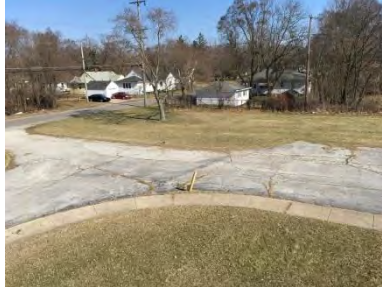
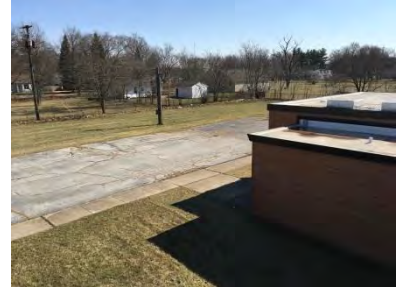
Pavements

- Asphalt and exterior concrete is in very poor condition
- The site is long and narrow with an area for parking expansion if needed.

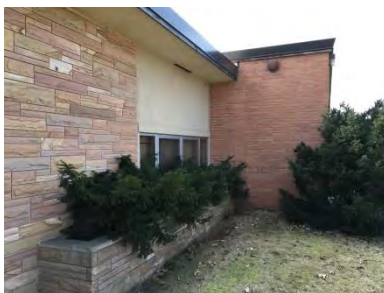
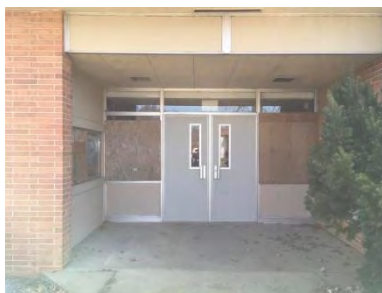
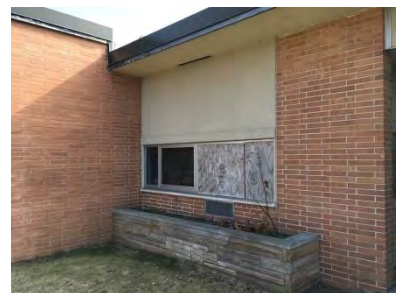
Building Envelope Assessment

- Exterior walls are masonry with brick veneer in good condition
- Classroom exterior walls are steel stud framed with EIFS below and above the aluminum awning style windows. The back of the building has been vandalized with extensive damage to the EIFS and window systems.
- The exterior unit vent louvers have been removed allowing water to enter into the wall cavity.
- Soffit and fascia are painted plywood that are in fair condition

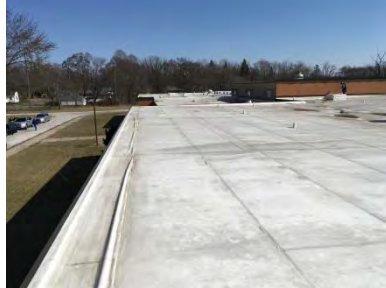
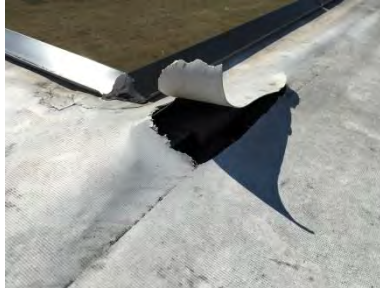
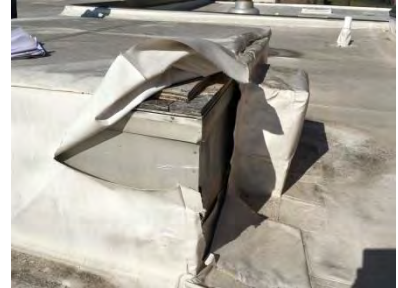
Roof System Assessment

- Approximately 20,000 SF of total roof area
- White TPO in poor condition with a few areas in need of immediate repair

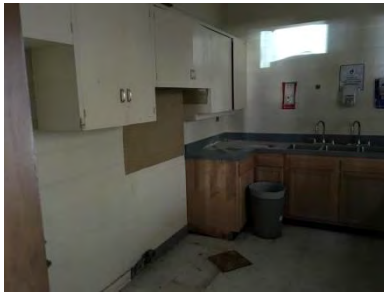
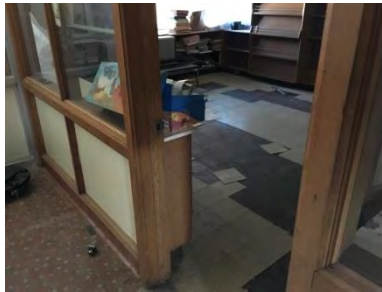
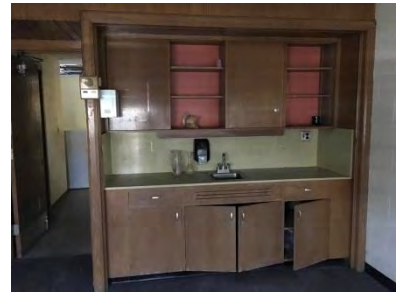
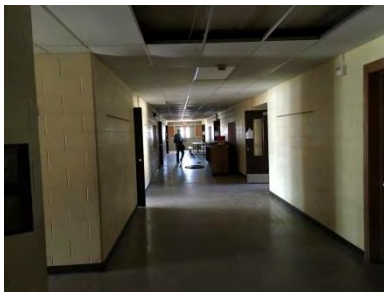
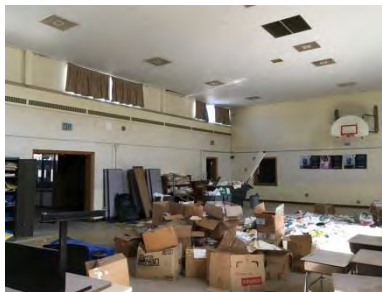
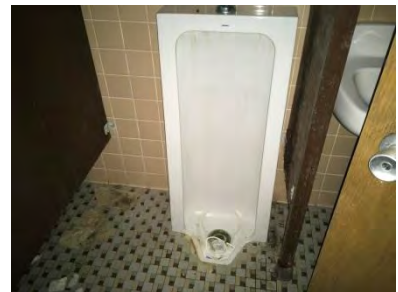
Interior Finishes Assessment

- Flooring
 - Terrazzo tile throughout the corridors in good condition
 - Ceramic tile in toilet rooms in fair condition
 - VCT and carpet in classrooms and offices in poor condition
- Ceilings
 - 2'x4' suspended acoustic system in poor to fair condition
 - Gym has 12"x12" adhered tile in fair condition
- Walls
 - Interior walls are mostly painted masonry block in good condition
- Casework
 - Wood casework and paneling in fair condition
 - Classrooms have chalk boards in fair condition
- Doors
 - Wood doors in wood frames in fair condition

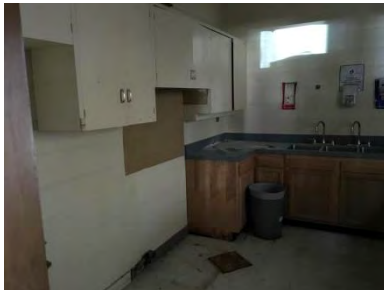
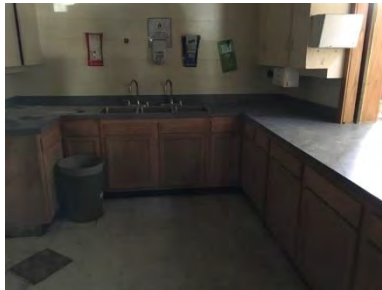
- Clear paths of egress
- Illuminated exit signs appear to be adequate
- Exiting corridor doors have panic hardware installed
- Many interior doors missing hardware
- Fire alarm system in place

- Very small kitchen with residential casework

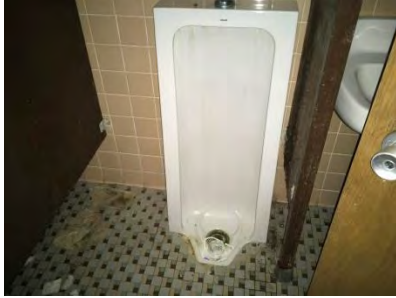
Plumbing Piping and Systems

- Plumbing piping is routed thru tunnels and assumed to be original to building.

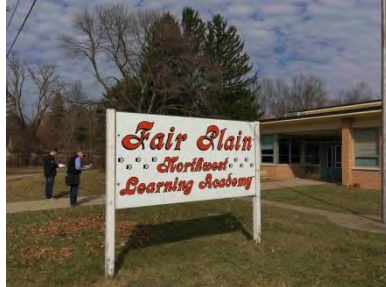
Entrance Signage

- Unlit painted wooden sign

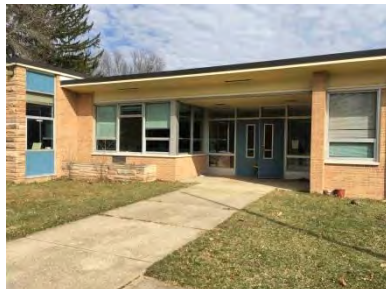
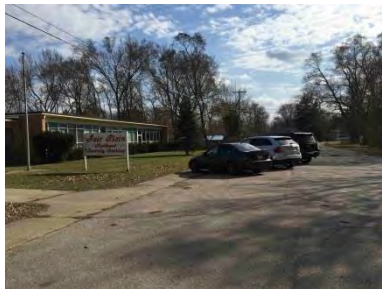
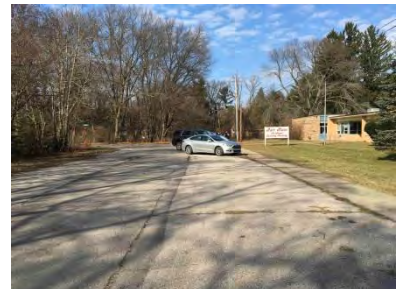
Pavements

- Asphalt and exterior concrete is in poor condition

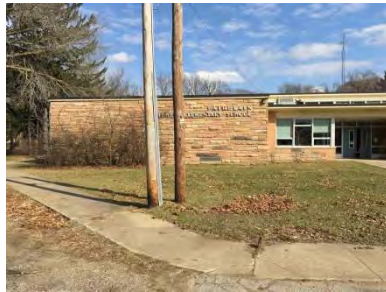
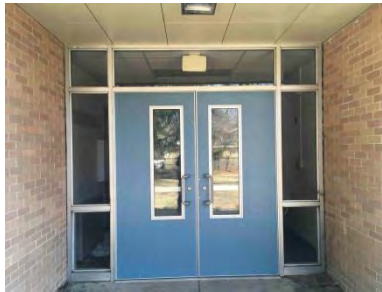
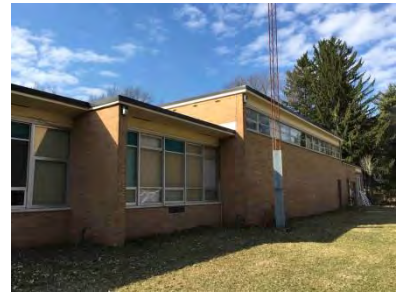
Building Envelope Assessment

- Masonry block with brick veneer in good condition
- Aluminum framed double pane windows with composite panels in good condition
- FRP doors installed in aluminum frames in good condition
- Hollow metal doors and frames in fair condition

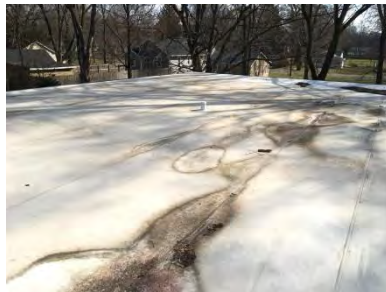
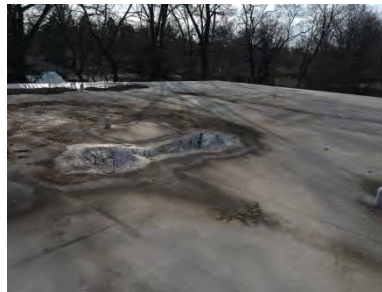
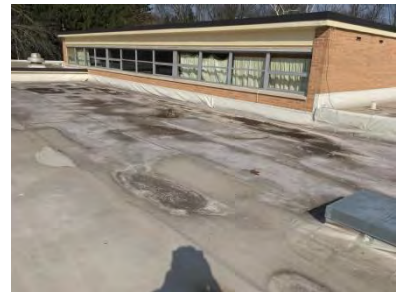
Roof System Assessment

- Approximately 15,000 SF of total roof area
- Duro-Last white TPO system
- Approximately 2,200 SF of roof at the office area is in poor condition
- Remaining portions of the roof are in fair condition
- No roof overflow drains or edge scuppers were observed

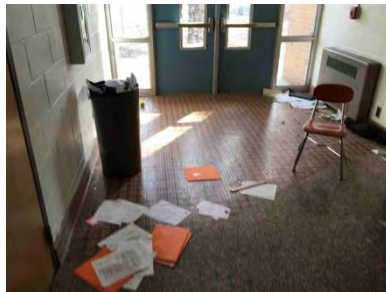
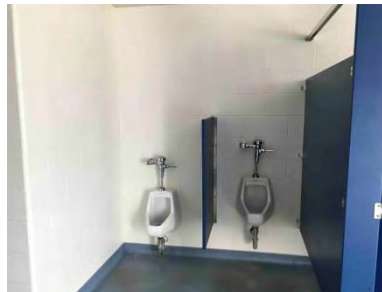
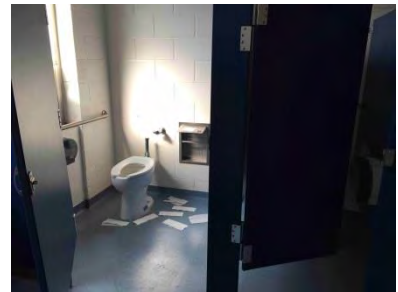
Interior

- Toilet rooms are barrier free accessible
- Clear egress paths
- Panic hardware at all corridor exiting doors

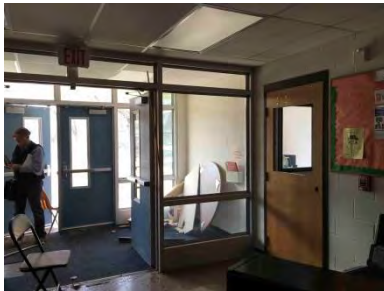
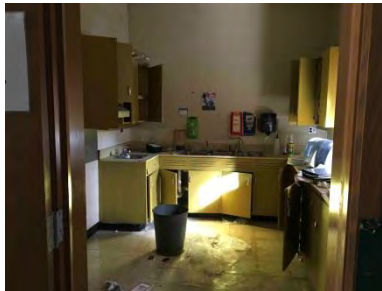
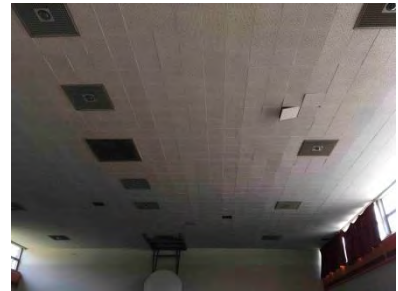
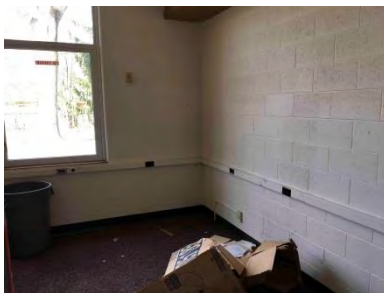
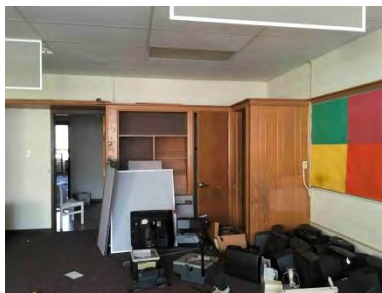
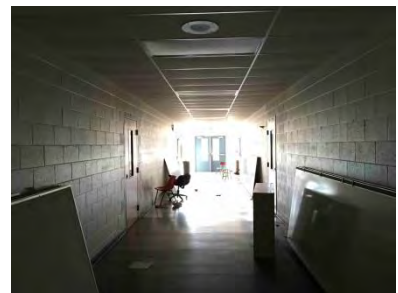
Interior Finishes Assessment

- Flooring
 - Terrazzo in corridors is in good condition
 - VCT and carpet in classrooms and office areas that are in poor condition
- Ceilings
 - 2'x4' suspended acoustic ceiling systems are in fair condition
 - 12"x12" adhered acoustic tile installed in the gym in poor condition
- Painted masonry block walls in good condition
- Original wood casework and paneling is outdated and in fair condition
- Wood doors installed in wood frames in fair condition

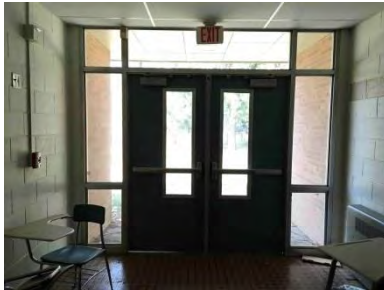
Life Safety Assessment

- Fire alarm system installed
- Exit signs are installed at corridor exits
- Panic hardware is installed at corridor exiting doors

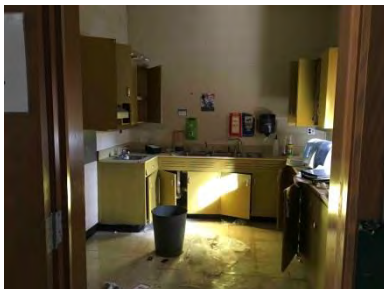
Food Service Assessment

- Extremely small kitchen with just a few outdated cabinets

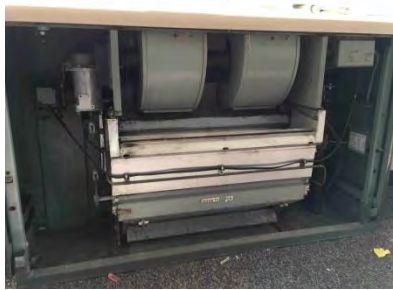
Building Systems

- Original horizontal unit ventilators in poor condition and well beyond expected service life. Units need to be replaced.
- Trane RTU installed in 2006 for office area, 2.5 Tons. Unit is near end of expected service life.
- Fin tube high along gym wall windows
- (4) Rooftop exhaust fans from 2006 and older.

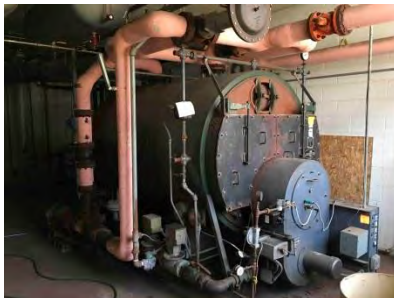
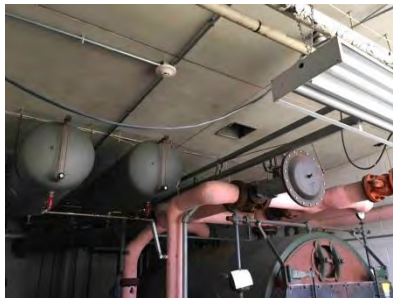
Central Plant Systems

- (1) Johnston heating hot water boiler, 4000 MBH, installed in 1971. Boiler is in average condition but beyond expected service life.
- Heating hot water piping is routed thru tunnels to terminal devices. Piping to tunnels is welded steel, not insulated. It is assumed piping in tunnels is original to the building.

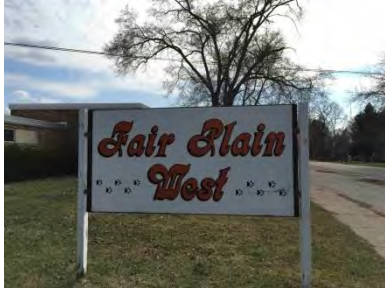
Signage

- Painted wooden sign was placed along the street

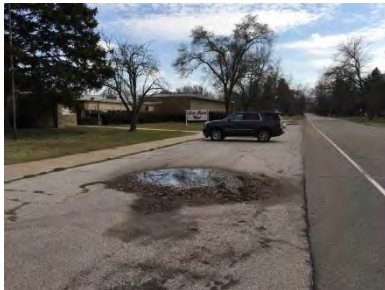
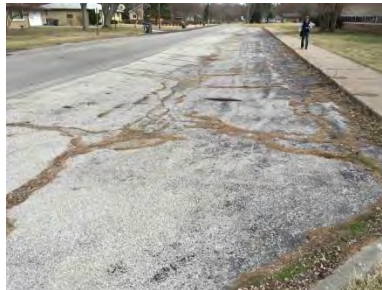
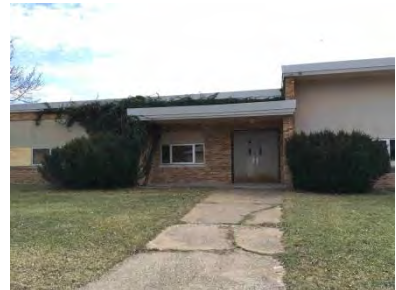
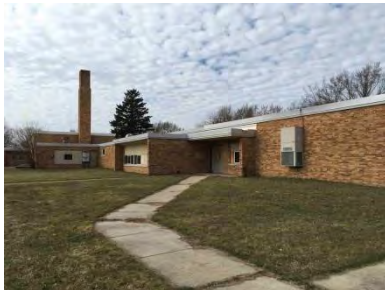
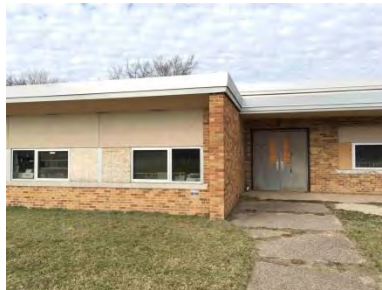
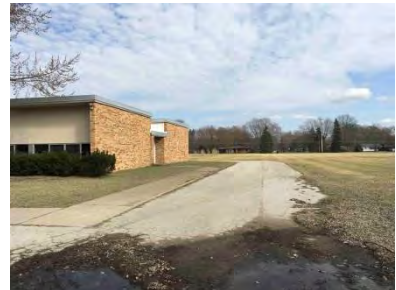
Pavements

- Asphalt and exterior concrete is in very poor condition

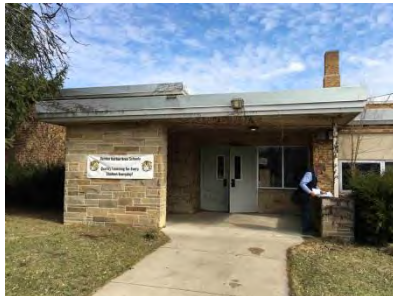
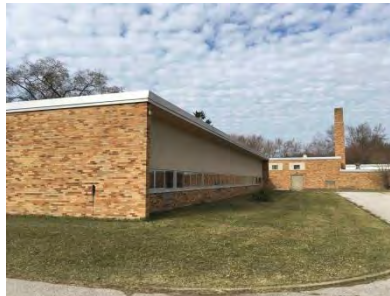
Building Envelope Assessment

- Masonry block exterior walls with brick veneer and sand stone at main entry. Sandstone is in good condition
- The bushes and vines along the front of the building are quite overgrown
- Brick exterior with EIFS infill panels above windows.
- EIFS panels are in need of some repair and recoated due to heavy staining
- Sealants at control joints and the perimeter of the windows need to be replaced
- The top portion of the brick chimney stack is deteriorated and repairs are needed
- Many windows are covered with plywood due to broken glass
- Doors are aluminum in good condition

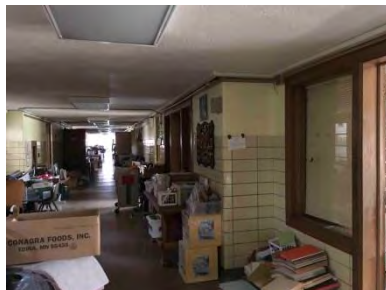
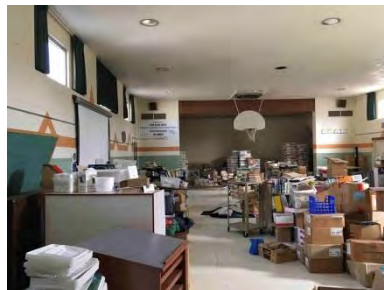
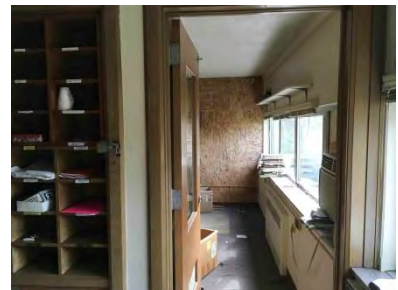
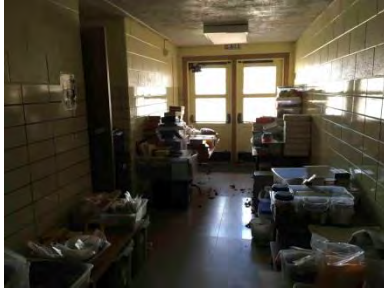
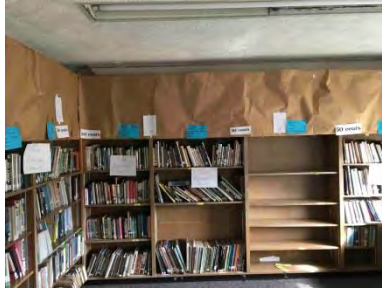
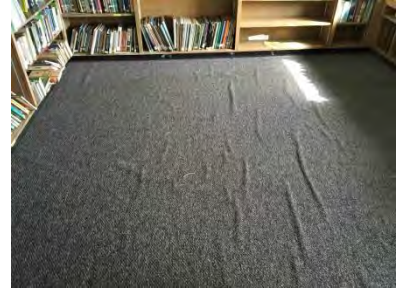
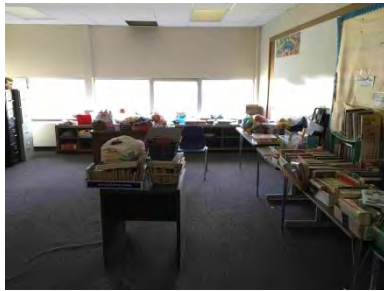
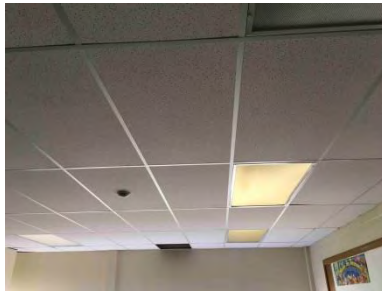
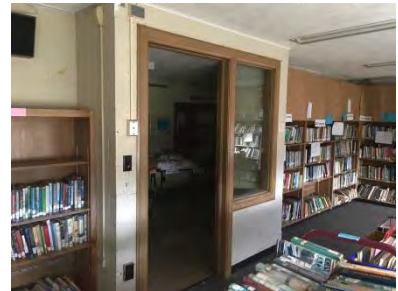
Interior Finishes Assessment

- Terrazzo floors in corridors and toilet rooms in good condition
- Carpet is in poor condition
- VCT in gym and some classrooms in good condition
- Combination of 2'x4' suspended acoustic ceiling systems, and plaster. Suspended system is in fair condition. Plastered ceilings have some damage and is water stained in areas.
- Glazed block walls in corridors, gym, kitchen and some of the classrooms in original building section is in fair condition
- Wood casework and wood paneling in the original portion of the building are in fair condition
- Wood doors in wood frames in fair condition

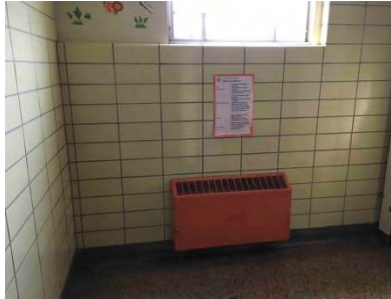
Building Systems

- Old horizontal unit ventilators that appear original to building are in poor condition and should be replaced.
- Gymnasium has old vertical heat/vent unit that is due to be replaced.

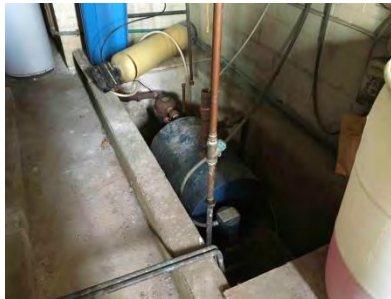
Central Plant Systems

- (1) Johnston steam boiler, 2,024 lbs/hr capacity, installed in 1986. Boiler is near end of service life.
- Steam distribution piping routed thru tunnels, assumed to be original to building.

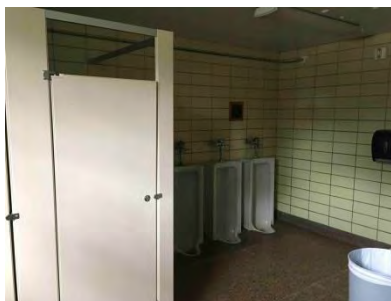
Plumbing Fixtures

- Most fixtures appear to be in poor condition and in need of some repair.

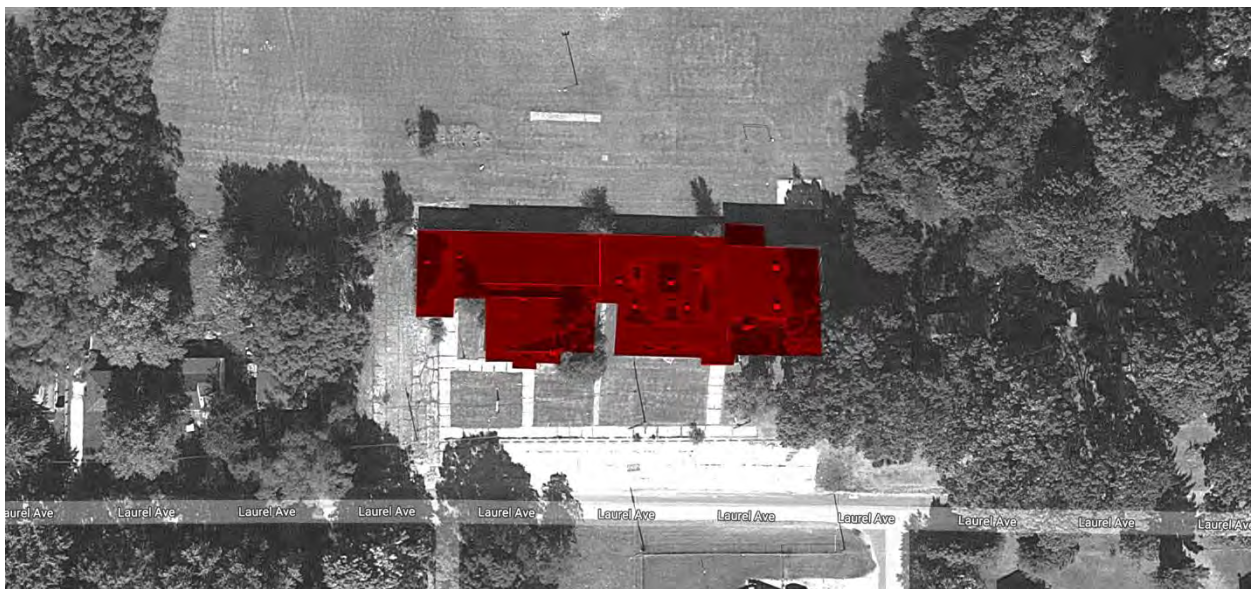
Roof Conditions & Anticipated Service Life Plan

Approximately 17,300 SF of black EPDM in poor condition

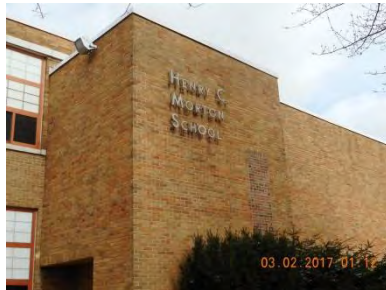
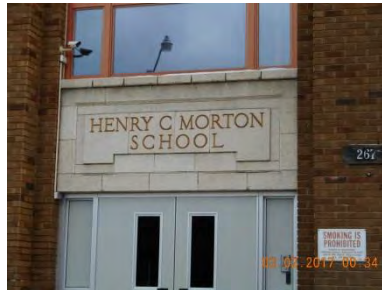
Entrance Signage

- Signage is located on the building

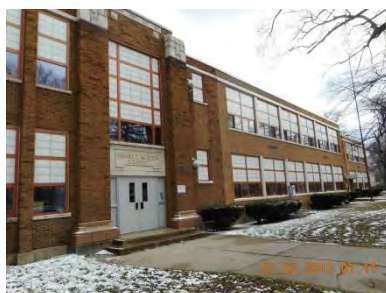
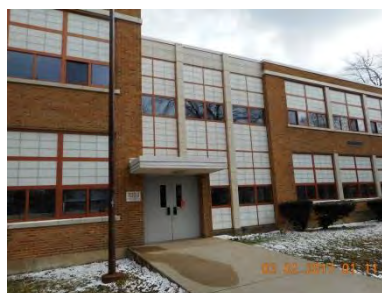
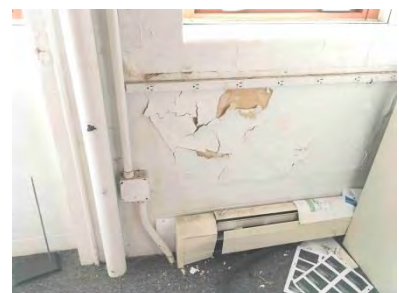
Pavements

- Asphalt and exterior concrete is in poor condition

Building Envelope Assessment

- Exterior masonry block walls with brick veneer in good condition
- Kalwall window system with one row of vision glass at each floor level in good condition
- FRP main entry doors in aluminum frames in good condition
- Several areas on the inside of the exterior walls has visible water damage

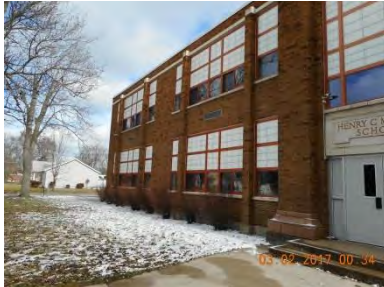
Exterior

- Main entry has stair access only
- Other entries have accessible ramps in place

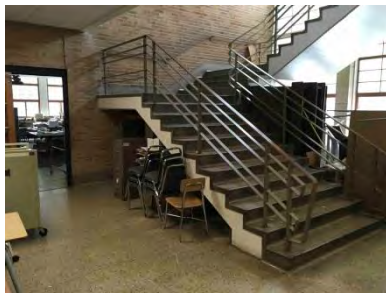
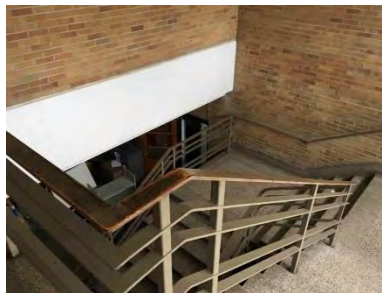
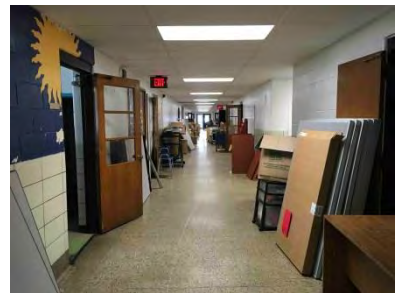
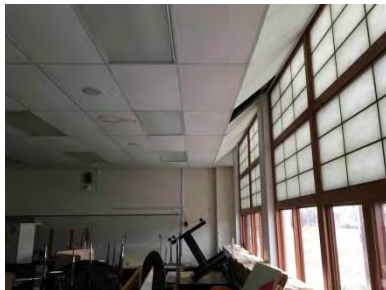
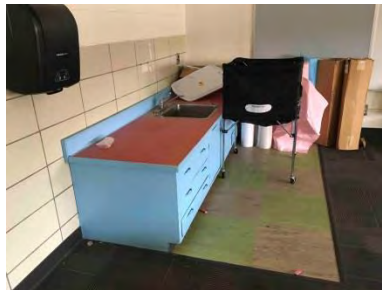
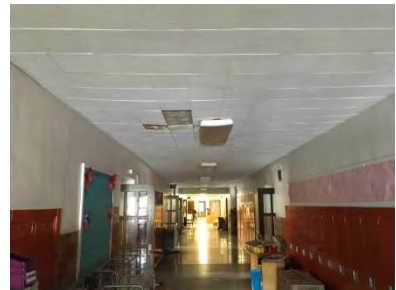
Interior Finishes Assessment

- Flooring
 - Terrazzo flooring is in good condition within the corridors, toilet rooms and a majority of the classrooms
 - The north addition has terrazzo in the corridors and VCT and carpet in the classrooms
- Ceilings
 - 2'x4' suspended acoustic ceiling systems in poor condition that is installed below the original plaster ceilings
 - 12"x12" adhered tile in poor condition
- Walls
 - Glazed block throughout the corridors and classrooms
 - Exposed brick at the main entry and in the stairwells
- Casework
 - Wood casework and shelving in fair condition
- Doors
 - Interior doors are mainly wood installed in wood frames in fair to good condition

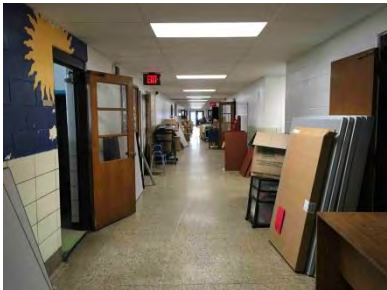
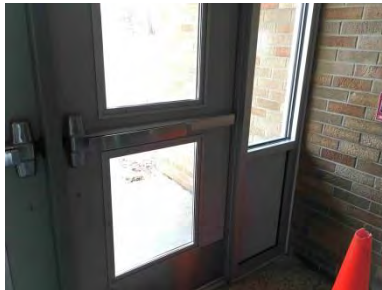
Life Safety Assessment

- Illuminated exit signage was noted
- Panic hardware installed at corridor exiting doors
- Fire alarm doesn't appear to be a full system

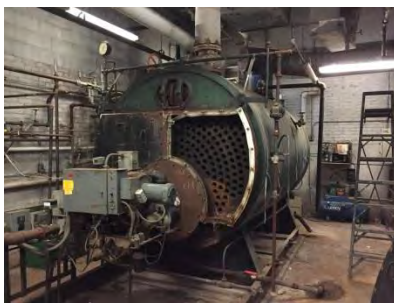
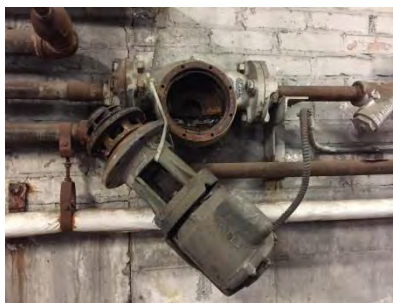
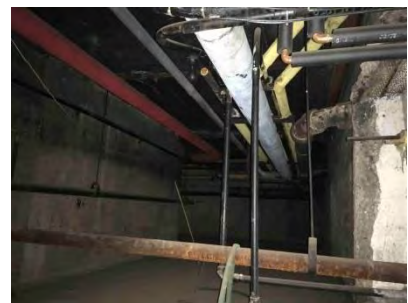
Central Plant Systems

- Old basement boiler room appears to be abandoned.
- Current boiler room contains (1) Johnston steam boiler, that has front casing removed. Boiler tubes are visible and exposed. Boiler appears to serve a steam heating system with piping routed thru tunnels.
- Boiler has certificate of inspection from October 2016.
- Steam distribution piping routed thru tunnels, assumed to be original to building.

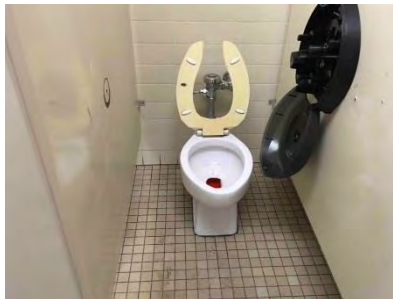
Plumbing Fixtures

- Bathroom fixtures old, in poor condition and need to be replaced.
- Some fixtures removed and missing.
