UNOCCUPIED BUILDINGS

2017 Facility Assessment

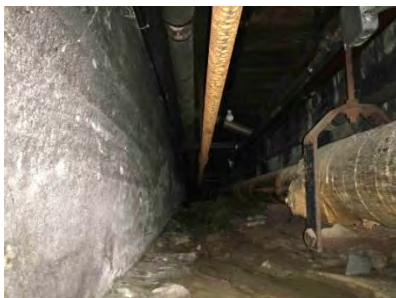
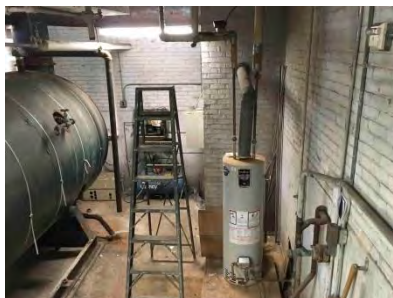
Plumbing Piping and Systems

- Plumbing piping is routed thru tunnels and assumed to be original to building.

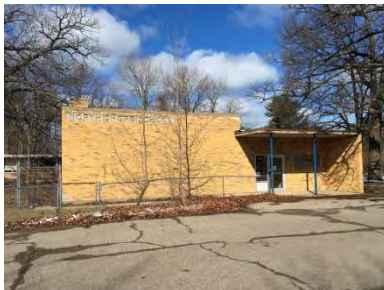
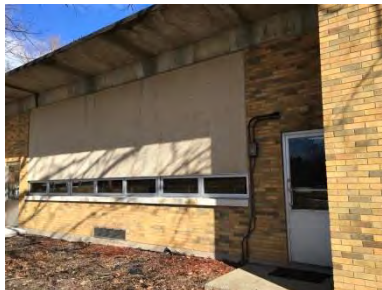
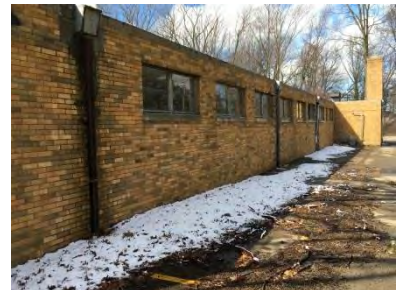
Exterior

- Masonry block with brick veneer in very poor condition
- Aluminum single pane awning windows with EIFS panels above in poor condition
- Aluminum exterior doors and hollow metal doors all in poor condition

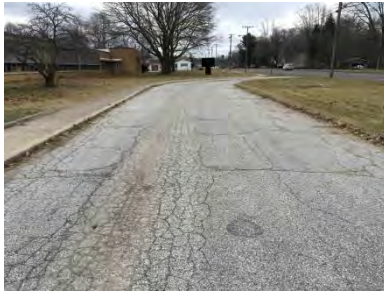
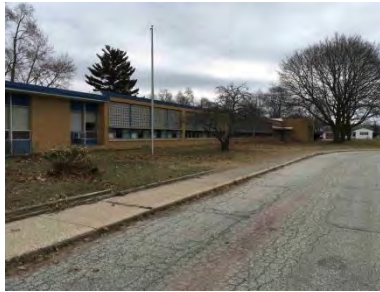
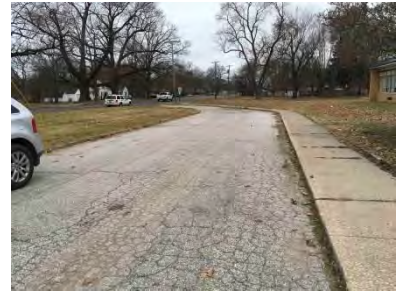
Pavements

- Asphalt and exterior concrete is in poor condition

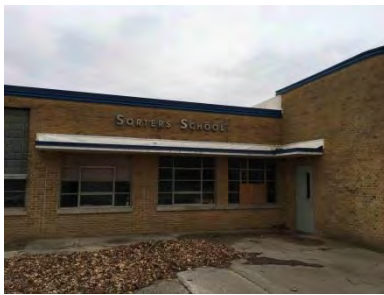
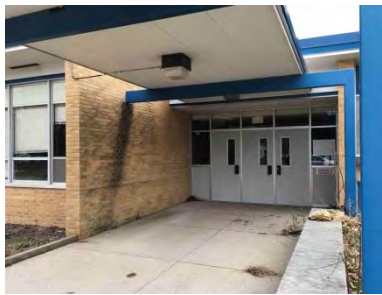
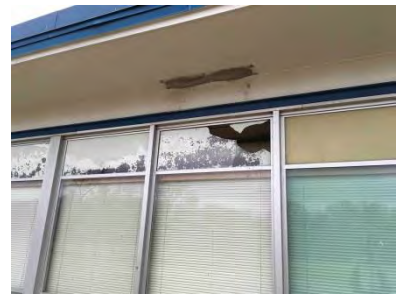
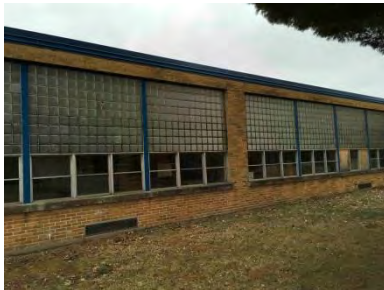
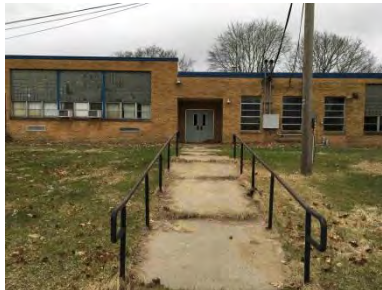
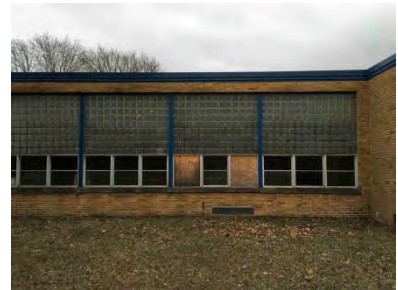
Building Envelope Assessment

- Masonry block with brick veneer is in fair to good condition
- Aluminum framed double pane awning windows in fair condition with several broken sections
- Glass block infill above operable windows at the back of the building that have many broken due to vandalism
- FRP main entry doors in good condition while the remaining exterior doors are hollow metal in poor condition

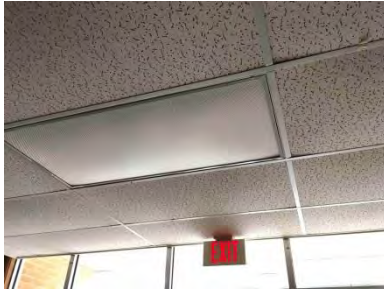
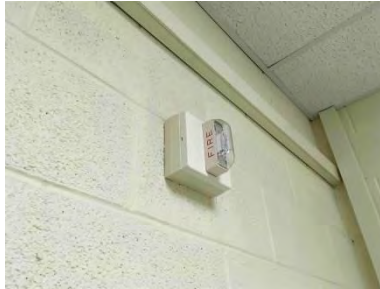
Life Safety Assessment

- Building has a fire alarm system throughout
- Illuminated exit signs are installed throughout

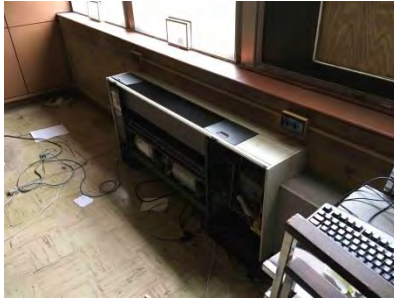
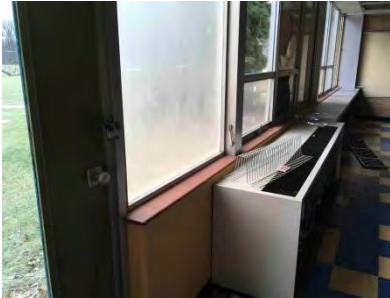
Building Systems

- Old horizontal unit ventilators, not original. Most front panels removed, some missing. Units need to be replaced.
- Large cabinet unit heaters serve the Gym.

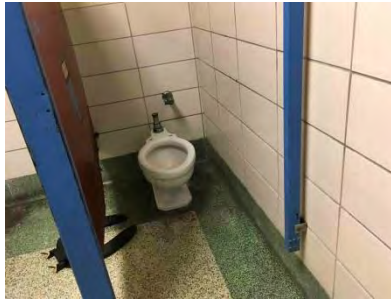
Plumbing Fixtures

- Bathroom fixtures are old and need to be replaced. Some have been removed and are missing. Some flush valves removed/missing.

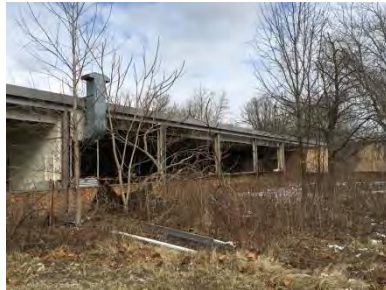
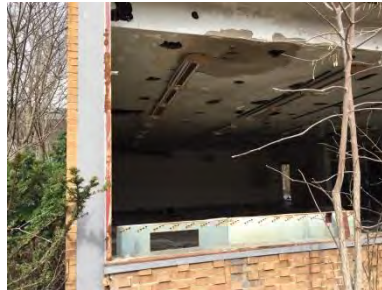
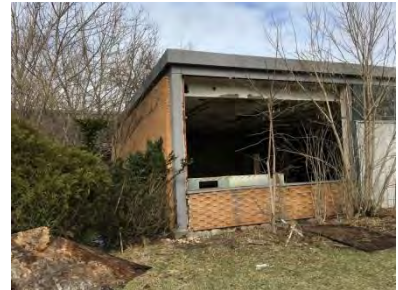
Building Envelope Assessment

- Only the building shell remains and is in extremely poor condition
- Building is approximately 20,300 SF
- No further assessment was conducted

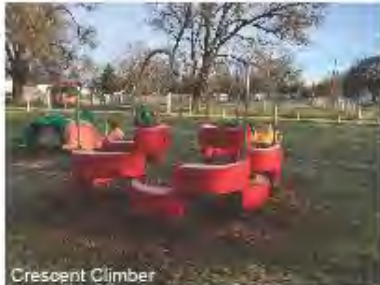
Crescent Climber

ASTM F 1487, 9.2.1 Play Structure Use Zone
ASTM F 1487, 13.2.1 Maintenance - Play Surfacing

Recommendations: Provide and maintain safety surfacing to proper depth. Bee and Snail Spring Toys are less than 6'-0" away from climber. Equipment should be relocated to achieve proper use zones.

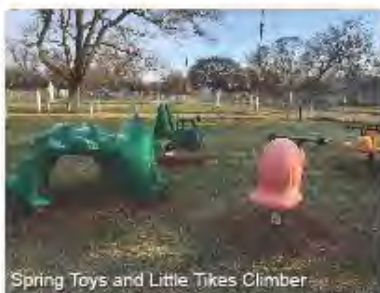
Spring Toys and Little Tikes Climber

ASTM F 1487, 9.2.1 Play Structure Use Zone
ASTM F 1487, 13.2.1 Maintenance - Play Surfacing

Recommendations: Provide and maintain safety surfacing to proper depth. Spring Toys and Climber don't have proper use zones. Equipment should be relocated to achieve proper use zones.

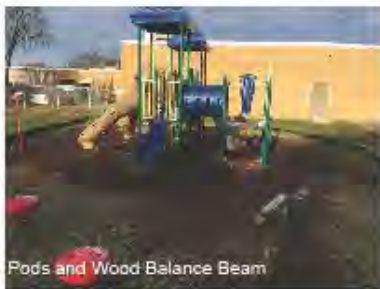
Pods and Wood Balance Beam

ASTM F 1487, 8.1.1 Balance Beams
ASTM F 1487, 9.2.1 Play Structure Use Zone
ASTM F 1487, 13.2.1 Maintenance - Play Surfacing

Recommendations: Provide and maintain safety surfacing to proper depth. Pods are less than 6'-0" away from play border. Border should be relocated to achieve proper use zone. Balance beams shall be no higher than 12" above protective surface for 2-5 years olds and no higher than 16" for 5-12 year olds. High end of existing balance beam is too high at 21".

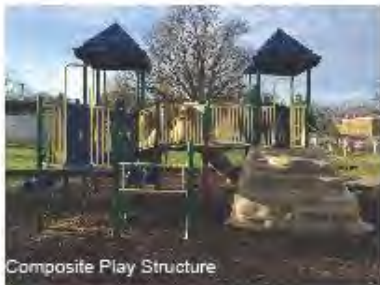
Composite Play Structure

ASTM F 1487, 3.1.48 Trip Hazard
ASTM F 1487, 6.1 Head and Neck Entrapment
ASTM F 1487, 6.3 Protrusions
ASTM F 1487, 7.4.4.1 Inadequate Barriers
ASTM F 1487, 10.1.4 Accessibility (tripping, paved path within use zone)
ASTM F 1487, 13.1 Maintenance (broken equipment)
ASTM F 1487, 13.2.1 Maintenance - Play surfacing

General Findings: Insufficient safety surfacing. Head and Neck entrapment. Broken section of equipment. Missing barrier panel. Protruding border spikes. See additional information to follow. Existing paved path is within the transfer point use zone.

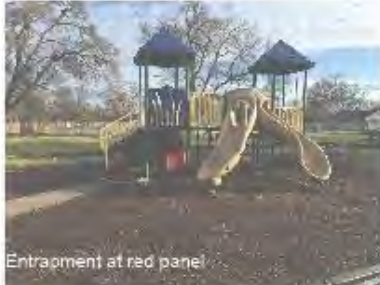
Entrapment at red panel

ASTM F 1487, 6.1 Head and Neck Entrapment

Recommendations: Head and Neck entrapment occurs between bar of red panel on storefront and deck. Adjust panel height location to 9"± from deck.

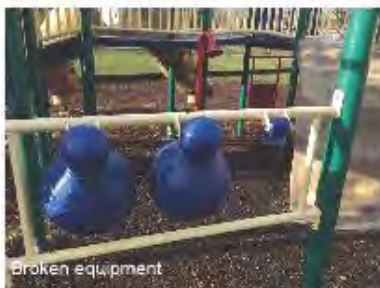
Broken equipment

ASTM F 1487, 13.1 Maintenance (broken equipment)

Recommendations: Remove and replace broken section of equipment.

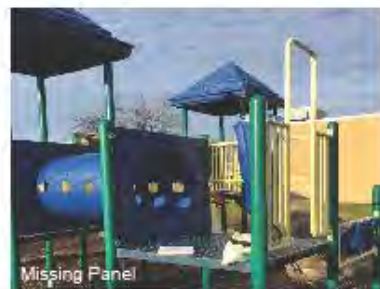
Missing Panel

ASTM F 1487, 7.4.4.1 Inadequate Barriers

Recommendations: Missing panel. Temporarily infill to prevent falls until new panel can be purchased and installed.

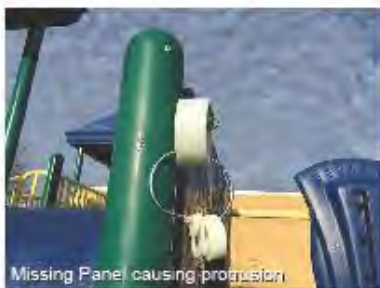
Missing Panel causing protrusion

ASTM F 1487, 6.3 Protrusions

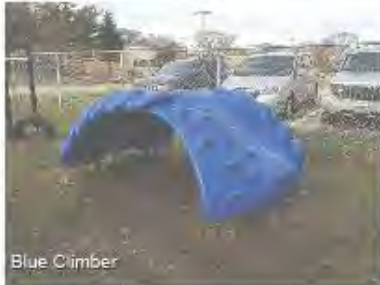
Blue Climber

ASTM F 1487, 9.2.1 Play Structure Use Zone
ASTM F 1487, 13.2.1 Maintenance - Play surfacing

Recommendations: Provide and maintain safety surfacing to proper depth. Climber is located less than 6' from existing fencing.

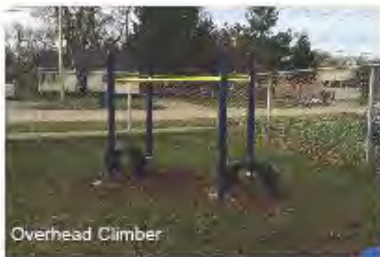
Overhead Climber

ASTM F 1487, 13.2.1 Maintenance - Play surfacing

Recommendations: Provide and maintain safety surfacing to proper depth. Exposed footings must be covered once new safety surface is installed.

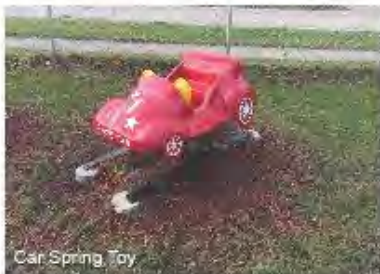
Car Spring Toy

ASTM F 1487, 9.2.1 Play Structure Use Zone
ASTM F 1487, 13.2.1 Maintenance - Play surfacing

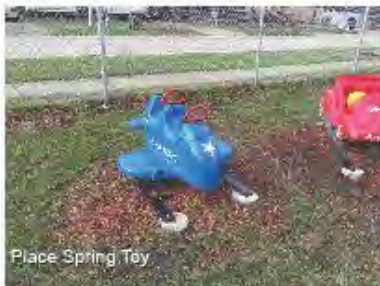
Plane Spring Toy

ASTM F 1487, 9.2.1 Play Structure Use Zone
ASTM F 1487, 13.2.1 Maintenance - Play surfacing

Recommendations: Provide and maintain safety surfacing to proper depth. Exposed footings must be covered once new safety surface is installed. Spring Toy is located less than 6' from existing fencing and from red spring toy.
