2020 Communication Meeting

Michigan Public Service Commission
Energy Operations Division

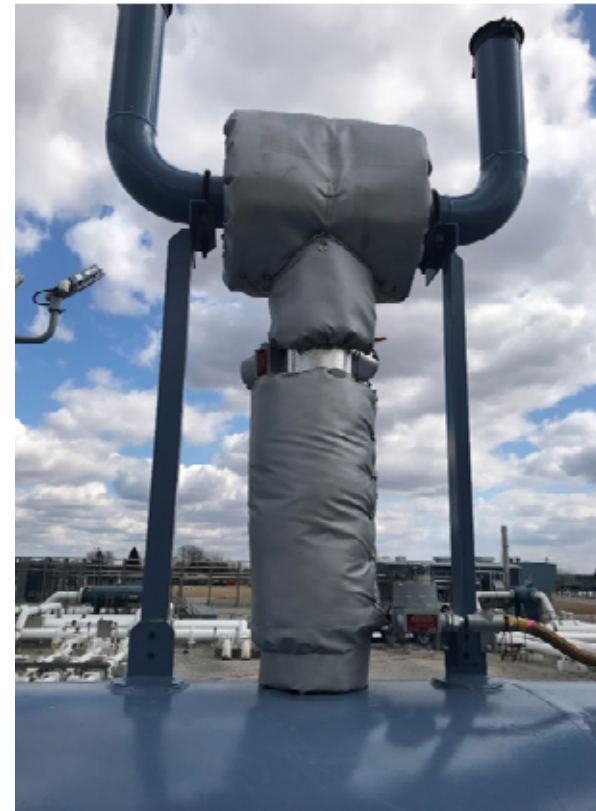
Significant Incident – 3105

- Type: Equipment Failure
- Characteristics:
 - Venting Slug Catcher Relief
 - 4” modulating relief valve manufactured by Anderson Greenwood.
 - Placed into service on January 10, 2019.
- Description:
 - External temperatures and moisture content of the natural gas caused internal components of the relief valve to freeze
 - Freezing caused the valve to actuate below its set pressure.
 - Heat trace and insulation was installed per manufacturer’s recommendation.

- Recommend Operator refrain from placing equipment that has failed back into service prior to determining the cause of failure.
- Recommend Operator refrain from isolating pressure relief valves on equipment even if the operating pressure is below the equipment's MAOP, unless a lock-out tag-out procedure is developed that encompasses all equipment that could cause the operating pressure to exceed the MAOP.
- Recommend Operator conduct a system-wide investigation for similar configurations where heat trace and insulation may be needed to prevent freezing of a pilot and conduct necessary enhancements.
- Recommend Operator provide training to Gas System Planning on how to calculate gas loss.

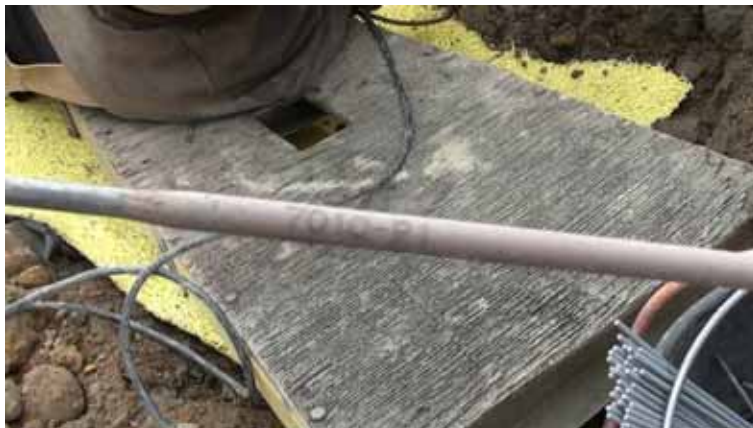
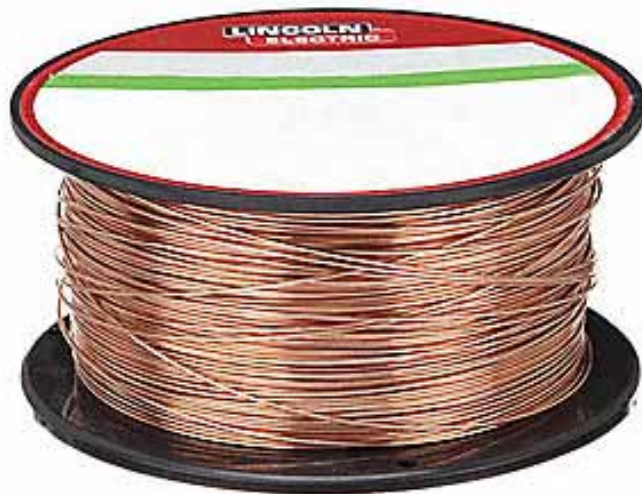
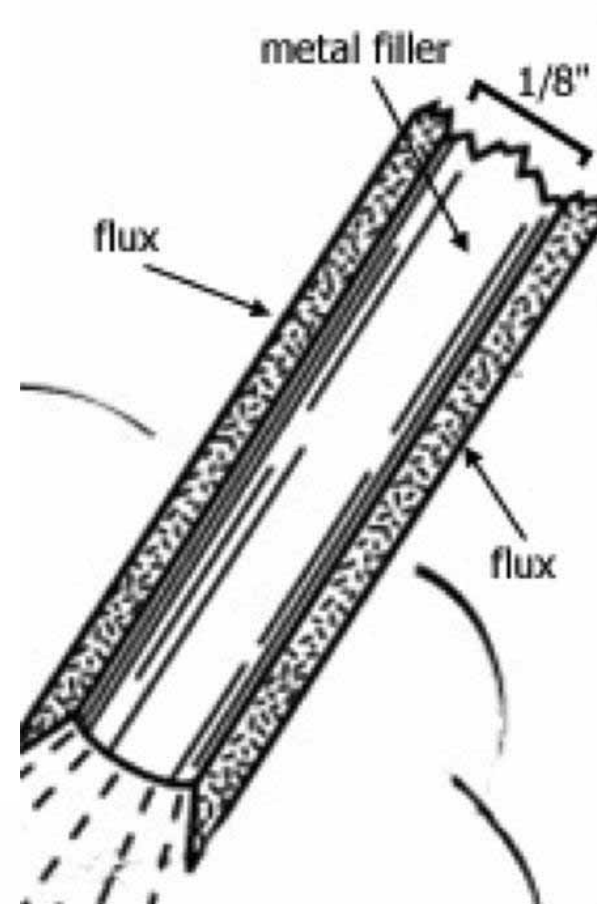
State-wide NDT Reject Rates

- Common GMAW rejects:
 - Incomplete fusion due to cold lap (IFD). IFD is common with GMAW process used for production welding in field.
 - Porosity (P). P is caused by trapped gas.
 - Inadequate penetration due to high-low (IPD). IPD is typically caused by bad fit up.
 - Incomplete fusion (IF). IF is a welder problem sometimes concentrated specific welders.
- Recommendations:
 - Operators should consider what process is the most appropriate for the application (SMAW vs GMAW).
 - Operators should analyze NDT results to identify higher than normal reject rates and if rejects are concentrated to a specific welder. Do this as the project is ongoing in order to make alterations.
 - Consider placing welding inspectors on projects to oversee work.

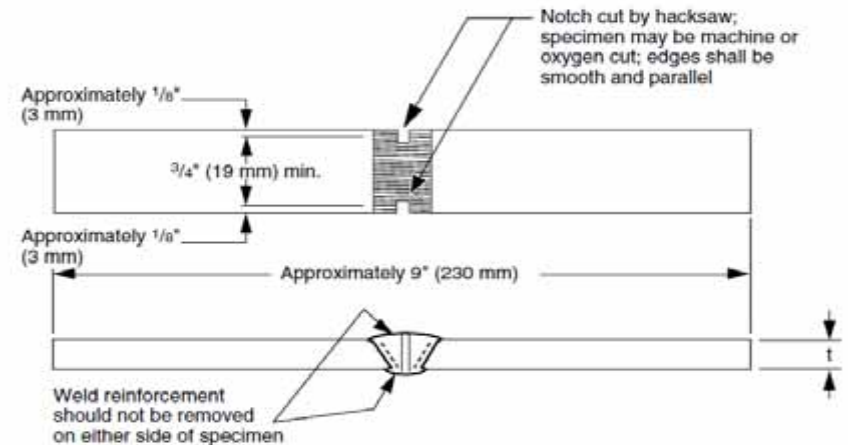
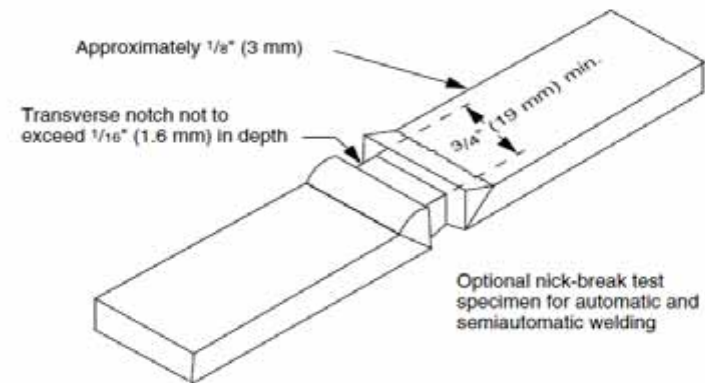
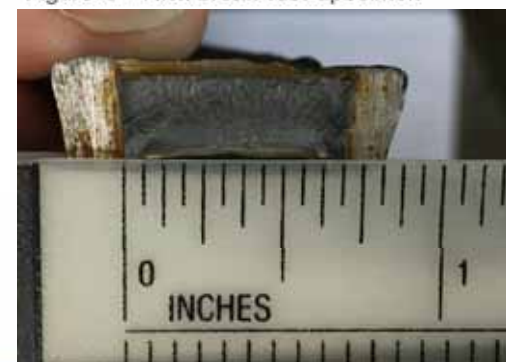
Figure 5—Nick-break Test Specimen

- 192.225(a) – Failure to use the correct welding procedure for Grade B pipe [35,000 psig YS]. Welding procedure utilized only applies to pipe and fitting materials “API 5L Specifications greater than Grade X42 up to/ including X60 pipe.”
- 192.227(a) – Failure to follow API 1104 Section 5.6.3.1 when qualifying welders. As part of the preparation for nick-break testing, welders notched the external and internal reinforcement of the test specimen. SMAW manual process.

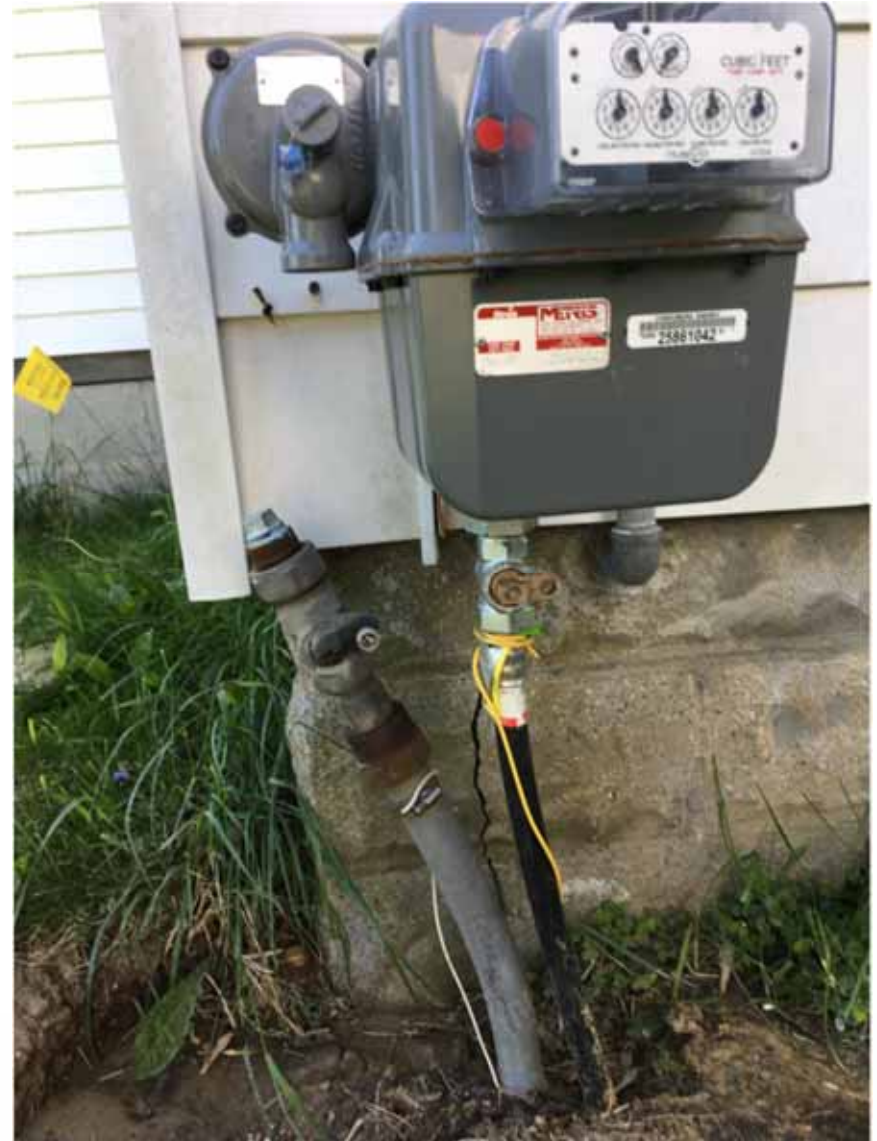
- 192.227(a): Failure to have a qualified welder. Test records indicate welder did not follow specified welding procedure when qualifying. Used wrong electrode.
- 192.379 - Failure to provide each service line that is not placed in service upon completion of installation with a locking device on the valve that is closed to prevent the flow of gas to the customer, a mechanical device or fitting that will prevent the flow of gas in the service line or in the meter assembly, or physically disconnect the customer's piping from the gas supply and seal the open ends. Customer not home.

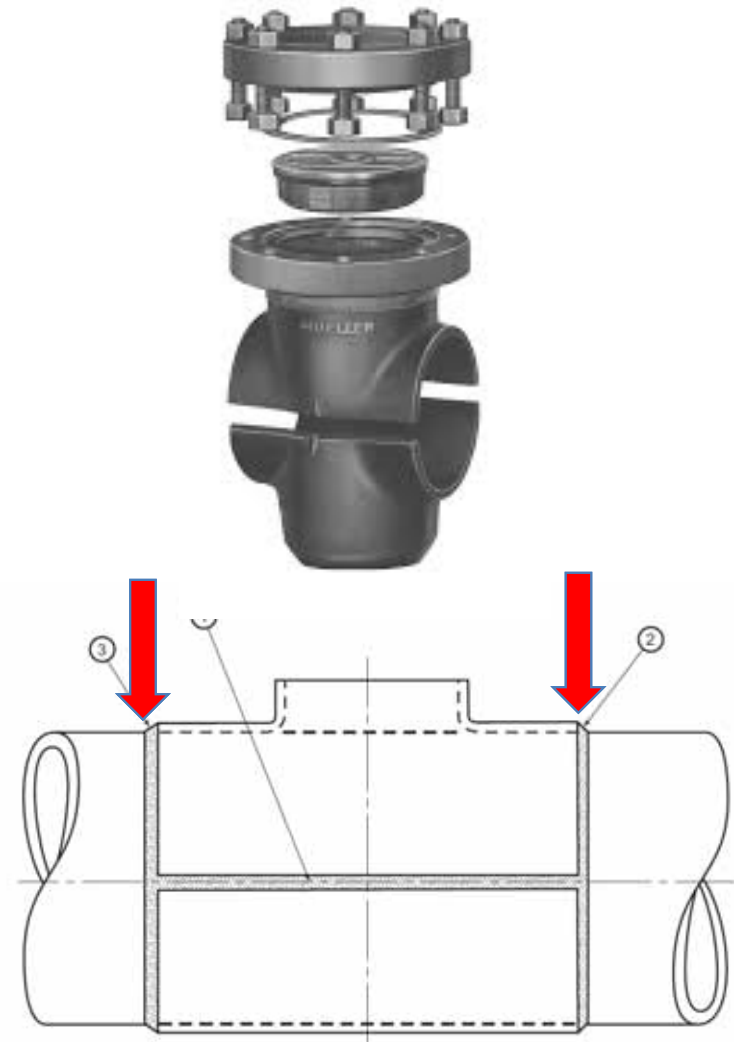
Figure B-9—Encirclement Tee

- R460.20332 - Failure to discontinue an inactive service line with components located inside a structure within 9 months of becoming inactive (no customer on record for a continuous 24-month period).
- R460.20304b – Failure to use in-service welding procedure to weld a bottom out pressure control fitting on a transmission line. Welding procedure must be qualified to Appendix B for in-service welding.

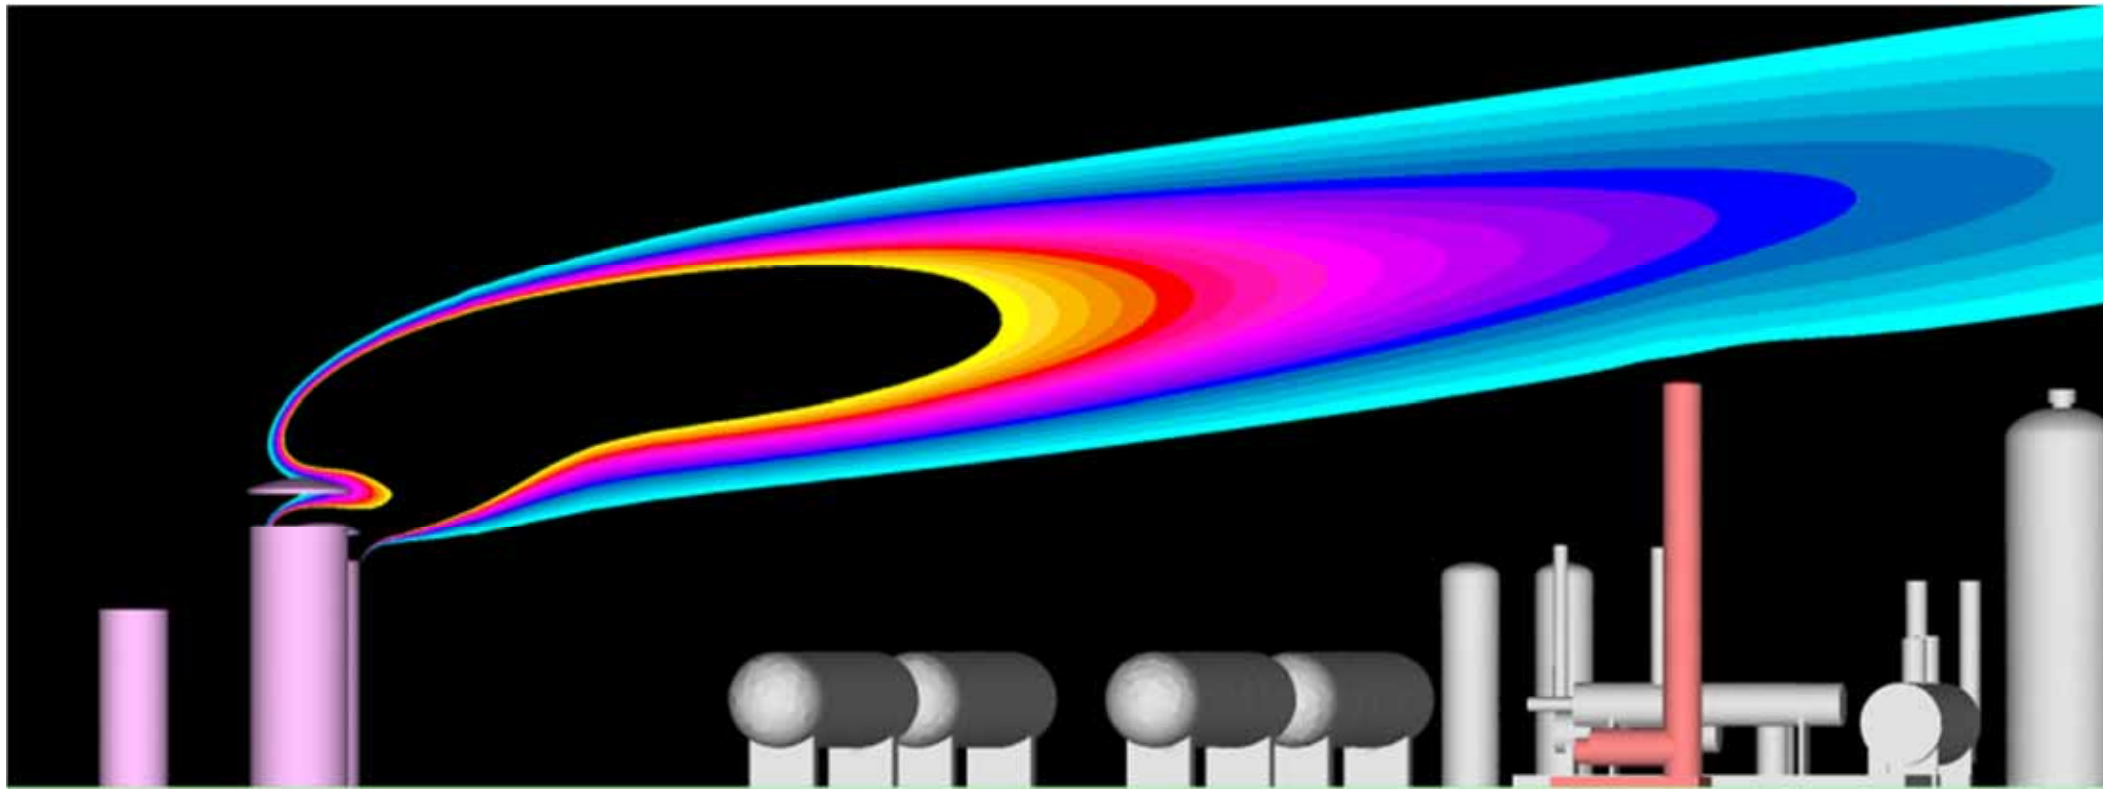
Significant Incident — 478629

- Cause of initial Plant 3 ESD:
 - Grounding issue interfering with the communication system.
- Solution:
 - Move the grounding systems further apart.

- Cause of ignition:
 - Low velocity of gas discharge from blowdown silencer in conjunction with a close proximity to the thermal oxidizer.
- Solution:
 - Remove the silencers and install straight pipe blowdowns.

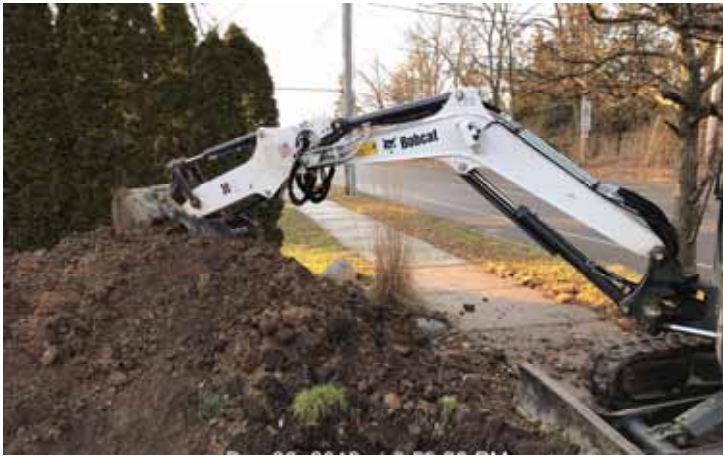
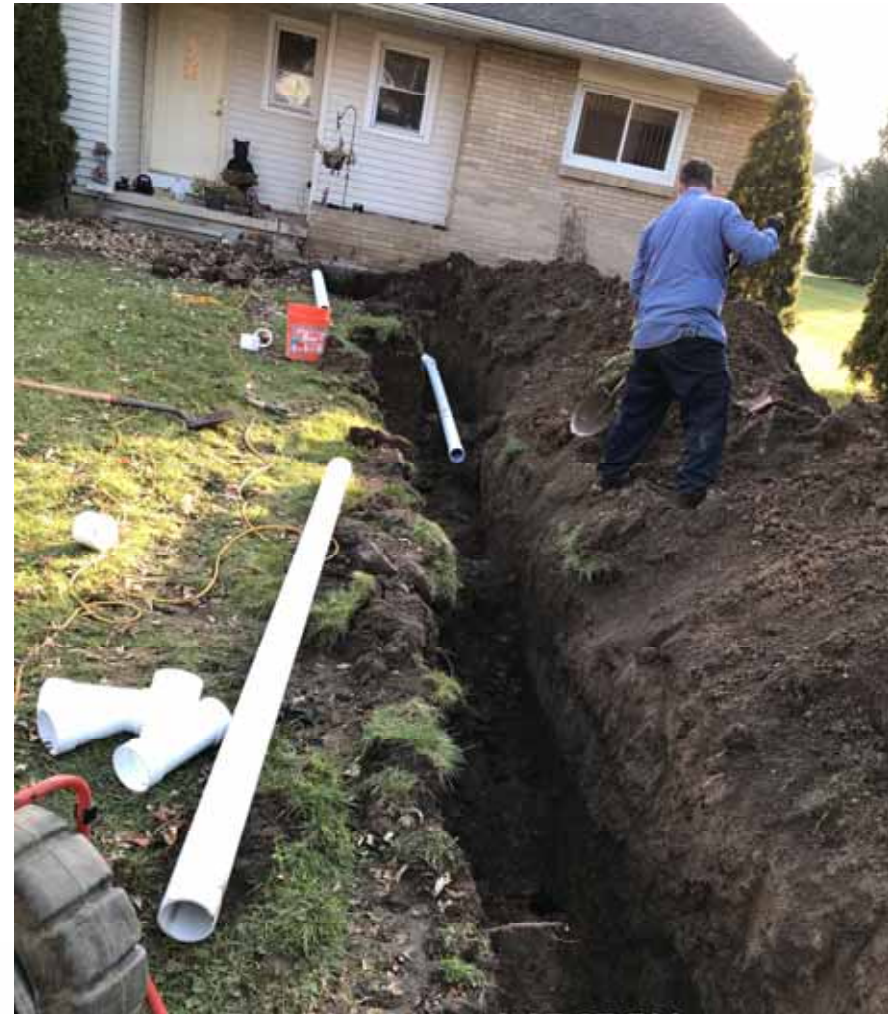
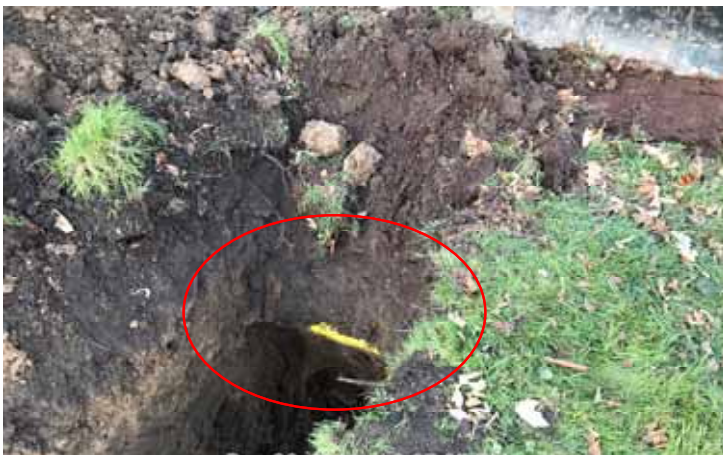
1st Encounter

- Excavator Violations:
 - MCL 460.725(1) – Failure to provide a dig notice to the notification system at least 72 hours, but not more than 14 calendar days, before the start of any blasting or excavation.
