# Transmission Incident History

October 8, 2019

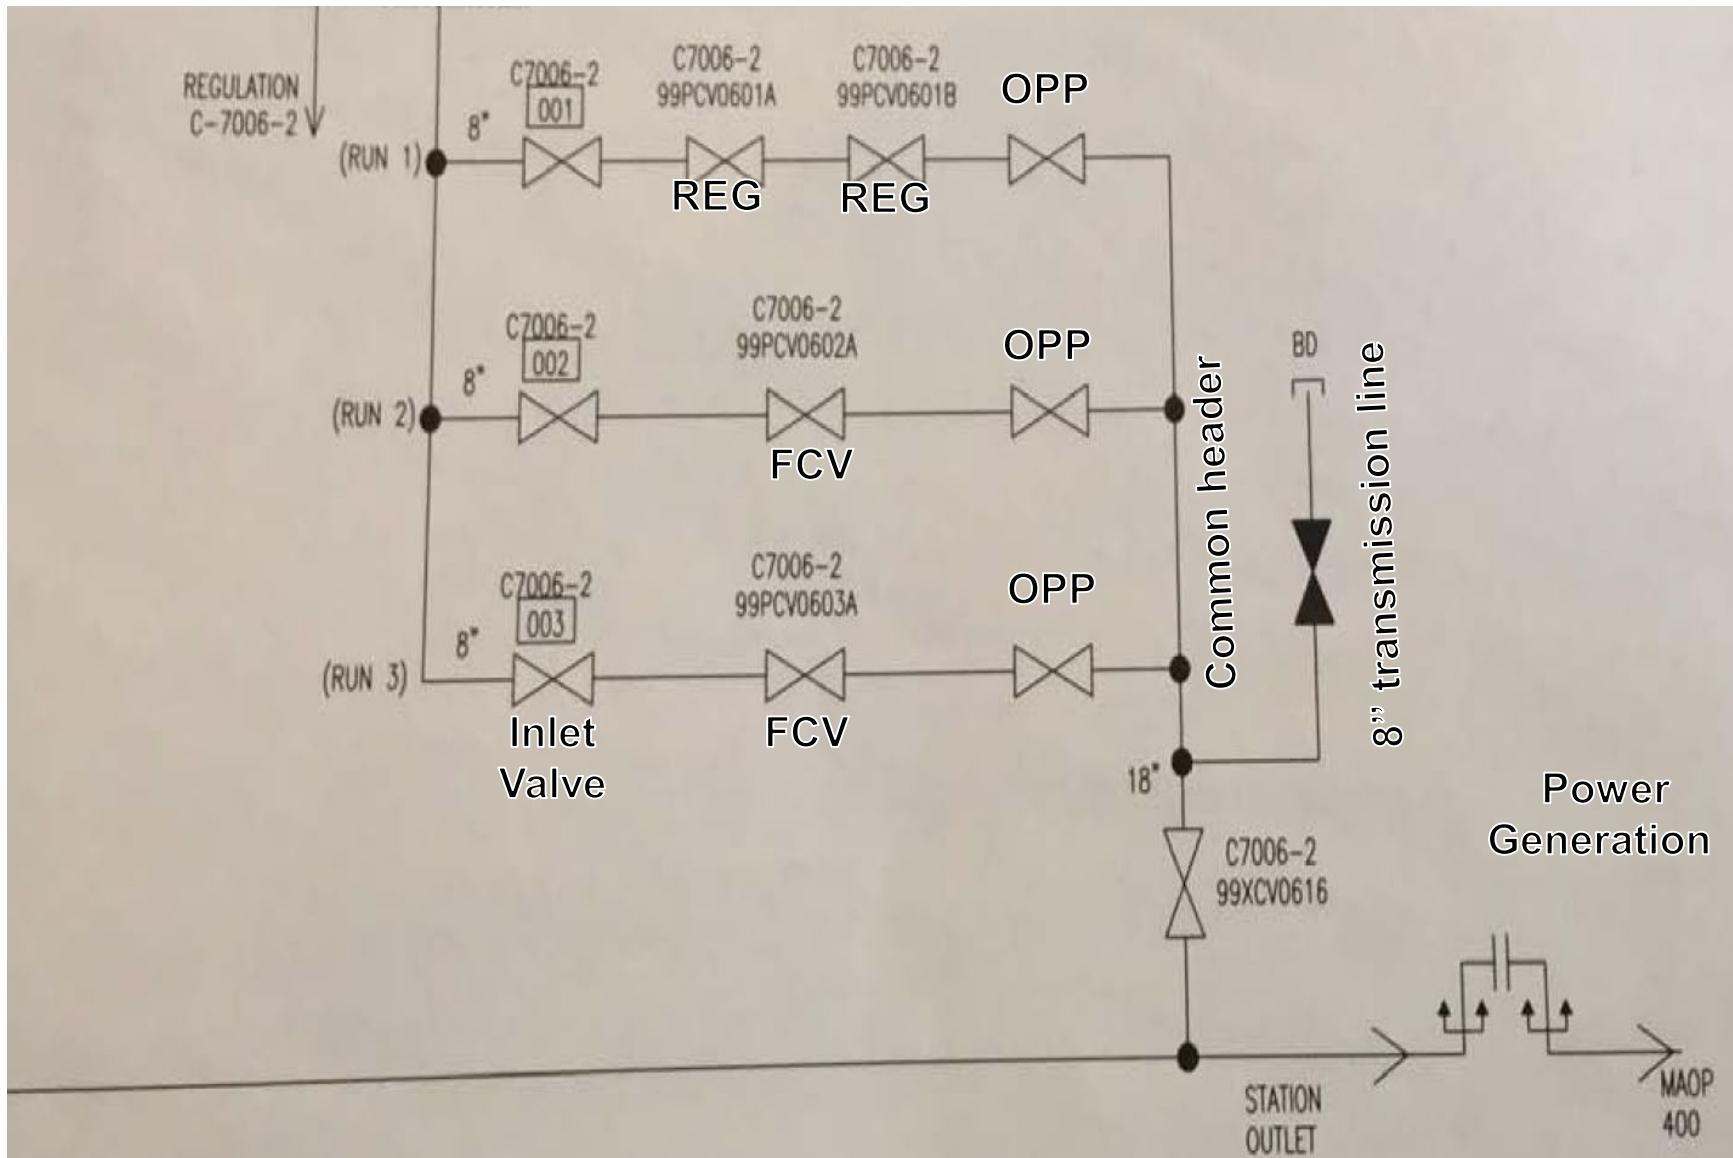
# 2018 Incident – 436025 Cont.

- Operator #1 Violations:
  - 192.605(a): Flow control valves and overpressure protection valves not tested prior to being returned to service on the day of incident.
  - 192.605(b)(5): Failure to have procedures for cycling gas flow.
  - 192.605(c)(1): Failure to have procedures for responding to, investigating, and correcting the cause of an increase in pressure above outside normal operating limits or the operation of any safety device.

- Operator #1 Recommendations:
  - Provide training to ensure individuals performing covered tasks have the necessary knowledge, skills, and abilities.
  - Monitor outlet pressures with SCADA alarms or text message notification.
  - Develop AOC procedure to leak survey pipelines that experienced an overpressure.
  - Develop AOC procedure to check variations from normal operation after abnormal operation.
  - Install actuator on existing valve on 8-inch transmission line as redundant OPP.

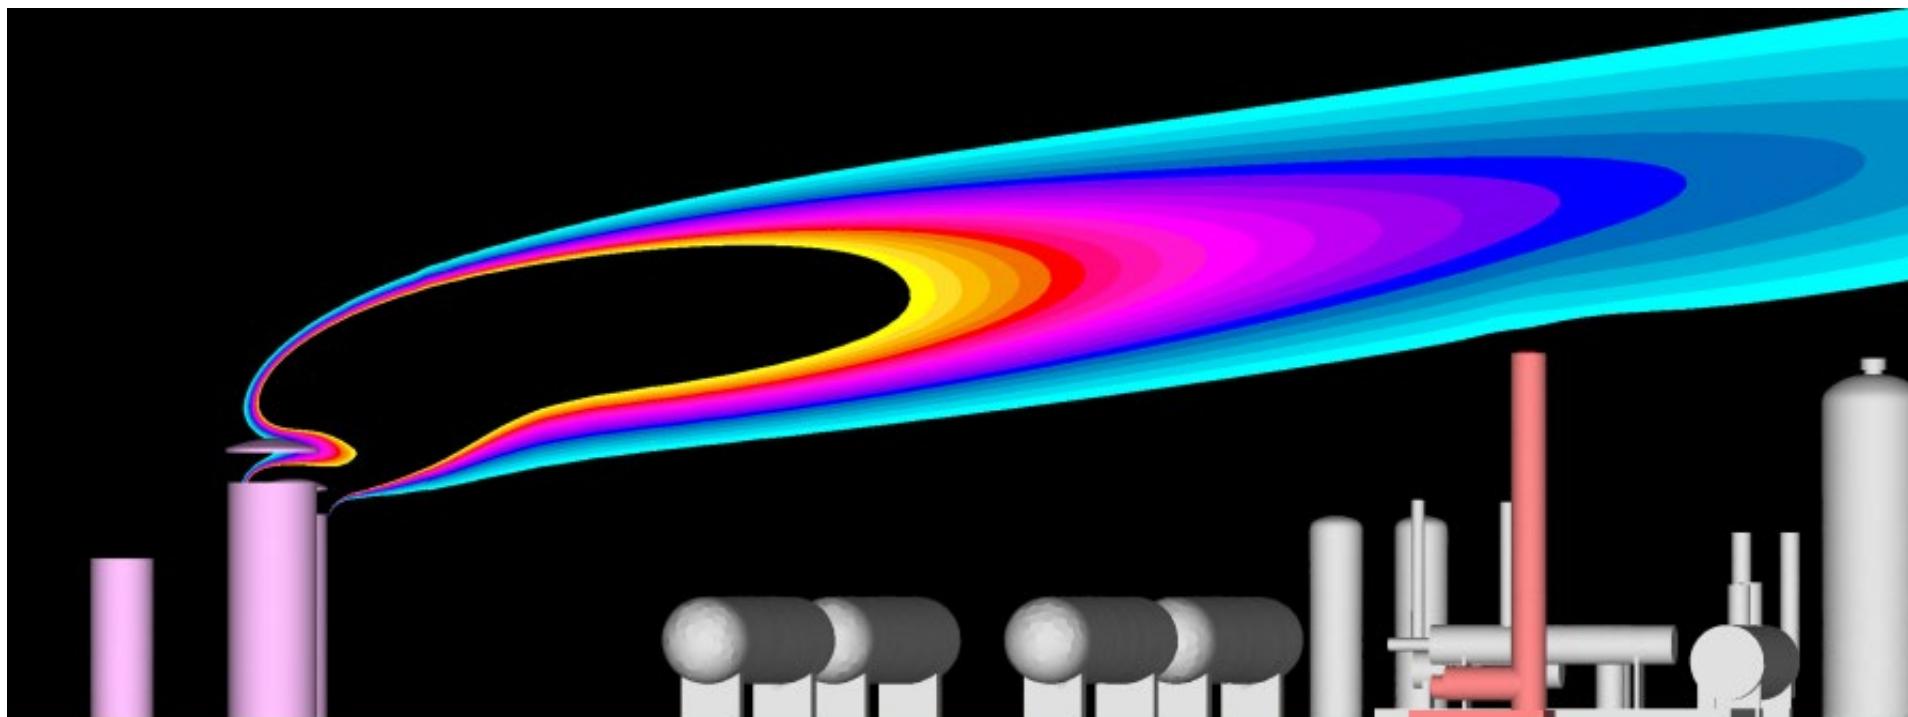
# 2019 Incident – 478629 Cont.

- Cause of initial Plant 3 ESD:  
Grounding issue interfering  
with the communication  
system.
  - Solution: Move the  
grounding systems further  
apart.

- Cause of ignition: Low velocity of gas discharge from blowdown silencer in conjunction with a close proximity to the thermal oxidizer.
  - Solution: Remove the silencers and install straight pipe blowdowns.
