**Enbridge Energy, Limited Partnership
Enbridge Line 5 - Straits of Mackinac**

**Coating Inspections, Findings and Repairs
from Activities Completed in 2017**

**Anchor Inspection Work Plan:
Interim Report**

Submitted: January 16, 2018

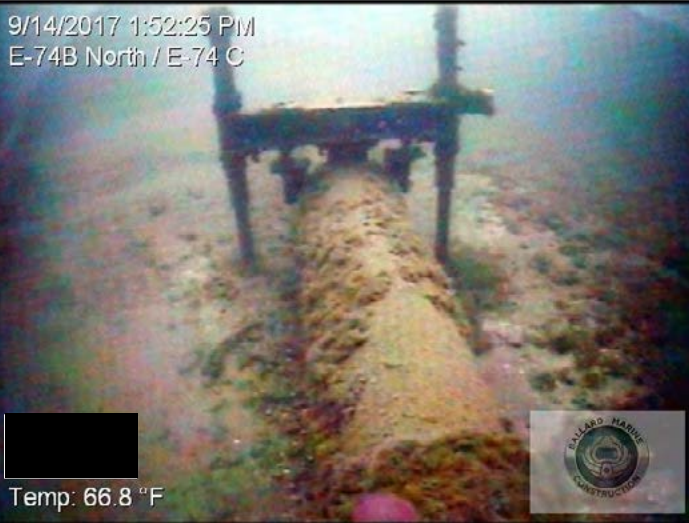
9/14/2017 1:52:25 PM
E-74B North / E-74 C

There were no holidays, areas of interest, or other unusual characteristics observed around this anchor

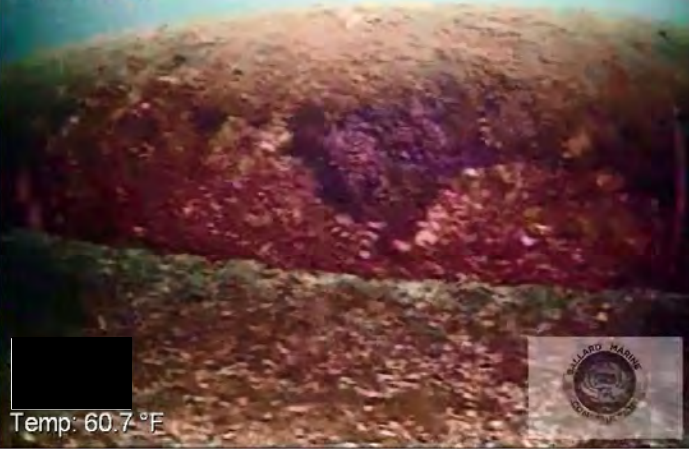
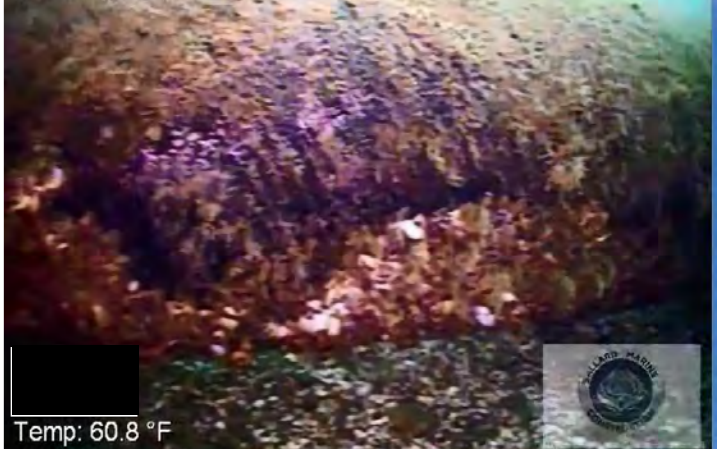
9/14/2017 2:33:11 PM
E-71B / E-72

There were no holidays, area's of interest, or any other unusual characteristics observed around this anchor.

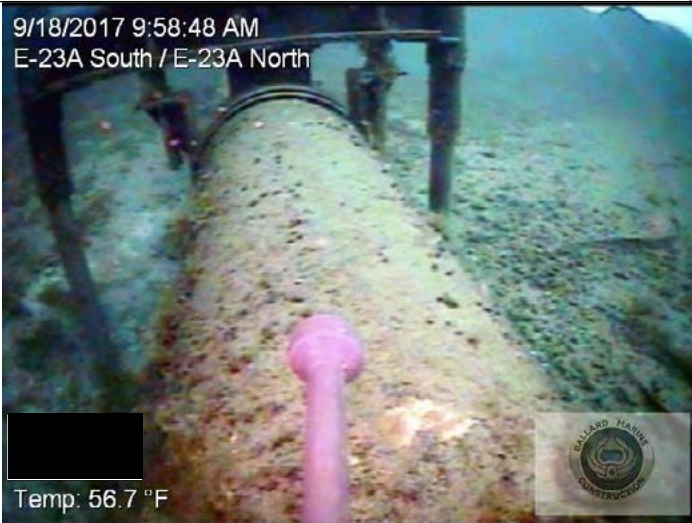
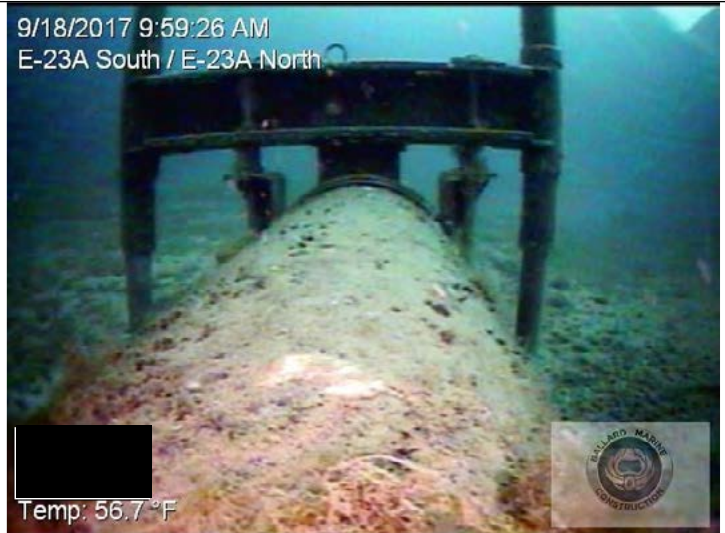
9/18/2017 9:58:48 AM
E-23A South / E-23A North

There were no holidays, area's of interest, or other unusual characteristics observed at this anchor.

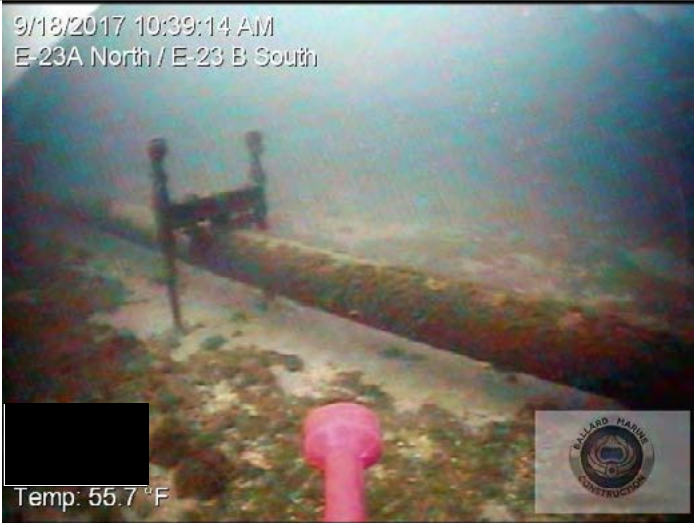
9/18/2017 10:39:14 AM
E-23A North / E-23 B South

There were no holidays, areas of interest, or unusual characteristics observed at this anchor.

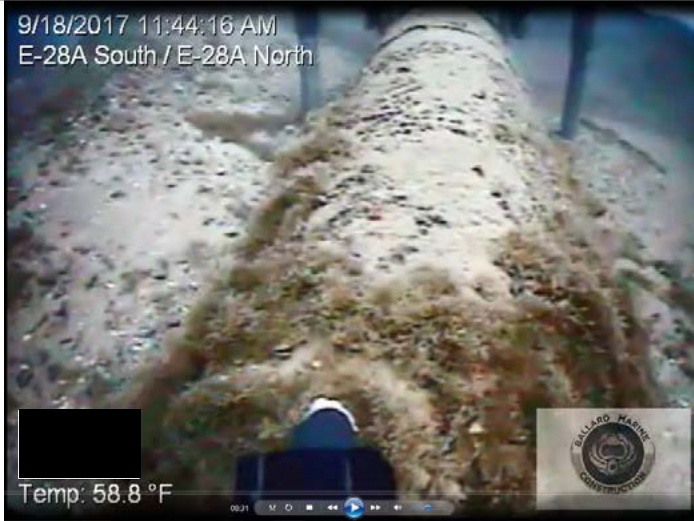
Feature #1

There were no holidays, areas of interest, or unusual characteristics observed around this anchor.

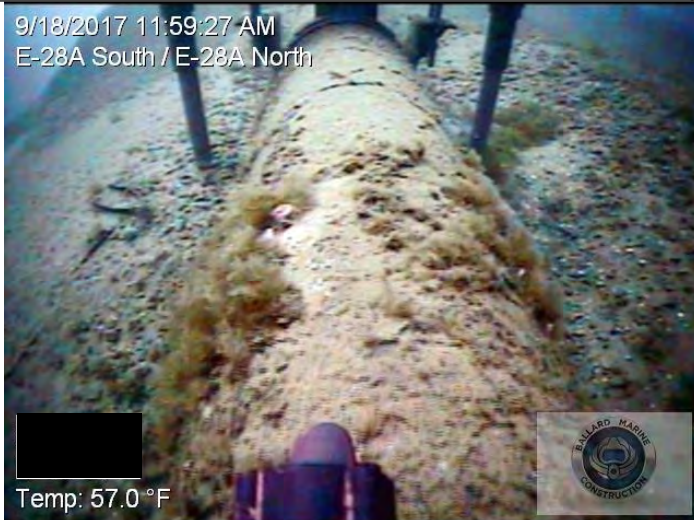
Feature #2

Date: 9-18-17 Frame(HH:MM:SS) 11:59:27

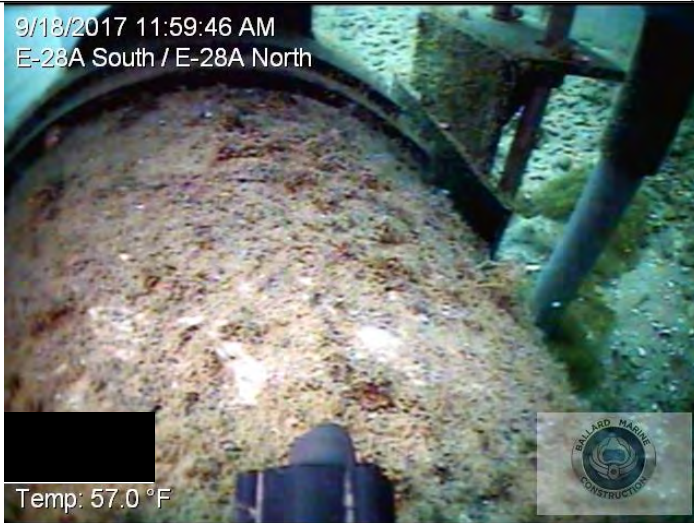
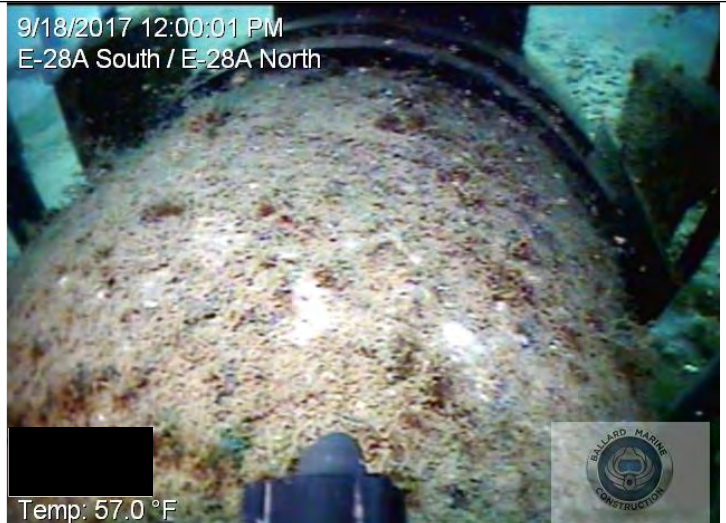
9/18/2017 11:59:46 AM
E-28A South / E-28A North

Date: 9-18-17 Frame(HH:MM:SS) 11:59:46

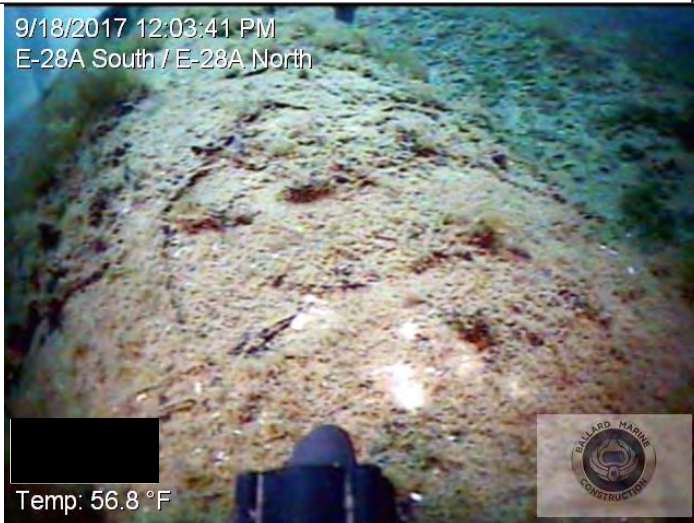
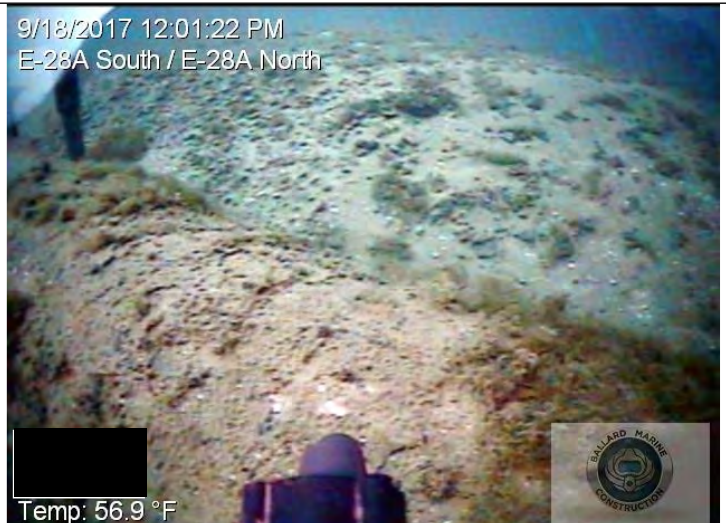
9/18/2017 12:03:41 PM
E-28A South / E-28A North

Date: 9-18-17 Frame(HH:MM:SS) 12:03:41

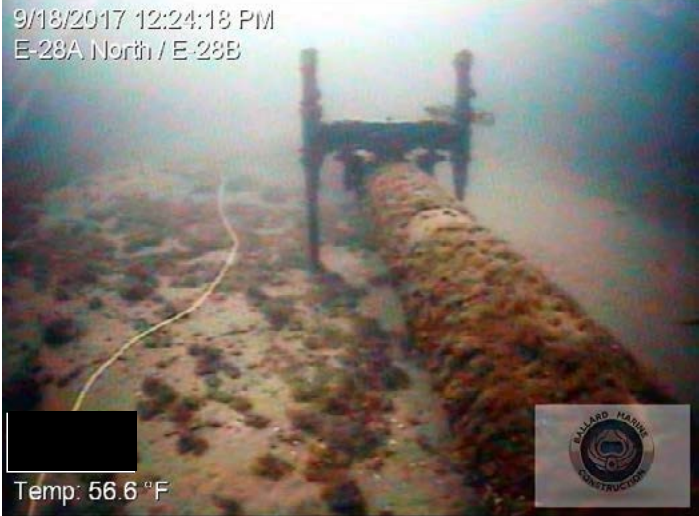
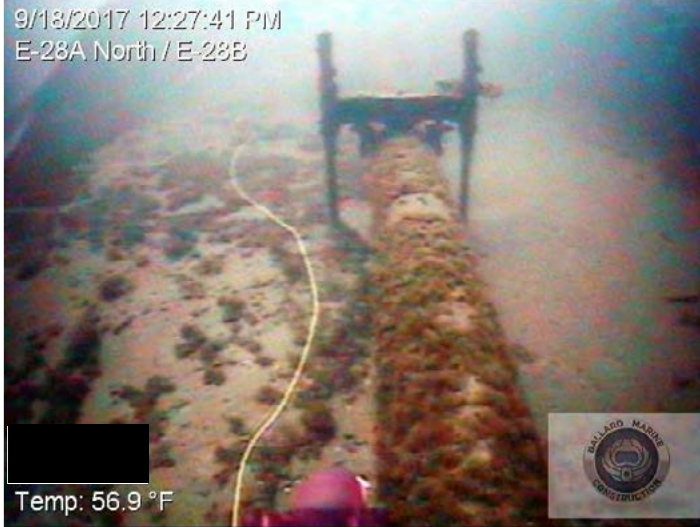
Overall North Affected Area							
For all sections of dislodged coating or holidays, provide pictures below. Included the date and time stamps associated with video surveillance.							
<div data-bbox="94 554 789 1066"> <div>9/18/2017 12:24:18 PM E-28A North / E-28B</div>

<div>Temp: 56.9 °F</div> </div>			
Date:	9-18-17	Frame(HH:MM:SS)	12:24:18	Date:	9-18-17	Frame(HH:MM:SS)	12:27:41
Comments:

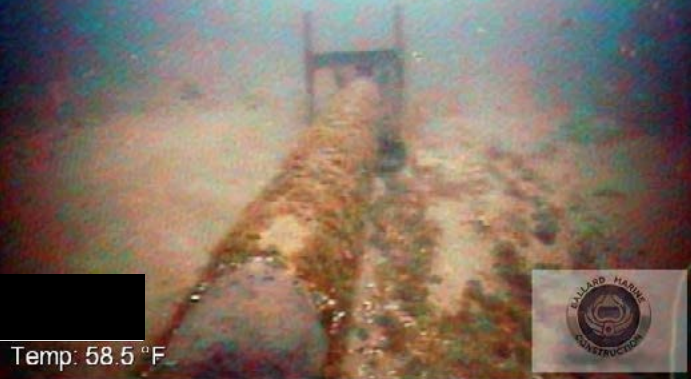
9/18/2017 12:46:43 PM
E-30A / E-30B

Date: 9-18-17 Frame(HH:MM:SS) 12:46:43

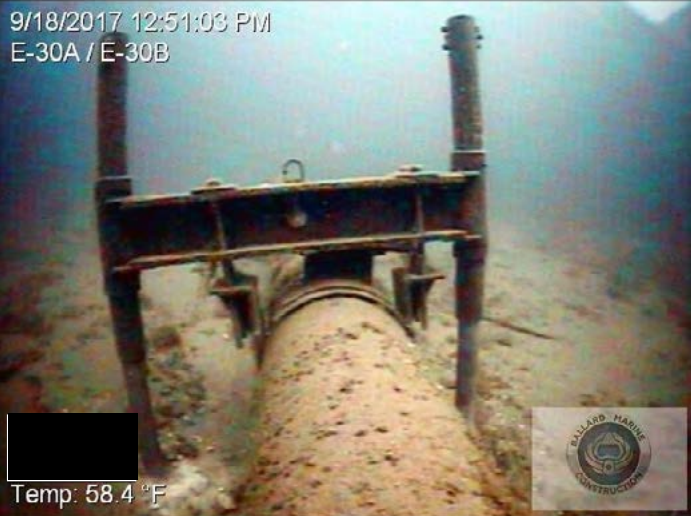
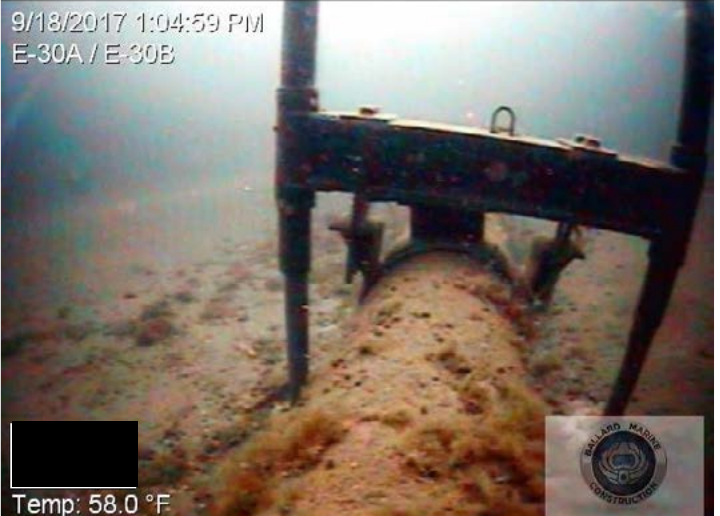
9/18/2017 12:51:03 PM
E-30A / E-30B

Date: 9-18-17 Frame(HH:MM:SS) 12:51:03

Date: 9-18-17 Frame(HH:MM:SS) 13:04:59

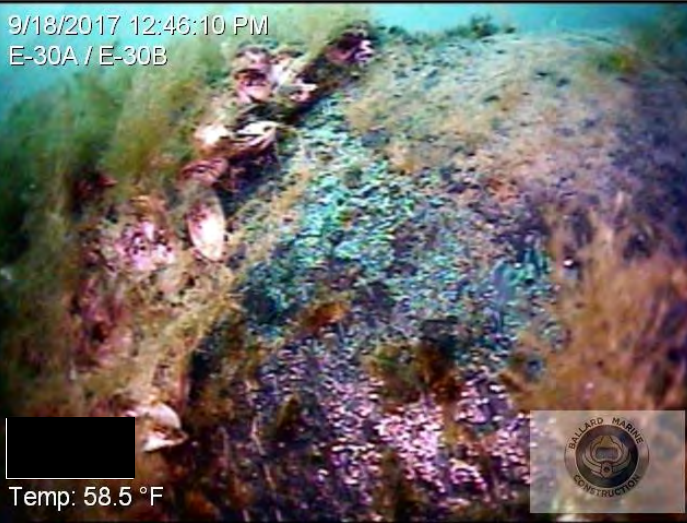
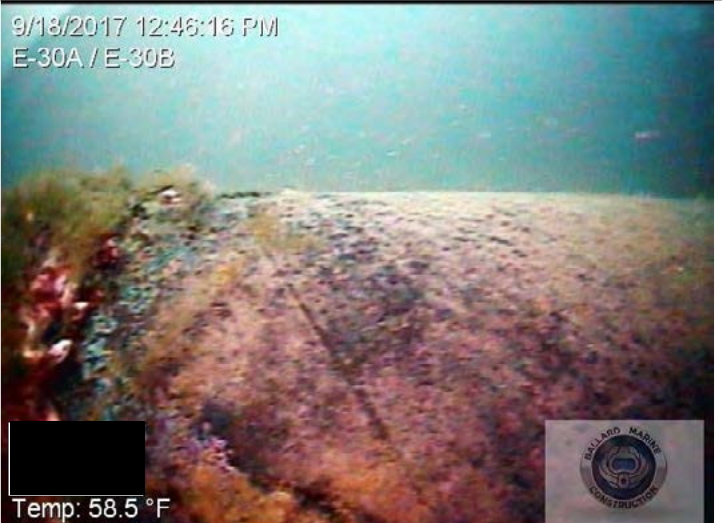
9/18/2017 12:46:10 PM
E-30A / E-30B

Date: 9-18-17 Frame(HH:MM:SS) 12:46:10

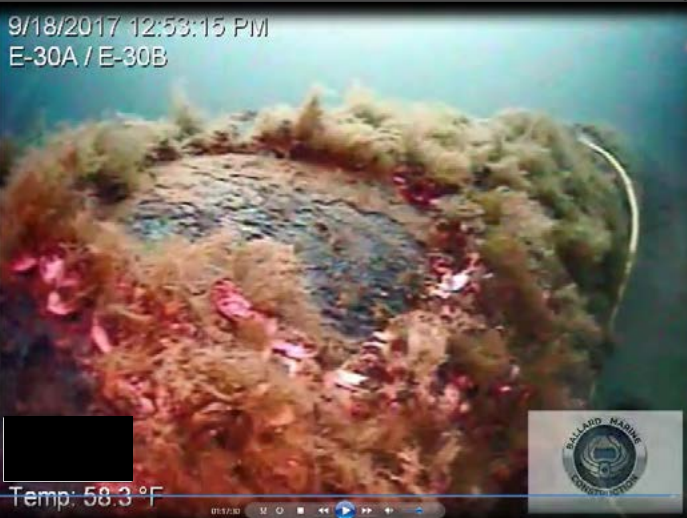
9/18/2017 12:53:15 PM
E-30A / E-30B

Date: 9-18-17 Frame(HH:MM:SS) 12:53:15

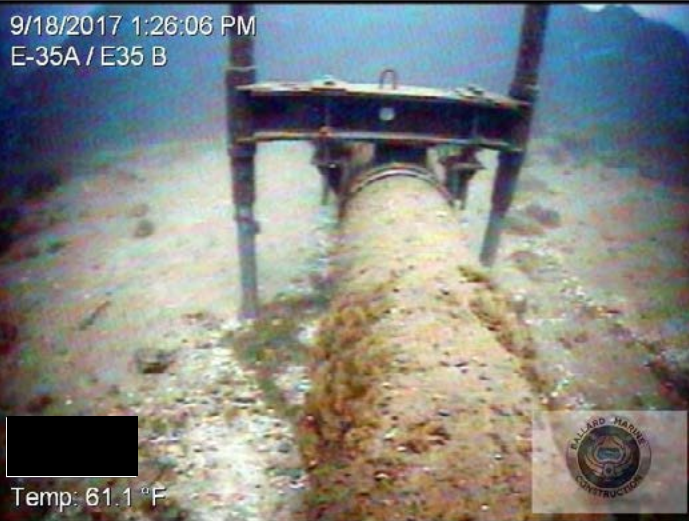
9/18/2017 1:26:06 PM
E-35A / E35 B

Date: 9-18-17 Frame(HH:MM:SS) 13:26:06

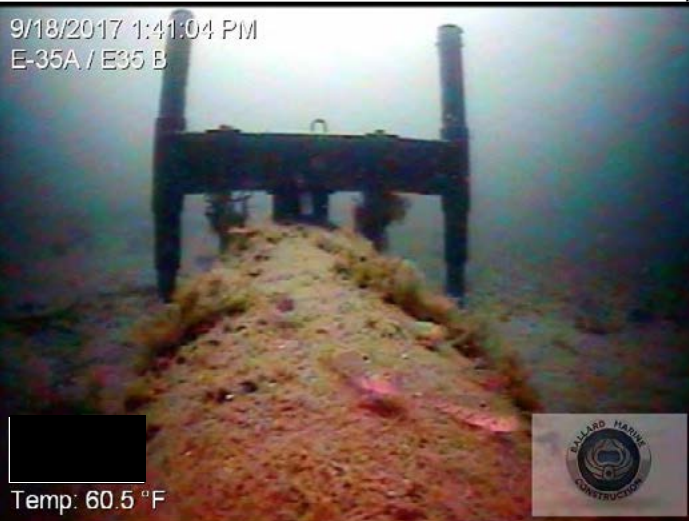
9/18/2017 1:41:04 PM
E-35A / E35 B

Date: 9-18-17 Frame(HH:MM:SS) 13:41:04

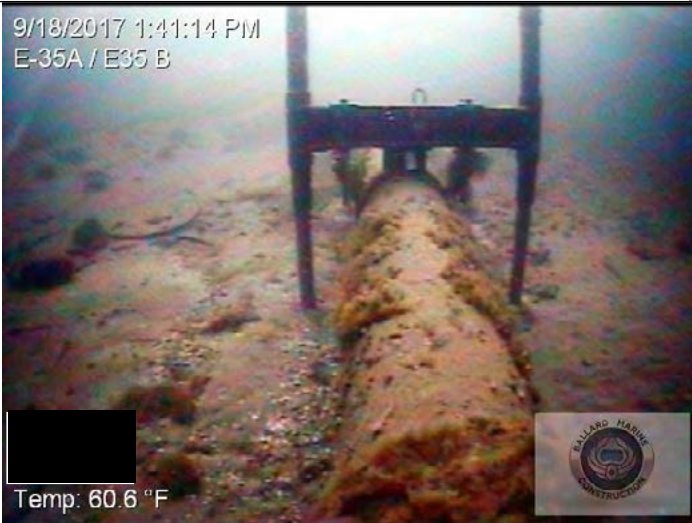
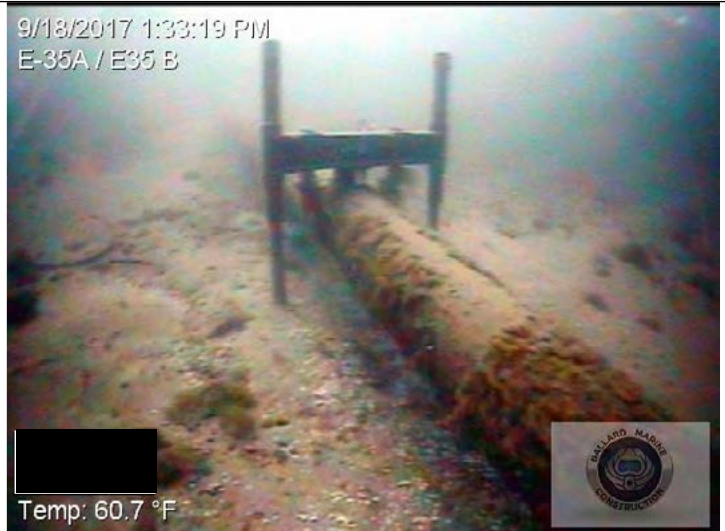
9/18/2017 1:41:14 PM
E-35A / E35 B

Date: 9-18-17 Frame(HH:MM:SS) 13:41:14

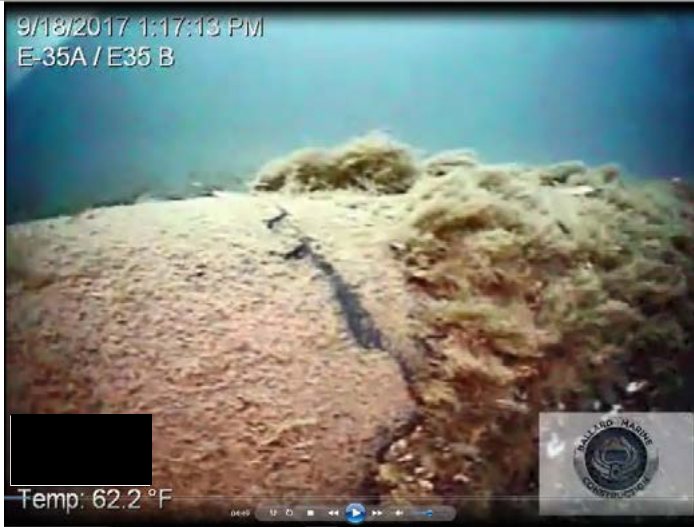
Feature #1

Date: 9-18-17 Frame(HH:MM:SS) 13:17:13

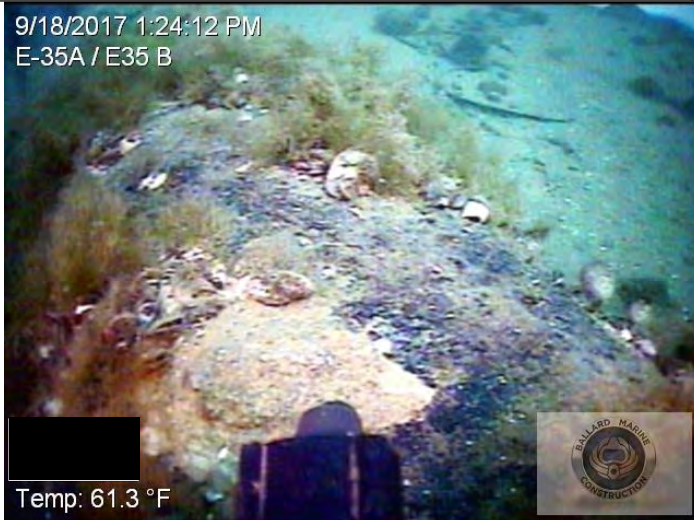
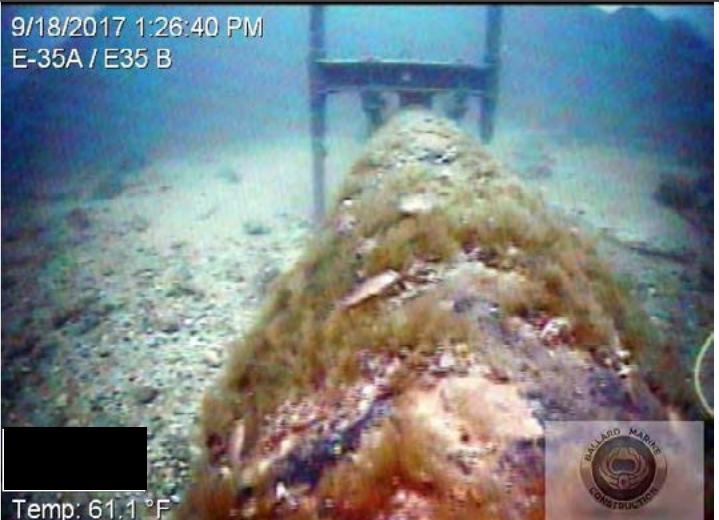
Feature #2

Date: 9-18-17 Frame(HH:MM:SS) 13:24:12

Date: 9-18-17 Frame(HH:MM:SS) 13:26:40

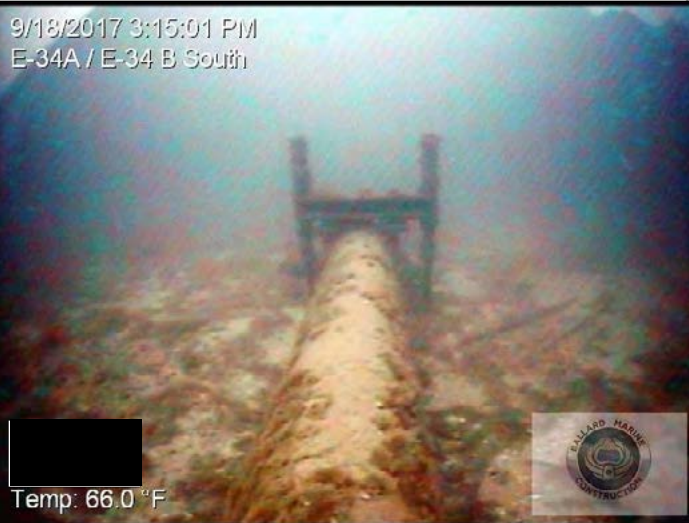
9/18/2017 3:15:01 PM
E-34A / E-34 B South

Date: 15:15:01 Frame(HH:MM:SS)

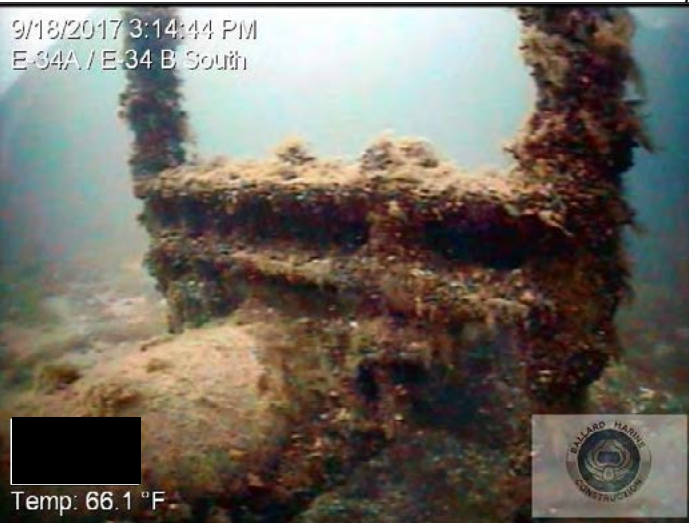
9/18/2017 3:14:44 PM
E-34A / E-34 B South

Date: 9-18-17 Frame(HH:MM:SS) 15:14:44

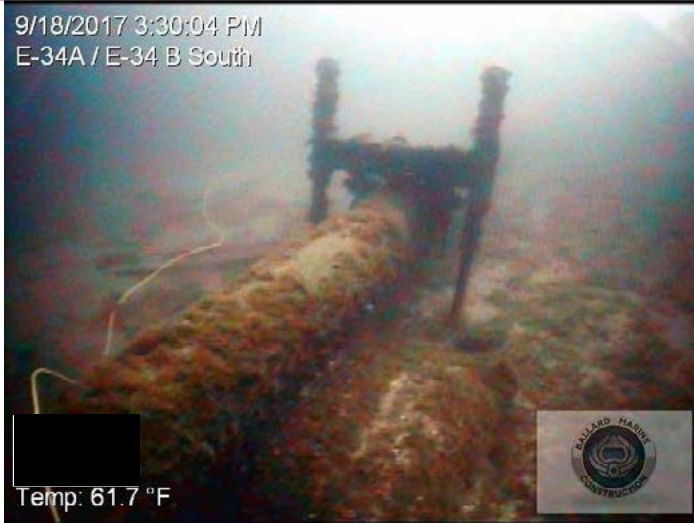
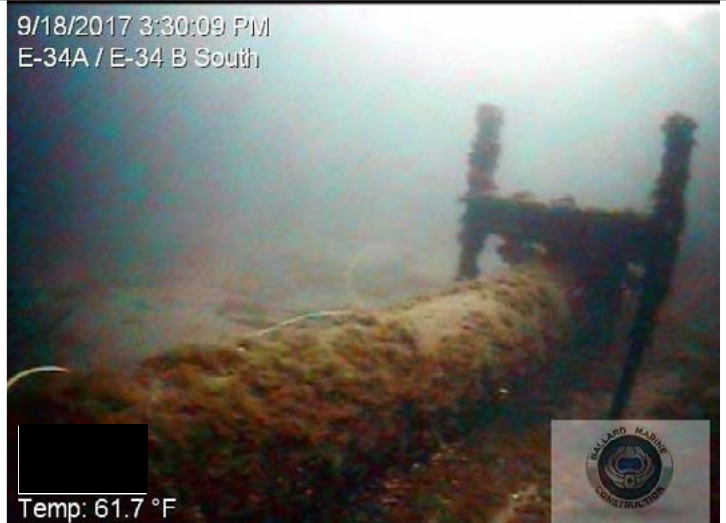
9/18/2017 3:30:04 PM
E-34A / E-34 B South

Date: 9-18-17 Frame(HH:MM:SS) 15:30:04

Date: 9-18-17 Frame(HH:MM:SS) 15:30:09

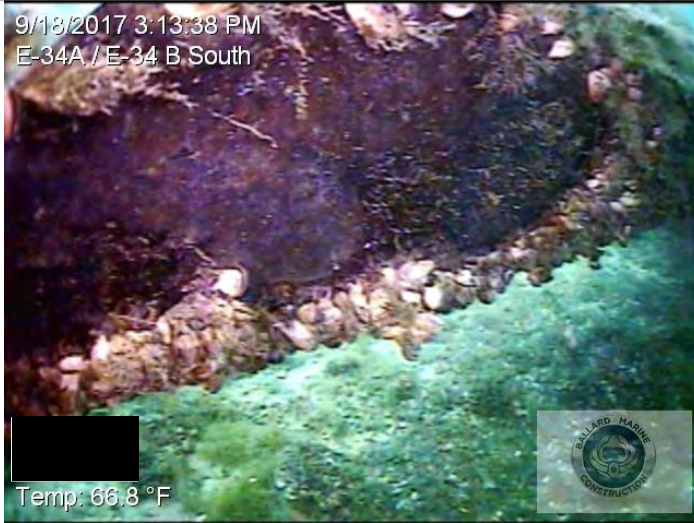
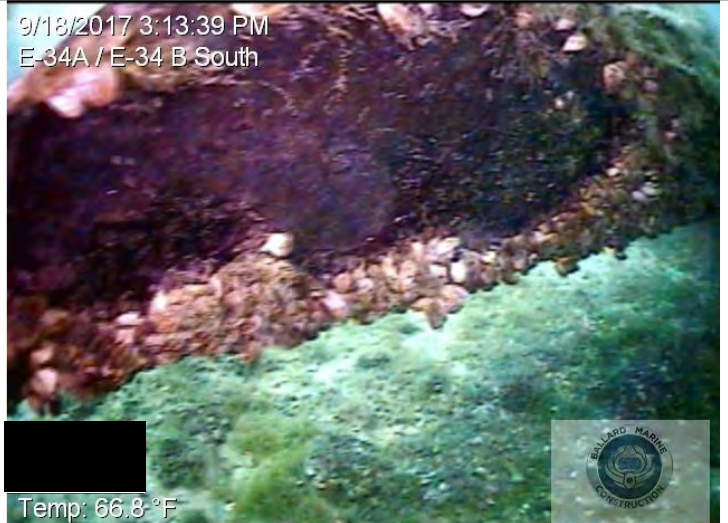
9/18/2017 3:13:38 PM
E-34A / E-34 B South

Date:	9-18-17	Frame(HH:MM:SS)	15:13:38
-------	---------	-----------------	----------

Date:	9-18-17	Frame(HH:MM:SS)	15:13:39
-------	---------	-----------------	----------

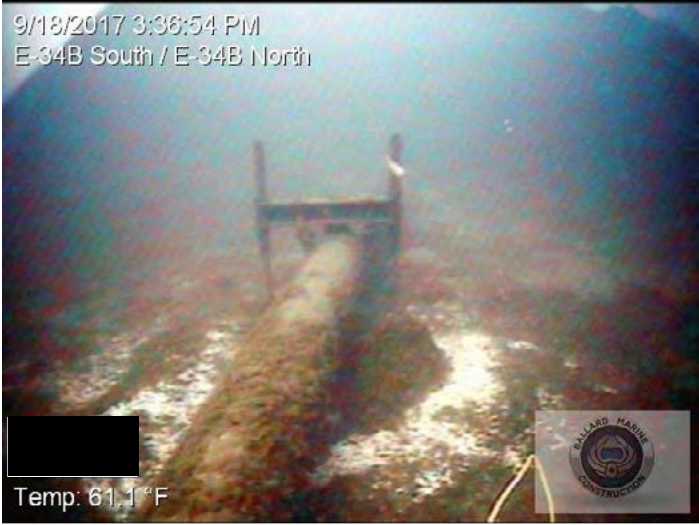
Overall South Affected Area							
<i>For all sections of dislodged coating or holidays, provide pictures below. Included the date and time stamps associated with video surveillance.</i>							
<div style="border: 1px solid black; padding: 5px;"> <div style="font-size: small; margin-bottom: 5px;"> 9/18/2017 3:36:54 PM E-34B South / E-34B North </div>

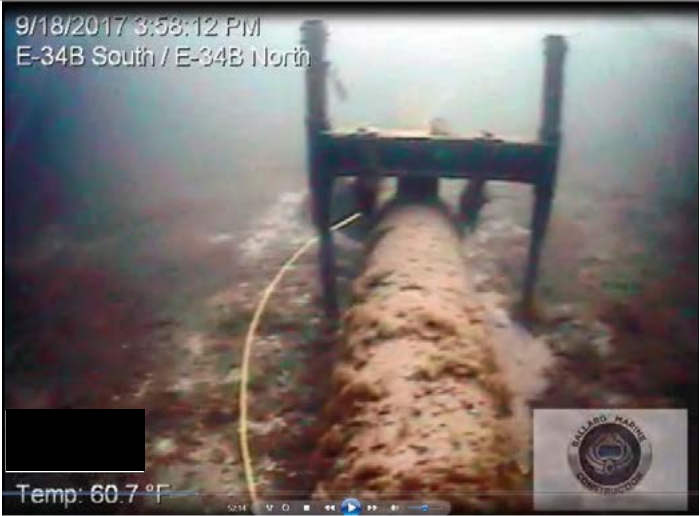
Overall North Affected Area							
<i>For all sections of dislodged coating or holidays, provide pictures below. Included the date and time stamps associated with video surveillance.</i>							
<div style="border: 1px solid black; padding: 5px;"> <div style="font-size: small; margin-bottom: 5px;"> 9/18/2017 3:58:12 PM E-34B South / E-34B North </div>

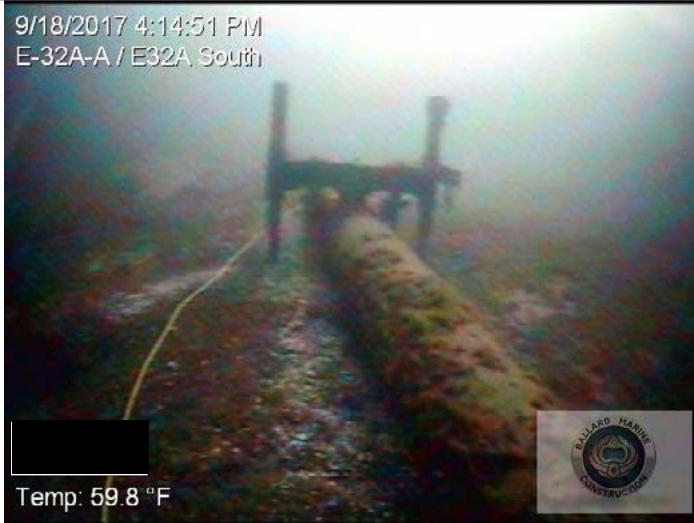
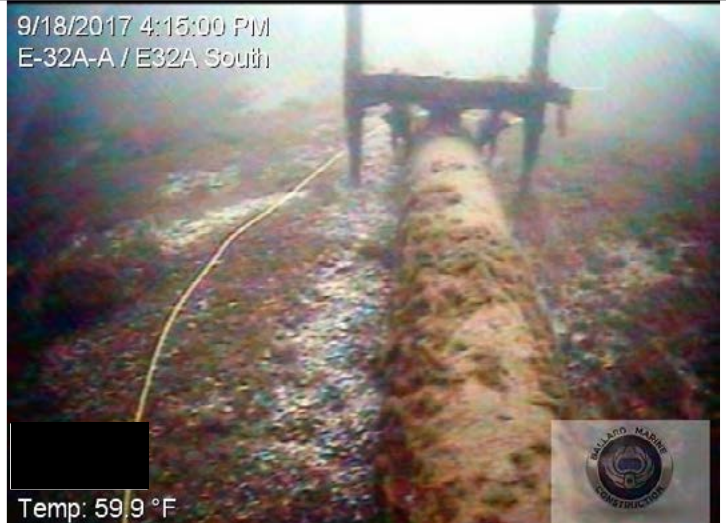
9/18/2017 4:14:51 PM
E-32A-A / E32A South

Date: 9-18-17 Frame(HH:MM:SS) 16:14:51

Date: 9-18-17 Frame(HH:MM:SS) 16:15:00

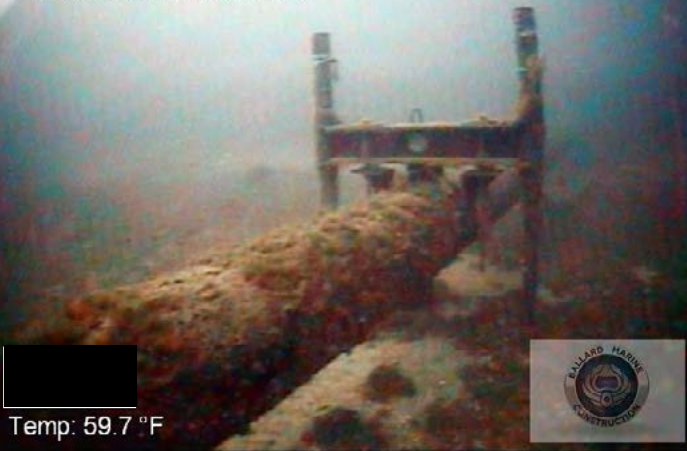
9/18/2017 4:24:15 PM
E-32A South / E-32A North

Date:	9-18-17	Frame(HH:MM:SS)	16:24:15	Date:		Frame(HH:MM:SS)	
-------	---------	-----------------	----------	-------	--	-----------------	--

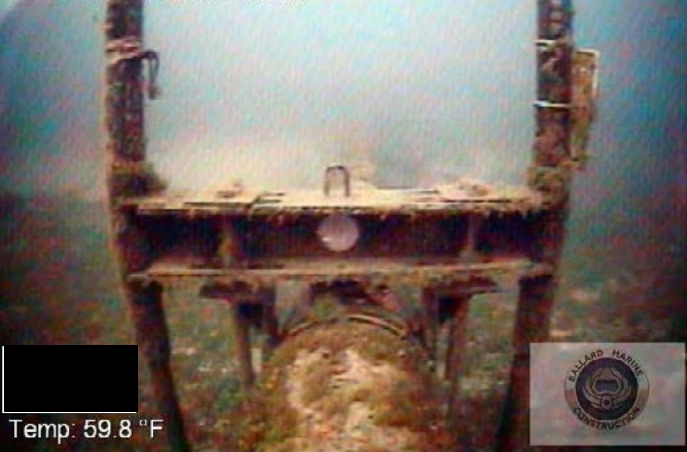
9/18/2017 4:27:49 PM
E-32A South / E-32A North

Date:	9-18-17	Frame(HH:MM:SS)	16:27:49	Date:		Frame(HH:MM:SS)	
-------	---------	-----------------	----------	-------	--	-----------------	--

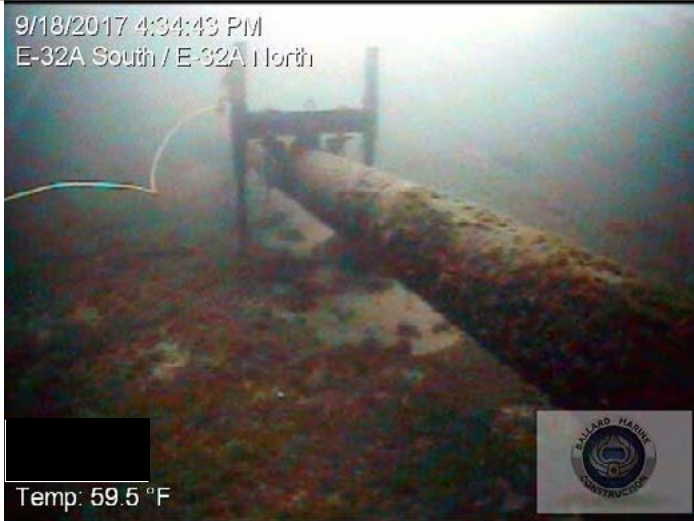
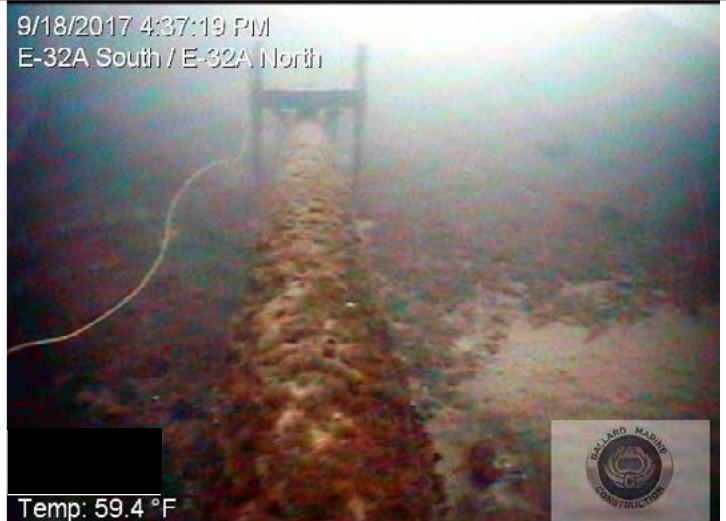
9/18/2017 4:34:43 PM
E-32A South / E-32A North

Date:	9-18-17	Frame(HH:MM:SS)	16:34:43	Date:	9-18-17	Frame(HH:MM:SS)	16:37:19
-------	---------	-----------------	----------	-------	---------	-----------------	----------

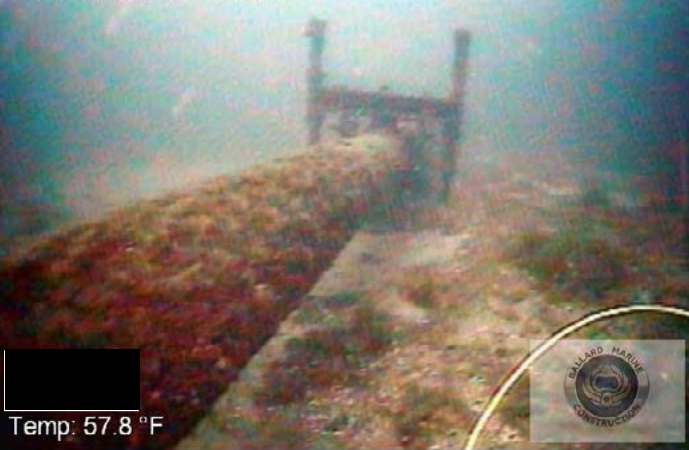
9/18/2017 4:47:40 PM
E-32A North / E-32B South

Date:	9-18-17	Frame(HH:MM:SS)	16:47:40	Date:		Frame(HH:MM:SS)	
-------	---------	-----------------	----------	-------	--	-----------------	--

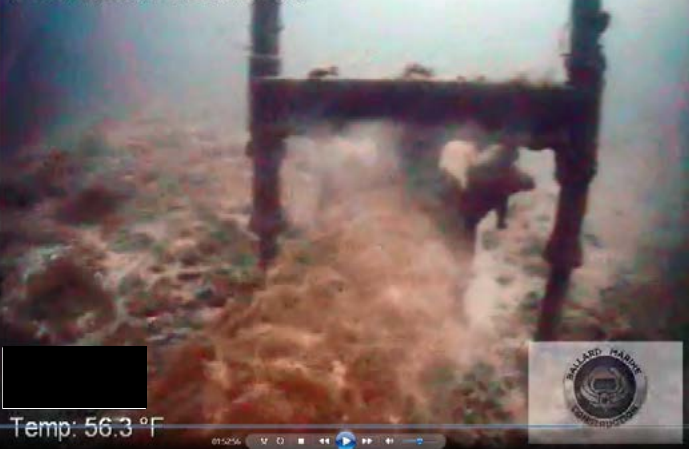
9/18/2017 4:58:55 PM
E-32A North / E-32B South

Date:	9-18-17	Frame(HH:MM:SS)	16:58:55	Date:		Frame(HH:MM:SS)	
-------	---------	-----------------	----------	-------	--	-----------------	--

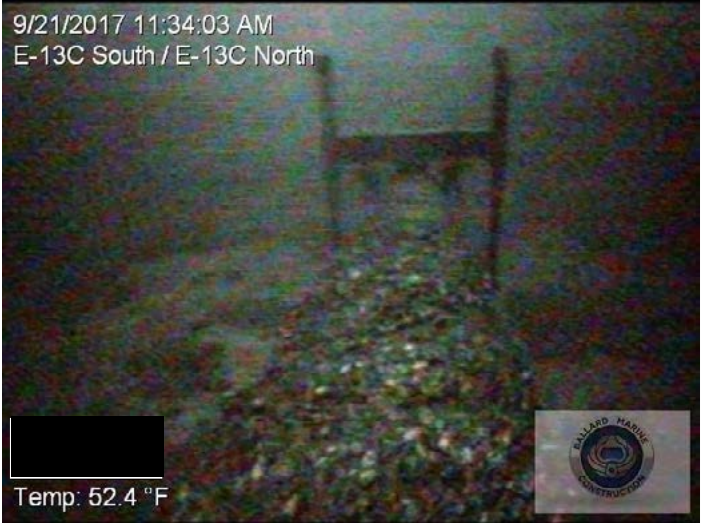
Overall North Affected Area							
<p align="center"><i>For all sections of dislodged coating or holidays, provide pictures below. Included the date and time stamps associated with video surveillance.</i></p>							
<div data-bbox="99 548 407 604"> <p>9/21/2017 11:34:03 AM E-13C South / E-13C North</p> </div>

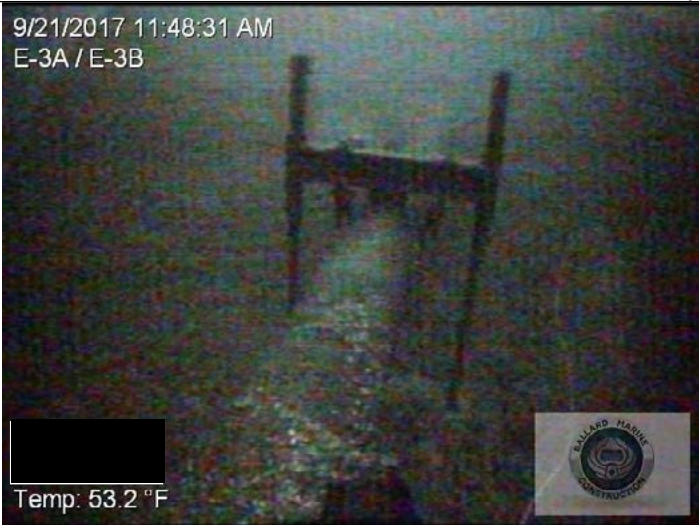
Overall North Affected Area							
<p><i>For all sections of dislodged coating or holidays, provide pictures below. Included the date and time stamps associated with video surveillance.</i></p>							
<div data-bbox="99 378 367 436"> <p>9/21/2017 11:48:31 AM E-3A / E-3B</p> </div>

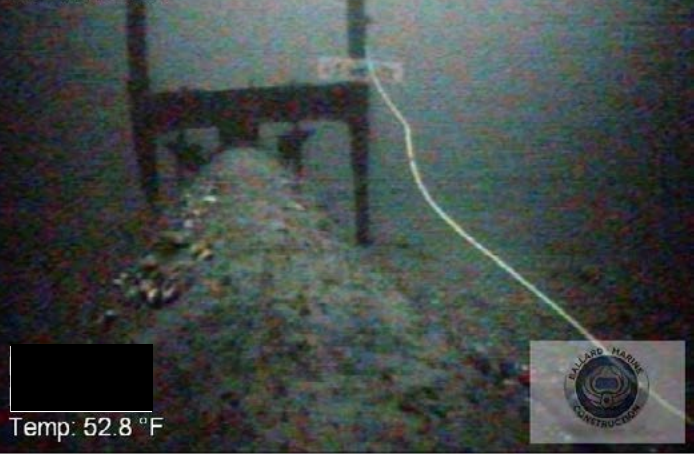
Overall South Affected Area							
<p><i>For all sections of dislodged coating or holidays, provide pictures below. Included the date and time stamps associated with video surveillance.</i></p>							
<div data-bbox="99 401 367 464"> <p>9/21/2017 11:59:24 AM E-76A / E-76B</p> </div>

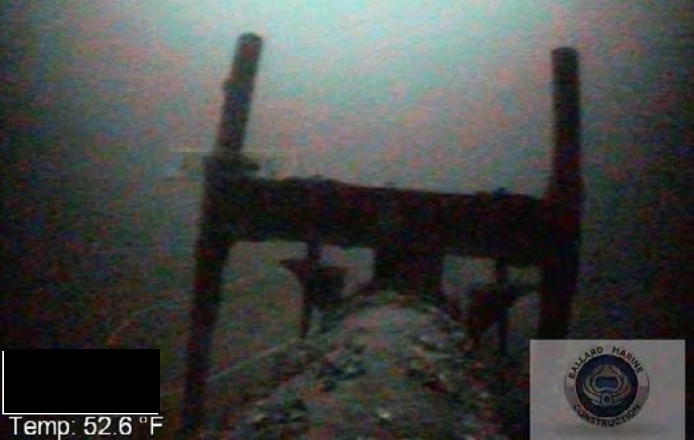
Anchor							
<p><i>For all sections of dislodged coating or holidays, provide pictures below. Included the date and time stamps associated with video surveillance.</i></p>							
<div data-bbox="99 1255 367 1318"> <p>9/21/2017 12:08:00 PM E-76A / E-76B</p> </div>

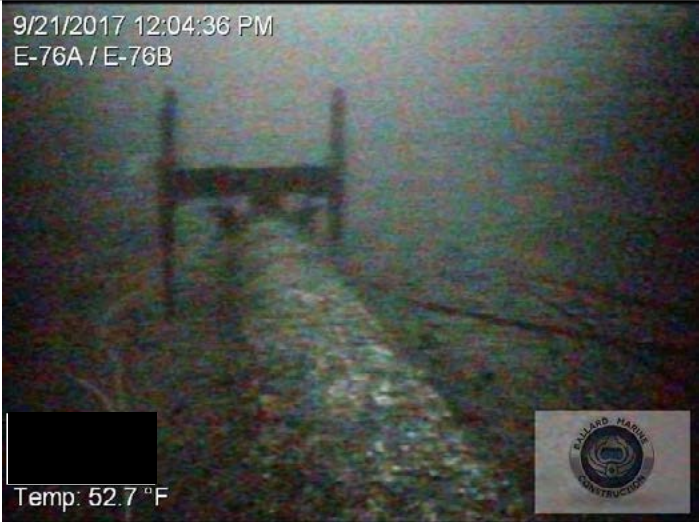
Overall North Affected Area							
<p><i>For all sections of dislodged coating or holidays, provide pictures below. Included the date and time stamps associated with video surveillance.</i></p>							
<div data-bbox="99 390 368 447"> <p>9/21/2017 12:04:36 PM E-76A / E-76B</p> </div>

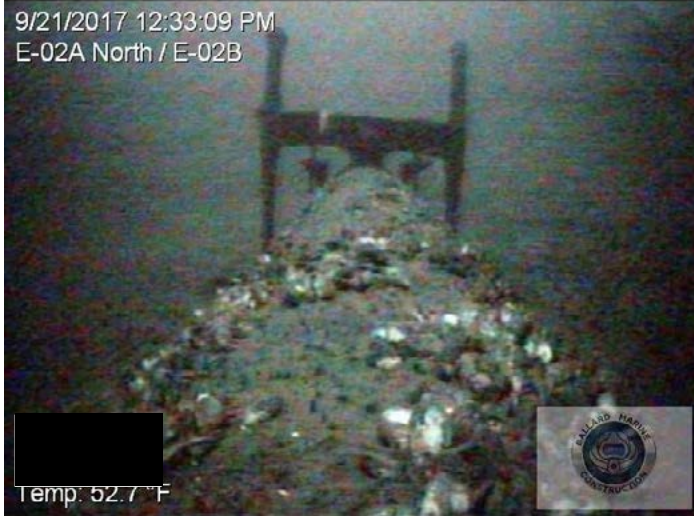
Overall South Affected Area

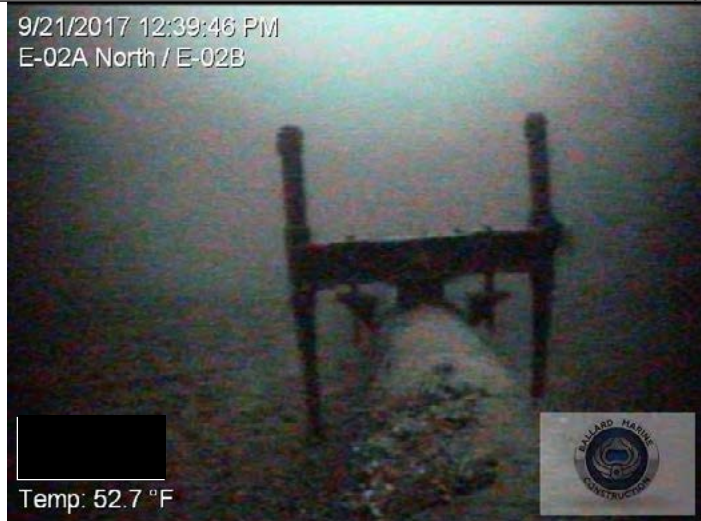
Overall North Affected Area

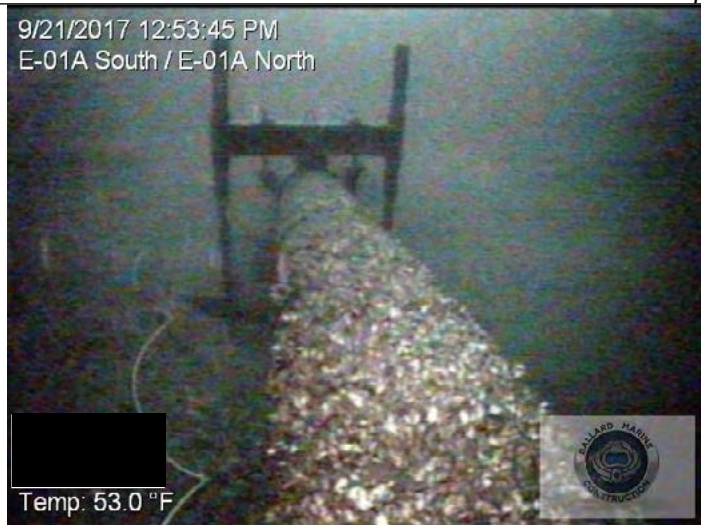
Overall North Affected Area

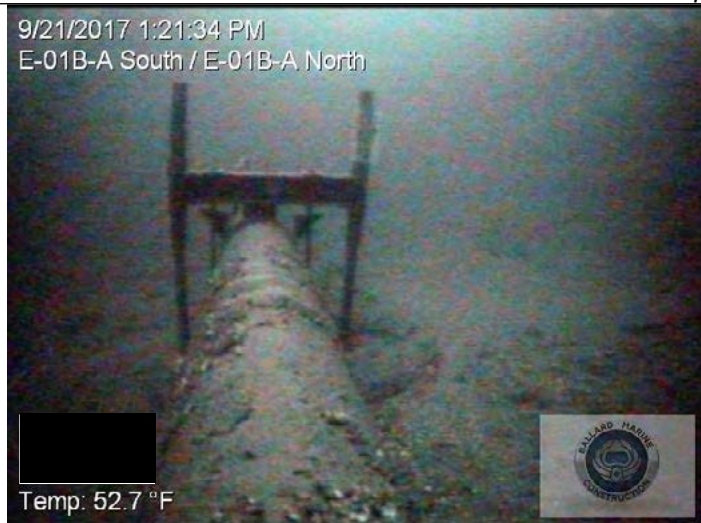
Overall North Affected Area

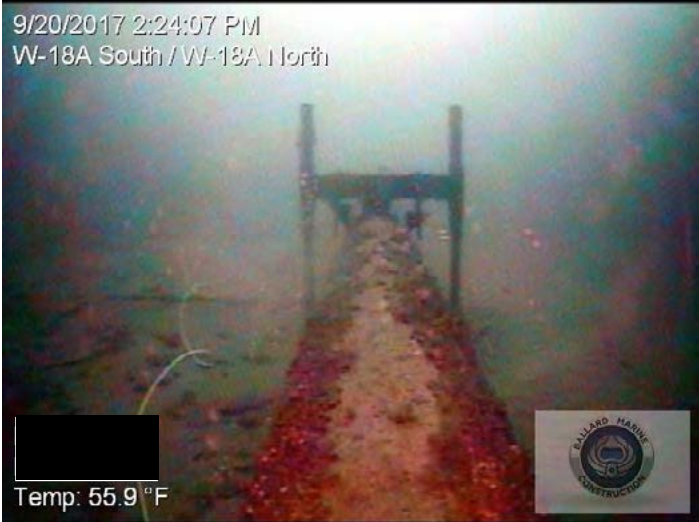
Overall North Affected Area							
<p><i>For all sections of dislodged coating or holidays, provide pictures below. Included the date and time stamps associated with video surveillance.</i></p>							
<div data-bbox="99 556 423 615"> <p>9/20/2017 2:24:07 PM W-18A South / W-18A North</p> </div>

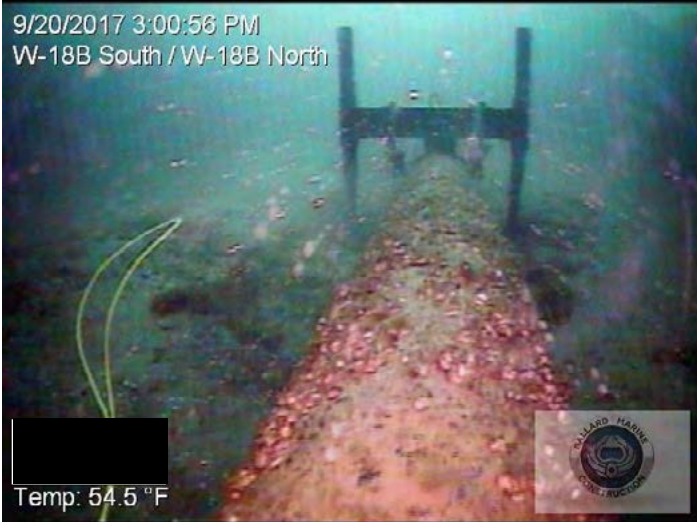
Overall North Affected Area							
<p>Comments:</p> <p align="center"><i>For all sections of dislodged coating or holidays, provide pictures below. Included the date and time stamps associated with video surveillance.</i></p>

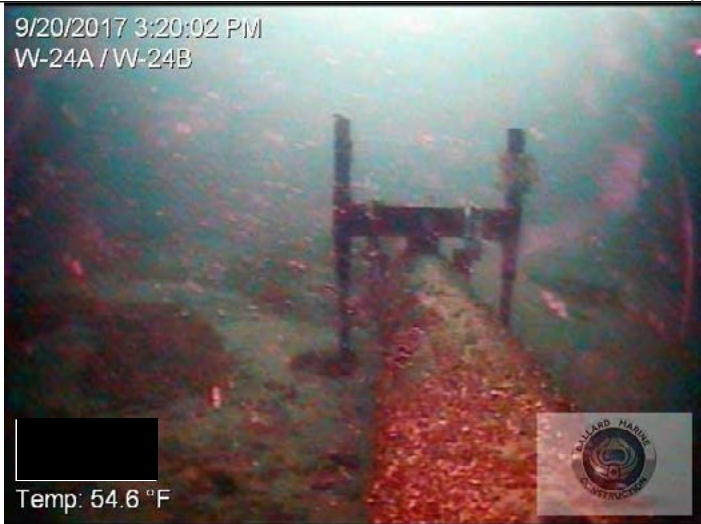
Overall South Affected Area											
<i>For all sections of dislodged coating or holidays, provide pictures below. Included the date and time stamps associated with video surveillance.</i>											
<div style="border: 1px solid black; padding: 5px;"> <div style="font-size: small; margin-bottom: 5px;">9/20/2017 3:20:02 PM W-24A / W-24B</div>

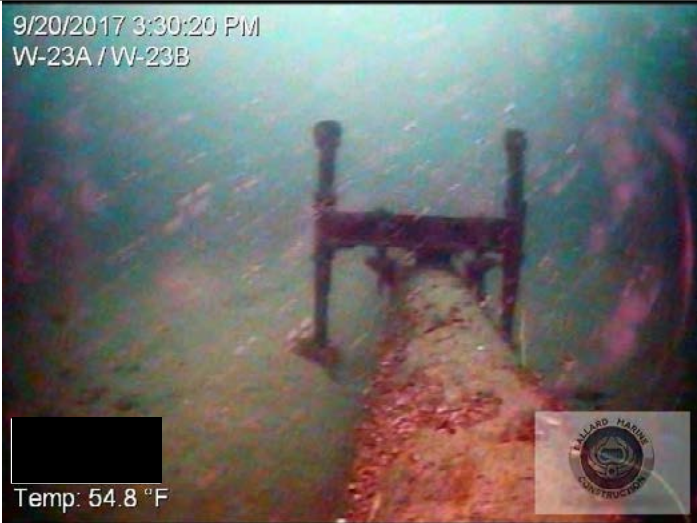
Overall South Affected Area							
<i>For all sections of dislodged coating or holidays, provide pictures below. Included the date and time stamps associated with video surveillance.</i>							
<div style="border: 1px solid black; padding: 5px;"> <div style="font-size: small; margin-bottom: 5px;">9/20/2017 3:30:20 PM W-23A / W-23B</div>

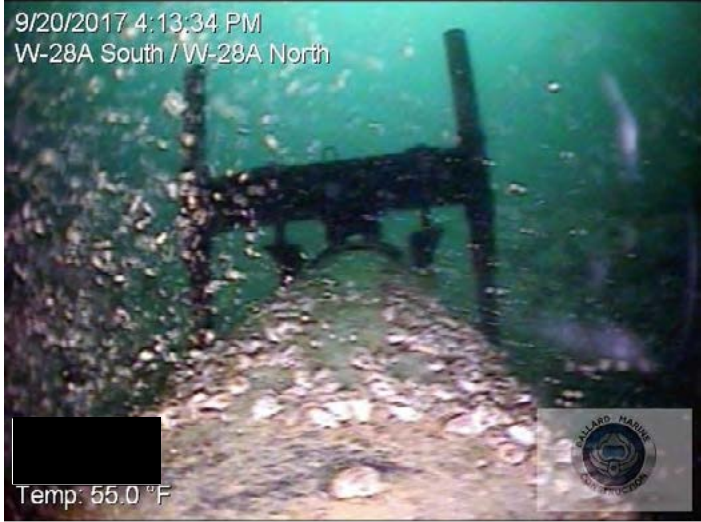
Overall North Affected Area							
<p><i>For all sections of dislodged coating or holidays, provide pictures below. Included the date and time stamps associated with video surveillance.</i></p>							
<div data-bbox="92 338 789 856"> <div> 9/20/2017 4:13:34 PM W-28A South / W-28A North </div>

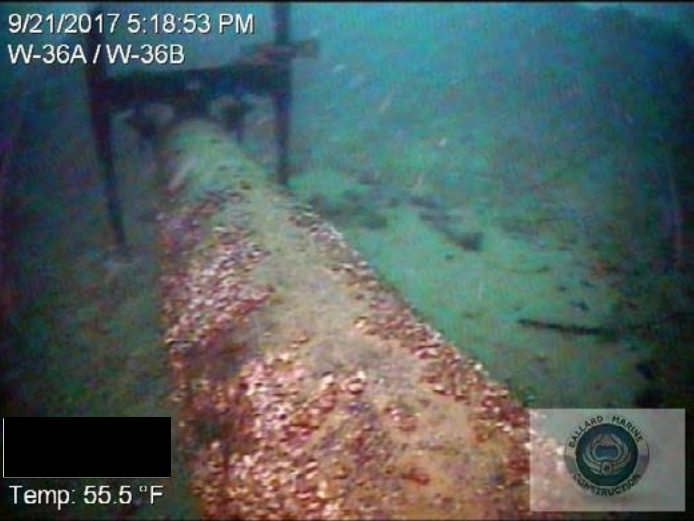
South End of Affected and Non-Affected Area							
<i>For all sections of dislodged coating or holidays, provide pictures below. Included the date and time stamps associated with video surveillance.</i>							
<div style="border: 1px solid black; padding: 5px;"> <div style="font-size: small; margin-bottom: 5px;">9/21/2017 5:18:53 PM W-36A / W-36B</div>
