**Enbridge Energy, Limited Partnership
Enbridge Line 5 - Straits of Mackinac**

**Coating Inspections, Findings and Repairs
from Activities Completed in 2017**

**Anchor Inspection Work Plan:
Interim Report**

Submitted: January 16, 2018

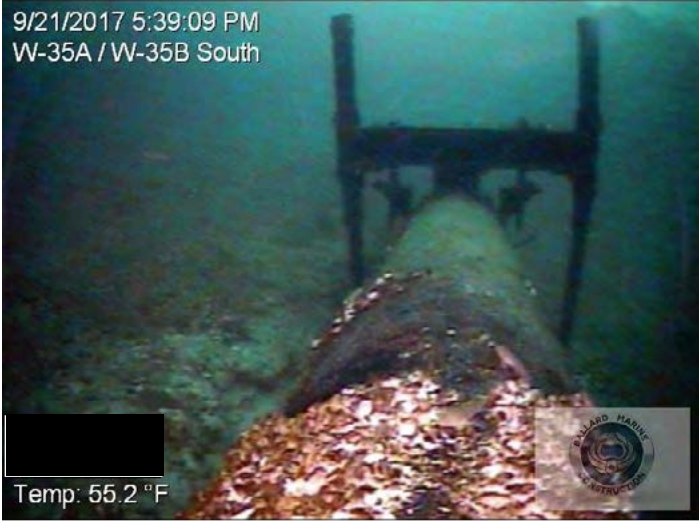
Overall North Affected Area							
<p><i>For all sections of dislodged coating or holidays, provide pictures below. Included the date and time stamps associated with video surveillance.</i></p>							
<div data-bbox="99 548 354 606"> <p>9/21/2017 5:39:09 PM W-35A / W-35B South</p> </div>

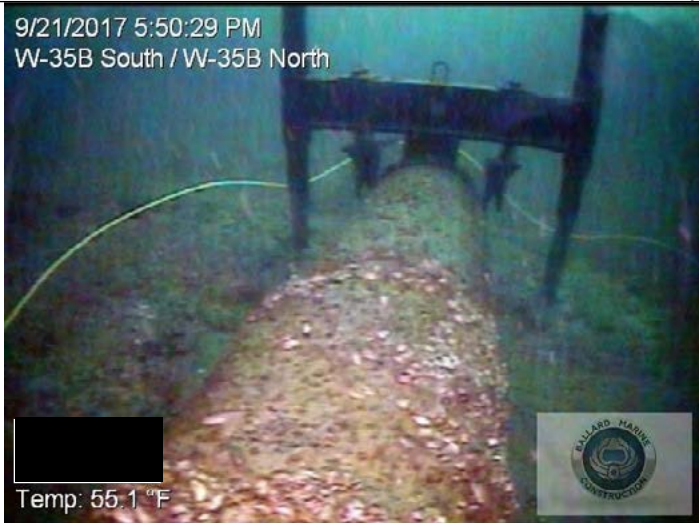
Overall North Affected Area							
<p><i>For all sections of dislodged coating or holidays, provide pictures below. Included the date and time stamps associated with video surveillance.</i></p>							
<div data-bbox="92 436 787 955"> <div>9/21/2017 5:50:29 PM W-35B South / W-35B North</div>

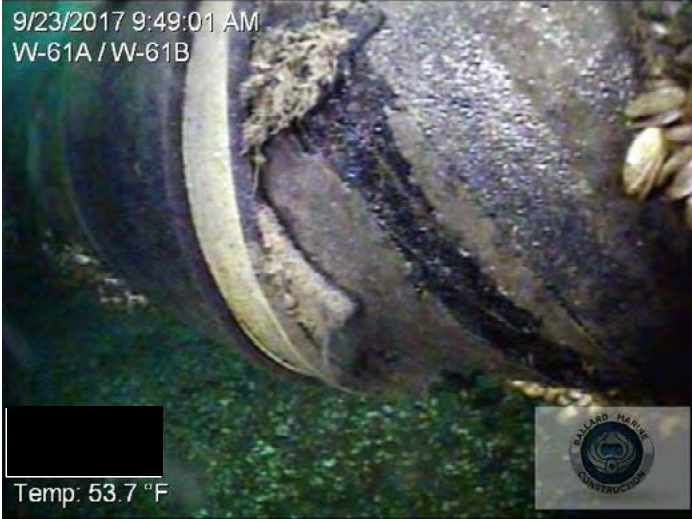
Feature #3

Feature 3 Notes: Picture shows possible dislodged coating beginning at anchor and continuing to the north.

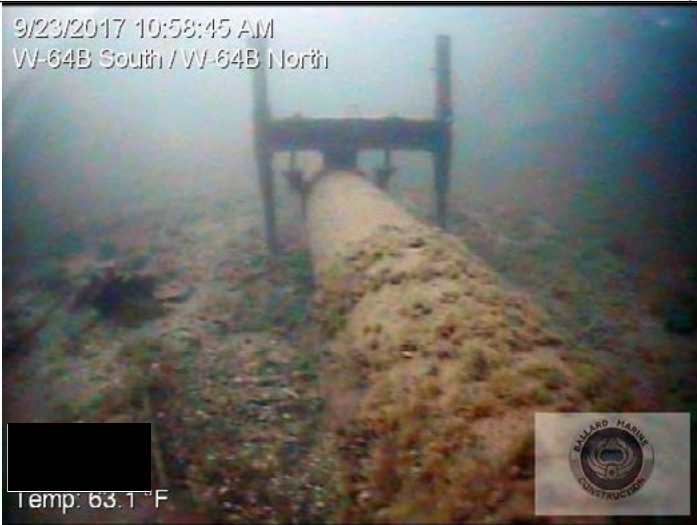
Overall North Affected Area							
<p><i>For all sections of dislodged coating or holidays, provide pictures below. Included the date and time stamps associated with video surveillance.</i></p>							
<div data-bbox="94 541 423 600"> <p>9/23/2017 10:58:45 AM W-64B South / VV-64B North</p> </div>

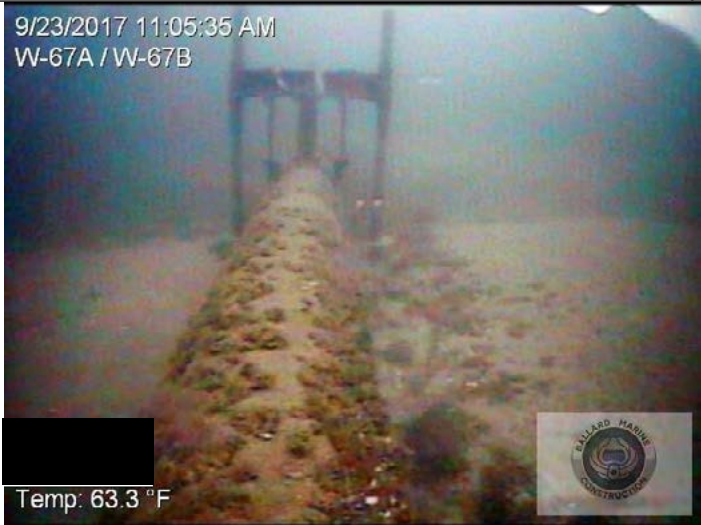
Overall South Affected Area							
<p align="center"><i>For all sections of dislodged coating or holidays, provide pictures below. Included the date and time stamps associated with video surveillance.</i></p>							
<div data-bbox="99 531 368 590"> <p>9/23/2017 11:05:35 AM W-67A / W-67B</p> </div>
