# Diver Inspection Form for L5 Straits of Mackinac

Date:	09/30/17	Diver:	Troy Baskett, Maurice Unger, Chad Cantrell, George Palmer
AFE / W.O.#:	20011702	Company Rep / Inspector:	[REDACTED]
Pipe Support Anchor:	E-1 (E-74A/E-74B South)	Water Depth (ft):	[REDACTED]
Longitude:	[REDACTED]	Latitude:	[REDACTED]

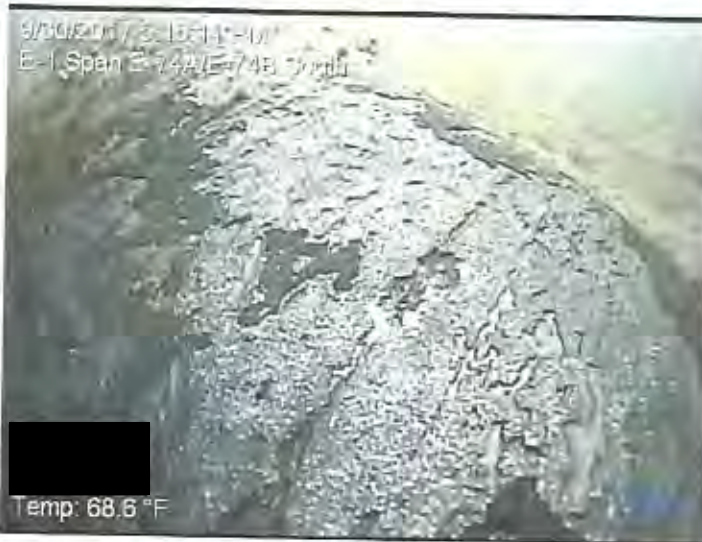
Date:	09/30/17	Frame(HH:MM:SS)	05:15:11	Date:		Frame(HH:MM:SS)	
-------	----------	-----------------	----------	-------	--	-----------------	--

<p>Biota Coating Repair EAS-2 is 9' North of Anchor</p> <p>Feature 1, Possible dislodged area of adjacent coating due to movement when touched, 0% of the area showed bare metal after deposit removal</p> <p>Feature 3, 0% of the area showed bare metal after deposit removal</p> <p>Feature 4, Approximately 75% of the area showed bare metal after deposit removal</p> <p>Feature 5, 100% of the area showed bare metal after deposit removal</p>

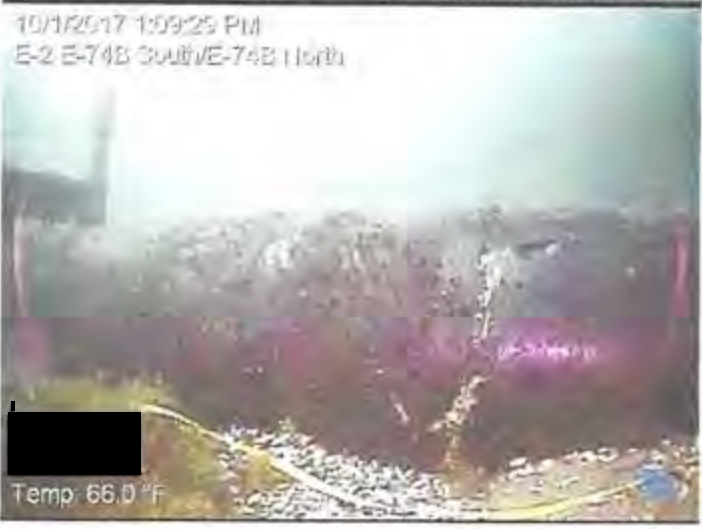
Date:	10/1/17	Frame(HH:MM:SS)	01:09:29	Date:	10/1/17	Frame(HH:MM:SS)	02:08:06

Cathodic Protection and Coating Measurements (for Feature # 3)							
CP Reading #1 (mV) (north end of feature)	-261 -265	CP Reading #2 (mV) (center of feature)	NR	CP Reading #3 (mV) (south end of feature)	-275 -267		
DFT #1 (mil) (north end of feature)	125	DFT #2 (mil) (center of feature)	NR	DFT #3 (mil) (south end of feature)	130		
(record #2 for features < 2" long; record #1 and #3 for features 2"-8" long; record #1, #2 and #3 for features >8" long)							
Temperature (°F)	N/R	DFT Adjacent to Feature (mil) (~2" away from edge)	110	DFT Adjacent to Feature (mil) (~8"-12" away from edge)	90		
			150		170		
			100		105		
			90		120		
<p>Provide 1 to 2 photos of feature, below:                      Included the date and time stamps associated with video surveillance.</p>							
<p>10/1/2017 1:09:29 PM                      E-2 E-74B South/E-74B North</p>

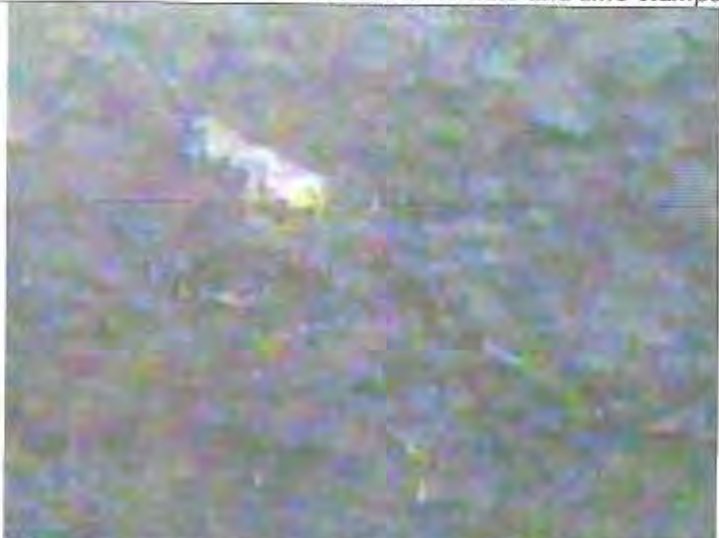
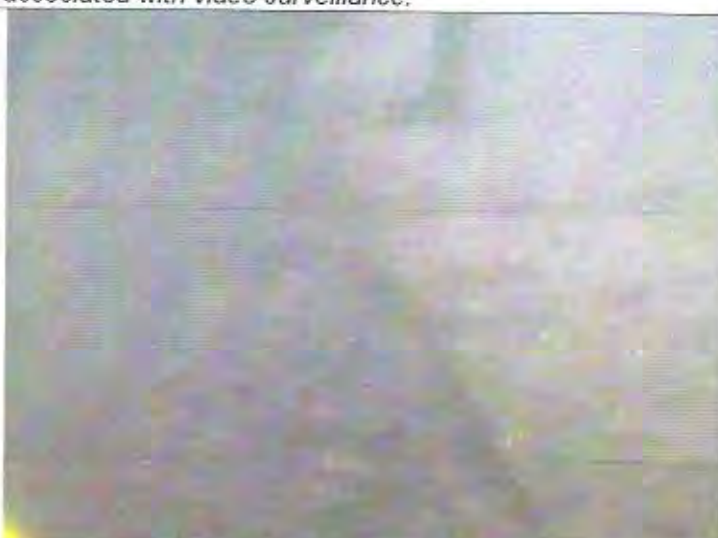
Date:	10/26/17	Frame(HH:MM:SS)	00:14:35	Date:	10/26/17
				Frame(HH:MM:SS)	00:21:24

Cathodic Protection and Coating Measurements (for Feature # 1)					
CP Reading #1 (mV) (north end of feature)	N/R	CP Reading #2 (mV) (center of feature)	N/R	CP Reading #3 (mV) (south end of feature)	N/R
DFT #1 (mil) (north end of feature)	N/R	DFT #2 (mil) (center of feature)	N/R	DFT #3 (mil) (south end of feature)	N/R
(record #2 for features < 2" long; record #1 and #3 for features 2"-8" long; record #1, #2 and #3 for features >8" long)					
Temperature (°F)	58°	DFT Adjacent to Feature (mil) (~2" away from edge)	N/R	DFT Adjacent to Feature (mil) (~8"-12" away from edge)	N/R
			N/R		N/R
			N/R		N/R
			N/R		N/R
<p align="center">Provide 1 to 2 photos of feature, below: Included the date and time stamps associated with video surveillance.</p>

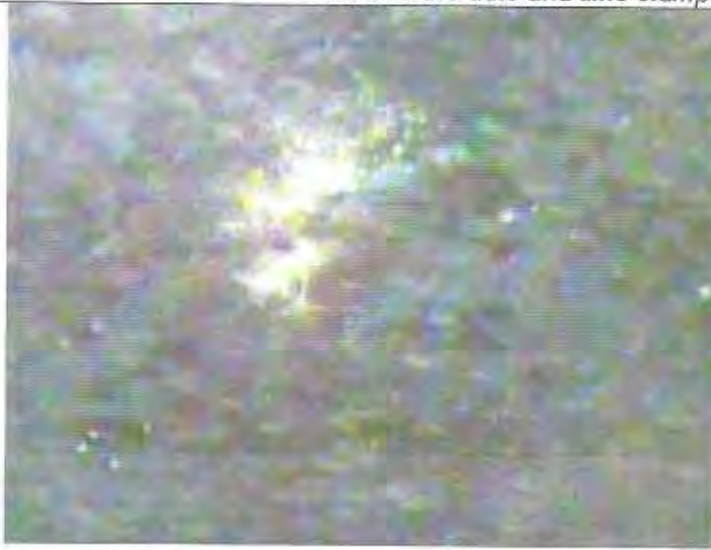
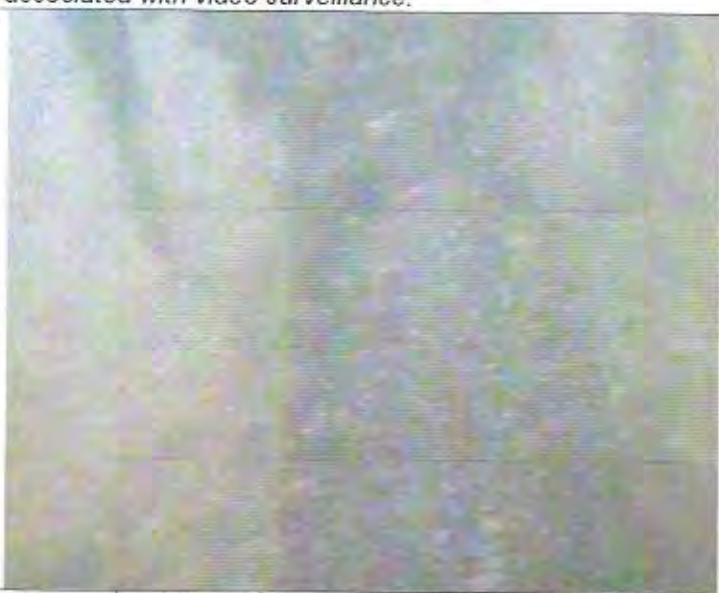
Date:	10/26/17	Frame(HH:MM:SS)	00:18:49	Date:	10/26/17
				Frame(HH:MM:SS)	00:19:54

Comments/Issues/Discussion	
	<p>Feature 3, Dislodged area is 12" X 18" area that is lifting</p> <p>Feature 5, Dislodged area is approximately 30% of area from anchor to 6' South that has outer wrap missing</p> <p>Feature 6, Dislodged area is approximately 5% of area from anchor to 6' North that has outer wrap missing</p>

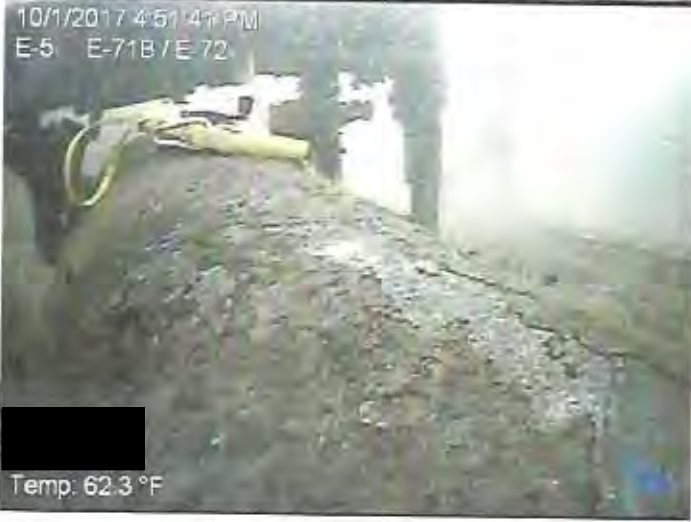
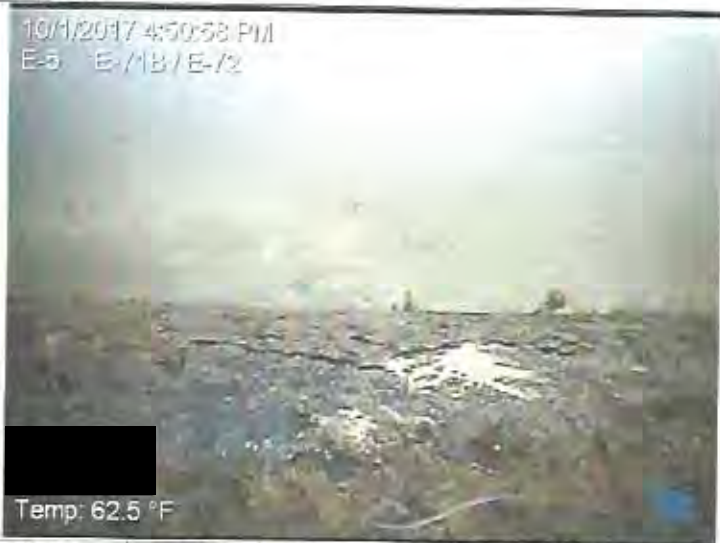
Date:	10/1/17	Frame(HH:MM:SS)	04:51:41	Date:	10/1/17
				Frame(HH:MM:SS)	04:50:58

Cathodic Protection and Coating Measurements (for Feature # 3)					
CP Reading #1 (mV) (north end of feature)	NR	CP Reading #2 (mV) (center of feature)	-1630 -1681	CP Reading #3 (mV) (south end of feature)	NR
DFT #1 (mil) (north end of feature)	NR	DFT #2 (mil) (center of feature)	100	DFT #3 (mil) (south end of feature)	NR
(record #2 for features < 2" long; record #1 and #3 for features 2"-8" long; record #1, #2 and #3 for features >8" long)					
Temperature (°F)	N/R	DFT Adjacent to Feature (mil) (~2" away from edge)	140	DFT Adjacent to Feature (mil) (~8"-12" away from edge)	145
			160		180
			180		145
			135		180
Provide 1 to 2 photos of feature, below: Included the date and time stamps associated with video surveillance.

Note: CP reading #2 indicates probe contact with pipe metal. Because no bare metal was observed, we believe the CP gun probe tip penetrated residual coating for this reading.

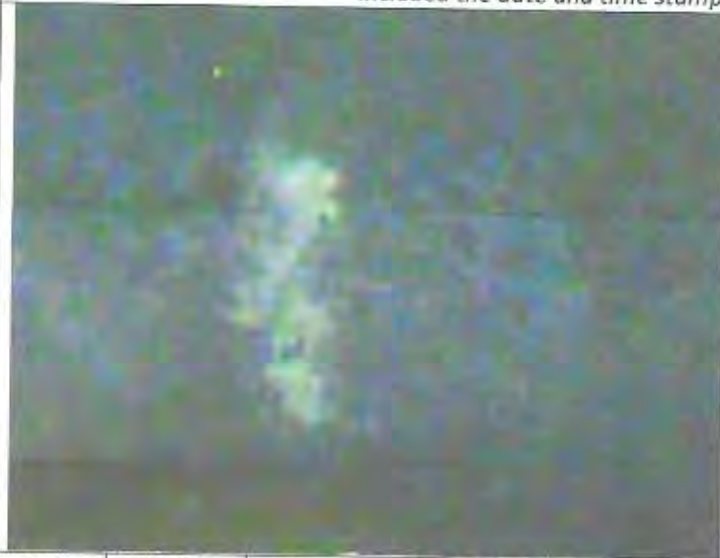
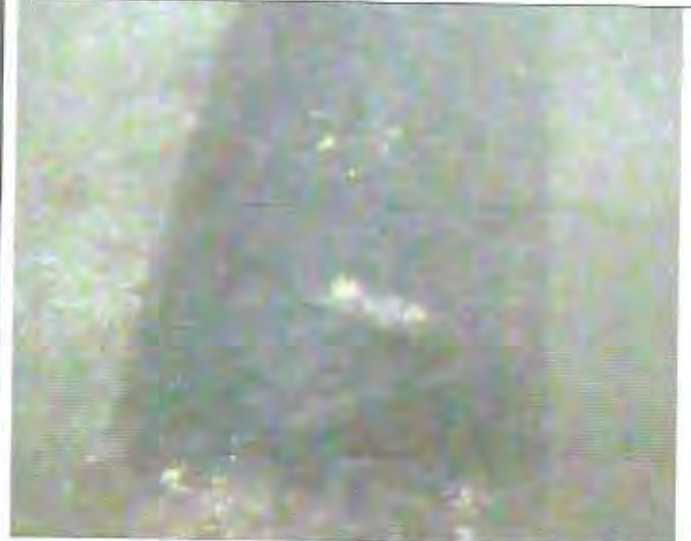
Date:	10/26/17	Frame(HH:MM:SS)	00:14:34	Date:	10/26/17	Frame(HH:MM:SS)	00:22:14
-------	----------	-----------------	----------	-------	----------	-----------------	----------

Comments/Issues/Discussion	
	<p>Feature 1, Approximately 2% of the area showed bare metal after deposit removal. Sample taken of deposit, peeling some coating off with sample, believed to be outer wrap</p> <p>Feature 2, Approximately 75% of the area showed bare metal after deposit removal</p> <p>Feature 3, Approximately 25% of the area showed bare metal after deposit removal</p> <p>Feature 4, 0% of the area showed bare metal after deposit removal—outer wrap missing – after DFTs and CP readings, no bare metal as the diver visually thought</p>

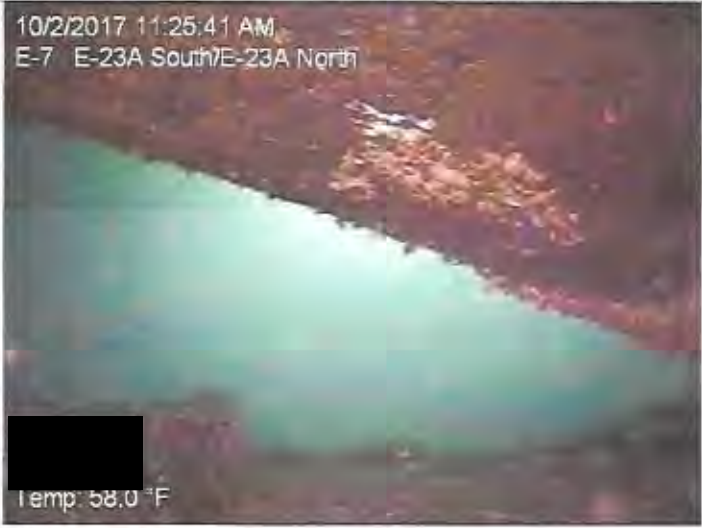
Cathodic Protection and Coating Measurements (for Feature # 1)					
CP Reading #1 (mV) (north end of feature)	-1480 -1500	CP Reading #2 (mV) (center of feature)	N/R	CP Reading #3 (mV) (south end of feature)	-1460 -1485
DFT #1 (mil) (north end of feature)	<25	DFT #2 (mil) (center of feature)	N/R	DFT #3 (mil) (south end of feature)	<25
(record #2 for features < 2" long; record #1 and #3 for features 2"-8" long; record #1, #2 and #3 for features >8" long)					
Temperature (°F)	51°	DFT Adjacent to Feature (mil) (~2" away from edge)	145	DFT Adjacent to Feature (mil) (~8"-12" away from edge)	150
			100		130
			135		99
			85		99
Provide 1 to 2 photos of feature, below: Included the date and time stamps associated with video surveillance.					
<div> <div>10/2/2017 11:25:41 AM</div> <div>E-7 E-23A South/E-23A North</div>

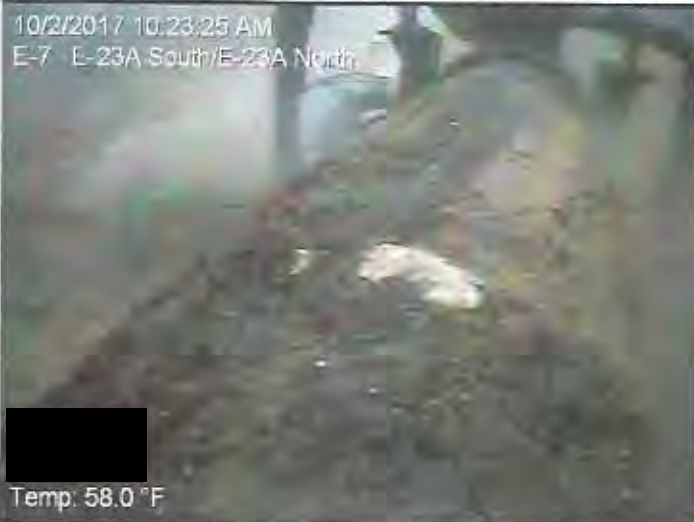
Cathodic Protection and Coating Measurements (for Feature # 2)					
CP Reading #1 (mV) (north end of feature)	-1606 -1608	CP Reading #2 (mV) (center of feature)	N/R	CP Reading #3 (mV) (south end of feature)	-1604 -1609
DFT #1 (mil) (north end of feature)	<25	DFT #2 (mil) (center of feature)	N/R	DFT #3 (mil) (south end of feature)	<25
(record #2 for features < 2" long; record #1 and #3 for features 2"-8" long; record #1, #2 and #3 for features >8" long)					
Temperature (°F)	51°	DFT Adjacent to Feature (mil) (~2" away from edge)	95	DFT Adjacent to Feature (mil) (~8"-12" away from edge)	110
			135		165
			125		115
			110		115
Provide 1 to 2 photos of feature, below: Included the date and time stamps associated with video surveillance.					
<div data-bbox="105 625 795 1144"> <div>10/2/2017 10:23:25 AM</div> <div>E-7 E-23A South/E-23A North</div>

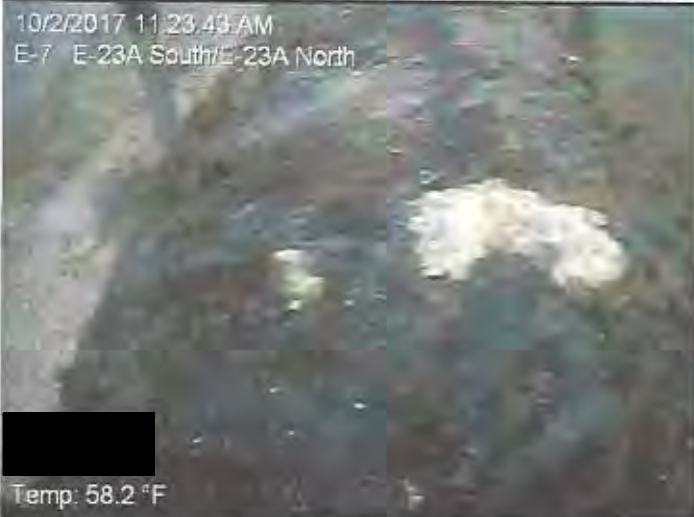
Cathodic Protection and Coating Measurements (for Feature # 3)					
CP Reading #1 (mV) (north end of feature)	N/R	CP Reading #2 (mV) (center of feature)	-1587 -1597	CP Reading #3 (mV) (south end of feature)	N/R
DFT #1 (mil) (north end of feature)	N/R	DFT #2 (mil) (center of feature)	100	DFT #3 (mil) (south end of feature)	N/R
(record #2 for features < 2" long; record #1 and #3 for features 2"-8" long; record #1, #2 and #3 for features >8" long)					
Temperature (°F)	51°	DFT Adjacent to Feature (mil) (~2" away from edge)	100	DFT Adjacent to Feature (mil) (~8"-12" away from edge)	140
			85		120
			107		130
			130		120
Provide 1 to 2 photos of feature, below: Included the date and time stamps associated with video surveillance.					
<div> <div>10/2/2017 11:23:43 AM</div> <div>E-7 E-23A South/E-23A North</div>

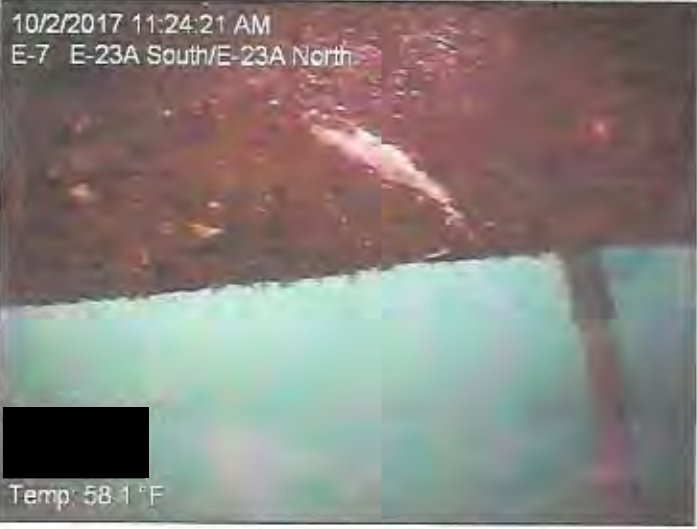
Cathodic Protection and Coating Measurements (for Feature # 4)					
CP Reading #1 (mV) (north end of feature)	-200 -202	CP Reading #2 (mV) (center of feature)	N/R	CP Reading #3 (mV) (south end of feature)	-198 -202
DFT #1 (mil) (north end of feature)	74	DFT #2 (mil) (center of feature)	N/R	DFT #3 (mil) (south end of feature)	135
(record #2 for features < 2" long; record #1 and #3 for features 2"-8" long; record #1, #2 and #3 for features >8" long)					
Temperature (°F)	51°	DFT Adjacent to Feature (mil) (~2" away from edge)	175	DFT Adjacent to Feature (mil) (~8"-12" away from edge)	190
			95		120
			140		102
			135		125
Provide 1 to 2 photos of feature, below:					
Included the date and time stamps associated with video surveillance.					
<div data-bbox="110 661 462 724"> 10/2/2017 11:24:21 AM  E-7 E-23A South/E-23A North </div>

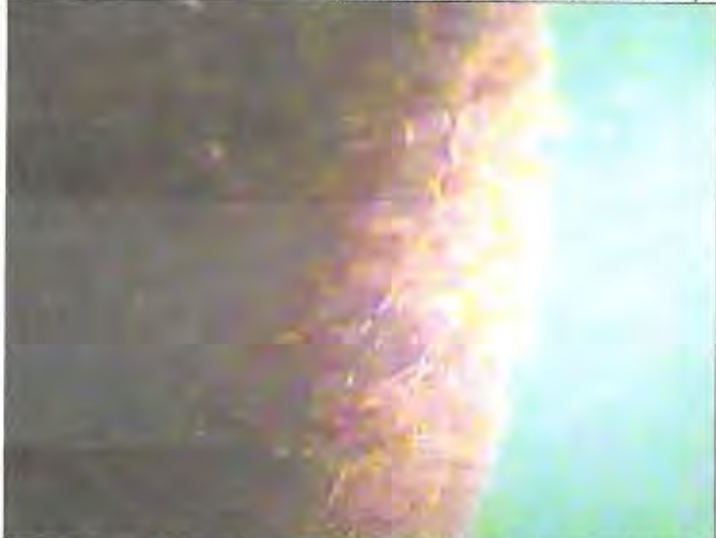
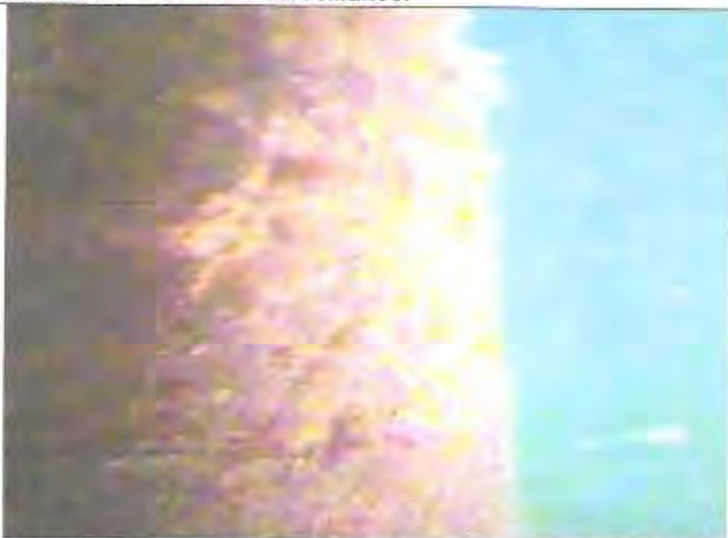
Cathodic Protection and Coating Measurements (for Feature # 1)					
CP Reading #1 (mV) (north end of feature)	N/R	CP Reading #2 (mV) (center of feature)	N/R	CP Reading #3 (mV) (south end of feature)	N/R
DFT #1 (mil) (north end of feature)	N/R	DFT #2 (mil) (center of feature)	N/R	DFT #3 (mil) (south end of feature)	N/R
(record #2 for features < 2" long; record #1 and #3 for features 2"-8" long; record #1, #2 and #3 for features >8" long)					
Temperature (°F)	58°	DFT Adjacent to Feature (mil) (~2" away from edge)	N/R	DFT Adjacent to Feature (mil) (~8"-12" away from edge)	N/R
			N/R		N/R
			N/R		N/R
			N/R		N/R
Provide 1 to 2 photos of feature, below: Included the date and time stamps associated with video surveillance.

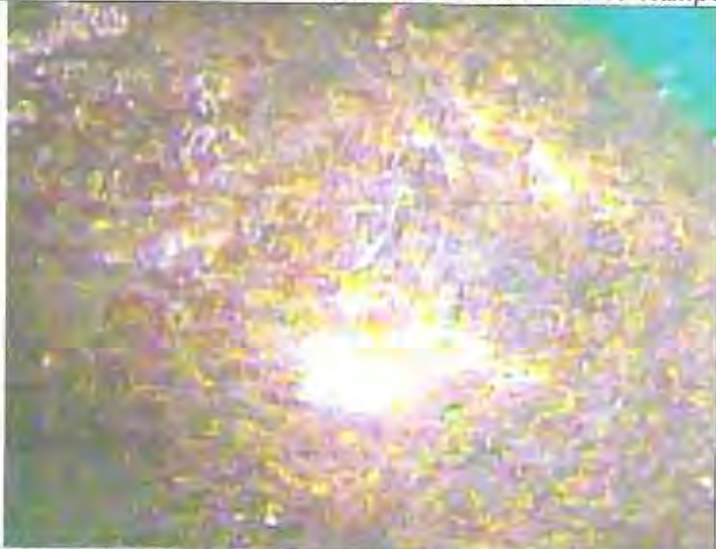
Cathodic Protection and Coating Measurements (for Feature # 2)					
CP Reading #1 (mV) (north end of feature)	N/R	CP Reading #2 (mV) (center of feature)	N/R	CP Reading #3 (mV) (south end of feature)	N/R
DFT #1 (mil) (north end of feature)	N/R	DFT #2 (mil) (center of feature)	N/R	DFT #3 (mil) (south end of feature)	N/R
(record #2 for features < 2" long; record #1 and #3 for features 2"-8" long; record #1, #2 and #3 for features >8" long)					
Temperature (°F)	58°	DFT Adjacent to Feature (mil) (~2" away from edge)	N/R	DFT Adjacent to Feature (mil) (~8"-12" away from edge)	N/R
			N/R		N/R
			N/R		N/R
			N/R		N/R
Provide 1 to 2 photos of feature, below: Included the date and time stamps associated with video surveillance.

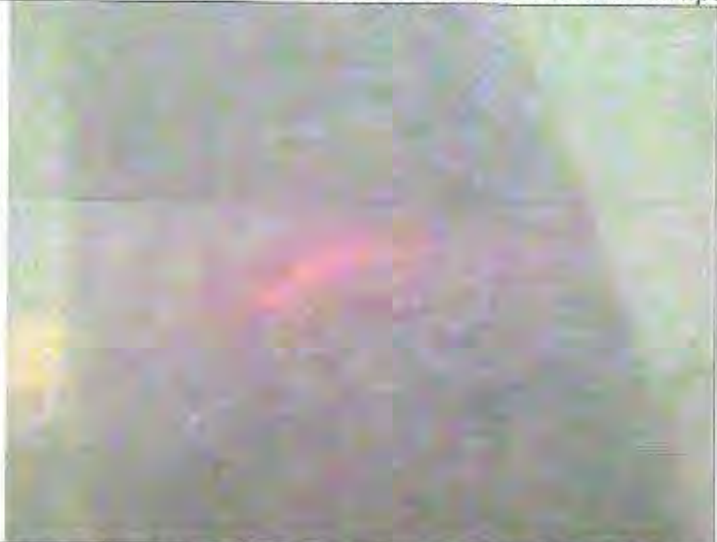
Cathodic Protection and Coating Measurements (for Feature # 3)					
CP Reading #1 (mV) (north end of feature)	N/R	CP Reading #2 (mV) (center of feature)	N/R	CP Reading #3 (mV) (south end of feature)	N/R
DFT #1 (mil) (north end of feature)	N/R	DFT #2 (mil) (center of feature)	N/R	DFT #3 (mil) (south end of feature)	N/R
(record #2 for features < 2" long; record #1 and #3 for features 2"-8" long; record #1, #2 and #3 for features >8" long)					
Temperature (°F)	58°	DFT Adjacent to Feature (mil) (~2" away from edge)	N/R	DFT Adjacent to Feature (mil) (~8"-12" away from edge)	N/R
			N/R		N/R
			N/R		N/R
			N/R		N/R
Provide 1 to 2 photos of feature, below: Included the date and time stamps associated with video surveillance.

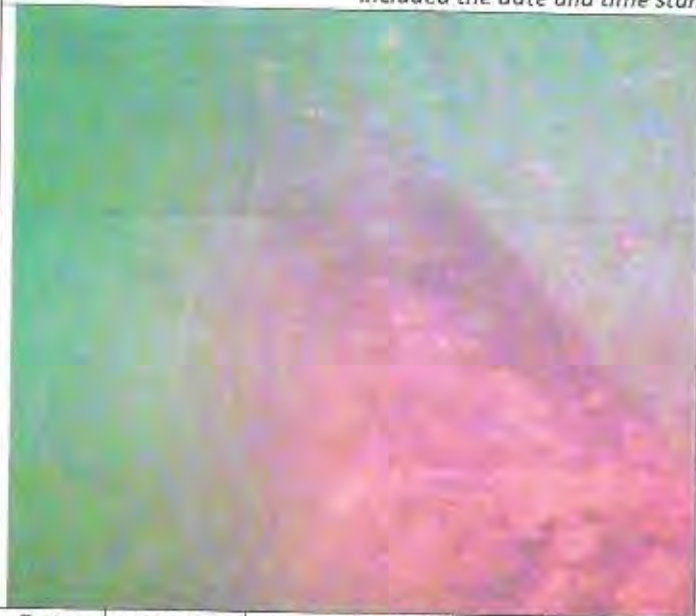
Comments/Issues/Discussion	
	<p>Feature 1, Dislodged area is approximately 85% of area from anchor to 6' South that has outer wrap missing</p> <p>Feature 5, Dislodged area is approximately 10% of area from anchor to 6' North that has outer wrap missing</p>
	<div style="display: flex; justify-content: space-between;"> <div data-bbox="289 779 727 955">

Cathodic Protection and Coating Measurements (for Feature # 1)					
CP Reading #1 (mV) (north end of feature)	N/R	CP Reading #2 (mV) (center of feature)	N/R	CP Reading #3 (mV) (south end of feature)	N/R
DFT #1 (mil) (north end of feature)	N/R	DFT #2 (mil) (center of feature)	N/R	DFT #3 (mil) (south end of feature)	N/R
(record #2 for features < 2" long; record #1 and #3 for features 2"-8" long; record #1, #2 and #3 for features >8" long)					
Temperature (°F)	58°	DFT Adjacent to Feature (mil) (~2" away from edge)	N/R	DFT Adjacent to Feature (mil) (~8"-12" away from edge)	N/R
			N/R		N/R
			N/R		N/R
			N/R		N/R

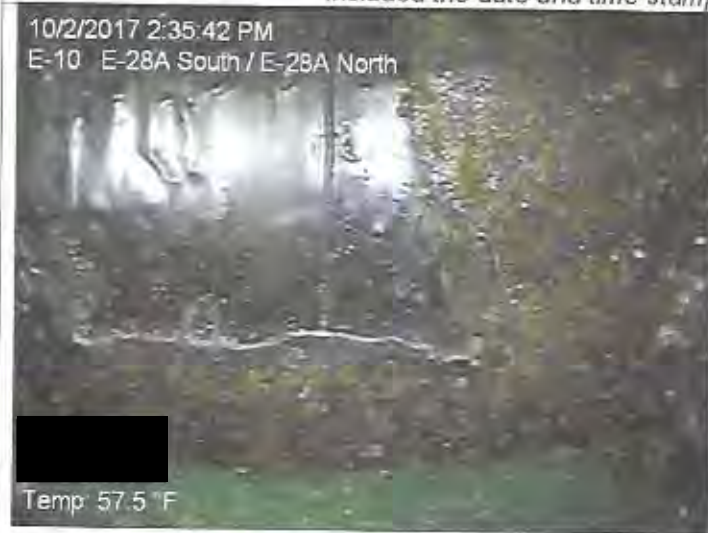
Cathodic Protection and Coating Measurements (for Feature # 1)					
CP Reading #1 (mV) (north end of feature)	N/R	CP Reading #2 (mV) (center of feature)	N/R	CP Reading #3 (mV) (south end of feature)	N/R
DFT #1 (mil) (north end of feature)	95	DFT #2 (mil) (center of feature)	80	DFT #3 (mil) (south end of feature)	80
(record #2 for features < 2" long; record #1 and #3 for features 2"-8" long; record #1, #2 and #3 for features >8" long)					
Temperature (°F)	56°	DFT Adjacent to Feature (mil) (~2" away from edge)	80	DFT Adjacent to Feature (mil) (~8"-12" away from edge)	80
			115		120
			115		82
			115		82

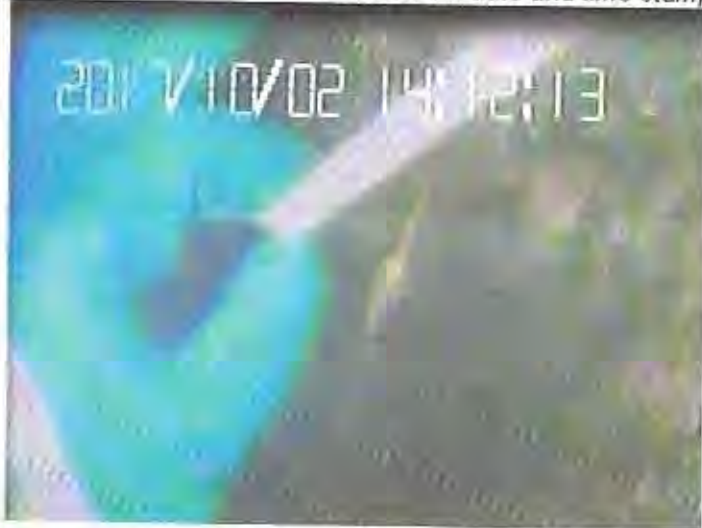
Cathodic Protection and Coating Measurements (for Feature # 3)					
CP Reading #1 (mV) (north end of feature)	-272 -282	CP Reading #2 (mV) (center of feature)	N/R	CP Reading #3 (mV) (south end of feature)	-285 -291
DFT #1 (mil) (north end of feature)	140	DFT #2 (mil) (center of feature)	N/R	DFT #3 (mil) (south end of feature)	135
(record #2 for features < 2" long; record #1 and #3 for features 2"-8" long; record #1, #2 and #3 for features >8" long)					
Temperature (°F)	54°	DFT Adjacent to Feature (mil) (~2" away from edge)	180	DFT Adjacent to Feature (mil) (~8"-12" away from edge)	115
			180		190
			200		170
			160		180
Provide 1 to 2 photos of feature, below: Included the date and time stamps associated with video surveillance.

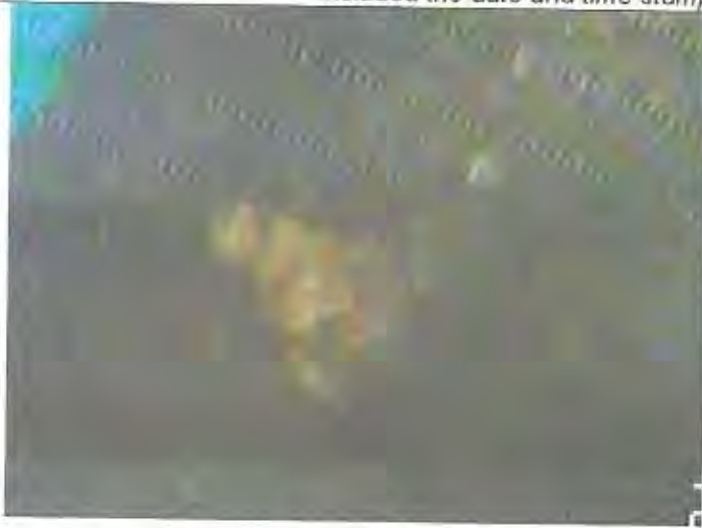
Cathodic Protection and Coating Measurements (for Feature # 4)					
CP Reading #1 (mV) (north end of feature)	-208 -212	CP Reading #2 (mV) (center of feature)	N/R	CP Reading #3 (mV) (south end of feature)	-205 -213
DFT #1 (mil) (north end of feature)	210	DFT #2 (mil) (center of feature)	N/R	DFT #3 (mil) (south end of feature)	240
(record #2 for features < 2" long; record #1 and #3 for features 2"-8" long; record #1, #2 and #3 for features >8" long)					
Temperature (°F)	54°	DFT Adjacent to Feature (mil) (~2" away from edge)	250	DFT Adjacent to Feature (mil) (~8"-12" away from edge)	160
			210		120
			240		190
			230		190
<p>Provide 1 to 2 photos of feature, below: Included the date and time stamps associated with video surveillance.</p> <div style="display: flex;"> <div style="flex: 1;">

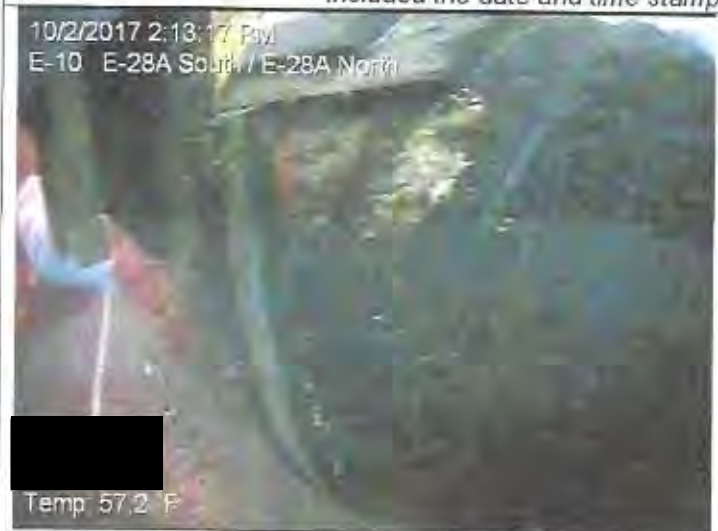
Cathodic Protection and Coating Measurements (for Feature # 5)					
CP Reading #1 (mV) (north end of feature)	-1571 -1568	CP Reading #2 (mV) (center of feature)	N/R	CP Reading #3 (mV) (south end of feature)	-1571 -1575
DFT #1 (mil) (north end of feature)	27	DFT #2 (mil) (center of feature)	N/R	DFT #3 (mil) (south end of feature)	66
(record #2 for features < 2" long; record #1 and #3 for features 2"-8" long; record #1, #2 and #3 for features >8" long)					
Temperature (°F)	56°	DFT Adjacent to Feature (mil) (~2" away from edge)	190	DFT Adjacent to Feature (mil) (~8"-12" away from edge)	170
			125		160
			135		95
			125		160

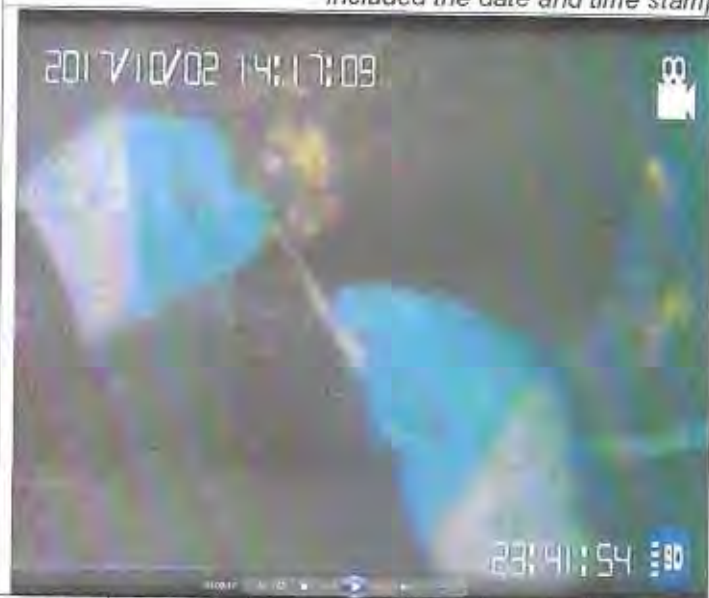
Cathodic Protection and Coating Measurements (for Feature # 6)					
CP Reading #1 (mV) (north end of feature)	-1569 -1568	CP Reading #2 (mV) (center of feature)	N/R	CP Reading #3 (mV) (south end of feature)	-1559 -1563
DFT #1 (mil) (north end of feature)	<25	DFT #2 (mil) (center of feature)	N/R	DFT #3 (mil) (south end of feature)	<25
(record #2 for features < 2" long; record #1 and #3 for features 2"-8" long; record #1, #2 and #3 for features >8" long)					
Temperature (°F)	56°	DFT Adjacent to Feature (mil) (~2" away from edge)	100	DFT Adjacent to Feature (mil) (~8"-12" away from edge)	105
			95		94
			101		98
			103		109

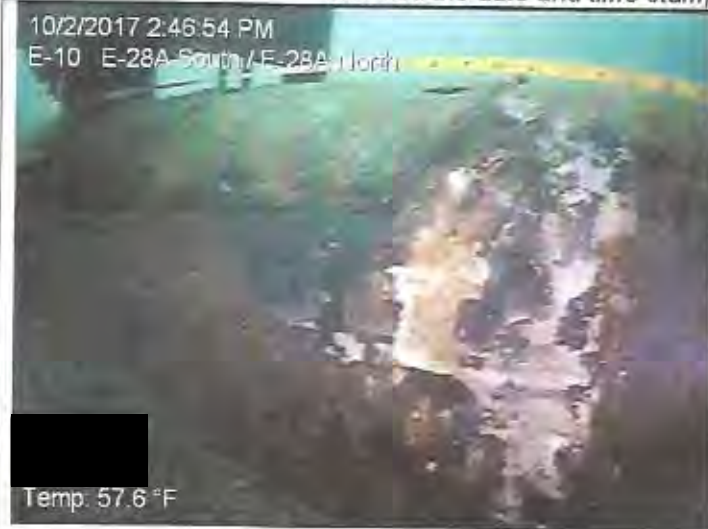
Cathodic Protection and Coating Measurements (for Feature # 7)					
CP Reading #1 (mV) (north end of feature)	-1475 -1476	CP Reading #2 (mV) (center of feature)	-1470 -1472	CP Reading #3 (mV) (south end of feature)	-1476 -1483
DFT #1 (mil) (north end of feature)	<25	DFT #2 (mil) (center of feature)	25	DFT #3 (mil) (south end of feature)	<25
(record #2 for features < 2' long; record #1 and #3 for features 2'-8" long; record #1, #2 and #3 for features >8" long)					
Temperature (°F)	56°	DFT Adjacent to Feature (mil) (~2" away from edge)	70	DFT Adjacent to Feature (mil) (~8"-12" away from edge)	73
			101		96
			75		66
			95		51

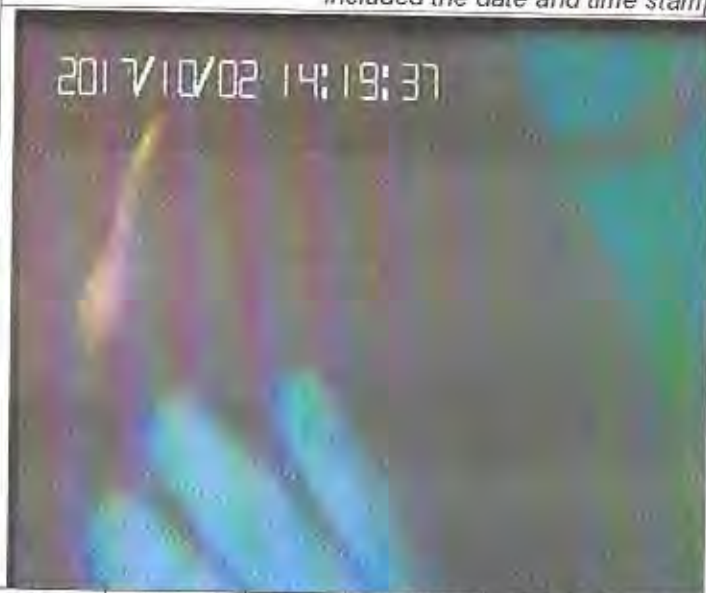
Cathodic Protection and Coating Measurements (for Feature # 8)					
CP Reading #1 (mV) (north end of feature)	-210 -208	CP Reading #2 (mV) (center of feature)	N/R	CP Reading #3 (mV) (south end of feature)	-227 -224
DFT #1 (mil) (north end of feature)	92	DFT #2 (mil) (center of feature)	N/R	DFT #3 (mil) (south end of feature)	78
(record #2 for features < 2" long; record #1 and #3 for features 2"-8" long; record #1, #2 and #3 for features >8" long)					
Temperature (°F)	56°	DFT Adjacent to Feature (mil) (~2" away from edge)	110	DFT Adjacent to Feature (mil) (~8"-12" away from edge)	110
			88		105
			96		98
			76		94
Provide 1 to 2 photos of feature, below: Included the date and time stamps associated with video surveillance.

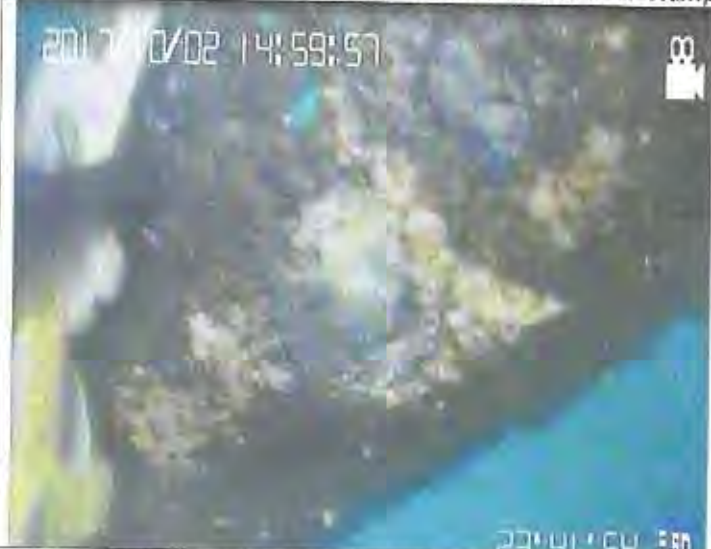
Cathodic Protection and Coating Measurements (for Feature # 11)					
CP Reading #1 (mV) (north end of feature)	-1509 -1511	CP Reading #2 (mV) (center of feature)	-1476 -1479	CP Reading #3 (mV) (south end of feature)	-1453 -1457
DFT #1 (mil) (north end of feature)	<25	DFT #2 (mil) (center of feature)	<25	DFT #3 (mil) (south end of feature)	<25
(record #2 for features < 2" long; record #1 and #3 for features 2"-8" long; record #1, #2 and #3 for features >8" long)					
Temperature (°F)	56°	DFT Adjacent to Feature (mil) (~2" away from edge)	94	DFT Adjacent to Feature (mil) (~8"-12" away from edge)	75
			111		89
			100		110
			105		93
Provide 1 to 2 photos of feature, below: Included the date and time stamps associated with video surveillance.

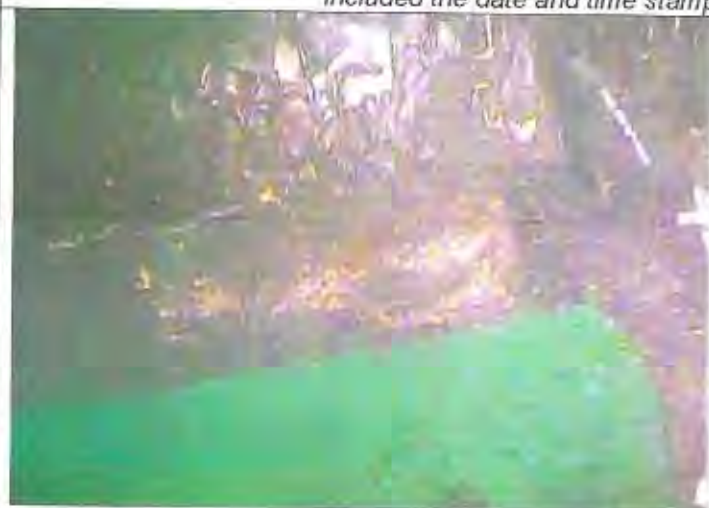
Cathodic Protection and Coating Measurements (for Feature # 12)					
CP Reading #1 (mV) (north end of feature)	-374 -372	CP Reading #2 (mV) (center of feature)	-1485 -1487	CP Reading #3 (mV) (south end of feature)	-405 -401
DFT #1 (mil) (north end of feature)	93	DFT #2 (mil) (center of feature)	<25	DFT #3 (mil) (south end of feature)	110
(record #2 for features < 2" long; record #1 and #3 for features 2"-8" long; record #1, #2 and #3 for features >8" long)					
Temperature (°F)	57°	DFT Adjacent to Feature (mil) (~2" away from edge)	98	DFT Adjacent to Feature (mil) (~8"-12" away from edge)	119
			100		96
			104		96
			109		111

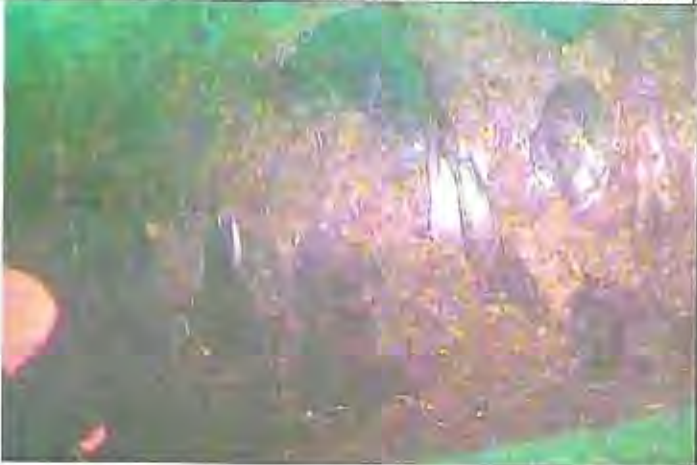
Cathodic Protection and Coating Measurements (for Feature #14)					
CP Reading #1 (mV) (north end of feature)	N/R	CP Reading #2 (mV) (center of feature)	N/R	CP Reading #3 (mV) (south end of feature)	N/R
DFT #1 (mil) (north end of feature)	105	DFT #2 (mil) (center of feature)	105	DFT #3 (mil) (south end of feature)	94
(record #2 for features < 2" long; record #1 and #3 for features 2"-8" long; record #1, #2 and #3 for features >8" long)					
Temperature (°F)	57°	DFT Adjacent to Feature (mil) (~2" away from edge)	125	DFT Adjacent to Feature (mil) (~8"-12" away from edge)	86
			125		108
			110		105
			111		121
Provide 1 to 2 photos of feature, below: Included the date and time stamps associated with video surveillance.

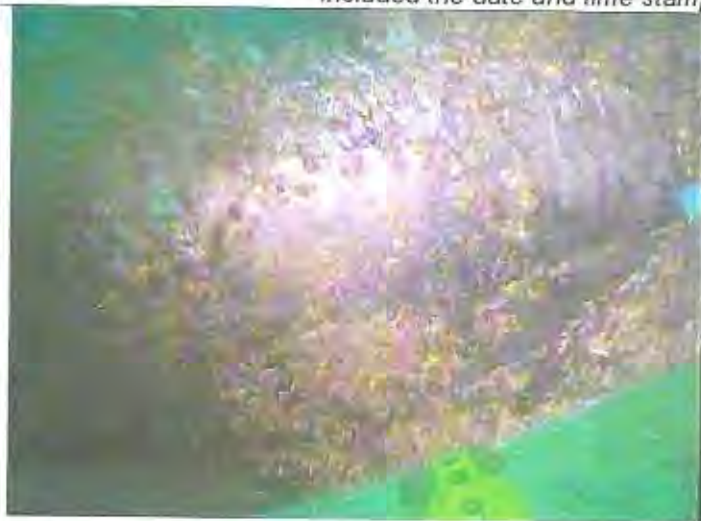
Cathodic Protection and Coating Measurements (for Feature #17)					
CP Reading #1 (mV) (north end of feature)	N/R	CP Reading #2 (mV) (center of feature)	N/R	CP Reading #3 (mV) (south end of feature)	N/R
DFT #1 (mil) (north end of feature)	71	DFT #2 (mil) (center of feature)	70	DFT #3 (mil) (south end of feature)	74
(record #2 for features < 2" long; record #1 and #3 for features 2"-8" long; record #1, #2 and #3 for features >8" long)					
Temperature (°F)	57°	DFT Adjacent to Feature (mil) (~2" away from edge)	100	DFT Adjacent to Feature (mil) (~8"-12" away from edge)	105
			84		87
			72		125
			115		102

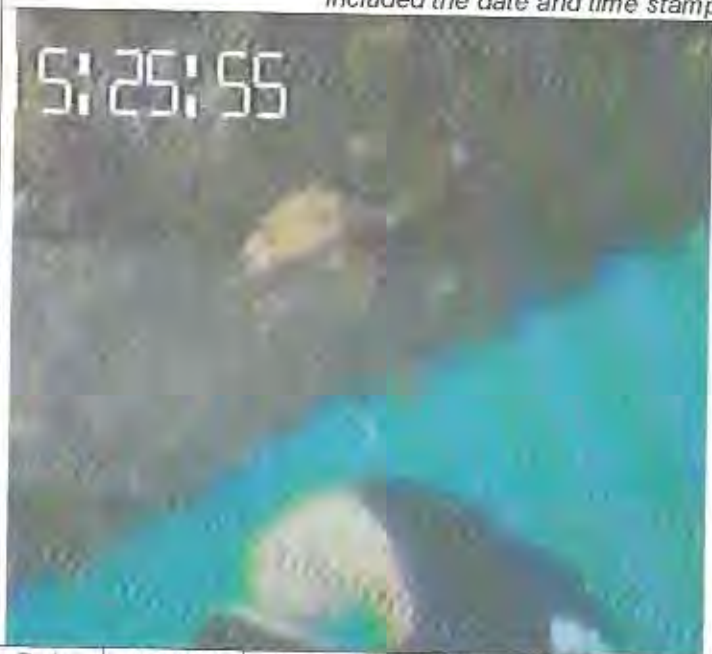
Cathodic Protection and Coating Measurements (for Feature # 18)					
CP Reading #1 (mV) (north end of feature)	N/R	CP Reading #2 (mV) (center of feature)	-293 -289	CP Reading #3 (mV) (south end of feature)	N/R
DFT #1 (mil) (north end of feature)	N/R	DFT #2 (mil) (center of feature)	49	DFT #3 (mil) (south end of feature)	N/R
(record #2 for features < 2" long; record #1 and #3 for features 2"-8" long; record #1, #2 and #3 for features >8" long)					
Temperature (°F)	56°	DFT Adjacent to Feature (mil) (~2" away from edge)	95	DFT Adjacent to Feature (mil) (~8"-12" away from edge)	110
			115		115
			110		100
			80		90

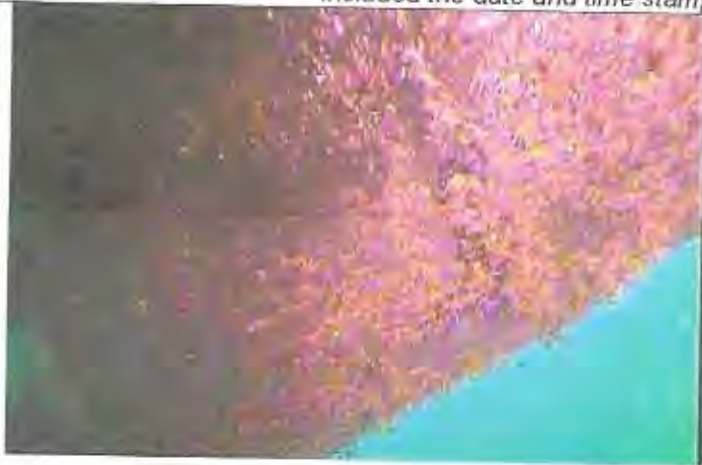
Cathodic Protection and Coating Measurements (for Feature #20)					
CP Reading #1 (mV) (north end of feature)	N/R	CP Reading #2 (mV) (center of feature)	N/R	CP Reading #3 (mV) (south end of feature)	N/R
DFT #1 (mil) (north end of feature)	110	DFT #2 (mil) (center of feature)	N/R	DFT #3 (mil) (south end of feature)	115
(record #2 for features < 2" long; record #1 and #3 for features 2"-8" long; record #1, #2 and #3 for features >8" long)					
Temperature (°F)	57°	DFT Adjacent to Feature (mil) (~2" away from edge)	115	DFT Adjacent to Feature (mil) (~8"-12" away from edge)	83
			115		115
			112		95
			109		110
Provide 1 to 2 photos of feature, below: Included the date and time stamps associated with video surveillance.

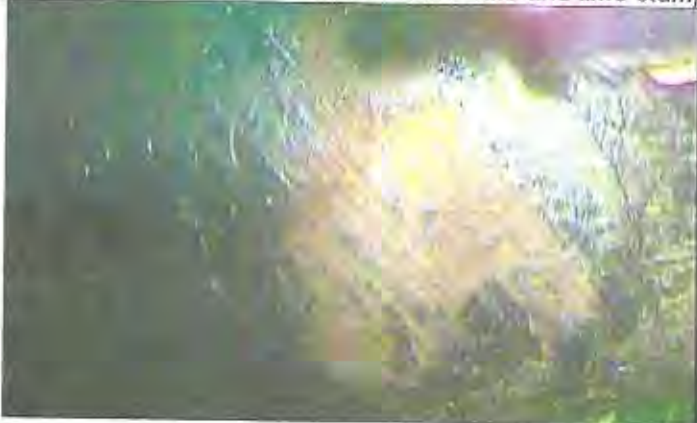
Cathodic Protection and Coating Measurements (for Feature #21)					
CP Reading #1 (mV) (north end of feature)	N/R	CP Reading #2 (mV) (center of feature)	N/R	CP Reading #3 (mV) (south end of feature)	N/R
DFT #1 (mil) (north end of feature)	77	DFT #2 (mil) (center of feature)	76	DFT #3 (mil) (south end of feature)	87
(record #2 for features < 2" long; record #1 and #3 for features 2"-8" long; record #1, #2 and #3 for features >8" long)					
Temperature (°F)	57°	DFT Adjacent to Feature (mil) (~2" away from edge)	84	DFT Adjacent to Feature (mil) (~8"-12" away from edge)	82
			69		91
			91		94
			105		100
Provide 1 to 2 photos of feature, below: Included the date and time stamps associated with video surveillance.

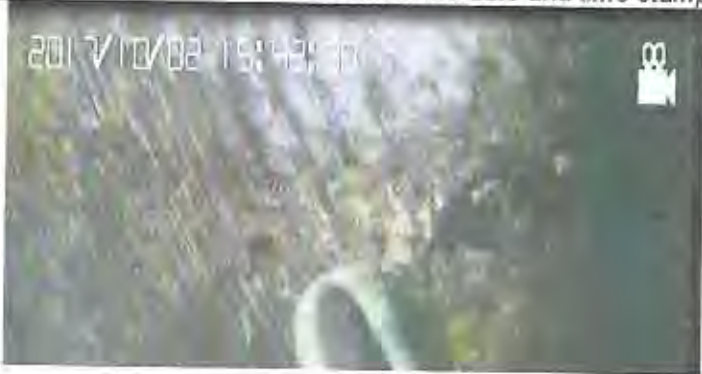
Cathodic Protection and Coating Measurements (for Feature # 22)					
<b>CP Reading #1 (mV)</b> (north end of feature)	N/R	<b>CP Reading #2 (mV)</b> (center of feature)	-177 -180	<b>CP Reading #3 (mV)</b> (south end of feature)	N/R
<b>DFT #1 (mil)</b> (north end of feature)	N/R	<b>DFT #2 (mil)</b> (center of feature)	101	<b>DFT #3 (mil)</b> (south end of feature)	N/R
(record #2 for features < 2" long; record #1 and #3 for features 2"-8" long; record #1, #2 and #3 for features >8" long)					
<b>Temperature (°F)</b>	56°	<b>DFT Adjacent to Feature (mil)</b> (~2" away from edge)	105	<b>DFT Adjacent to Feature (mil)</b> (~8"-12" away from edge)	95
			100		120
			125		100
			79		109
<p>Provide 1 to 2 photos of feature, below:            Included the date and time stamps associated with video surveillance.</p>

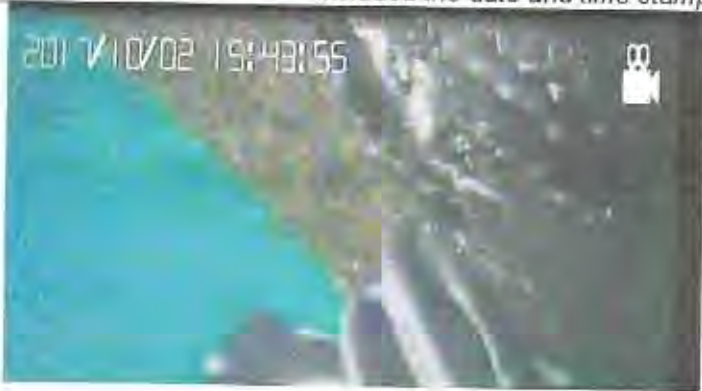
Cathodic Protection and Coating Measurements (for Feature #23)					
CP Reading #1 (mV) (north end of feature)	-1601 -1607	CP Reading #2 (mV) (center of feature)	-347 -347	CP Reading #3 (mV) (south end of feature)	-300 -303
DFT #1 (mil) (north end of feature)	71	DFT #2 (mil) (center of feature)	52	DFT #3 (mil) (south end of feature)	65
(record #2 for features < 2" long; record #1 and #3 for features 2"-8" long; record #1, #2 and #3 for features >8" long)					
Temperature (°F)	56°	DFT Adjacent to Feature (mil) (~2" away from edge)	110	DFT Adjacent to Feature (mil) (~8"-12" away from edge)	88
			38		70
			105		94
			100		95
Provide 1 to 2 photos of feature, below: Included the date and time stamps associated with video surveillance.

Note: CP reading #1 indicates probe contact with pipe metal. Because no bare metal was observed, we believe the CP gun probe tip penetrated residual coating for this reading.

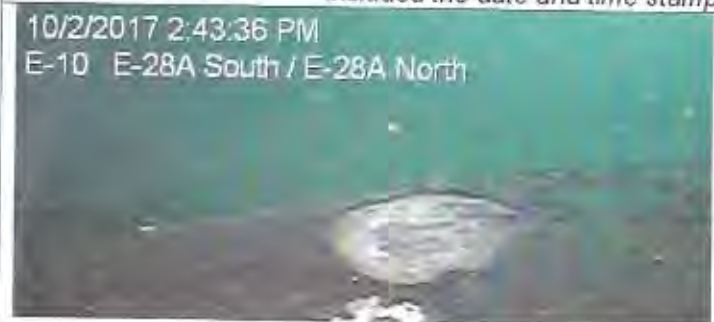
Date:	10/2/17	Frame(HH:MM:SS)	02:43:36	Date:		Frame(HH:MM:SS)	
-------	---------	-----------------	----------	-------	--	-----------------	--

Temperature (°F)	56°	DFT Adjacent to Feature (mil) (~2" away from edge)	84	DFT Adjacent to Feature (mil) (~8"-12" away from edge)	85
			75		72
			76		105
			70		73

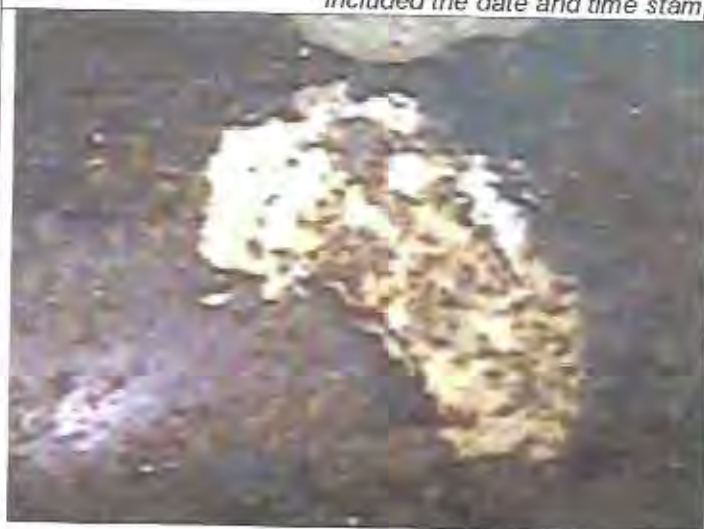
Date: 10/3/17    Frame(HH:MM:SS)    N/R	Date:    Frame(HH:MM:SS)
---	--------------------------

Cathodic Protection and Coating Measurements (for Feature #25)					
<b>CP Reading #1 (mV)</b> (north end of feature)	-196 -200	<b>CP Reading #2 (mV)</b> (center of feature)	N/R	<b>CP Reading #3 (mV)</b> (south end of feature)	-1500 -1513
<b>DFT #1 (mil)</b> (north end of feature)	73	<b>DFT #2 (mil)</b> (center of feature)	N/R	<b>DFT #3 (mil)</b> (south end of feature)	<25
(record #2 for features < 2" long; record #1 and #3 for features 2"-8" long; record #1, #2 and #3 for features >8" long)					
<b>Temperature (°F)</b>	56°	<b>DFT Adjacent to Feature (mil)</b> (~2" away from edge)	80	<b>DFT Adjacent to Feature (mil)</b> (~8"-12" away from edge)	59
			75		74
			74		115
			75		72

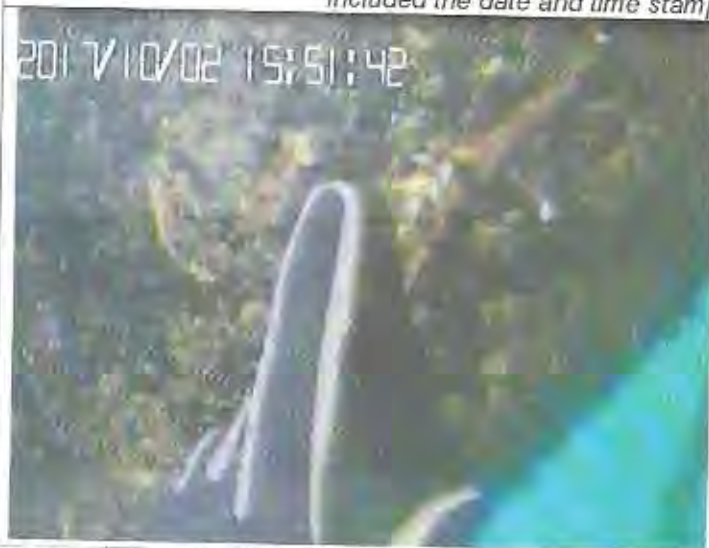
Date:	10/2/17	Frame(HH:MM:SS)	15:51:42	Date:		Frame(HH:MM:SS)	
-------	---------	-----------------	----------	-------	--	-----------------	--

CP Reading #1 (mV) (north end of feature)	N/R	CP Reading #2 (mV) (center of feature)	-179 -181	CP Reading #3 (mV) (south end of feature)	N/R
DFT #1 (mil) (north end of feature)	N/R	DFT #2 (mil) (center of feature)	74	DFT #3 (mil) (south end of feature)	N/R
(record #2 for features < 2' long; record #1 and #3 for features 2'-8' long; record #1, #2 and #3 for features >8' long)					
Temperature (°F)	56°	DFT Adjacent to Feature (mil) (~2" away from edge)	74	DFT Adjacent to Feature (mil) (~8"-12" away from edge)	70
			66		82
			69		74
			71		105

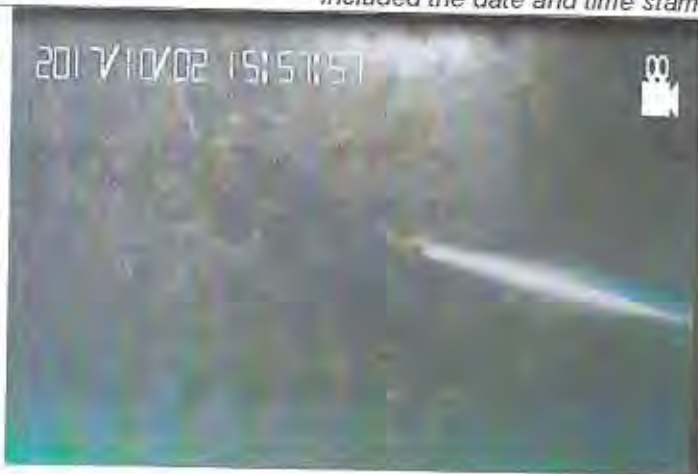
Date:	10/2/17	Frame(HH:MM:SS)	15:57:57	Date:		Frame(HH:MM:SS)	
-------	---------	-----------------	----------	-------	--	-----------------	--

CP Reading #1 (mV) (north end of feature)	N/R	CP Reading #2 (mV) (center of feature)	-265 -265	CP Reading #3 (mV) (south end of feature)	N/R
DFT #1 (mil) (north end of feature)	N/R	DFT #2 (mil) (center of feature)	74	DFT #3 (mil) (south end of feature)	N/R
(record #2 for features < 2" long; record #1 and #3 for features 2"-8" long; record #1, #2 and #3 for features >8" long)					
Temperature (°F)	56°	DFT Adjacent to Feature (mil) (~2" away from edge)	76	DFT Adjacent to Feature (mil) (~8"-12" away from edge)	110
			78		51
			76		74
			74		72

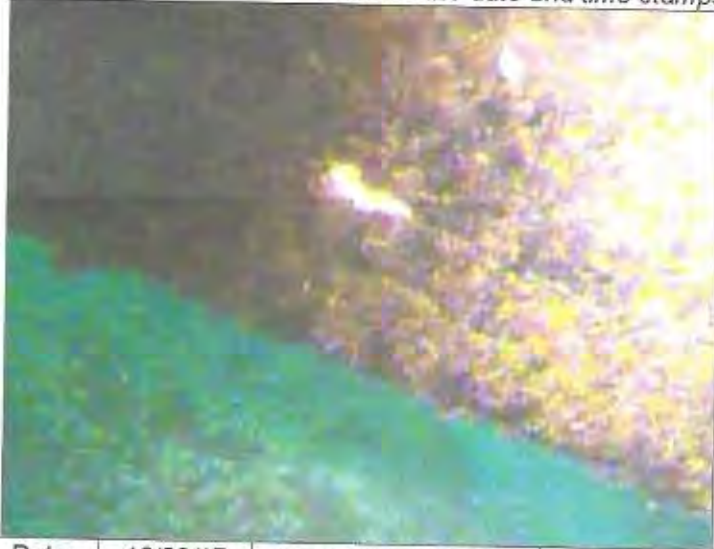
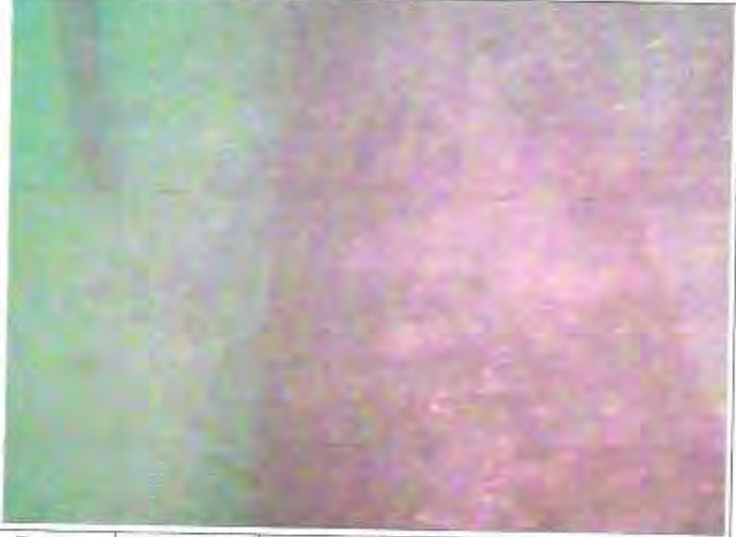
Date:	10/28/17	Frame(HH:MM:SS)	00:19:45	Date:	10/28/17
					Frame(HH:MM:SS)
					00:22:22

Cathodic Protection and Coating Measurements (for Feature # 1)					
CP Reading #1 (mV) (north end of feature)	N/R	CP Reading #2 (mV) (center of feature)	N/R	CP Reading #3 (mV) (south end of feature)	N/R
DFT #1 (mil) (north end of feature)	N/R	DFT #2 (mil) (center of feature)	N/R	DFT #3 (mil) (south end of feature)	N/R
(record #2 for features < 2" long; record #1 and #3 for features 2"-8" long; record #1, #2 and #3 for features >8" long)					
Temperature (°F)	54°	DFT Adjacent to Feature (mil) (~2" away from edge)	N/R	DFT Adjacent to Feature (mil) (~8"-12" away from edge)	N/R
			N/R		N/R
			N/R		N/R
			N/R		N/R
Provide 1 to 2 photos of feature, below: Included the date and time stamps associated with video surveillance.
