# Diver Inspection Form for L5 Straits of Mackinac

Date:	09/30/17	Diver:	Troy Baskett, Maurice Unger, Chad Cantrell, George Palmer
AFE / W.O.#:	20011702	Company Rep / Inspector:	[REDACTED]
Pipe Support Anchor:	E-1 (E-74A/E-74B South)	Water Depth (ft):	[REDACTED]
Longitude:	[REDACTED]	Latitude:	[REDACTED]

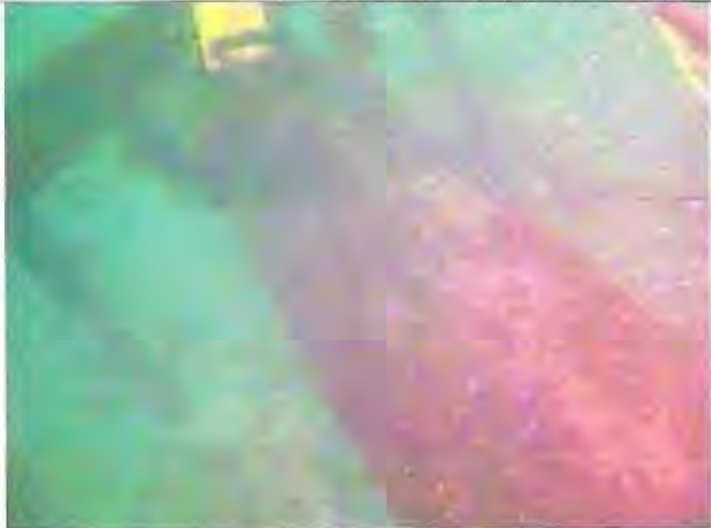
Date:	10/28/17	Frame(HH:MM:SS)	00:22:47	Date:	
					Frame(HH:MM:SS)

Comments/Issues/Discussion	
	<p>Feature 1, Dislodged area is approximately 95% of area from anchor to 6' South of anchor that has outer wrap missing</p> <p>Feature 2, Deposit is 27" X 5" with a Dislodged 24" X 1½" area through the Deposit</p> <p>Feature 4, Dislodged area is approximately 100% of area from anchor to 6' North of anchor that has outer wrap missing</p>

Cathodic Protection and Coating Measurements (for Feature # 1)					
CP Reading #1 (mV) (north end of feature)	N/R	CP Reading #2 (mV) (center of feature)	N/R	CP Reading #3 (mV) (south end of feature)	N/R
DFT #1 (mil) (north end of feature)	N/R	DFT #2 (mil) (center of feature)	N/R	DFT #3 (mil) (south end of feature)	N/R
(record #2 for features < 2" long; record #1 and #3 for features 2"-8" long; record #1, #2 and #3 for features >8" long)					
Temperature (°F)	54°	DFT Adjacent to Feature (mil) (~2" away from edge)	N/R	DFT Adjacent to Feature (mil) (~8"-12" away from edge)	N/R
			N/R		N/R
			N/R		N/R
			N/R		N/R
Provide 1 to 2 photos of feature, below: Included the date and time stamps associated with video surveillance.

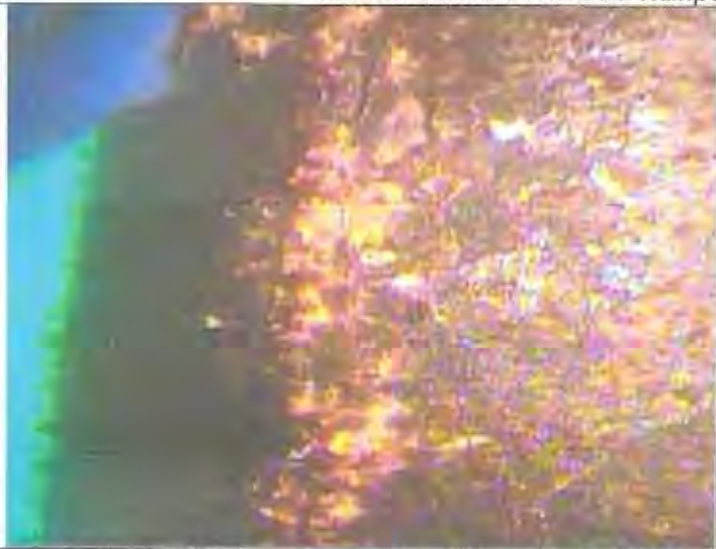
Date:	10/28/17	Frame(HH:MM:SS)	00:15:52	Date:	
				Frame(HH:MM:SS)

Cathodic Protection and Coating Measurements (for Feature # 2)					
CP Reading #1 (mV) (north end of feature)	N/R	CP Reading #2 (mV) (center of feature)	N/R	CP Reading #3 (mV) (south end of feature)	N/R
DFT #1 (mil) (north end of feature)	N/R	DFT #2 (mil) (center of feature)	N/R	DFT #3 (mil) (south end of feature)	N/R
(record #2 for features < 2" long; record #1 and #3 for features 2"-8" long; record #1, #2 and #3 for features >8" long)					
Temperature (°F)	54°	DFT Adjacent to Feature (mil) (~2" away from edge)	N/R	DFT Adjacent to Feature (mil) (~8"-12" away from edge)	N/R
			N/R		N/R
			N/R		N/R
			N/R		N/R
Provide 1 to 2 photos of feature, below: Included the date and time stamps associated with video surveillance.

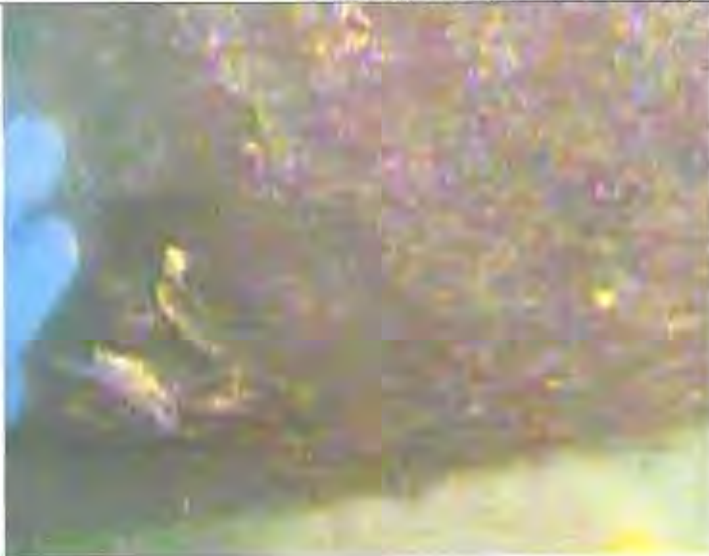
Date:	10/28/17	Frame(HH:MM:SS)	00:22:16	Date:	
					Frame(HH:MM:SS)

Cathodic Protection and Coating Measurements (for Feature # 3)					
CP Reading #1 (mV) (north end of feature)	N/R	CP Reading #2 (mV) (center of feature)	N/R	CP Reading #3 (mV) (south end of feature)	N/R
DFT #1 (mil) (north end of feature)	N/R	DFT #2 (mil) (center of feature)	N/R	DFT #3 (mil) (south end of feature)	N/R
(record #2 for features < 2" long; record #1 and #3 for features 2"-8" long; record #1, #2 and #3 for features >8" long)					
Temperature (°F)	54°	DFT Adjacent to Feature (mil) (~2" away from edge)	N/R	DFT Adjacent to Feature (mil) (~8"-12" away from edge)	N/R
			N/R		N/R
			N/R		N/R
			N/R		N/R
Provide 1 to 2 photos of feature, below: Included the date and time stamps associated with video surveillance.

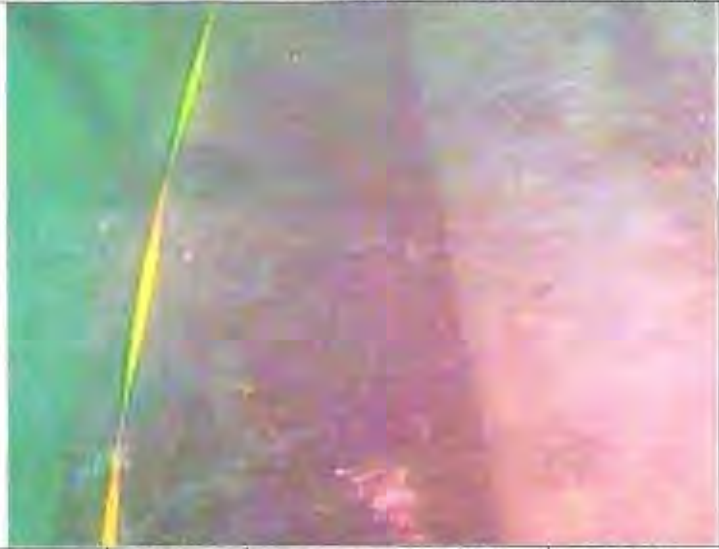
Date:	10/28/17	Frame(HH:MM:SS)	00:21:53	Date:

Cathodic Protection and Coating Measurements (for Feature # 4)					
<b>CP Reading #1 (mV)</b> (north end of feature)	N/R	<b>CP Reading #2 (mV)</b> (center of feature)	N/R	<b>CP Reading #3 (mV)</b> (south end of feature)	N/R
<b>DFT #1 (mil)</b> (north end of feature)	N/R	<b>DFT #2 (mil)</b> (center of feature)	N/R	<b>DFT #3 (mil)</b> (south end of feature)	N/R
(record #2 for features < 2" long; record #1 and #3 for features 2"-8" long; record #1, #2 and #3 for features >8" long)					
<b>Temperature (°F)</b>	54°	<b>DFT Adjacent to Feature (mil)</b> (~2" away from edge)	N/R	<b>DFT Adjacent to Feature (mil)</b> (~8"-12" away from edge)	N/R
			N/R		N/R
			N/R		N/R
			N/R		N/R
Provide 1 to 2 photos of feature, below: Included the date and time stamps associated with video surveillance.

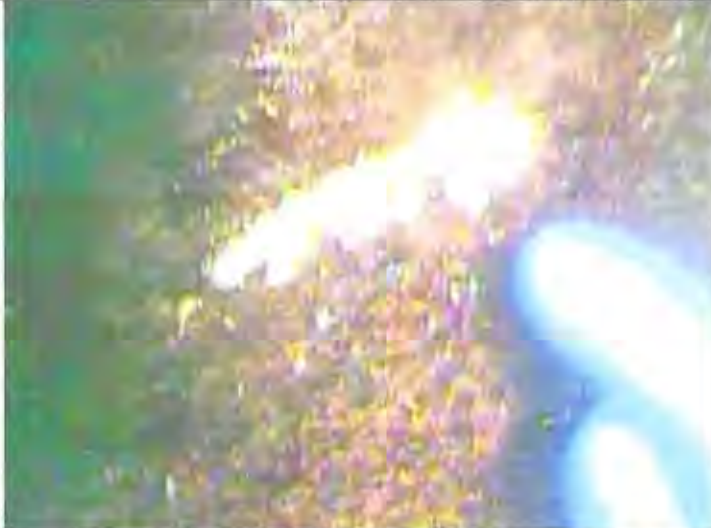
Date:	10/28/17	Frame(HH:MM:SS)	00:21:18	Date:	
					Frame(HH:MM:SS)

Cathodic Protection and Coating Measurements (for Feature # 5)					
CP Reading #1 (mV) (north end of feature)	N/R	CP Reading #2 (mV) (center of feature)	N/R	CP Reading #3 (mV) (south end of feature)	N/R
DFT #1 (mil) (north end of feature)	N/R	DFT #2 (mil) (center of feature)	N/R	DFT #3 (mil) (south end of feature)	N/R
(record #2 for features < 2" long; record #1 and #3 for features 2"-8" long; record #1, #2 and #3 for features >8" long)					
Temperature (°F)	54°	DFT Adjacent to Feature (mil) (~2" away from edge)	N/R	DFT Adjacent to Feature (mil) (~8"-12" away from edge)	N/R
			N/R		N/R
			N/R		N/R
			N/R		N/R
Provide 1 to 2 photos of feature, below: Included the date and time stamps associated with video surveillance.

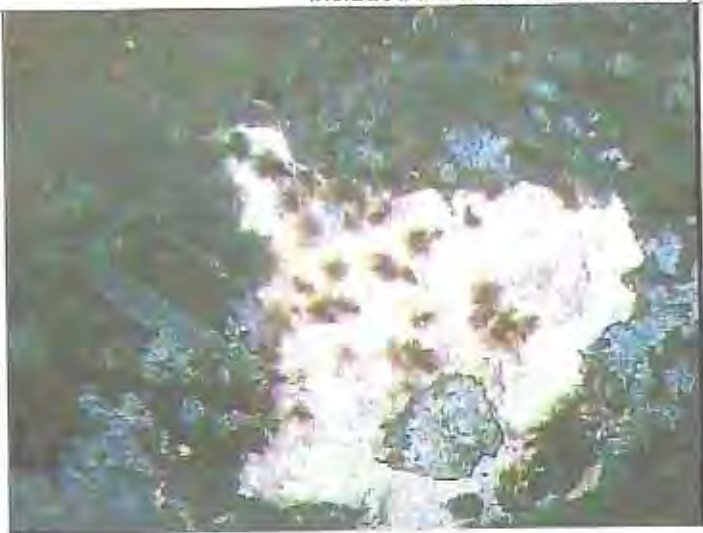
Date: 10/6/17 Frame(HH:MM:SS) 00:32:54

CP Reading #1 (mV) (north end of feature)	N/R	CP Reading #2 (mV) (center of feature)	N/R	CP Reading #3 (mV) (south end of feature)	N/R
DFT #1 (mil) (north end of feature)	N/R	DFT #2 (mil) (center of feature)	N/R	DFT #3 (mil) (south end of feature)	N/R
(record #2 for features < 2" long; record #1 and #3 for features 2"-8" long; record #1, #2 and #3 for features >8" long)					
Temperature (°F)	56°	DFT Adjacent to Feature (mil) (~2" away from edge)	84	DFT Adjacent to Feature (mil) (~8"-12" away from edge)	80
			84		62
			48		52
			66		64

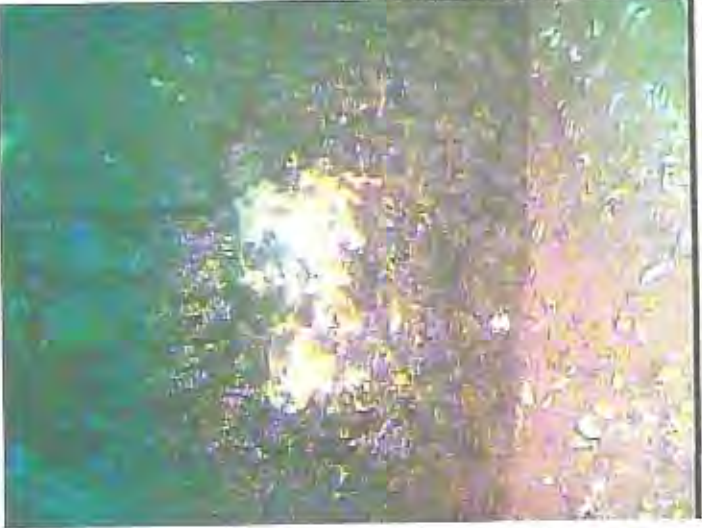
Date:	10/6/17	Frame(HH:MM:SS)	00:31:50	Date:	Frame(HH:MM:SS)

Cathodic Protection and Coating Measurements (for Feature # 3)					
CP Reading #1 (mV) (north end of feature)	N/R	CP Reading #2 (mV) (center of feature)	N/R	CP Reading #3 (mV) (south end of feature)	N/R
DFT #1 (mil) (north end of feature)	N/R	DFT #2 (mil) (center of feature)	N/R	DFT #3 (mil) (south end of feature)	N/R
(record #2 for features < 2" long; record #1 and #3 for features 2"-8" long; record #1, #2 and #3 for features >8" long)					
Temperature (°F)	57°	DFT Adjacent to Feature (mil) (~2" away from edge)	N/R	DFT Adjacent to Feature (mil) (~8"-12" away from edge)	N/R
			N/R		N/R
			N/R		N/R
			N/R		N/R
Provide 1 to 2 photos of feature, below: Included the date and time stamps associated with video surveillance.

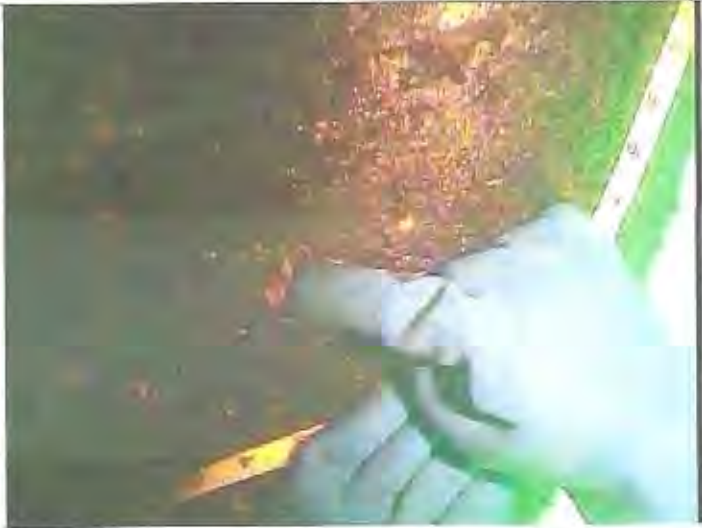
Date:	10/6/17	Frame(HH:MM:SS)	00:30:46	Date:		Frame(HH:MM:SS)	
-------	---------	-----------------	----------	-------	--	-----------------	--

Cathodic Protection and Coating Measurements (for Feature # 4)					
CP Reading #1 (mV) (north end of feature)	N/R	CP Reading #2 (mV) (center of feature)	N/R	CP Reading #3 (mV) (south end of feature)	N/R
DFT #1 (mil) (north end of feature)	N/R	DFT #2 (mil) (center of feature)	N/R	DFT #3 (mil) (south end of feature)	N/R
(record #2 for features < 2" long; record #1 and #3 for features 2"-8" long; record #1, #2 and #3 for features >8" long)					
Temperature (°F)	57°	DFT Adjacent to Feature (mil) (~2" away from edge)	N/R	DFT Adjacent to Feature (mil) (~8"-12" away from edge)	N/R
			N/R		N/R
			N/R		N/R
			N/R		N/R
Provide 1 to 2 photos of feature, below: Included the date and time stamps associated with video surveillance.

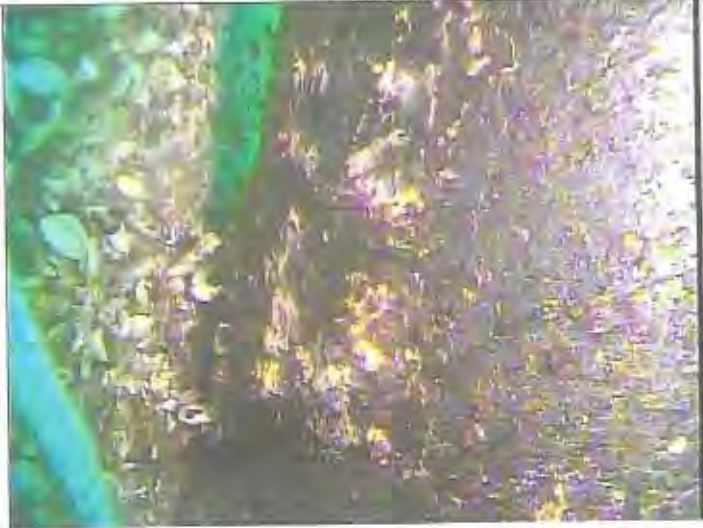
Date:	10/6/17	Frame(HH:MM:SS)	00:31:10	Date:	Frame(HH:MM:SS)

Cathodic Protection and Coating Measurements (for Feature # 5)					
CP Reading #1 (mV) (north end of feature)	N/R	CP Reading #2 (mV) (center of feature)	N/R	CP Reading #3 (mV) (south end of feature)	N/R
DFT #1 (mil) (north end of feature)	N/R	DFT #2 (mil) (center of feature)	N/R	DFT #3 (mil) (south end of feature)	N/R
(record #2 for features < 2" long; record #1 and #3 for features 2"-8" long; record #1, #2 and #3 for features >8" long)					
Temperature (°F)	57°	DFT Adjacent to Feature (mil) (~2" away from edge)	N/R	DFT Adjacent to Feature (mil) (~8"-12" away from edge)	N/R
			N/R		N/R
			N/R		N/R
			N/R		N/R
Provide 1 to 2 photos of feature, below: Included the date and time stamps associated with video surveillance.

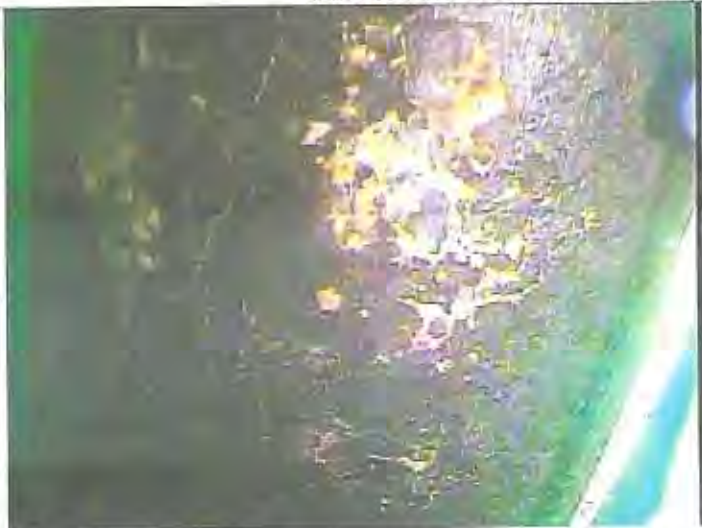
Date:	10/6/17	Frame(HH:MM:SS)	00:33:32	Date:	Frame(HH:MM:SS)

Cathodic Protection and Coating Measurements (for Feature # 6)					
CP Reading #1 (mV) (north end of feature)	N/R	CP Reading #2 (mV) (center of feature)	N/R	CP Reading #3 (mV) (south end of feature)	N/R
DFT #1 (mil) (north end of feature)	N/R	DFT #2 (mil) (center of feature)	N/R	DFT #3 (mil) (south end of feature)	N/R
(record #2 for features < 2" long; record #1 and #3 for features 2"-8" long; record #1, #2 and #3 for features >8" long)					
Temperature (°F)	57°	DFT Adjacent to Feature (mil) (~2" away from edge)	N/R	DFT Adjacent to Feature (mil) (~8"-12" away from edge)	N/R
			N/R		N/R
			N/R		N/R
			N/R		N/R
Provide 1 to 2 photos of feature, below: Included the date and time stamps associated with video surveillance.

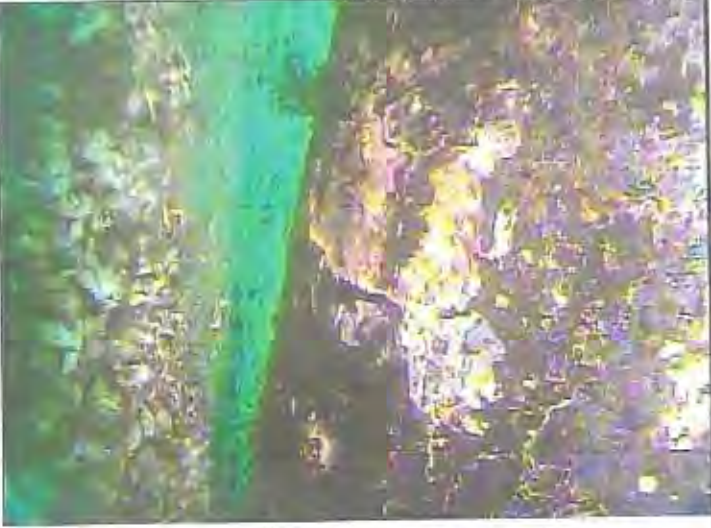
Date:	10/6/17	Frame(HH:MM:SS)	00:34:50	Date:		Frame(HH:MM:SS)	
-------	---------	-----------------	----------	-------	--	-----------------	--

Cathodic Protection and Coating Measurements (for Feature # 7)					
CP Reading #1 (mV) (north end of feature)	N/R	CP Reading #2 (mV) (center of feature)	N/R	CP Reading #3 (mV) (south end of feature)	N/R
DFT #1 (mil) (north end of feature)	N/R	DFT #2 (mil) (center of feature)	N/R	DFT #3 (mil) (south end of feature)	N/R
(record #2 for features < 2" long; record #1 and #3 for features 2"-8" long; record #1, #2 and #3 for features >8" long)					
Temperature (°F)	57°	DFT Adjacent to Feature (mil) (~2" away from edge)	N/R	DFT Adjacent to Feature (mil) (~8"-12" away from edge)	N/R
			N/R		N/R
			N/R		N/R
			N/R		N/R
Provide 1 to 2 photos of feature, below: Included the date and time stamps associated with video surveillance.

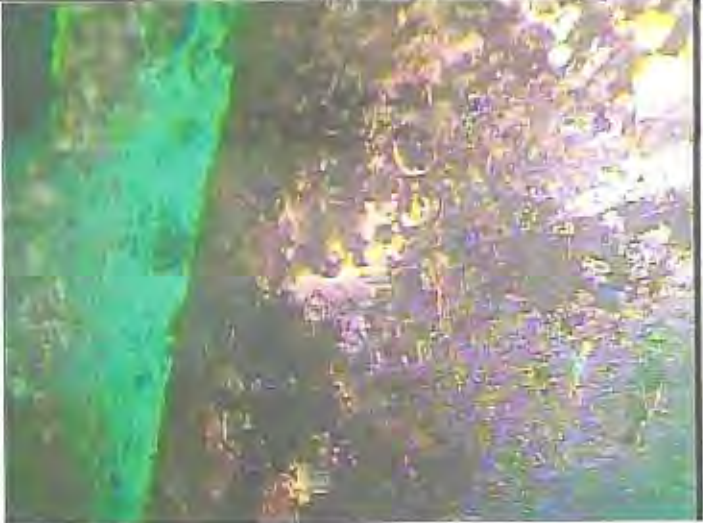
Date:	10/617	Frame(HH:MM:SS)	00:35:39	Date:	
				Frame(HH:MM:SS)

Cathodic Protection and Coating Measurements (for Feature # 8)					
CP Reading #1 (mV) (north end of feature)	N/R	CP Reading #2 (mV) (center of feature)	N/R	CP Reading #3 (mV) (south end of feature)	N/R
DFT #1 (mil) (north end of feature)	N/R	DFT #2 (mil) (center of feature)	N/R	DFT #3 (mil) (south end of feature)	N/R
(record #2 for features < 2" long; record #1 and #3 for features 2"-8" long; record #1, #2 and #3 for features >8" long)					
Temperature (°F)	57°	DFT Adjacent to Feature (mil) (~2" away from edge)	N/R	DFT Adjacent to Feature (mil) (~8"-12" away from edge)	N/R
			N/R		N/R
			N/R		N/R
			N/R		N/R
Provide 1 to 2 photos of feature, below: Included the date and time stamps associated with video surveillance.

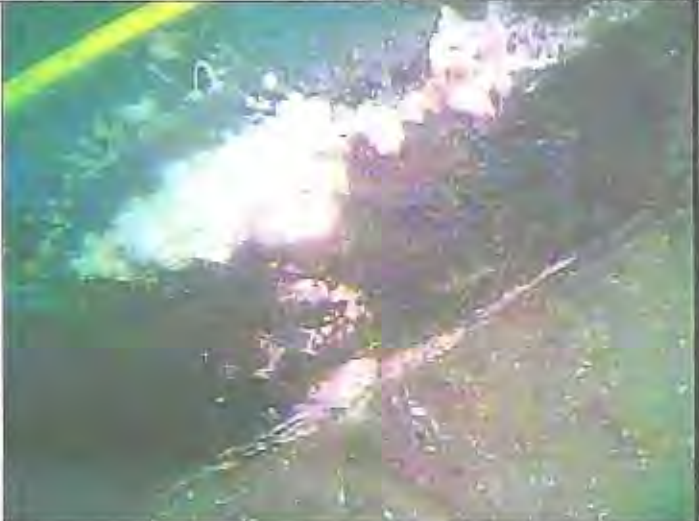
Date:	10/6/17	Frame(HH:MM:SS)	00:36:47	Date:	
				Frame(HH:MM:SS)

Cathodic Protection and Coating Measurements (for Feature # 9)					
CP Reading #1 (mV) (north end of feature)	-1513 -1505	CP Reading #2 (mV) (center of feature)	-1464 -1295	CP Reading #3 (mV) (south end of feature)	-1499 -1509
DFT #1 (mil) (north end of feature)	<25	DFT #2 (mil) (center of feature)	<25	DFT #3 (mil) (south end of feature)	66
(record #2 for features < 2" long; record #1 and #3 for features 2"-8" long; record #1, #2 and #3 for features >8" long)					
Temperature (°F)	57°	DFT Adjacent to Feature (mil) (~2" away from edge)	72	DFT Adjacent to Feature (mil) (~8"-12" away from edge)	82
			72		58
			82		80
			74		68
Provide 1 to 2 photos of feature, below: Included the date and time stamps associated with video surveillance.

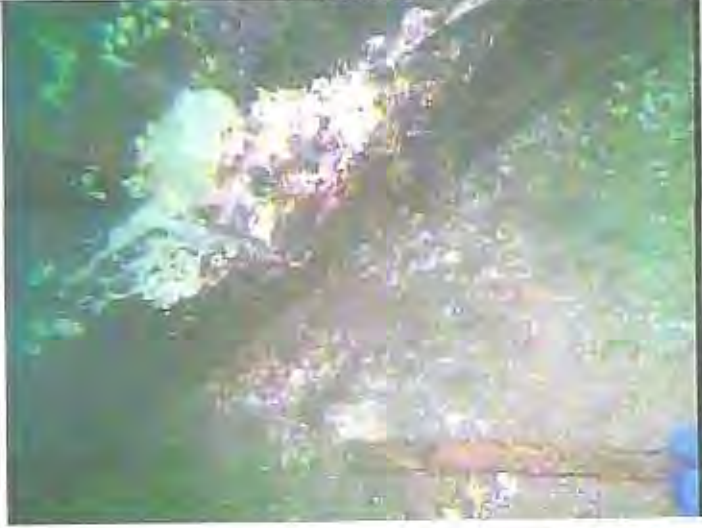
<div style="border: 1px solid black; height: 150px; width: 100%;"></div>		
Date:	10/6/17	Frame(HH:MM:SS)	00:38:11	Date:	
				Frame(HH:MM:SS)

Cathodic Protection and Coating Measurements (for Feature # 10)					
CP Reading #1 (mV) (north end of feature)	N/A	CP Reading #2 (mV) (center of feature)	N/A	CP Reading #3 (mV) (south end of feature)	N/A
DFT #1 (mil) (north end of feature)	N/A	DFT #2 (mil) (center of feature)	N/A	DFT #3 (mil) (south end of feature)	N/A
(record #2 for features < 2" long; record #1 and #3 for features 2"-8" long; record #1, #2 and #3 for features >8" long)					
Temperature (°F)	57°	DFT Adjacent to Feature (mil) (~2" away from edge)	N/A	DFT Adjacent to Feature (mil) (~8"-12" away from edge)	N/A
			N/A		N/A
			N/A		N/A
			N/A		N/A
Provide 1 to 2 photos of feature, below: Included the date and time stamps associated with video surveillance.

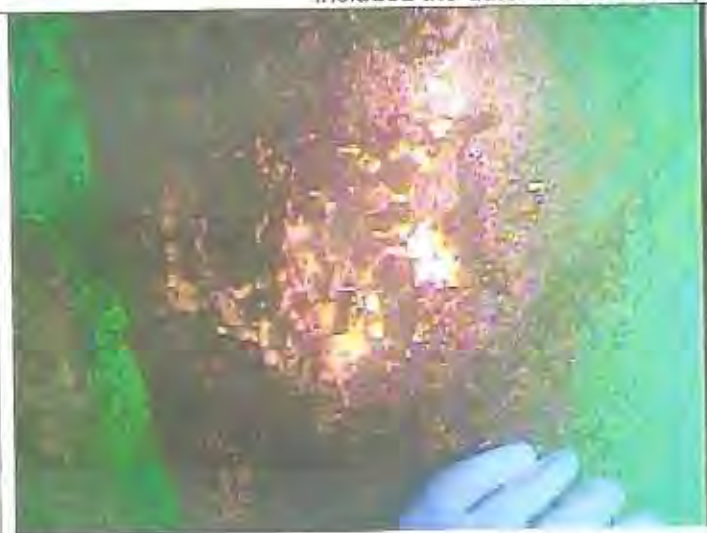
Date:	10/6/17	Frame(HH:MM:SS)	00:44:05	Date:		Frame(HH:MM:SS)	
-------	---------	-----------------	----------	-------	--	-----------------	--

CP Reading #1 (mV) (north end of feature)	-1511 -1507	CP Reading #2 (mV) (center of feature)	-1493 -1486	CP Reading #3 (mV) (south end of feature)	-1473 -1457
DFT #1 (mil) (north end of feature)	<25	DFT #2 (mil) (center of feature)	59	DFT #3 (mil) (south end of feature)	64
(record #2 for features < 2" long; record #1 and #3 for features 2"-8" long; record #1, #2 and #3 for features >8" long)					
Temperature (°F)	57°	DFT Adjacent to Feature (mil) (~2" away from edge)	71	DFT Adjacent to Feature (mil) (~8"-12" away from edge)	88
			73		67
			45		50
			79		70

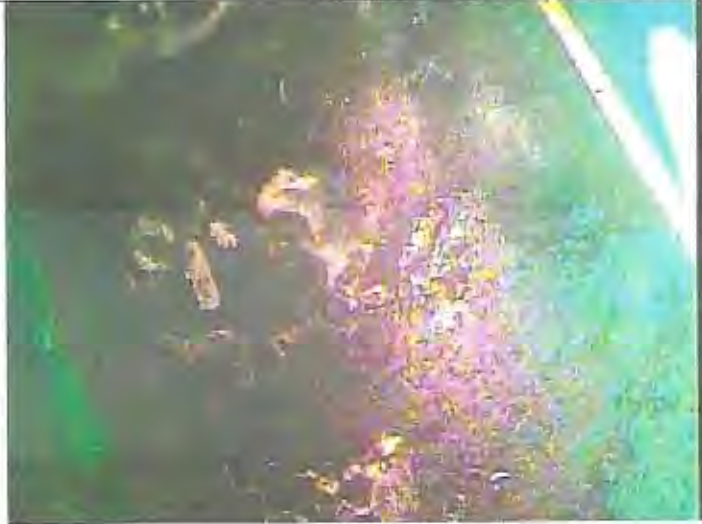
Date:	10/6/17	Frame(HH:MM:SS)	00:46:57	Date:	
				Frame(HH:MM:SS)

Cathodic Protection and Coating Measurements (for Feature # 12)					
CP Reading #1 (mV) (north end of feature)	N/R	CP Reading #2 (mV) (center of feature)	N/R	CP Reading #3 (mV) (south end of feature)	N/R
DFT #1 (mil) (north end of feature)	N/R	DFT #2 (mil) (center of feature)	N/R	DFT #3 (mil) (south end of feature)	N/R
(record #2 for features < 2" long; record #1 and #3 for features 2"-8" long; record #1, #2 and #3 for features >8" long)					
Temperature (°F)	57°	DFT Adjacent to Feature (mil) (~2" away from edge)	N/R	DFT Adjacent to Feature (mil) (~8"-12" away from edge)	N/R
			N/R		N/R
			N/R		N/R
			N/R		N/R
Provide 1 to 2 photos of feature, below: Included the date and time stamps associated with video surveillance.

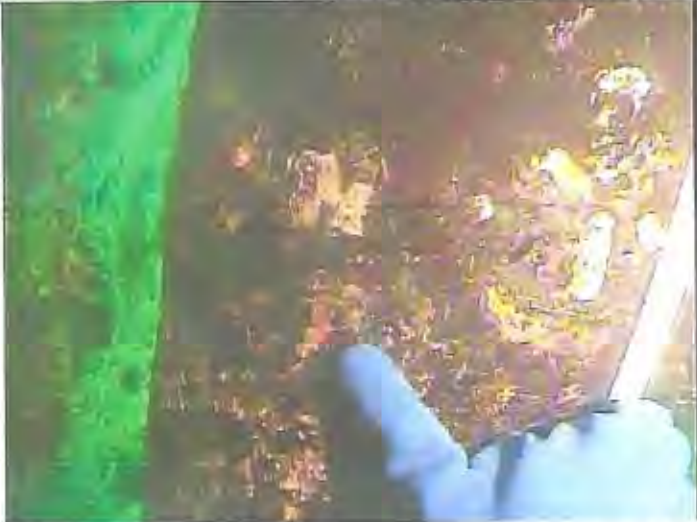
Date:	10/6/17	Frame(HH:MM:SS)	00:49:30	Date:	
			Frame(HH:MM:SS)

Cathodic Protection and Coating Measurements (for Feature # 13)					
CP Reading #1 (mV) (north end of feature)	N/R	CP Reading #2 (mV) (center of feature)	N/R	CP Reading #3 (mV) (south end of feature)	N/R
DFT #1 (mil) (north end of feature)	N/R	DFT #2 (mil) (center of feature)	N/R	DFT #3 (mil) (south end of feature)	N/R
(record #2 for features < 2" long; record #1 and #3 for features 2"-8" long; record #1, #2 and #3 for features >8" long)					
Temperature (°F)	57°	DFT Adjacent to Feature (mil) (~2" away from edge)	N/R	DFT Adjacent to Feature (mil) (~8"-12" away from edge)	N/R
			N/R		N/R
			N/R		N/R
			N/R		N/R
Provide 1 to 2 photos of feature, below: Included the date and time stamps associated with video surveillance.

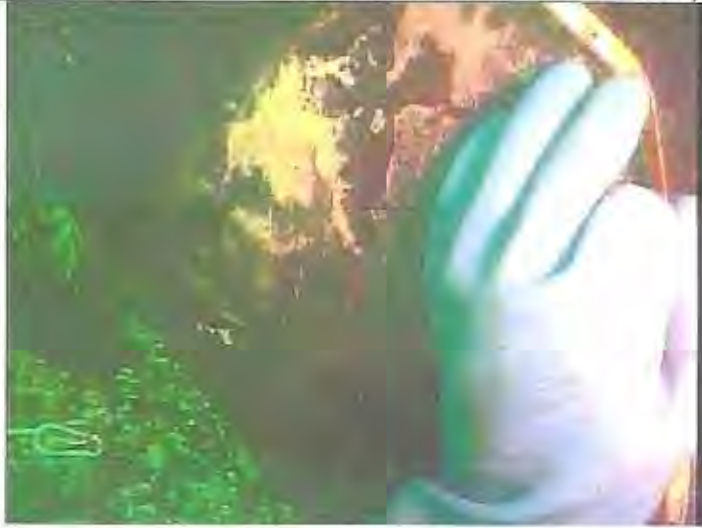
Date:	10/6/17	Frame(HH:MM:SS)	00:51:48	Date:	
				Frame(HH:MM:SS)

Cathodic Protection and Coating Measurements (for Feature # 15)					
CP Reading #1 (mV) (north end of feature)	N/R	CP Reading #2 (mV) (center of feature)	N/R	CP Reading #3 (mV) (south end of feature)	N/R
DFT #1 (mil) (north end of feature)	N/R	DFT #2 (mil) (center of feature)	N/R	DFT #3 (mil) (south end of feature)	N/R
(record #2 for features < 2" long; record #1 and #3 for features 2"-8" long; record #1, #2 and #3 for features >8" long)					
Temperature (°F)	57°	DFT Adjacent to Feature (mil) (~2" away from edge)	N/R	DFT Adjacent to Feature (mil) (~8"-12" away from edge)	N/R
			N/R		N/R
			N/R		N/R
			N/R		N/R
<p>Provide 1 to 2 photos of feature, below:                      Included the date and time stamps associated with video surveillance.</p>

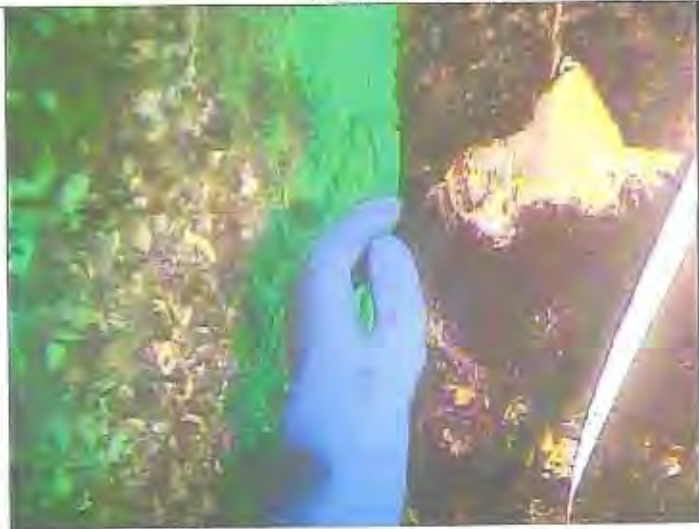
Date: 10/6/17 Frame(HH:MM:SS) 00:53:58

CP Reading #1 (mV) (north end of feature)	N/R	CP Reading #2 (mV) (center of feature)	N/R	CP Reading #3 (mV) (south end of feature)	N/R
DFT #1 (mil) (north end of feature)	N/R	DFT #2 (mil) (center of feature)	N/R	DFT #3 (mil) (south end of feature)	N/R
(record #2 for features < 2" long; record #1 and #3 for features 2"-8" long; record #1, #2 and #3 for features >8" long)					
Temperature (°F)	57°	DFT Adjacent to Feature (mil) (~2" away from edge)	N/R	DFT Adjacent to Feature (mil) (~8"-12" away from edge)	N/R
			N/R		N/R
			N/R		N/R
			N/R		N/R

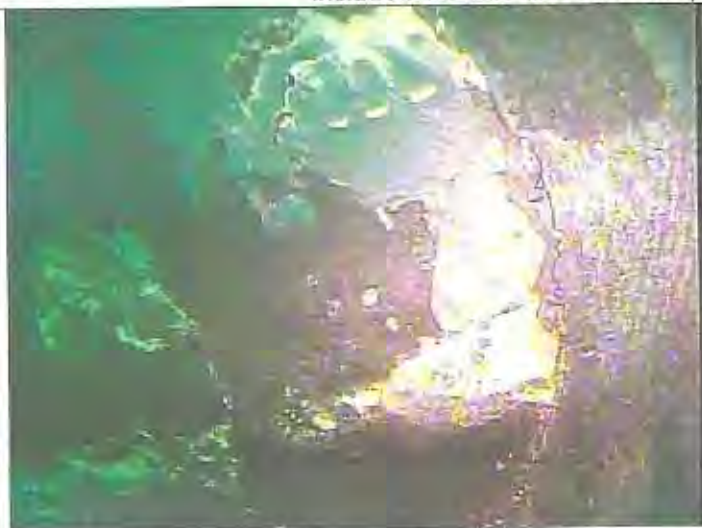
Date:	10/6/17	Frame(HH:MM:SS)	00:20:58	Date:	
				Frame(HH:MM:SS)

Cathodic Protection and Coating Measurements (for Feature # 17)					
CP Reading #1 (mV) (north end of feature)	-1501 -1505	CP Reading #2 (mV) (center of feature)	N/R	CP Reading #3 (mV) (south end of feature)	-1475 -1482
DFT #1 (mil) (north end of feature)	<25	DFT #2 (mil) (center of feature)	N/R	DFT #3 (mil) (south end of feature)	<25
(record #2 for features < 2" long; record #1 and #3 for features 2"-8" long; record #1, #2 and #3 for features >8" long)					
Temperature (°F)	57°	DFT Adjacent to Feature (mil) (~2" away from edge)	88	DFT Adjacent to Feature (mil) (~8"-12" away from edge)	82
			62		50
			84		66
			86		96
Provide 1 to 2 photos of feature, below: Included the date and time stamps associated with video surveillance.

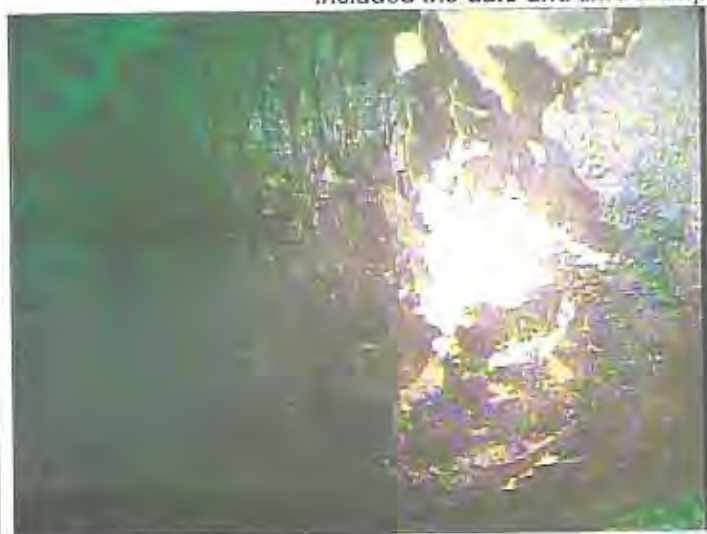
Date:	10/6/17	Frame(HH:MM:SS)	00:38:08	Date:		Frame(HH:MM:SS)	
-------	---------	-----------------	----------	-------	--	-----------------	--

CP Reading #1 (mV) (north end of feature)	N/R	CP Reading #2 (mV) (center of feature)	N/R	CP Reading #3 (mV) (south end of feature)	N/R
DFT #1 (mil) (north end of feature)	54	DFT #2 (mil) (center of feature)	N/R	DFT #3 (mil) (south end of feature)	60
(record #2 for features < 2" long; record #1 and #3 for features 2"-8" long; record #1, #2 and #3 for features >8" long)					
Temperature (°F)	57°	DFT Adjacent to Feature (mil) (~2" away from edge)	100	DFT Adjacent to Feature (mil) (~8"-12" away from edge)	100
			80		82
			80		51
			62		74

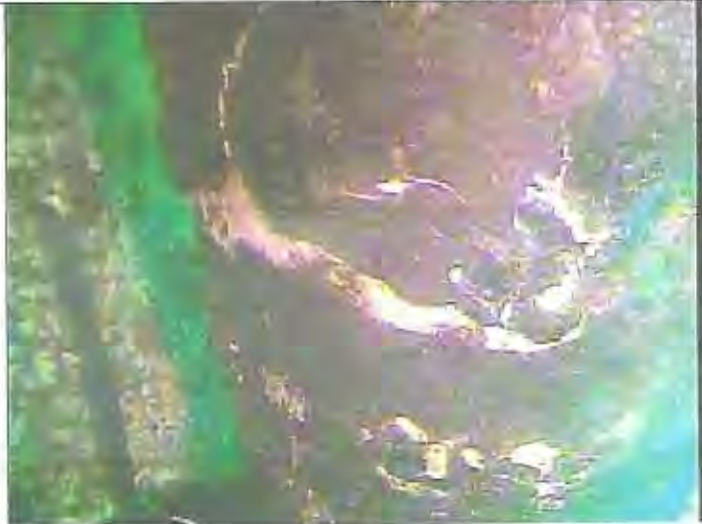
Date:	10/6/17	Frame(HH:MM:SS)	00:48:52	Date:	
				Frame(HH:MM:SS)

Cathodic Protection and Coating Measurements (for Feature # 19)					
CP Reading #1 (mV) (north end of feature)	-250 -243	CP Reading #2 (mV) (center of feature)	-331 -324	CP Reading #3 (mV) (south end of feature)	-287 -279
DFT #1 (mil) (north end of feature)	72	DFT #2 (mil) (center of feature)	38	DFT #3 (mil) (south end of feature)	74
(record #2 for features < 2' long; record #1 and #3 for features 2'-8" long; record #1, #2 and #3 for features >8" long)					
Temperature (°F)	57°	DFT Adjacent to Feature (mil) (~2" away from edge)	80	DFT Adjacent to Feature (mil) (~8"-12" away from edge)	120
			100		78
			72		110
			72		70
Provide 1 to 2 photos of feature, below: Included the date and time stamps associated with video surveillance.

Note: Diver was mistaken when he observed the apparent holiday, and that DFT and CP readings confirm the existence of coating.

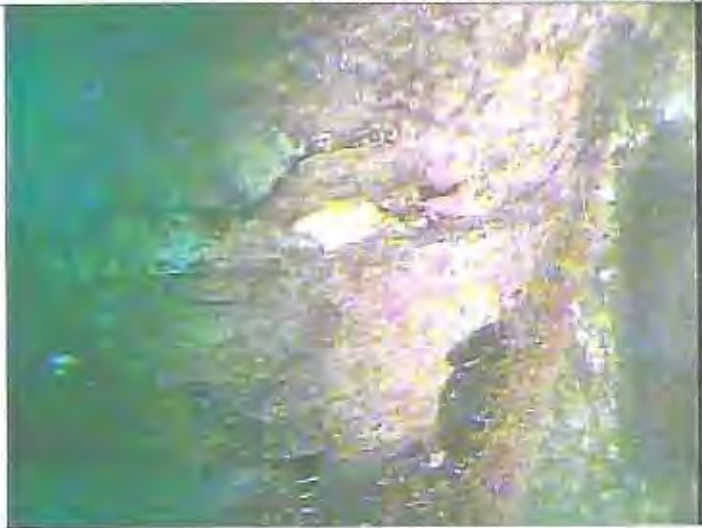
Date:	10/6/17	Frame(HH:MM:SS)	00:51:23	Date:	
				Frame(HH:MM:SS)

Cathodic Protection and Coating Measurements (for Feature #20)					
CP Reading #1 (mV) (north end of feature)	N/R	CP Reading #2 (mV) (center of feature)	N/R	CP Reading #3 (mV) (south end of feature)	N/R
DFT #1 (mil) (north end of feature)	N/R	DFT #2 (mil) (center of feature)	N/R	DFT #3 (mil) (south end of feature)	N/R
(record #2 for features < 2" long; record #1 and #3 for features 2"-8" long; record #1, #2 and #3 for features >8" long)					
Temperature (°F)	57°	DFT Adjacent to Feature (mil) (~2" away from edge)	N/R	DFT Adjacent to Feature (mil) (~8"-12" away from edge)	N/R
			N/R		N/R
			N/R		N/R
			N/R		N/R
Provide 1 to 2 photos of feature, below: Included the date and time stamps associated with video surveillance.

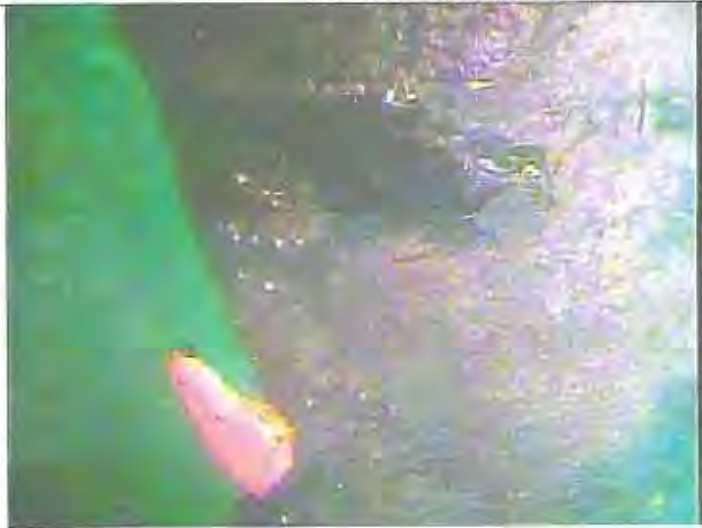
Date:	10/6/17	Frame(HH:MM:SS)	1:00:15	Date:	
				Frame(HH:MM:SS)

Cathodic Protection and Coating Measurements (for Feature # 21)					
<b>CP Reading #1 (mV)</b> (north end of feature)	N/R	<b>CP Reading #2 (mV)</b> (center of feature)	N/R	<b>CP Reading #3 (mV)</b> (south end of feature)	N/R
<b>DFT #1 (mil)</b> (north end of feature)	72	<b>DFT #2 (mil)</b> (center of feature)	84	<b>DFT #3 (mil)</b> (south end of feature)	65
(record #2 for features < 2" long; record #1 and #3 for features 2"-8" long; record #1, #2 and #3 for features >8" long)					
<b>Temperature (°F)</b>	57°	<b>DFT Adjacent to Feature (mil)</b> (~2" away from edge)	105	<b>DFT Adjacent to Feature (mil)</b> (~8"-12" away from edge)	105
			105		95
			94		94
			94		95
<i>Provide 1 to 2 photos of feature, below: Included the date and time stamps associated with video surveillance.</i>

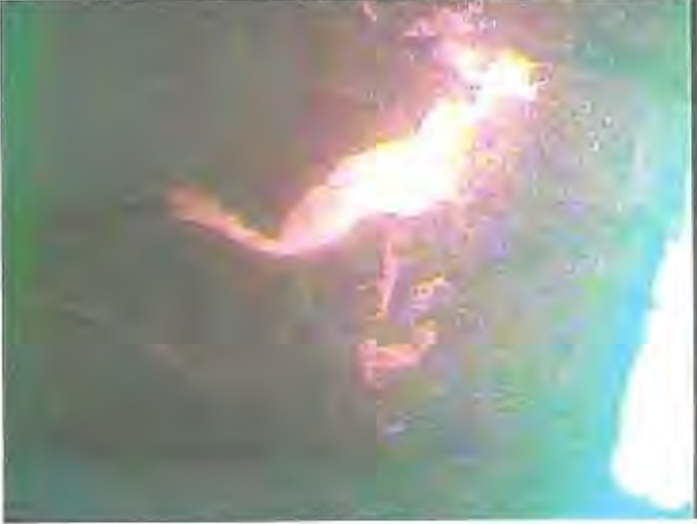
Date:	10/9/17	Frame(HH:MM:SS)	00:24:36	Date:	
				Frame(HH:MM:SS)

Cathodic Protection and Coating Measurements (for Feature # 22)					
CP Reading #1 (mV) (north end of feature)	N/R	CP Reading #2 (mV) (center of feature)	N/R	CP Reading #3 (mV) (south end of feature)	N/R
DFT #1 (mil) (north end of feature)	82	DFT #2 (mil) (center of feature)	110	DFT #3 (mil) (south end of feature)	94
(record #2 for features < 2" long; record #1 and #3 for features 2"-8" long; record #1, #2 and #3 for features >8" long)					
Temperature (°F)	56°	DFT Adjacent to Feature (mil) (~2" away from edge)	100	DFT Adjacent to Feature (mil) (~8"-12" away from edge)	110
			94		100
			110		125
			125		85
Provide 1 to 2 photos of feature, below: Included the date and time stamps associated with video surveillance.

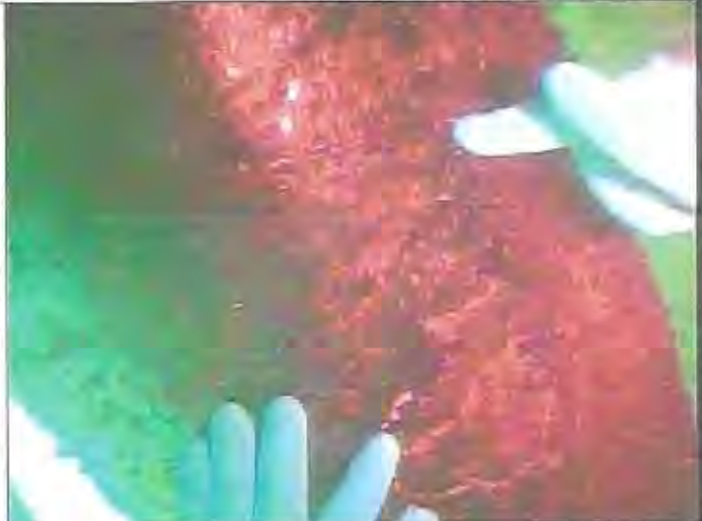
Date:	10/9/17	Frame(HH:MM:SS)	00:36:07	Date:	
				Frame(HH:MM:SS)

Cathodic Protection and Coating Measurements (for Feature # 23)					
<b>CP Reading #1 (mV)</b> (north end of feature)	N/R	<b>CP Reading #2 (mV)</b> (center of feature)	N/R	<b>CP Reading #3 (mV)</b> (south end of feature)	N/R
<b>DFT #1 (mil)</b> (north end of feature)	N/R	<b>DFT #2 (mil)</b> (center of feature)	N/R	<b>DFT #3 (mil)</b> (south end of feature)	N/R
(record #2 for features < 2" long; record #1 and #3 for features 2"-8" long; record #1, #2 and #3 for features >8" long)					
<b>Temperature (°F)</b>	56°	<b>DFT Adjacent to Feature (mil)</b> (~2" away from edge)	N/R	<b>DFT Adjacent to Feature (mil)</b> (~8"-12" away from edge)	N/R
			N/R		N/R
			N/R		N/R
			N/R		N/R
<i>Provide 1 to 2 photos of feature, below: Included the date and time stamps associated with video surveillance.</i>

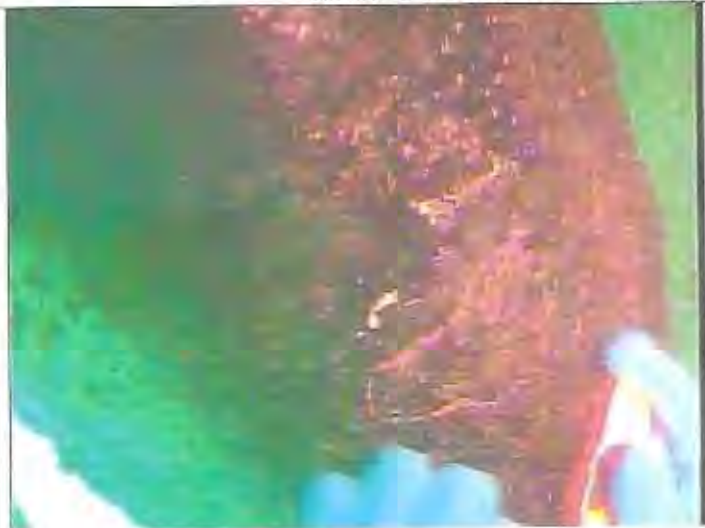
Date:	10/9/17	Frame(HH:MM:SS)	00:37:28	Date:	
				Frame(HH:MM:SS)

Cathodic Protection and Coating Measurements (for Feature # 24)					
CP Reading #1 (mV) (north end of feature)	N/R	CP Reading #2 (mV) (center of feature)	N/R	CP Reading #3 (mV) (south end of feature)	N/R
DFT #1 (mil) (north end of feature)	N/R	DFT #2 (mil) (center of feature)	N/R	DFT #3 (mil) (south end of feature)	N/R
Temperature (°F)	56°	DFT Adjacent to Feature (mil) (~2" away from edge)	N/R	DFT Adjacent to Feature (mil) (~8"-12" away from edge)	N/R
			N/R		N/R
			N/R		N/R
			N/R		N/R
Provide 1 to 2 photos of feature, below: Included the date and time stamps associated with video surveillance.

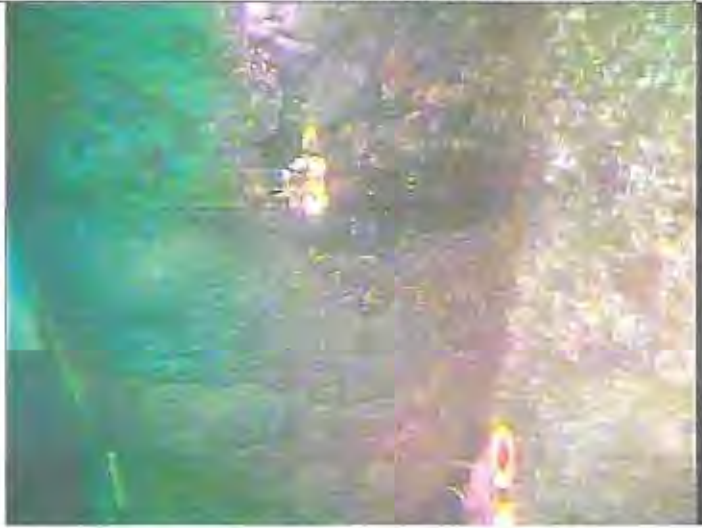
Date:	10/9/17	Frame(HH:MM:SS)	00:48:53	Date:	
				Frame(HH:MM:SS)

Cathodic Protection and Coating Measurements (for Feature # 25)					
CP Reading #1 (mV) (north end of feature)	N/R	CP Reading #2 (mV) (center of feature)	N/R	CP Reading #3 (mV) (south end of feature)	N/R
DFT #1 (mil) (north end of feature)	120	DFT #2 (mil) (center of feature)	74	DFT #3 (mil) (south end of feature)	72
(record #2 for features < 2" long; record #1 and #3 for features 2"-8" long; record #1, #2 and #3 for features >8" long)					
Temperature (°F)	56°	DFT Adjacent to Feature (mil) (~2" away from edge)	115	DFT Adjacent to Feature (mil) (~8"-12" away from edge)	135
			115		120
			115		160
			110		160
Provide 1 to 2 photos of feature, below: Included the date and time stamps associated with video surveillance.

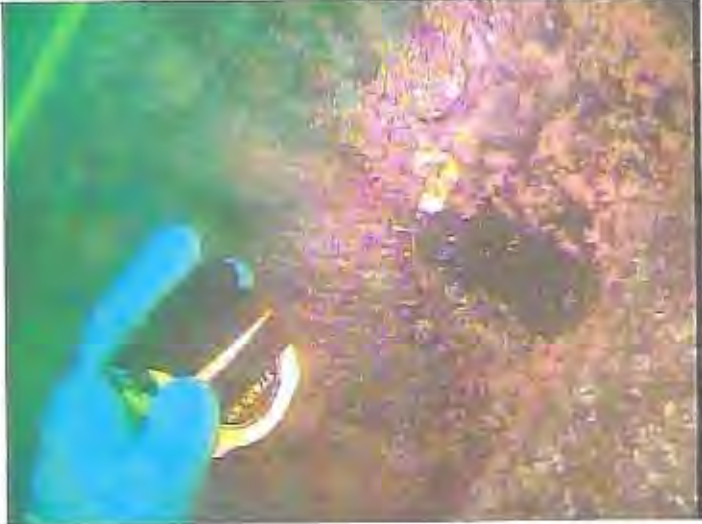
Date:	10/9/17	Frame(HH:MM:SS)	00:58:23	Date:	
				Frame(HH:MM:SS)

Cathodic Protection and Coating Measurements (for Feature # 26)					
CP Reading #1 (mV) (north end of feature)	N/R	CP Reading #2 (mV) (center of feature)	N/R	CP Reading #3 (mV) (south end of feature)	N/R
DFT #1 (mil) (north end of feature)	135	DFT #2 (mil) (center of feature)	N/R	DFT #3 (mil) (south end of feature)	145
(record #2 for features < 2" long; record #1 and #3 for features 2"-8" long; record #1, #2 and #3 for features >8" long)					
Temperature (°F)	56°	DFT Adjacent to Feature (mil) (~2" away from edge)	145	DFT Adjacent to Feature (mil) (~8"-12" away from edge)	145
			135		92
			145		105
			115		135
Provide 1 to 2 photos of feature, below: Included the date and time stamps associated with video surveillance.

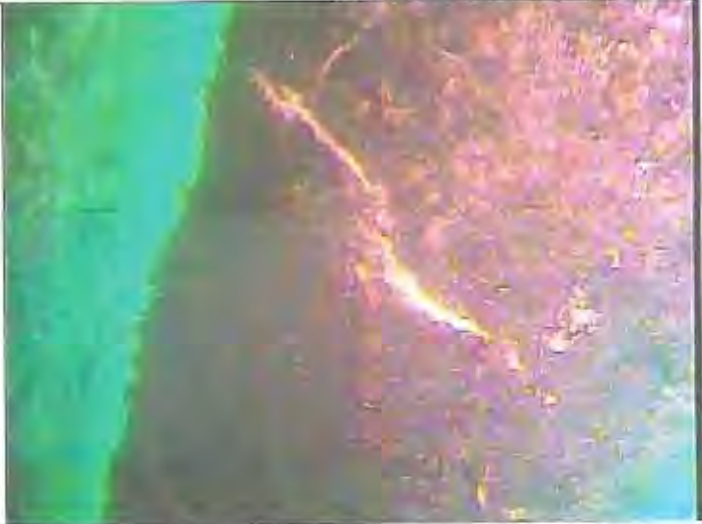
Date:	10/9/17	Frame(HH:MM:SS)	00:59:17	Date:

Cathodic Protection and Coating Measurements (for Feature # 27)					
CP Reading #1 (mV) (north end of feature)	N/R	CP Reading #2 (mV) (center of feature)	N/R	CP Reading #3 (mV) (south end of feature)	N/R
DFT #1 (mil) (north end of feature)	N/R	DFT #2 (mil) (center of feature)	N/R	DFT #3 (mil) (south end of feature)	N/R
(record #2 for features < 2" long; record #1 and #3 for features 2"-8" long; record #1, #2 and #3 for features >8" long)					
Temperature (°F)	56°	DFT Adjacent to Feature (mil) (~2" away from edge)	N/R	DFT Adjacent to Feature (mil) (~8"-12" away from edge)	N/R
			N/R		N/R
			N/R		N/R
			N/R		N/R
Provide 1 to 2 photos of feature, below: Included the date and time stamps associated with video surveillance.

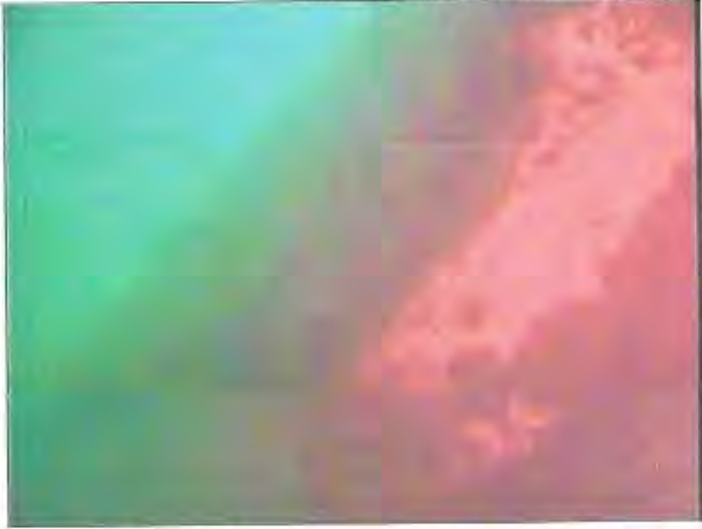
Date:	10/9/17	Frame(HH:MM:SS)	00:10:44	Date:	Frame(HH:MM:SS)

Cathodic Protection and Coating Measurements (for Feature # 28)					
CP Reading #1 (mV) (north end of feature)	N/R	CP Reading #2 (mV) (center of feature)	N/R	CP Reading #3 (mV) (south end of feature)	N/R
DFT #1 (mil) (north end of feature)	N/R	DFT #2 (mil) (center of feature)	N/R	DFT #3 (mil) (south end of feature)	N/R
(record #2 for features < 2" long; record #1 and #3 for features 2"-8" long; record #1, #2 and #3 for features >8" long)					
Temperature (°F)	56°	DFT Adjacent to Feature (mil) (~2" away from edge)	N/R	DFT Adjacent to Feature (mil) (~8"-12" away from edge)	N/R
			N/R		N/R
			N/R		N/R
			N/R		N/R
Provide 1 to 2 photos of feature, below: Included the date and time stamps associated with video surveillance.

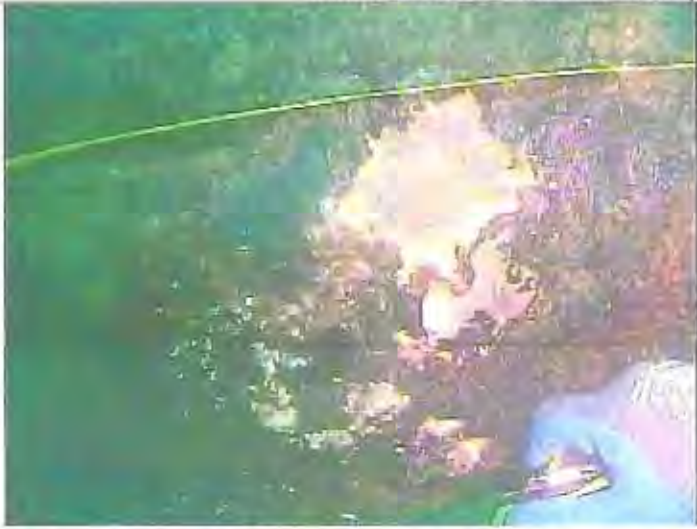
Date:	10/9/17	Frame(HH:MM:SS)	00:12:10	Date:	
				Frame(HH:MM:SS)

Cathodic Protection and Coating Measurements (for Feature # 29)					
CP Reading #1 (mV) (north end of feature)	N/R	CP Reading #2 (mV) (center of feature)	N/R	CP Reading #3 (mV) (south end of feature)	N/R
DFT #1 (mil) (north end of feature)	N/R	DFT #2 (mil) (center of feature)	N/R	DFT #3 (mil) (south end of feature)	N/R
(record #2 for features < 2" long; record #1 and #3 for features 2"-8" long; record #1, #2 and #3 for features >8" long)					
Temperature (°F)	56°	DFT Adjacent to Feature (mil) (~2" away from edge)	N/R	DFT Adjacent to Feature (mil) (~8"-12" away from edge)	N/R
			N/R		N/R
			N/R		N/R
			N/R		N/R
Provide 1 to 2 photos of feature, below: Included the date and time stamps associated with video surveillance.

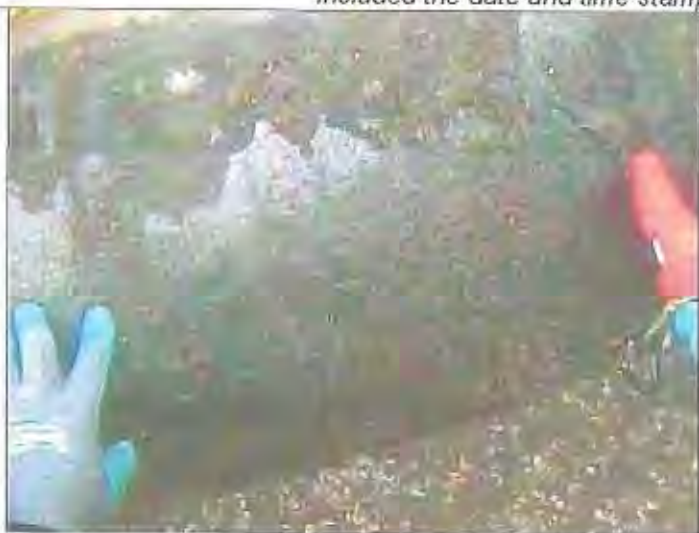
Date: 10/9/17 Frame(HH:MM:SS) 00:26:02

CP Reading #1 (mV) (north end of feature)	N/R	CP Reading #2 (mV) (center of feature)	N/R	CP Reading #3 (mV) (south end of feature)	N/R
DFT #1 (mil) (north end of feature)	90	DFT #2 (mil) (center of feature)	92	DFT #3 (mil) (south end of feature)	88
(record #2 for features < 2" long; record #1 and #3 for features 2"-8" long; record #1, #2 and #3 for features >8" long)					
Temperature (°F)	56°	DFT Adjacent to Feature (mil) (~2" away from edge)	90	DFT Adjacent to Feature (mil) (~8"-12" away from edge)	105
			105		110
			110		88
			100		105

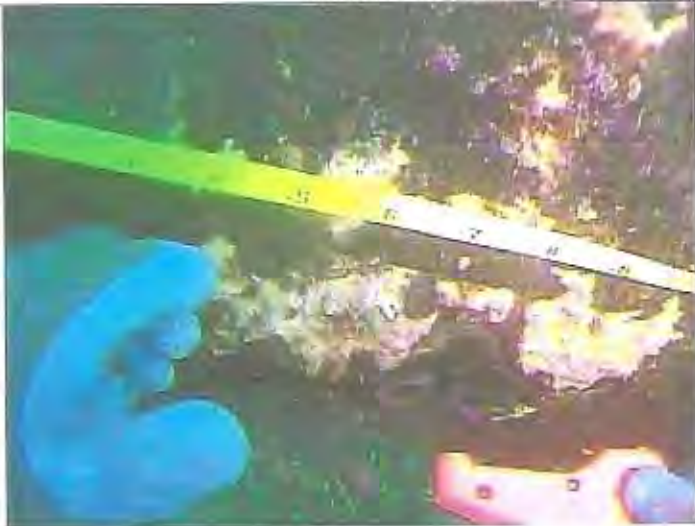
Date:	10/9/17	Frame(HH:MM:SS)	00:38:02	Date:		Frame(HH:MM:SS)	
-------	---------	-----------------	----------	-------	--	-----------------	--

CP Reading #1 (mV) (north end of feature)	N/R	CP Reading #2 (mV) (center of feature)	N/R	CP Reading #3 (mV) (south end of feature)	N/R
DFT #1 (mil) (north end of feature)	88	DFT #2 (mil) (center of feature)	88	DFT #3 (mil) (south end of feature)	96
(record #2 for features < 2" long; record #1 and #3 for features 2"-8" long; record #1, #2 and #3 for features >8" long)					
Temperature (°F)	56°	DFT Adjacent to Feature (mil) (~2" away from edge)	112	DFT Adjacent to Feature (mil) (~8"-12" away from edge)	96
			120		92
			90		125
			108		120

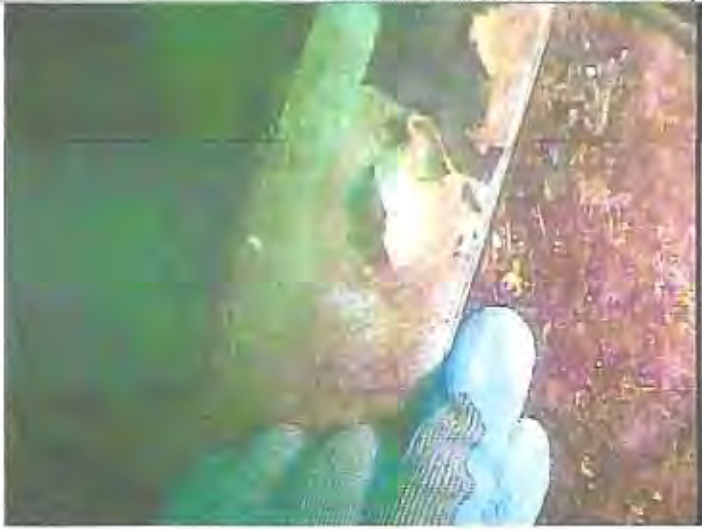
Date:	10/9/17	Frame(HH:MM:SS)	00:41:20	Date:	
				Frame(HH:MM:SS)

Cathodic Protection and Coating Measurements (for Feature # 32)					
CP Reading #1 (mV) (north end of feature)	N/R	CP Reading #2 (mV) (center of feature)	N/R	CP Reading #3 (mV) (south end of feature)	N/R
DFT #1 (mil) (north end of feature)	N/R	DFT #2 (mil) (center of feature)	N/R	DFT #3 (mil) (south end of feature)	N/R
(record #2 for features < 2" long; record #1 and #3 for features 2"-8" long; record #1, #2 and #3 for features >8" long)					
Temperature (°F)	56°	DFT Adjacent to Feature (mil) (~2" away from edge)	N/R	DFT Adjacent to Feature (mil) (~8"-12" away from edge)	N/R
			N/R		N/R
			N/R		N/R
			N/R		N/R
Provide 1 to 2 photos of feature, below: Included the date and time stamps associated with video surveillance.

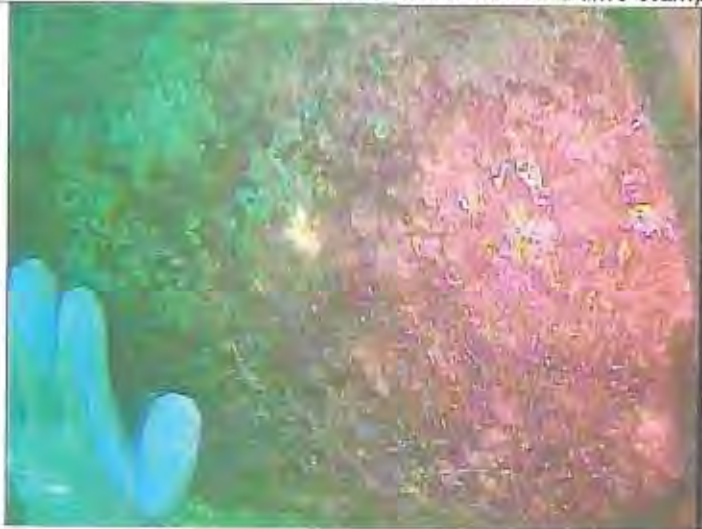
Date:	10/9/17	Frame(HH:MM:SS)	00:46:03	Date:	
				Frame(HH:MM:SS)

Cathodic Protection and Coating Measurements (for Feature # 33)					
CP Reading #1 (mV) (north end of feature)	N/R	CP Reading #2 (mV) (center of feature)	N/R	CP Reading #3 (mV) (south end of feature)	N/R
DFT #1 (mil) (north end of feature)	N/R	DFT #2 (mil) (center of feature)	N/R	DFT #3 (mil) (south end of feature)	N/R
(record #2 for features < 2" long; record #1 and #3 for features 2"-8" long; record #1, #2 and #3 for features >8" long)					
Temperature (°F)	56°	DFT Adjacent to Feature (mil) (~2" away from edge)	N/R	DFT Adjacent to Feature (mil) (~8"-12" away from edge)	N/R
			N/R		N/R
			N/R		N/R
			N/R		N/R
Provide 1 to 2 photos of feature, below: Included the date and time stamps associated with video surveillance.

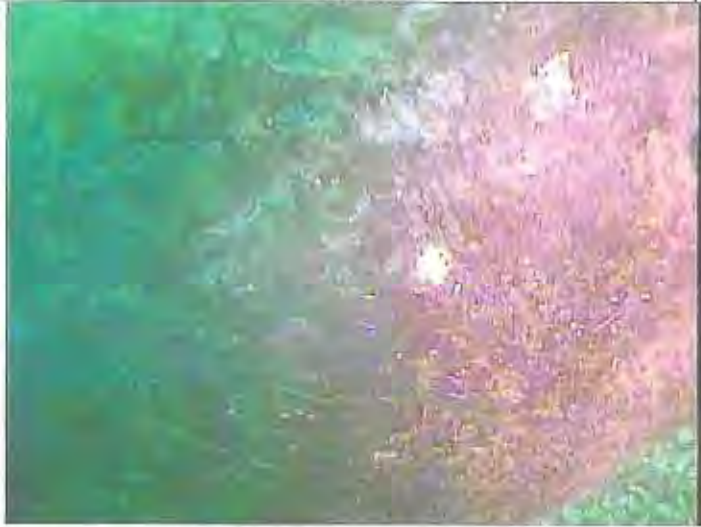
Date:	10/9/17	Frame(HH:MM:SS)	00:48:38	Date:	
				Frame(HH:MM:SS)

Cathodic Protection and Coating Measurements (for Feature # 34)					
CP Reading #1 (mV) (north end of feature)	N/R	CP Reading #2 (mV) (center of feature)	N/R	CP Reading #3 (mV) (south end of feature)	N/R
DFT #1 (mil) (north end of feature)	N/R	DFT #2 (mil) (center of feature)	N/R	DFT #3 (mil) (south end of feature)	N/R
(record #2 for features < 2" long; record #1 and #3 for features 2"-8" long; record #1, #2 and #3 for features >8" long)					
Temperature (°F)	56°	DFT Adjacent to Feature (mil) (~2" away from edge)	N/R	DFT Adjacent to Feature (mil) (~8"-12" away from edge)	N/R
			N/R		N/R
			N/R		N/R
			N/R		N/R
Provide 1 to 2 photos of feature, below: Included the date and time stamps associated with video surveillance.
