# Diver Inspection Form for L5 Straits of Mackinac

Date:	09/30/17	Diver:	Troy Baskett, Maurice Unger, Chad Cantrell, George Palmer
AFE / W.O.#:	20011702	Company Rep / Inspector:	[REDACTED]
Pipe Support Anchor:	E-1 (E-74A/E-74B South)	Water Depth (ft):	[REDACTED]
Longitude:	[REDACTED]	Latitude:	[REDACTED]

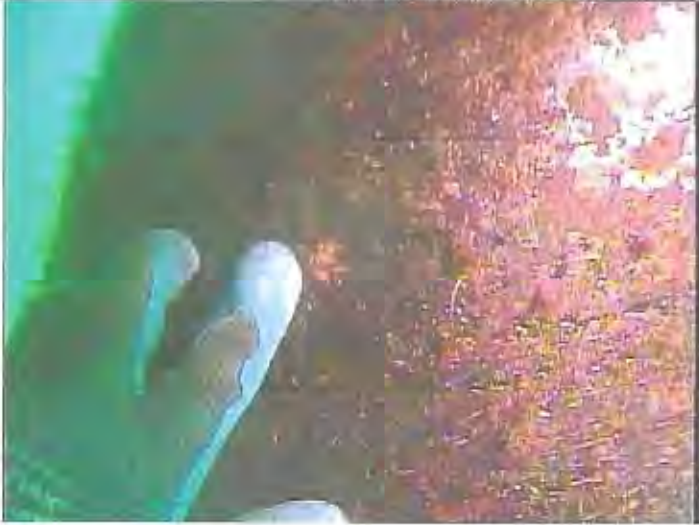
Date:	10/9/17	Frame(HH:MM:SS)	00:50:03	Date:	
					Frame(HH:MM:SS)

Cathodic Protection and Coating Measurements (for Feature # 35)					
<b>CP Reading #1 (mV)</b> (north end of feature)	N/R	<b>CP Reading #2 (mV)</b> (center of feature)	N/R	<b>CP Reading #3 (mV)</b> (south end of feature)	N/R
<b>DFT #1 (mil)</b> (north end of feature)	N/R	<b>DFT #2 (mil)</b> (center of feature)	N/R	<b>DFT #3 (mil)</b> (south end of feature)	N/R
(record #2 for features < 2" long; record #1 and #3 for features 2"-8" long; record #1, #2 and #3 for features >8" long)					
<b>Temperature (°F)</b>	56°	<b>DFT Adjacent to Feature (mil)</b> (~2" away from edge)	N/R	<b>DFT Adjacent to Feature (mil)</b> (~8"-12" away from edge)	N/R
			N/R		N/R
			N/R		N/R
			N/R		N/R
Provide 1 to 2 photos of feature, below: Included the date and time stamps associated with video surveillance.

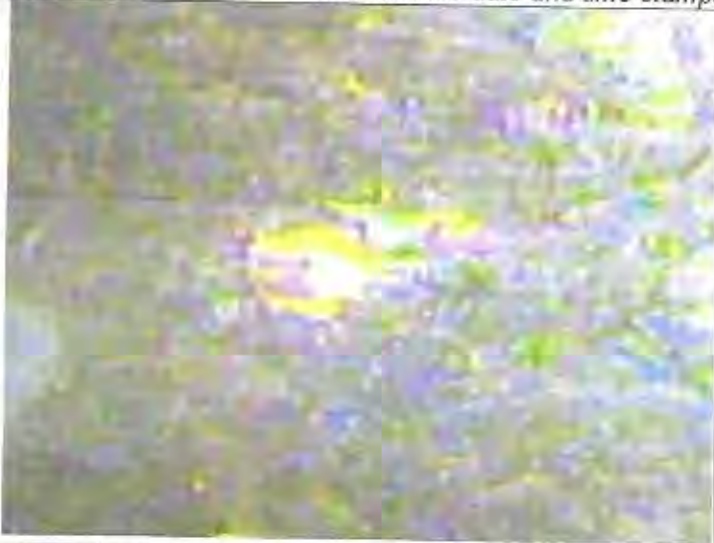
Date:	10/22/17	Frame(HH:MM:SS)	00:26:54	Date:	Frame(HH:MM:SS) N/R

Cathodic Protection and Coating Measurements (for Feature # 1)					
CP Reading #1 (mV) (north end of feature)	N/R	CP Reading #2 (mV) (center of feature)	N/R	CP Reading #3 (mV) (south end of feature)	N/R
DFT #1 (mil) (north end of feature)	N/R	DFT #2 (mil) (center of feature)	N/R	DFT #3 (mil) (south end of feature)	N/R
(record #2 for features < 2" long; record #1 and #3 for features 2"-8" long; record #1, #2 and #3 for features >8" long)					
Temperature (°F)	58°	DFT Adjacent to Feature (mil) (~2" away from edge)	N/R	DFT Adjacent to Feature (mil) (~8"-12" away from edge)	N/R
			N/R		N/R
			N/R		N/R
			N/R		N/R
Provide 1 to 2 photos of feature, below: Included the date and time stamps associated with video surveillance.

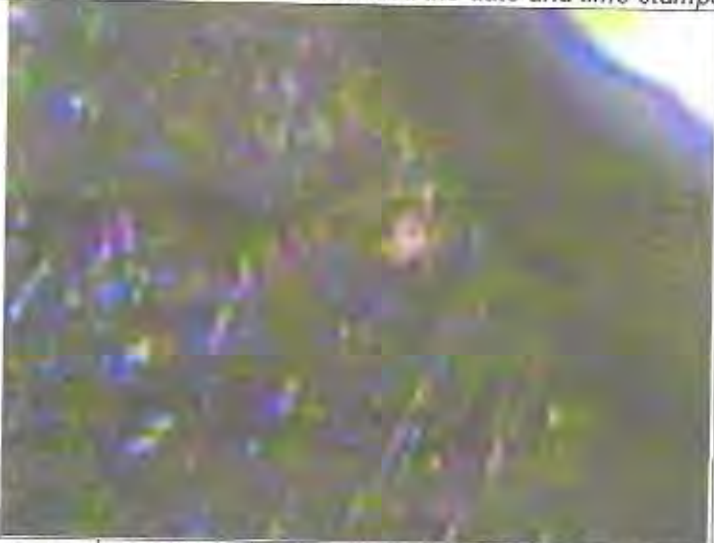
Date:	10/22/17	Frame(HH:MM:SS)	00:29:57	Date:	
				Frame(HH:MM:SS)	N/R

Cathodic Protection and Coating Measurements (for Feature # 2)					
CP Reading #1 (mV) (north end of feature)	N/R	CP Reading #2 (mV) (center of feature)	N/R	CP Reading #3 (mV) (south end of feature)	N/R
DFT #1 (mil) (north end of feature)	N/R	DFT #2 (mil) (center of feature)	N/R	DFT #3 (mil) (south end of feature)	N/R
(record #2 for features < 2" long; record #1 and #3 for features 2"-8" long; record #1, #2 and #3 for features >8" long)					
Temperature (°F)	58°	DFT Adjacent to Feature (mil) (~2" away from edge)	N/R	DFT Adjacent to Feature (mil) (~8"-12" away from edge)	N/R
			N/R		N/R
			N/R		N/R
			N/R		N/R
Provide 1 to 2 photos of feature, below: Included the date and time stamps associated with video surveillance.

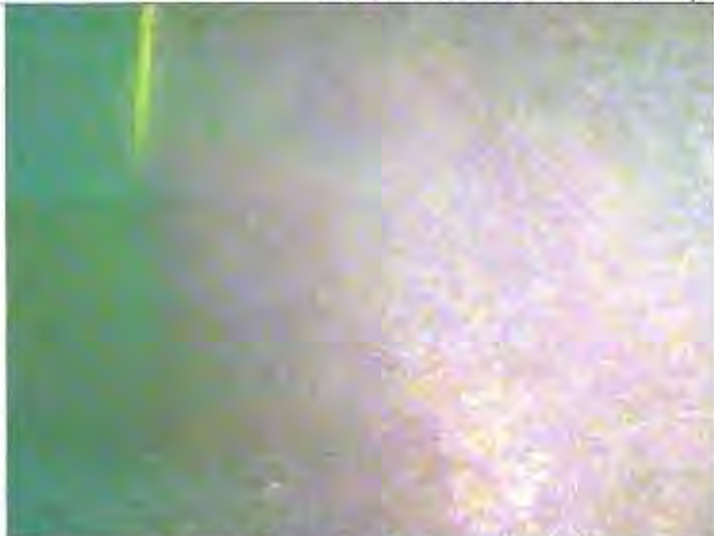
Date:	10/29/17	Frame(HH:MM:SS)	00:15:03	Date:	
				Frame(HH:MM:SS)

Comments/Issues/Discussion	
	<p>Feature 2, Dislodged area is approximately 70% of area from anchor to 6' South that has outer wrap missing</p> <p>NO FEATURES IDENTIFIED NORTH OF ANCHOR</p>

Cathodic Protection and Coating Measurements (for Feature # 2)					
CP Reading #1 (mV) (north end of feature)	N/R	CP Reading #2 (mV) (center of feature)	N/R	CP Reading #3 (mV) (south end of feature)	N/R
DFT #1 (mil) (north end of feature)	N/R	DFT #2 (mil) (center of feature)	N/R	DFT #3 (mil) (south end of feature)	N/R
(record #2 for features < 2" long; record #1 and #3 for features 2"-8" long; record #1, #2 and #3 for features >8" long)					
Temperature (°F)	56°	DFT Adjacent to Feature (mil) (~2" away from edge)	N/R	DFT Adjacent to Feature (mil) (~8"-12" away from edge)	N/R
			N/R		N/R
			N/R		N/R
			N/R		N/R
Provide 1 to 2 photos of feature, below: Included the date and time stamps associated with video surveillance.

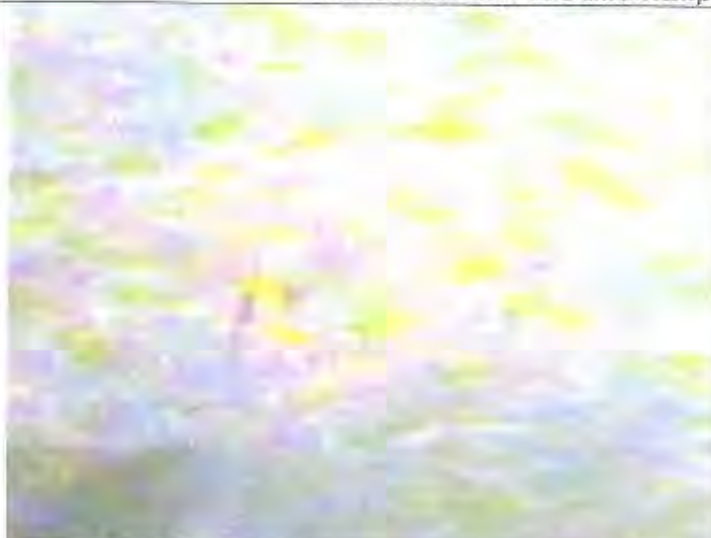
Date:	10/29/17	Frame(HH:MM:SS)	00:15:50	Date:

Cathodic Protection and Coating Measurements (for Feature # 3)					
CP Reading #1 (mV) (north end of feature)	N/R	CP Reading #2 (mV) (center of feature)	N/R	CP Reading #3 (mV) (south end of feature)	N/R
DFT #1 (mil) (north end of feature)	N/R	DFT #2 (mil) (center of feature)	N/R	DFT #3 (mil) (south end of feature)	N/R
(record #2 for features < 2" long; record #1 and #3 for features 2"-8" long; record #1, #2 and #3 for features >8" long)					
Temperature (°F)	56°	DFT Adjacent to Feature (mil) (~2" away from edge)	N/R	DFT Adjacent to Feature (mil) (~8"-12" away from edge)	N/R
			N/R		N/R
			N/R		N/R
			N/R		N/R
Provide 1 to 2 photos of feature, below: Included the date and time stamps associated with video surveillance.

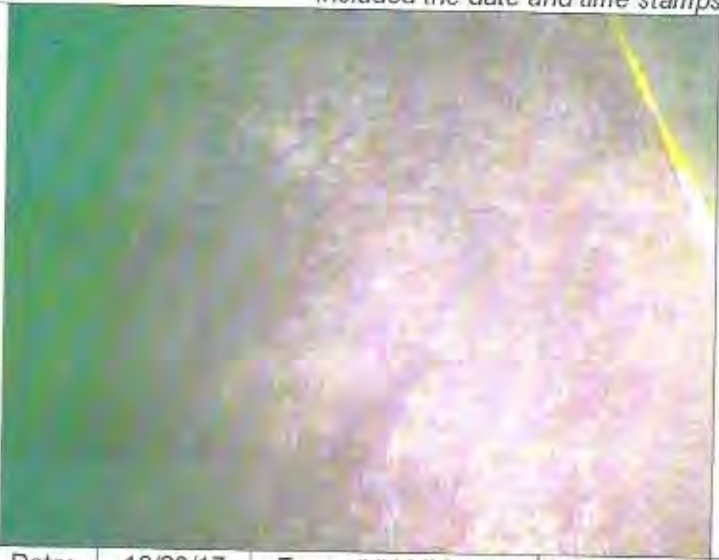
Date:	10/29/17	Frame(HH:MM:SS)	00:20:03	Date:	
				Frame(HH:MM:SS)

Cathodic Protection and Coating Measurements (OVERVIEW OF 6' NORTH ANCHOR)					
CP Reading #1 (mV) (north end of feature)	N/R	CP Reading #2 (mV) (center of feature)	N/R	CP Reading #3 (mV) (south end of feature)	N/R
DFT #1 (mil) (north end of feature)	N/R	DFT #2 (mil) (center of feature)	N/R	DFT #3 (mil) (south end of feature)	N/R
(record #2 for features < 2" long; record #1 and #3 for features 2"-8" long; record #1, #2 and #3 for features >8" long)					
Temperature (°F)	56°	DFT Adjacent to Feature (mil) (~2" away from edge)	N/R	DFT Adjacent to Feature (mil) (~8"-12" away from edge)	N/R
			N/R		N/R
			N/R		N/R
			N/R		N/R
<p>Provide 1 to 2 photos of feature, below:                      Included the date and time stamps associated with video surveillance.</p>

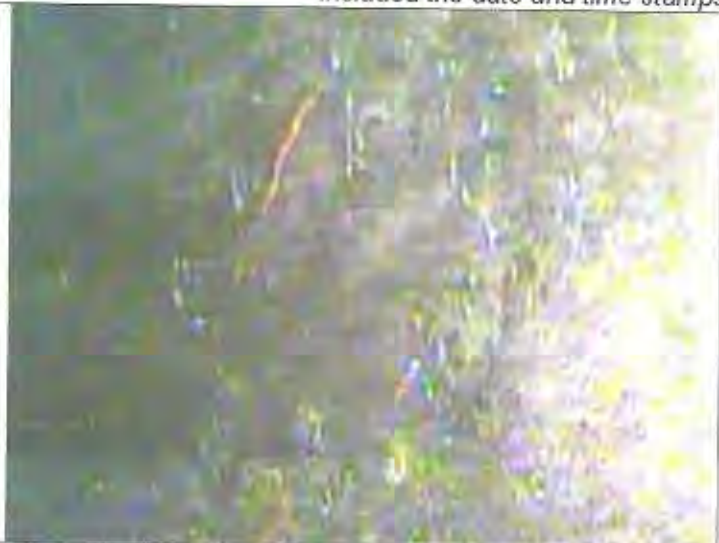
Date:	10/29/17	Frame(HH:MM:SS)	00:13:20	Date:	
				Frame(HH:MM:SS)

Cathodic Protection and Coating Measurements (for Feature # 2)					
CP Reading #1 (mV) (north end of feature)	N/R	CP Reading #2 (mV) (center of feature)	N/R	CP Reading #3 (mV) (south end of feature)	N/R
DFT #1 (mil) (north end of feature)	N/R	DFT #2 (mil) (center of feature)	N/R	DFT #3 (mil) (south end of feature)	N/R
(record #2 for features < 2" long; record #1 and #3 for features 2"-8" long; record #1, #2 and #3 for features >8" long)					
Temperature (°F)	58°	DFT Adjacent to Feature (mil) (~2" away from edge)	N/R	DFT Adjacent to Feature (mil) (~8"-12" away from edge)	N/R
			N/R		N/R
			N/R		N/R
			N/R		N/R
Provide 1 to 2 photos of feature, below: Included the date and time stamps associated with video surveillance.

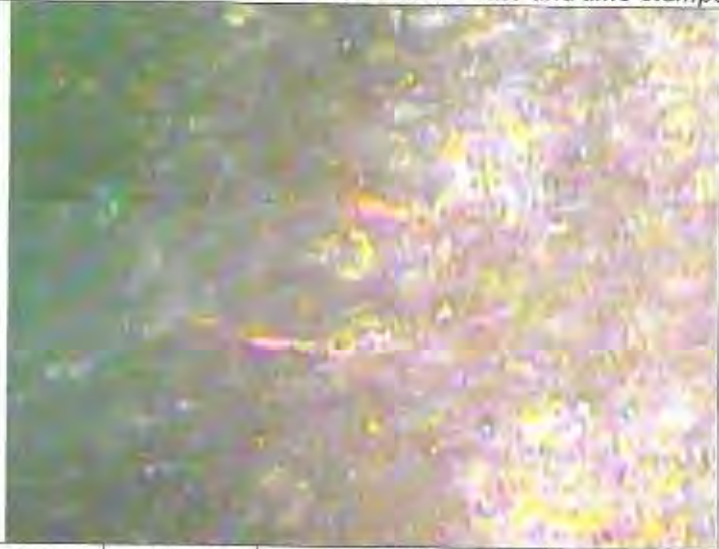
Date:	10/29/17	Frame(HH:MM:SS)	00:13:58	Date:	
					Frame(HH:MM:SS)

Cathodic Protection and Coating Measurements (for Feature # 3)					
<b>CP Reading #1 (mV)</b> (north end of feature)	N/R	<b>CP Reading #2 (mV)</b> (center of feature)	N/R	<b>CP Reading #3 (mV)</b> (south end of feature)	N/R
<b>DFT #1 (mil)</b> (north end of feature)	N/R	<b>DFT #2 (mil)</b> (center of feature)	N/R	<b>DFT #3 (mil)</b> (south end of feature)	N/R
(record #2 for features < 2" long; record #1 and #3 for features 2"-8" long; record #1, #2 and #3 for features >8" long)					
<b>Temperature (°F)</b>	58°	<b>DFT Adjacent to Feature (mil)</b> (~2" away from edge)	N/R	<b>DFT Adjacent to Feature (mil)</b> (~8"-12" away from edge)	N/R
			N/R		N/R
			N/R		N/R
			N/R		N/R
Provide 1 to 2 photos of feature, below: Included the date and time stamps associated with video surveillance.

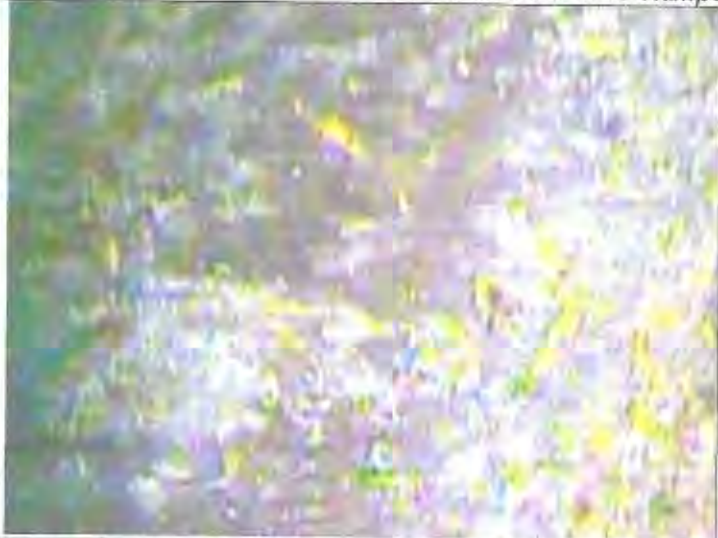
Date:	10/29/17	Frame(HH:MM:SS)	00:14:32	Date:	
				Frame(HH:MM:SS)

Cathodic Protection and Coating Measurements (for Feature # 4)					
CP Reading #1 (mV) (north end of feature)	N/R	CP Reading #2 (mV) (center of feature)	N/R	CP Reading #3 (mV) (south end of feature)	N/R
DFT #1 (mil) (north end of feature)	N/R	DFT #2 (mil) (center of feature)	N/R	DFT #3 (mil) (south end of feature)	N/R
(record #2 for features < 2" long; record #1 and #3 for features 2"-8" long; record #1, #2 and #3 for features >8" long)					
Temperature (°F)	58°	DFT Adjacent to Feature (mil) (~2" away from edge)	N/R	DFT Adjacent to Feature (mil) (~8"-12" away from edge)	N/R
			N/R		N/R
			N/R		N/R
			N/R		N/R
Provide 1 to 2 photos of feature, below: Included the date and time stamps associated with video surveillance.

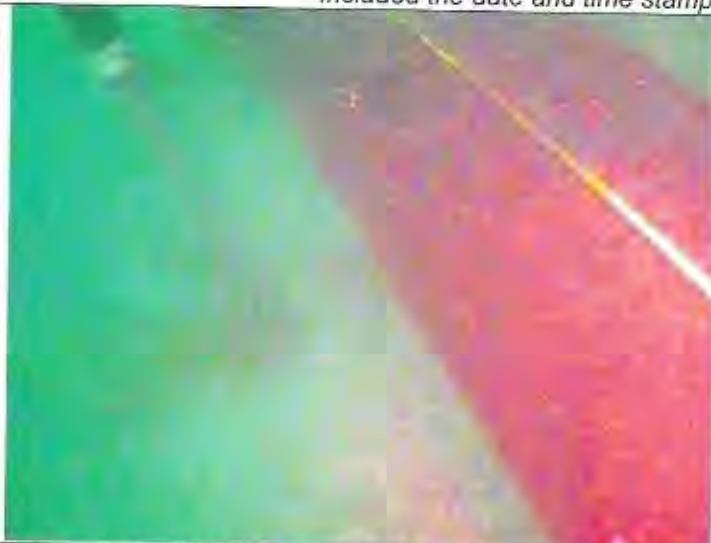
Feature 1, Dislodged area is approximately 100% of area from anchor to 6' South that has outer wrap missing

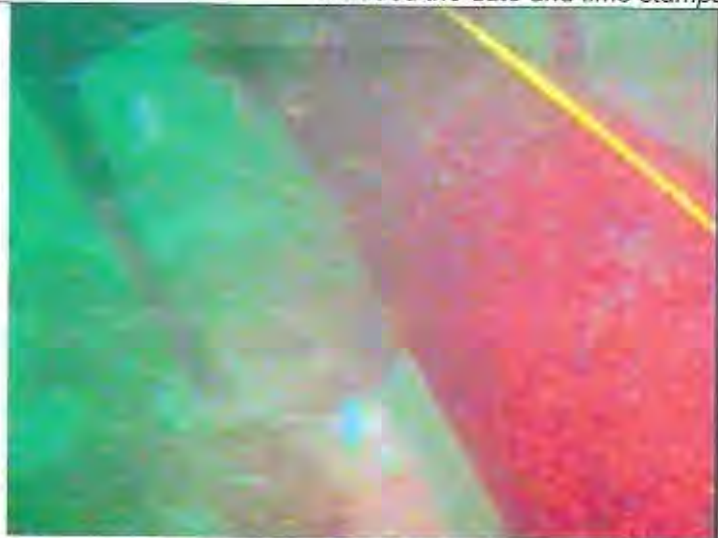
Feature 3, Dislodged area is approximately 100% of area from anchor to 6' North that has outer wrap missing

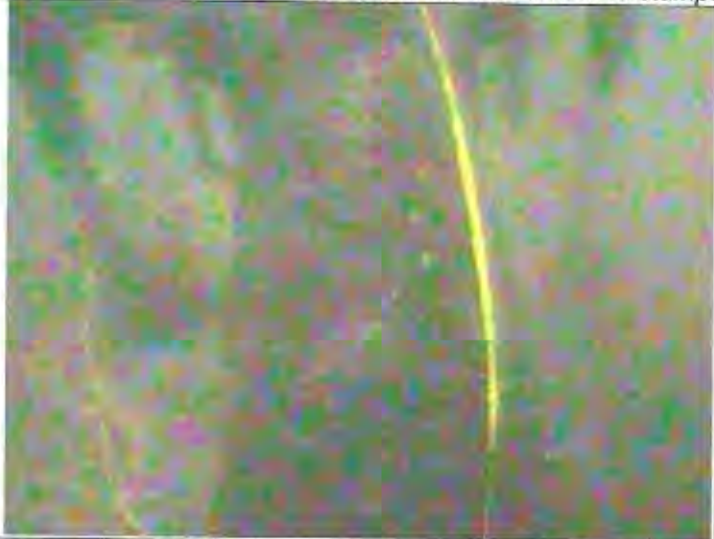
Date:	10/28/17	Frame(HH:MM:SS)	00:14:13	Date:	
					Frame(HH:MM:SS)

Cathodic Protection and Coating Measurements (for Feature # 1)					
<b>CP Reading #1 (mV)</b> (north end of feature)	N/R	<b>CP Reading #2 (mV)</b> (center of feature)	N/R	<b>CP Reading #3 (mV)</b> (south end of feature)	N/R
<b>DFT #1 (mil)</b> (north end of feature)	N/R	<b>DFT #2 (mil)</b> (center of feature)	N/R	<b>DFT #3 (mil)</b> (south end of feature)	N/R
(record #2 for features < 2" long; record #1 and #3 for features 2"-8" long; record #1, #2 and #3 for features >8" long)					
<b>Temperature (°F)</b>	58°	<b>DFT Adjacent to Feature (mil)</b> (~2" away from edge)	N/R	<b>DFT Adjacent to Feature (mil)</b> (~8"-12" away from edge)	N/R
			N/R		N/R
			N/R		N/R
			N/R		N/R
Provide 1 to 2 photos of feature, below: Included the date and time stamps associated with video surveillance.

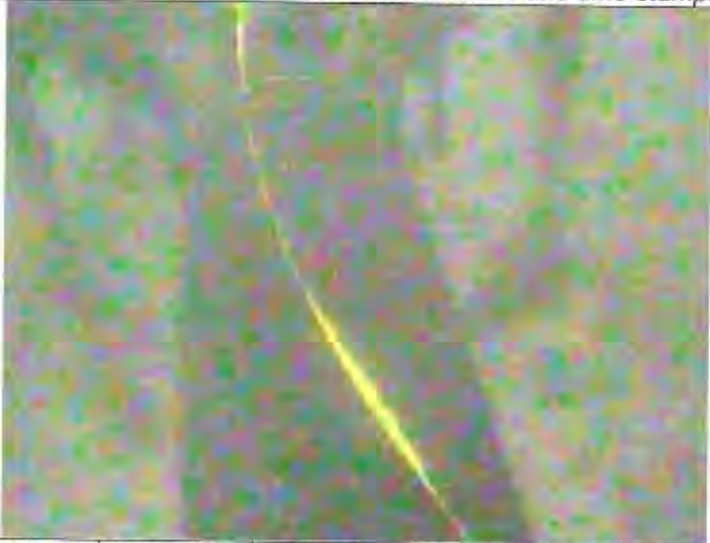
Date:	10/28/17	Frame(HH:MM:SS)	00:20:05	Date:	Frame(HH:MM:SS)

Cathodic Protection and Coating Measurements (for Feature # 2)					
CP Reading #1 (mV) (north end of feature)	N/R	CP Reading #2 (mV) (center of feature)	N/R	CP Reading #3 (mV) (south end of feature)	N/R
DFT #1 (mil) (north end of feature)	N/R	DFT #2 (mil) (center of feature)	N/R	DFT #3 (mil) (south end of feature)	N/R
(record #2 for features < 2" long; record #1 and #3 for features 2"-8" long; record #1, #2 and #3 for features >8" long)					
Temperature (°F)	58°	DFT Adjacent to Feature (mil) (~2" away from edge)	N/R	DFT Adjacent to Feature (mil) (~8"-12" away from edge)	N/R
			N/R		N/R
			N/R		N/R
			N/R		N/R
Provide 1 to 2 photos of feature, below: Included the date and time stamps associated with video surveillance.

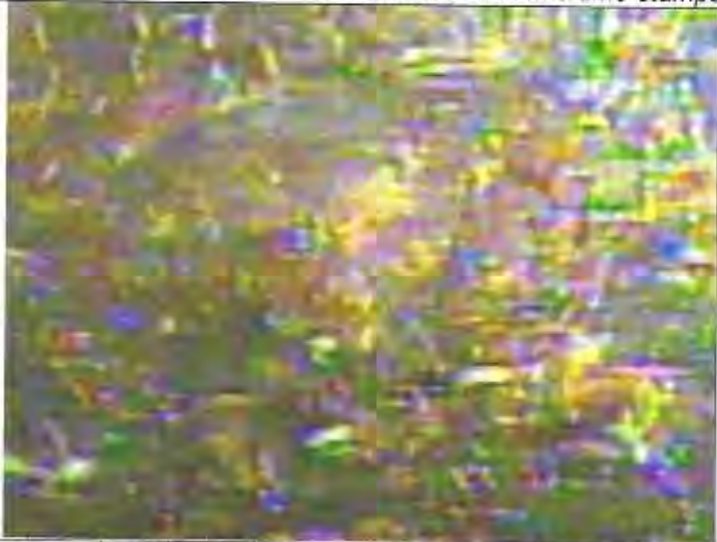
Date:	10/28/17	Frame(HH:MM:SS)	00:19:21	Date:	
				Frame(HH:MM:SS)

Cathodic Protection and Coating Measurements (for Feature # 3)					
CP Reading #1 (mV) (north end of feature)	N/R	CP Reading #2 (mV) (center of feature)	N/R	CP Reading #3 (mV) (south end of feature)	N/R
DFT #1 (mil) (north end of feature)	N/R	DFT #2 (mil) (center of feature)	N/R	DFT #3 (mil) (south end of feature)	N/R
(record #2 for features < 2" long; record #1 and #3 for features 2"-8" long; record #1, #2 and #3 for features >8" long)					
Temperature (°F)	58°	DFT Adjacent to Feature (mil) (~2" away from edge)	N/R	DFT Adjacent to Feature (mil) (~8"-12" away from edge)	N/R
			N/R		N/R
			N/R		N/R
			N/R		N/R
Provide 1 to 2 photos of feature, below: Included the date and time stamps associated with video surveillance.

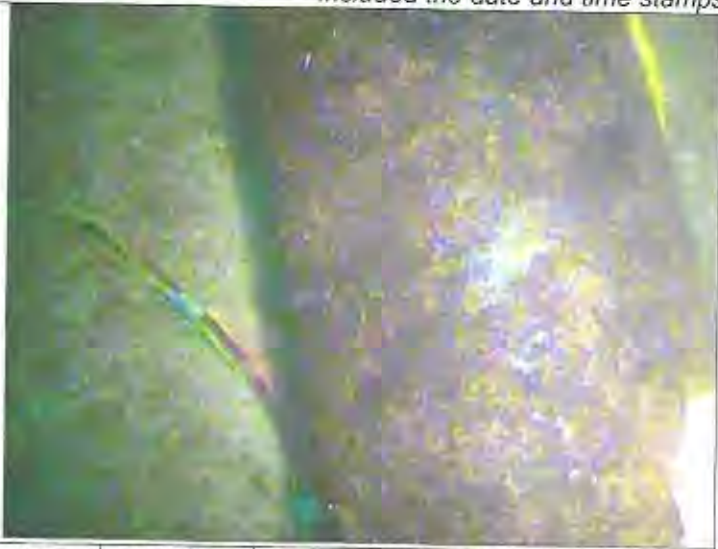
Date:	10/23/17	Frame(HH:MM:SS)	00:14:32	Date:	
				Frame(HH:MM:SS)	N/R

Feature 1, Dislodged area is approximately 60% of area from anchor to 6' South that has outer wrap missing

Cathodic Protection and Coating Measurements (for Feature # 1)					
CP Reading #1 (mV) (north end of feature)	N/R	CP Reading #2 (mV) (center of feature)	N/R	CP Reading #3 (mV) (south end of feature)	N/R
DFT #1 (mil) (north end of feature)	N/R	DFT #2 (mil) (center of feature)	N/R	DFT #3 (mil) (south end of feature)	N/R
(record #2 for features < 2" long; record #1 and #3 for features 2"-8" long; record #1, #2 and #3 for features >8" long)					
Temperature (°F)	56°	DFT Adjacent to Feature (mil) (~2" away from edge)	N/R	DFT Adjacent to Feature (mil) (~8"-12" away from edge)	N/R
			N/R		N/R
			N/R		N/R
			N/R		N/R
Provide 1 to 2 photos of feature, below: Included the date and time stamps associated with video surveillance.

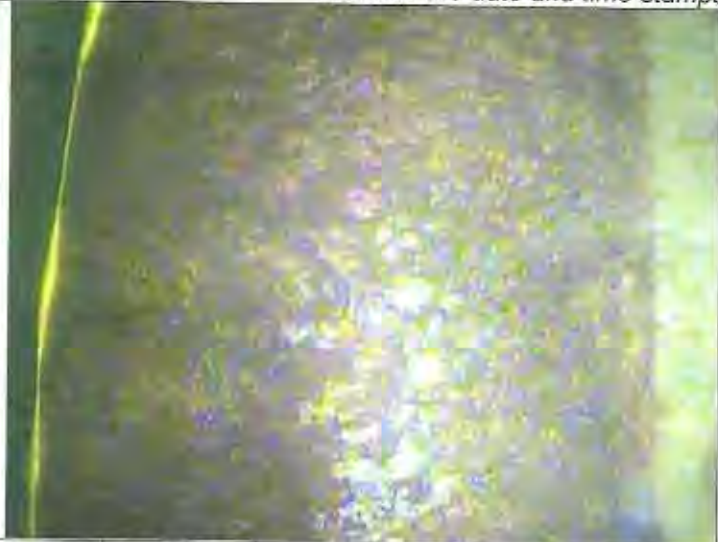
Date:	10/23/17	Frame(HH:MM:SS)	00:17:10	Date:	
				Frame(HH:MM:SS)	N/R

Feature 2, Dislodged area is approximately 5% of area from anchor to 6' North that has outer wrap missing

Cathodic Protection and Coating Measurements (for Feature # 2)					
CP Reading #1 (mV) (north end of feature)	N/R	CP Reading #2 (mV) (center of feature)	N/R	CP Reading #3 (mV) (south end of feature)	N/R
DFT #1 (mil) (north end of feature)	N/R	DFT #2 (mil) (center of feature)	N/R	DFT #3 (mil) (south end of feature)	N/R
(record #2 for features < 2" long; record #1 and #3 for features 2"-8" long; record #1, #2 and #3 for features >8" long)					
Temperature (°F)	58°	DFT Adjacent to Feature (mil) (~2" away from edge)	N/R	DFT Adjacent to Feature (mil) (~8"-12" away from edge)	N/R
			N/R		N/R
			N/R		N/R
			N/R		N/R
Provide 1 to 2 photos of feature, below: Included the date and time stamps associated with video surveillance.

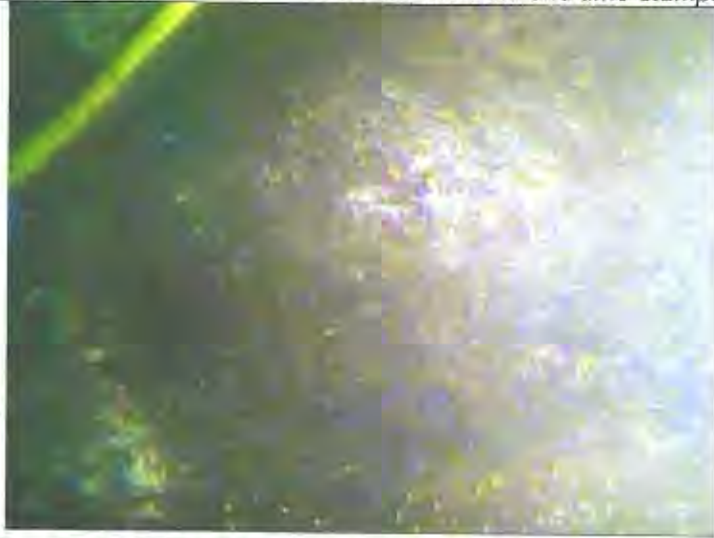
Date:	10/23/17	Frame(HH:MM:SS)	00:12:07	Date:	
					Frame(HH:MM:SS)

Comments/Issues/Discussion		
	<p>Feature 1, Dislodged area is approximately 10% of area from anchor to 6' South that has outer wrap missing</p> <p>NO FEATURES IDENTIFIED NORTH OF ANCHOR</p>

Cathodic Protection and Coating Measurements (for Feature # 1)					
CP Reading #1 (mV) (north end of feature)	N/R	CP Reading #2 (mV) (center of feature)	N/R	CP Reading #3 (mV) (south end of feature)	N/R
DFT #1 (mil) (north end of feature)	N/R	DFT #2 (mil) (center of feature)	N/R	DFT #3 (mil) (south end of feature)	N/R
(record #2 for features < 2" long; record #1 and #3 for features 2"-8" long; record #1, #2 and #3 for features >8" long)					
Temperature (°F)	56°	DFT Adjacent to Feature (mil) (~2" away from edge)	N/R	DFT Adjacent to Feature (mil) (~8"-12" away from edge)	N/R
			N/R		N/R
			N/R		N/R
			N/R		N/R
Provide 1 to 2 photos of feature, below: Included the date and time stamps associated with video surveillance.

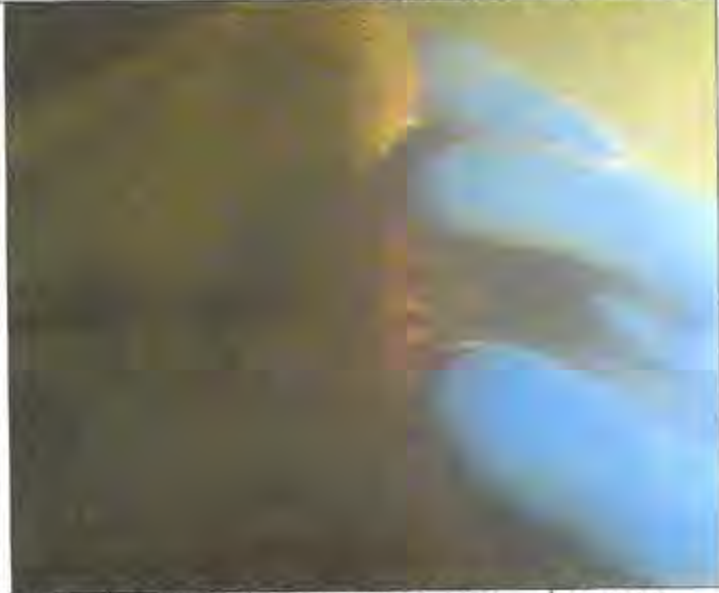
Date:	10/23/17	Frame(HH:MM:SS)	00:15:23	Date:	
				Frame(HH:MM:SS)

Cathodic Protection and Coating Measurements (for Feature # 2)					
CP Reading #1 (mV) (north end of feature)	N/R	CP Reading #2 (mV) (center of feature)	N/R	CP Reading #3 (mV) (south end of feature)	N/R
DFT #1 (mil) (north end of feature)	N/R	DFT #2 (mil) (center of feature)	N/R	DFT #3 (mil) (south end of feature)	N/R
(record #2 for features < 2" long; record #1 and #3 for features 2"-8" long; record #1, #2 and #3 for features >8" long)					
Temperature (°F)	52	DFT Adjacent to Feature (mil) (~2" away from edge)	N/R	DFT Adjacent to Feature (mil) (~8"-12" away from edge)	N/R
			N/R		N/R
			N/R		N/R
			N/R		N/R
Provide 1 to 2 photos of feature, below: Included the date and time stamps associated with video surveillance.

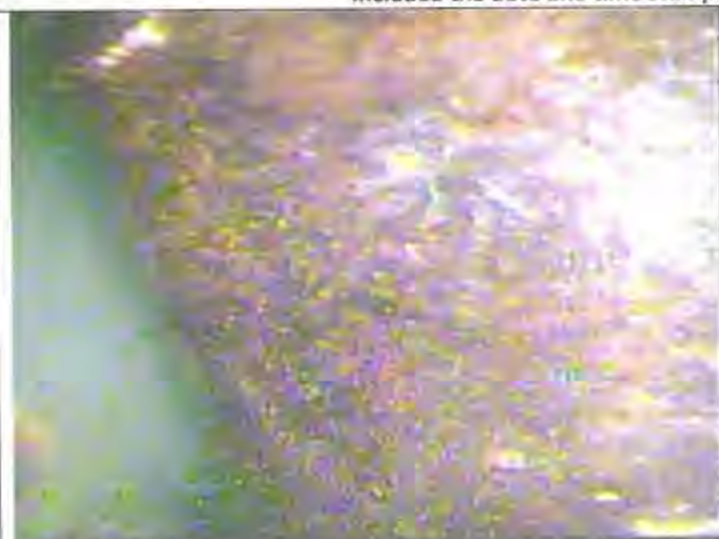
Date:	10/23/17	Frame(HH:MM:SS)	00:15:41	Date:		Frame(HH:MM:SS)	
-------	----------	-----------------	----------	-------	--	-----------------	--

Feature 3, Dislodged area is approximately 100% of area from anchor to 6' South that has outer wrap missing

Cathodic Protection and Coating Measurements (for Feature # 3)					
CP Reading #1 (mV) (north end of feature)	N/R	CP Reading #2 (mV) (center of feature)	N/R	CP Reading #3 (mV) (south end of feature)	N/R
DFT #1 (mil) (north end of feature)	N/R	DFT #2 (mil) (center of feature)	N/R	DFT #3 (mil) (south end of feature)	N/R
(record #2 for features < 2" long; record #1 and #3 for features 2"-8" long; record #1, #2 and #3 for features >8" long)					
Temperature (°F)	52	DFT Adjacent to Feature (mil) (~2" away from edge)	N/R	DFT Adjacent to Feature (mil) (~8"-12" away from edge)	N/R
			N/R		N/R
			N/R		N/R
			N/R		N/R
<p align="center">Provide 1 to 2 photos of feature, below: Included the date and time stamps associated with video surveillance.</p>

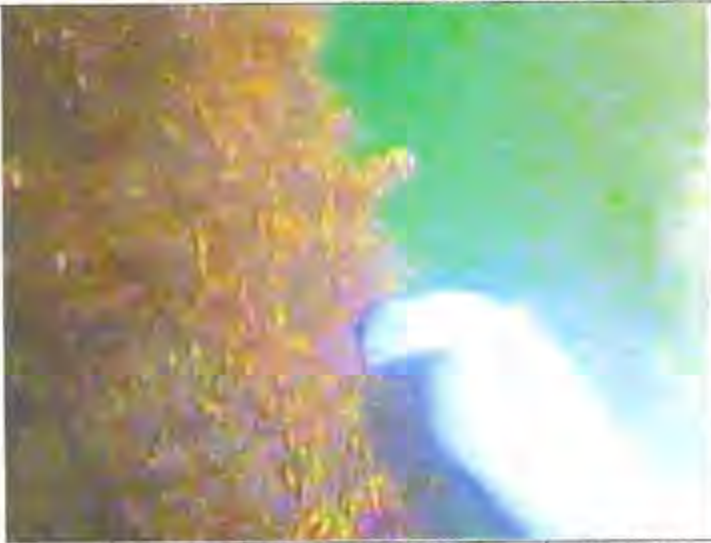
<div></div>		
Date:	10/23/17	Frame(HH:MM:SS)	00:20:03	Date:	
					Frame(HH:MM:SS)

Cathodic Protection and Coating Measurements (for Feature # 4)					
CP Reading #1 (mV) (north end of feature)	N/R	CP Reading #2 (mV) (center of feature)	N/R	CP Reading #3 (mV) (south end of feature)	N/R
DFT #1 (mil) (north end of feature)	N/R	DFT #2 (mil) (center of feature)	N/R	DFT #3 (mil) (south end of feature)	N/R
(record #2 for features < 2" long; record #1 and #3 for features 2"-8" long; record #1, #2 and #3 for features >8" long)					
Temperature (°F)	52	DFT Adjacent to Feature (mil) (~2" away from edge)	N/R	DFT Adjacent to Feature (mil) (~8"-12" away from edge)	N/R
			N/R		N/R
			N/R		N/R
			N/R		N/R
<p align="center">Provide 1 to 2 photos of feature, below: Included the date and time stamps associated with video surveillance.</p>

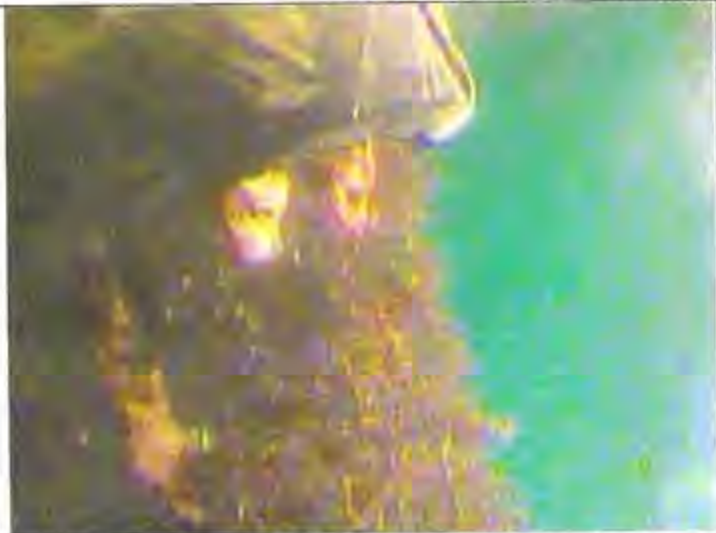
Date:	10/23/17	Frame(HH:MM:SS)	00:20:03	Date:	
					Frame(HH:MM:SS)

Cathodic Protection and Coating Measurements (for Feature # 5)					
CP Reading #1 (mV) (north end of feature)	N/R	CP Reading #2 (mV) (center of feature)	N/R	CP Reading #3 (mV) (south end of feature)	N/R
DFT #1 (mil) (north end of feature)	N/R	DFT #2 (mil) (center of feature)	N/R	DFT #3 (mil) (south end of feature)	N/R
(record #2 for features < 2" long; record #1 and #3 for features 2"-8" long; record #1, #2 and #3 for features >8" long)					
Temperature (°F)	52	DFT Adjacent to Feature (mil) (~2" away from edge)	N/R	DFT Adjacent to Feature (mil) (~8"-12" away from edge)	N/R
			N/R		N/R
			N/R		N/R
			N/R		N/R
<p align="center">Provide 1 to 2 photos of feature, below: Included the date and time stamps associated with video surveillance.</p>

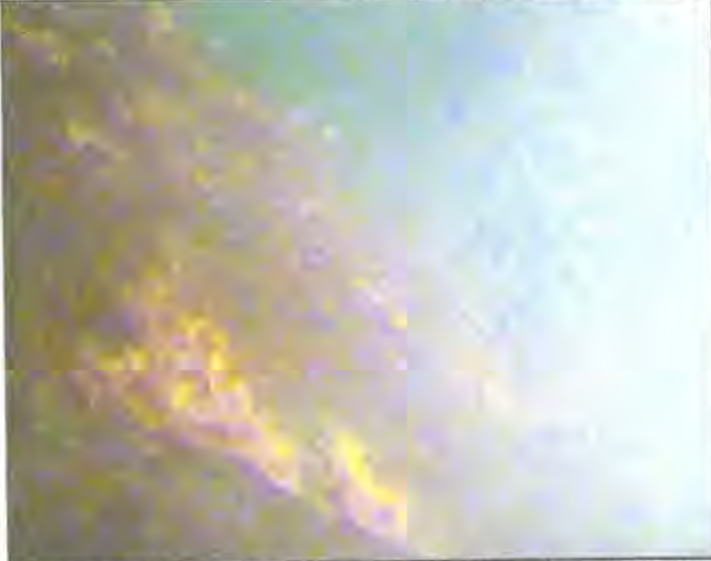
Date:	10/23/17	Frame(HH:MM:SS)	00:21:28	Date:	
				Frame(HH:MM:SS)

Cathodic Protection and Coating Measurements (for Feature # 6)					
CP Reading #1 (mV) (north end of feature)	N/R	CP Reading #2 (mV) (center of feature)	N/R	CP Reading #3 (mV) (south end of feature)	N/R
DFT #1 (mil) (north end of feature)	N/R	DFT #2 (mil) (center of feature)	N/R	DFT #3 (mil) (south end of feature)	N/R
(record #2 for features < 2" long; record #1 and #3 for features 2"-8" long; record #1, #2 and #3 for features >8" long)					
Temperature (°F)	52	DFT Adjacent to Feature (mil) (~2" away from edge)	N/R	DFT Adjacent to Feature (mil) (~8"-12" away from edge)	N/R
			N/R		N/R
			N/R		N/R
			N/R		N/R
Provide 1 to 2 photos of feature, below: Included the date and time stamps associated with video surveillance.

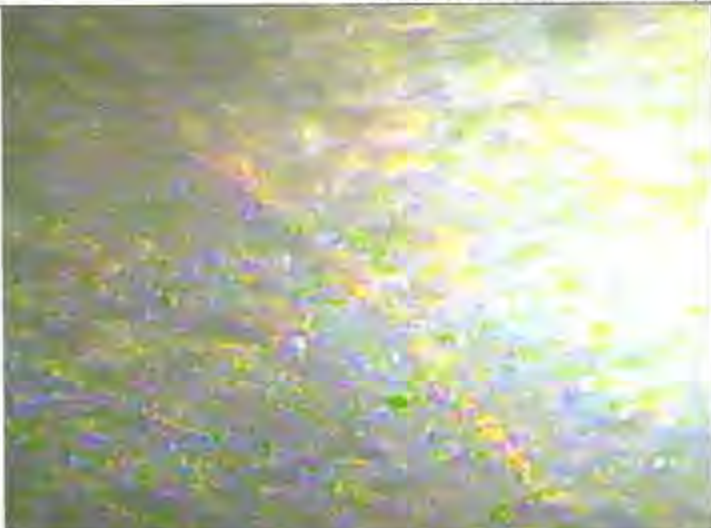
Date:	10/23/17	Frame(HH:MM:SS)	00:22:44	Date:	
		Frame(HH:MM:SS)

Cathodic Protection and Coating Measurements (for Feature # 7)					
CP Reading #1 (mV) (north end of feature)	N/R	CP Reading #2 (mV) (center of feature)	N/R	CP Reading #3 (mV) (south end of feature)	N/R
DFT #1 (mil) (north end of feature)	N/R	DFT #2 (mil) (center of feature)	N/R	DFT #3 (mil) (south end of feature)	N/R
(record #2 for features < 2" long; record #1 and #3 for features 2"-8" long; record #1, #2 and #3 for features >8" long)					
Temperature (°F)	52	DFT Adjacent to Feature (mil) (~2" away from edge)	N/R	DFT Adjacent to Feature (mil) (~8"-12" away from edge)	N/R
			N/R		N/R
			N/R		N/R
			N/R		N/R
Provide 1 to 2 photos of feature, below: Included the date and time stamps associated with video surveillance.

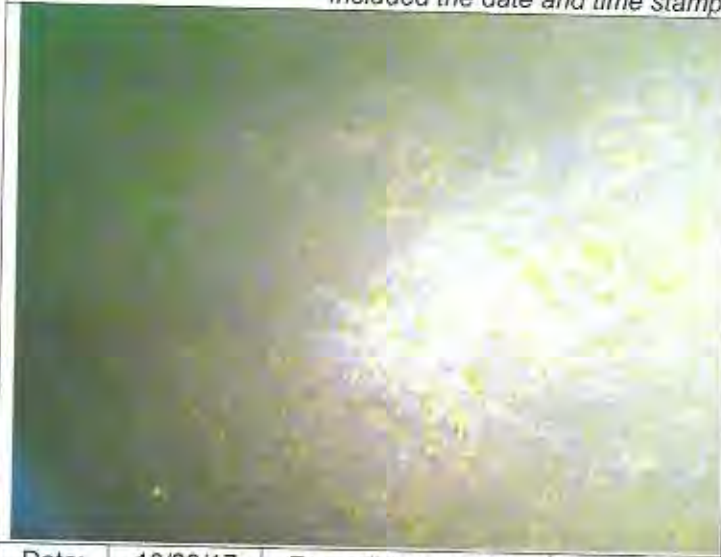
Date:	10/23/17	Frame(HH:MM:SS)	00:10:51	Date:		Frame(HH:MM:SS)	N/R
-------	----------	-----------------	----------	-------	--	-----------------	-----

Feature 1, Dislodged area is approximately 100% of area from anchor to 6' South that has outer wrap missing  
 Feature 2, Dislodged area is approximately 10% of area from anchor to 6' North that has outer wrap missing

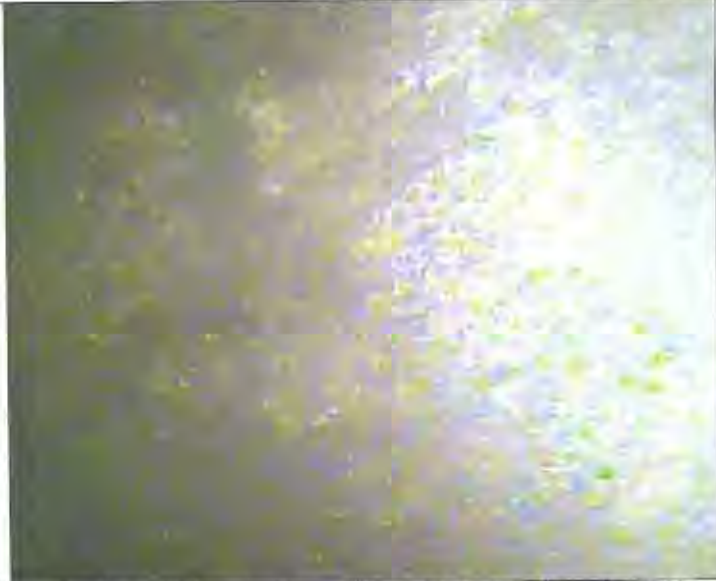
Date:	10/23/17	Frame(HH:MM:SS)	00:19:41	Date:	
		Frame(HH:MM:SS)

Comments/Issues/Discussion		
	<p>Feature 3, Dislodged area is approximately 10% of area from anchor to 6' South that has outer wrap missing</p> <p>Feature 4, Deposit ½" X ¼" within a Dislodged area 5" X 3"</p> <p>Feature 6, Deposit 24" X ¼" with in a Dislodged area 24" X 3"</p> <p>Feature 7, Dislodged area is approximately 20% of area from anchor to 6' North that has outer wrap missing</p>

Cathodic Protection and Coating Measurements (for Feature # 3)					
<b>CP Reading #1 (mV)</b> (north end of feature)	N/R	<b>CP Reading #2 (mV)</b> (center of feature)	N/R	<b>CP Reading #3 (mV)</b> (south end of feature)	N/R
<b>DFT #1 (mil)</b> (north end of feature)	N/R	<b>DFT #2 (mil)</b> (center of feature)	N/R	<b>DFT #3 (mil)</b> (south end of feature)	N/R
(record #2 for features < 2" long; record #1 and #3 for features 2"-8" long; record #1, #2 and #3 for features >8" long)					
<b>Temperature (°F)</b>	<b>54°</b>	<b>DFT Adjacent to Feature (mil)</b> (~2" away from edge)	N/R	<b>DFT Adjacent to Feature (mil)</b> (~8"-12" away from edge)	N/R
			N/R		N/R
			N/R		N/R
			N/R		N/R
Provide 1 to 2 photos of feature, below: Included the date and time stamps associated with video surveillance.

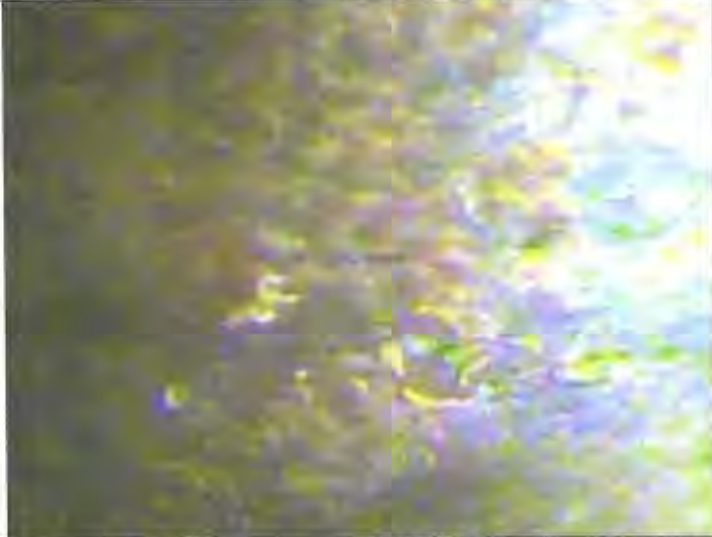
Date:	10/23/17	Frame(HH:MM:SS)	00:24:09	Date:		Frame(HH:MM:SS)

Cathodic Protection and Coating Measurements (for Feature # 4)							
CP Reading #1 (mV) (north end of feature)	N/R	CP Reading #2 (mV) (center of feature)	N/R	CP Reading #3 (mV) (south end of feature)	N/R		
DFT #1 (mil) (north end of feature)	N/R	DFT #2 (mil) (center of feature)	N/R	DFT #3 (mil) (south end of feature)	N/R		
(record #2 for features < 2" long; record #1 and #3 for features 2"-8" long; record #1, #2 and #3 for features >8" long)							
Temperature (°F)	54°	DFT Adjacent to Feature (mil) (~2" away from edge)	N/R	DFT Adjacent to Feature (mil) (~8"-12" away from edge)	N/R		
			N/R		N/R		
			N/R		N/R		
			N/R		N/R		
Provide 1 to 2 photos of feature, below: Included the date and time stamps associated with video surveillance.

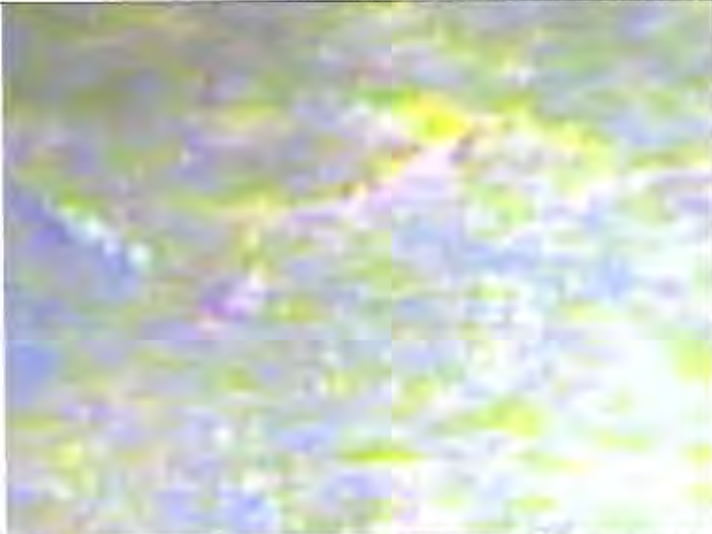
Date:	10/23/17	Frame(HH:MM:SS)	00:26:00	Date:	
				Frame(HH:MM:SS)

Cathodic Protection and Coating Measurements (for Feature # 5)					
CP Reading #1 (mV) (north end of feature)	N/R	CP Reading #2 (mV) (center of feature)	N/R	CP Reading #3 (mV) (south end of feature)	N/R
DFT #1 (mil) (north end of feature)	N/R	DFT #2 (mil) (center of feature)	N/R	DFT #3 (mil) (south end of feature)	N/R
(record #2 for features < 2" long; record #1 and #3 for features 2"-8" long; record #1, #2 and #3 for features >8" long)					
Temperature (°F)	54°	DFT Adjacent to Feature (mil) (~2" away from edge)	N/R	DFT Adjacent to Feature (mil) (~8"-12" away from edge)	N/R
			N/R		N/R
			N/R		N/R
			N/R		N/R
Provide 1 to 2 photos of feature, below: Included the date and time stamps associated with video surveillance.

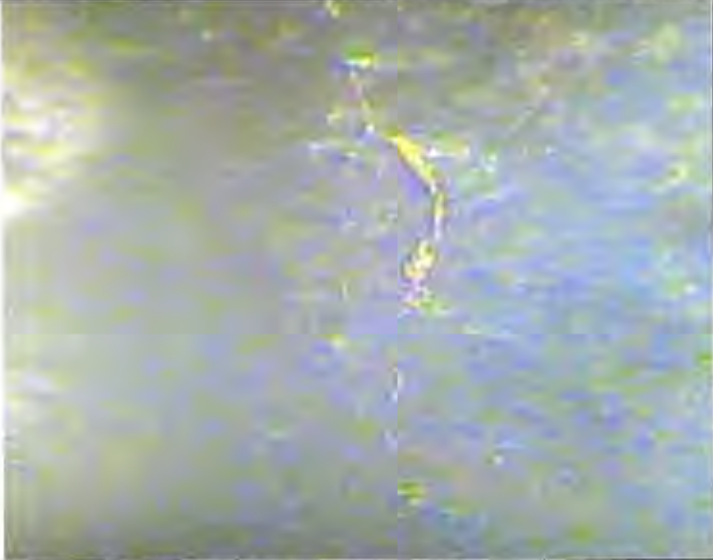
Date:	10/23/17	Frame(HH:MM:SS)	00:32:11	Date:	
				Frame(HH:MM:SS)

Cathodic Protection and Coating Measurements (for Feature # 6)					
CP Reading #1 (mV) (north end of feature)	N/R	CP Reading #2 (mV) (center of feature)	N/R	CP Reading #3 (mV) (south end of feature)	N/R
DFT #1 (mil) (north end of feature)	N/R	DFT #2 (mil) (center of feature)	N/R	DFT #3 (mil) (south end of feature)	N/R
(record #2 for features < 2" long; record #1 and #3 for features 2"-8" long; record #1, #2 and #3 for features >8" long)					
Temperature (°F)	54°	DFT Adjacent to Feature (mil) (~2" away from edge)	N/R	DFT Adjacent to Feature (mil) (~8"-12" away from edge)	N/R
			N/R		N/R
			N/R		N/R
			N/R		N/R
Provide 1 to 2 photos of feature, below: Included the date and time stamps associated with video surveillance.

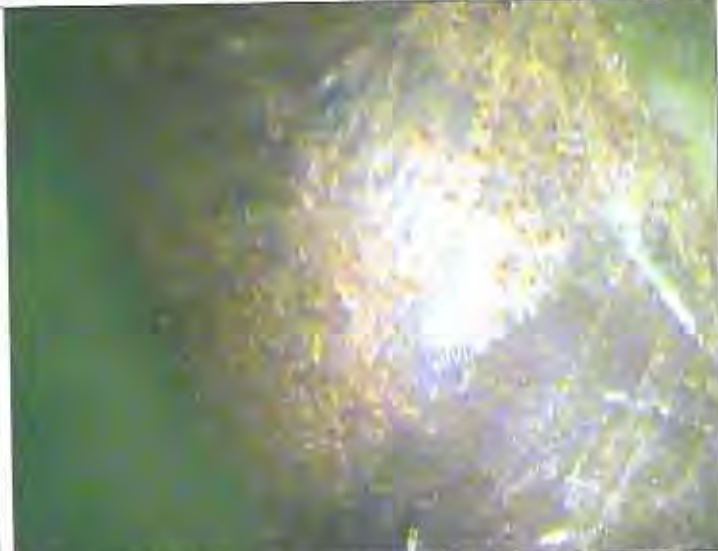
Date:	10/23/17	Frame(HH:MM:SS)	00:31:03	Date:	
				Frame(HH:MM:SS)

Cathodic Protection and Coating Measurements (for Feature # 7)					
CP Reading #1 (mV) (north end of feature)	N/R	CP Reading #2 (mV) (center of feature)	N/R	CP Reading #3 (mV) (south end of feature)	N/R
DFT #1 (mil) (north end of feature)	N/R	DFT #2 (mil) (center of feature)	N/R	DFT #3 (mil) (south end of feature)	N/R
(record #2 for features < 2" long; record #1 and #3 for features 2"-8" long; record #1, #2 and #3 for features >8" long)					
Temperature (°F)	54°	DFT Adjacent to Feature (mil) (~2" away from edge)	N/R	DFT Adjacent to Feature (mil) (~8"-12" away from edge)	N/R
			N/R		N/R
			N/R		N/R
			N/R		N/R
Provide 1 to 2 photos of feature, below: Included the date and time stamps associated with video surveillance.

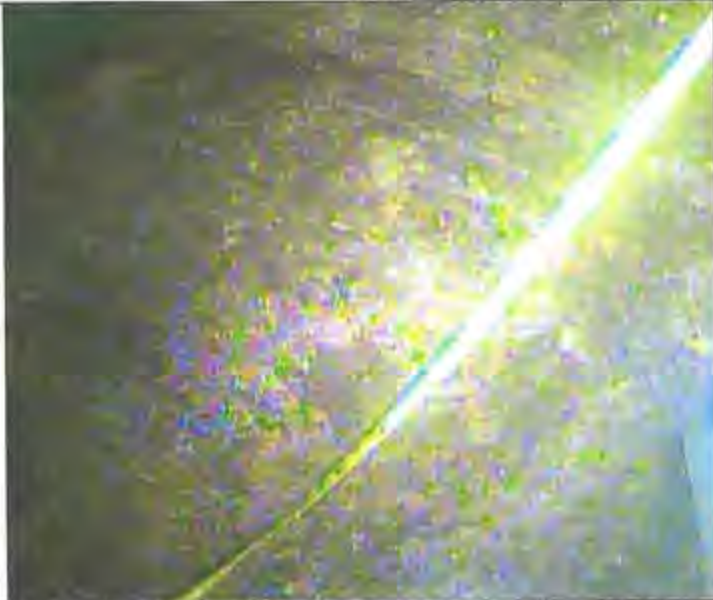
Date: 10/23/17	Frame(HH:MM:SS)	00:19:58	Date:		Frame(HH:MM:SS)

Comments/Issues/Discussion	
	<p>Feature 1, Dislodged area is approximately 100% of area from anchor to 6' South that has outer wrap missing</p> <p>Feature 2, Deposit 3" X ¼" within a Dislodged area 9" X 9"</p> <p>Note: Features 4-7 appears to be over a weld</p>
	<div style="display: flex; justify-content: space-between;"> <div style="width: 45%;">

Cathodic Protection and Coating Measurements (for Feature # 1)					
CP Reading #1 (mV) (north end of feature)	N/R	CP Reading #2 (mV) (center of feature)	N/R	CP Reading #3 (mV) (south end of feature)	N/R
DFT #1 (mil) (north end of feature)	N/R	DFT #2 (mil) (center of feature)	N/R	DFT #3 (mil) (south end of feature)	N/R
(record #2 for features < 2" long; record #1 and #3 for features 2"-8" long; record #1, #2 and #3 for features >8" long)					
Temperature (°F)	54°	DFT Adjacent to Feature (mil) (~2" away from edge)	N/R	DFT Adjacent to Feature (mil) (~8"-12" away from edge)	N/R
			N/R		N/R
			N/R		N/R
			N/R		N/R
Provide 1 to 2 photos of feature, below: Included the date and time stamps associated with video surveillance.

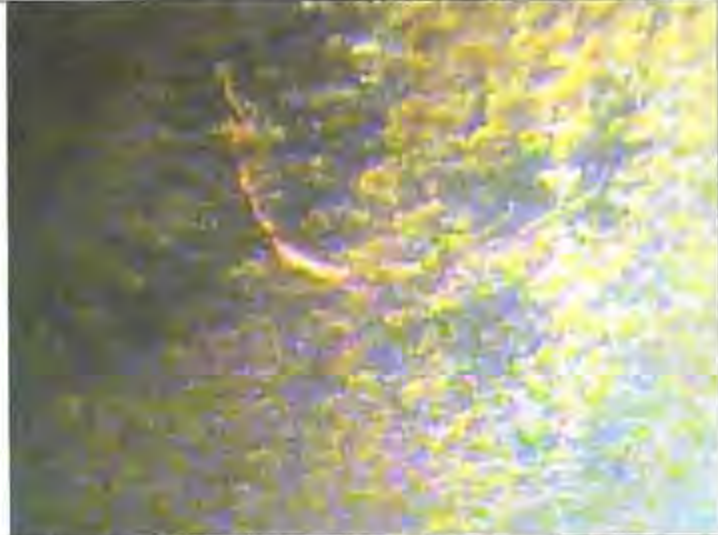
Date:	10/23/17	Frame(HH:MM:SS)	00:19:30	Date:

Cathodic Protection and Coating Measurements (for Feature # 2)					
CP Reading #1 (mV) (north end of feature)	N/R	CP Reading #2 (mV) (center of feature)	N/R	CP Reading #3 (mV) (south end of feature)	N/R
DFT #1 (mil) (north end of feature)	N/R	DFT #2 (mil) (center of feature)	N/R	DFT #3 (mil) (south end of feature)	N/R
(record #2 for features < 2" long; record #1 and #3 for features 2"-8" long; record #1, #2 and #3 for features >8" long)					
Temperature (°F)	54°	DFT Adjacent to Feature (mil) (~2" away from edge)	N/R	DFT Adjacent to Feature (mil) (~8"-12" away from edge)	N/R
			N/R		N/R
			N/R		N/R
			N/R		N/R
Provide 1 to 2 photos of feature, below: Included the date and time stamps associated with video surveillance.

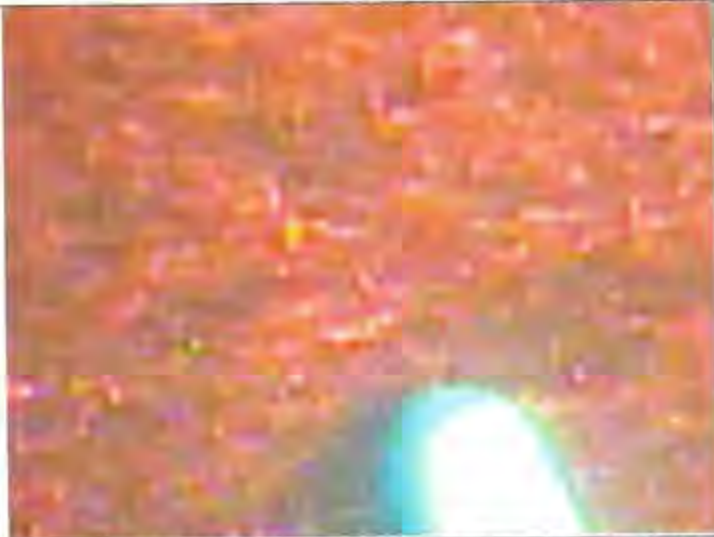
Date:	10/23/17	Frame(HH:MM:SS)	00:21:24	Date:	
				Frame(HH:MM:SS)

Cathodic Protection and Coating Measurements (for Feature # 3)					
CP Reading #1 (mV) (north end of feature)	N/R	CP Reading #2 (mV) (center of feature)	N/R	CP Reading #3 (mV) (south end of feature)	N/R
DFT #1 (mil) (north end of feature)	N/R	DFT #2 (mil) (center of feature)	N/R	DFT #3 (mil) (south end of feature)	N/R
(record #2 for features < 2" long; record #1 and #3 for features 2"-8" long; record #1, #2 and #3 for features >8" long)					
Temperature (°F)	54°	DFT Adjacent to Feature (mil) (~2" away from edge)	N/R	DFT Adjacent to Feature (mil) (~8"-12" away from edge)	N/R
			N/R		N/R
			N/R		N/R
			N/R		N/R
Provide 1 to 2 photos of feature, below: Included the date and time stamps associated with video surveillance.

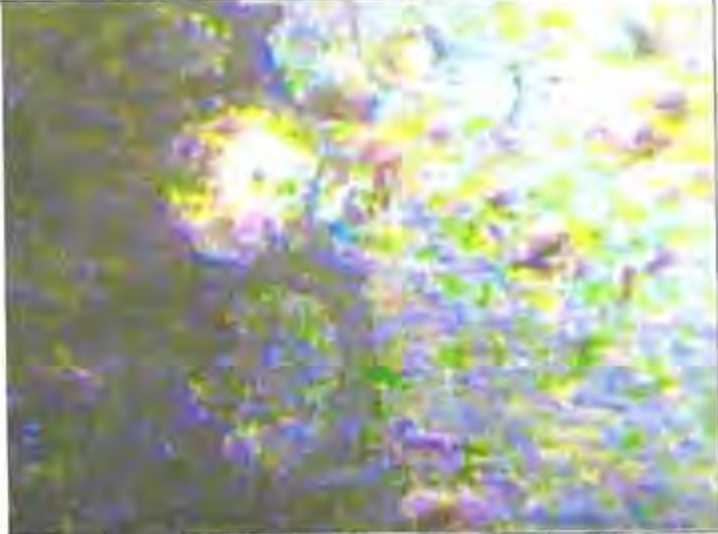
Date:	10/23/17	Frame(HH:MM:SS)	00:25:30	Date:		Frame(HH:MM:SS)

Cathodic Protection and Coating Measurements (for Feature # 4)							
CP Reading #1 (mV) (north end of feature)	N/R	CP Reading #2 (mV) (center of feature)	N/R	CP Reading #3 (mV) (south end of feature)	N/R		
DFT #1 (mil) (north end of feature)	N/R	DFT #2 (mil) (center of feature)	N/R	DFT #3 (mil) (south end of feature)	N/R		
(record #2 for features < 2" long; record #1 and #3 for features 2"-8" long; record #1, #2 and #3 for features >8" long)							
Temperature (°F)	54°	DFT Adjacent to Feature (mil) (~2" away from edge)	N/R	DFT Adjacent to Feature (mil) (~8"-12" away from edge)	N/R		
			N/R		N/R		
			N/R		N/R		
			N/R		N/R		
Provide 1 to 2 photos of feature, below: Included the date and time stamps associated with video surveillance.

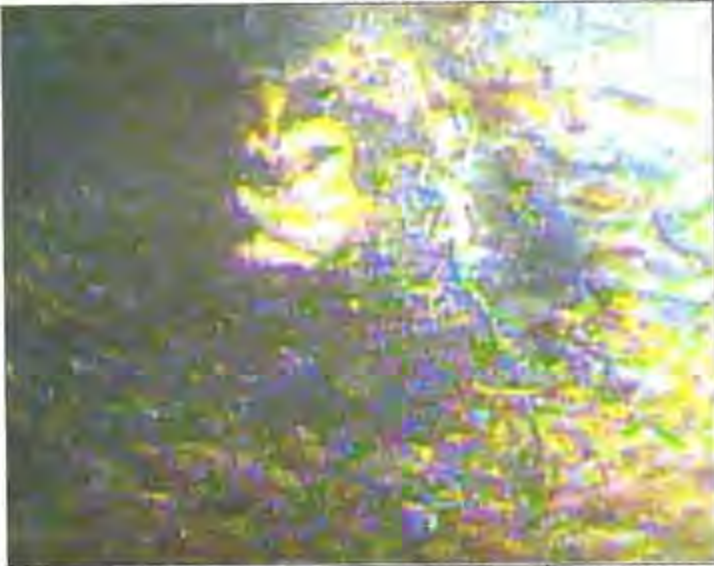
Date:	10/23/17	Frame(HH:MM:SS)	00:25:40	Date:	
				Frame(HH:MM:SS)

Cathodic Protection and Coating Measurements (for Feature # 5)					
CP Reading #1 (mV) (north end of feature)	N/R	CP Reading #2 (mV) (center of feature)	N/R	CP Reading #3 (mV) (south end of feature)	N/R
DFT #1 (mil) (north end of feature)	N/R	DFT #2 (mil) (center of feature)	N/R	DFT #3 (mil) (south end of feature)	N/R
(record #2 for features < 2" long; record #1 and #3 for features 2"-8" long; record #1, #2 and #3 for features >8" long)					
Temperature (°F)	54°	DFT Adjacent to Feature (mil) (~2" away from edge)	N/R	DFT Adjacent to Feature (mil) (~8"-12" away from edge)	N/R
			N/R		N/R
			N/R		N/R
			N/R		N/R
Provide 1 to 2 photos of feature, below: Included the date and time stamps associated with video surveillance.

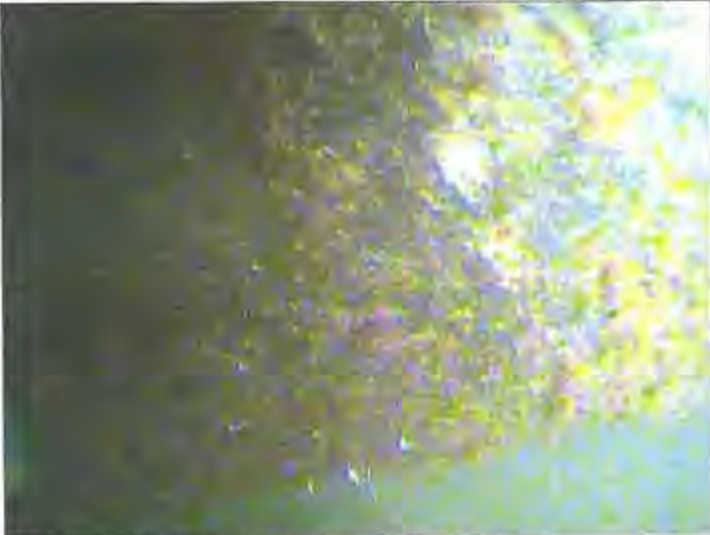
Date:	10/23/17	Frame(HH:MM:SS)		Date:	00:25:51
					Frame(HH:MM:SS)

Cathodic Protection and Coating Measurements (for Feature # 6)					
CP Reading #1 (mV) (north end of feature)	N/R	CP Reading #2 (mV) (center of feature)	N/R	CP Reading #3 (mV) (south end of feature)	N/R
DFT #1 (mil) (north end of feature)	N/R	DFT #2 (mil) (center of feature)	N/R	DFT #3 (mil) (south end of feature)	N/R
(record #2 for features < 2" long; record #1 and #3 for features 2"-8" long; record #1, #2 and #3 for features >8" long)					
Temperature (°F)	54°	DFT Adjacent to Feature (mil) (~2" away from edge)	N/R	DFT Adjacent to Feature (mil) (~8"-12" away from edge)	N/R
			N/R		N/R
			N/R		N/R
			N/R		N/R
Provide 1 to 2 photos of feature, below: Included the date and time stamps associated with video surveillance.

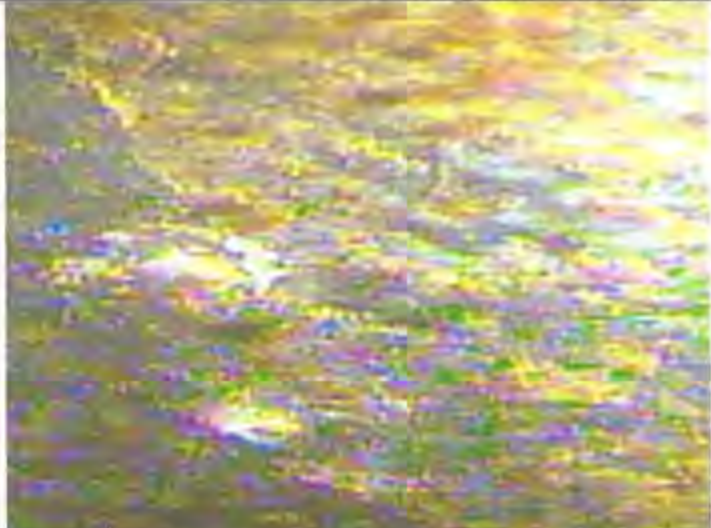
Date:	10/23/17	Frame(HH:MM:SS)	00:26:39	Date:	
					Frame(HH:MM:SS)

Cathodic Protection and Coating Measurements (for Feature # 7)					
CP Reading #1 (mV) (north end of feature)	N/R	CP Reading #2 (mV) (center of feature)	N/R	CP Reading #3 (mV) (south end of feature)	N/R
DFT #1 (mil) (north end of feature)	N/R	DFT #2 (mil) (center of feature)	N/R	DFT #3 (mil) (south end of feature)	N/R
(record #2 for features < 2" long; record #1 and #3 for features 2"-8" long; record #1, #2 and #3 for features >8" long)					
Temperature (°F)	54°	DFT Adjacent to Feature (mil) (~2" away from edge)	N/R	DFT Adjacent to Feature (mil) (~8"-12" away from edge)	N/R
			N/R		N/R
			N/R		N/R
			N/R		N/R
Provide 1 to 2 photos of feature, below: Included the date and time stamps associated with video surveillance.
