# Diver Inspection Form for L5 Straits of Mackinac

Date:	09/30/17	Diver:	Troy Baskett, Maurice Unger, Chad Cantrell, George Palmer
AFE / W.O.#:	20011702	Company Rep / Inspector:	[REDACTED]
Pipe Support Anchor:	E-1 (E-74A/E-74B South)	Water Depth (ft):	[REDACTED]
Longitude:	[REDACTED]	Latitude:	[REDACTED]

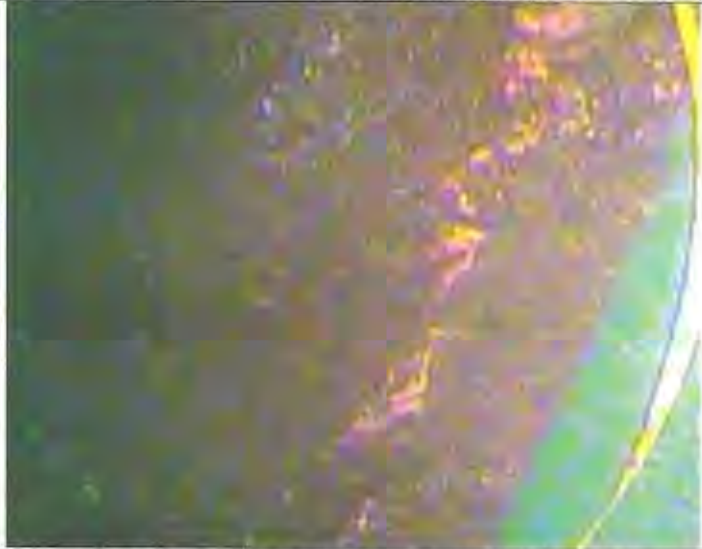
Date: 11/5/17	Frame(HH:MM:SS)	00:21:44	Date:		Frame(HH:MM:SS)

Cathodic Protection and Coating Measurements (for Feature # 2)					
CP Reading #1 (mV) (north end of feature)	N/R	CP Reading #2 (mV) (center of feature)	N/R	CP Reading #3 (mV) (south end of feature)	N/R
DFT #1 (mil) (north end of feature)	N/R	DFT #2 (mil) (center of feature)	N/R	DFT #3 (mil) (south end of feature)	N/R
(record #2 for features < 2" long; record #1 and #3 for features 2"-8" long; record #1, #2 and #3 for features >8" long)					
Temperature (°F)	50	DFT Adjacent to Feature (mil) (~2" away from edge)	N/R	DFT Adjacent to Feature (mil) (~8"-12" away from edge)	N/R
			N/R		N/R
			N/R		N/R
			N/R		N/R
Provide 1 to 2 photos of feature, below: Included the date and time stamps associated with video surveillance.

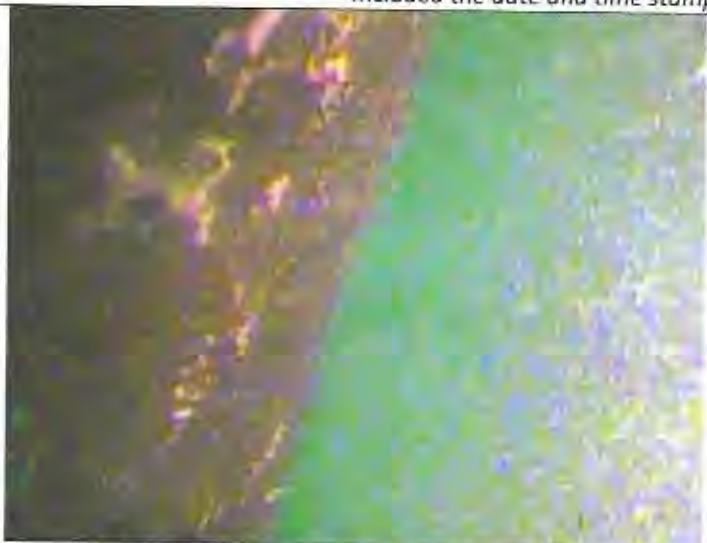
Date:	11/5/17	Frame(HH:MM:SS)	00:19:10	Date:	
				Frame(HH:MM:SS)

Feature 3, Dislodged area is approximately 30% of area from anchor to 6' South that has outer wrap missing

Cathodic Protection and Coating Measurements (for Feature # 3)					
CP Reading #1 (mV) (north end of feature)	N/R	CP Reading #2 (mV) (center of feature)	N/R	CP Reading #3 (mV) (south end of feature)	N/R
DFT #1 (mil) (north end of feature)	N/R	DFT #2 (mil) (center of feature)	N/R	DFT #3 (mil) (south end of feature)	N/R
(record #2 for features < 2" long; record #1 and #3 for features 2"-8" long; record #1, #2 and #3 for features >8" long)					
Temperature (°F)	50	DFT Adjacent to Feature (mil) (~2" away from edge)	N/R	DFT Adjacent to Feature (mil) (~8"-12" away from edge)	N/R
			N/R		N/R
			N/R		N/R
			N/R		N/R
Provide 1 to 2 photos of feature, below: Included the date and time stamps associated with video surveillance.

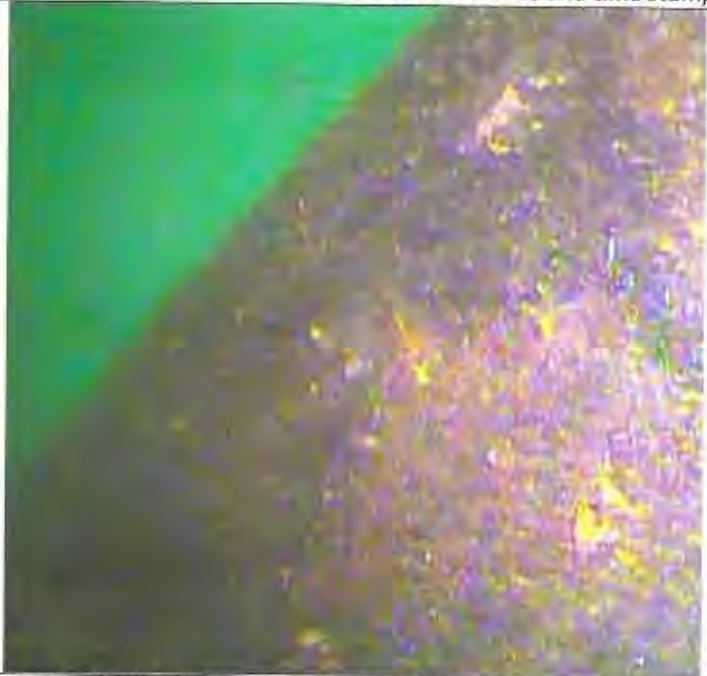
Date:	11/5/17	Frame(HH:MM:SS)	00:25:53	Date:	
				Frame(HH:MM:SS)

Cathodic Protection and Coating Measurements (for Feature # 4)					
CP Reading #1 (mV) (north end of feature)	N/R	CP Reading #2 (mV) (center of feature)	N/R	CP Reading #3 (mV) (south end of feature)	N/R
DFT #1 (mil) (north end of feature)	N/R	DFT #2 (mil) (center of feature)	N/R	DFT #3 (mil) (south end of feature)	N/R
(record #2 for features < 2" long; record #1 and #3 for features 2"-8" long; record #1, #2 and #3 for features >8" long)					
Temperature (°F)	50	DFT Adjacent to Feature (mil) (~2" away from edge)	N/R	DFT Adjacent to Feature (mil) (~8"-12" away from edge)	N/R
			N/R		N/R
			N/R		N/R
			N/R		N/R
Provide 1 to 2 photos of feature, below: Included the date and time stamps associated with video surveillance.

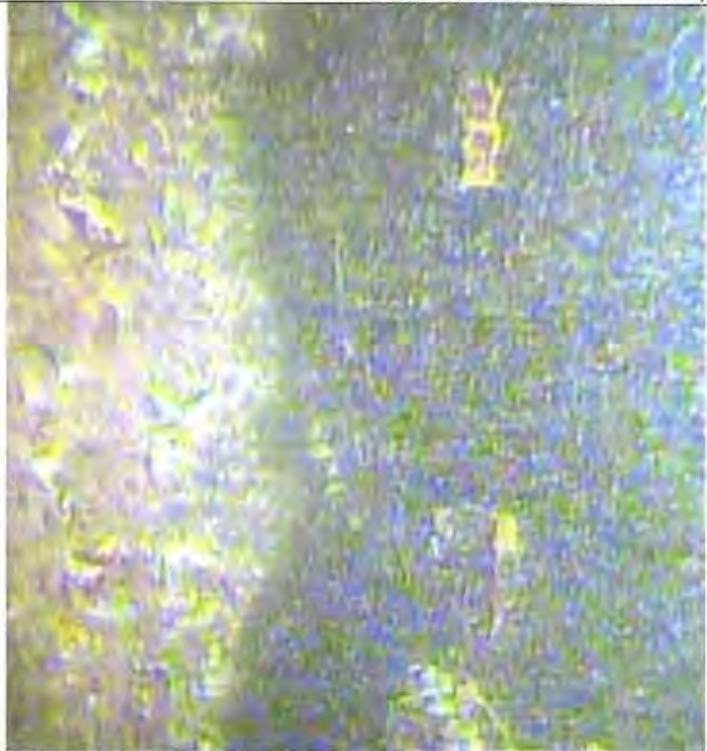
Date:	11/5/17	Frame(HH:MM:SS)	00:30:04	Date:	
				Frame(HH:MM:SS)

Cathodic Protection and Coating Measurements (for Feature # 5)					
CP Reading #1 (mV) (north end of feature)	N/R	CP Reading #2 (mV) (center of feature)	N/R	CP Reading #3 (mV) (south end of feature)	N/R
DFT #1 (mil) (north end of feature)	N/R	DFT #2 (mil) (center of feature)	N/R	DFT #3 (mil) (south end of feature)	N/R
(record #2 for features < 2" long; record #1 and #3 for features 2"-8" long; record #1, #2 and #3 for features >8" long)					
Temperature (°F)	50	DFT Adjacent to Feature (mil) (~2" away from edge)	N/R	DFT Adjacent to Feature (mil) (~8"-12" away from edge)	N/R
			N/R		N/R
			N/R		N/R
			N/R		N/R
Provide 1 to 2 photos of feature, below: Included the date and time stamps associated with video surveillance.

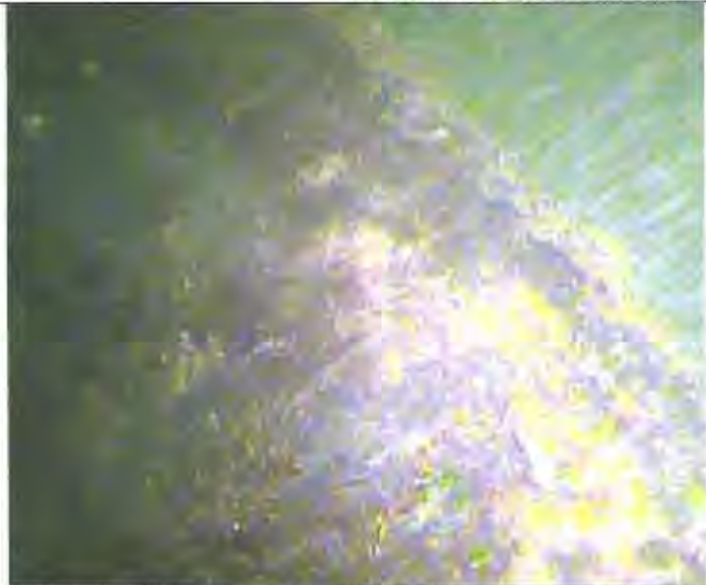
Date:	11/5/17	Frame(HH:MM:SS)	00:30:32	Date:	
					Frame(HH:MM:SS)

Feature 6, Dislodged area is approximately 50% of area from anchor to 6' North that has outer wrap missing

Cathodic Protection and Coating Measurements (for Feature # 6)					
CP Reading #1 (mV) (north end of feature)	N/R	CP Reading #2 (mV) (center of feature)	N/R	CP Reading #3 (mV) (south end of feature)	N/R
DFT #1 (mil) (north end of feature)	N/R	DFT #2 (mil) (center of feature)	N/R	DFT #3 (mil) (south end of feature)	N/R
(record #2 for features < 2" long; record #1 and #3 for features 2"-8" long; record #1, #2 and #3 for features >8" long)					
Temperature (°F)	50	DFT Adjacent to Feature (mil) (~2" away from edge)	N/R	DFT Adjacent to Feature (mil) (~8"-12" away from edge)	N/R
			N/R		N/R
			N/R		N/R
			N/R		N/R
Provide 1 to 2 photos of feature, below: Included the date and time stamps associated with video surveillance.

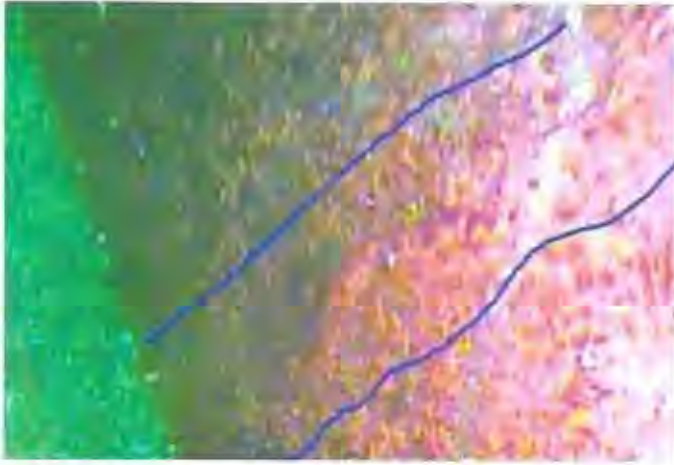
Date:	10/14/17	Frame(HH:MM:SS)	00:33:23	Date:

Cathodic Protection and Coating Measurements (for Feature # 1)					
CP Reading #1 (mV) (north end of feature)	N/R	CP Reading #2 (mV) (center of feature)	N/R	CP Reading #3 (mV) (south end of feature)	N/R
DFT #1 (mil) (north end of feature)	140	DFT #2 (mil) (center of feature)	140	DFT #3 (mil) (south end of feature)	82
(record #2 for features < 2" long; record #1 and #3 for features 2"-8" long; record #1, #2 and #3 for features >8" long)					
Temperature (°F)	55°	DFT Adjacent to Feature (mil) (~2" away from edge)	200	DFT Adjacent to Feature (mil) (~8"-12" away from edge)	145
			125		130
			135		110
			250		180
Provide 1 to 2 photos of feature, below: Included the date and time stamps associated with video surveillance.

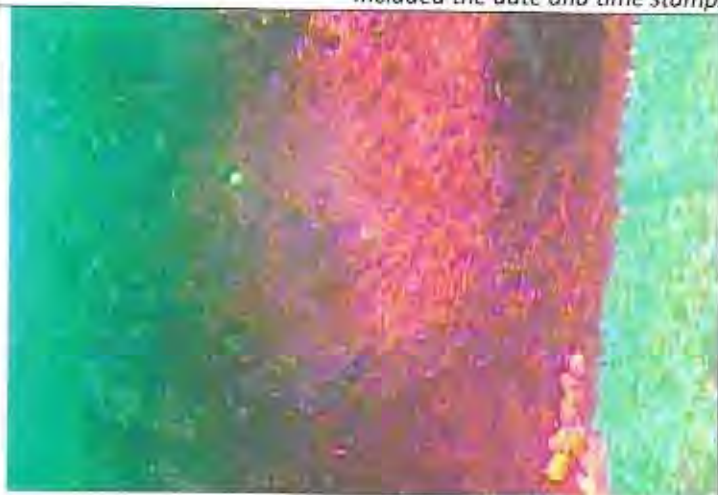
Date:	10/14/17	Frame(HH:MM:SS)	00:15:12	Date:	
					Frame(HH:MM:SS)

Cathodic Protection and Coating Measurements (for Feature # 2)					
CP Reading #1 (mV) (north end of feature)	N/R	CP Reading #2 (mV) (center of feature)	N/R	CP Reading #3 (mV) (south end of feature)	N/R
DFT #1 (mil) (north end of feature)	160	DFT #2 (mil) (center of feature)	130	DFT #3 (mil) (south end of feature)	145
(record #2 for features < 2" long; record #1 and #3 for features 2"-8" long; record #1, #2 and #3 for features >8" long)					
Temperature (°F)	55°	DFT Adjacent to Feature (mil) (~2" away from edge)	160	DFT Adjacent to Feature (mil) (~8"-12" away from edge)	120
			200		200
			170		200
			200		250
Provide 1 to 2 photos of feature, below: Included the date and time stamps associated with video surveillance.

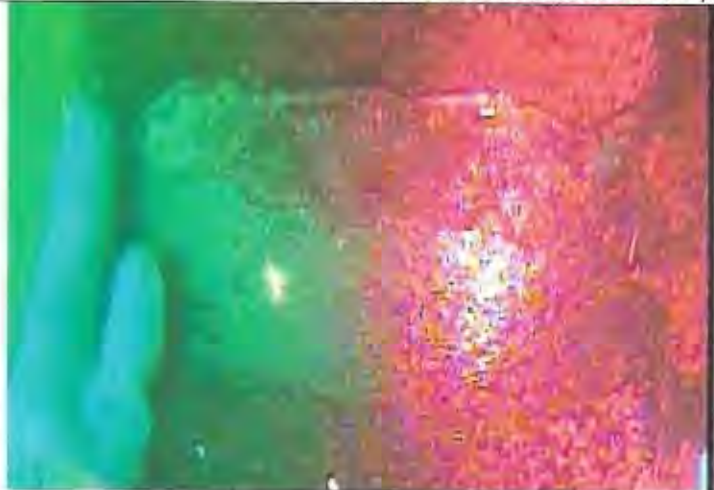
Date:	10/14/17	Frame(HH:MM:SS)	00:36:50	Date:	
		Frame(HH:MM:SS)

Cathodic Protection and Coating Measurements (for Feature # 3)					
<b>CP Reading #1 (mV)</b> (north end of feature)	<b>N/R</b>	<b>CP Reading #2 (mV)</b> (center of feature)	<b>N/R</b>	<b>CP Reading #3 (mV)</b> (south end of feature)	<b>N/R</b>
<b>DFT #1 (mil)</b> (north end of feature)	<b>170</b>	<b>DFT #2 (mil)</b> (center of feature)	<b>150</b>	<b>DFT #3 (mil)</b> (south end of feature)	<b>200</b>
(record #2 for features < 2" long; record #1 and #3 for features 2"-8" long; record #1, #2 and #3 for features >8" long)					
<b>Temperature (°F)</b>	<b>55°</b>	<b>DFT Adjacent to Feature (mil)</b> (~2" away from edge)	<b>210</b>	<b>DFT Adjacent to Feature (mil)</b> (~8"-12" away from edge)	<b>180</b>
			<b>135</b>		<b>200</b>
			<b>190</b>		<b>240</b>
			<b>200</b>		<b>250</b>
Provide 1 to 2 photos of feature, below: Included the date and time stamps associated with video surveillance.

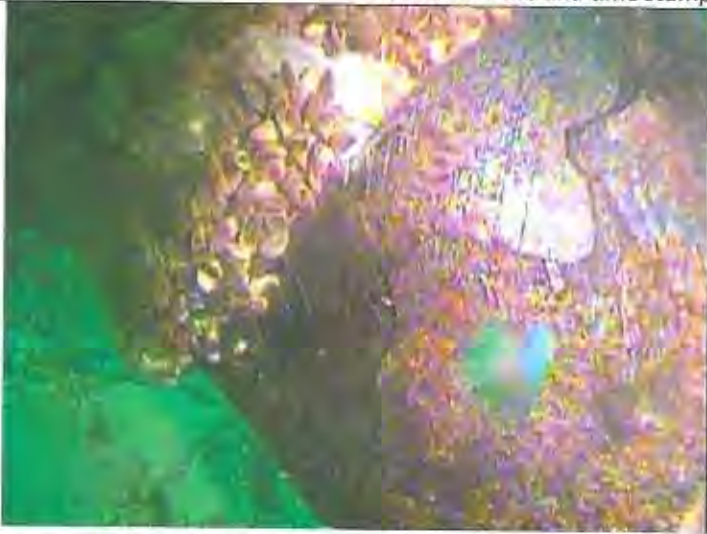
Date:	10/14/17	Frame(HH:MM:SS)	00:52:56	Date:	
					Frame(HH:MM:SS)

Cathodic Protection and Coating Measurements (for Feature # 4)					
CP Reading #1 (mV) (north end of feature)	N/R	CP Reading #2 (mV) (center of feature)	N/R	CP Reading #3 (mV) (south end of feature)	N/R
DFT #1 (mil) (north end of feature)	160	DFT #2 (mil) (center of feature)	150	DFT #3 (mil) (south end of feature)	160
(record #2 for features < 2" long; record #1 and #3 for features 2"-8" long; record #1, #2 and #3 for features >8" long)					
Temperature (°F)	55°	DFT Adjacent to Feature (mil) (~2" away from edge)	190	DFT Adjacent to Feature (mil) (~8"-12" away from edge)	200
			170		190
			170		160
			200		170
Provide 1 to 2 photos of feature, below: Included the date and time stamps associated with video surveillance.

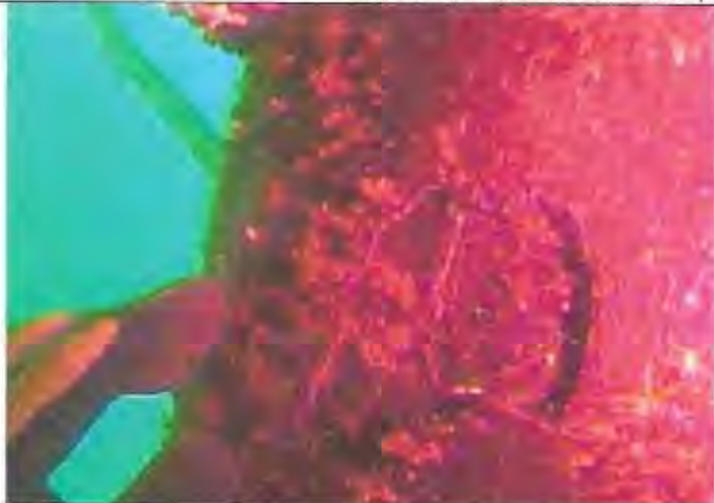
Date:	10/14/17	Frame(HH:MM:SS)	00:14:40	Date:	
					Frame(HH:MM:SS)

Cathodic Protection and Coating Measurements (for Feature # 5)					
CP Reading #1 (mV) (north end of feature)	N/R	CP Reading #2 (mV) (center of feature)	N/R	CP Reading #3 (mV) (south end of feature)	N/R
DFT #1 (mil) (north end of feature)	94	DFT #2 (mil) (center of feature)	N/R	DFT #3 (mil) (south end of feature)	94
(record #2 for features < 2" long; record #1 and #3 for features 2"-8" long; record #1, #2 and #3 for features >8" long)					
Temperature (°F)	55°	DFT Adjacent to Feature (mil) (~2" away from edge)	115	DFT Adjacent to Feature (mil) (~8"-12" away from edge)	125
			120		115
			150		105
			125		92
Provide 1 to 2 photos of feature, below: Included the date and time stamps associated with video surveillance.

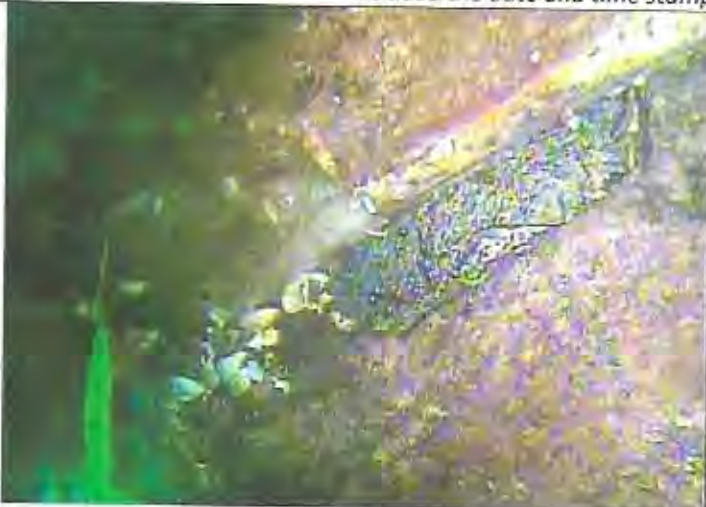
Date:	10/14/17	Frame(HH:MM:SS)	00:17:47	Date:	
				Frame(HH:MM:SS)

Cathodic Protection and Coating Measurements (for Feature # 6)					
CP Reading #1 (mV) (north end of feature)	N/R	CP Reading #2 (mV) (center of feature)	N/R	CP Reading #3 (mV) (south end of feature)	N/R
DFT #1 (mil) (north end of feature)	92	DFT #2 (mil) (center of feature)	N/R	DFT #3 (mil) (south end of feature)	84
(record #2 for features < 2" long; record #1 and #3 for features 2"-8" long; record #1, #2 and #3 for features >8" long)					
Temperature (°F)	55°	DFT Adjacent to Feature (mil) (~2" away from edge)	110	DFT Adjacent to Feature (mil) (~8"-12" away from edge)	110
			120		115
			110		110
			110		95
Provide 1 to 2 photos of feature, below: Included the date and time stamps associated with video surveillance.

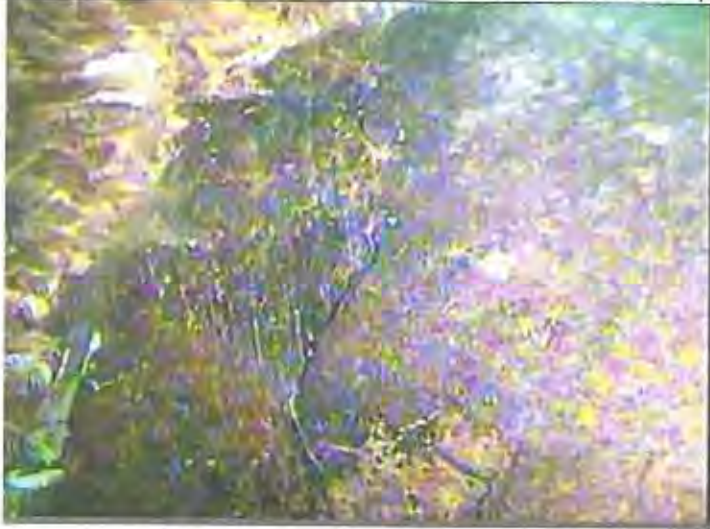
Date:	10/14/17	Frame(HH:MM:SS)	00:28:09	Date:	
				Frame(HH:MM:SS)

Cathodic Protection and Coating Measurements (for Feature # 7)					
CP Reading #1 (mV) (north end of feature)	N/R	CP Reading #2 (mV) (center of feature)	N/R	CP Reading #3 (mV) (south end of feature)	N/R
DFT #1 (mil) (north end of feature)	88	DFT #2 (mil) (center of feature)	N/R	DFT #3 (mil) (south end of feature)	92
(record #2 for features < 2" long; record #1 and #3 for features 2"-8" long; record #1, #2 and #3 for features >8" long)					
Temperature (°F)	55°	DFT Adjacent to Feature (mil) (~2" away from edge)	115	DFT Adjacent to Feature (mil) (~8"-12" away from edge)	94
			110		110
			115		120
			105		110
Provide 1 to 2 photos of feature, below: Included the date and time stamps associated with video surveillance.

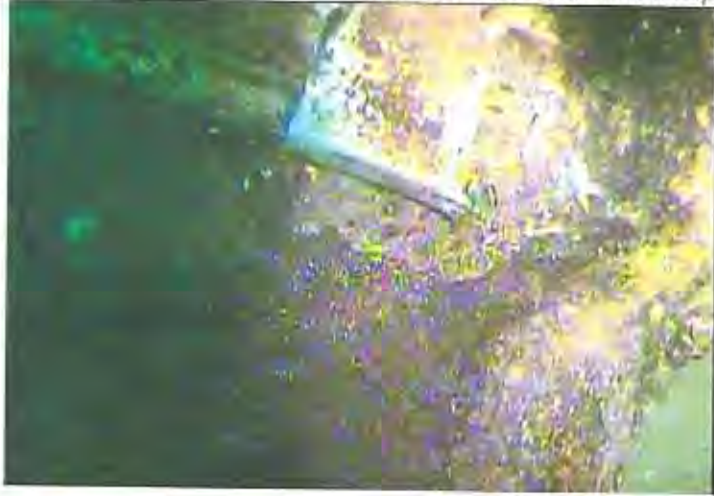
Date:	10/14/17	Frame(HH:MM:SS)	00:47:31	Date:	
					Frame(HH:MM:SS)

Cathodic Protection and Coating Measurements (for Feature # 9)					
CP Reading #1 (mV) (north end of feature)	N/R	CP Reading #2 (mV) (center of feature)	N/R	CP Reading #3 (mV) (south end of feature)	N/R
DFT #1 (mil) (north end of feature)	88	DFT #2 (mil) (center of feature)	N/R	DFT #3 (mil) (south end of feature)	90
(record #2 for features < 2" long; record #1 and #3 for features 2"-8" long; record #1, #2 and #3 for features >8" long)					
Temperature (°F)	55°	DFT Adjacent to Feature (mil) (~2" away from edge)	98	DFT Adjacent to Feature (mil) (~8"-12" away from edge)	105
			110		100
			110		100
			105		115
Provide 1 to 2 photos of feature, below: Included the date and time stamps associated with video surveillance.

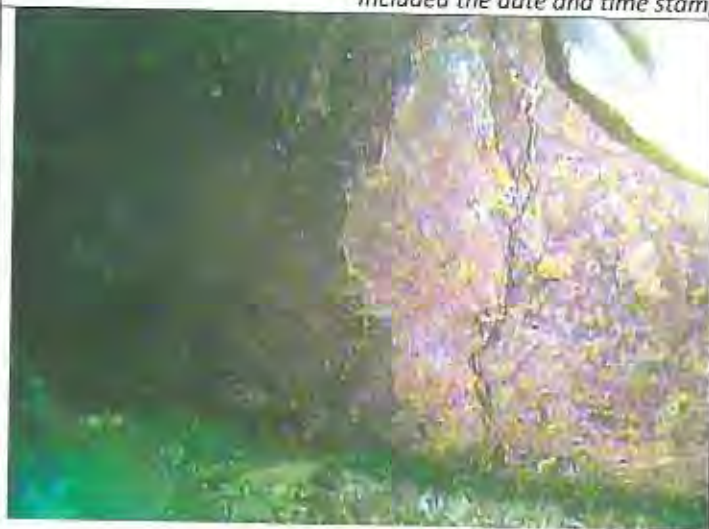
Date:	10/14/17	Frame(HH:MM:SS)	00:55:30	Date:		Frame(HH:MM:SS)	
-------	----------	-----------------	----------	-------	--	-----------------	--

CP Reading #1 (mV) (north end of feature)	N/R	CP Reading #2 (mV) (center of feature)	N/R	CP Reading #3 (mV) (south end of feature)	N/R
DFT #1 (mil) (north end of feature)	78	DFT #2 (mil) (center of feature)	86	DFT #3 (mil) (south end of feature)	88
(record #2 for features < 2" long; record #1 and #3 for features 2"-8" long; record #1, #2 and #3 for features >8" long)					
Temperature (°F)	55°	DFT Adjacent to Feature (mil) (~2" away from edge)	90	DFT Adjacent to Feature (mil) (~8"-12" away from edge)	120
			125		130
			110		120
			120		100

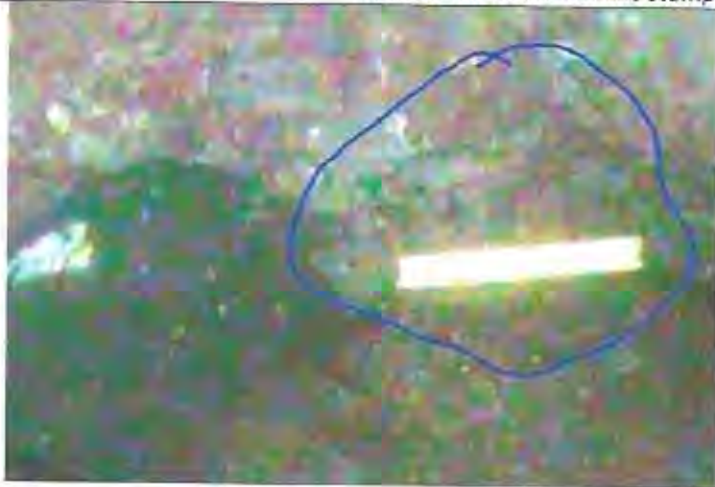
Date:	10/14/17	Frame(HH:MM:SS)	00:25:05	Date:	
				Frame(HH:MM:SS)

Cathodic Protection and Coating Measurements (for Feature # 11)					
CP Reading #1 (mV) (north end of feature)	N/R	CP Reading #2 (mV) (center of feature)	N/R	CP Reading #3 (mV) (south end of feature)	N/R
DFT #1 (mil) (north end of feature)	105	DFT #2 (mil) (center of feature)	N/R	DFT #3 (mil) (south end of feature)	104
(record #2 for features < 2" long; record #1 and #3 for features 2"-8" long; record #1, #2 and #3 for features >8" long)					
Temperature (°F)	55°	DFT Adjacent to Feature (mil) (~2" away from edge)	125	DFT Adjacent to Feature (mil) (~8"-12" away from edge)	125
			115		120
			115		125
			120		120
Provide 1 to 2 photos of feature, below: Included the date and time stamps associated with video surveillance.

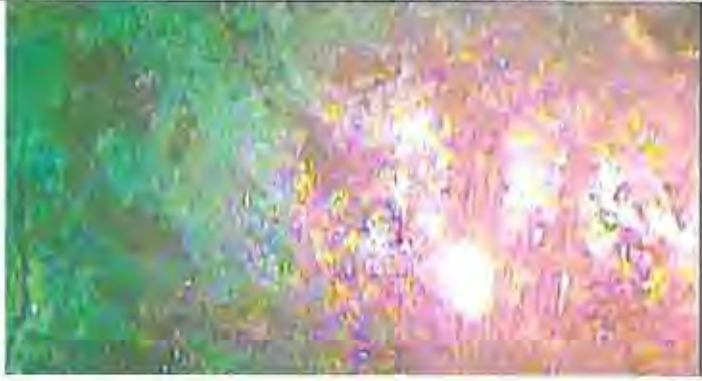
Date:	10/09/17	Frame(HH:MM:SS)	00:05:30	Date:	
				Frame(HH:MM:SS)

Cathodic Protection and Coating Measurements (for Feature # 1)					
CP Reading #1 (mV) (north end of feature)	N/R	CP Reading #2 (mV) (center of feature)	N/R	CP Reading #3 (mV) (south end of feature)	N/R
DFT #1 (mil) (north end of feature)	N/R	DFT #2 (mil) (center of feature)	N/R	DFT #3 (mil) (south end of feature)	N/R
(record #2 for features < 2" long; record #1 and #3 for features 2 - 8" long; record #1, #2 and #3 for features >8" long)					
Temperature (°F)	56°	DFT Adjacent to Feature (mil) (~2" away from edge)	N/R	DFT Adjacent to Feature (mil) (~8 - 12" away from edge)	N/R
			N/R		N/R
			N/R		N/R
			N/R		N/R
Provide 1 to 2 photos of feature, below: Included the date and time stamps associated with video surveillance.

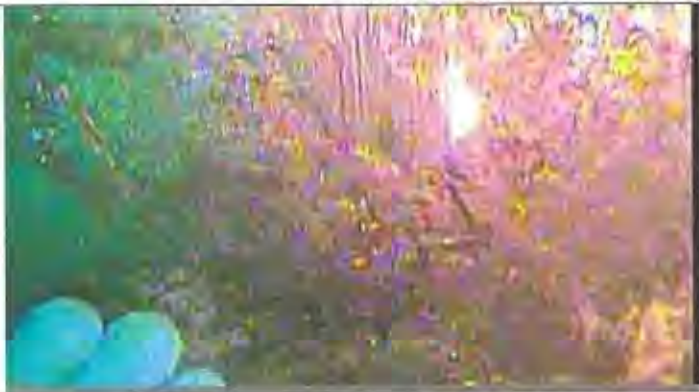
Date: 10/09/17	Frame(HH:MM:SS)	00:06:55	Date:		Frame(HH:MM:SS)

Cathodic Protection and Coating Measurements (for Feature # 2)					
CP Reading #1 (mV) (north end of feature)	N/R	CP Reading #2 (mV) (center of feature)	N/R	CP Reading #3 (mV) (south end of feature)	N/R
DFT #1 (mil) (north end of feature)	N/R	DFT #2 (mil) (center of feature)	N/R	DFT #3 (mil) (south end of feature)	N/R
(record #2 for features < 2" long; record #1 and #3 for features 2 - 8" long; record #1, #2 and #3 for features >8" long)					
Temperature (°F)	56°	DFT Adjacent to Feature (mil) (~2" away from edge)	N/R	DFT Adjacent to Feature (mil) (~8 - 12" away from edge)	N/R
			N/R		N/R
			N/R		N/R
			N/R		N/R
Provide 1 to 2 photos of feature, below: Included the date and time stamps associated with video surveillance.

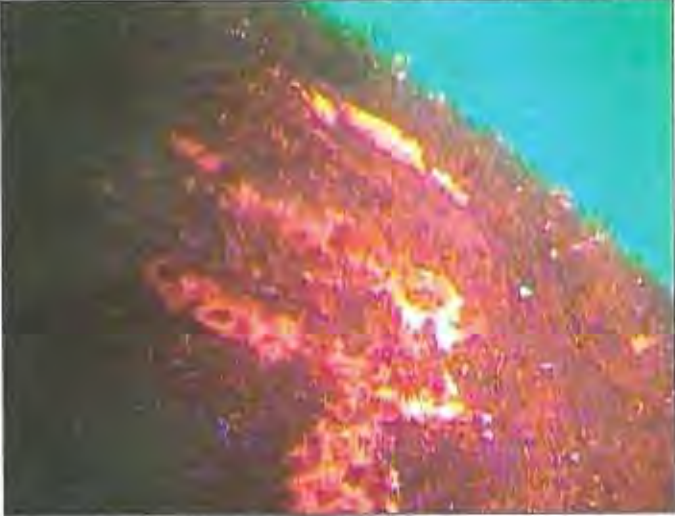
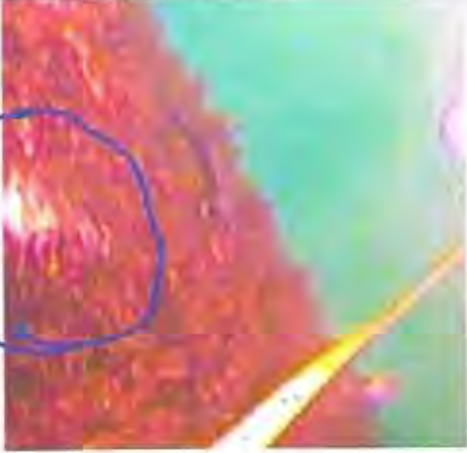
Date:	10/9/17	Frame(HH:MM:SS)	00:39:38	Date:	10.13.17
				Frame(HH:MM:SS)	00:16:56

Cathodic Protection and Coating Measurements (for Feature # 3)					
CP Reading #1 (mV) (north end of feature)	-1653 -1636	CP Reading #2 (mV) (center of feature)	-483 -482	CP Reading #3 (mV) (south end of feature)	-1583 -1553
DFT #1 (mil) (north end of feature)	90	DFT #2 (mil) (center of feature)	N/R	DFT #3 (mil) (south end of feature)	<25
(record #2 for features < 2" long; record #1 and #3 for features 2 - 8" long; record #1, #2 and #3 for features >8" long)					
Temperature (°F)	56°	DFT Adjacent to Feature (mil) (~2" away from edge)	N/R	DFT Adjacent to Feature (mil) (~8 - 12" away from edge)	N/R
			N/R		N/R
			N/R		N/R
			N/R		N/R
Provide 1 to 2 photos of feature, below: Included the date and time stamps associated with video surveillance.

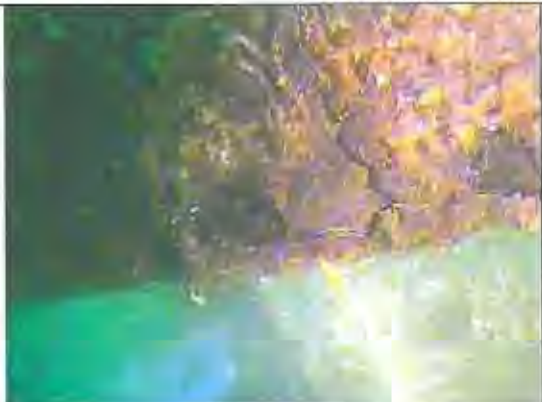
Date:	10/09/17	Frame(HH:MM:SS)	00:13:59	Date:	
				Frame(HH:MM:SS)

Cathodic Protection and Coating Measurements (for Feature # 4)					
CP Reading #1 (mV) (north end of feature)	N/R	CP Reading #2 (mV) (center of feature)	N/R	CP Reading #3 (mV) (south end of feature)	N/R
DFT #1 (mil) (north end of feature)	96	DFT #2 (mil) (center of feature)	N/R	DFT #3 (mil) (south end of feature)	96
(record #2 for features < 2" long; record #1 and #3 for features 2 - 8" long; record #1, #2 and #3 for features >8" long)					
Temperature (°F)	56°	DFT Adjacent to Feature (mil) (~2" away from edge)	100	DFT Adjacent to Feature (mil) (~8 - 12" away from edge)	115
			96		95
			115		114
			120		112
Provide 1 to 2 photos of feature, below: Included the date and time stamps associated with video surveillance.

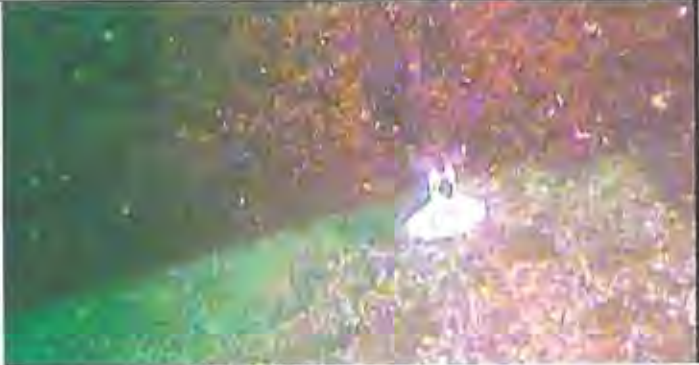
Date:	10/13/17	Frame(HH:MM:SS)	00:50:31	Date:	
		Frame(HH:MM:SS)

Cathodic Protection and Coating Measurements (for Feature # 5)					
<b>CP Reading #1 (mV)</b> (north end of feature)	<b>N/R</b>	<b>CP Reading #2 (mV)</b> (center of feature)	<b>N/R</b>	<b>CP Reading #3 (mV)</b> (south end of feature)	<b>N/R</b>
<b>DFT #1 (mil)</b> (north end of feature)	<b>100</b>	<b>DFT #2 (mil)</b> (center of feature)	<b>120</b>	<b>DFT #3 (mil)</b> (south end of feature)	<b>101</b>
(record #2 for features < 2" long; record #1 and #3 for features 2 - 8" long; record #1, #2 and #3 for features >8" long)					
<b>Temperature (°F)</b>	<b>56°</b>	<b>DFT Adjacent to Feature (mil)</b> (~2" away from edge)	<b>250</b>	<b>DFT Adjacent to Feature (mil)</b> (~8 - 12" away from edge)	<b>200</b>
			<b>190</b>		<b>200</b>
			<b>170</b>		<b>200</b>
			<b>200</b>		<b>200</b>
Provide 1 to 2 photos of feature, below: Included the date and time stamps associated with video surveillance.

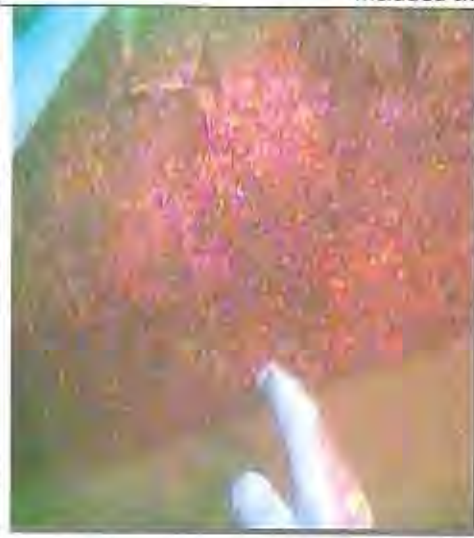
</div> <div data-bbox="560 630 1550 1165"></div>					
Date:	10/09/17	Frame(HH:MM:SS)	00:38:28	Date:	
				Frame(HH:MM:SS)

Cathodic Protection and Coating Measurements (for Feature # 6)					
<b>CP Reading #1 (mV)</b> (north end of feature)	<b>N/R</b>	<b>CP Reading #2 (mV)</b> (center of feature)	<b>N/R</b>	<b>CP Reading #3 (mV)</b> (south end of feature)	<b>N/R</b>
<b>DFT #1 (mil)</b> (north end of feature)	<b>155</b>	<b>DFT #2 (mil)</b> (center of feature)	<b>N/R</b>	<b>DFT #3 (mil)</b> (south end of feature)	<b>185</b>
(record #2 for features < 2" long; record #1 and #3 for features 2 - 8" long; record #1, #2 and #3 for features >8" long)					
<b>Temperature (°F)</b>	<b>56°</b>	<b>DFT Adjacent to Feature (mil)</b> (~2" away from edge)	<b>200</b>	<b>DFT Adjacent to Feature (mil)</b> (~8 - 12" away from edge)	<b>200</b>
			<b>200</b>		<b>210</b>
			<b>200</b>		<b>170</b>
			<b>200</b>		<b>230</b>
<p align="center"><i>Provide 1 to 2 photos of feature, below: Included the date and time stamps associated with video surveillance.</i></p>

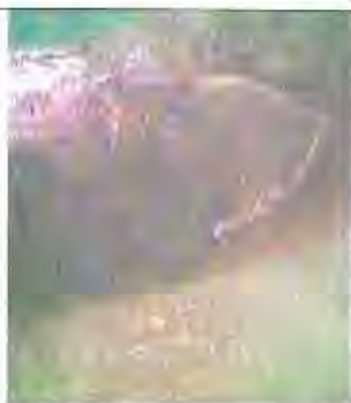
Date:	10/9/17	Frame(HH:MM:SS)	00:37:17	Date:		Frame(HH:MM:SS)	
-------	---------	-----------------	----------	-------	--	-----------------	--

<b>CP Reading #1 (mV)</b> (north end of feature)	<b>N/R</b>	<b>CP Reading #2 (mV)</b> (center of feature)	<b>N/R</b>	<b>CP Reading #3 (mV)</b> (south end of feature)	<b>N/R</b>
<b>DFT #1 (mil)</b> (north end of feature)	<b>120</b>	<b>DFT #2 (mil)</b> (center of feature)	<b>160</b>	<b>DFT #3 (mil)</b> (south end of feature)	<b>125</b>
(record #2 for features < 2" long; record #1 and #3 for features 2 - 8" long; record #1, #2 and #3 for features >8" long)					
<b>Temperature (°F)</b>	<b>56°</b>	<b>DFT Adjacent to Feature (mil)</b> (~2" away from edge)	<b>225</b>	<b>DFT Adjacent to Feature (mil)</b> (~8 - 12" away from edge)	<b>190</b>
			<b>190</b>		<b>225</b>
			<b>145</b>		<b>140</b>
			<b>180</b>		<b>210</b>

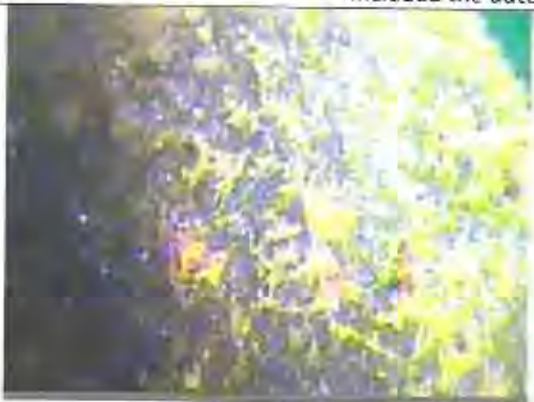
Date:	10/13/17	Frame(HH:MM:SS)	00:26:31	Date:	
				Frame(HH:MM:SS)

Cathodic Protection and Coating Measurements (for Feature # 10)					
CP Reading #1 (mV) (north end of feature)	N/R	CP Reading #2 (mV) (center of feature)	N/R	CP Reading #3 (mV) (south end of feature)	N/R
DFT #1 (mil) (north end of feature)	N/R	DFT #2 (mil) (center of feature)	N/R	DFT #3 (mil) (south end of feature)	N/R
(record #2 for features < 2" long; record #1 and #3 for features 2 - 8" long; record #1, #2 and #3 for features >8" long)					
Temperature (°F)	56°	DFT Adjacent to Feature (mil) (~2" away from edge)	N/R	DFT Adjacent to Feature (mil) (~8 - 12" away from edge)	N/R
			N/R		N/R
			N/R		N/R
			N/R		N/R
Provide 1 to 2 photos of feature, below: Included the date and time stamps associated with video surveillance.

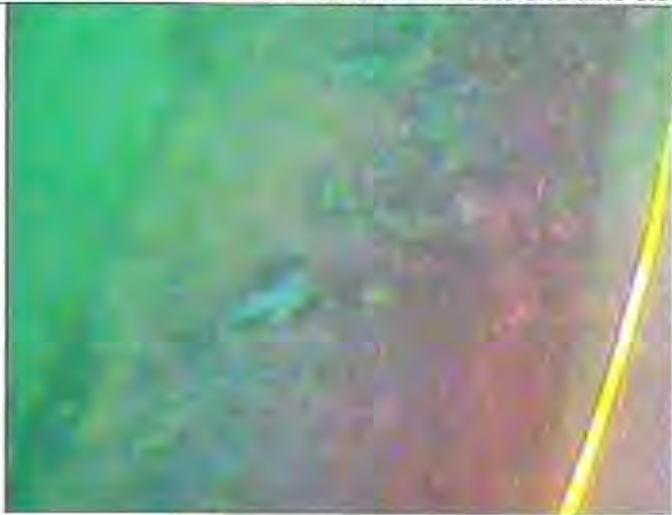
Date:	10/20/17	Frame(HH:MM:SS)	00:13:41	Date:	
					Frame(HH:MM:SS)

Cathodic Protection and Coating Measurements (for Feature # 1)					
CP Reading #1 (mV) (north end of feature)	N/R	CP Reading #2 (mV) (center of feature)	N/R	CP Reading #3 (mV) (south end of feature)	N/R
DFT #1 (mil) (north end of feature)	N/R	DFT #2 (mil) (center of feature)	N/R	DFT #3 (mil) (south end of feature)	N/R
(record #2 for features < 2" long; record #1 and #3 for features 2 - 8" long; record #1, #2 and #3 for features >8" long)					
Temperature (°F)	59°	DFT Adjacent to Feature (mil) (~2" away from edge)	N/R	DFT Adjacent to Feature (mil) (~8 - 12" away from edge)	N/R
			N/R		N/R
			N/R		N/R
			N/R		N/R
Provide 1 to 2 photos of feature, below: Included the date and time stamps associated with video surveillance.

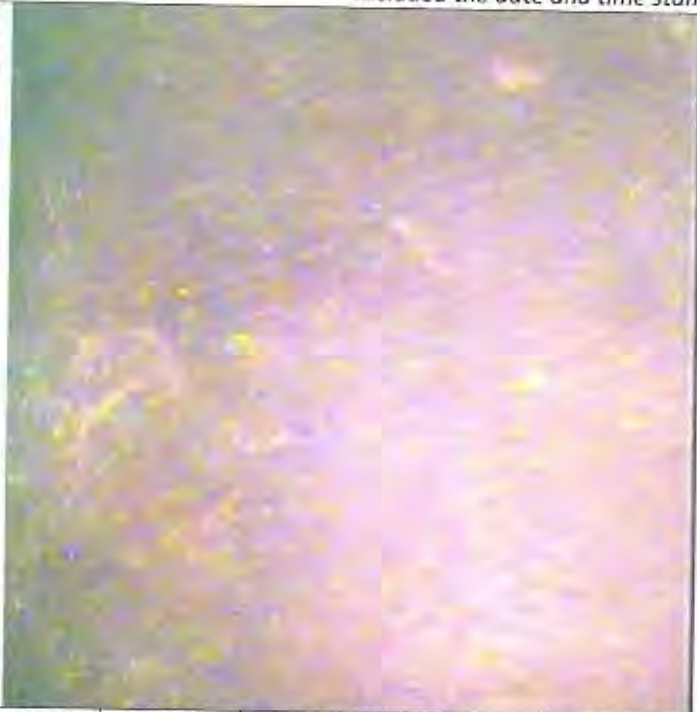
Date:	10/21/17	Frame(HH:MM:SS)	00:19:50	Date:	
				Frame(HH:MM:SS)

Features 2, Dislodged area is approximately 80% of area 11" to 6' South of anchor that has outer wrap missing

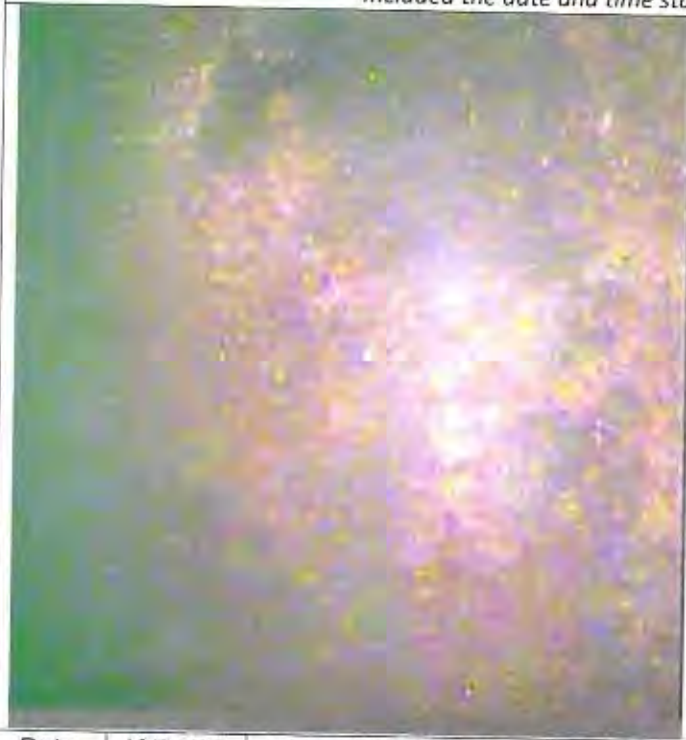
Date:	10/21/17	Frame(HH:MM:SS)	00:26:47	Date:		Frame(HH:MM:SS)	
-------	----------	-----------------	----------	-------	--	-----------------	--

Feature 6, Dislodged area is approximately 90% of area from anchor to 6' North that has outer wrap missing

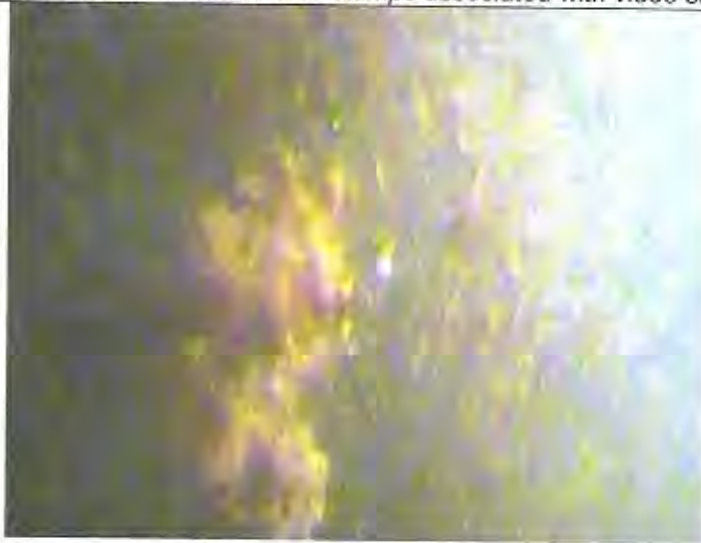
<b>Diver Inspection Form for L5 Straits of Mackinac</b>	
<b>Dislodged coating observed on the lake floor:</b> <input type="checkbox"/> YES <input checked="" type="checkbox"/> NO		<b>Lake floor location wrt pipe:</b>	In span 18" off lake floor
<b>Comments/Issues/Discussion</b>			
Feature 13, Deposit 2" X 1" within a Dislodged area 5" X 5"

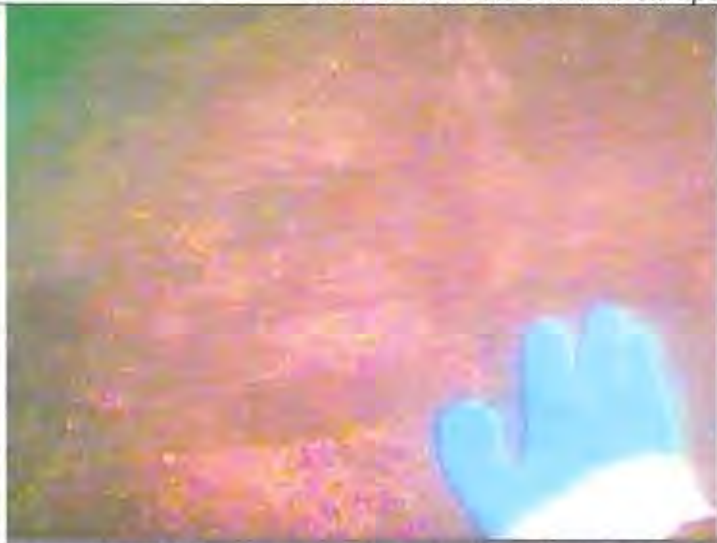
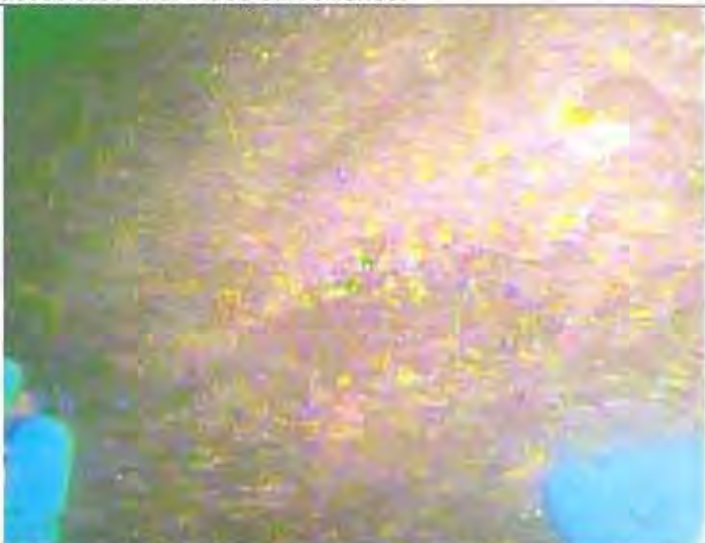
Comments/Issues/Discussion		
	<p>Feature 1, Dislodged area is approximately 95% of area from anchor to 6' South that has outer wrap missing</p> <p>Feature 5, Dislodged area is approximately 100% of area from anchor to 6' North that has outer wrap missing</p>

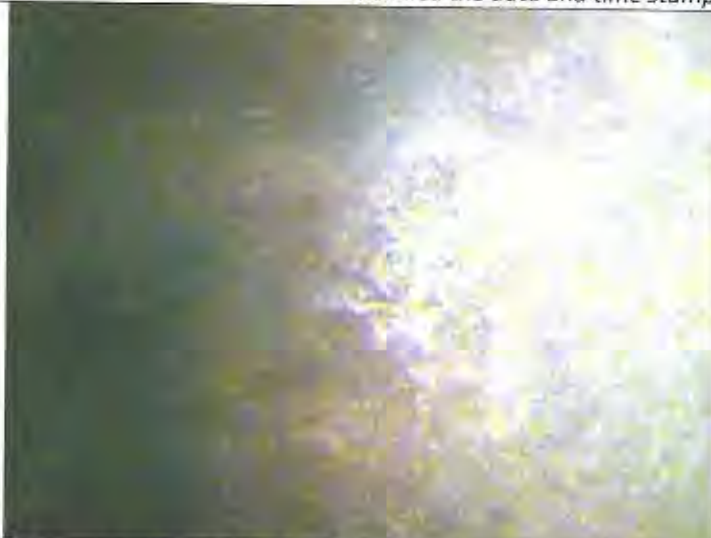
Date:	11/11/17	Frame(HH:MM:SS)	00:17:37	Date:	
				Frame(HH:MM:SS)

Cathodic Protection and Coating Measurements (for Feature # 2)					
CP Reading #1 (mV) (north end of feature)	N/R	CP Reading #2 (mV) (center of feature)	N/R	CP Reading #3 (mV) (south end of feature)	N/R
DFT #1 (mil) (north end of feature)	N/R	DFT #2 (mil) (center of feature)	N/R	DFT #3 (mil) (south end of feature)	N/R
(record #2 for features < 2" long; record #1 and #3 for features 2"-8" long; record #1, #2 and #3 for features >8" long)					
Temperature (°F)	49°	DFT Adjacent to Feature (mil) (~2" away from edge)	N/R	DFT Adjacent to Feature (mil) (~8"-12" away from edge)	N/R
			N/R		N/R
			N/R		N/R
			N/R		N/R
Provide 1 to 2 photos of feature, below: Included the date and time stamps associated with video surveillance.

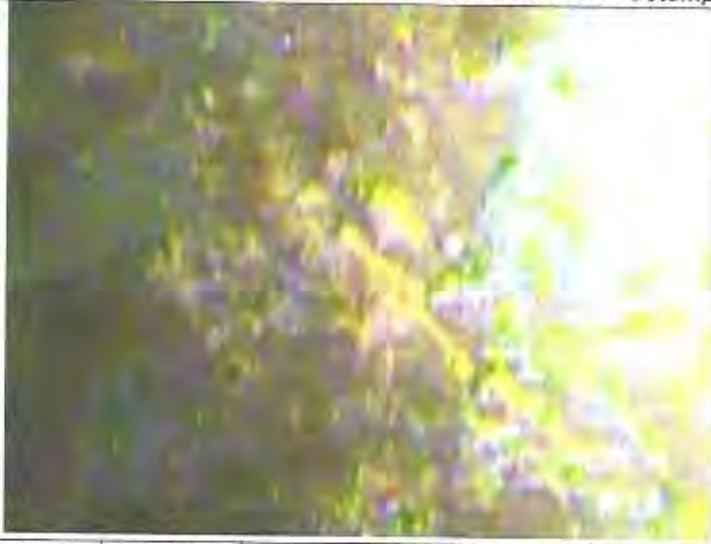
Date:	11/11/17	Frame(HH:MM:SS)	00:22:43	Date:	
				Frame(HH:MM:SS)

Cathodic Protection and Coating Measurements (for Feature # 7)					
CP Reading #1 (mV) (north end of feature)	N/R	CP Reading #2 (mV) (center of feature)	N/R	CP Reading #3 (mV) (south end of feature)	N/R
DFT #1 (mil) (north end of feature)	N/R	DFT #2 (mil) (center of feature)	N/R	DFT #3 (mil) (south end of feature)	N/R
(record #2 for features < 2" long; record #1 and #3 for features 2"-8" long; record #1, #2 and #3 for features >8" long)					
Temperature (°F)	49°	DFT Adjacent to Feature (mil) (~2" away from edge)	N/R	DFT Adjacent to Feature (mil) (~8"-12" away from edge)	N/R
			N/R		N/R
			N/R		N/R
			N/R		N/R
Provide 1 to 2 photos of feature, below: Included the date and time stamps associated with video surveillance.

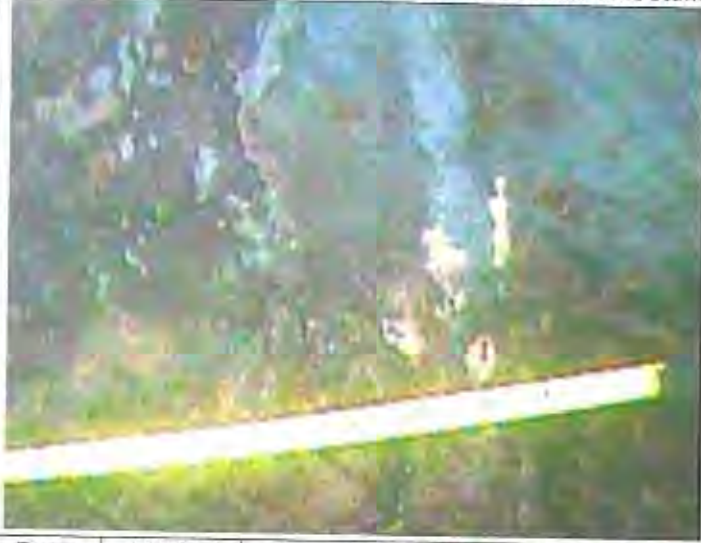
Date:	10/12/17	Frame(HH:MM:SS)	00:29:36	Date:	
				Frame(HH:MM:SS)

Cathodic Protection and Coating Measurements (for Feature # 1)					
CP Reading #1 (mV) (north end of feature)	N/R	CP Reading #2 (mV) (center of feature)	N/R	CP Reading #3 (mV) (south end of feature)	N/R
DFT #1 (mil) (north end of feature)	N/R	DFT #2 (mil) (center of feature)	N/R	DFT #3 (mil) (south end of feature)	N/R
(record #2 for features < 2" long; record #1 and #3 for features 2 - 8" long; record #1, #2 and #3 for features >8" long)					
Temperature (°F)	54°	DFT Adjacent to Feature (mil) (~2" away from edge)	N/R N/R N/R N/R	DFT Adjacent to Feature (mil) (~8 - 12" away from edge)	N/R N/R N/R N/R
Provide 1 to 2 photos of feature, below: Included the date and time stamps associated with video surveillance.

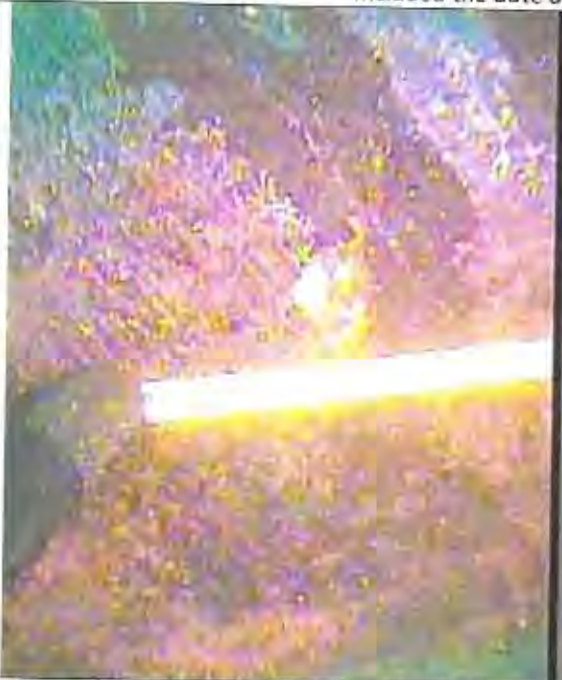
Date:	10/12/17	Frame(HH:MM:SS)	00:33:46	Date:	
				Frame(HH:MM:SS)

Cathodic Protection and Coating Measurements (for Feature # 2)					
CP Reading #1 (mV) (north end of feature)	N/R	CP Reading #2 (mV) (center of feature)	N/R	CP Reading #3 (mV) (south end of feature)	N/R
DFT #1 (mil) (north end of feature)	N/R	DFT #2 (mil) (center of feature)	N/R	DFT #3 (mil) (south end of feature)	N/R
(record #2 for features < 2" long; record #1 and #3 for features 2 - 8" long; record #1, #2 and #3 for features >8" long)					
Temperature (°F)	54°	DFT Adjacent to Feature (mil) (~2" away from edge)	N/R	DFT Adjacent to Feature (mil) (~8 - 12" away from edge)	N/R
			N/R		N/R
			N/R		N/R
			N/R		N/R
Provide 1 to 2 photos of feature, below: Included the date and time stamps associated with video surveillance.

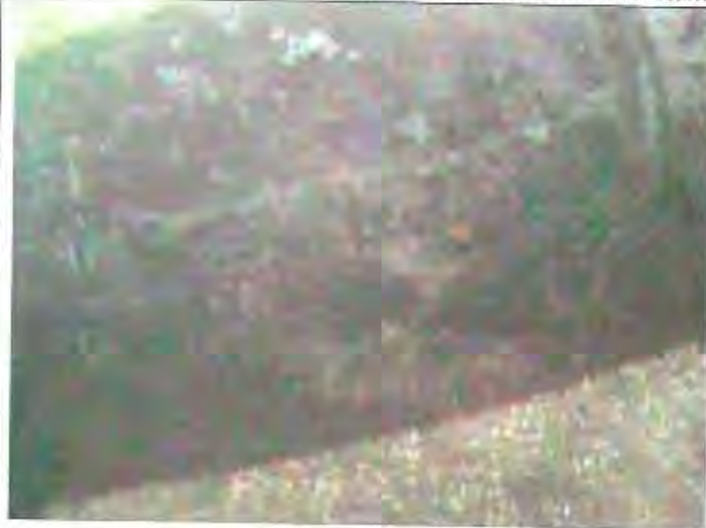
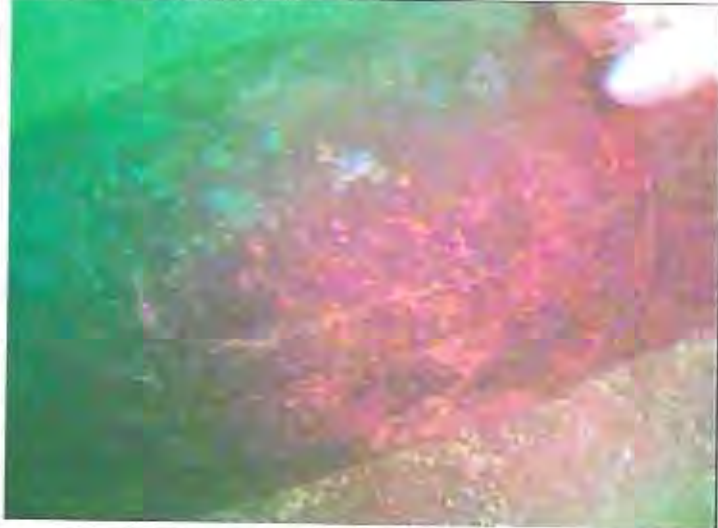
Date:	10/12/17	Frame(HH:MM:SS)	00:44:29	Date:	10/12/17
				Frame(HH:MM:SS)	00:45:04

Cathodic Protection and Coating Measurements (for Feature # 4)					
CP Reading #1 (mV) (north end of feature)	N/R	CP Reading #2 (mV) (center of feature)	N/R	CP Reading #3 (mV) (south end of feature)	N/R
DFT #1 (mil) (north end of feature)	N/R	DFT #2 (mil) (center of feature)	N/R	DFT #3 (mil) (south end of feature)	N/R
(record #2 for features < 2" long; record #1 and #3 for features 2 - 8" long; record #1, #2 and #3 for features >8" long)					
Temperature (°F)	54°	DFT Adjacent to Feature (mil) (~2" away from edge)	N/R	DFT Adjacent to Feature (mil) (~8 - 12" away from edge)	N/R
			N/R		N/R
			N/R		N/R
			N/R		N/R
Provide 1 to 2 photos of feature, below: Included the date and time stamps associated with video surveillance.

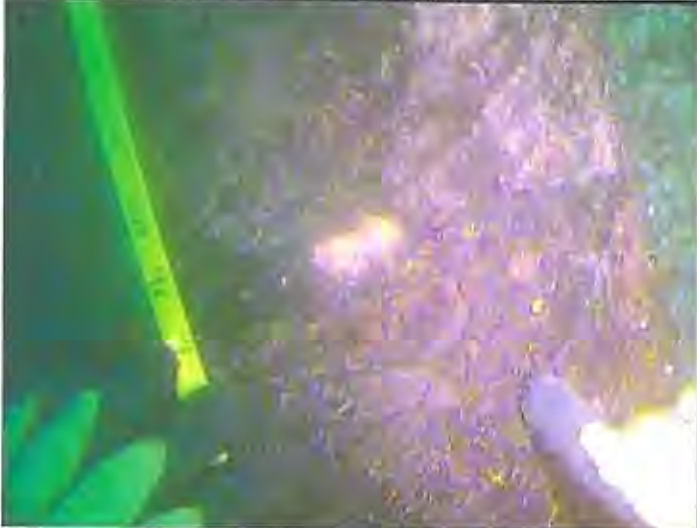
Date:	10/10/17	Frame(HH:MM:SS)	00:41:48	Date:	
					Frame(HH:MM:SS)

Cathodic Protection and Coating Measurements (for Feature # 1)					
CP Reading #1 (mV) (north end of feature)	N/R	CP Reading #2 (mV) (center of feature)	N/R	CP Reading #3 (mV) (south end of feature)	N/R
DFT #1 (mil) (north end of feature)	N/R	DFT #2 (mil) (center of feature)	N/R	DFT #3 (mil) (south end of feature)	N/R
(record #2 for features < 2" long; record #1 and #3 for features 2 - 8" long; record #1, #2 and #3 for features >8" long)					
Temperature (°F)		DFT Adjacent to Feature (mil) (~2" away from edge)	N/R	DFT Adjacent to Feature (mil) (~8 - 12" away from edge)	N/R
			N/R		N/R
			N/R		N/R
			N/R		N/R
Provide 1 to 2 photos of feature, below: Included the date and time stamps associated with video surveillance.

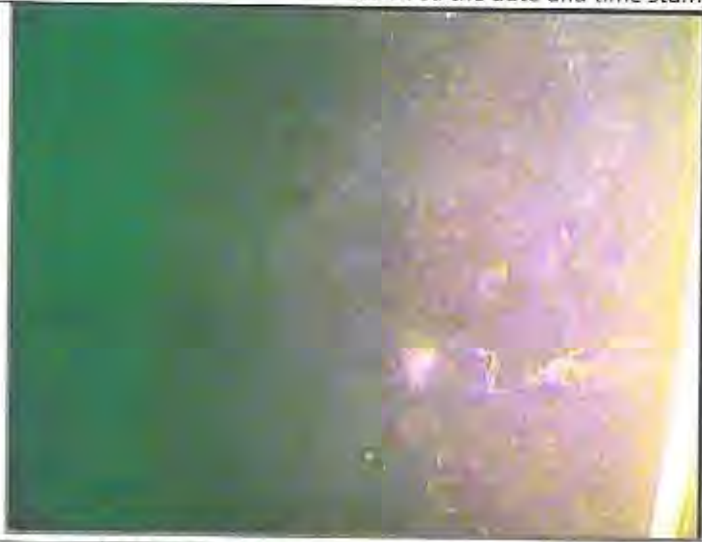
Date:	10/10/17	Frame(HH:MM:SS)	00:42:28	Date:	Frame(HH:MM:SS)

Cathodic Protection and Coating Measurements (for Feature # 2)					
CP Reading #1 (mV) (north end of feature)	N/R	CP Reading #2 (mV) (center of feature)	N/R	CP Reading #3 (mV) (south end of feature)	N/R
DFT #1 (mil) (north end of feature)	N/R	DFT #2 (mil) (center of feature)	N/R	DFT #3 (mil) (south end of feature)	N/R
(record #2 for features < 2" long; record #1 and #3 for features 2 - 8" long; record #1, #2 and #3 for features >8" long)					
Temperature (°F)	56°	DFT Adjacent to Feature (mil) (~2" away from edge)	N/R	DFT Adjacent to Feature (mil) (~8 - 12" away from edge)	N/R
			N/R		N/R
			N/R		N/R
			N/R		N/R
Provide 1 to 2 photos of feature, below: Included the date and time stamps associated with video surveillance.

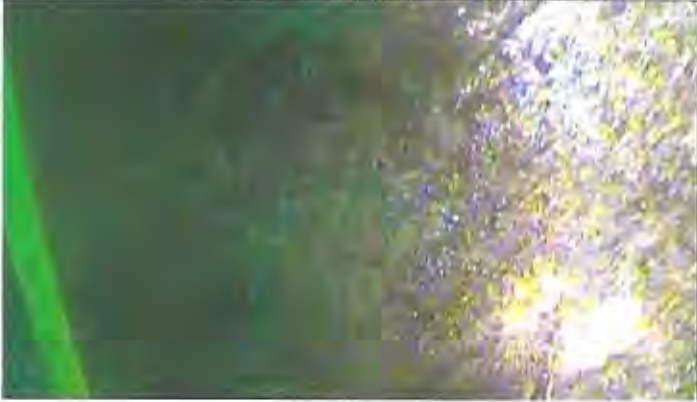
Date:	10/10/17	Frame(HH:MM:SS)	00:44:39	Date:	
					Frame(HH:MM:SS)

Cathodic Protection and Coating Measurements (for Feature # 4)					
CP Reading #1 (mV) (north end of feature)	N/R	CP Reading #2 (mV) (center of feature)	N/R	CP Reading #3 (mV) (south end of feature)	N/R
DFT #1 (mil) (north end of feature)	N/R	DFT #2 (mil) (center of feature)	N/R	DFT #3 (mil) (south end of feature)	N/R
(record #2 for features < 2" long; record #1 and #3 for features 2 - 8" long; record #1, #2 and #3 for features >8" long)					
Temperature (°F)	56°	DFT Adjacent to Feature (mil) (~2" away from edge)	N/R	DFT Adjacent to Feature (mil) (~8 - 12" away from edge)	N/R
			N/R		N/R
			N/R		N/R
			N/R		N/R
Provide 1 to 2 photos of feature, below: Included the date and time stamps associated with video surveillance.

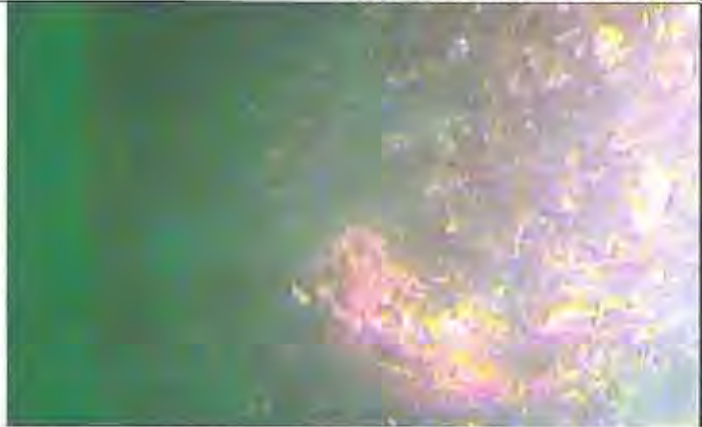
Date:	10/10/17	Frame(HH:MM:SS)	00:45:33	Date:	
				Frame(HH:MM:SS)

Cathodic Protection and Coating Measurements (for Feature # 5)					
CP Reading #1 (mV) (north end of feature)	N/R	CP Reading #2 (mV) (center of feature)	N/R	CP Reading #3 (mV) (south end of feature)	N/R
DFT #1 (mil) (north end of feature)	N/R	DFT #2 (mil) (center of feature)	N/R	DFT #3 (mil) (south end of feature)	N/R
(record #2 for features < 2" long; record #1 and #3 for features 2 - 8" long; record #1, #2 and #3 for features >8" long)					
Temperature (°F)	56°	DFT Adjacent to Feature (mil) (~2" away from edge)	N/R	DFT Adjacent to Feature (mil) (~8 - 12" away from edge)	N/R
			N/R		N/R
			N/R		N/R
			N/R		N/R
Provide 1 to 2 photos of feature, below: Included the date and time stamps associated with video surveillance.
