# Diver Inspection Form for L5 Straits of Mackinac

Date:	09/30/17	Diver:	Troy Baskett, Maurice Unger, Chad Cantrell, George Palmer
AFE / W.O.#:	20011702	Company Rep / Inspector:	[REDACTED]
Pipe Support Anchor:	E-1 (E-74A/E-74B South)	Water Depth (ft):	[REDACTED]
Longitude:	[REDACTED]	Latitude:	[REDACTED]

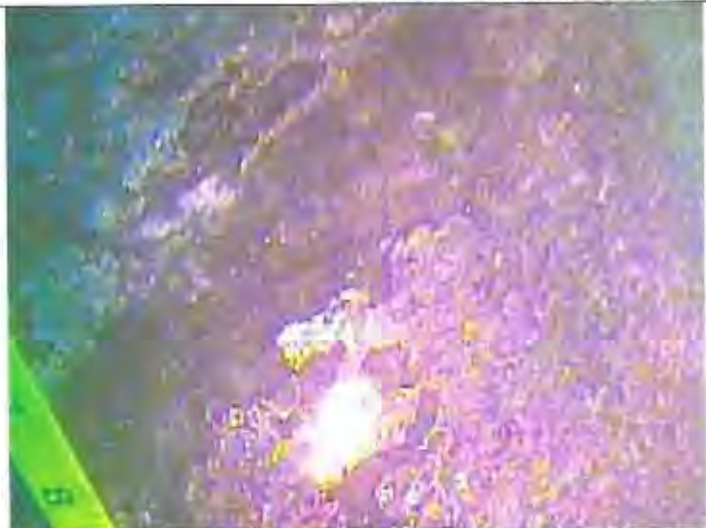
Date:	10/10/17	Frame(HH:MM:SS)	00:49:00	Date:	
				Frame(HH:MM:SS)

Cathodic Protection and Coating Measurements (for Feature # 6)					
CP Reading #1 (mV) (north end of feature)	N/R	CP Reading #2 (mV) (center of feature)	N/R	CP Reading #3 (mV) (south end of feature)	N/R
DFT #1 (mil) (north end of feature)	N/R	DFT #2 (mil) (center of feature)	N/R	DFT #3 (mil) (south end of feature)	N/R
(record #2 for features < 2" long; record #1 and #3 for features 2 - 8" long; record #1, #2 and #3 for features >8" long)					
Temperature (°F)	56°	DFT Adjacent to Feature (mil) (~2" away from edge)	N/R	DFT Adjacent to Feature (mil) (~8 - 12" away from edge)	N/R
			N/R		N/R
			N/R		N/R
			N/R		N/R
Provide 1 to 2 photos of feature, below: Included the date and time stamps associated with video surveillance.

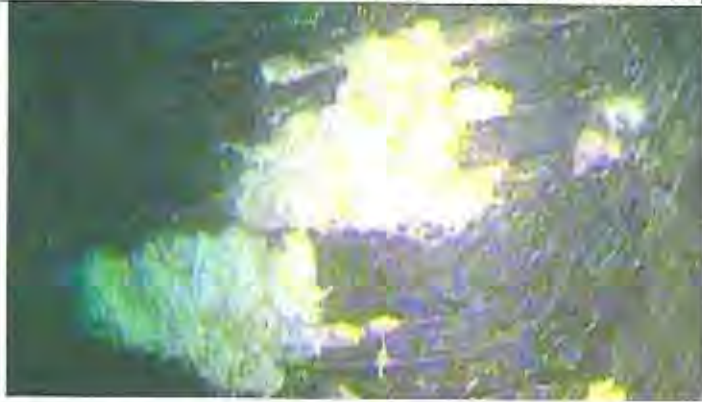
Date:	10/10/17	Frame(HH:MM:SS)	00:50:52	Date:	
					Frame(HH:MM:SS)

Cathodic Protection and Coating Measurements (for Feature # 7)					
CP Reading #1 (mV) (north end of feature)	N/R	CP Reading #2 (mV) (center of feature)	N/R	CP Reading #3 (mV) (south end of feature)	N/R
DFT #1 (mil) (north end of feature)	N/R	DFT #2 (mil) (center of feature)	N/R	DFT #3 (mil) (south end of feature)	N/R
(record #2 for features < 2" long; record #1 and #3 for features 2 - 8" long; record #1, #2 and #3 for features >8" long)					
Temperature (°F)	56°	DFT Adjacent to Feature (mil) (~2" away from edge)	N/R	DFT Adjacent to Feature (mil) (~8 - 12" away from edge)	N/R
			N/R		N/R
			N/R		N/R
			N/R		N/R
Provide 1 to 2 photos of feature, below: Included the date and time stamps associated with video surveillance.

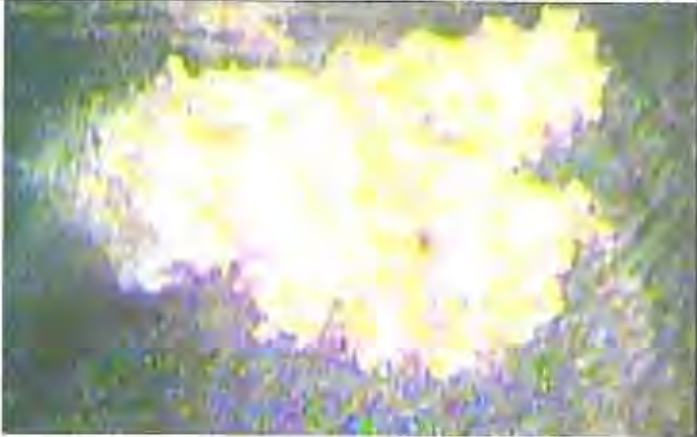
Date:	10/10/17	Frame(HH:MM:SS)	00:51:14	Date:	
				Frame(HH:MM:SS)

Cathodic Protection and Coating Measurements (for Feature # 8)					
CP Reading #1 (mV) (north end of feature)	N/R	CP Reading #2 (mV) (center of feature)	N/R	CP Reading #3 (mV) (south end of feature)	N/R
DFT #1 (mil) (north end of feature)	N/R	DFT #2 (mil) (center of feature)	N/R	DFT #3 (mil) (south end of feature)	N/R
(record #2 for features < 2" long; record #1 and #3 for features 2 - 8" long; record #1, #2 and #3 for features >8" long)					
Temperature (°F)	56°	DFT Adjacent to Feature (mil) (~2" away from edge)	N/R	DFT Adjacent to Feature (mil) (~8 - 12" away from edge)	N/R
			N/R		N/R
			N/R		N/R
			N/R		N/R
Provide 1 to 2 photos of feature, below: Included the date and time stamps associated with video surveillance.

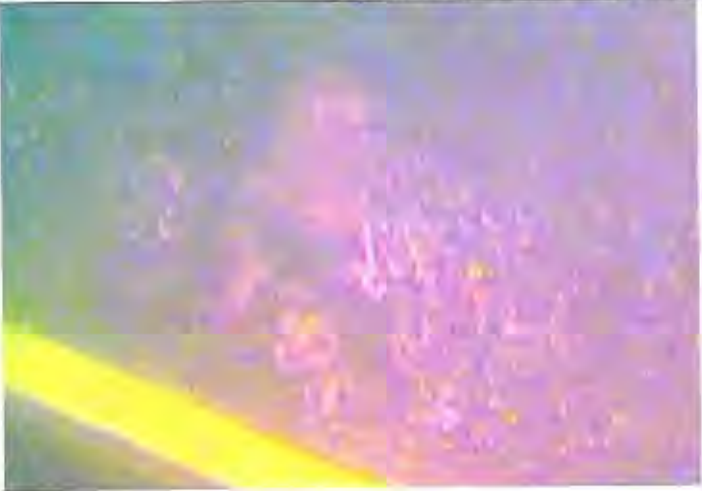
Date:	10/10/17	Frame(HH:MM:SS)	00:37:28	Date:	
				Frame(HH:MM:SS)

Cathodic Protection and Coating Measurements (for Feature # 1)					
CP Reading #1 (mV) (north end of feature)	N/R	CP Reading #2 (mV) (center of feature)	N/R	CP Reading #3 (mV) (south end of feature)	N/R
DFT #1 (mil) (north end of feature)	N/R	DFT #2 (mil) (center of feature)	N/R	DFT #3 (mil) (south end of feature)	N/R
(record #2 for features < 2" long; record #1 and #3 for features 2 - 8" long; record #1, #2 and #3 for features >8" long)					
Temperature (°F)		DFT Adjacent to Feature (mil) (~2" away from edge)	N/R	DFT Adjacent to Feature (mil) (~8 - 12" away from edge)	N/R
			N/R		N/R
			N/R		N/R
			N/R		N/R
Provide 1 to 2 photos of feature, below: Included the date and time stamps associated with video surveillance.

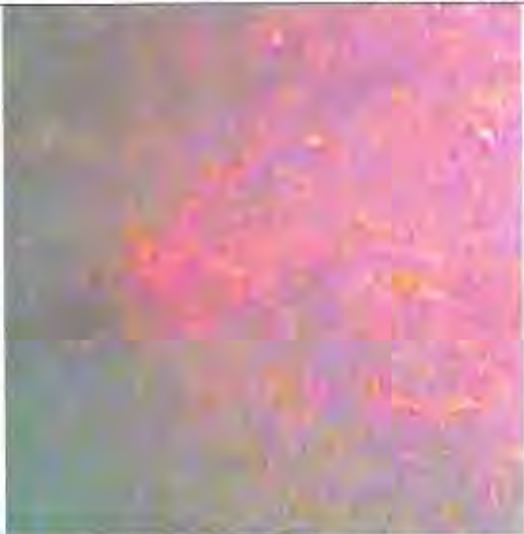
Date:	10/10/17	Frame(HH:MM:SS)	00:39:35	Date:	
				Frame(HH:MM:SS)

Cathodic Protection and Coating Measurements (for Feature # 2)					
<b>CP Reading #1 (mV)</b> (north end of feature)	N/R	<b>CP Reading #2 (mV)</b> (center of feature)	N/R	<b>CP Reading #3 (mV)</b> (south end of feature)	N/R
<b>DFT #1 (mil)</b> (north end of feature)	N/R	<b>DFT #2 (mil)</b> (center of feature)	N/R	<b>DFT #3 (mil)</b> (south end of feature)	N/R
(record #2 for features < 2" long; record #1 and #3 for features 2 - 8" long; record #1, #2 and #3 for features >8" long)					
<b>Temperature (°F)</b>	56°	<b>DFT Adjacent to Feature (mil)</b> (~2" away from edge)	N/R	<b>DFT Adjacent to Feature (mil)</b> (~8 - 12" away from edge)	N/R
			N/R		N/R
			N/R		N/R
			N/R		N/R
<p align="center">Provide 1 to 2 photos of feature, below: Included the date and time stamps associated with video surveillance.</p>

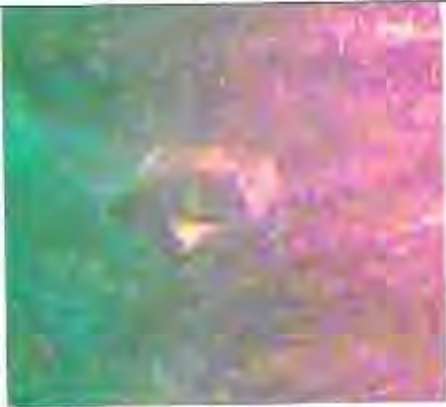
Date:	10/10/17	Frame(HH:MM:SS)	00:44:35	Date:	
					Frame(HH:MM:SS)

Cathodic Protection and Coating Measurements (for Feature # 4)					
CP Reading #1 (mV) (north end of feature)	N/R	CP Reading #2 (mV) (center of feature)	N/R	CP Reading #3 (mV) (south end of feature)	N/R
DFT #1 (mil) (north end of feature)	N/R	DFT #2 (mil) (center of feature)	N/R	DFT #3 (mil) (south end of feature)	N/R
(record #2 for features < 2" long; record #1 and #3 for features 2 - 8" long; record #1, #2 and #3 for features >8" long)					
Temperature (°F)	56°	DFT Adjacent to Feature (mil) (~2" away from edge)	N/R	DFT Adjacent to Feature (mil) (~8 - 12" away from edge)	N/R
			N/R		N/R
			N/R		N/R
			N/R		N/R
Provide 1 to 2 photos of feature, below: Included the date and time stamps associated with video surveillance.

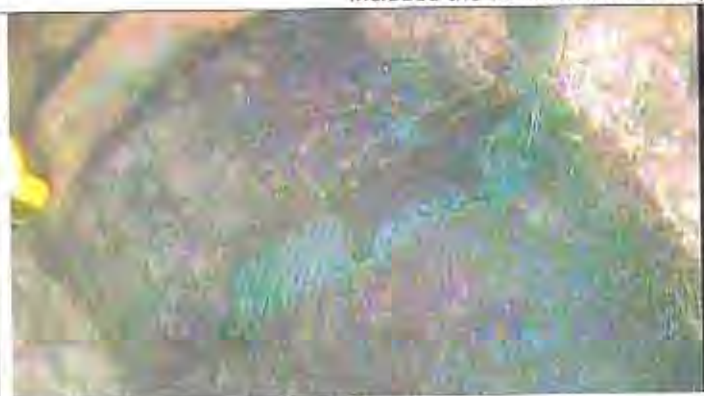
Date:	10/10/17	Frame(HH:MM:SS)	00:19:53	Date:		Frame(HH:MM:SS)	
-------	----------	-----------------	----------	-------	--	-----------------	--

CP Reading #1 (mV) (north end of feature)	N/R	CP Reading #2 (mV) (center of feature)	N/R	CP Reading #3 (mV) (south end of feature)	N/R
DFT #1 (mil) (north end of feature)	N/R	DFT #2 (mil) (center of feature)	N/R	DFT #3 (mil) (south end of feature)	N/R
(record #2 for features < 2" long; record #1 and #3 for features 2 - 8" long; record #1, #2 and #3 for features >8" long)					
Temperature (°F)	56°	DFT Adjacent to Feature (mil) (~2" away from edge)	N/R	DFT Adjacent to Feature (mil) (~8 - 12" away from edge)	N/R
			N/R		N/R
			N/R		N/R
			N/R		N/R

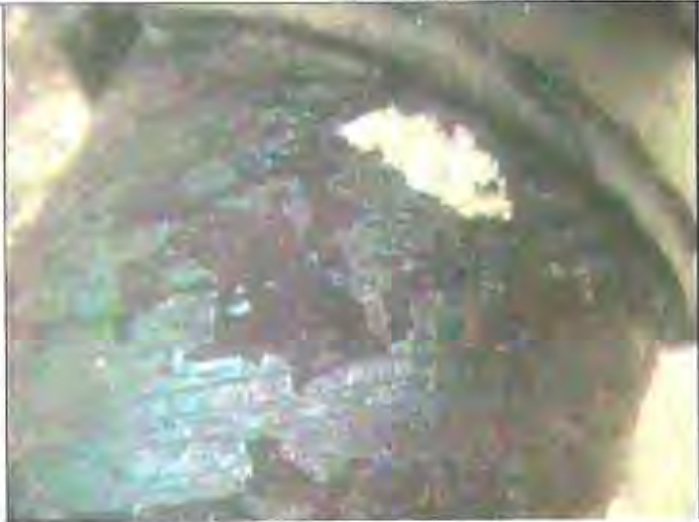
Date:	10/10/17	Frame(HH:MM:SS)	00:23:31	Date:	
				Frame(HH:MM:SS)

Cathodic Protection and Coating Measurements (for Feature # 6)					
CP Reading #1 (mV) (north end of feature)	N/R	CP Reading #2 (mV) (center of feature)	N/R	CP Reading #3 (mV) (south end of feature)	N/R
DFT #1 (mil) (north end of feature)	N/R	DFT #2 (mil) (center of feature)	N/R	DFT #3 (mil) (south end of feature)	N/R
(record #2 for features < 2" long; record #1 and #3 for features 2 - 8" long; record #1, #2 and #3 for features >8" long)					
Temperature (°F)	56°	DFT Adjacent to Feature (mil) (~2" away from edge)	N/R	DFT Adjacent to Feature (mil) (~8 - 12" away from edge)	N/R
			N/R		N/R
			N/R		N/R
			N/R		N/R
Provide 1 to 2 photos of feature, below: Included the date and time stamps associated with video surveillance.

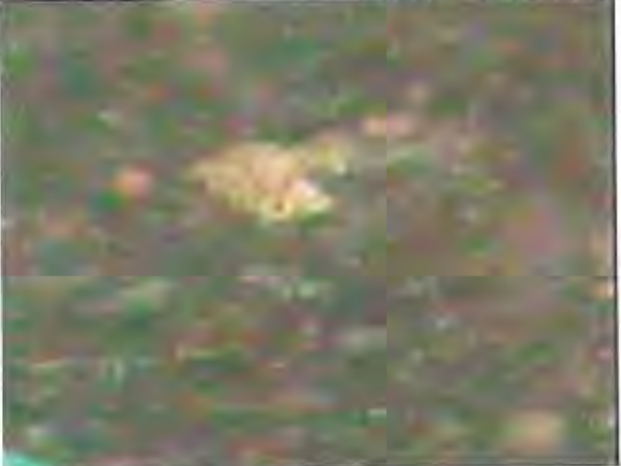
Date:	10/10/17	Frame(HH:MM:SS)	00:27:01	Date:	
				Frame(HH:MM:SS)

Cathodic Protection and Coating Measurements (for Feature # 7)					
CP Reading #1 (mV) (north end of feature)	N/R	CP Reading #2 (mV) (center of feature)	N/R	CP Reading #3 (mV) (south end of feature)	N/R
DFT #1 (mil) (north end of feature)	N/R	DFT #2 (mil) (center of feature)	N/R	DFT #3 (mil) (south end of feature)	N/R
(record #2 for features < 2" long; record #1 and #3 for features 2 - 8" long; record #1, #2 and #3 for features >8" long)					
Temperature (°F)	56°	DFT Adjacent to Feature (mil) (~2" away from edge)	N/R	DFT Adjacent to Feature (mil) (~8 - 12" away from edge)	N/R
			N/R		N/R
			N/R		N/R
			N/R		N/R
Provide 1 to 2 photos of feature, below: Included the date and time stamps associated with video surveillance.

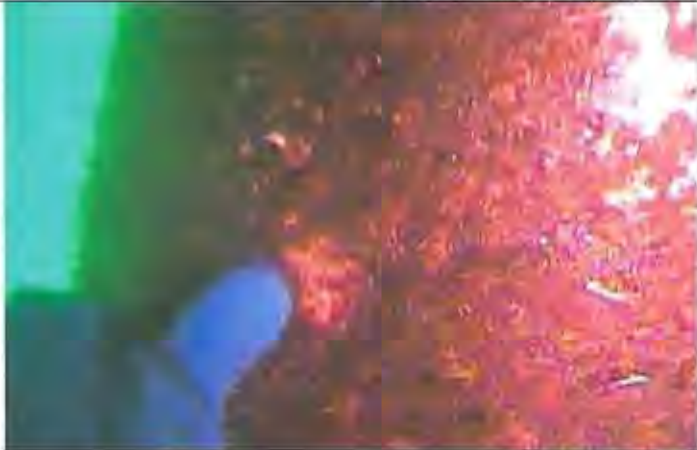
Date: 10/10/17	Frame(HH:MM:SS)	00:17:23	Date:		Frame(HH:MM:SS)

Cathodic Protection and Coating Measurements (for Feature # 1)					
CP Reading #1 (mV) (north end of feature)	N/R	CP Reading #2 (mV) (center of feature)	N/R	CP Reading #3 (mV) (south end of feature)	N/R
DFT #1 (mil) (north end of feature)	N/R	DFT #2 (mil) (center of feature)	N/R	DFT #3 (mil) (south end of feature)	N/R
(record #2 for features < 2" long; record #1 and #3 for features 2 - 8" long; record #1, #2 and #3 for features >8" long)					
Temperature (°F)		DFT Adjacent to Feature (mil) (~2" away from edge)	N/R	DFT Adjacent to Feature (mil) (~8 - 12" away from edge)	N/R
			N/R		N/R
			N/R		N/R
			N/R		N/R
Provide 1 to 2 photos of feature, below: Included the date and time stamps associated with video surveillance.

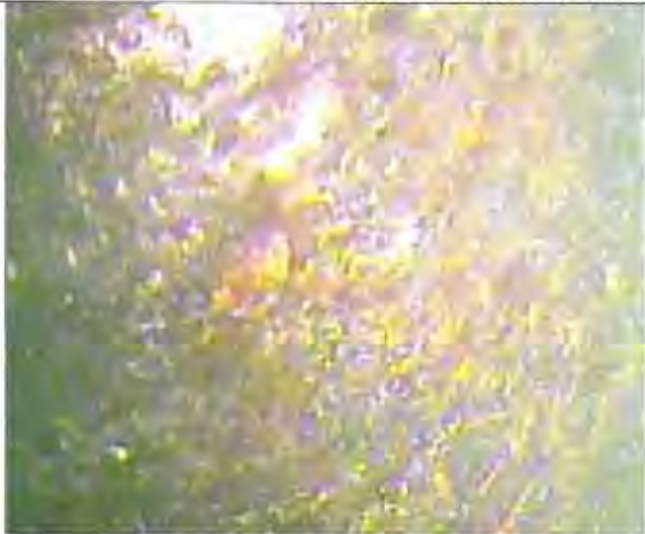
Date:	10/10/17	Frame(HH:MM:SS)	00:19:50	Date:

Cathodic Protection and Coating Measurements (for Feature # 2)					
CP Reading #1 (mV) (north end of feature)	N/R	CP Reading #2 (mV) (center of feature)	N/R	CP Reading #3 (mV) (south end of feature)	N/R
DFT #1 (mil) (north end of feature)	N/R	DFT #2 (mil) (center of feature)	N/R	DFT #3 (mil) (south end of feature)	N/R
(record #2 for features < 2" long; record #1 and #3 for features 2 - 8" long; record #1, #2 and #3 for features >8" long)					
Temperature (°F)	56°	DFT Adjacent to Feature (mil) (~2" away from edge)	N/R	DFT Adjacent to Feature (mil) (~8 - 12" away from edge)	N/R
			N/R		N/R
			N/R		N/R
			N/R		N/R
Provide 1 to 2 photos of feature, below: Included the date and time stamps associated with video surveillance.

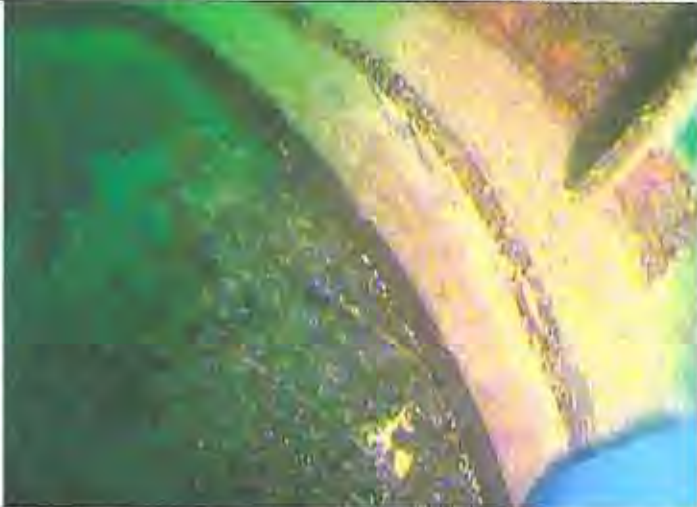
Date:	10/10/17	Frame(HH:MM:SS)	00:21:35	Date:	
					Frame(HH:MM:SS)

Cathodic Protection and Coating Measurements (for Feature # 3)					
CP Reading #1 (mV) (north end of feature)	N/R	CP Reading #2 (mV) (center of feature)	N/R	CP Reading #3 (mV) (south end of feature)	N/R
DFT #1 (mil) (north end of feature)	N/R	DFT #2 (mil) (center of feature)	N/R	DFT #3 (mil) (south end of feature)	N/R
(record #2 for features < 2" long; record #1 and #3 for features 2 - 8" long; record #1, #2 and #3 for features >8" long)					
Temperature (°F)	56°	DFT Adjacent to Feature (mil) (~2" away from edge)	N/R	DFT Adjacent to Feature (mil) (~8 - 12" away from edge)	N/R
			N/R		N/R
			N/R		N/R
			N/R		N/R
Provide 1 to 2 photos of feature, below; Included the date and time stamps associated with video surveillance.

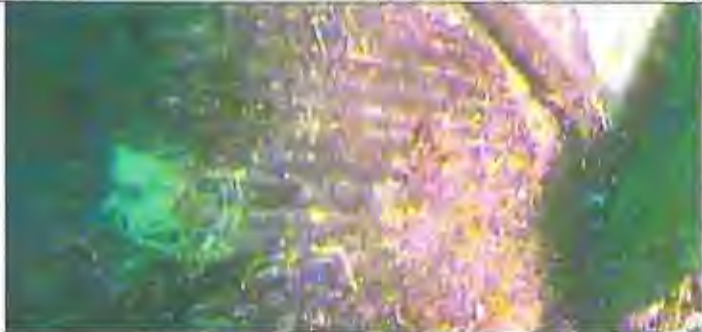
Date:	10/10/17	Frame(HH:MM:SS)	00:22:37	Date:	
					Frame(HH:MM:SS)

Cathodic Protection and Coating Measurements (for Feature # 4)					
CP Reading #1 (mV) (north end of feature)	N/R	CP Reading #2 (mV) (center of feature)	N/R	CP Reading #3 (mV) (south end of feature)	N/R
DFT #1 (mil) (north end of feature)	N/R	DFT #2 (mil) (center of feature)	N/R	DFT #3 (mil) (south end of feature)	N/R
(record #2 for features < 2" long; record #1 and #3 for features 2 - 8" long; record #1, #2 and #3 for features >8" long)					
Temperature (°F)	56°	DFT Adjacent to Feature (mil) (~2" away from edge)	N/R	DFT Adjacent to Feature (mil) (~8 - 12" away from edge)	N/R
			N/R		N/R
			N/R		N/R
			N/R		N/R
Provide 1 to 2 photos of feature, below: Included the date and time stamps associated with video surveillance.

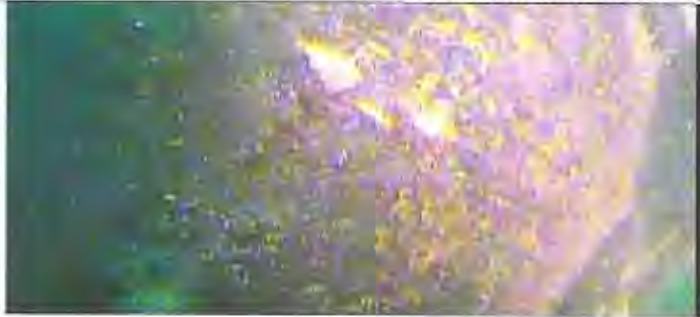
Date:	10/10/17	Frame(HH:MM:SS)	00:23:34	Date:

Cathodic Protection and Coating Measurements (for Feature # 5)					
CP Reading #1 (mV) (north end of feature)	N/R	CP Reading #2 (mV) (center of feature)	N/R	CP Reading #3 (mV) (south end of feature)	N/R
DFT #1 (mil) (north end of feature)	N/R	DFT #2 (mil) (center of feature)	N/R	DFT #3 (mil) (south end of feature)	N/R
(record #2 for features < 2" long; record #1 and #3 for features 2 - 8" long; record #1, #2 and #3 for features >8" long)					
Temperature (°F)	56°	DFT Adjacent to Feature (mil) (~2" away from edge)	N/R	DFT Adjacent to Feature (mil) (~8 - 12" away from edge)	N/R
			N/R		N/R
			N/R		N/R
			N/R		N/R
Provide 1 to 2 photos of feature, below: Included the date and time stamps associated with video surveillance.

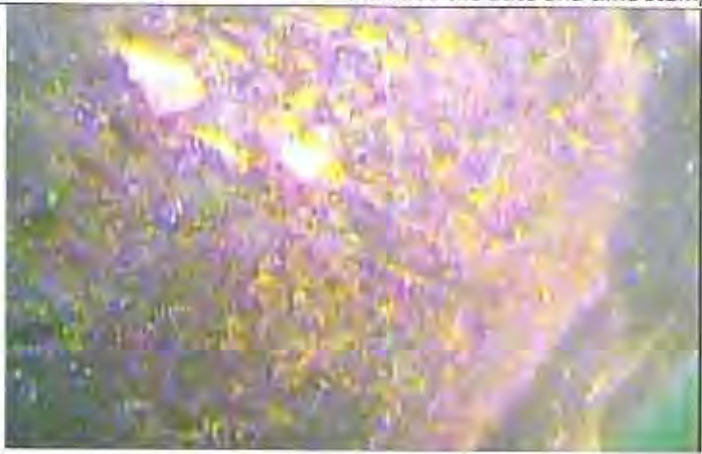
Date:	10/10/17	Frame(HH:MM:SS)	00:24:27	Date:	
					Frame(HH:MM:SS)

Cathodic Protection and Coating Measurements (for Feature # 6)					
CP Reading #1 (mV) (north end of feature)	N/R	CP Reading #2 (mV) (center of feature)	N/R	CP Reading #3 (mV) (south end of feature)	N/R
DFT #1 (mil) (north end of feature)	N/R	DFT #2 (mil) (center of feature)	N/R	DFT #3 (mil) (south end of feature)	N/R
(record #2 for features < 2" long; record #1 and #3 for features 2 - 8" long; record #1, #2 and #3 for features >8" long)					
Temperature (°F)	56°	DFT Adjacent to Feature (mil) (~2" away from edge)	N/R	DFT Adjacent to Feature (mil) (~8 - 12" away from edge)	N/R
			N/R		N/R
			N/R		N/R
			N/R		N/R
Provide 1 to 2 photos of feature, below: Included the date and time stamps associated with video surveillance.

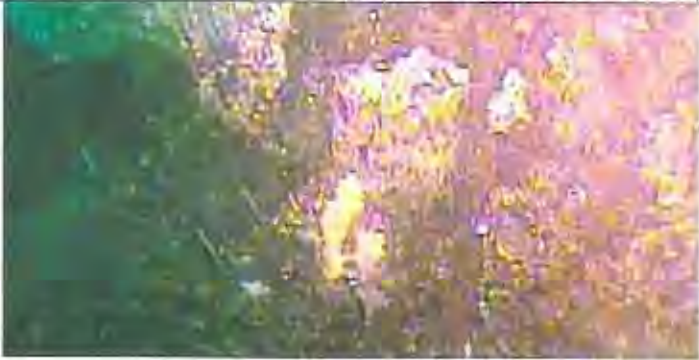
Date:	10/10/17	Frame(HH:MM:SS)	00:25:16	Date:

Cathodic Protection and Coating Measurements (for Feature # 7)					
CP Reading #1 (mV) (north end of feature)	N/R	CP Reading #2 (mV) (center of feature)	N/R	CP Reading #3 (mV) (south end of feature)	N/R
DFT #1 (mil) (north end of feature)	N/R	DFT #2 (mil) (center of feature)	N/R	DFT #3 (mil) (south end of feature)	N/R
(record #2 for features < 2" long; record #1 and #3 for features 2 - 8" long; record #1, #2 and #3 for features >8" long)					
Temperature (°F)	56°	DFT Adjacent to Feature (mil) (~2" away from edge)	N/R	DFT Adjacent to Feature (mil) (~8 - 12" away from edge)	N/R
			N/R		N/R
			N/R		N/R
			N/R		N/R
Provide 1 to 2 photos of feature, below: Included the date and time stamps associated with video surveillance.

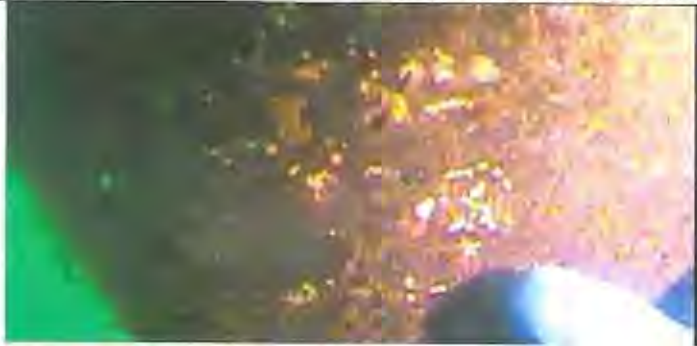
Date:	10/10/17	Frame(HH:MM:SS)	00:27:44	Date:	
					Frame(HH:MM:SS)

Cathodic Protection and Coating Measurements (for Feature # 8)					
CP Reading #1 (mV) (north end of feature)	N/R	CP Reading #2 (mV) (center of feature)	N/R	CP Reading #3 (mV) (south end of feature)	N/R
DFT #1 (mil) (north end of feature)	N/R	DFT #2 (mil) (center of feature)	N/R	DFT #3 (mil) (south end of feature)	N/R
(record #2 for features < 2" long; record #1 and #3 for features 2 - 8" long; record #1, #2 and #3 for features >8" long)					
Temperature (°F)	56°	DFT Adjacent to Feature (mil) (~2" away from edge)	N/R	DFT Adjacent to Feature (mil) (~8 - 12" away from edge)	N/R
			N/R		N/R
			N/R		N/R
			N/R		N/R
Provide 1 to 2 photos of feature, below: Included the date and time stamps associated with video surveillance.

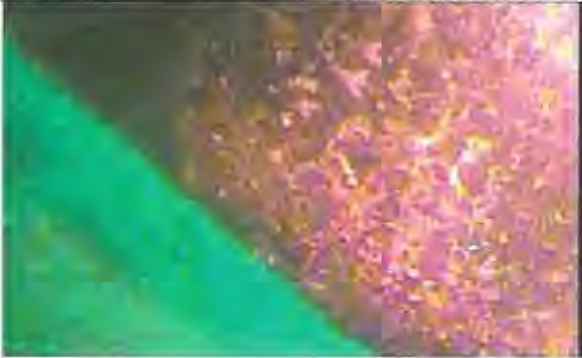
Date:	10/10/17	Frame(HH:MM:SS)	00:28:15	Date:	
				Frame(HH:MM:SS)

Cathodic Protection and Coating Measurements (for Feature # 9)					
CP Reading #1 (mV) (north end of feature)	N/R	CP Reading #2 (mV) (center of feature)	N/R	CP Reading #3 (mV) (south end of feature)	N/R
DFT #1 (mil) (north end of feature)	N/R	DFT #2 (mil) (center of feature)	N/R	DFT #3 (mil) (south end of feature)	N/R
(record #2 for features < 2" long; record #1 and #3 for features 2 - 8" long; record #1, #2 and #3 for features >8" long)					
Temperature (°F)	56°	DFT Adjacent to Feature (mil) (~2" away from edge)	N/R	DFT Adjacent to Feature (mil) (~8 - 12" away from edge)	N/R
			N/R		N/R
			N/R		N/R
			N/R		N/R
Provide 1 to 2 photos of feature, below: Included the date and time stamps associated with video surveillance.

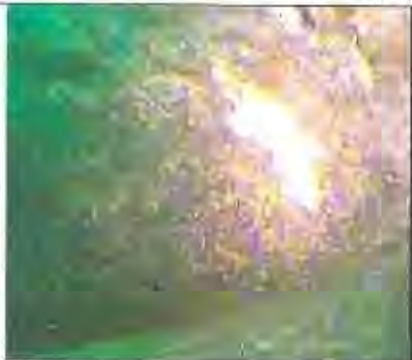
Date:	10/10/17	Frame(HH:MM:SS)	00:30:09	Date:	
					Frame(HH:MM:SS)

Cathodic Protection and Coating Measurements (for Feature # 10)					
CP Reading #1 (mV) (north end of feature)	N/R	CP Reading #2 (mV) (center of feature)	N/R	CP Reading #3 (mV) (south end of feature)	N/R
DFT #1 (mil) (north end of feature)	N/R	DFT #2 (mil) (center of feature)	N/R	DFT #3 (mil) (south end of feature)	N/R
(record #2 for features < 2" long; record #1 and #3 for features 2 - 8" long; record #1, #2 and #3 for features >8" long)					
Temperature (°F)	56°	DFT Adjacent to Feature (mil) (~2" away from edge)	N/R	DFT Adjacent to Feature (mil) (~8 - 12" away from edge)	N/R
			N/R		N/R
			N/R		N/R
			N/R		N/R
Provide 1 to 2 photos of feature, below: Included the date and time stamps associated with video surveillance.

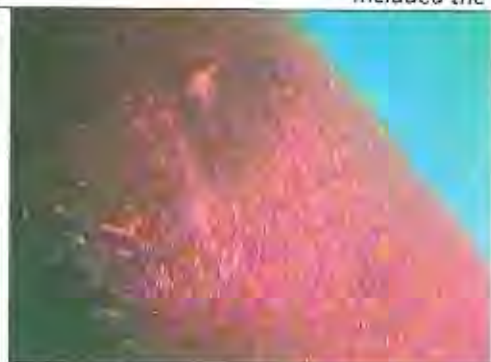
Date:	10/10/17	Frame(HH:MM:SS)	00:42:02	Date:		Frame(HH:MM:SS)	
-------	----------	-----------------	----------	-------	--	-----------------	--

<b>CP Reading #1 (mV)</b> (north end of feature)	<b>N/R</b>	<b>CP Reading #2 (mV)</b> (center of feature)	<b>N/R</b>	<b>CP Reading #3 (mV)</b> (south end of feature)	<b>N/R</b>
<b>DFT #1 (mil)</b> (north end of feature)	<b>125</b>	<b>DFT #2 (mil)</b> (center of feature)	<b>N/R</b>	<b>DFT #3 (mil)</b> (south end of feature)	<b>115</b>
(record #2 for features < 2" long; record #1 and #3 for features 2 - 8" long; record #1, #2 and #3 for features >8" long)					
<b>Temperature (°F)</b>	<b>56°</b>	<b>DFT Adjacent to Feature (mil)</b> (~2" away from edge)	<b>70</b>	<b>DFT Adjacent to Feature (mil)</b> (~8 - 12" away from edge)	<b>115</b>
			<b>170</b>		<b>200</b>
			<b>190</b>		<b>83</b>
			<b>245</b>		<b>115</b>

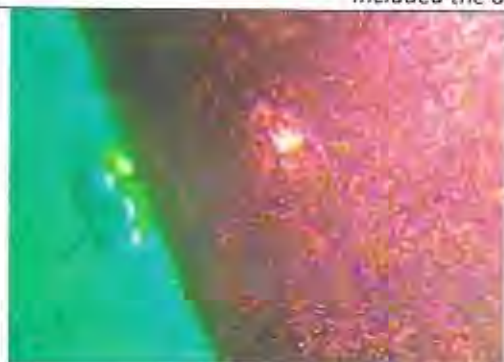
Date:	10/10/17	Frame(HH:MM:SS)	00:43:45	Date:		Frame(HH:MM:SS)	
-------	----------	-----------------	----------	-------	--	-----------------	--

<b>CP Reading #1 (mV)</b> (north end of feature)	N/R	<b>CP Reading #2 (mV)</b> (center of feature)	N/R	<b>CP Reading #3 (mV)</b> (south end of feature)	N/R
<b>DFT #1 (mil)</b> (north end of feature)	N/R	<b>DFT #2 (mil)</b> (center of feature)	N/R	<b>DFT #3 (mil)</b> (south end of feature)	N/R
(record #2 for features < 2" long; record #1 and #3 for features 2 - 8" long; record #1, #2 and #3 for features >8" long)					
<b>Temperature (°F)</b>	56°	<b>DFT Adjacent to Feature (mil)</b> (~2" away from edge)	N/R	<b>DFT Adjacent to Feature (mil)</b> (~8 - 12" away from edge)	N/R
			N/R		N/R
			N/R		N/R
			N/R		N/R

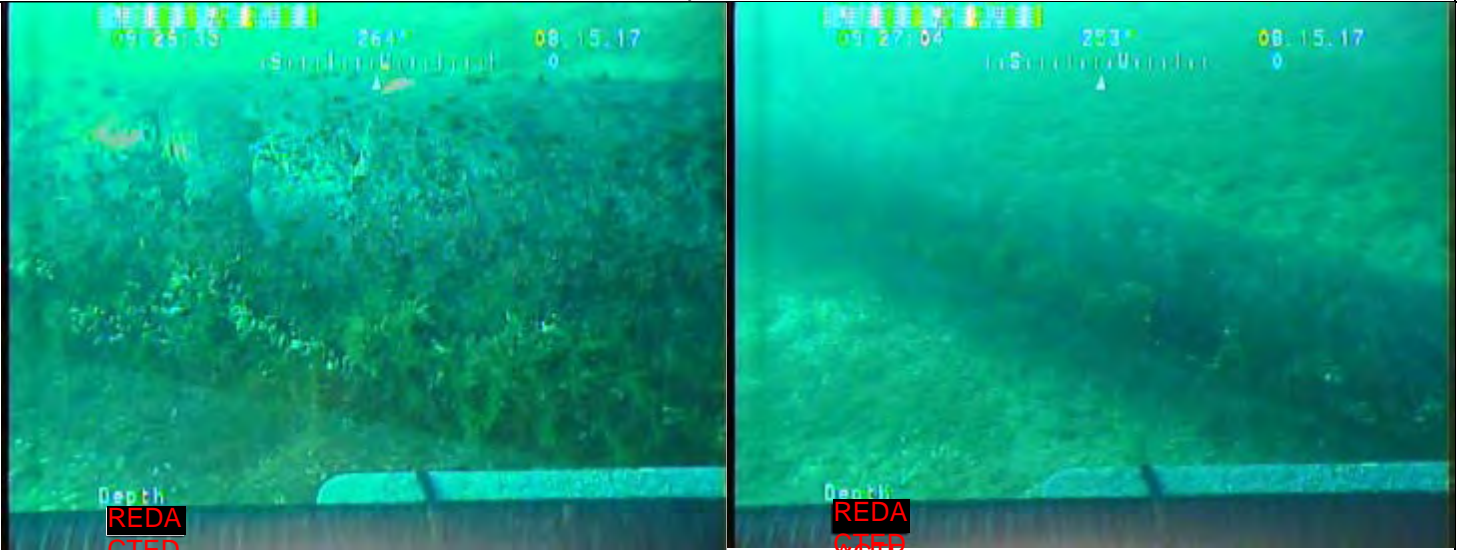
Date: 8/15/17 Frame(HH:MM:SS) 09:26:36 Date: 8/15/17 Frame(HH:MM:SS) 09:27:04

Visual Inspection (General Coating Condition)

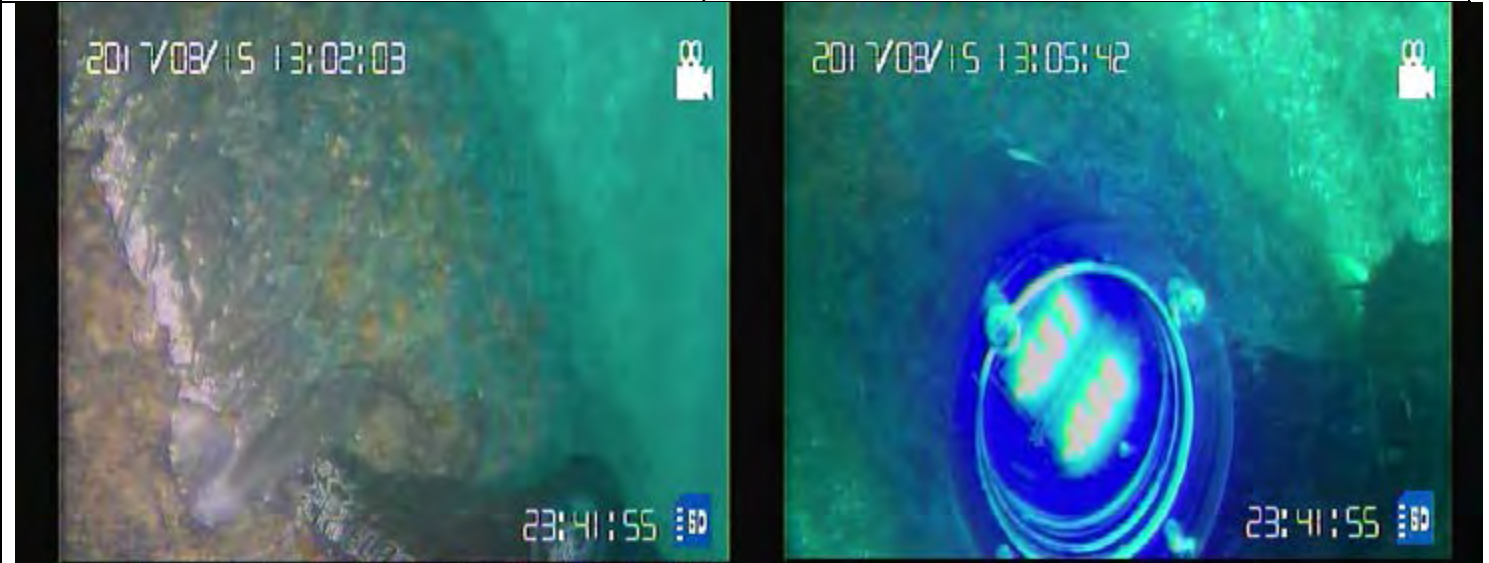
Date:	8/15/17	Frame(HH:MM:SS)	13:02:03	Date:	8/15/17	Frame(HH:MM:SS)	13:05:42
-------	---------	-----------------	----------	-------	---------	-----------------	----------

Cathodic Protection and Coating Measurements (if Holiday is found) -  
Holiday 1

CP Reading #1 (mV)	-1676 -1683	CP Reading #2 (mV)	-1674 -1681	CP Reading #3 (mV)	-1690 -1674
Temperature (°F)	NR	DFT at Holiday (mil)	≤ 25	DFT Adjacent to Holiday (mil)	96, 94, 95

The Polatrak CP gun was used to check for coating holiday through the white deposit. CP measurements could not be obtained, indicating the corrosion barrier coating is intact.

It is recommended to revisit this site to destructively remove the white deposit and inspect the coating condition beneath it. This should be performed during the recoating project so that any resulting coating damage can be repaired.

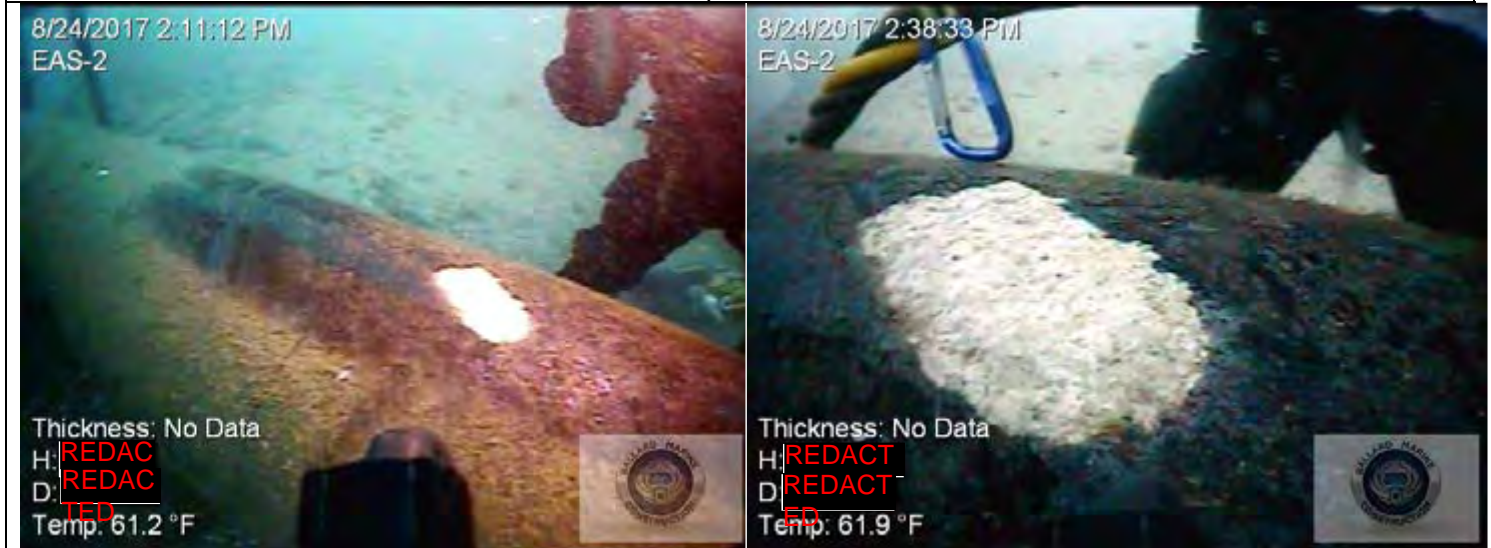
Date:	8/24/17	Frame(HH:MM:SS)	14:11:12	Date:	8/24/17	Frame(HH:MM:SS)	14:38:33
-------	---------	-----------------	----------	-------	---------	-----------------	----------

**Cathodic Protection and Coating Measurements (if Holiday is found)**  
(note: holiday could not be confirmed)

CP Reading #1 (mV) See note (below)	-261 -291	CP Reading #2 (mV)	N/R	CP Reading #3 (mV)	N/R
Temperature (°F)	NR	DFT at Feature (mil)	≥ 70 avg.117	DFT Adjacent to Feature (mil)	≥ 94 avg.127

Note: CP readings at this feature were recorded with the probe of Polatrak CP gun pressed firmly through the white substance covering the pipe. These readings were identical to 'open water' CP readings, which were recorded with the CP gun probe close to (but not touching) the pipe.

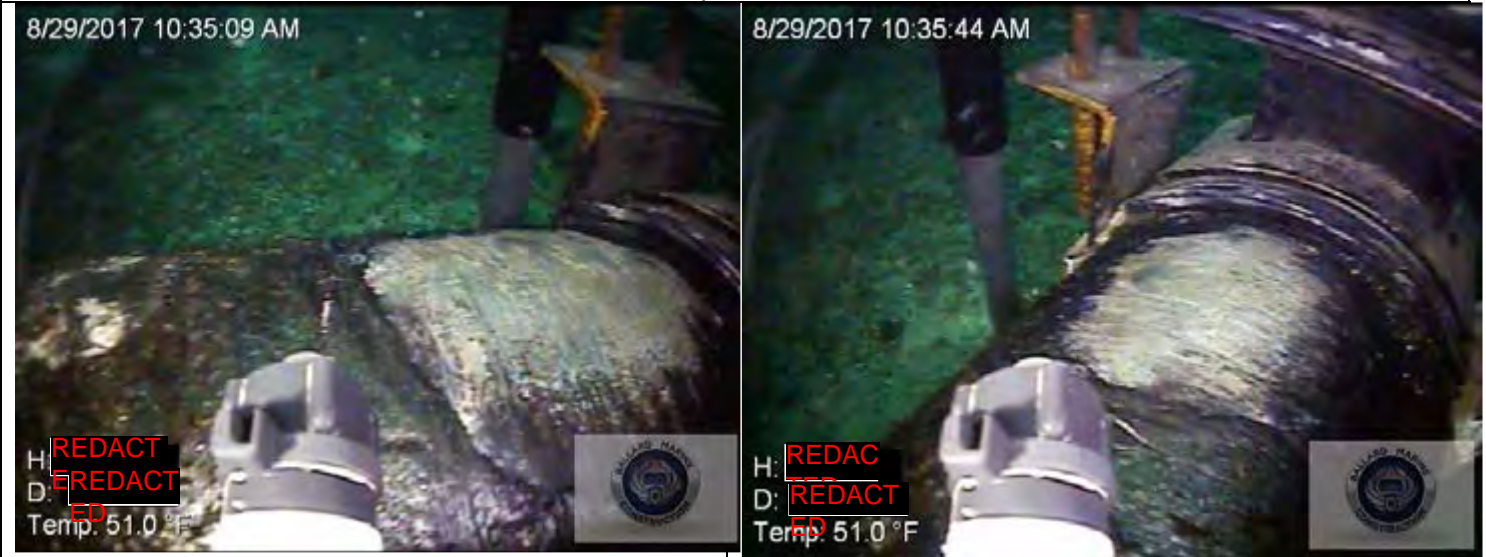
Date:	8/29/17	Frame(HH:MM:SS)	10:35:09	Date:	8/29/17	Frame(HH:MM:SS)	10:35:44
-------	---------	-----------------	----------	-------	---------	-----------------	----------

Visual Inspection (General Coating Condition and Holiday 1)

Two (2) features with DFT measurements below the minimum resolvable thickness of gauge were found. The Polatrak CP gun was used to confirm the existence of bare metal:  
Holiday 1 presented average CP reading of -963mV CSE (holiday confirmed).  
Holiday 2 presented average CP reading of -958mV CSE (holiday confirmed).

No external corrosion was detected by dive team.

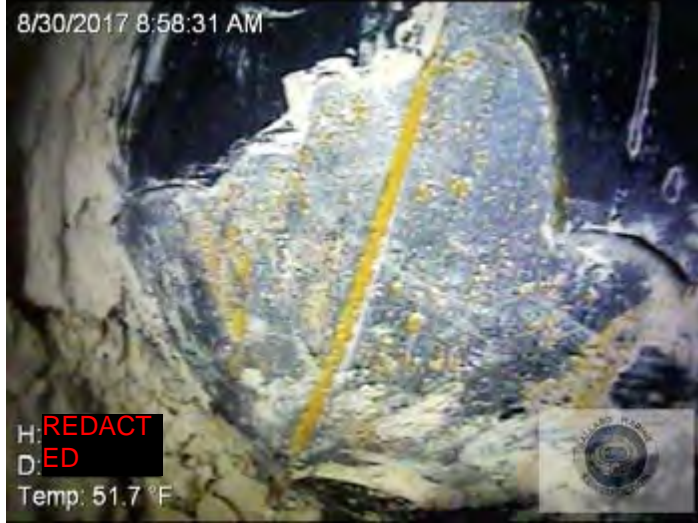
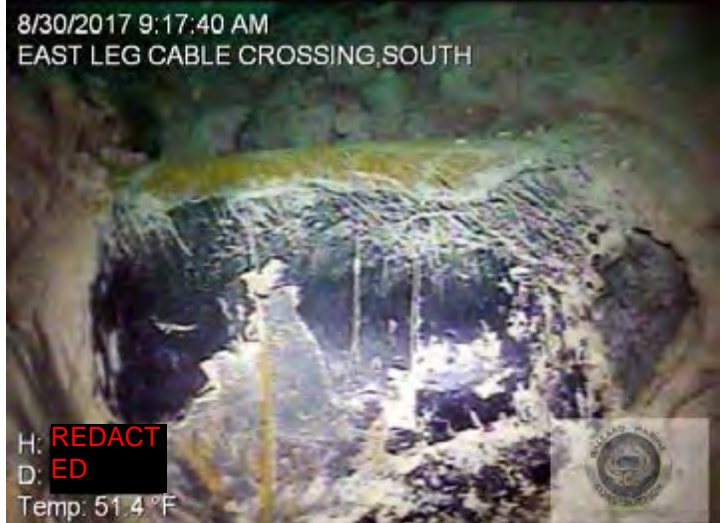
Date:	8/30/17	Frame(HH:MM:SS)	8:58:31	Date:	8/30/17	Frame(HH:MM:SS)	9:17:40
-------	---------	-----------------	---------	-------	---------	-----------------	---------

Cathodic Protection and Coating Measurements (if Holiday is found) -  
Holiday 1

CP Reading #1 (mV)	-955 -991	CP Reading #2 (mV)	-938 -965	CP Reading #3 (mV)	-951 -979
Temperature (°F)	44	DFT at Holiday (mil)	≤ 25	DFT Adjacent to Holiday (mil)	96, 84, 100, 135

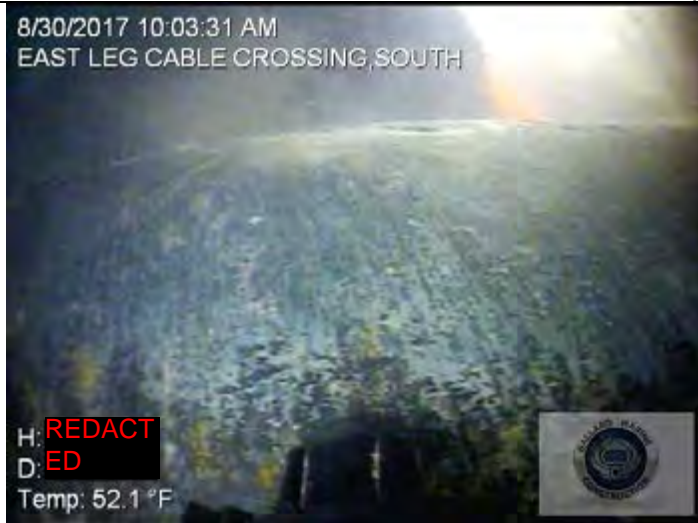
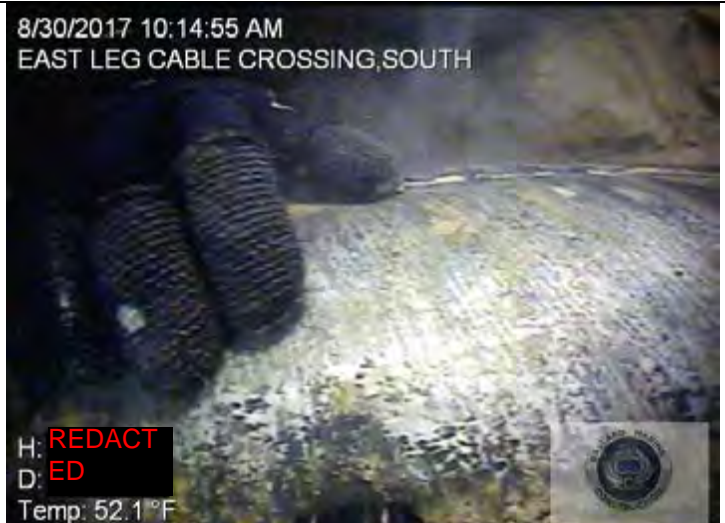
Date:	8/30/17	Frame(HH:MM:SS)	10:03:31	Date:	8/30/17	Frame(HH:MM:SS)	10:14:55
-------	---------	-----------------	----------	-------	---------	-----------------	----------

Cathodic Protection and Coating Measurements (if Holiday is found) -  
Holiday 2

CP Reading #1 (mV)	-981 -1012	CP Reading #2 (mV)	-907 -933	CP Reading #3 (mV)	-944 -974
Temperature (°F)	44	DFT at Holiday (mil)	≤ 25	DFT Adjacent to Holiday (mil)	105, 140, 76, 95, 84

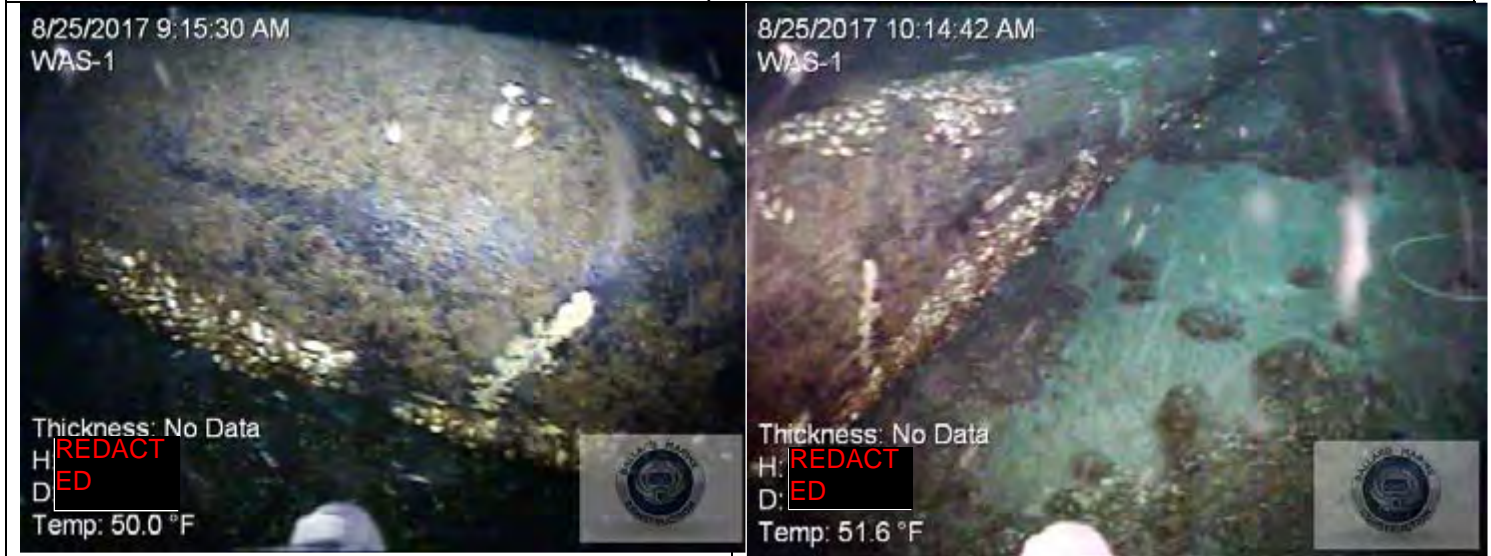
Date:	8/25/17	Frame(HH:MM:SS)	09:15:30	Date:	8/25/17	Frame(HH:MM:SS)	10:14:42
-------	---------	-----------------	----------	-------	---------	-----------------	----------

**Cathodic Protection and Coating Measurements (if Holiday is found) -  
Holiday 1**

CP Reading #1 (mV)	-1300 -1362	CP Reading #2 (mV)	-1277 -1336	CP Reading #3 (mV)	-1277 -1322
Temperature (°F)	43	DFT at Holiday (mil)	≤ 25	DFT Adjacent to Holiday (mil)	90, 93, 110

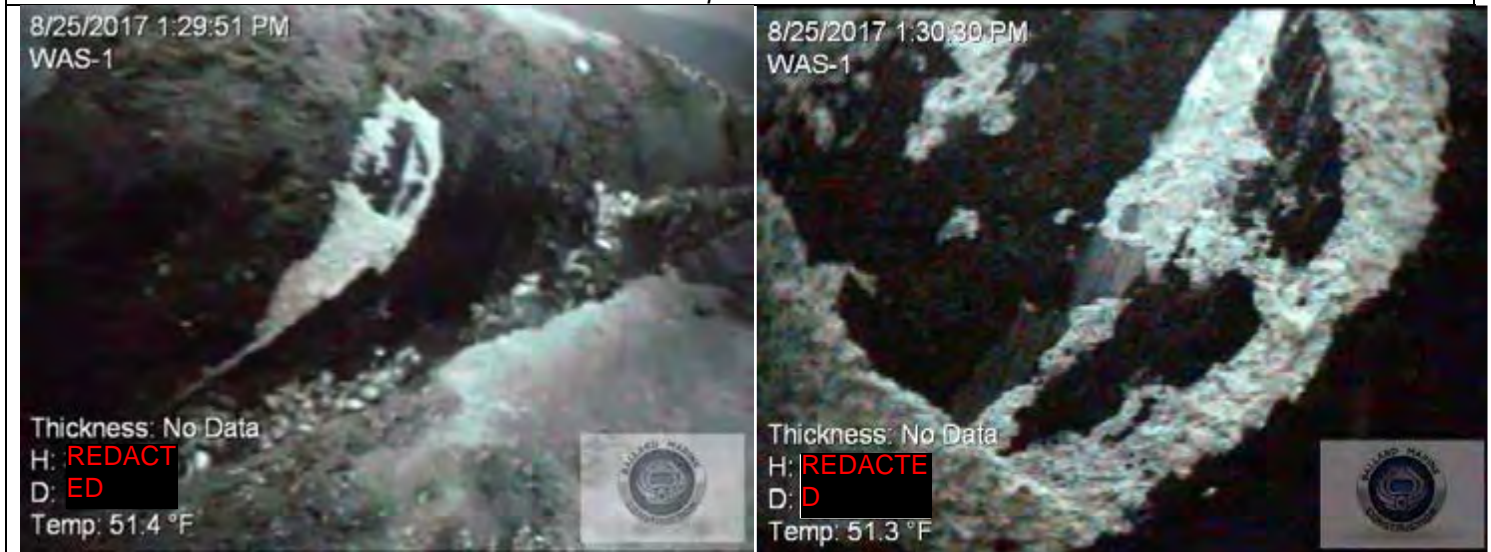
Date:	8/25/17	Frame(HH:MM:SS)	13:29:51	Date:	8/25/17	Frame(HH:MM:SS)	13:30:30
-------	---------	-----------------	----------	-------	---------	-----------------	----------

**Cathodic Protection and Coating Measurements (if Holiday is found) -  
Holiday 2**

CP Reading #1 (mV)	-1274 -1328	CP Reading #2 (mV)	-1283 -1237	CP Reading #3 (mV)	-1375 -1372
Temperature (°F)	43	DFT at Holiday (mil)	≤ 25	DFT Adjacent to Holiday (mil)	79, 94, 100

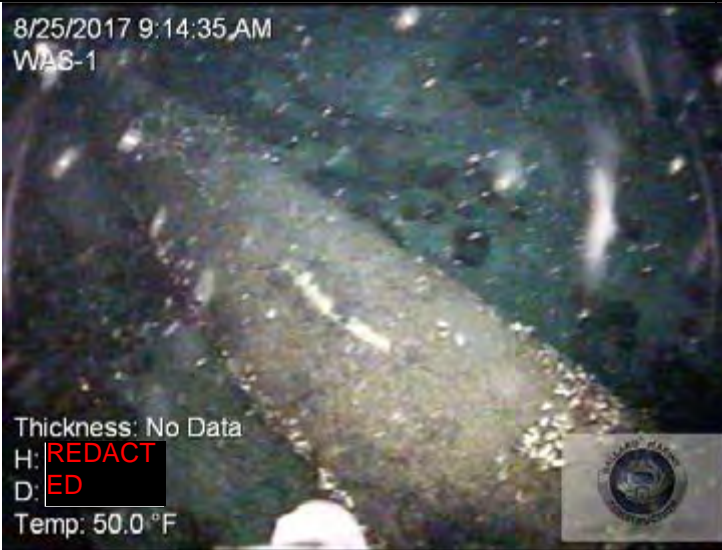
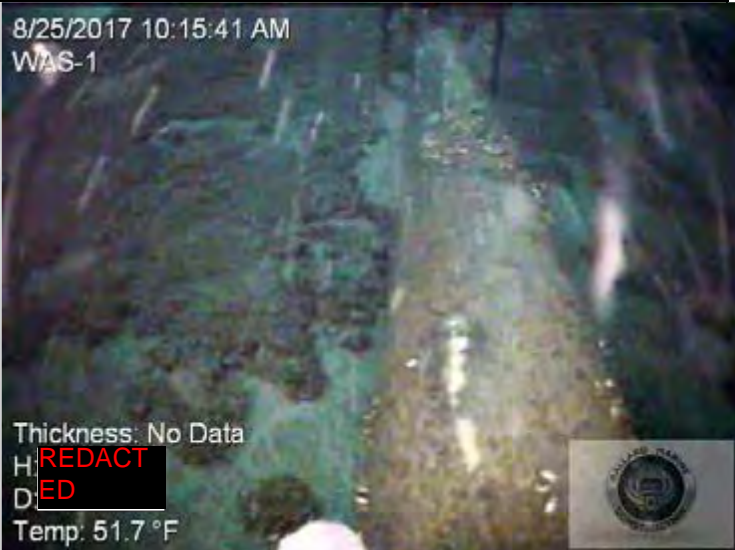
<div>                     Thickness: No Data                      H: REDACTED                      D: ED                      Temp: 51.7 °F                 </div> </div>			
Date:	8/25/17	Frame(HH:MM:SS)	09:14:35	Date:	8/25/17	Frame(HH:MM:SS)	10:15:41

**Cathodic Protection and Coating Measurements (if Holiday is found) -  
Holiday 3**

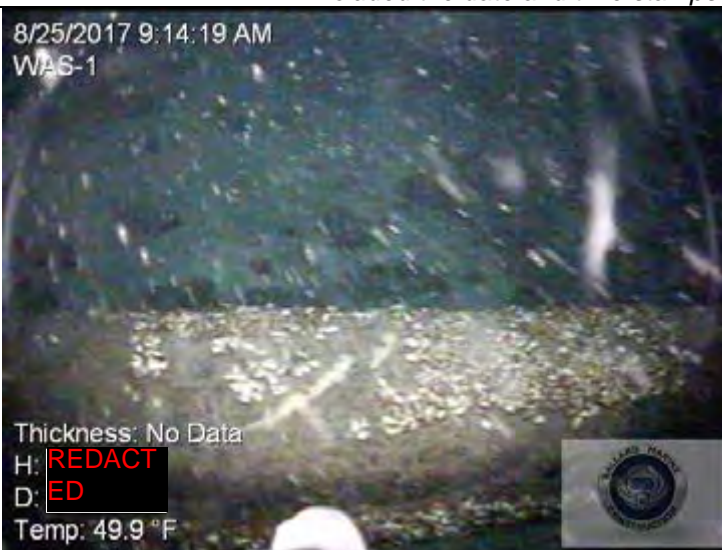
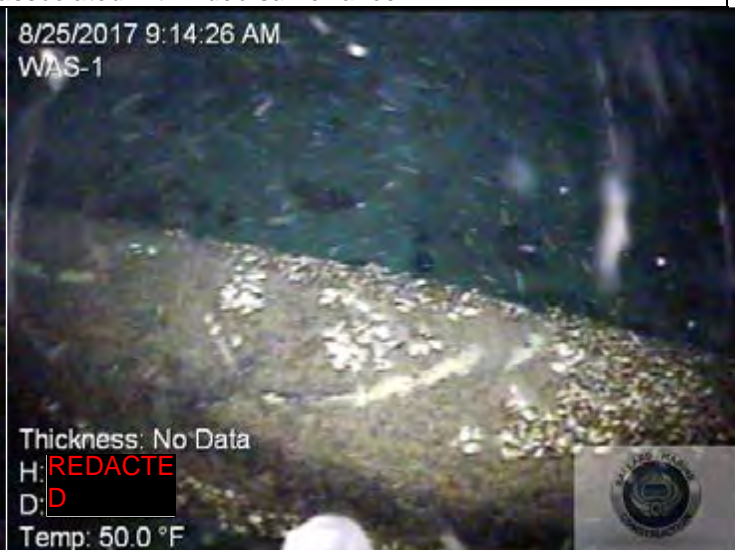
<div>                     Thickness: No Data                      H: REDACTED                      D: ED                      Temp: 50.0 °F                 </div> </div>			
Date:	8/25/17	Frame(HH:MM:SS)	09:14:19	Date:	8/25/17	Frame(HH:MM:SS)	09:14:26

**Cathodic Protection and Coating Measurements (if Holiday is found) -  
Holiday 4**

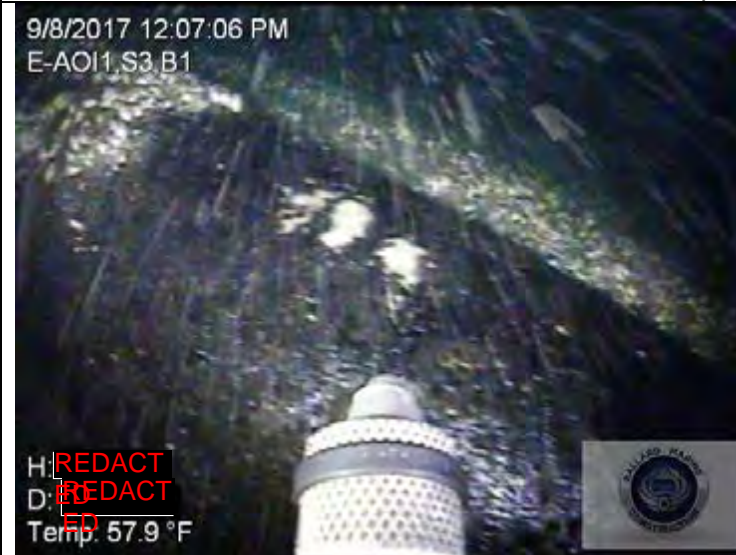
Date:	09/08/17	Frame(HH:MM:SS)	12:07:06	Date:		Frame(HH:MM:SS)	
-------	----------	-----------------	----------	-------	--	-----------------	--

Note: CP readings at this feature were recorded with the probe of Polatrak CP gun pressed firmly into the white substance coating the pipe. These readings were more electronegative than the 'open water' CP readings (-198mV / -170mV), but are not consistent with Line 5 pipe metal contact – indicating that the presence of a resistive coating on the pipe surface.

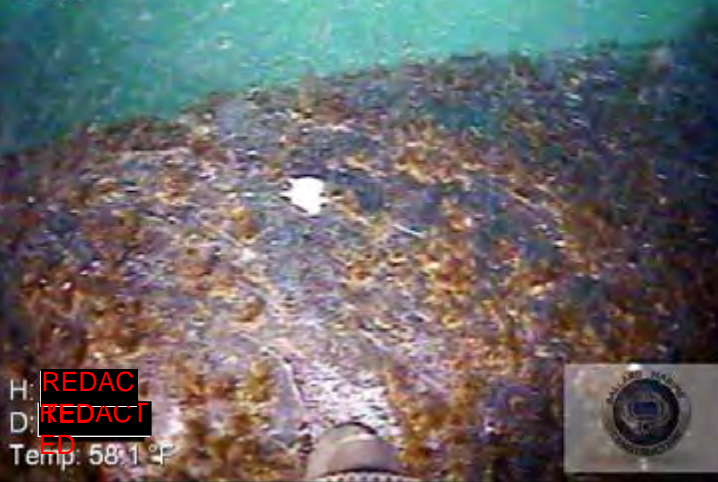
9/6/2017 2:47:47 PM  
E-AOI5

**Cathodic Protection and Coating Measurements (if Holiday is found)**  
(note: holiday could not be confirmed)

Note: CP readings at this feature were recorded with the probe of Polatrak CP gun pressed firmly into the white substance coating the pipe. These readings were more electronegative than the 'open water' CP readings (-101mV / -061mV), but are not consistent with Line 5 pipe metal contact – indicating that the presence of a resistive coating on the pipe surface.

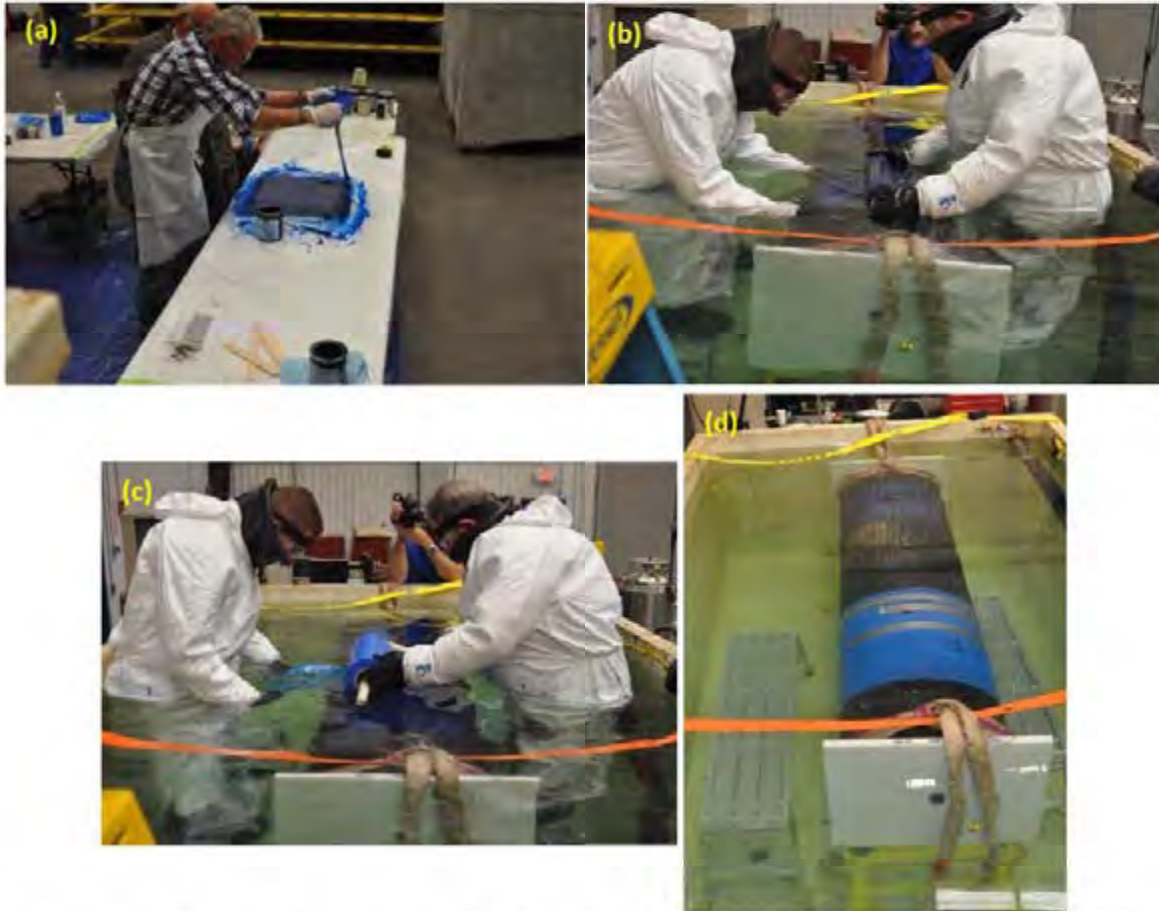
Figure 12: Application of patch repair at Area "A." Photographs show (a) impregnation of 12" x 12" fabric with epoxy; (b) application of repair on pipe in water tank; (c) wrapping repair with stricture; and (d) completed repair.
