# Diver Inspection Form for L5 Straits of Mackinac

Date:	09/30/17	Diver:	Troy Baskett, Maurice Unger, Chad Cantrell, George Palmer
AFE / W.O.#:	20011702	Company Rep / Inspector:	[REDACTED]
Pipe Support Anchor:	E-1 (E-74A/E-74B South)	Water Depth (ft):	[REDACTED]
Longitude:	[REDACTED]	Latitude:	[REDACTED]

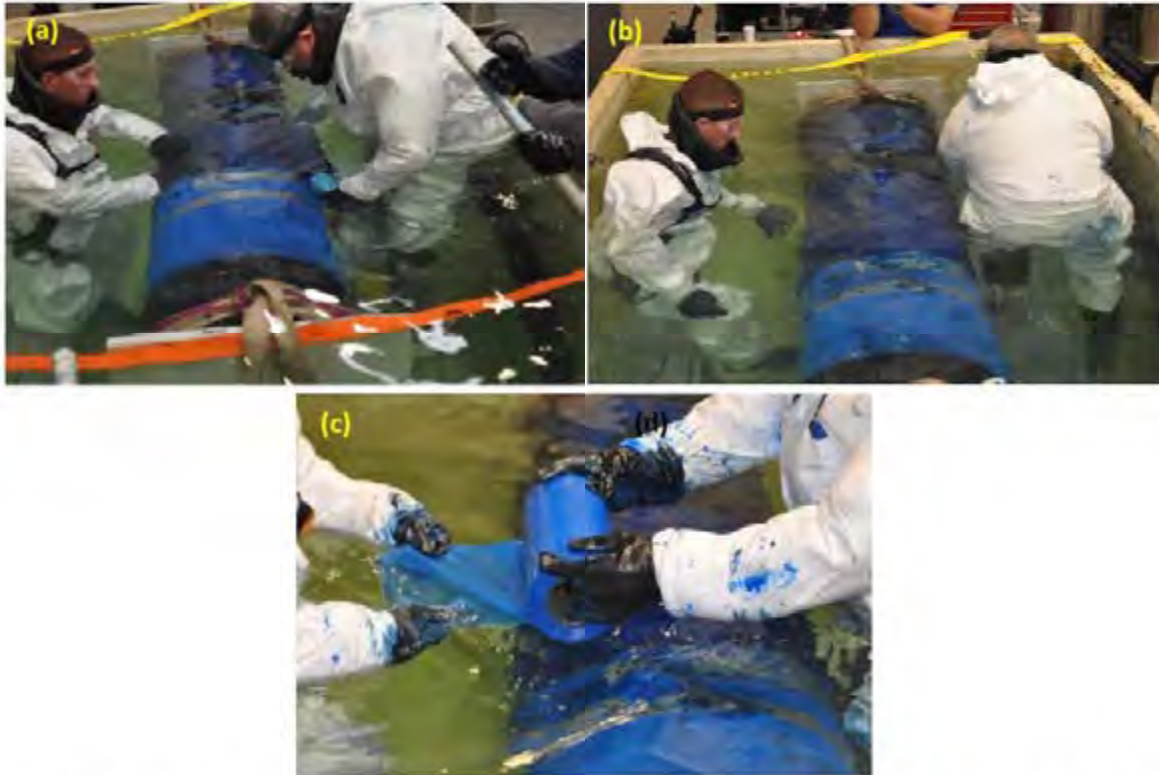
Figure 13: Application of full circumferential repair at Areas "B," "D," and "E." Photographs (a) and (b) show application of impregnated fabric around the circumference of pipe; (c) shows application of stricture.

For the next full-scale repair test, the exposed steel at Areas "B," "D," and "E" was covered with the BIO-DUR™ 563 SW epoxy filler to the approximate thickness of the original inner coal-tar coating. Four layers of a full 360° wrap repair were then applied to the pipe, covering all three test areas. A layer of stricture plastic was applied over the full circumferential repair to hold it in place during the curing cycle. The circumferential repair process is shown in Figure 13. Temperature data measured during the repair are shown in Figure 14.

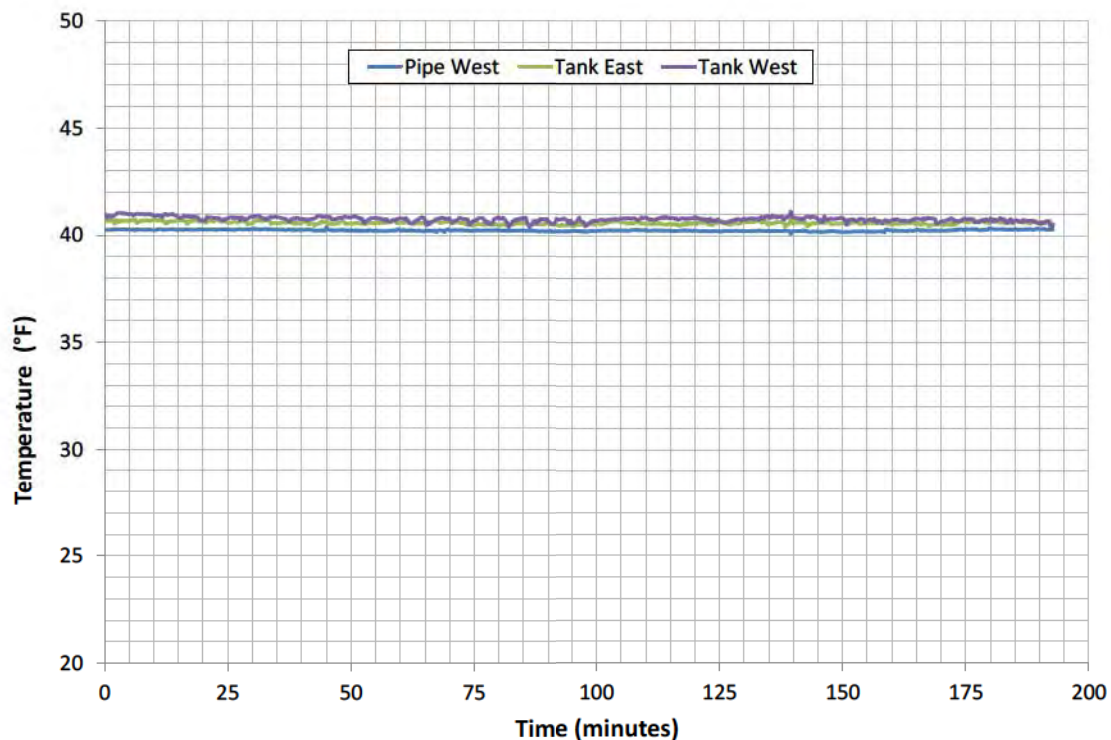
Figure 14: Graph of temperature data during application of full circumferential repair at Areas "B," "D," and "E" (see Figure 13). Water temperature remained near 40°F during installation of all repairs.

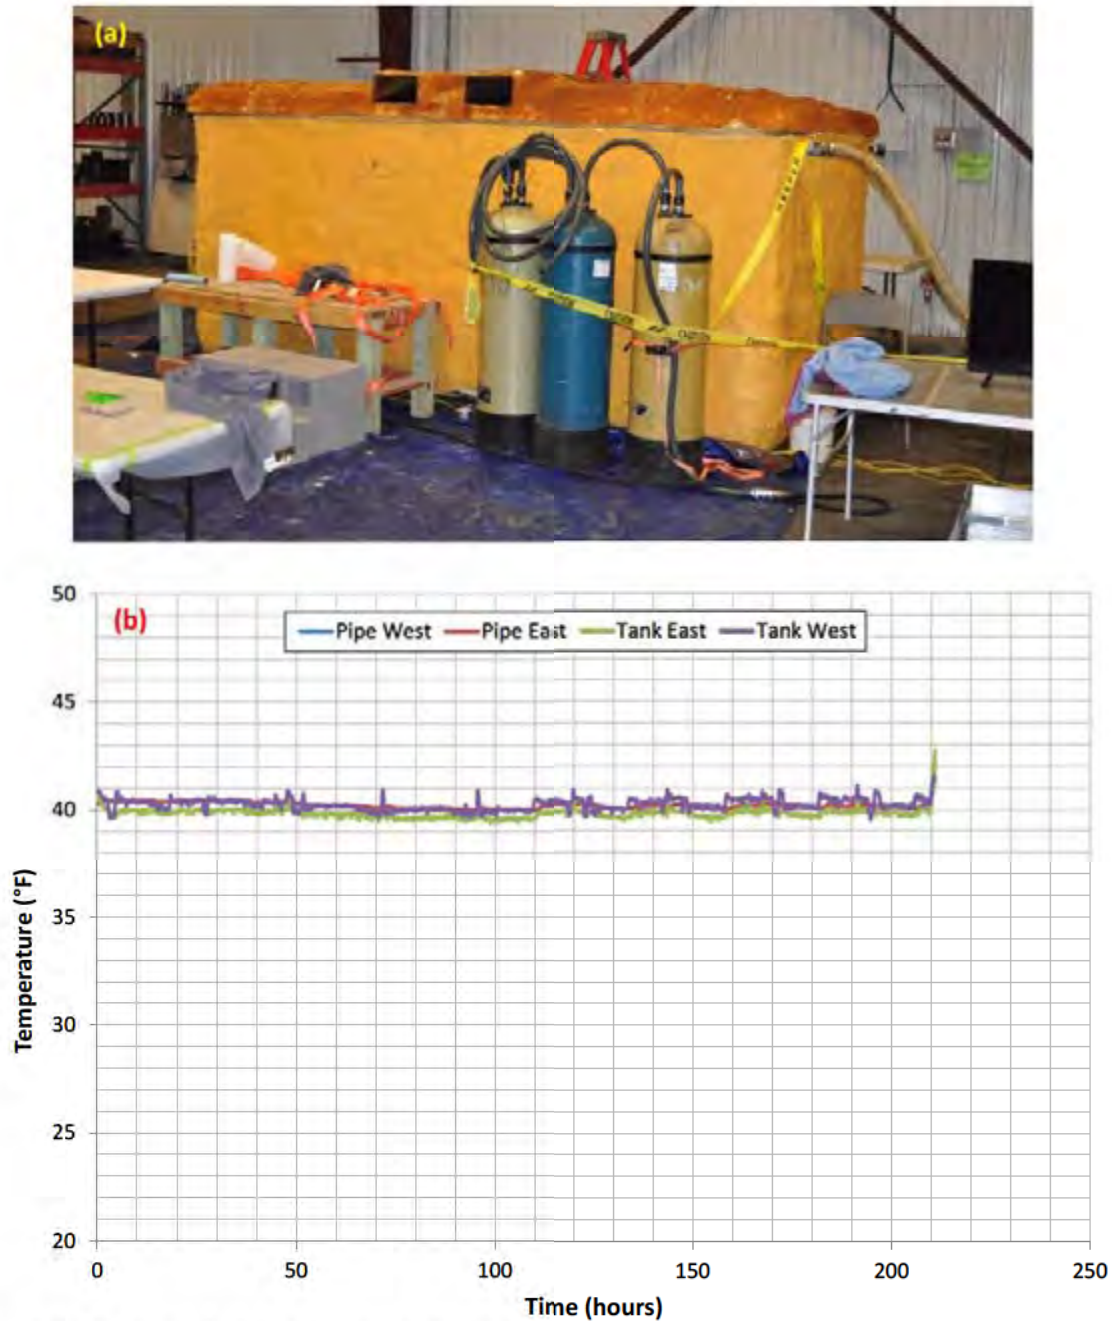
As with the laboratory repairs (see Section 3), the 20" diameter pipe was allowed to cure in the 40°F bath for 48 hours before initial durometer hardness testing. Figure 15 shows the water tank closed for testing and a plot of the temperature data, which remained steady at 40°F throughout the curing cycle.

Figure 15: (a) Photograph showing water tank and (b) graph of water-bath temperature during curing period of full-scale repairs.

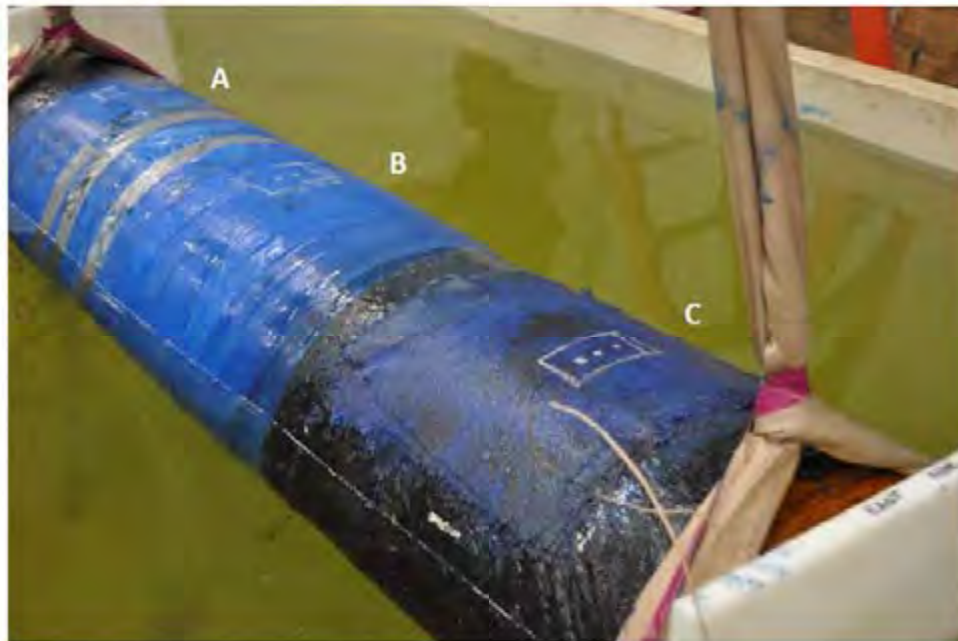
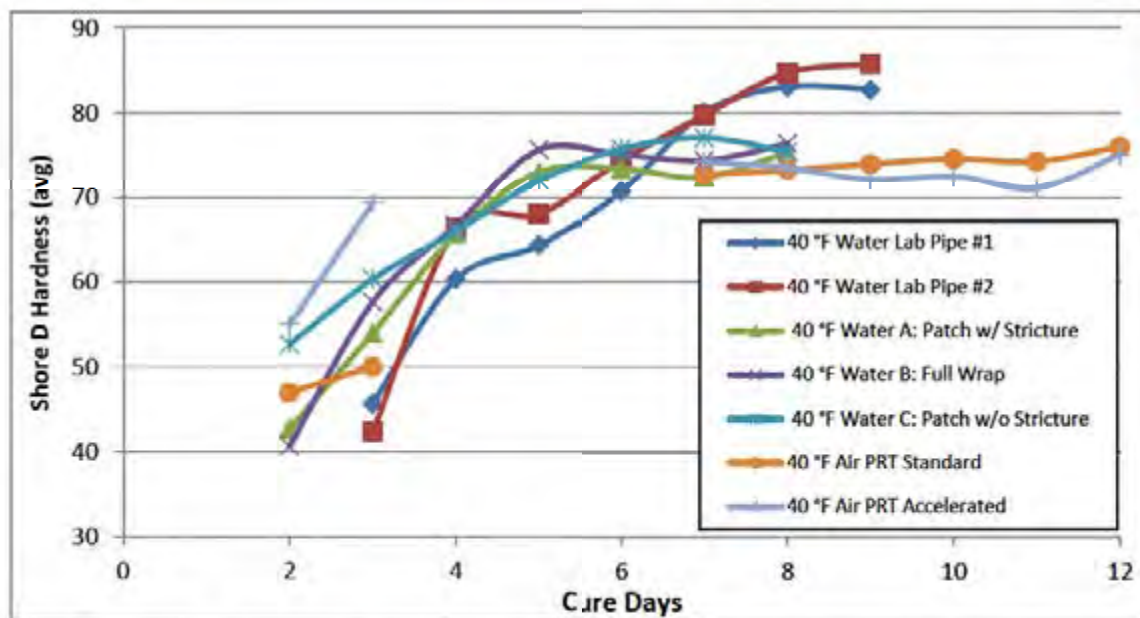
Three durometer hardness readings were taken at each repair area located at the top of the pipe every 24 hours by temporarily lifting the pipe out of the water bath (Figure 16(a)). In Areas "A" and "B," the readings were made through the thin stricture banding. In Area "C," the durometer hardness was measured directly on the fiber wrap. The average hardness results are presented in Figure 16(b) and Table 2. The durometer hardness data from the laboratory test (Section 3) are included in the graph along with air curing data supplied by PRT Incorporated.

The durometer hardness data from the full-scale test plateaued in the mid-70s Shore D after approximately 5 to 6 days at temperature. No significant change in hardness was observed after 6 days, and the measurements were suspended after 8 days in the water bath. According to PRT Incorporated, a Shore D hardness of 70 is considered to reflect a full cure.

Figure 16: (a) Photograph showing 20" pipe lifted from water tank to allow durometer hardness testing. Areas "A," "B," and "C" were tested every 24 hours after an initial waiting period of 48 hours. (b) Graph of Shore D Hardness as a function of cure time.

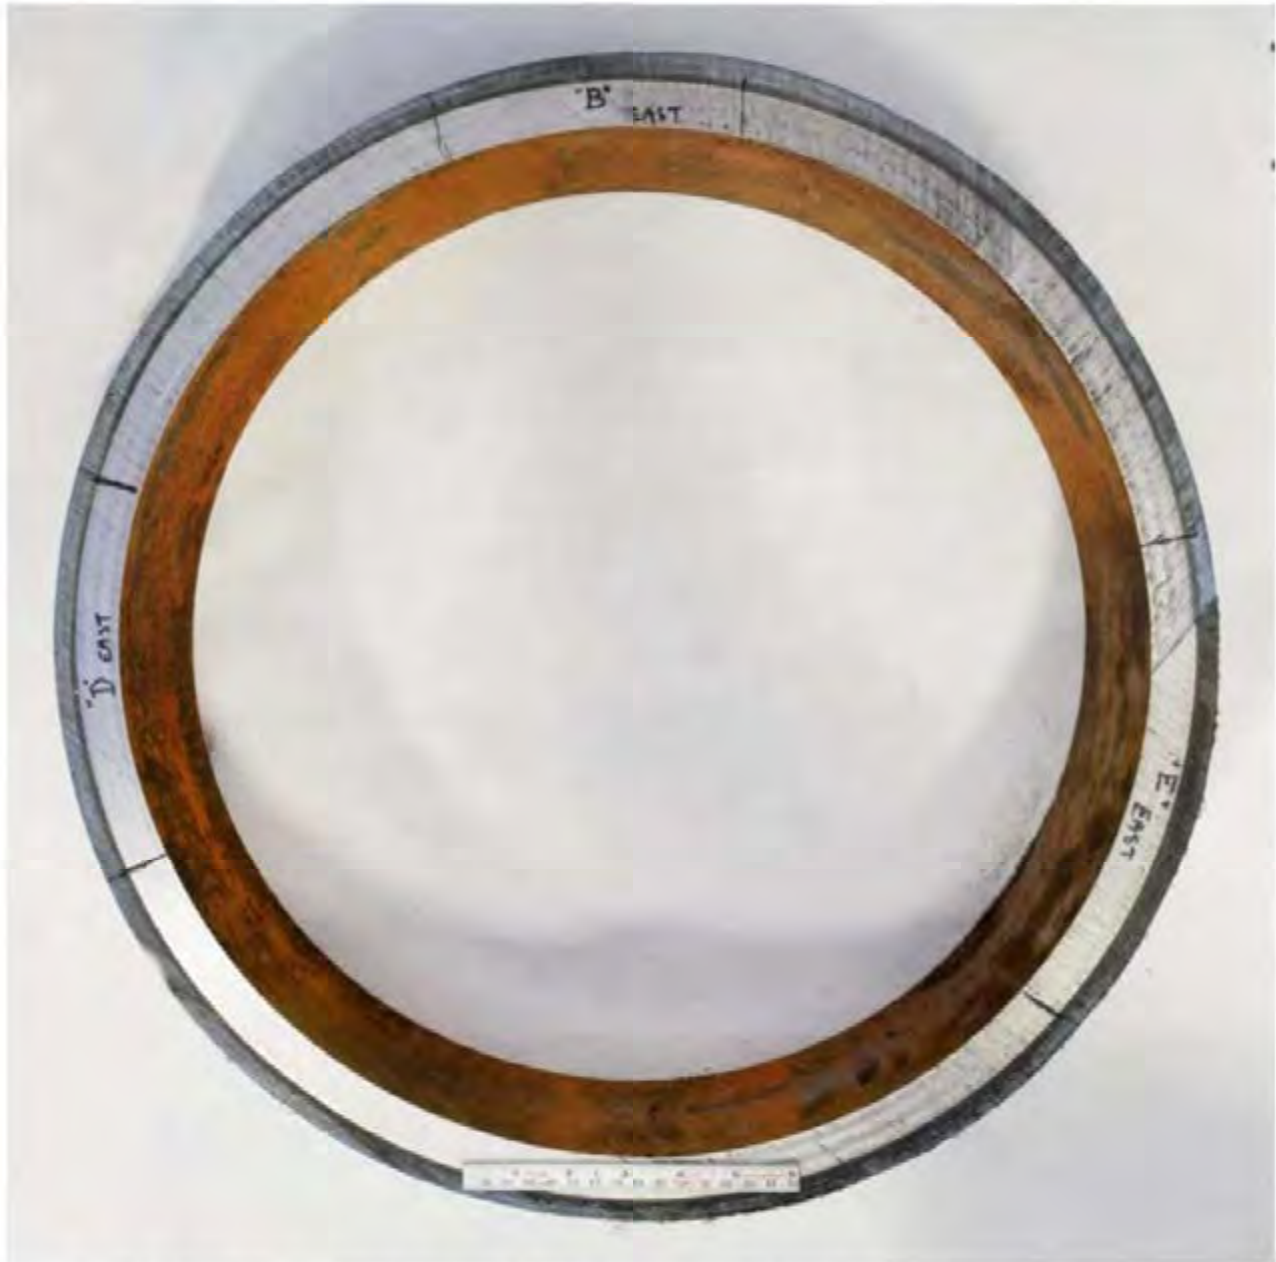
A cross-section through the three areas repaired with a full 360° wrap is shown in Figure 22. Closer views of each area are shown in Figure 23 to Figure 25. As with the patch repair in Area A, the full repairs appeared to be well bonded to the pipe, including at the outer edges of the wrap. Metallographic cross-sections through each area are shown in the lower photographs in Figure 23 to Figure 25, respectively. Again, the repairs were found to be relatively uniform and appeared to have good adhesion to the pipe wall, though areas of porosity were evident in the cross sections. The porosity is not extensive and does not appear to compromise the integrity of the repair.

Figure 22: Photograph of cross-sectional ring cut from center of 20" pipe sample containing repair Areas "B/D/E."

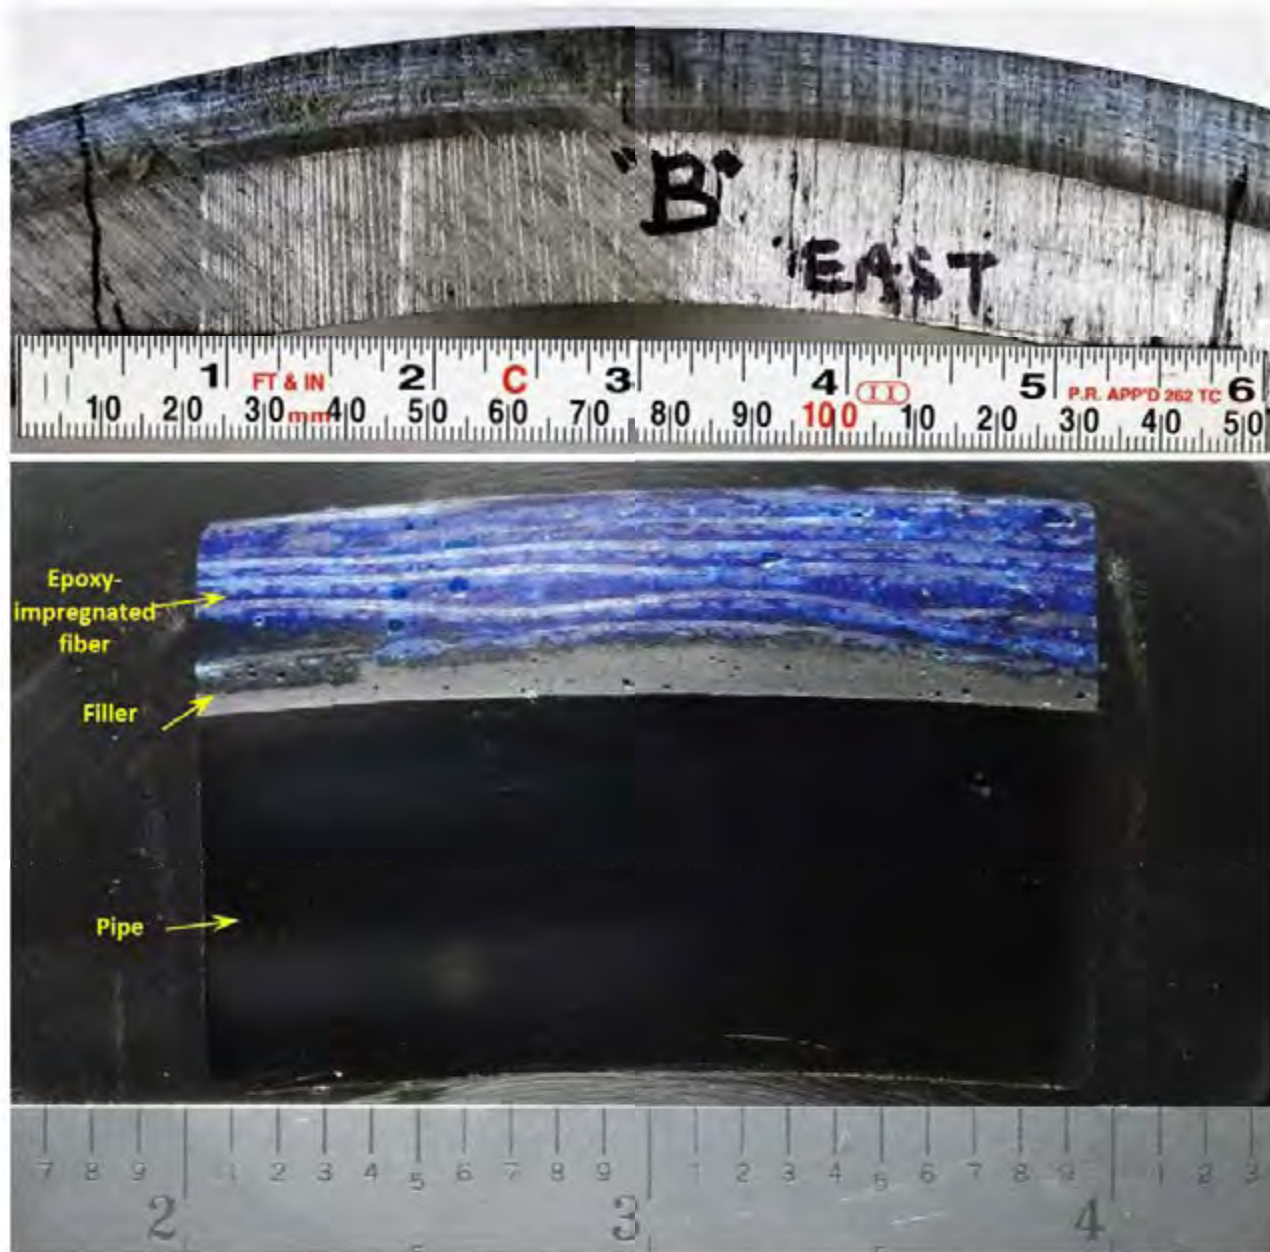
Figure 23: Metallographic cross-section of repair Area "B" located at top of pipe. A full 360° wrap and stricture was used in this repair.

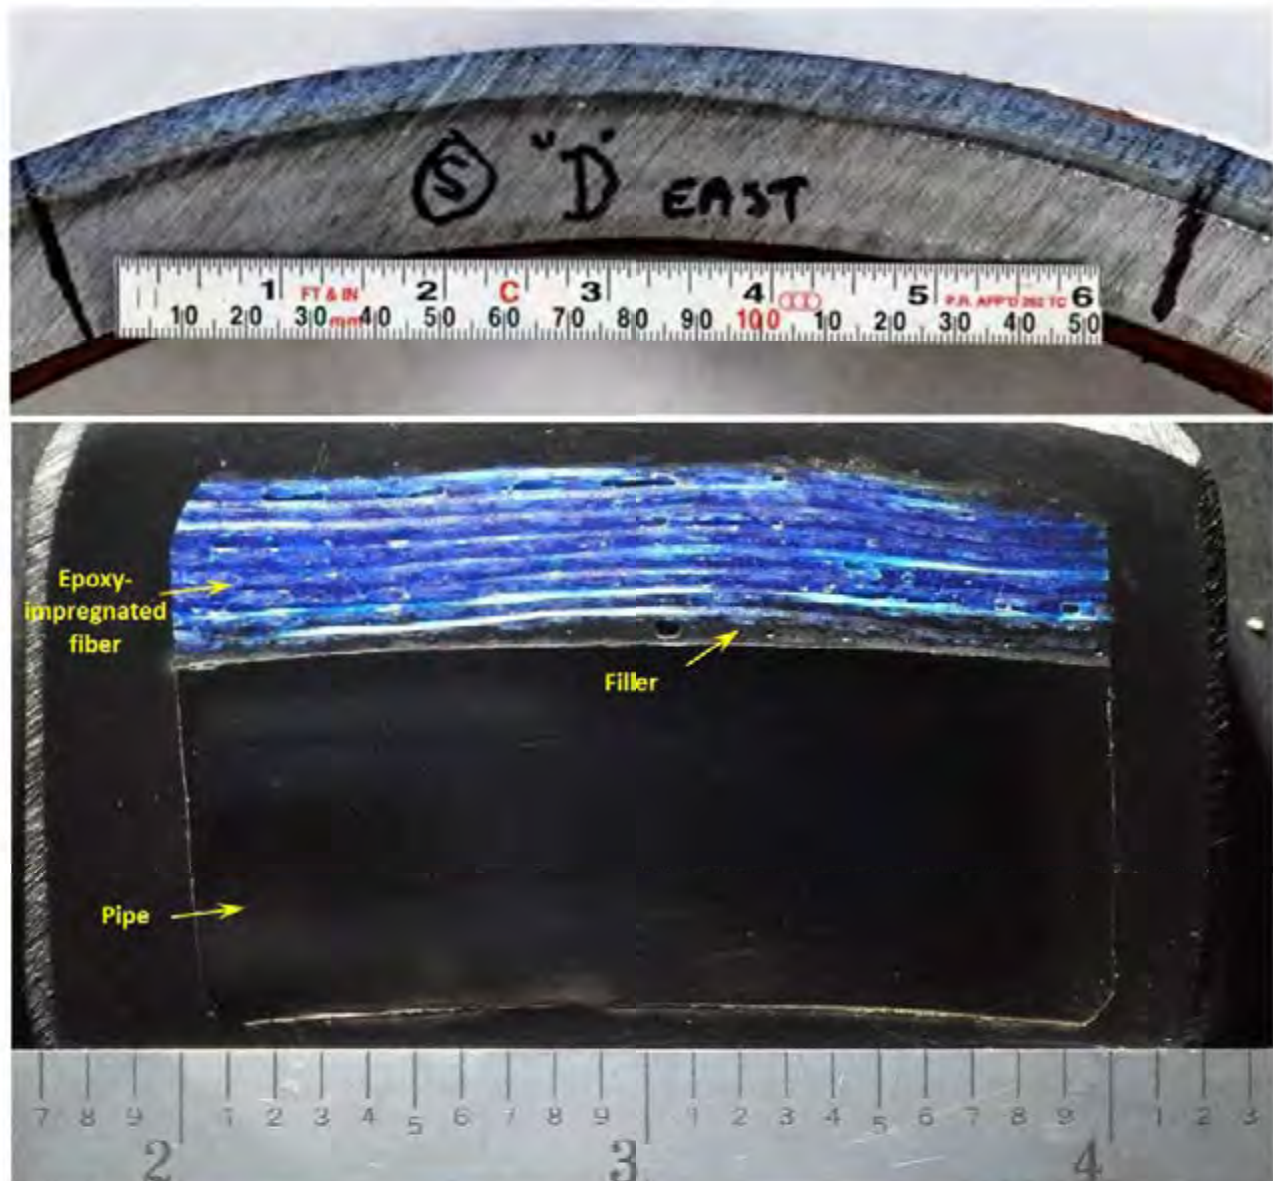
Figure 24: Metallographic cross-section of repair Area "D" located on south side (90°) of pipe. A full 360° wrap and stricture was used in this repair.

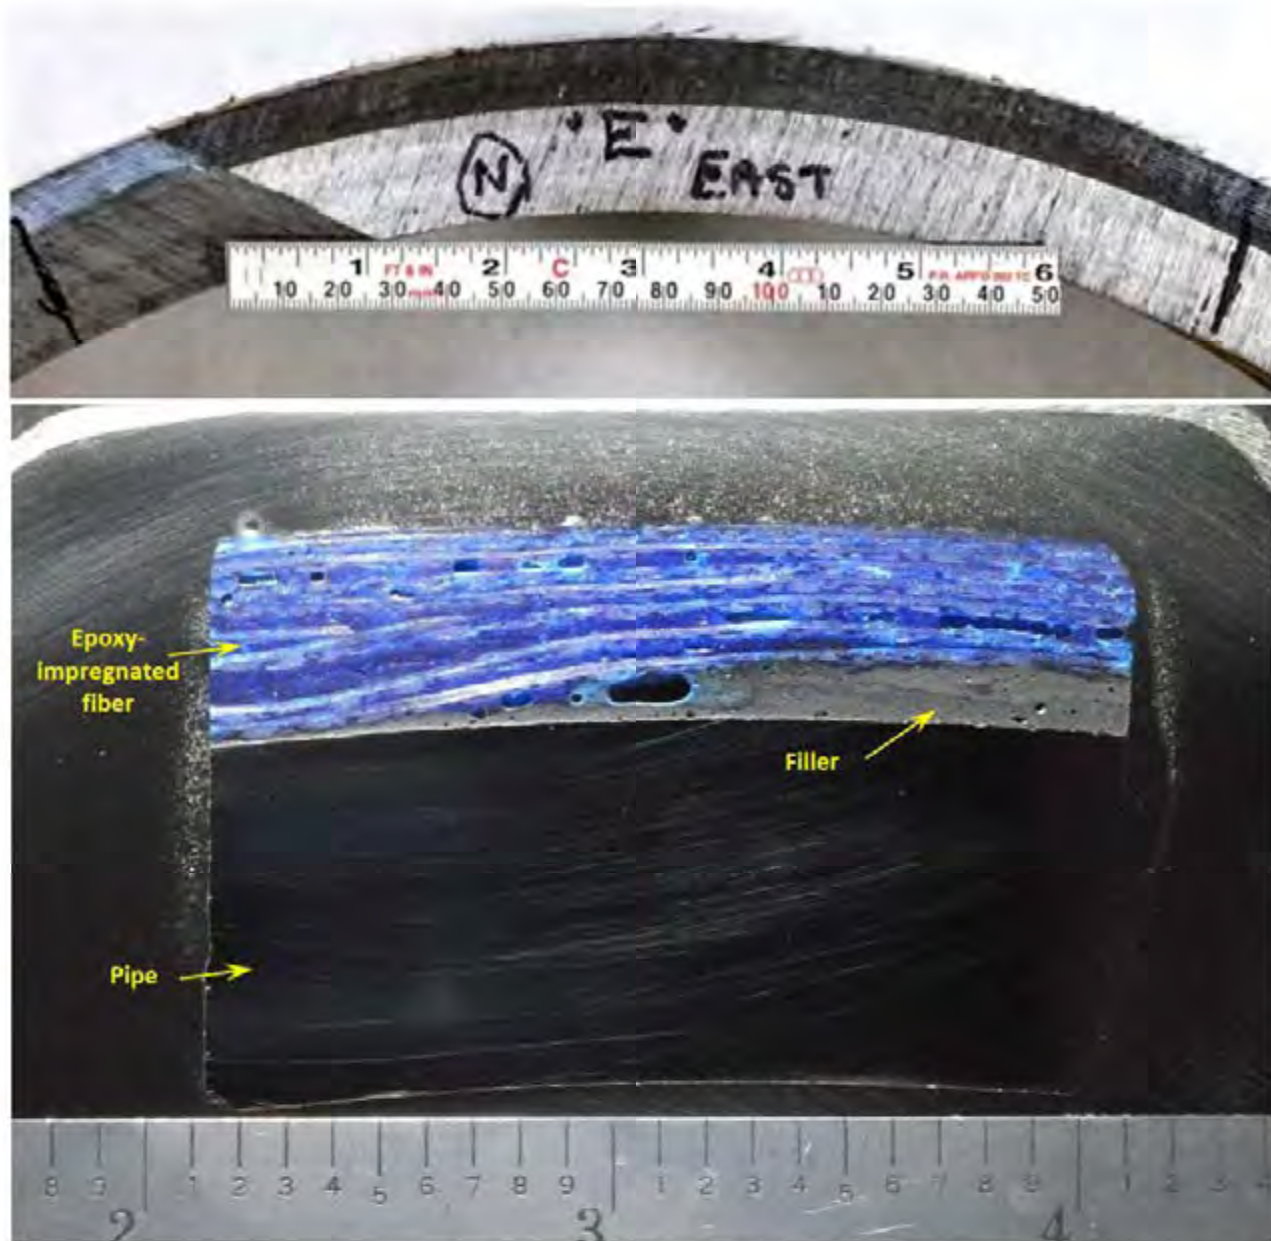
Figure 25: Metallographic cross-section of repair Area "E" located on north side (270°) of pipe. A full 360° wrap and stricture was used in this repair. (Reduction in thickness of filler material at left side of section is due to this section's being taken near edge of repair.)

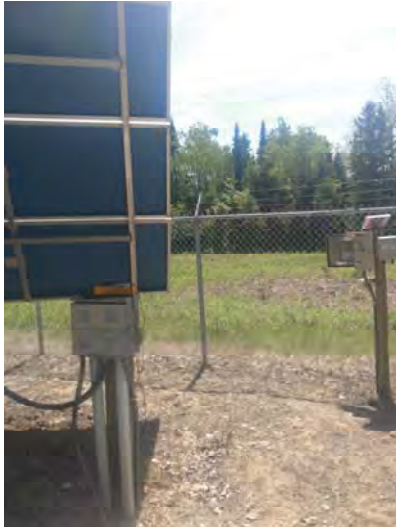
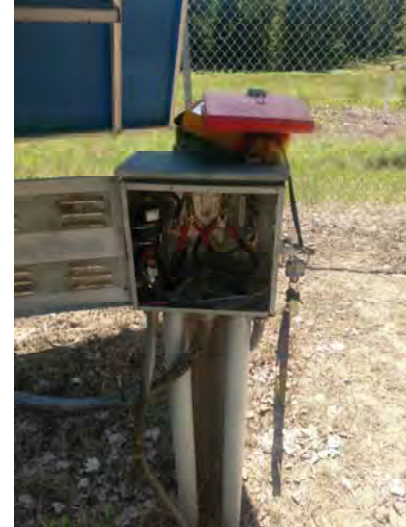
Rectifier Information					
Operator:	Enbridge	Location Description:	Hog Island		
Rectifier ID:	1444	GPS:

Rectifier Measurements					
DC Voltage:	25.53	Shunt Rating:	50/50	mV Across Shunt:	4.64
DC Amps:	4.63	Course Tap:	N/A	Fine Tap:	N/A

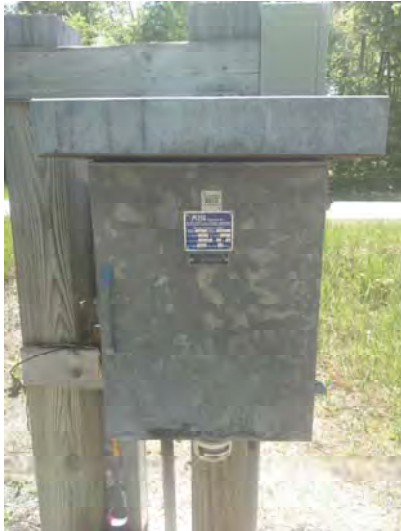
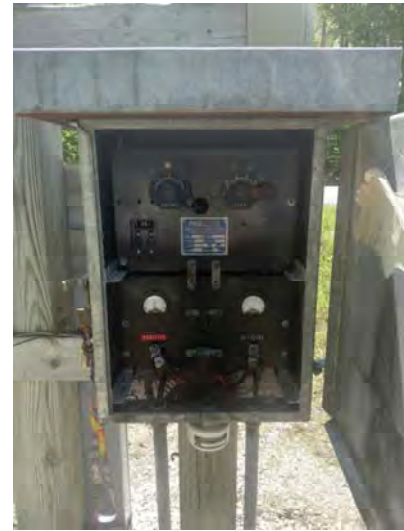
Rectifier Information					
Operator:	Enbridge	Location Description:	Cut River		
Rectifier ID:	1451	GPS:

Rectifier Measurements					
DC Voltage:	36.37	Shunt Rating:	50/25	mV Across Shunt:	5
DC Amps:	2.5	Course Tap:	3	Fine Tap:	6

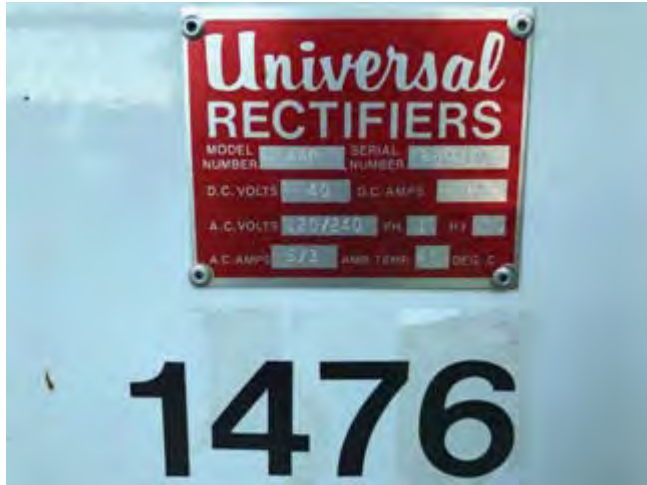
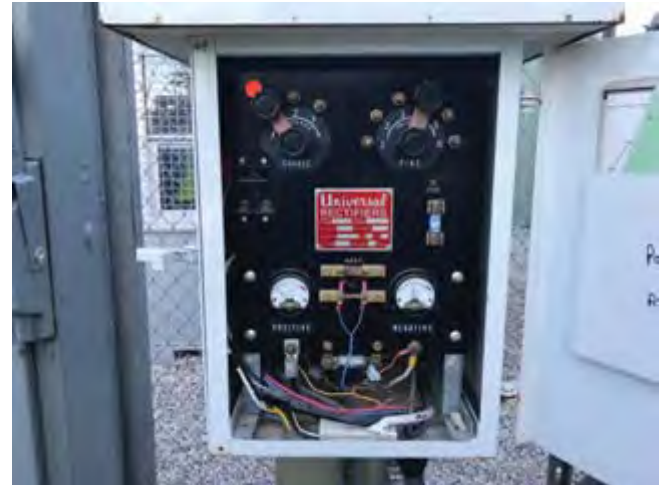
Rectifier Information					
Operator:	Enbridge	Location Description:	North Straits Station		
Rectifier ID:	1476	GPS:

Rectifier Measurements					
DC Voltage:	6.12	Shunt Rating:	50/15	mV Across Shunt:	20.4
DC Amps:	6.12	Course Tap:	1	Fine Tap:	4

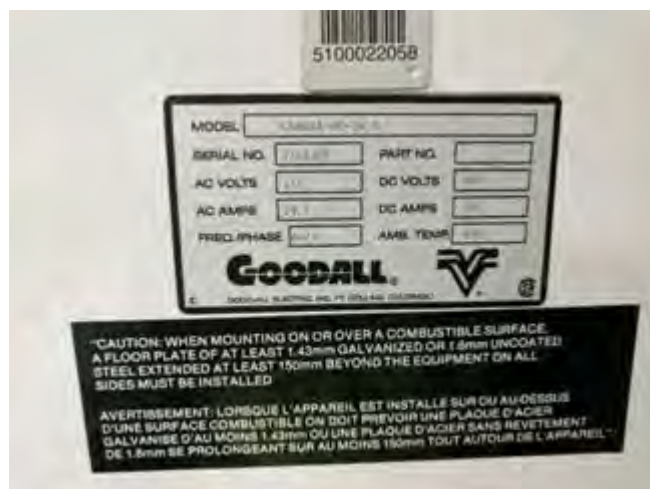
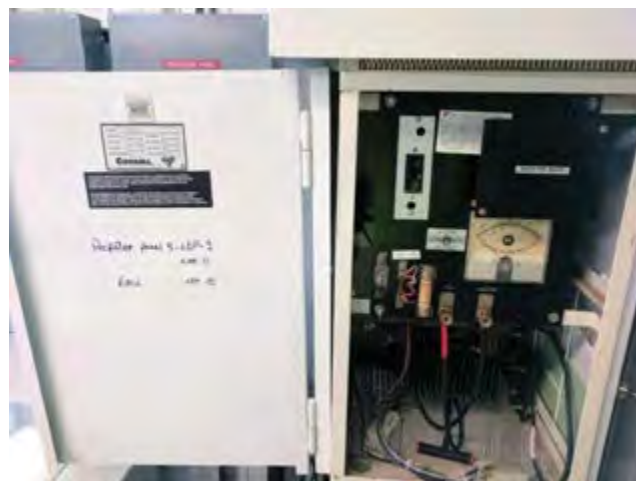
Rectifier Information					
Operator:	Enbridge	Location Description:	Mackinaw Station		
Rectifier ID:	1479	GPS:

Rectifier Measurements					
DC Voltage:	30.1	Shunt Rating:	50/40	mV Across Shunt:	16.2
DC Amps:	13	Course Tap:	2	Fine Tap:	4

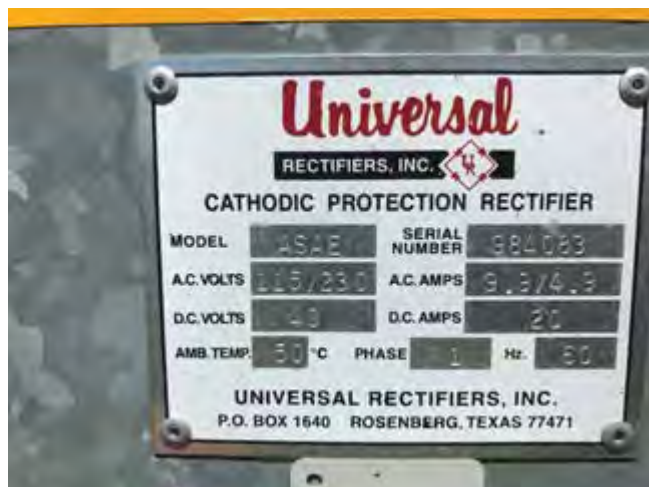
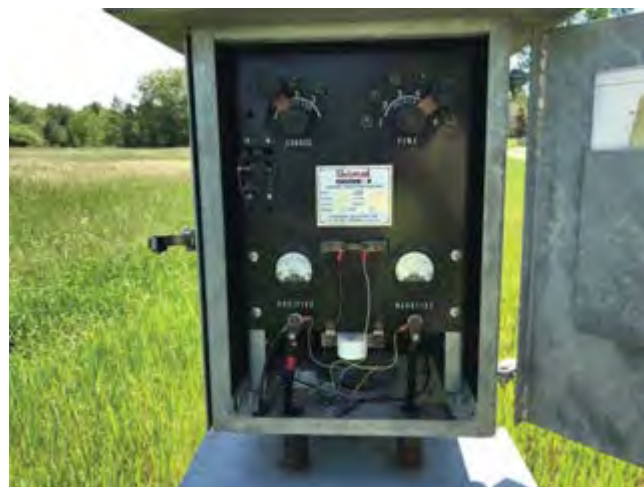
Rectifier Information					
Operator:	Enbridge	Location Description:	Topinabee		
Rectifier ID:	1498	GPS:

Rectifier Measurements					
DC Voltage:	10.05	Shunt Rating:	50/25	mV Across Shunt:	22.1
DC Amps:	11.05	Course Tap:	1	Fine Tap:	5

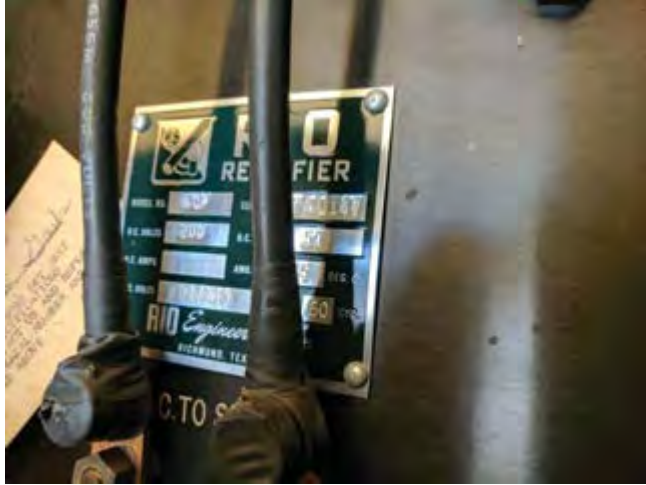
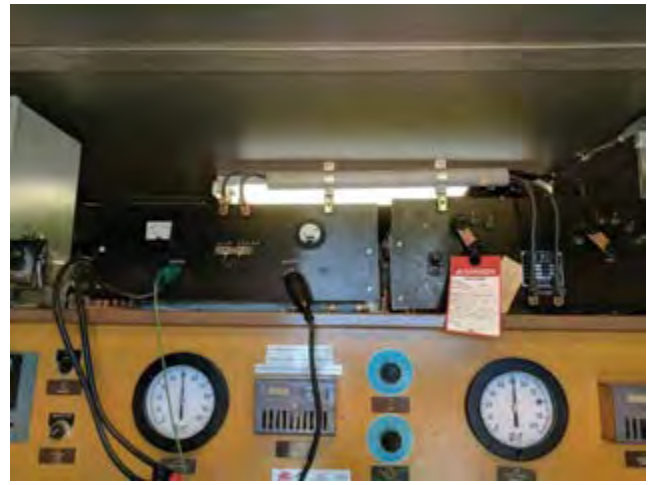
Rectifier Information					
Operator:	ATC	Location Description:	ATC Substation		
Rectifier ID:	ATC	GPS:

Rectifier Measurements					
DC Voltage:	26.5	Shunt Rating:	50/75	mV Across Shunt:	7.6
DC Amps:	11.4	Course Tap:	1	Fine Tap:	2
