Technical Data Sheet

Bridge Identification:	1231510000000B01 1231510000000B02
Facility Carried:	I-96
Feature Intersected:	Grand River
Location:	Windsor Township
County:	Eaton
Region:	University
Year Built:	1962
Year Reconstructed:	1987
Bridge Type:	Welded Plate Girder System
No. of Spans:	3
Deck Area:	14,350 S.F. (B01) 10,865 S.F. (B02)
Paint System:	Type 1
Paint Area:	32,500 S.F. (B01) 25,000 S.F. (B02)

Bridges B01& B02 of 23151 are three-span welded steel plate girder bridges carrying I-96 Eastbound and Westbound, respectively, over the Grand River in the Windsor Township in Eaton County. The three spans of Bridge B01 measure 128'-9", 142'-0", and 128'-9" from south to north with an overall bridge length of 399'-6". Bridge B01 has a sharp skew and has lateral bracing in the bay between the exterior girder and the first interior girder. The three spans of Bridge B02 measure 96'-3", 110'-0", and 96'-3" from south to north with an overall bridge length of 302'-6". Bridge B02 is not skewed and does not have lateral bracing. The out-to-out width of each deck is 35'-11", providing for two 12'-0" travel lanes and a shoulder nearly 4'-0" wide on each side of traffic. The bridge is supp

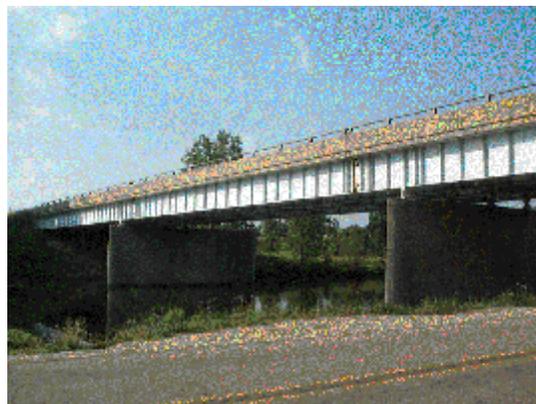
North Elevation View (2)

Span 2 of Bridge B01 contains a 110'-0" long suspended span supported by pin and hanger assemblies at the end of the plate girders cantilevered from Spans 1 and 3. Span 2 of Bridge B02 contains a 88'-7" long suspended span supported by pin and hanger assemblies at the end of the plate girders cantilevered from Spans 1 and 3.
