Attached you will find the job overview report. The report will contain detailed information from the Enbridge Energy, Straits of Mackinac pipeline inspection and repair project. Included with the report are: Daily Survey logs (inspection barge and diving barge), ROV inspection logs, and construction logs.

Project Overview

Veolia ES Special Services, Inc was retained by Enbridge Energy Inc. to inspect and repair 1 each, east and west, 24 inch diameter steel pipelines crossing the Straits of Mackinac. These lines run parallel to each other and are separated by approximately 1000 feet along the 4.6-mile length of the crossing, and are situated in water depths ranging from 0 to 250ffw. Both lines are buried out to water depths of approximately 50 feet, and then lie uncovered on the bottom.

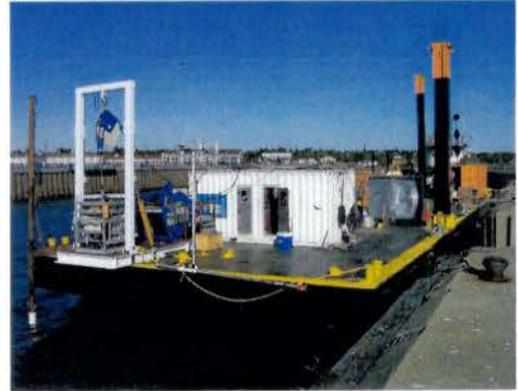
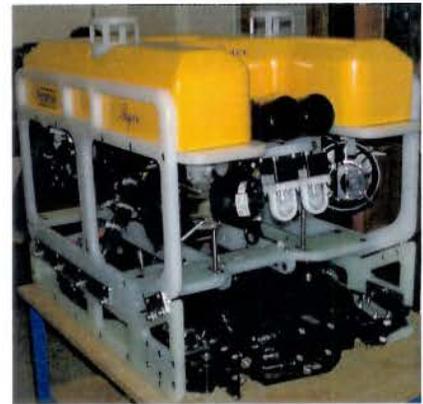
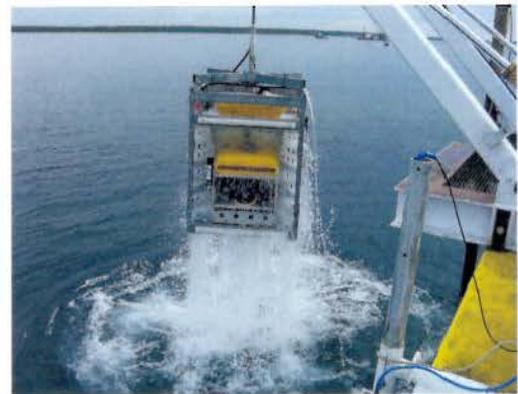
Remote Operated Vehicles – Seaeye “Tiger”

The “Tiger”, Remotely Operated Vehicle (ROV) system is extremely versatile and can be employed to carry out a variety of tasks including surveying, searching and inspections. A pilot on the surface controls the vehicle remotely by sending commands to the vehicle via an umbilical and tether. The vehicle can be moved in any direction or by using the autopilot facility remain accurately on course and depth to provide a stable platform. The pilot can also control the vehicle’s video system, lighting and any other equipment fitted to the unit.

For this inspection, the vehicle is fitted with altimeter and sector scanning sonar, which enabled the operator to see objects out of the visual range of the video camera. Navigation was provided by Alternative Positioning Solutions, Sonardyne tracking system in concert with RTK tracking and a stand-alone computer with Winfrog software. In use, the ROV is fitted with a Sonardyne acoustic transponder, which sends out a sound signal to be picked up by a hydrophone mounted on the side of the surface support barge. The offset of the vehicle (calculated by Winfrog) is fed to the navigation computer that plots a corresponding XY position based on Real Time Kinematics (RTK) information. Video from the on-board camera is recorded in a computerized and VHS format, with the operator entering position information to the on-screen display. Once data has been gathered as acoustic records, video documentation is encouraged in order to provide definitive ground truthing of the indications on the sonar record. Alternative Positioning Solutions calibration and survey reports are included as a separate report

In operation, the tug and barge is positioned over the pipeline using a live boat operation for the survey. With evidence of a strong fix RTK lock on the RTK as well as a solid return from the vehicle tracking system, the vehicle is launched from the surface to begin its descent to the bottom. Once on bottom, the operator utilizes the navigation system to guide the vehicle to the pipeline. With the pilot free to fly the vehicle, the survey supervisor takes notes with further direction given by the client representative on site. “Parking” the vehicle at the desired location attains accurate location of anomalies, while the Sonardyne tracking and RTK stabilize and update the position. This position is noted in the inspection log for future reference. After taking a fix on the span location, the ROV, tug and barge would proceed north on the pipeline to the next span. With the survey running a live boat operation, Veolia ES was able to survey in a more efficient manner.

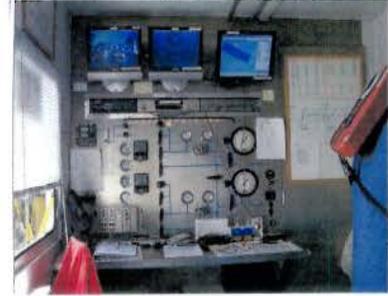
Span coordinates identified from the ROV survey used to plot anchor and mooring locations. Barge is positioned over anchor locations identified by the Hypack navigation system. The Hypack navigation program, located on the dive barge, brings in information provided from the Vector Sensor, Motion Reference Unit (MRU) and Link-quest tracking, which is then relayed to a monitor on the tug for the tug captain to follow. The anchors are then dropped approximately 750' from the pipeline and 1000' apart. Once both anchors are in position (2 anchor spread off the stern of the barge) the barge is towed into position and held in place with a constant speed and heading from the tugboat.

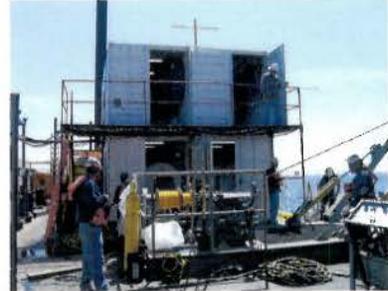
The Seaeye "Falcon" ROV is launched so that a specific repair procedure and location can be selected. Locations were selected based on their proximity to the center of the span, type of bottom encountered (smooth or irregular, hardness) and span height.

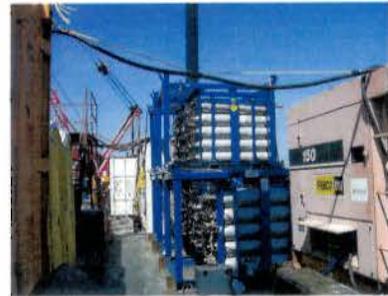
The dive bell is then lowered to the work site, guided by the ROV. Adjustments are then made for barge positioning.

When positioning of the barge is finished, guided by the remotely operated vehicle, the hydraulic drilling tool is then lowered to the work area and is held by the crane approximately 25' away from the pipeline.

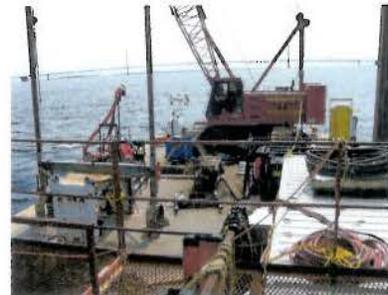
The screw anchor and saddle support, which is a prefabricated design, is designed to drill along both sides of the pipeline. Extensions can be added, for adjustment with sub-bottom material or span height. When drilling into the sub-bottom, a specified hydraulic pressure must be met. At that time, the upper and lower saddle supports are installed. Placing the support over and under the pipeline and then all-thread bolts bring all the support saddle together.

Dive operation begins and bottom time starts when the diver leaves the surface. Once on bottom, the diver will bring the drilling tool over the pipeline and lowers the drilling tool into place. Once in place, drilling will proceed. Diver will monitor drilling process until complete. When drilling is complete, the 3-pin assembly is disconnected and the hydraulic tool is lifted off the screw assembly and safely placed off the East Side of the pipeline to prevent dragging back into the pipe. Diver will then assemble the anchor and saddle into place. A repair (as detailed in above) is completed.

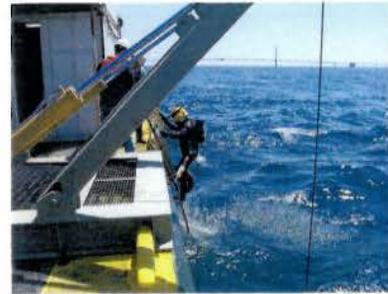
The final inspection and position of the pipeline repair is recorded from the ROV. Diver was brought to the surface and decompressed.

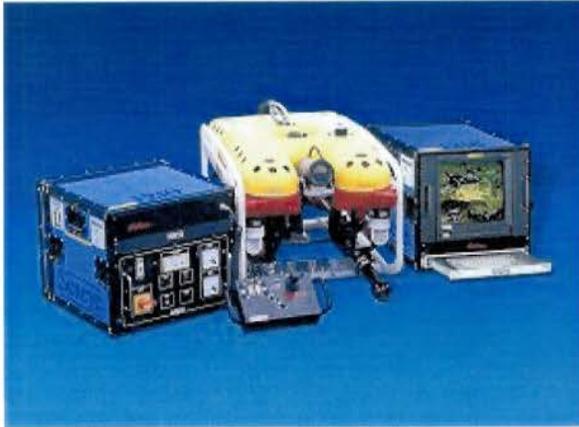
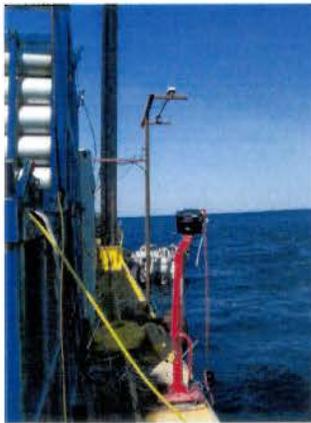
Diving Barge Remotely Operated Vehicle

The Seaeye Falcon is mainly used for diver observation from the barge diving operations and is equipped with a remote pan and tilt video camera with auto focus controls, as well as two 75 watt lights. The ROV is a free-swimming vehicle tethered to a surface support vessel and controlled by personnel on-board. For this operation, the vehicle was also fitted with sector scanning sonar, which enabled the operator to see objects out of the visual range of the video camera. Navigation was provided by the Link Quest tracking system in concert with a CSI Wireless Vector Sensor GPS tracking and a stand-alone computer with Coastal Oceanographic's Hypack software. In use, the ROV is fitted with an acoustic transponder, which

sends out a sound signal to be picked up by a hydrophone mounted on the side of the surface support barge. The offset of the vehicle (calculated by Link Quest) is fed to the navigation computer that plots a corresponding XY position based on GPS information. Video from the on-board camera is recorded in a computerized and VHS format, with the operator entering position information to the on-screen display. Once data has been gathered as acoustic records, video documentation is encouraged in order to provide definitive ground truthing of the indications on the sonar record.
