Pipelines and oil transportation in the Great Lakes

Enbridge Pipeline (Line 5) in the Straits of Mackinac

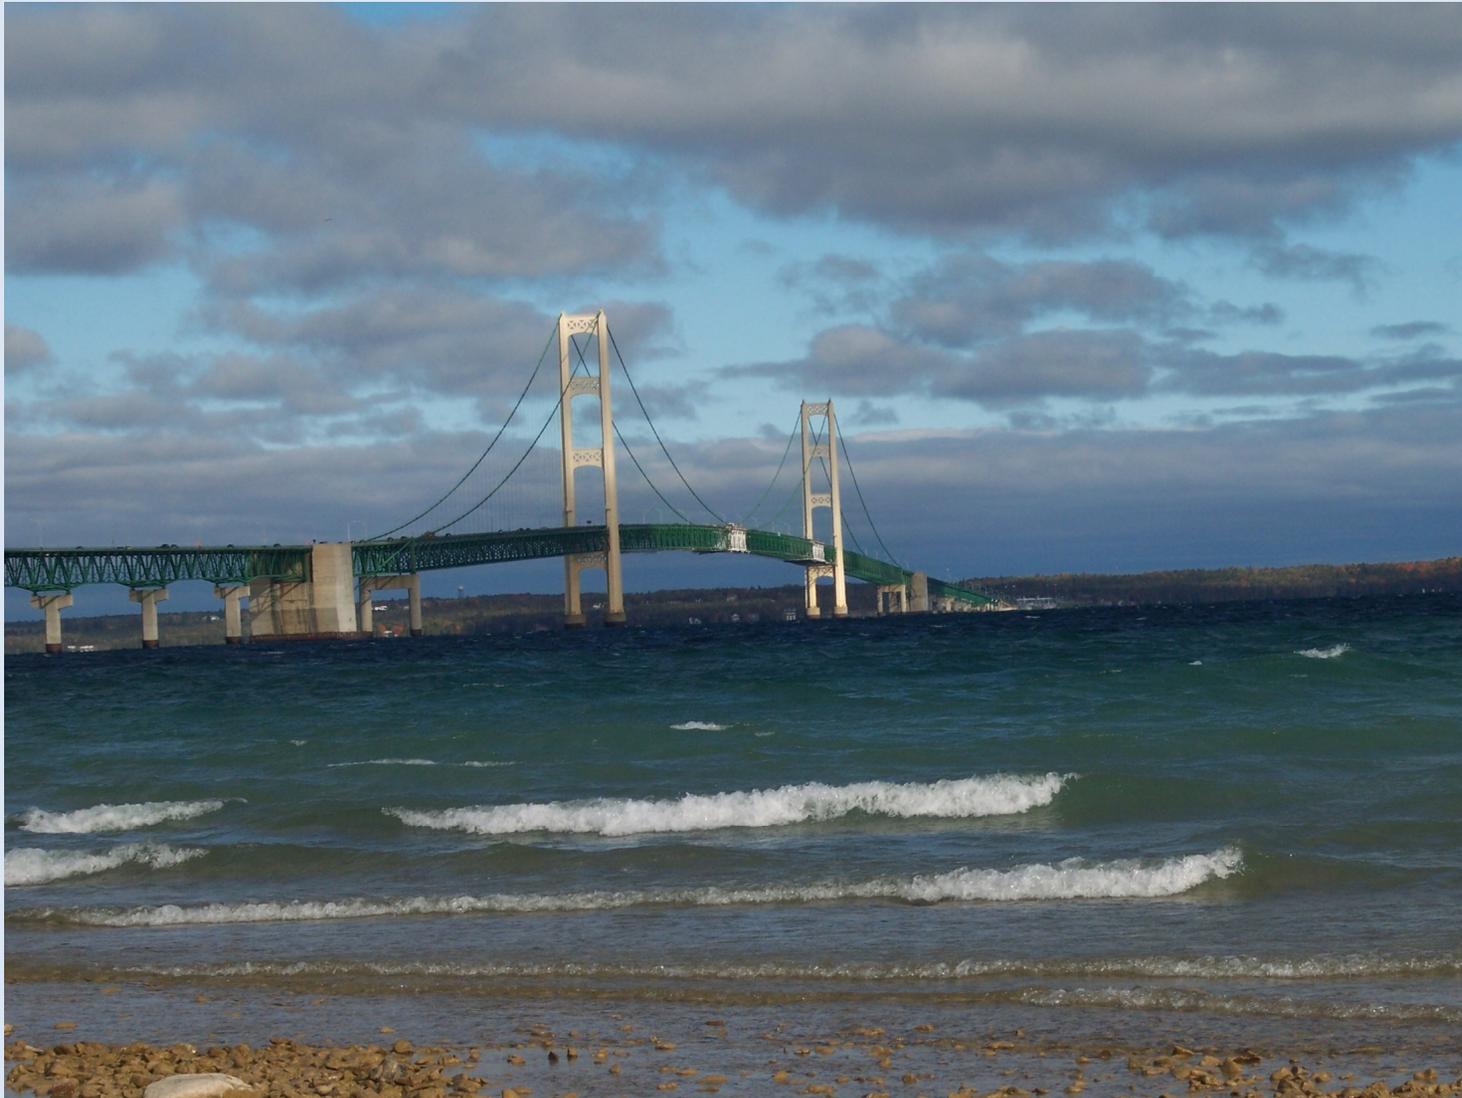
Line 5 can transport 22.7 million gallons/day. The Straits segment consists of the original pipe, laid 61 years ago.

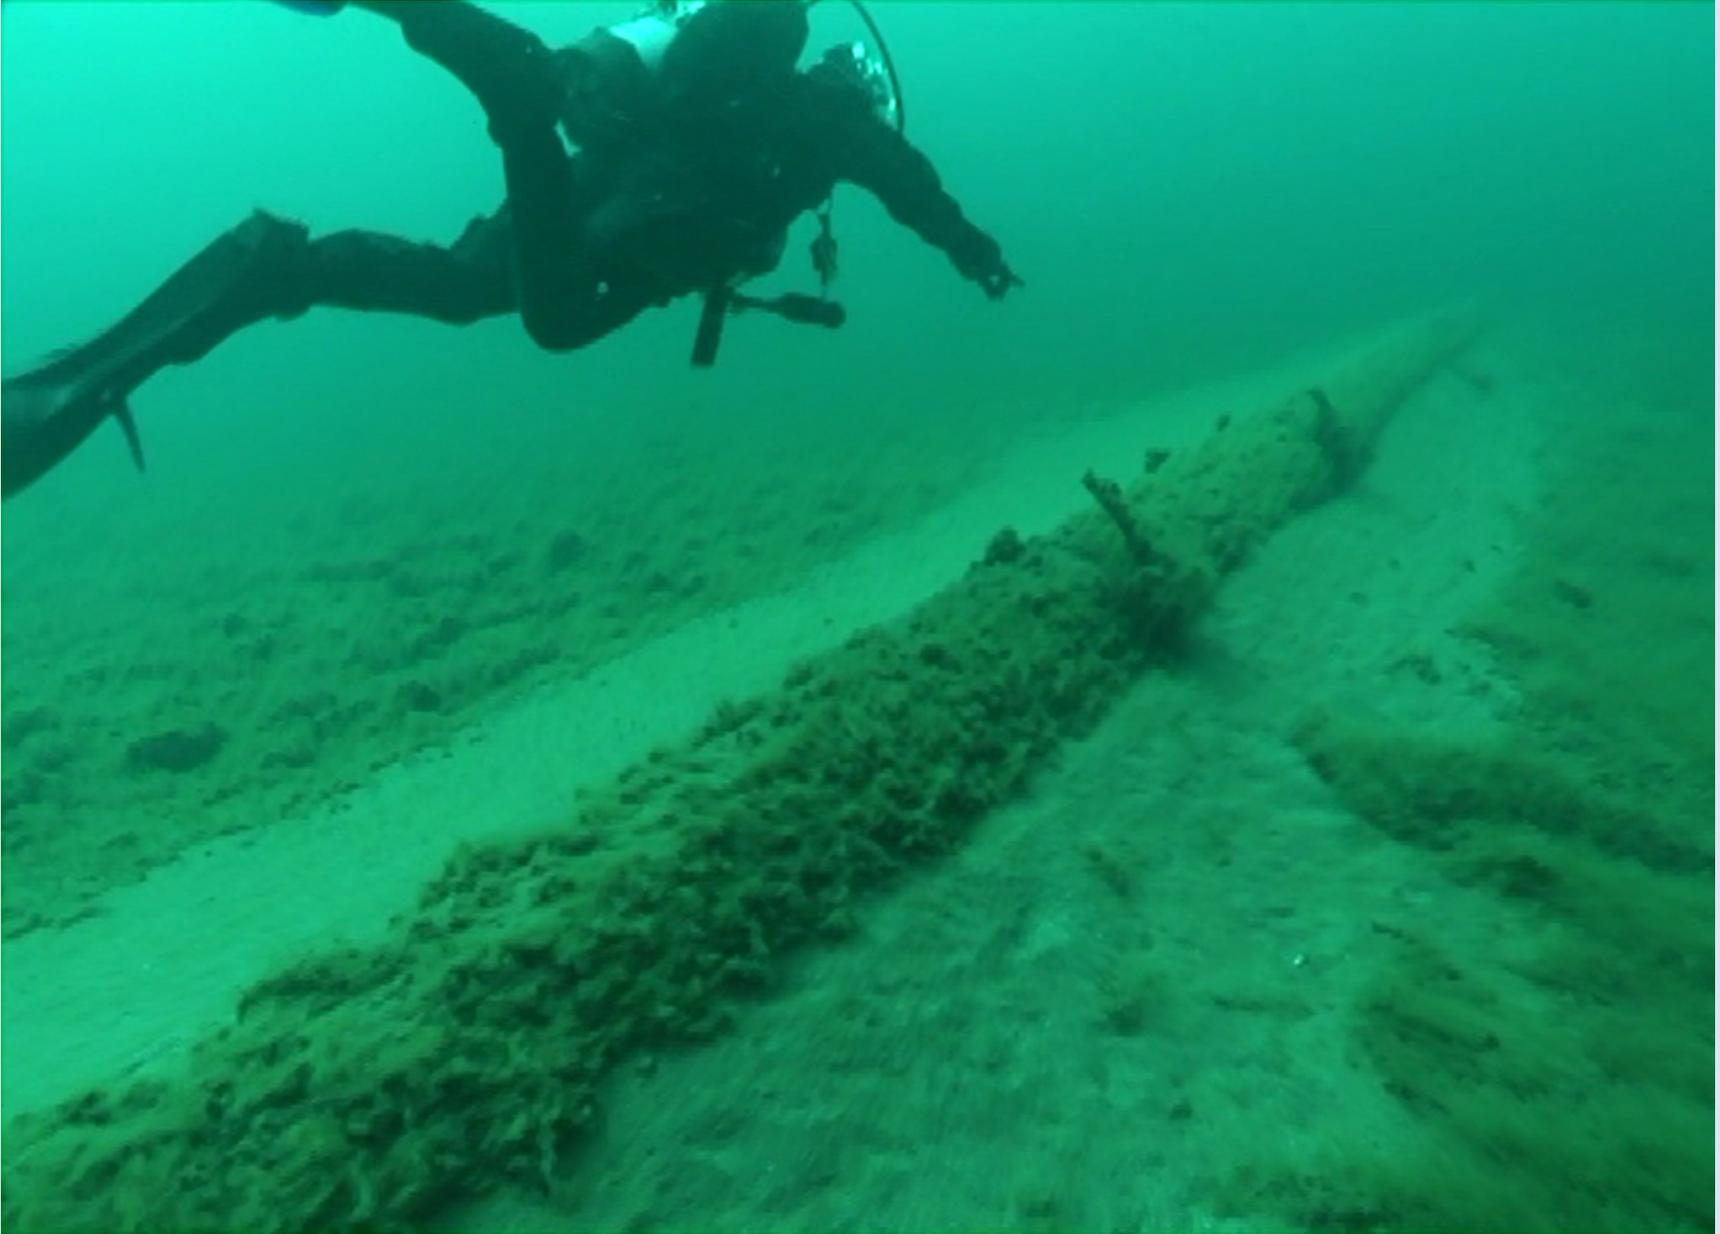
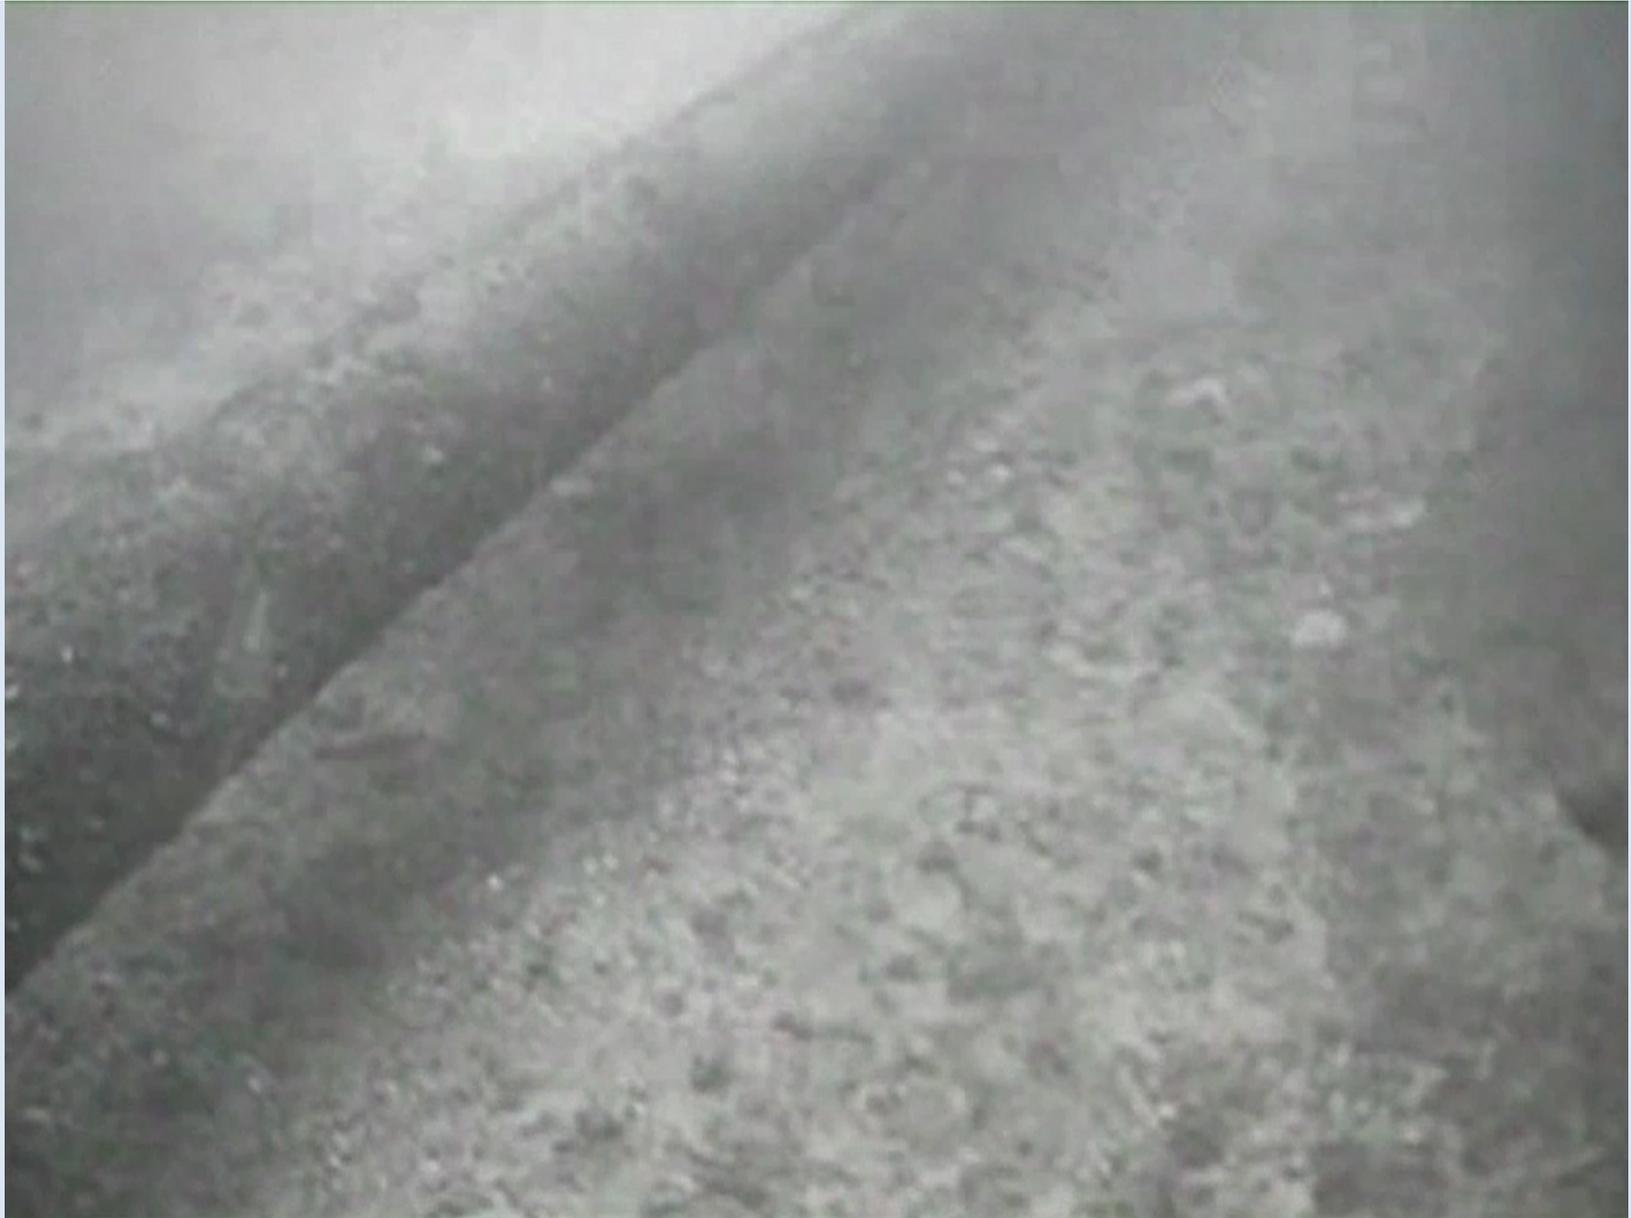
Portions of the pipeline in the Straits are
suspended over the lakebed.

National Wildlife Federation dive team takes first public video of pipeline in 2013.

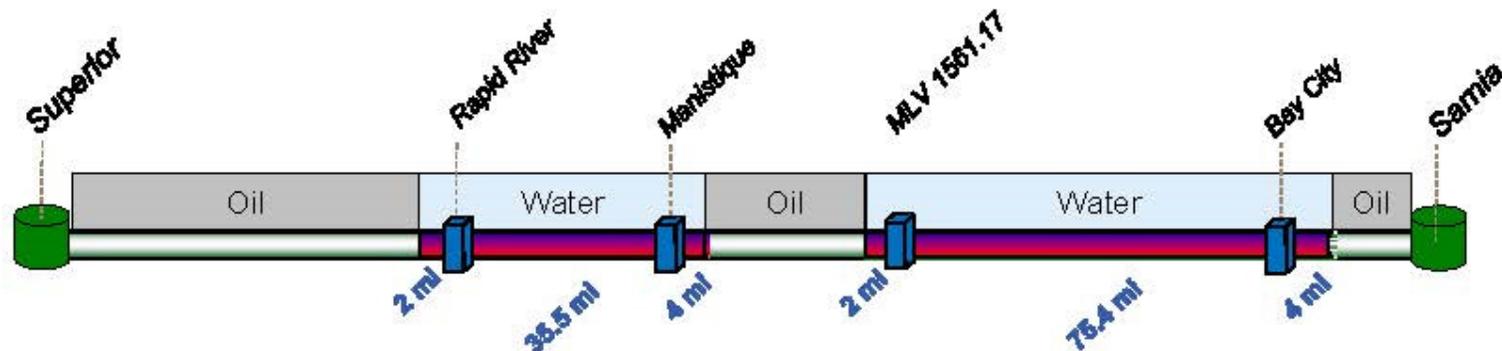
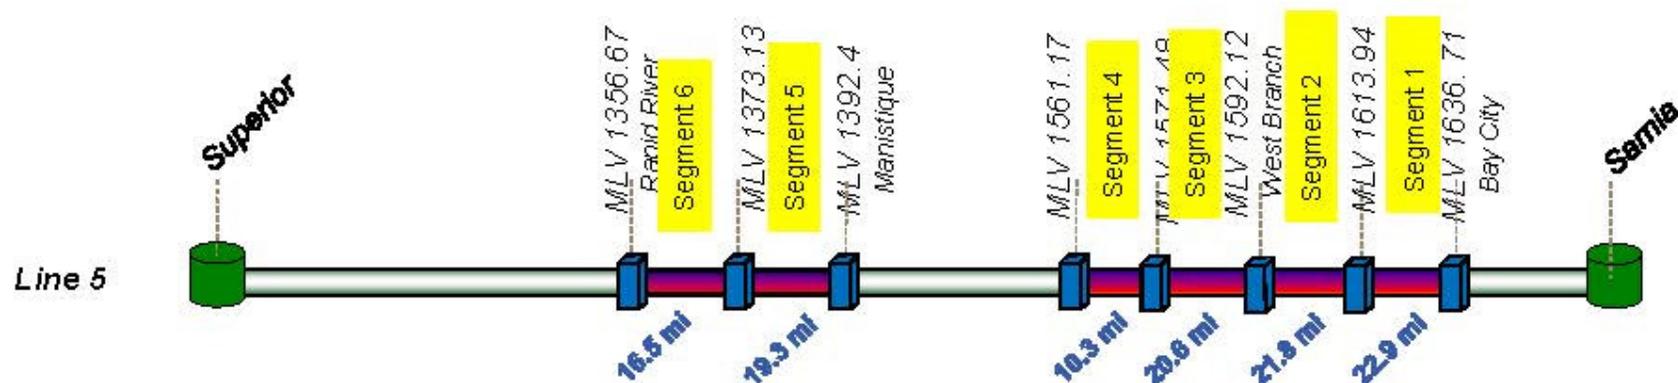
Line 5 Hydrostatic Test Overview

- 6 Test segments in 2 areas

1. 4 hour strength test at 100% SMYS (low point): 974 psi max pressure
2. 4 hour 15 minute leak test at 110% MOP
3. Water injected at Superior and positioned in test areas
4. Water pumped to Sarnia after test for treatment and disposal. 4 miles "slop" water in front of each test section. 2 miles contingency water behind each test section.
5. Tests performed against MLV's – Sealant Gel injected at each valve
6. All 6 segments tested simultaneously

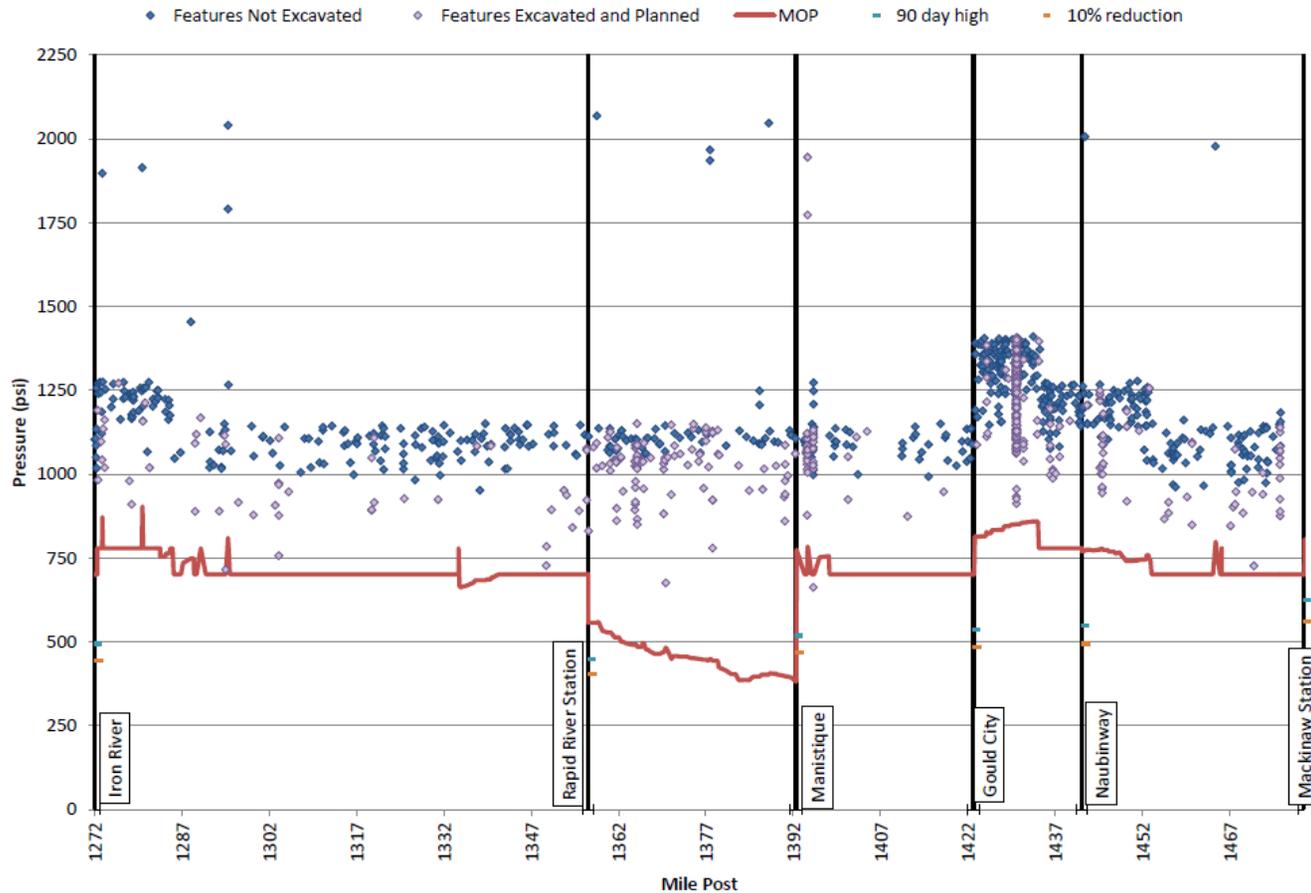
Line 5 Iron River to Mackinaw 2011 CDplus

Enbridge's report of anomalies along a section of Line 5. Dark blue dots represent anomalies that were not excavated.

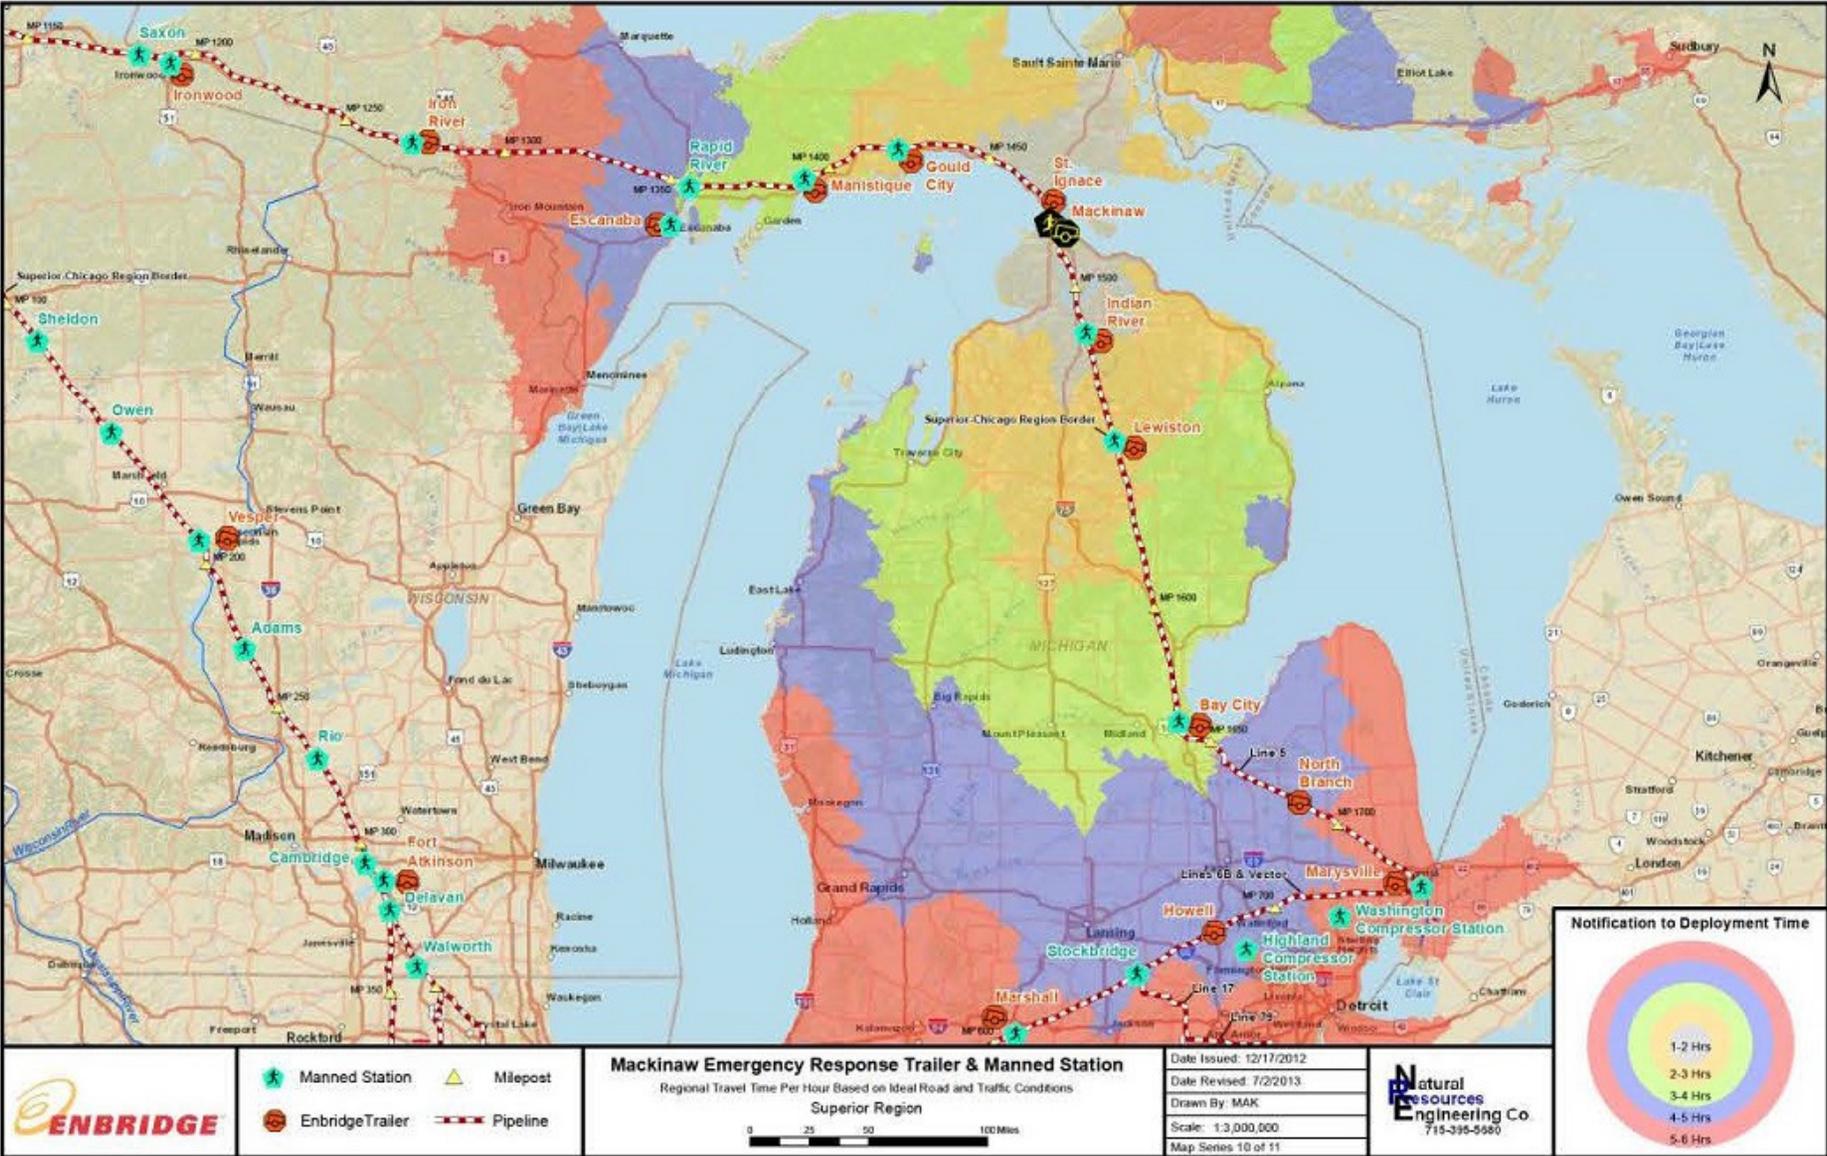
Spill response equipment available locally

Inventory of response equipment in emergency response trailers at St. Ignace and Mackinaw Stations

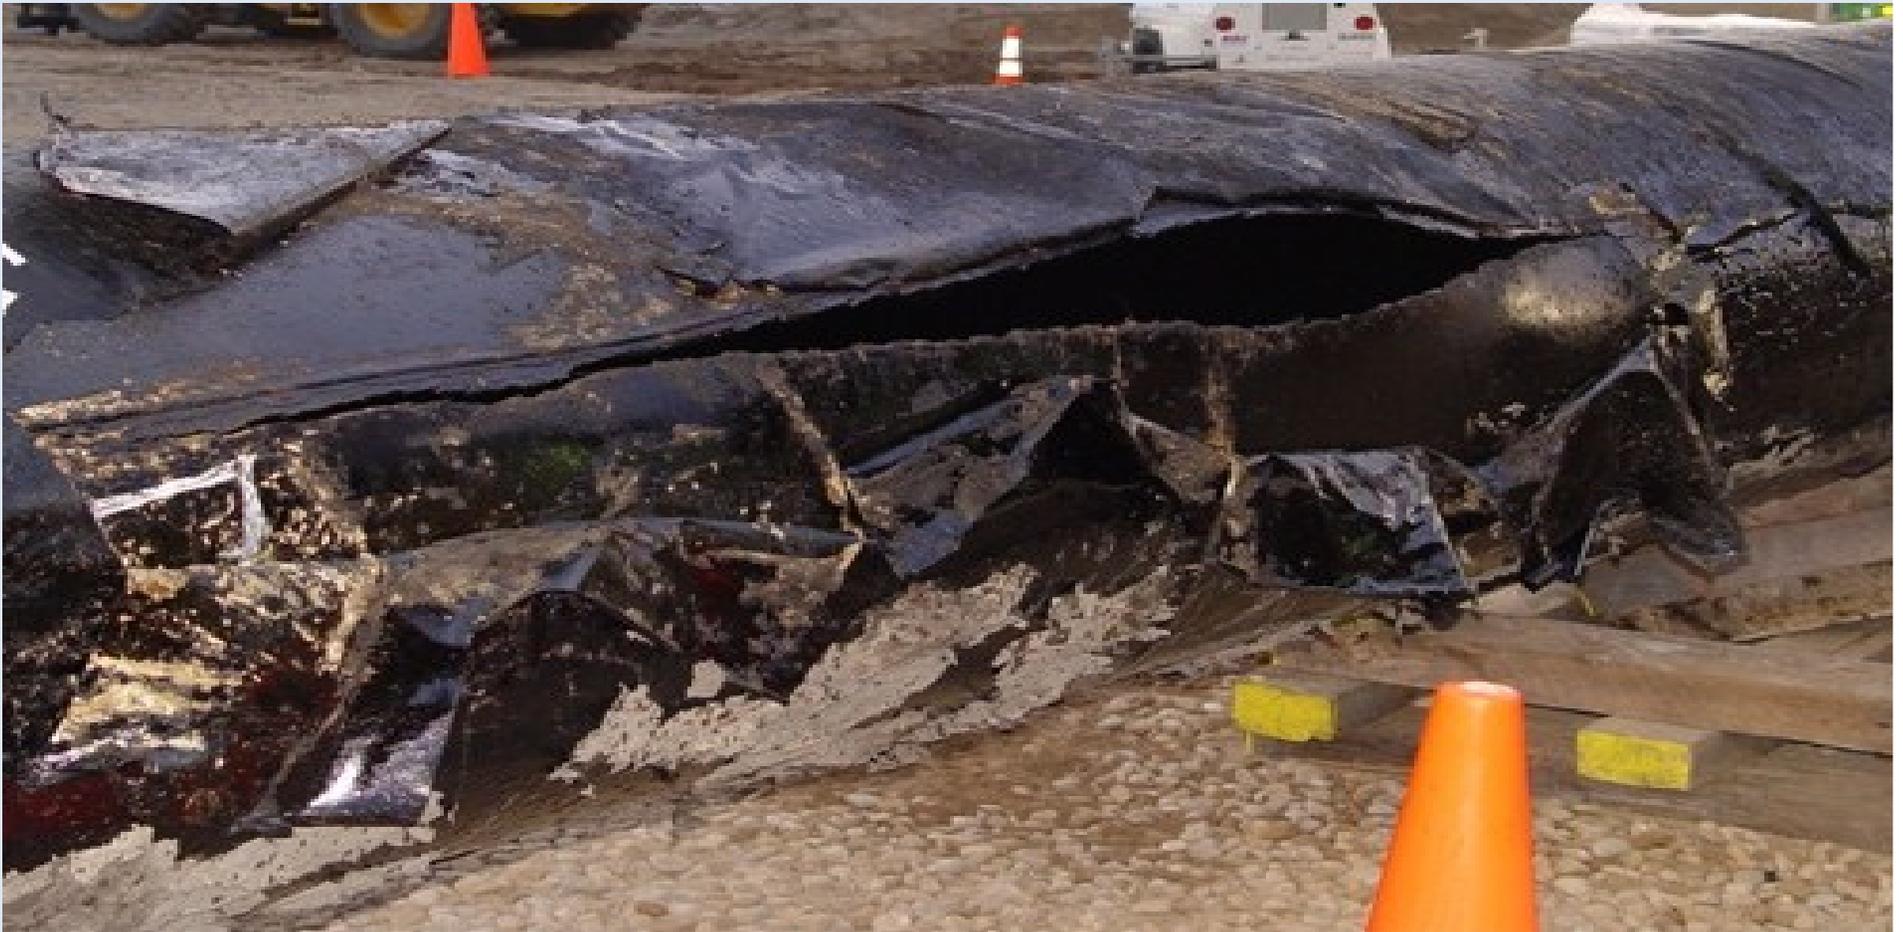
Ruptured Enbridge pipeline in
Kalamazoo River spill
