Using Asset Management Techniques in the Development of a Capital Program – A Case Study

**Tim Prince, Chief Engineer for the Oakland
County Water Resources Commissioner**

EVERGREEN–FARMINGTON SEWAGE DISPOSAL SYSTEM

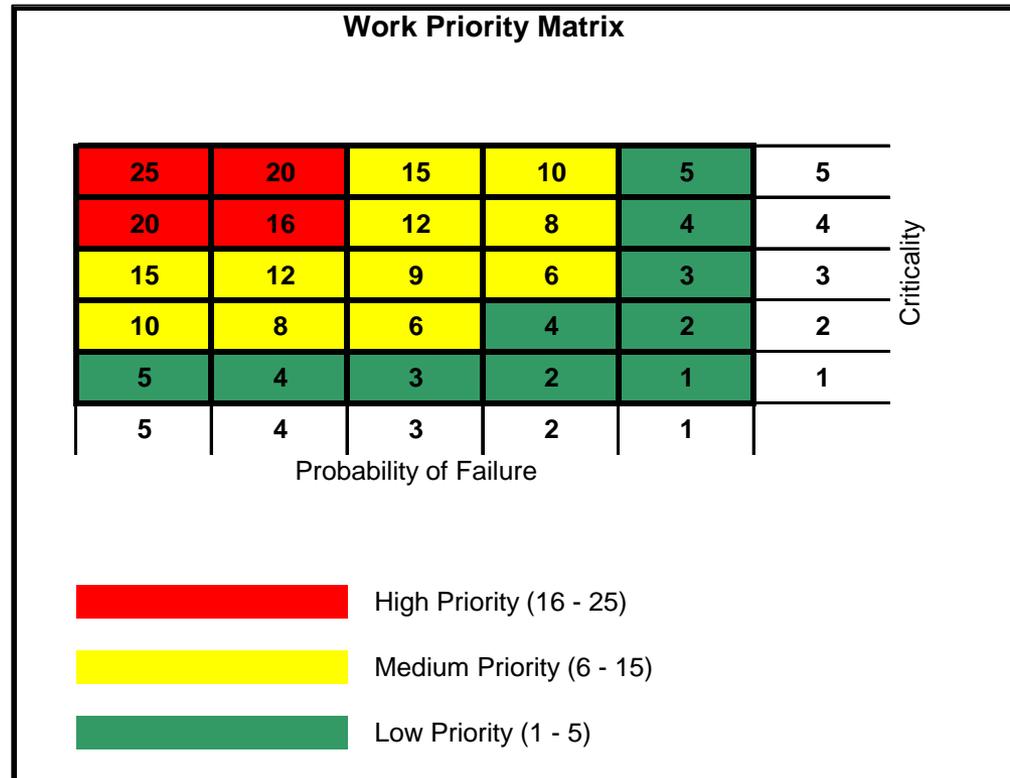
Business Risk Evaluation

- ▶ The Business Risk Score for any given asset is derived by multiplying the condition score by the criticality score.
