1925 Landfill

Corrective Action Monitoring and Maintenance Plan

The Dow Chemical Company
Compliance Schedule Task M-8
1925 Landfill Corrective Action
Monitoring and Maintenance Plan
(CAMMP)

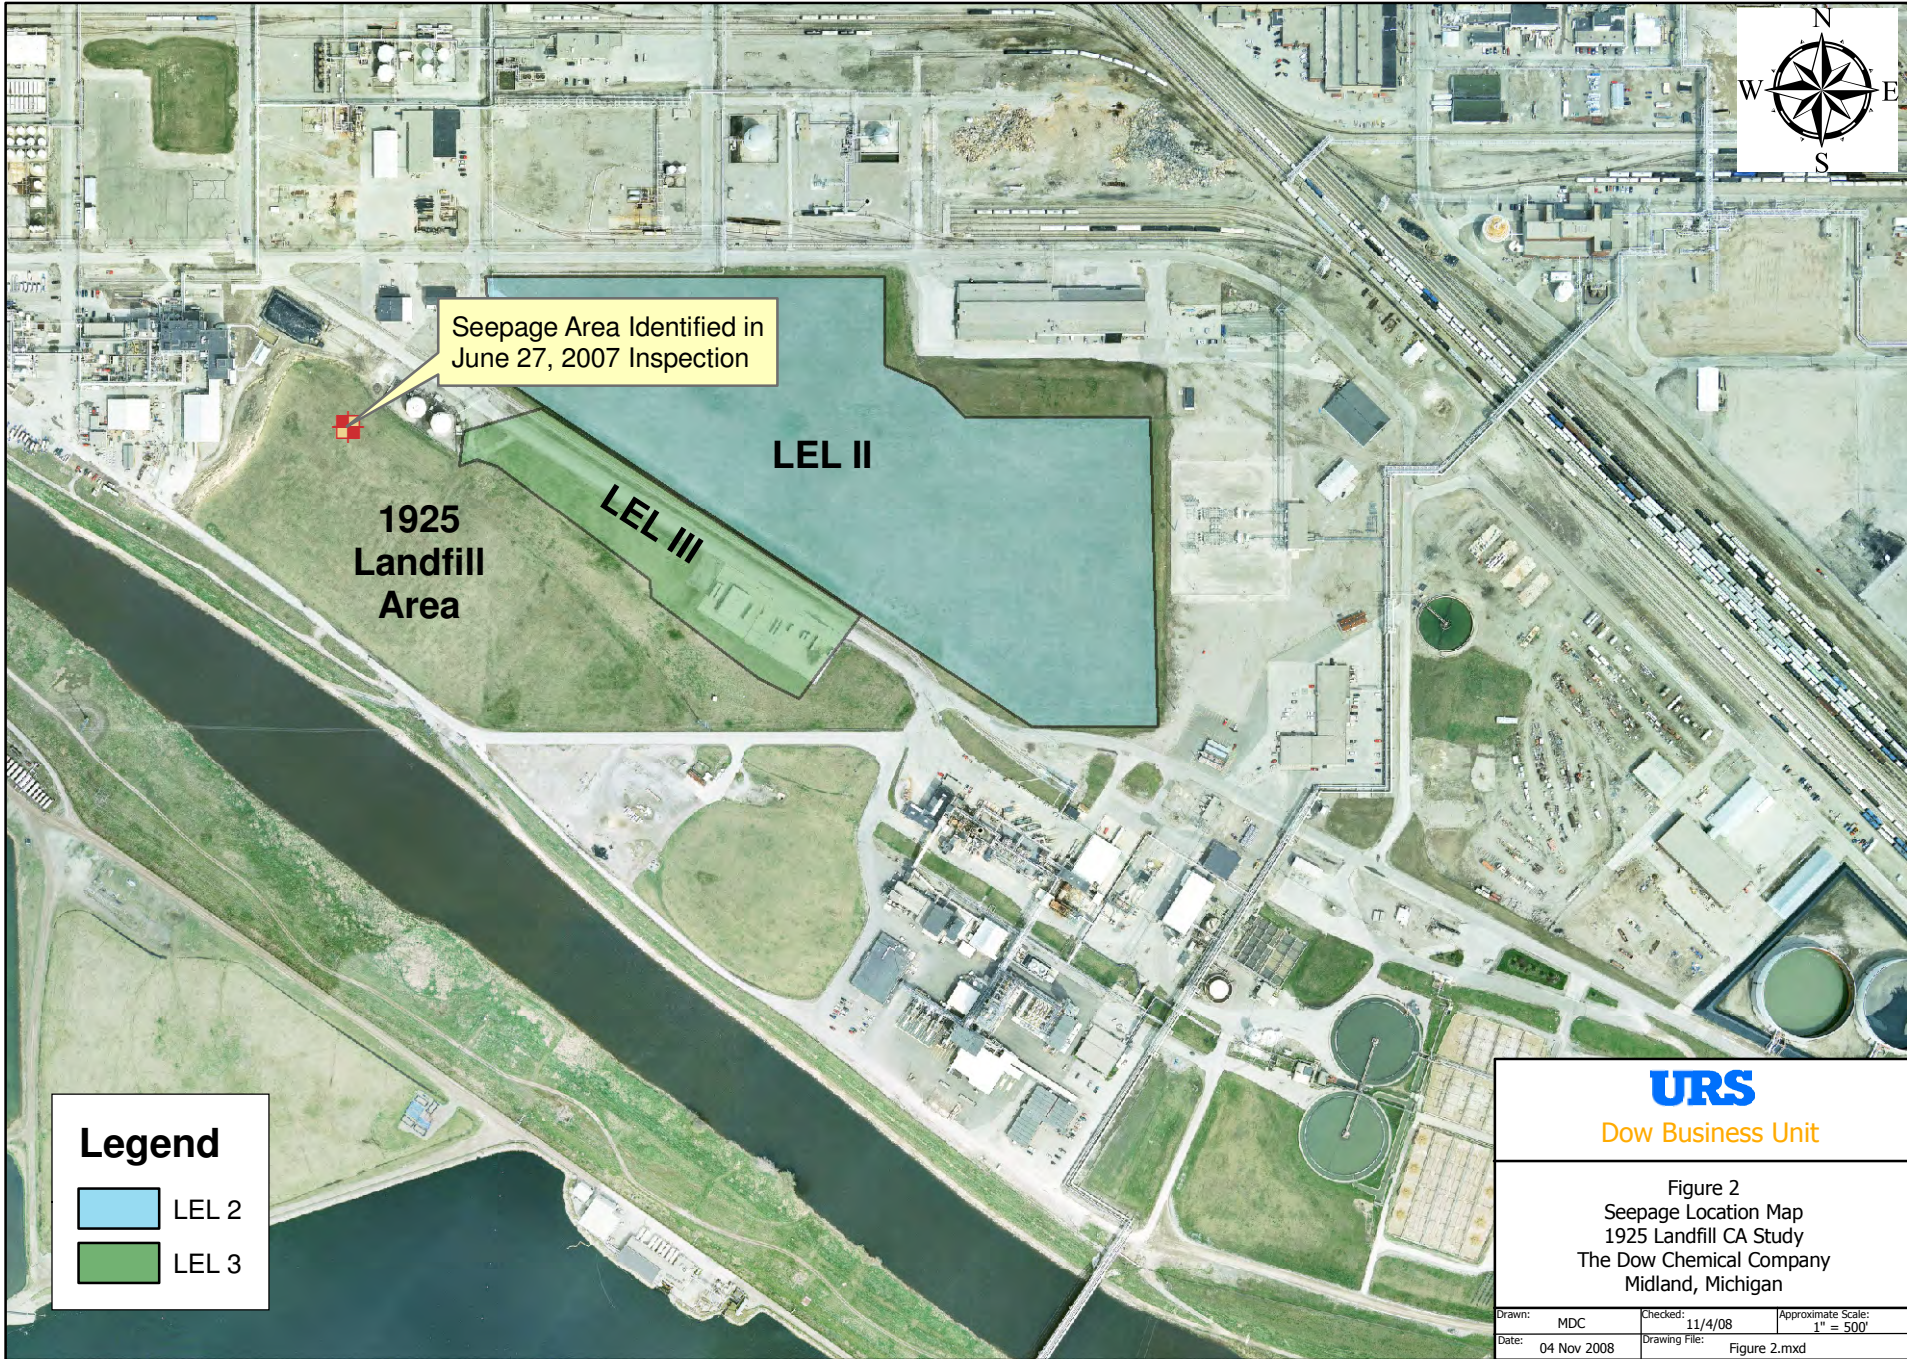
Seepage Area Identified in June 27, 2007 Inspection

1925
Landfill
Area

The seepage identified during the June 27, 2007 Final Cover Inspection was discovered by Dow prior to the Final Cover Inspection, and was repaired on June 4, 2007. Since that time, ground water levels measured in piezometers immediately adjacent to the seepage area indicate ground water head at an elevation above the top of the ground surface. This condition, if on-going, would likely result in additional seepage. Although excess hydraulic head is observed in this area, on-going seepage is not currently occurring. This area is inspected frequently and observed for signs of seepage. If, during the Pilot Corrective Action, seepage is observed, repairs will be made consistent with those made on June 4, 2007. Active seepage from this area appears to be under control; however the underlying cause of the seepage needs to be addressed and is the focus of this Pilot Corrective Action Study.

MW-4 vertical piezometer cluster. This area of recharge is likely the underlying cause of the seepage adjacent to piezometer PZ-2 (the area identified during the June 27, 2007 Final Cover Inspection).

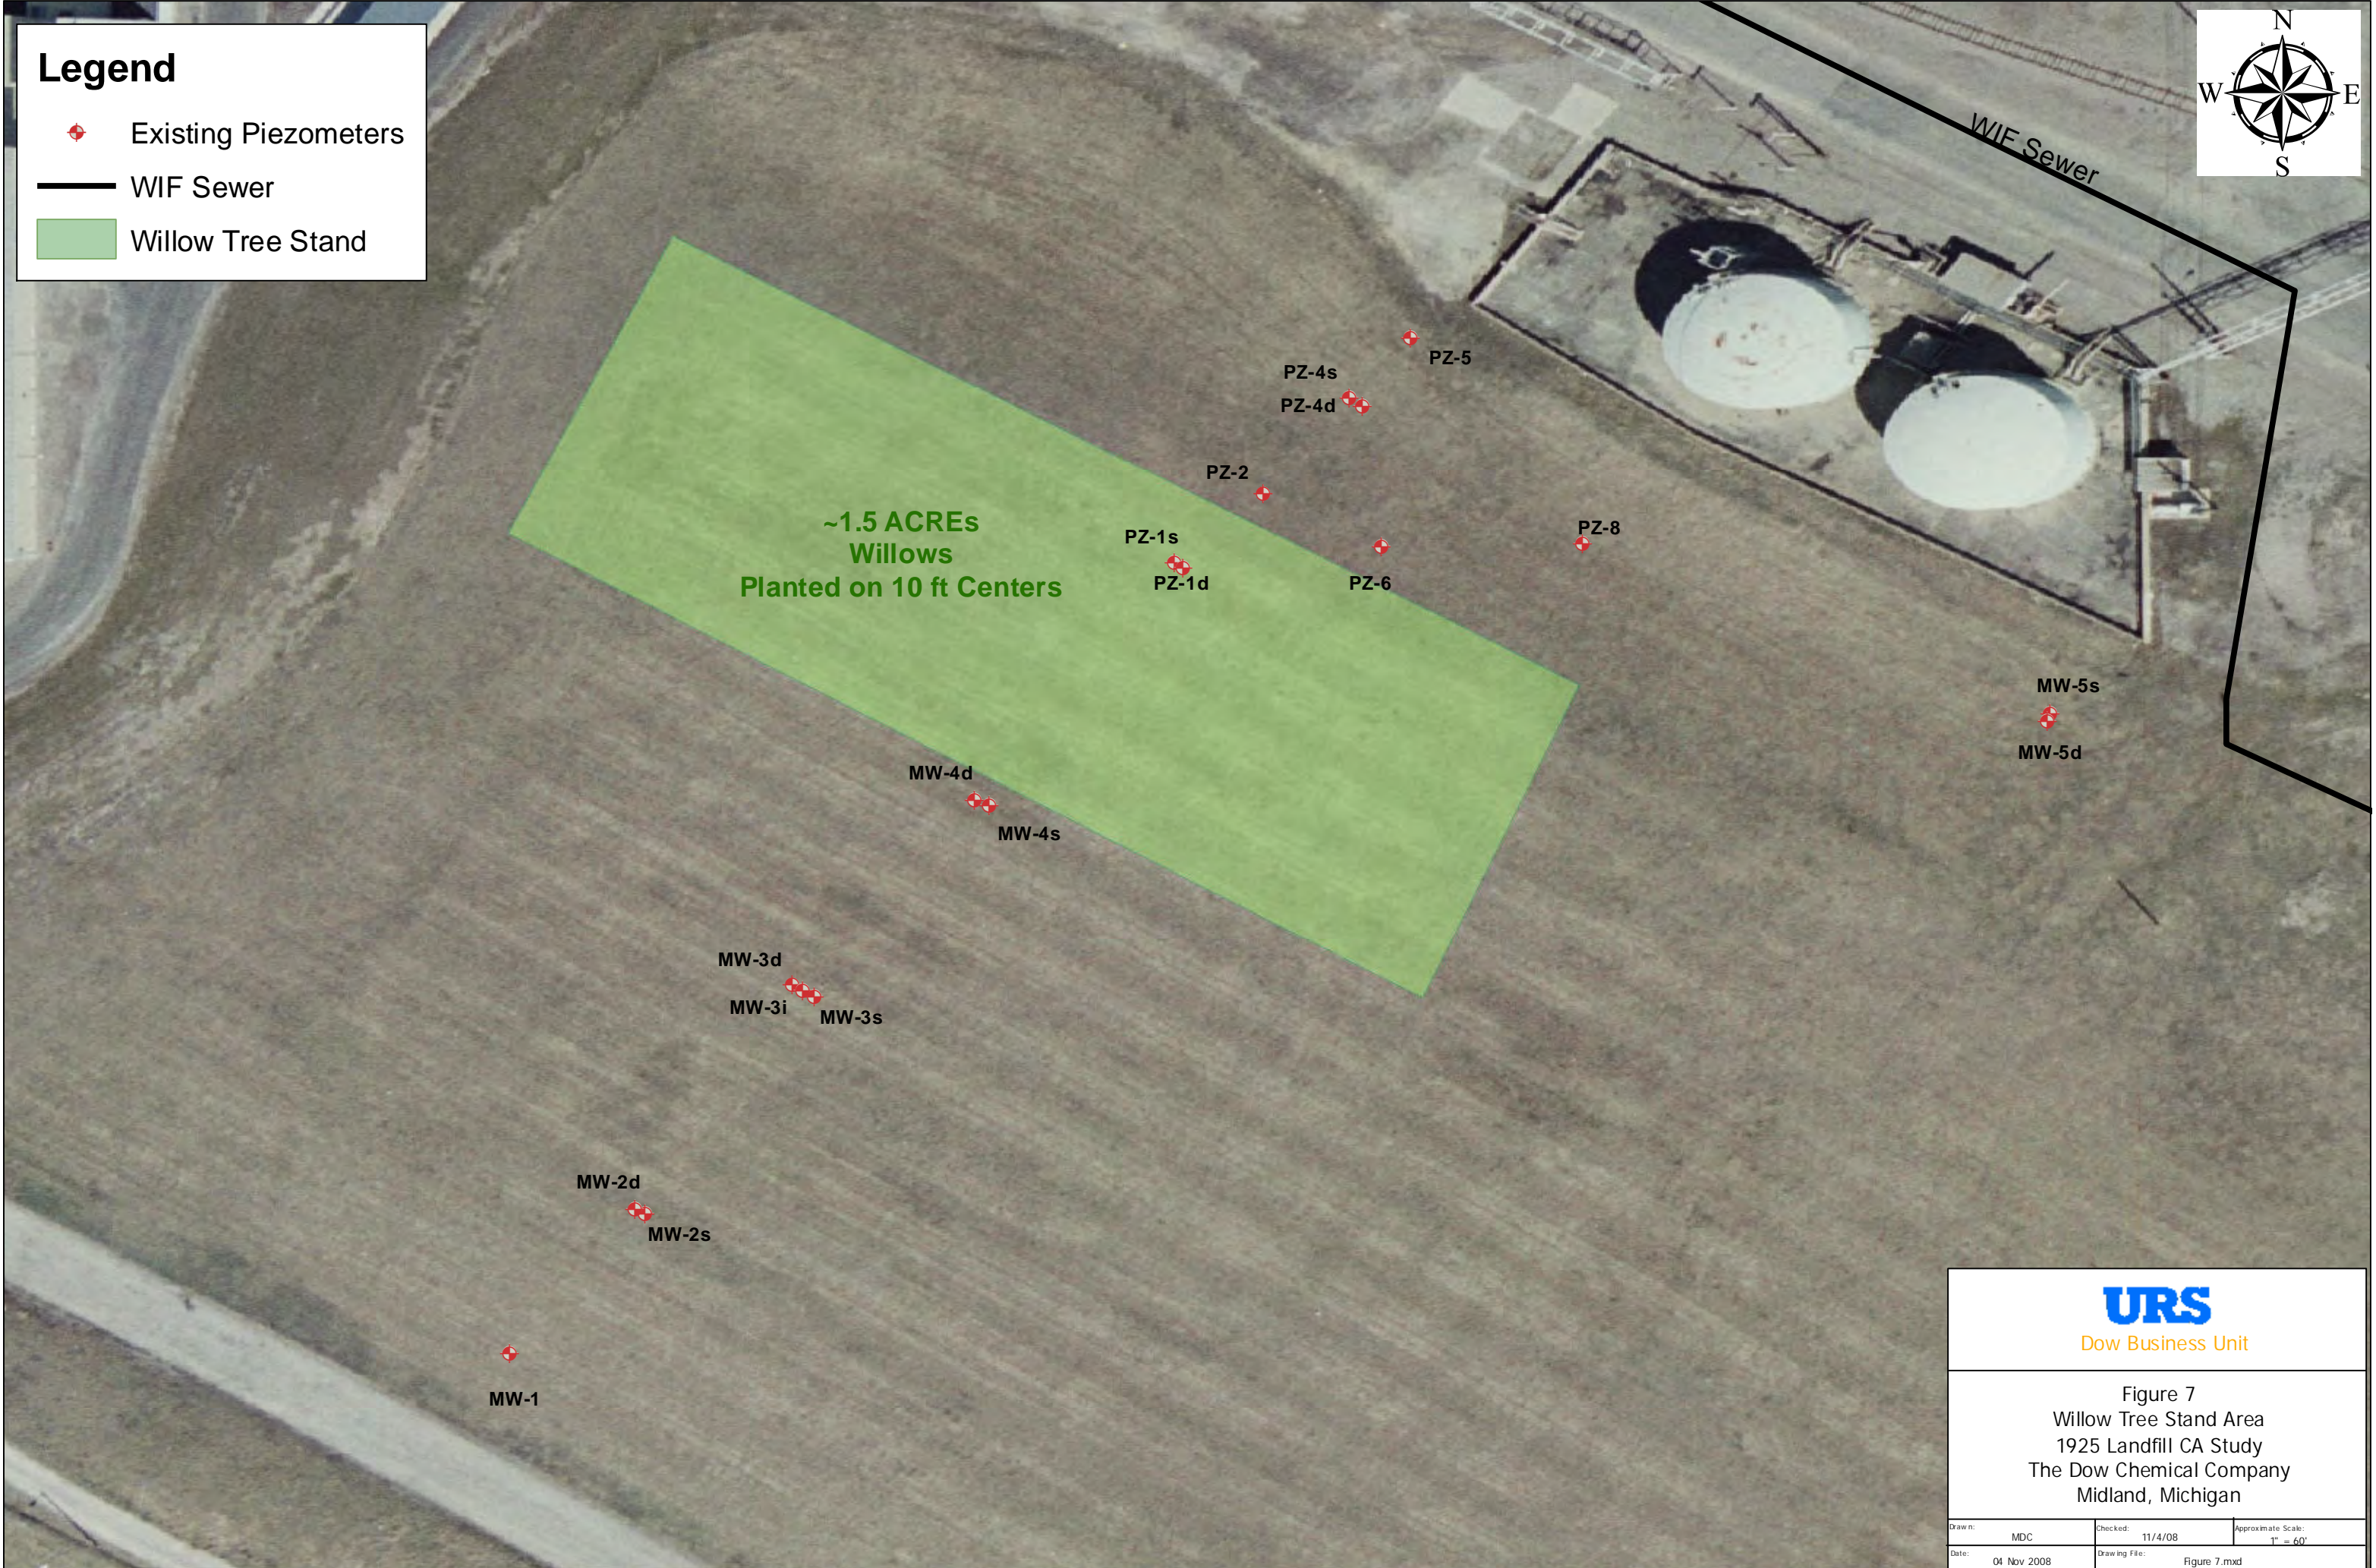
Figure 7
Willow Tree Stand Area
1925 Landfill CA Study
The Dow Chemical Company
Midland, Michigan

- Existing Piezometers
- WIF Sewer
- Willow Tree Stand

A stand of approximately 650 willow trees will be established by planting willow shoots approximately 18” below ground surface on 10-foot centers over approximately 1.5 acre area which overlaps the groundwater recharge area identified adjacent to the MW-4 vertical piezometer cluster (see Figure 7). The trees will be maintained and protected from damage by deer and other animals that can impact the saplings. In addition to the tree stand, several piezometers will be installed in the area to allow for monthly water level monitoring.
