# ATTACHMENT XIV.C5

# SURFACE IMPOUNDMENTS

TO:	Kip Cosan and Shane Bennett	DATE:	January 10,2012 Rev.1 February 1, 2012
FROM:	Vik Gautam, PE	PROJECT:	Dow Chemical Company
rkow.	Doug Wehner	I KOJECI.	T-Pond Dike Stability Analysis
COPIES:	File	JOB NO.:	41569029
ATTACHMENTS:	Figures 1 and 2; Appendix A (Boring Logs); Appendix B (Laboratory Test Data); Appendix C (Results of Slope Stability Analysis)	RE:	Evaluation and Recommendations For Slope Distress at T-Pond East Dike

Dow T-Pond Filtration Project Stability Analysis of Inboard Dike Slope With Rock Fill

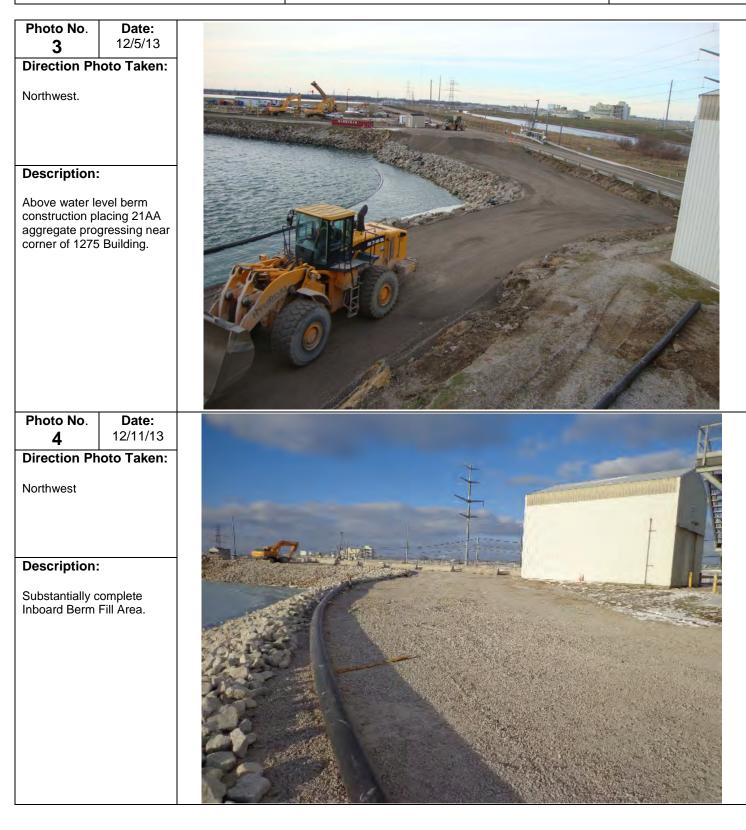
Tertiary Pond Embankment inboard Fill Midland Plant WWTP Midland, MI 48667 Project No.
