# Evaluation of Steady-Burn Warning Lights on Channelizing Drums in Work Zones

MDOT Project Number ORE09-11

## Final Report

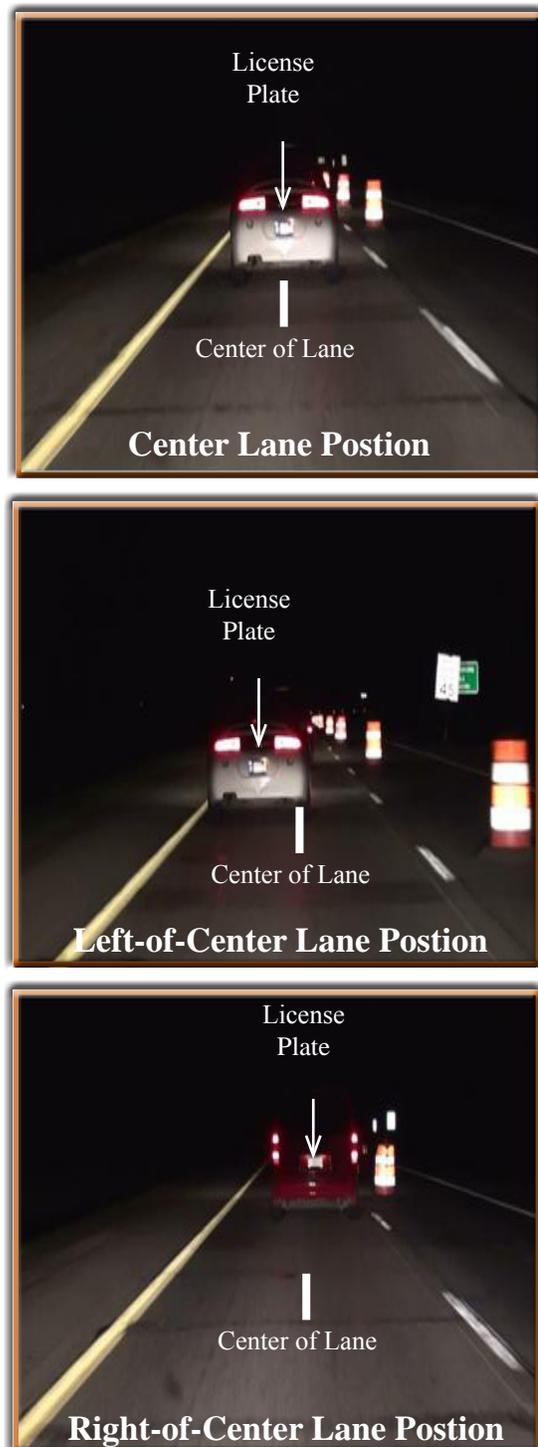
**FIGURE 3. Example of Vehicular Lateral Lane Position Assessment**

To provide consistent boundary definitions for each of the three lateral positions, the video reviewers were instructed to fixate their view on the position of the vehicle's license plate with respect to the center of the lane, provided that the license plate was centered on the vehicle. A vehicle was considered in center lateral position if any portion of the license plate was positioned over the center of the lane. A vehicle was considered to be positioned left or right of center if the entire license plate had shifted laterally beyond the center of the lane. Examples of the three lateral lane positions are shown in Figure 3. If the license plate was missing or off-center, the reviewer would utilize a secondary distinguishing feature on the center of the vehicle to determine the lateral position.

The amount of time spent in each lateral position was determined using the clock embedded in the video review window. All times were recorded

Each MOE was computed such that equal weighting was given to all subject vehicles, regardless of the amount of time that each vehicle was tracked. The following example provides an explanation of the procedure by which each MOE was computed for a subject vehicle. A review of the video for one particular run found the subject vehicle to have spent the initial 9 seconds in the left-of-center position, the next 14 seconds in the center position, the next 15 seconds right-of-center, and the final 18 seconds in the center position. The total tracking time for this subject vehicle was  $9+14+15+18 = 56$  seconds. A total of three steering reversals were observed, as follows: 1) left to center, 2) center to right, and 3) right to center. Thus, the rate of steering reversals was computed as  $(3/56)*60 = 3.21$  steering reversals per minute. The percent time spent in the center lane position was computed as  $(14+18)/56*100 = 57.14$  percent. The channelizing drums were on the left-

side of the lane. As such, the percent time spent in the position closest to the drums (i.e., left-of-center position) was  $(9/56)*100 = 16.07$  percent. Similar calculations were repeated for each of the 1,236 vehicles included in the data set.

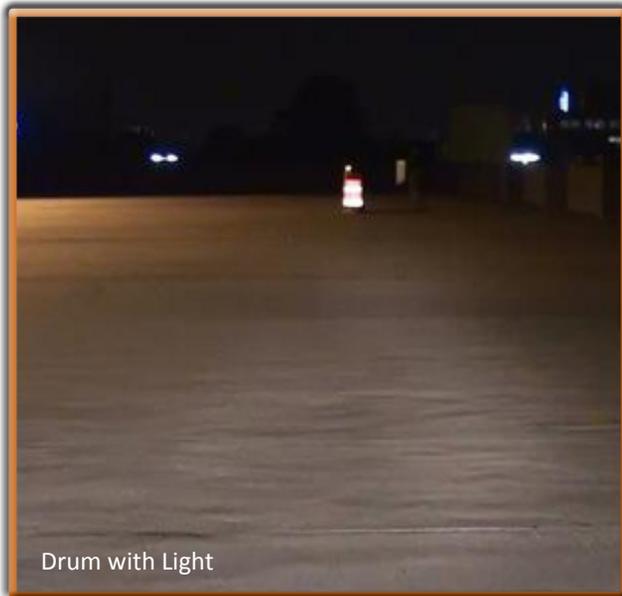
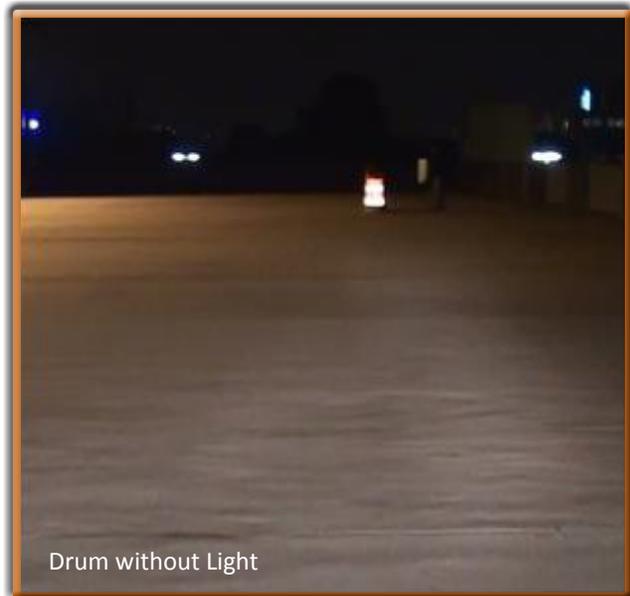
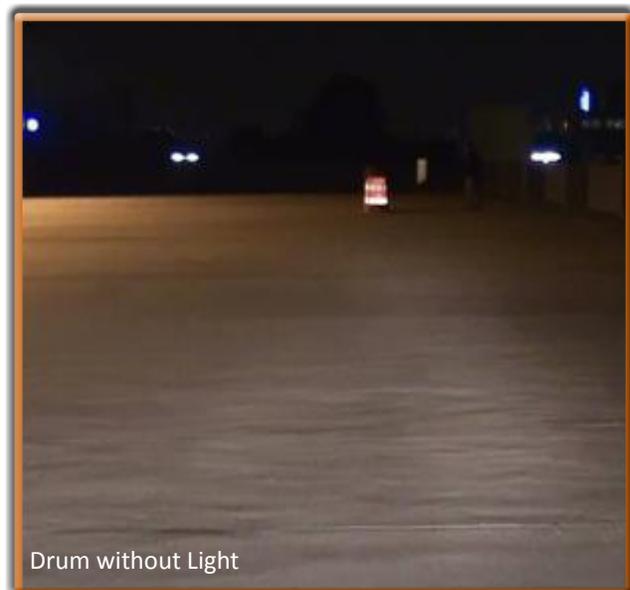
**FIGURE 4. Example Drum Scenarios Used in the Controlled Evaluation  
(Photographs taken from the 2002 Olds Alero at 200-ft with a 6-ft lateral offset)**

(a) Used prismatic drum

(b) Used high intensity drum

All drum scenarios were measured from the passenger seat of the vehicle at a distance of 200-ft. The 200-ft measurement distance was utilized as it represented the approximate field measurement distance, which corresponds to the distance that the drum (and steady burn warning light, if attached) maximized the 1-degree aperture measurement circle on the luminance meter. To provide consistency between measurements for drums with and without steady burn warning lights, the measurement circle was positioned identically for all drums, regardless of whether or not a light was attached. Three drum luminance measurements were recorded for each scenario after which the next scenario was prepared. Figure 4 provides photographs of various drums with and without lights viewed at a distance of 200-ft.

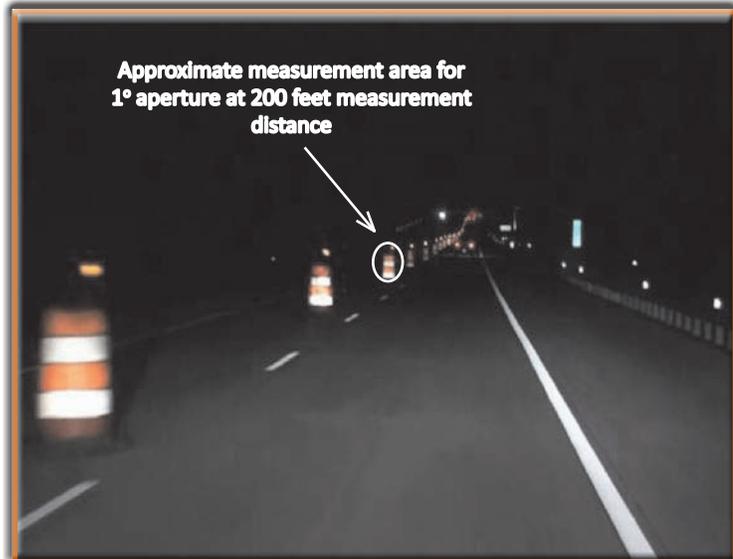
**Figure 5b. Luminance measurement of drums without steady burn warning lights, unlit freeway, high intensity sheeting**
