***PRINCIPLES OF
BUILDING
CONSTRUCTION:
NONCOMBUSTIBLE***

FEDERAL EMERGENCY MANAGEMENT AGENCY
UNITED STATES FIRE ADMINISTRATION
NATIONAL FIRE ACADEMY

MODULE 3: UNPROTECTED NONCOMBUSTIBLE BUILDINGS

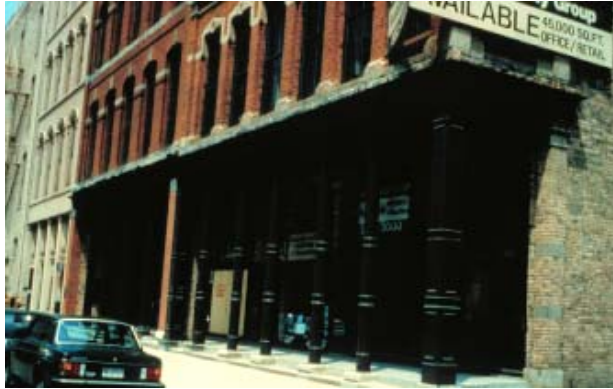
Cast-iron columns providing structural support for exterior wall

Cast iron was the first form of iron to be used as a structural element in buildings. Identified both for its strength under compression and a noncombustible material, it was first used in supporting columns around 1870. The columns could be manufactured easily at a foundry and transported to the construction site for installation. The forms used could be designed with a bell-shaped top and bottom to provide greater stability and still have heavy loads applied to them. Some early attempts to use cast iron for beams or girders were unsuccessful or had limited success, since cast iron has limited strength under tension or against shear forces. The problem with some of the earlier cast-iron materials was that, in many instances, they were not formed in a uniform manner. While the exterior of the column was uniform, the interior walls could be 1-inch thick on one side and 1/2-inch thick on the opposite side. Later, methods of pouring the forms with molten iron were improved and the quality also improved.

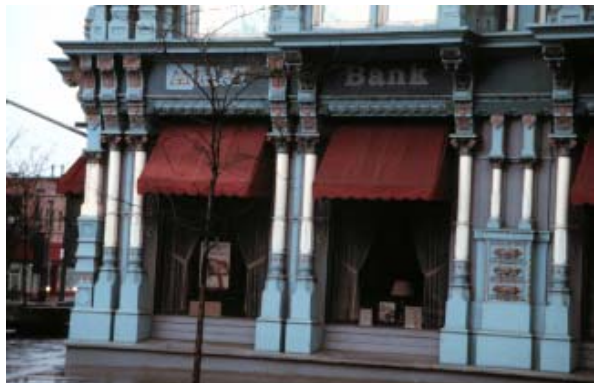
Cast-iron building front providing structural support to exterior wall of building

Cast iron could be formed to create arches and lintels to span window and door openings in walls, which provides greater flexibility to the building designer and the contractor installing the materials. Cast-iron lintels and arches typically replaced stone elements, which were much heavier and required extra strength in the load-bearing walls to carry the weight of the stone. Some attempts were made to create the complete building exterior wall from cast iron at a foundry, transporting the components to the construction site, and installing the pieces with bolts and rivets. Many such buildings still stand today, especially in the business districts of older cities.

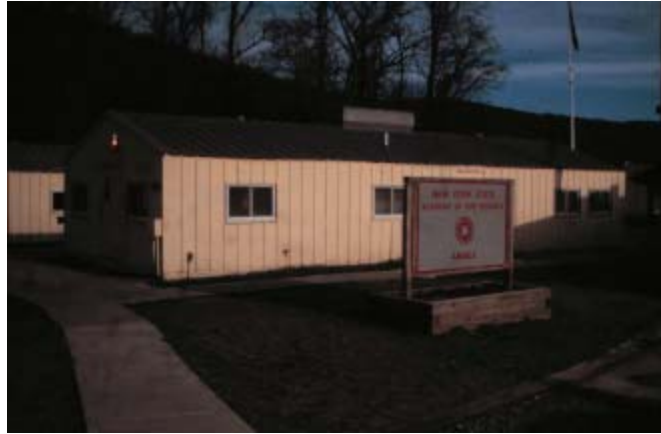
Lightweight steel construction buildings can be used for hundreds of different occupancies

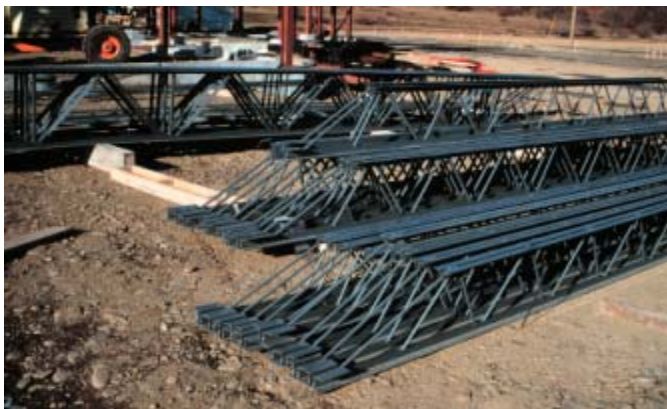
Steel bar joists are used to support floor and roof structural elements

Roof loads include a variety of loads that must be supported, ranging from the structural materials, snow or water loads (90 psi snow load requirement in upstate New York), heating and cooling equipment, compressors for refrigeration equipment, and the unexpected loads such as a company of firefighters assigned to a ventilation task during a fire. The most common structural material used to support the roofing materials is the lightweight steel bar joist. The bar joist is named for the steel bars that used to be formed in a "V", sandwiched support floor and roof loads between lightweight angle iron, and welded. The bars are usually 1/2 to 3/4 inch in diameter and the angle iron is typically 2 or 3 inches by 1/4 inch thick. Since the top is under compression it is the longer part of the element, and the bottom being under tension will not be supporting the beams or bearing wall. The "V" or "truss" principle provides the support from within the materials to carry the load and transfer it to the load-bearing elements such as beams and girders.

Roofing material for a pitched roof most typically will be sheets of corrugated steel attached to purlins that stretch across steel bar joists. Roof decking for a flat roof most typically is made from corrugated sheet steel attached to the steel bar joist, covered with a Styrofoam-type insulation covered with either asphalt paper and tar roof covering or a vinyl sheet roofing material. The roof then may be covered with round stone or lightweight patio-type masonry blocks that are used as foot paths over the roof so as not to damage the roofing materials. The Styrofoam insulation can produce a spongy or soft feeling when walking on the roof. This condition should be evaluated by firefighters to determine if the structural elements are weakened, or if the roof material is causing the soft feeling. While it would be preferred to have the roof elements identified on a building preplan, it may be necessary to make an inspection opening of the roof away from the fire area to determine the materials used. The roof elements will affect your ability to open a ventilation hole quickly.

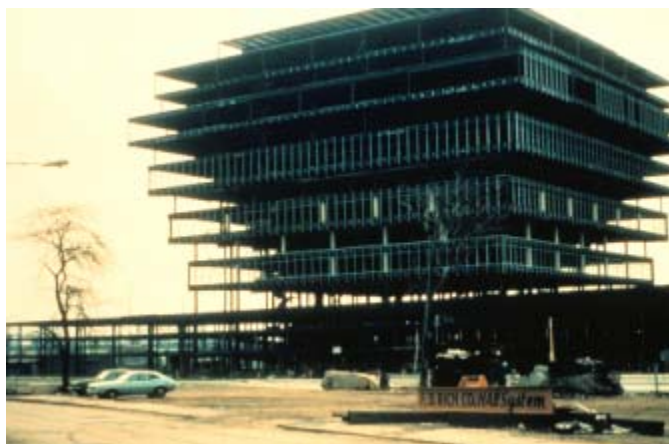
Multiple-story steel framework structure with limited or no special fire-resistance provided for the structural elements is considered an NFPA Type II Unprotected building

Steel skeleton frame buildings can be constructed two, three, or more stories in height. Each component of the structure is designed and installed so as to transfer the load to the ground. The entire building is only as strong as the weakest component of the framework. A frame of steel columns with steel beams attached to the columns creates a box-like support framework to support multiple floors and the roof. The framework starts in a fashion that is similar to the one-story structure with the steel column attached to a concrete pad and flanges which are attached to the columns and used to attach the beams that will extend to the next column. This same concept is used to create a framework for a two-story, three-story, or even taller building. In Module 4: Protected Noncombustible Buildings, this concept will be discussed when it is used to construct highrise buildings.

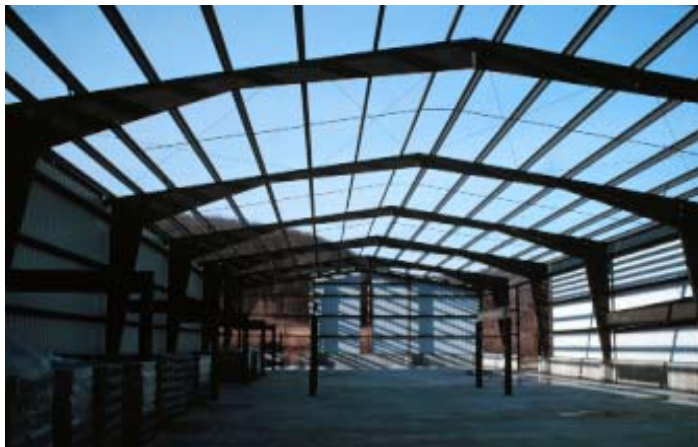
Rigid frame steel buildings use the arch principle to provide a clear span open floor space

The most common method of attaching a roof to a rigid frame building is to place lightweight steel bar joist from arch to arch. Corrugated steel sheet roofing then is attached to the steel bar joist. The roof elements are the lightest construction materials in the structural system and typically the first to fail under fire conditions. The structural arches made from substantial steel elements will absorb heat for a longer time before the materials start to relax, causing structure failure. One principle of this

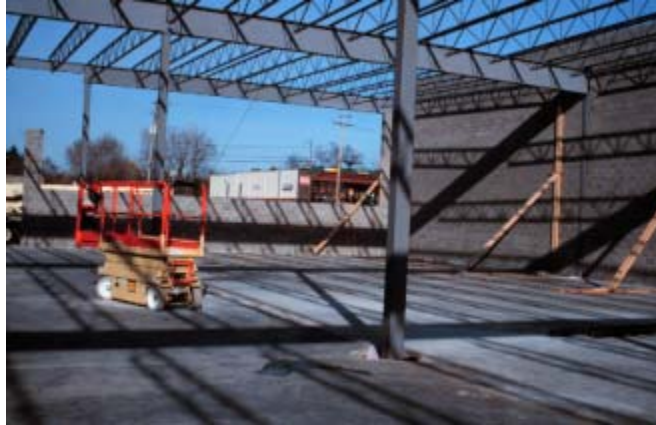
Steel columns of a box skeleton frame structure may be incorporated into a masonry wall, which also may provide support to the steel bar joist on the exterior wall

The steel box frame or rigid frame building typically does not rely on interior walls for structural support. Interior walls are typically non-load-bearing, and simply are used to segregate areas of the building. Exterior walls enclose the structure and, in some instances, may provide fire-resistance as the steel columns may be incorporated into masonry walls during the construction of the wall. Another construction technique is to use masonry exterior walls to provide support for the steel bar joist on the exterior of the structure, especially if the building is to be only a single span (one bar joist truss) floor or roof element. A masonry wall on each side of the building supports the roof or floor elements above.

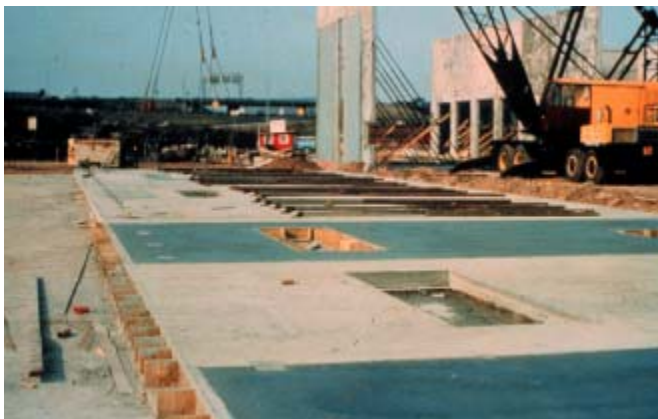
Poured-in-place concrete walls are tilted up once the concrete is cured and, once in place, often provide support for the steel bar joist roof supports

Many noncombustible buildings use a combination of masonry supports and structural steel. The masonry can be concrete block, poured-in-place concrete, or concrete panels prefabricated at another location and brought to the construction site. In some instances the concrete walls actually are poured and cured at the construction site adjacent to the position where they will be placed on a foundation. They are simply tilted up and secured in place after the concrete is cured.

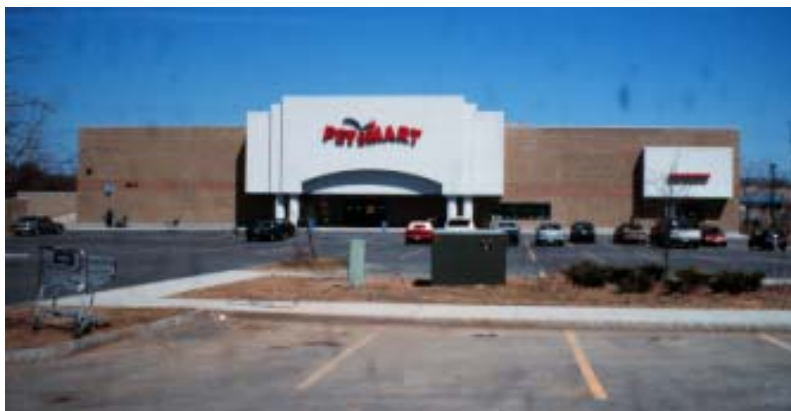
The "big box" structure is common today in nearly every community

The "big box" store is common today, and is used for many different occupancies. Chain lumber and hardware stores, office supply stores, and numerous other commercial operations use the big box building. The term "big box" comes from the many box-like structures created by the beams attached to the tops of the columns and when viewed from the top, it appears as many square steel boxes which will support either a floor system or, most commonly, a roof system.

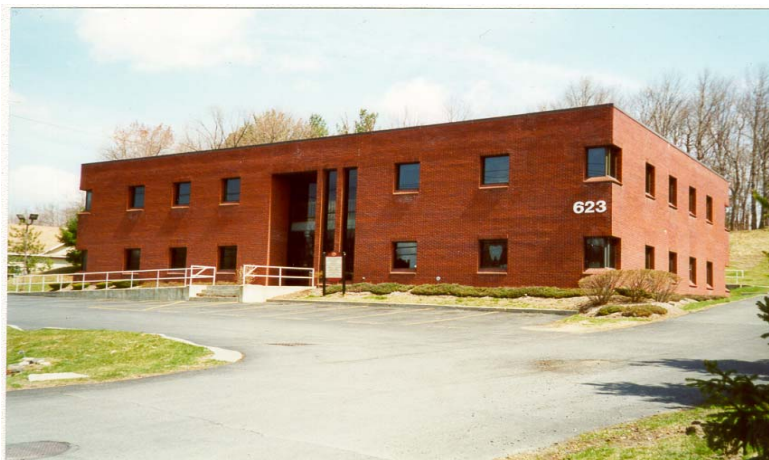
Protected steel frame structure

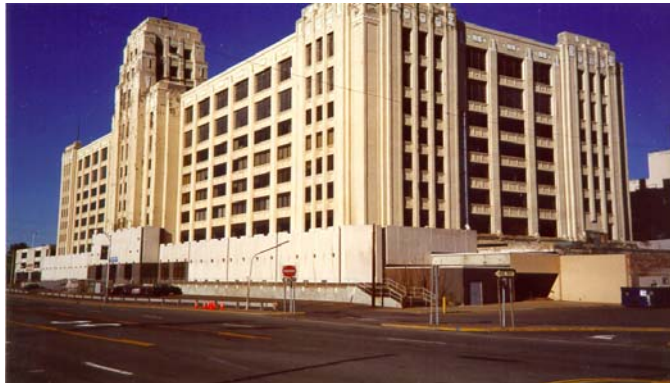
Concrete framed structure

Reinforced concrete structures became popular after the first modern structure was formed and poured in 1903. Concrete construction gained in popularity from 1920 to 1940, when cities started to grow using concrete to build buildings taller and bigger. Since buildings constructed during this era did not have air conditioning, it was necessary to arrange the floor plans so that rooms had exterior windows that could be opened for ventilation. Typically over the entrance door to the office or apartment was a small window called a transom. The purpose was to allow an opening high on the interior wall that would allow for cross ventilation, with the cooler air coming at the lower exterior windows and the warm air
