2020 TAMC Culvert Condition Assessment Final Report

Michigan
Transportation Asset
Management Council

Michigan Technological University

Center for Technology and Training
309 Dillman Hall
1400 Townsend Drive
Houghton, MI 49931

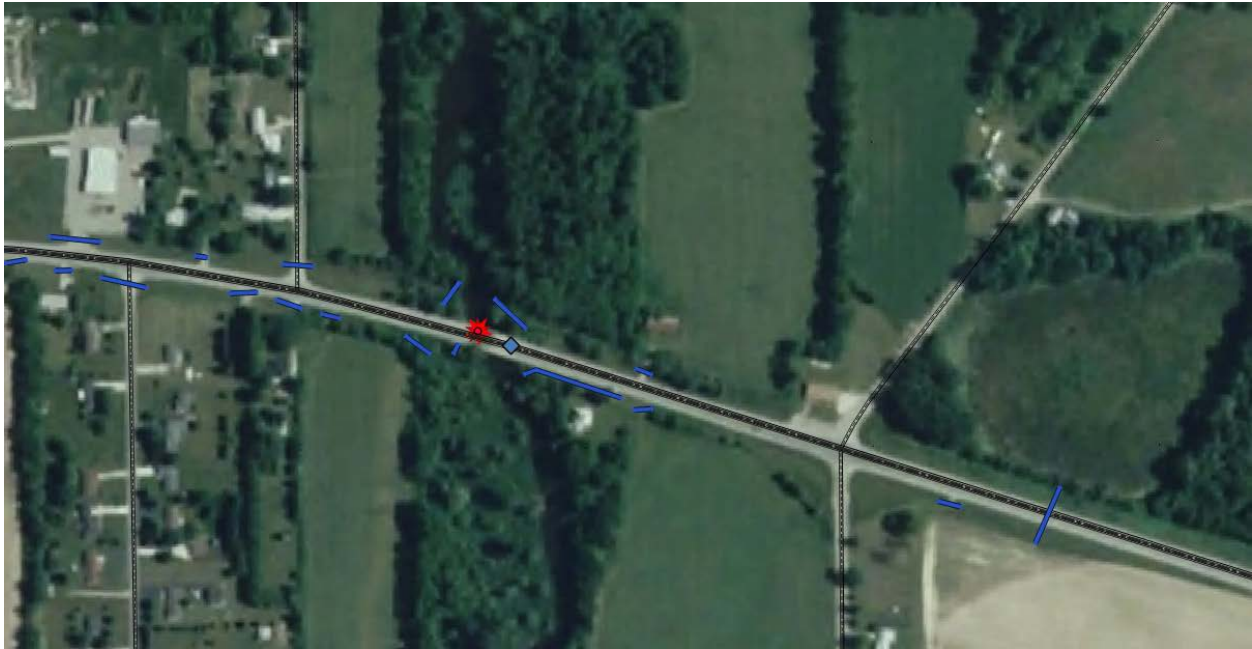
Figure 4: False positive new MDOT culvert shown by red star icon. MDOT bridge shown as blue diamond, MDOT culverts shown as dark blue lines

GIS data. Most of the false positives are located at bridges and are a result of how bridge data is collected using one data point, which is usually located at the abutment. Longer bridges will create false positives since the stream crossing point in many cases will be located at the center of the creek, which may be over 30 feet from the bridge abutment. These false positives are easy to identify and are relatively few in number, so it does not warrant a change in the collection protocol. Figure 4 and Figure 5 illustrate these types of false positives. Figure 6, Figure 7, and Figure 8 illustrate examples of potential new MDOT culverts.

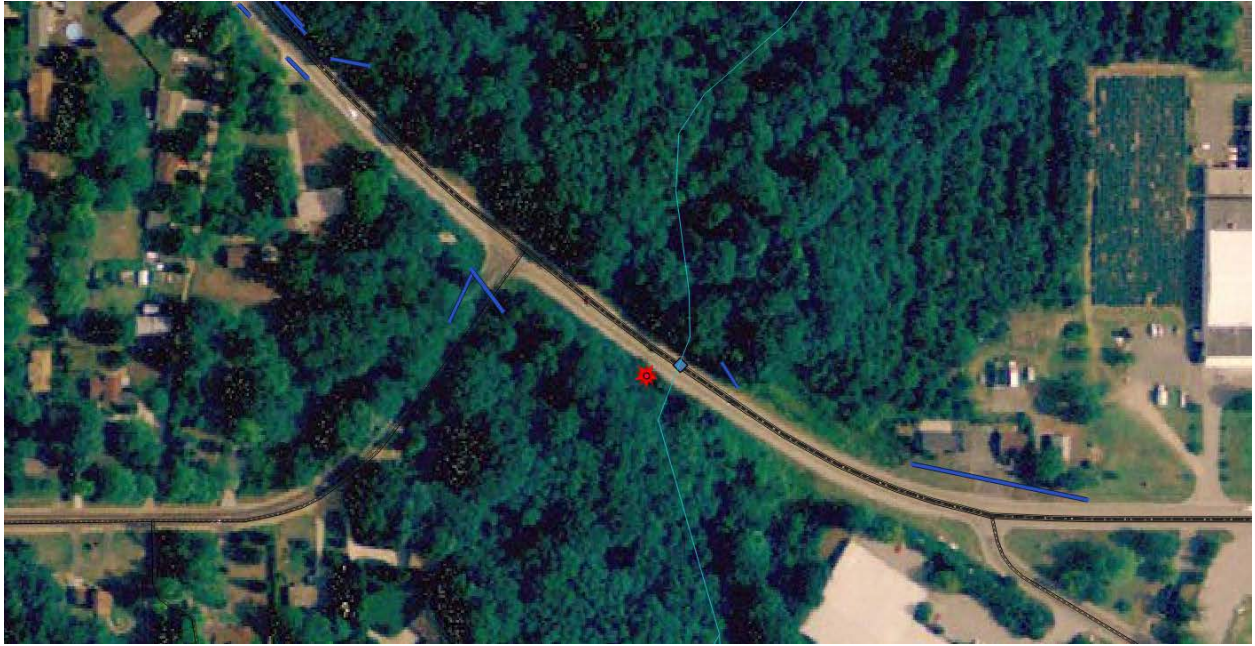
Figure 5: False positive new MDOT culvert shown by red star icon. MDOT bridge shown as blue diamond, MDOT culverts shown as dark blue lines.

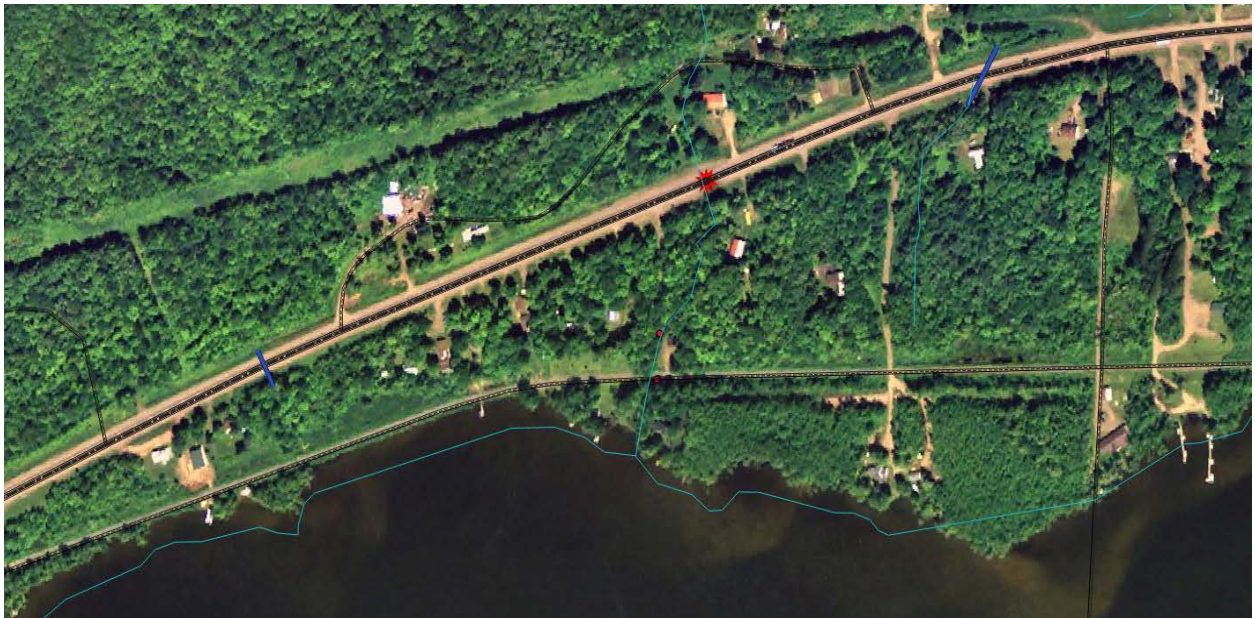
Figure 6: Potential new MDOT culvert shown as red star. Known MDOT culverts shown as dark blue lines, other stream crossing surveys shown as red circles.

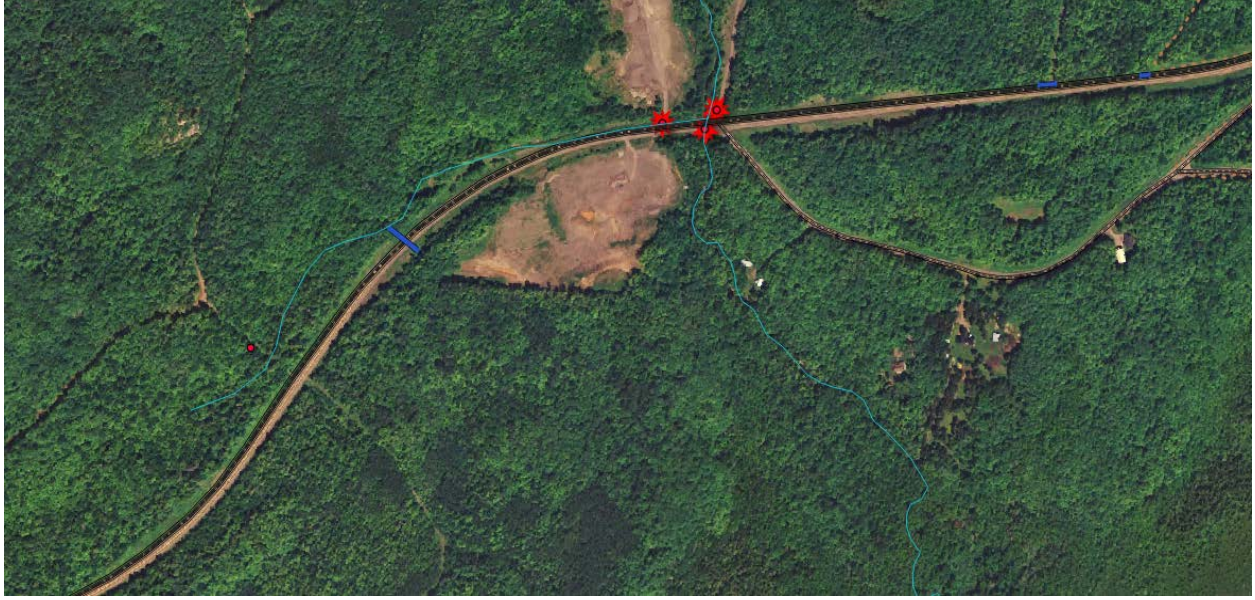
Figure 7: Potential new MDOT culverts shown as red stars. Known MDOT culverts shown as dark blue lines, other stream crossing surveys shown as red circles.

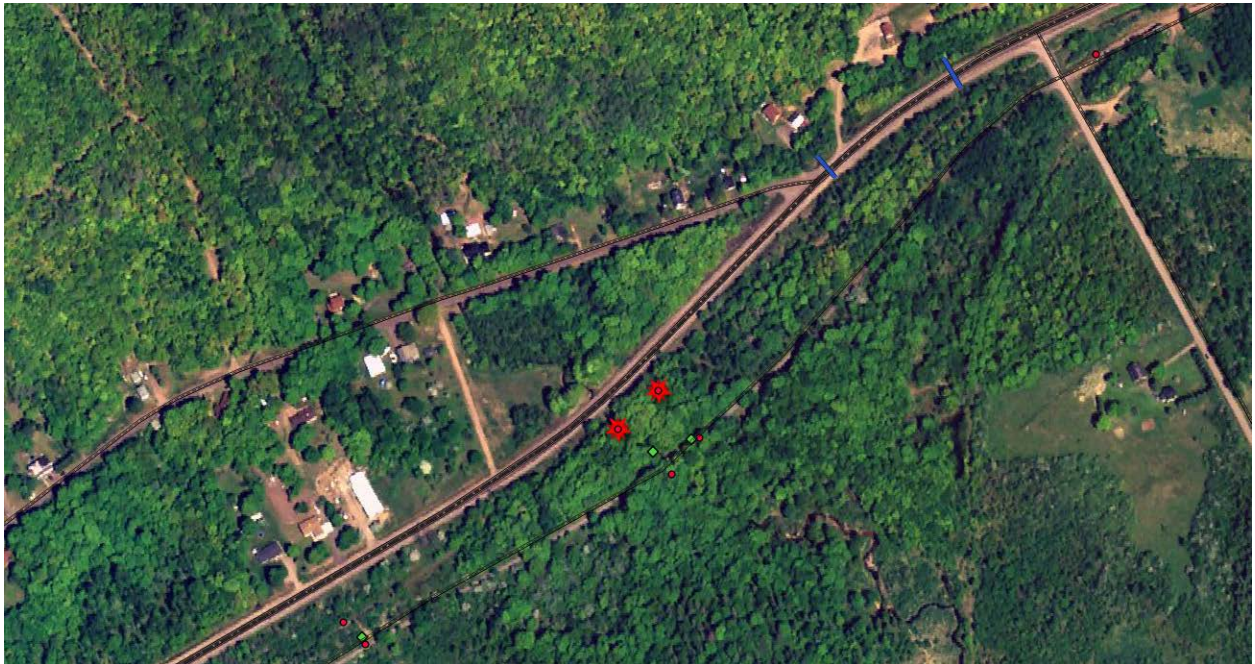
Figure 8: Potential new MDOT culverts shown as red stars. Existing MDOT culverts shown as dark blue lines, DNR bridges and culverts shown as green diamonds and other stream crossing surveys shown as red circles.

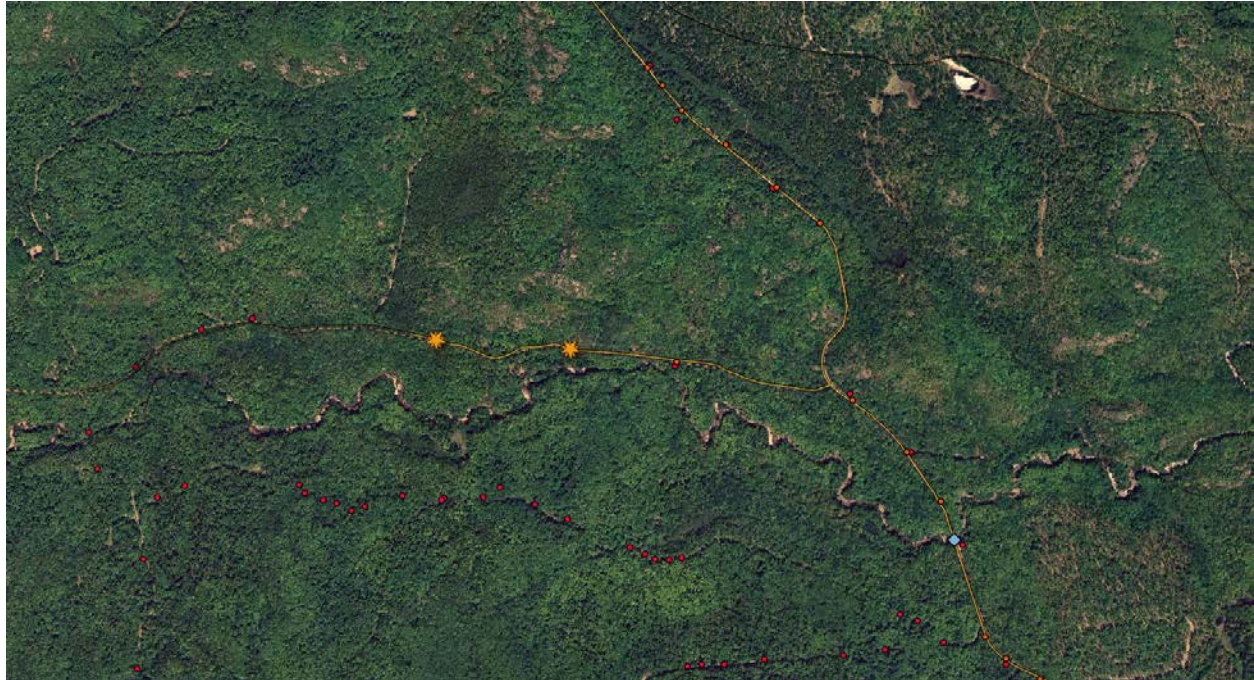
Figure 9: Potential new local agency culverts shown as orange stars, other stream crossings shown as red circles, known local agency culverts shown as orange circles, transportation bridges shown as blue diamonds

- 642 stream crossings were within the sphere of influence of local roads (Step C Input)
 - 37 were rejected as ambiguous (step K)
 - 65 were identified as matches (present in both data sets)
 - 331 were identified as possible previously unidentified local road culverts

Figure 9 illustrates examples of potential new local agency culverts identified by the process.
