## **ENBRIDGE LINE 6B INCIDENT**

# **KALAMAZOO RIVER BANK EROSION ASSESSMENT AND ACTION PLAN**

**MARCH 21, 2011**

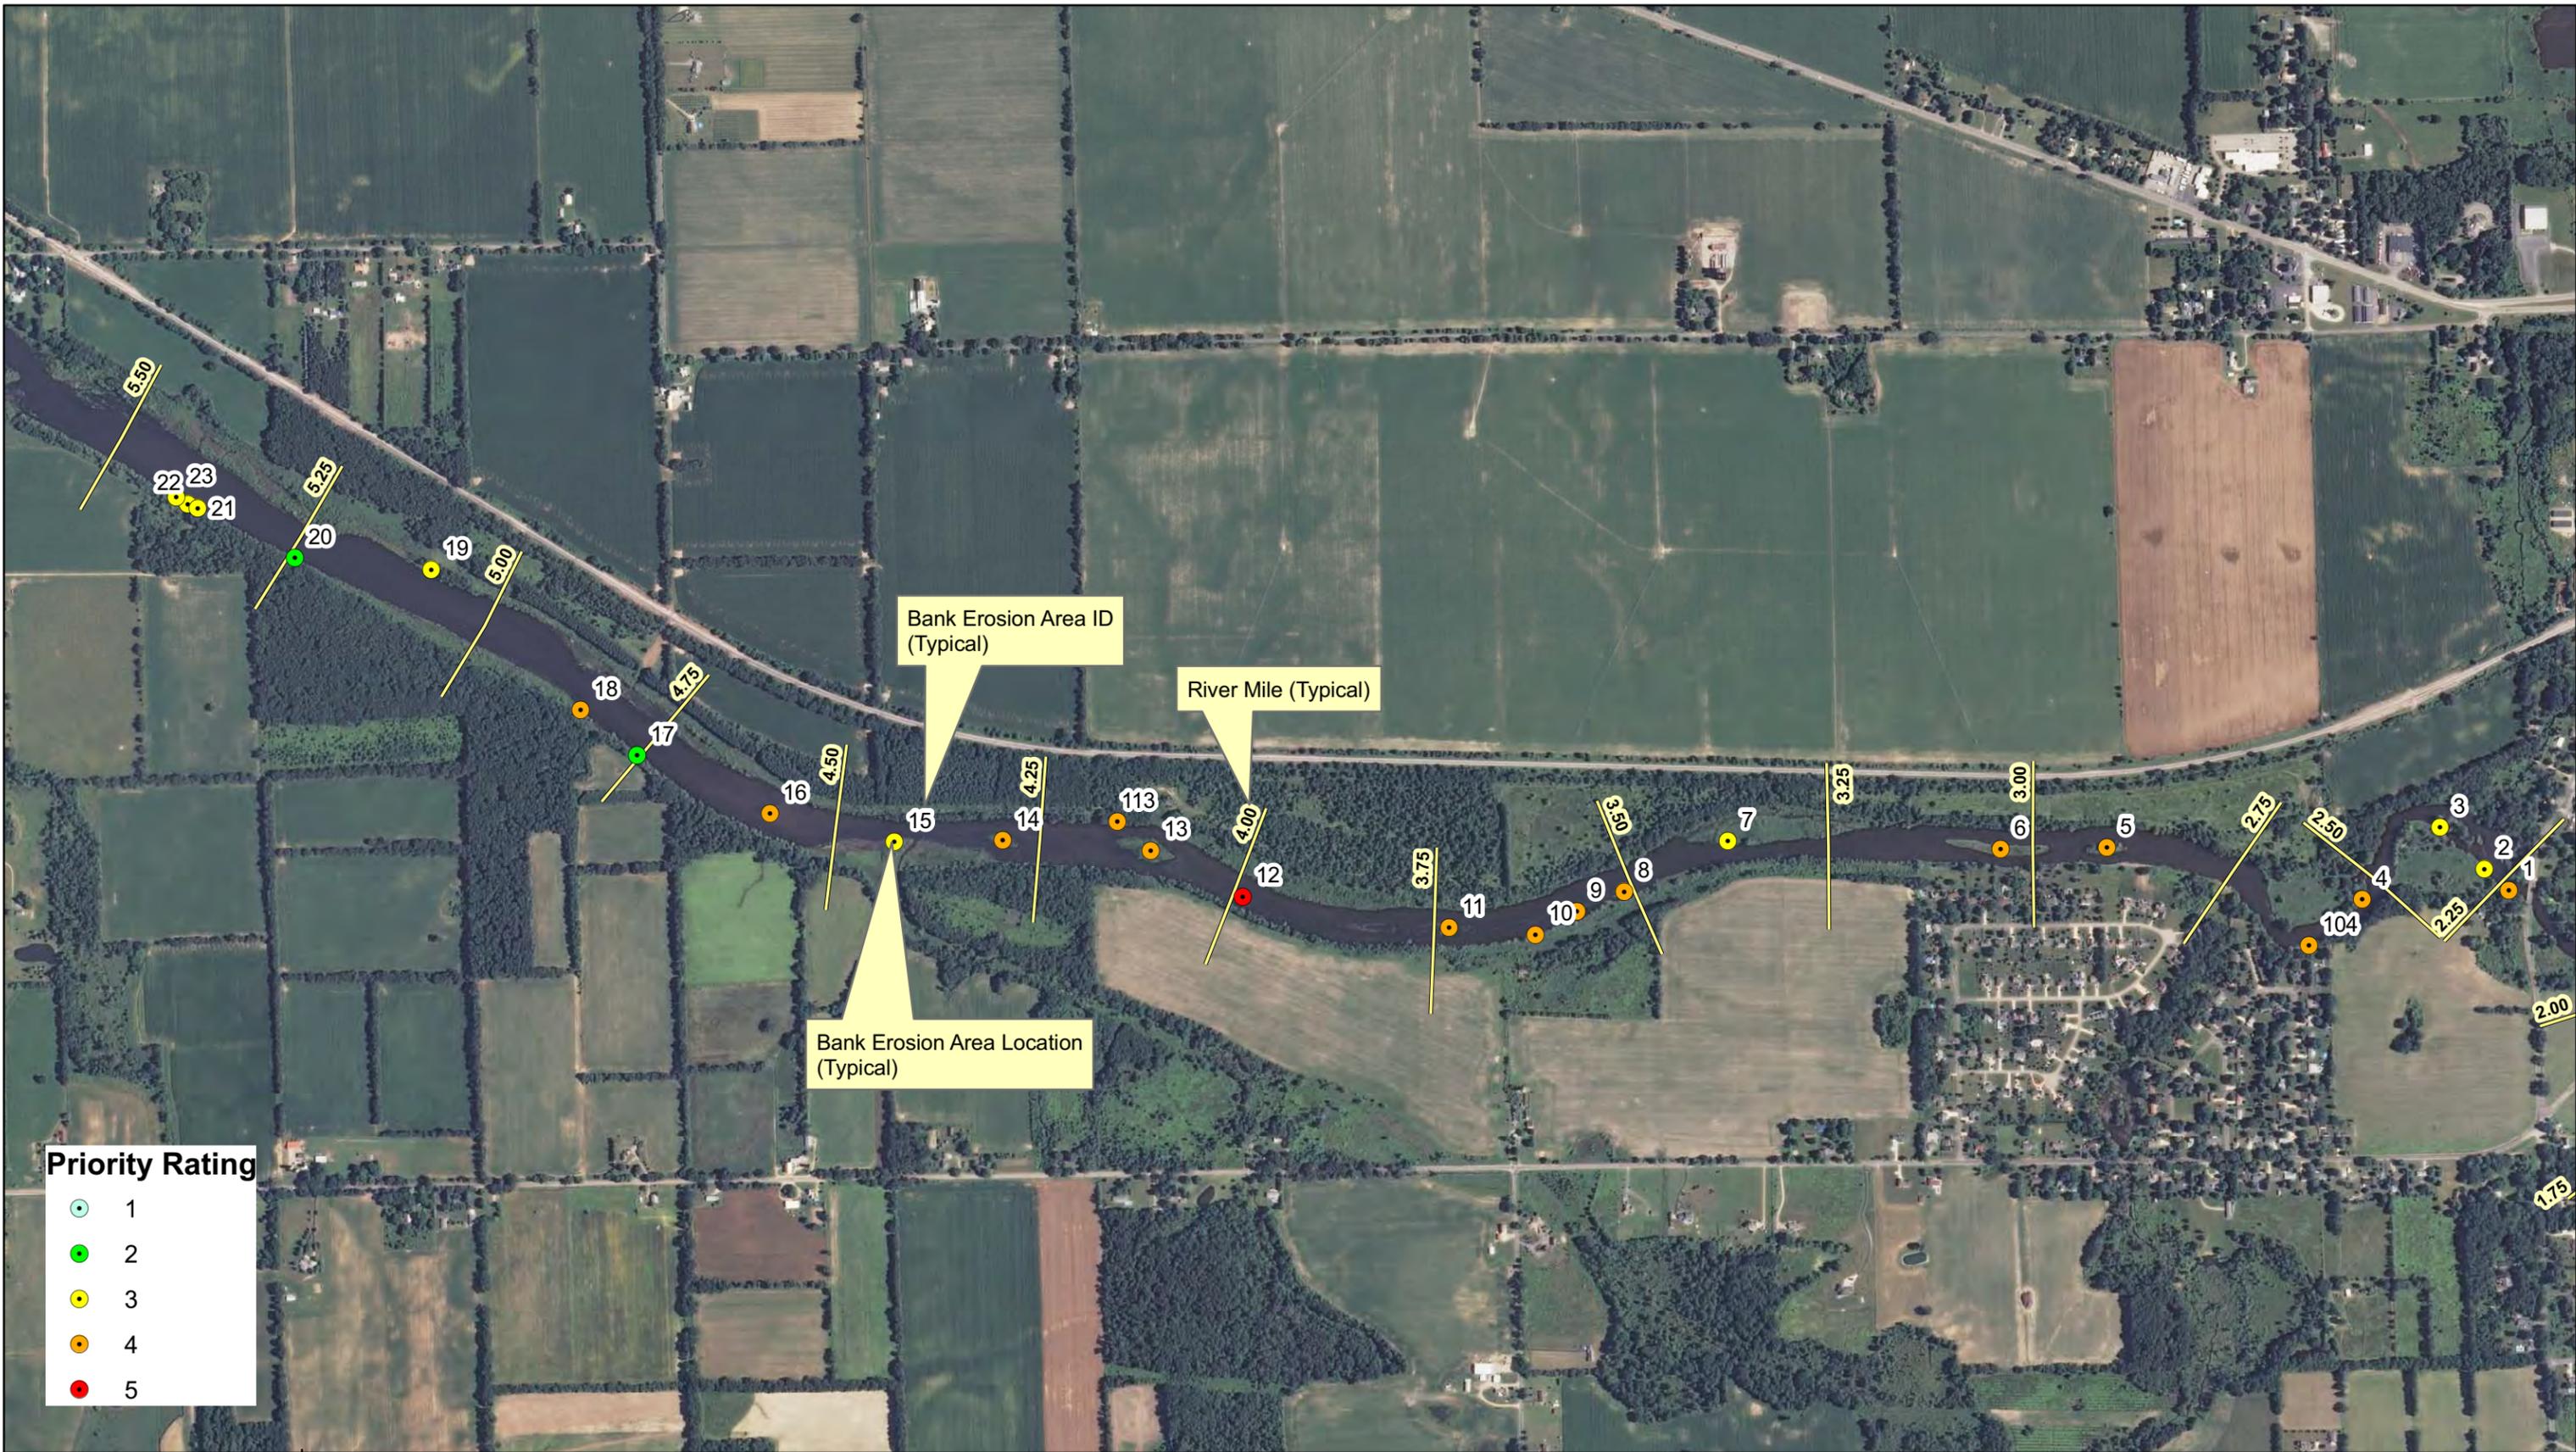
**BANK EROSION LOCATIONS**

**Priority Rating**

- 1
- 2
- 3
- 4
- 5

KALAMAZOO RIVER - BANK EROSION ASSESSMENT

As a result of continued field assessments, a bank erosion assessment table, location maps of erosion areas, and photo logs (Appendix A) are continually being updated. The table lists the location, extent, and composition of the observed areas of erosion. The erosion areas that are recorded are primarily a result of incident response activities (boat traffic, clean up, etc.).

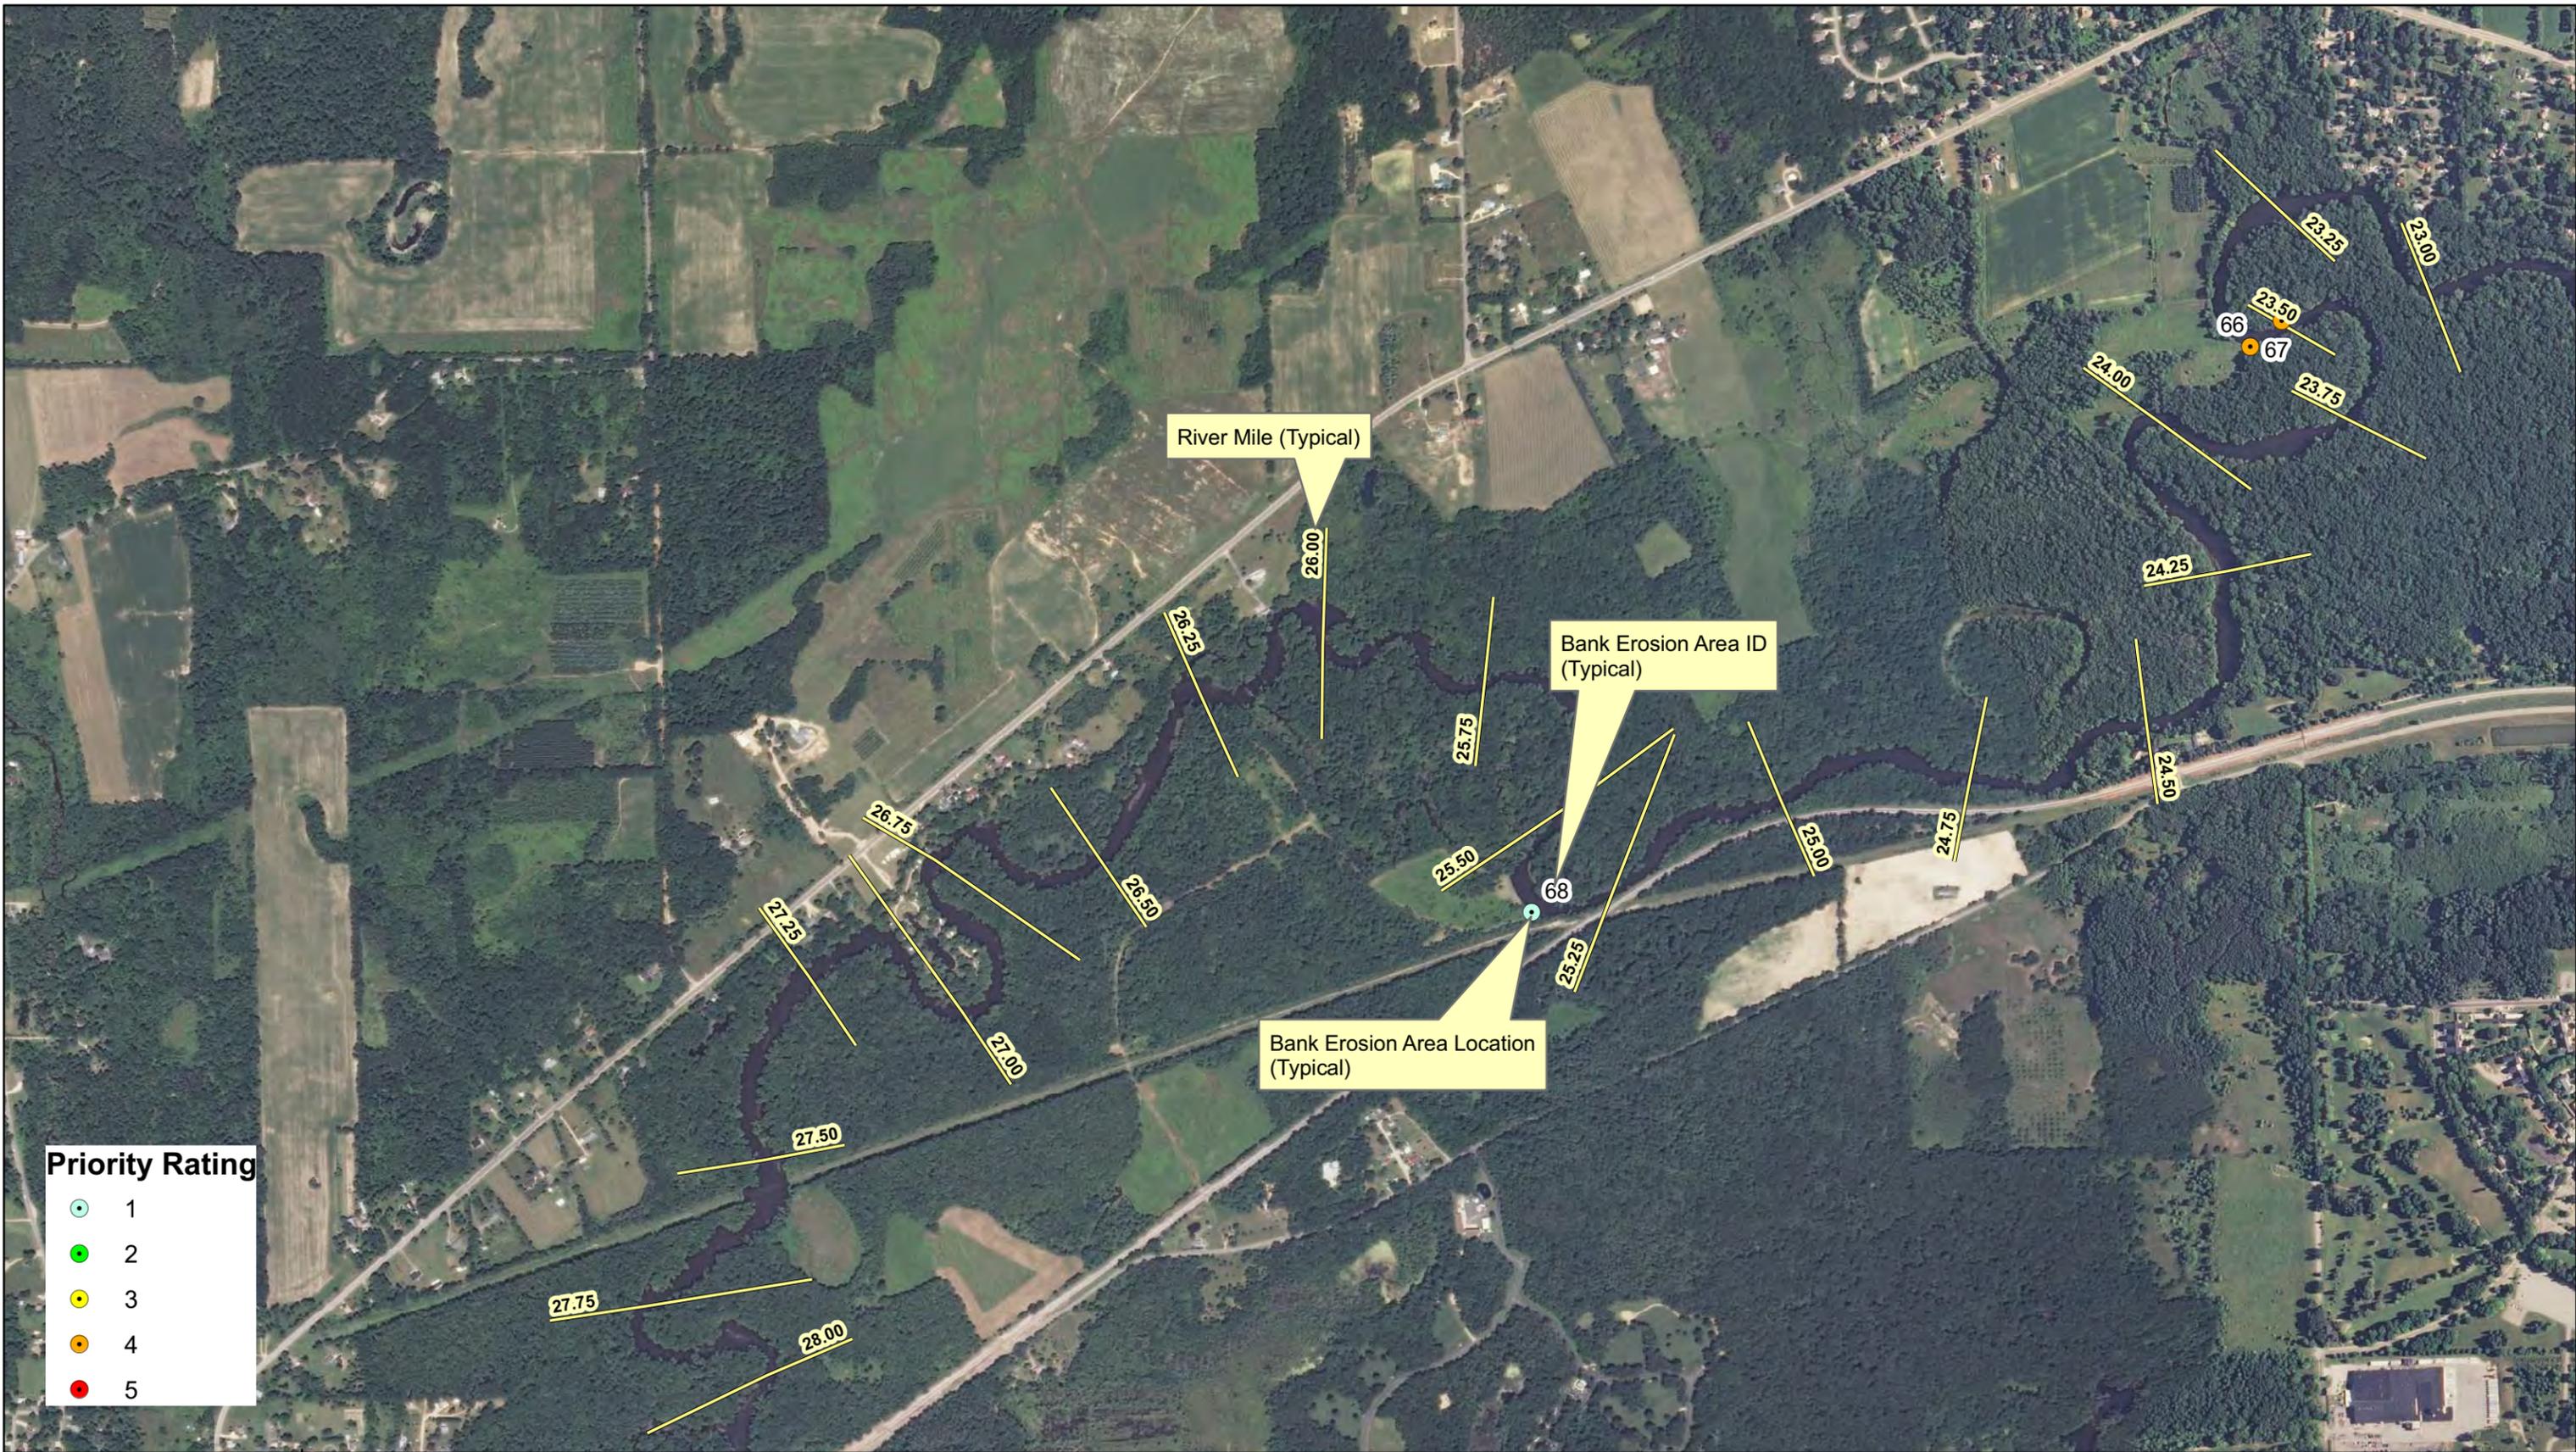
**BANK EROSION LOCATIONS**

KALAMAZOO RIVER - BANK EROSION ASSESSMENT
