***PRINCIPLES OF
BUILDING
CONSTRUCTION:
COMBUSTIBLE***

**FEDERAL EMERGENCY MANAGEMENT AGENCY
UNITED STATES FIRE ADMINISTRATION
NATIONAL FIRE ACADEMY**

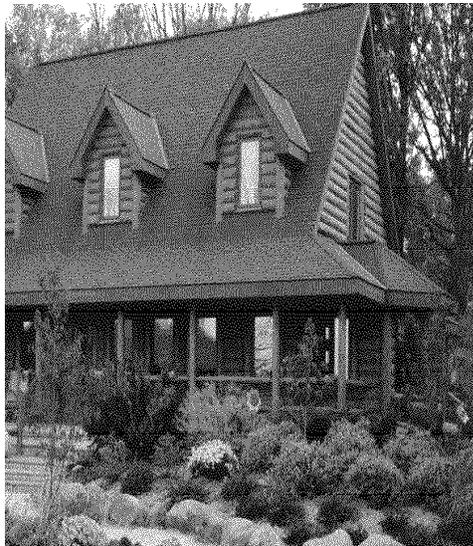
Log Construction

Log construction is the most basic of wood-frame construction methods. As the early settlers cleared the land of timber, the smaller logs were used to construct buildings by placing them one on top of another. They were fastened with a self-locking technique where the ends would be notched to interface with a notch from a second log at a 90-degree angle. With the limited availability of tools, mainly using an axe, the settlers could fashion a building from the logs quickly and easily.

Most modern log homes use logs that have been sawn or machined to produce flat surfaces and a uniform-size log. The logs used in most modern log homes have been kiln dried to prevent cracking and splitting. The logs are prepared with a tongue-and-groove arrangement, so that they lock when they are stacked to form walls. In between the tongue-and-groove splice, a neoprene or silicone weather seal is installed. The logs also are secured with a long nail or bolt that fastens the top log to the one below. This method of securing the logs is continued for the entire height of the wall. As logs in the wall are placed end-to-end for long wall sections, they also are prepared with a tongue-and-groove lock on the ends to provide additional strength to the wall and joint, as well as an additional weather seal.

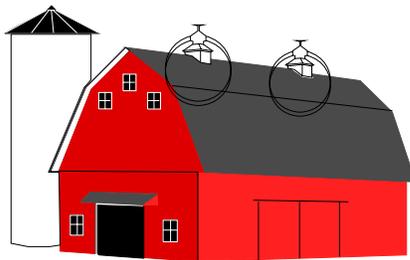
Post-and-Beam Construction

Post-and-beam construction followed the log construction methods and became popular as power saws became available. The construction methods used structural members that were typically a minimum of 4 by 4 inches. Structural elements consisted of posts for the vertical members and beams for the horizontal members that spanned between the posts. When erected, the building's skeleton of posts and beams could stand alone until a sheathing material was applied. In buildings such as barns, the dimension of the posts and beams would be much larger than 4 by 4 inches, while dwellings made from this method were the typical 4 by 4 inches or smaller structural elements. Many of the connections on these buildings used a locking technique with a mortise-and-tenon connection secured with a wooden peg through the connection to keep it from separating.

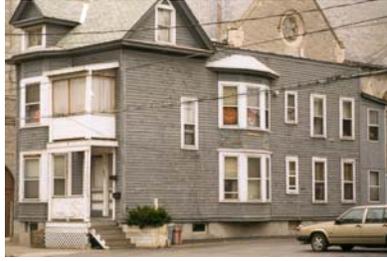
Balloon-Frame Construction

Balloon-frame construction was first used about 1833, and became a very popular method of wood-frame construction until about 1950. The advent of sawmills around 1833 opened the way for long and evenly shaped pieces of lumber which were needed for balloon-frame buildings.

With long continuous wall studs that could span from the foundation of a structure to the roof, a new era of building construction began. Most communities have wood-frame structures built prior to 1950, and most of those were constructed with the balloon-frame method. The first nails used to nail the lumber together were made in a blacksmith shop, and were called "cut nails." As machine-made nails became available, the process became even faster and ever more popular. Even when long timbers became scarce, some contractors simply nailed smaller pieces of wood together to make long wall studs.

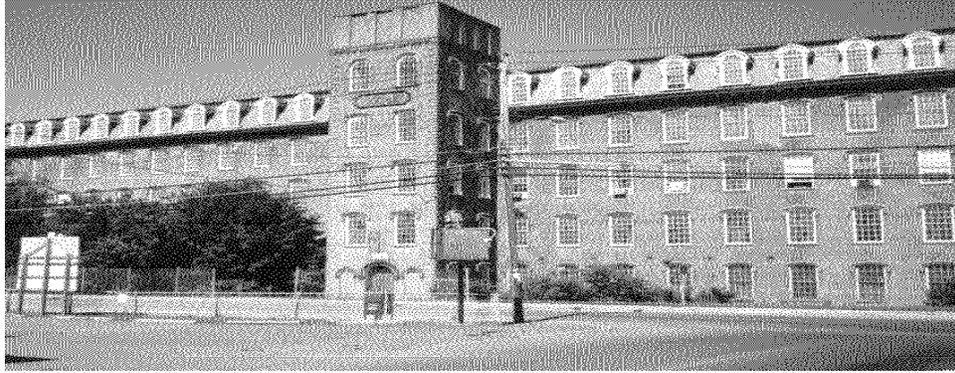
- 3-4.5 Floors must be of splined or tongued and grooved plank not less than 3" thick that is covered with a 1" minimum thick tongued and grooved flooring laid crosswise or diagonally to the plank or with 1/2" plywood or laminated plank 4" in thickness minimum covered with 1 inch tongued and grooved flooring laid crosswise or diagonally or with 1/2" plywood.
- 3-4.6 Roof decks must be of splined or tongued and grooved plank and must be a minimum of 2" in thickness, or 3" thick laminated plank, or 1 1/8" thick interior plywood (exterior glue), or of approved noncombustible or limited-combustible materials of equivalent fire durability.

Floors were made from heavy planks, with a finish floor laid diagonally across the planks, which provided additional strength. Typically a layer of asphalt-based paper would be placed between the plank and finish floor to prevent water or other moisture from seeping to the floors below, which could damage machinery or goods. Floors often were equipped with openings in the exterior wall that provided an avenue for water to escape that floor of the building. These devices resemble a mail door assembly installed in a dwelling's door to allow the mail carrier to open a slot and slide mail inside the opening. This device was called a "scupper." This is a critical element that should be looked for by the Incident Commander (IC) while reading a building, since water from an operating sprinkler system or water applied from a hoseline should find its way to a scupper. If not, the water may be adding weight to the floor and building. Floors were pierced for many reasons, which provides for fire, smoke, or heat extension to upper floors. Open stairwells, open freight elevator shafts, conveyor systems, or power transfer shafts often pierced floors without any fire separation or fire resistance.
