## Engineering Manual Preamble

## NBI Inspection Questions

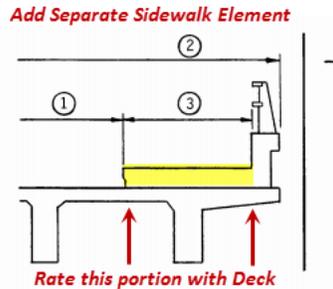
Item 50 = Curb or Sidewalk Width. When you add the sidewalk element for the case when there is a raised sidewalk, then use Item 50A (Left) and Item 50B (Right) times item 49 Length to get your sq.ft. of sidewalk.

Item 51 = Curb to Curb – This item is generally used when calculating epoxy overlay and healer sealer quantities. For decks with a small sidewalk you could simply use the Item 52 Out-Out to be close enough.
