SCAN 16 - MOISTURE, FROST,  
ICE EARLY WARNING SYSTEM  
(First Progress Report)

Research Laboratory Section  
Testing and Research Division  
Research Project 82 G-257  
Research Report No. R-1229

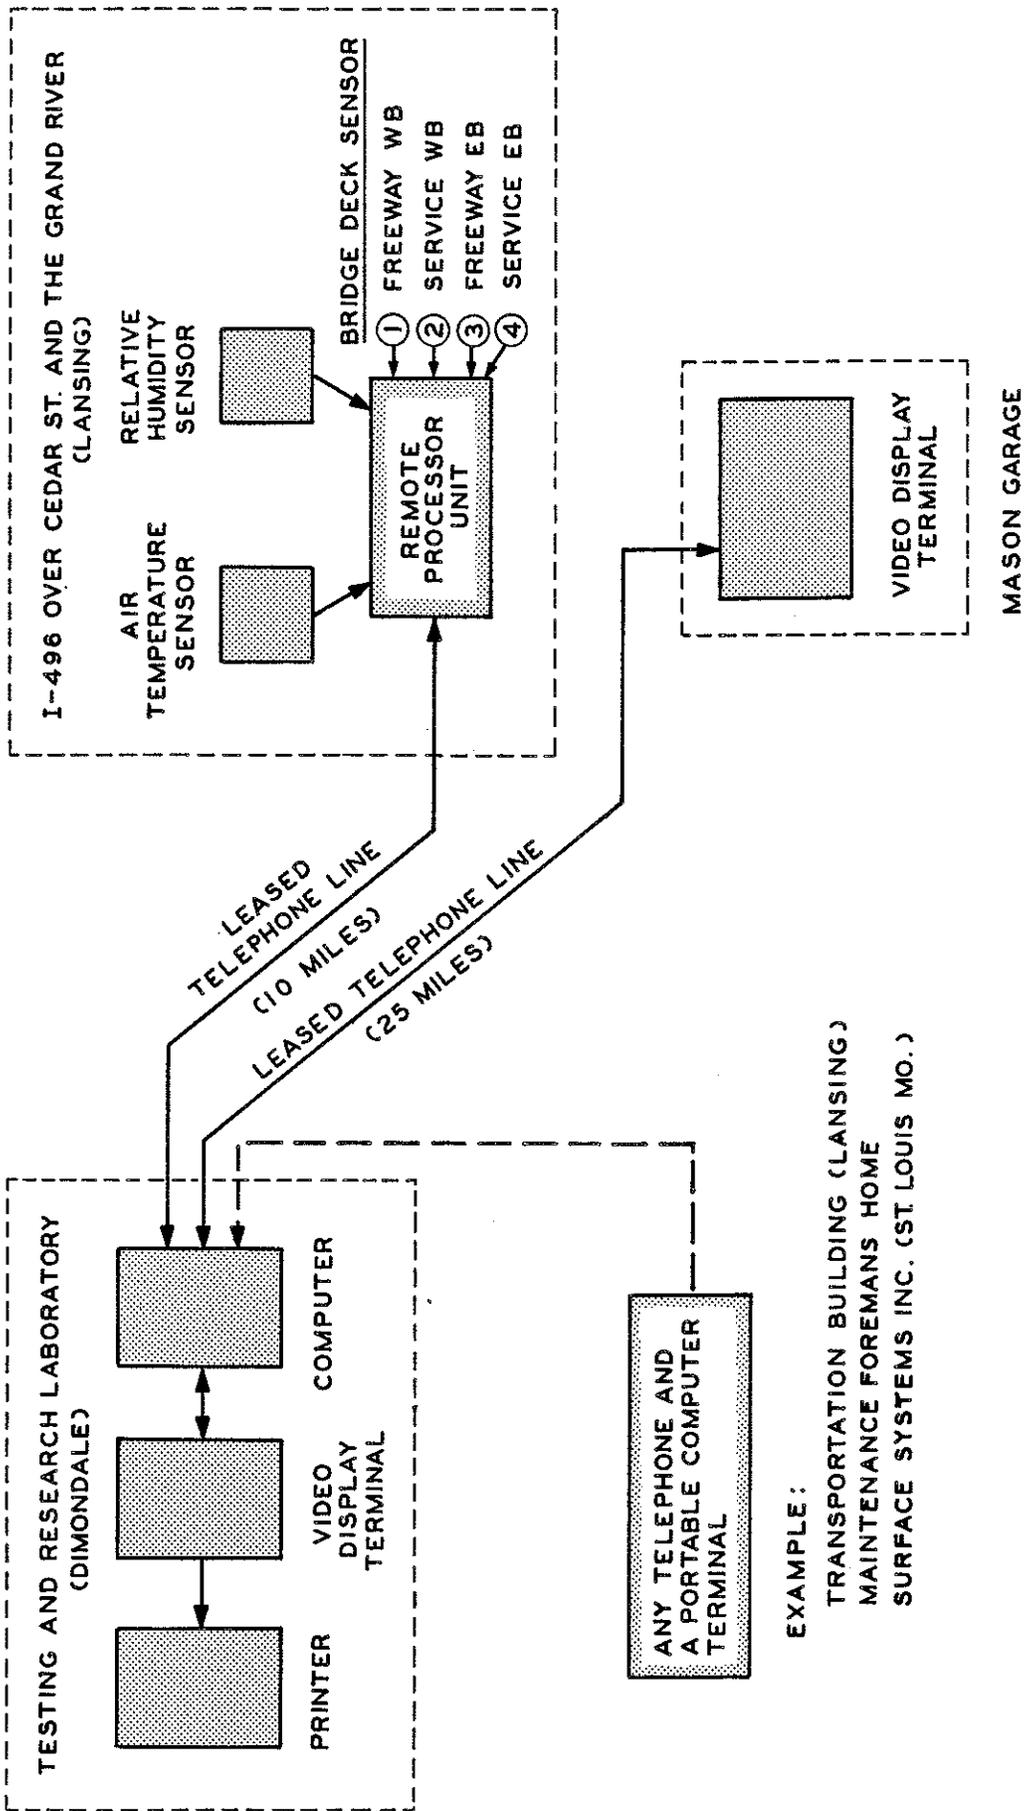
Figure 1. Scan 16 block diagram.

the control device for the system is a microcomputer, many different system configurations are possible. This report will describe the configuration of the system for monitoring surface conditions on four parallel bridges carrying I 496 and its service drives over Cedar St and the Grand River in Lansing. The block diagram of the system is shown in Figure 1. Figure 2 shows details of the bridge site.

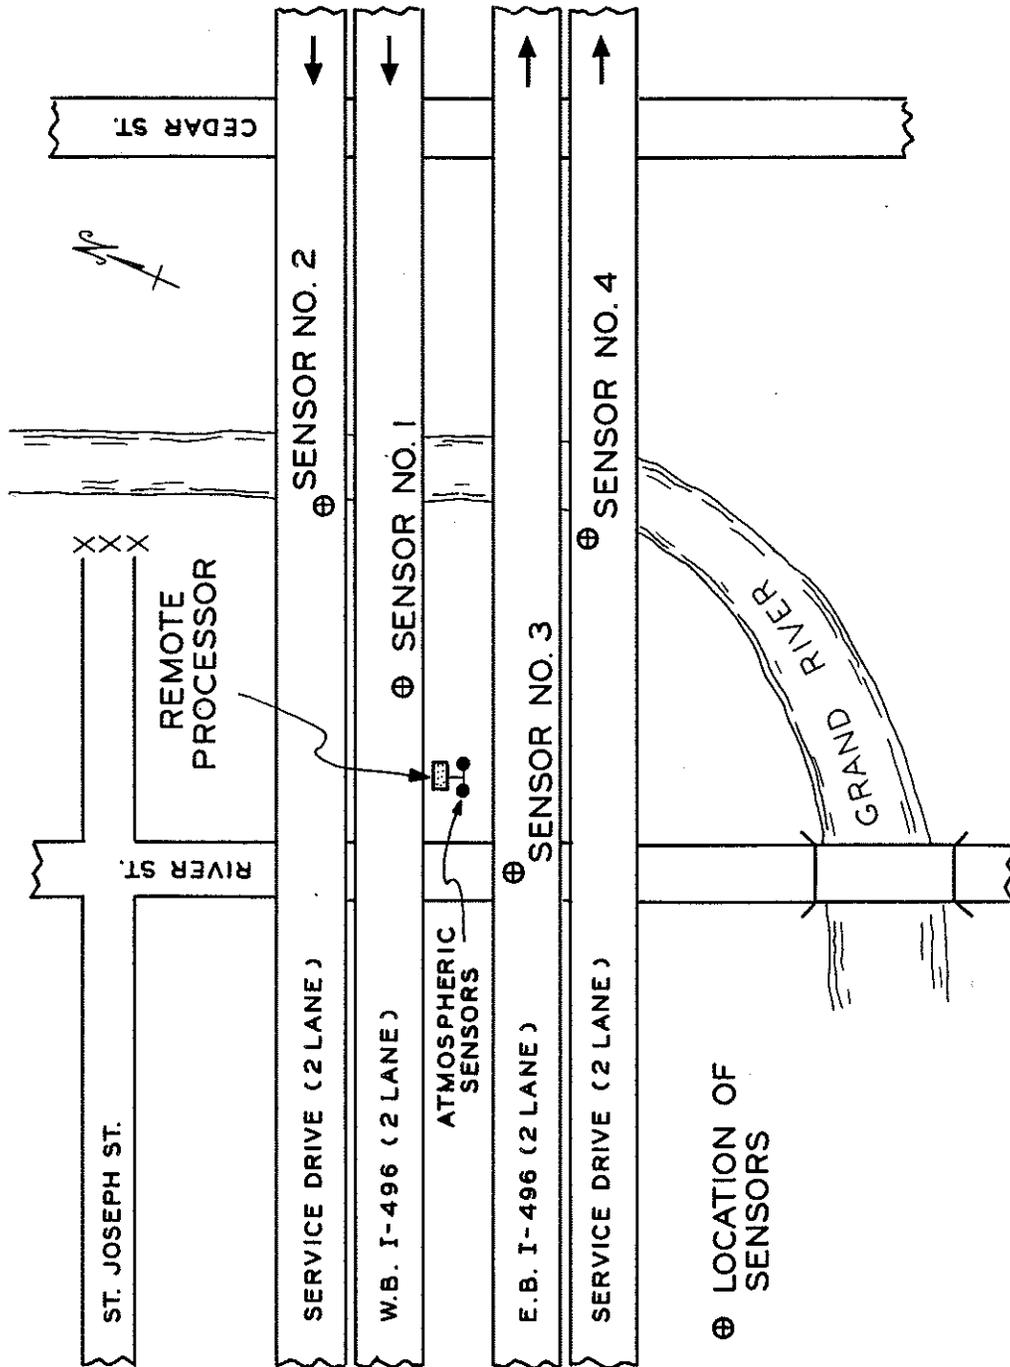
Figure 2. Location of ice detector sensors and remote processor unit.

The system uses four roadway sensors, two atmospheric sensors, and a remote processor unit all located at the bridge site. The roadway sensors determine the temperature of the surface and whether the surface is dry or if moisture is present. These sensors will also indicate how much deicing chemical is present providing there is sufficient moisture on the surface to form a solution and the temperature is below 40 F. The atmospheric sensors measure the relative humidity and the air temperature.
