DEPARTMENT OF STATE HIGHWAYS

February 26, 1976

Subject: Fiberglass Reinforced Pultrusions.
Research Project 75 NM-446. Research Report No. R-990.

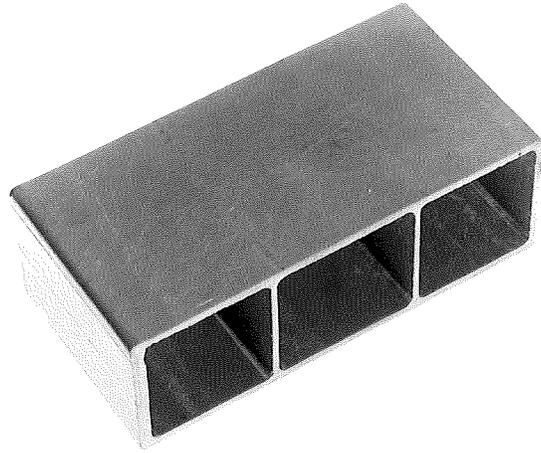
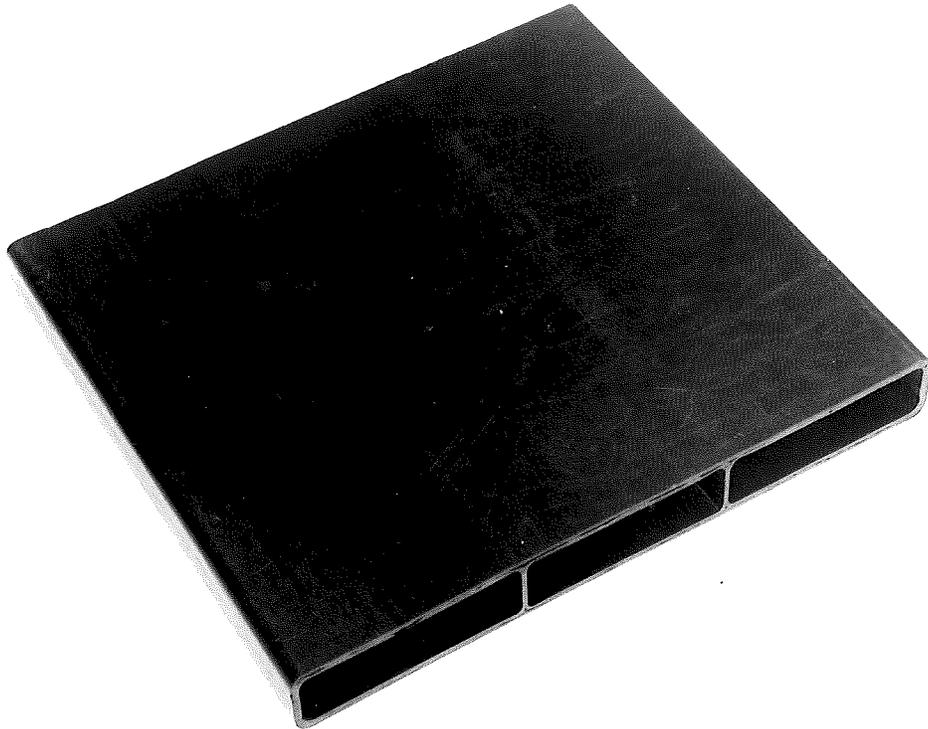
Figure 1. Two configurations of fiberglass pultrusions.

Manufacturer's literature describes fiberglass pultrusions as follows: "Pultrusion is a composite which consists of a thermosetting resin matrix and permanently bonded fiberglass reinforcement. The fibers are first pulled through the resin bath and then through a heated die, where the resin saturated fibers are polymerized. The configuration of the heated die determines the configuration of the end product." The two configurations supplied to the Department as samples are shown in Figure 1.
