APPENDIX TABLE OF CONTENTS

APPENDIX A: LITERATURE REVIEW OF BEST PRACTICES

This document will provide guidance on how and what inventory data to collect for the TAMC Michigan local agency culvert pilot, particularly with regards to condition evaluation of culverts. It will outline the inventory data input into Roadsoft as described in the Condition Evaluation webinar presented on April 26, 2018 and May 2, 2018, and provide information regarding what culvert aspects should be inspected for a given culvert type.

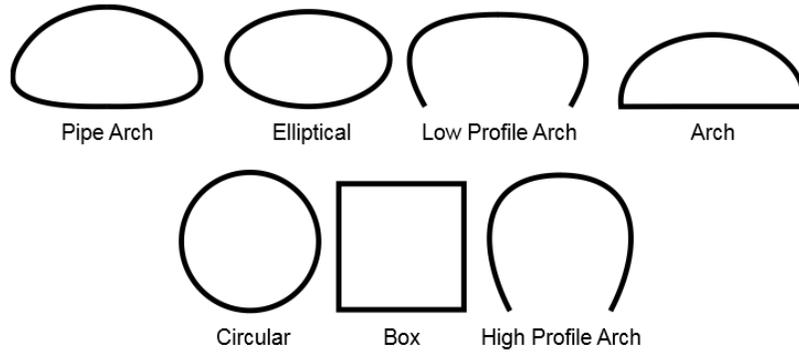
Figure 1. Common Shapes (Note that arch and box shapes may be 3-sided, supported by footings)

Shape – Original shape of the culvert, reference Figure 1 for common shapes.

- Undefined
 - Arch
 - Circular
 - High Profile Arch
 - Horizontal Ellipse
 - Low Profile Arch
 - Other
 - Pear
 - Pipe Arch
 - Rectangular
 - Underpass
 - Vertical Ellipse
- Modified Roadsoft Fields**
- Box
 - Multi-cell box
 - 3-sided
 - Slab/superstructure & abutment

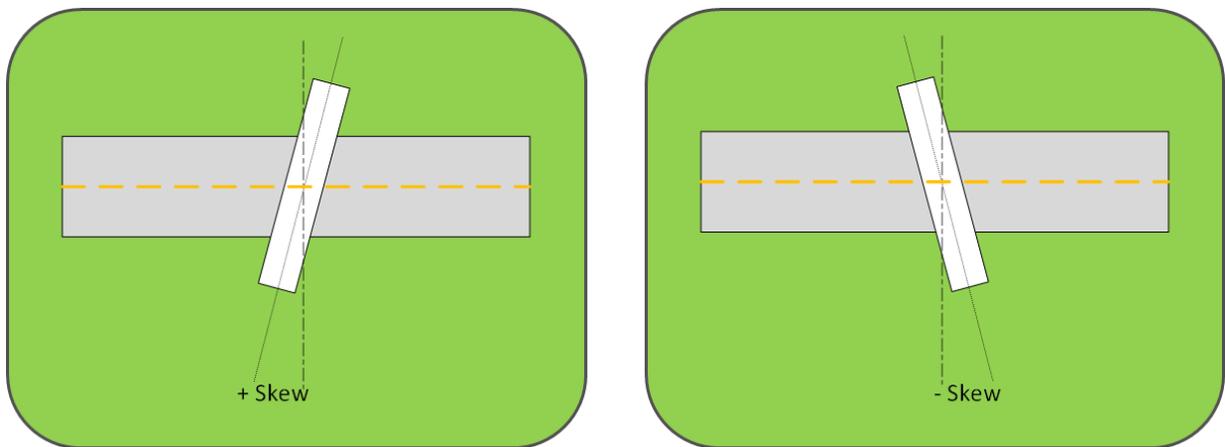
Figure 2. Positive and Negative Skew Angles

Skew Angle – The acute angle formed by the intersection of the line normal to the centerline of the road with the centerline of the road with the centerline of a culvert. Reference Figure 2.

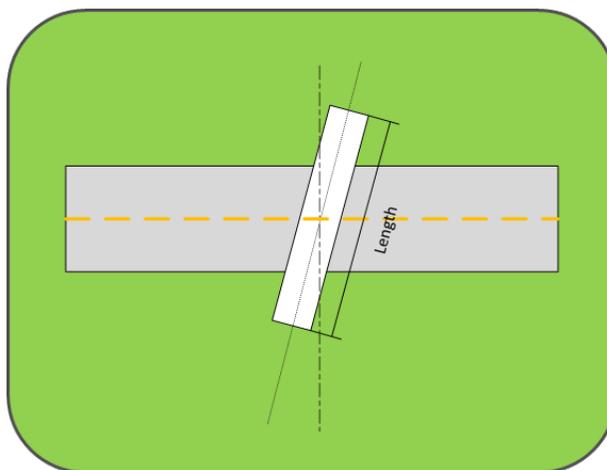
Figure 3. Length of Culvert

Length – Horizontal distance of the culvert from inlet to outlet. Reference Figure 3.

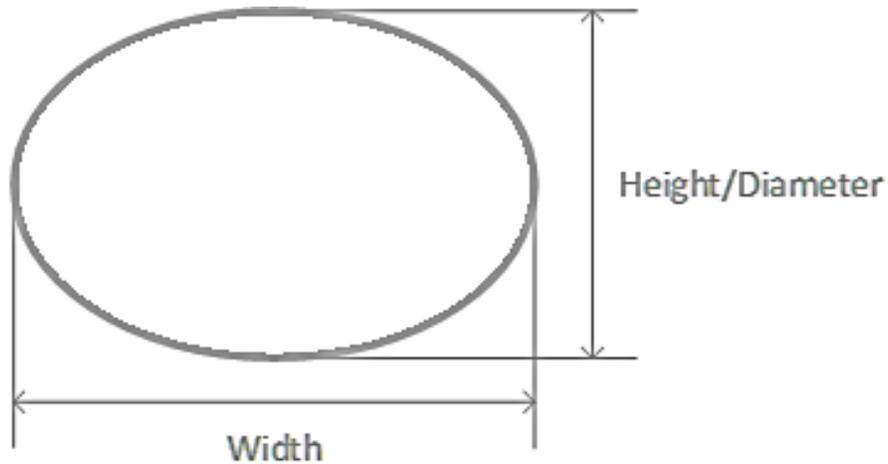
Figure 4. Width & Height/Diameter of Culvert Structures

Width – The original distance of the culvert opening (perpendicular to the length). Reference Figure 4.

Height / Diameter – The original height of the culvert opening. Reference Figure 4.

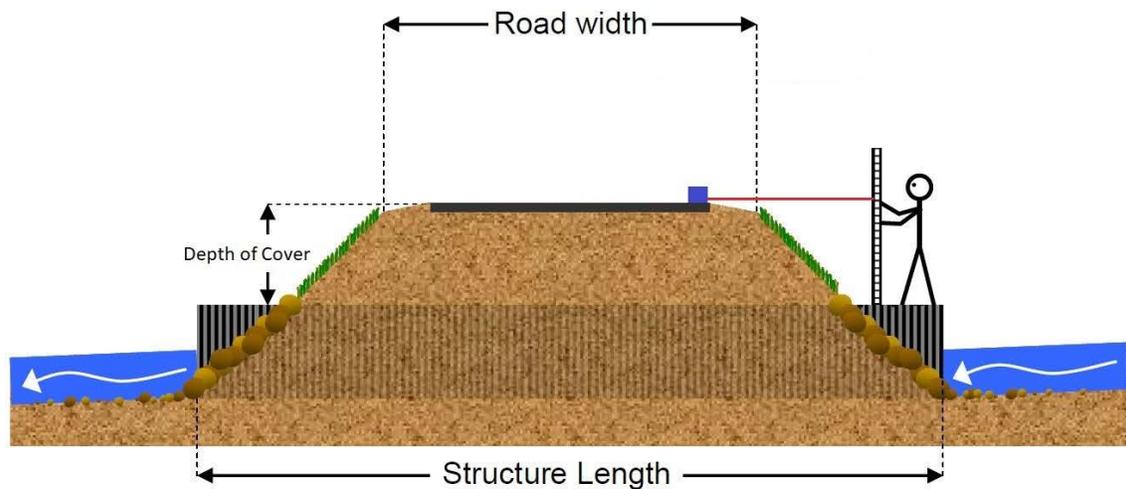
Figure 5. Measuring Depth of Cover

Depth of Cover – The depth of soil from the roadway to the peak of the culvert structure. Reference Figure 5 on how to take measurement.
